ARIZONA DEPARTMENT OF TRANSPORTATION

REPORT NUMBER: FHWA-AZ--8801

PAVING FABRICS FOR REDUCING REFLECTIVE CRACKING

Final Report

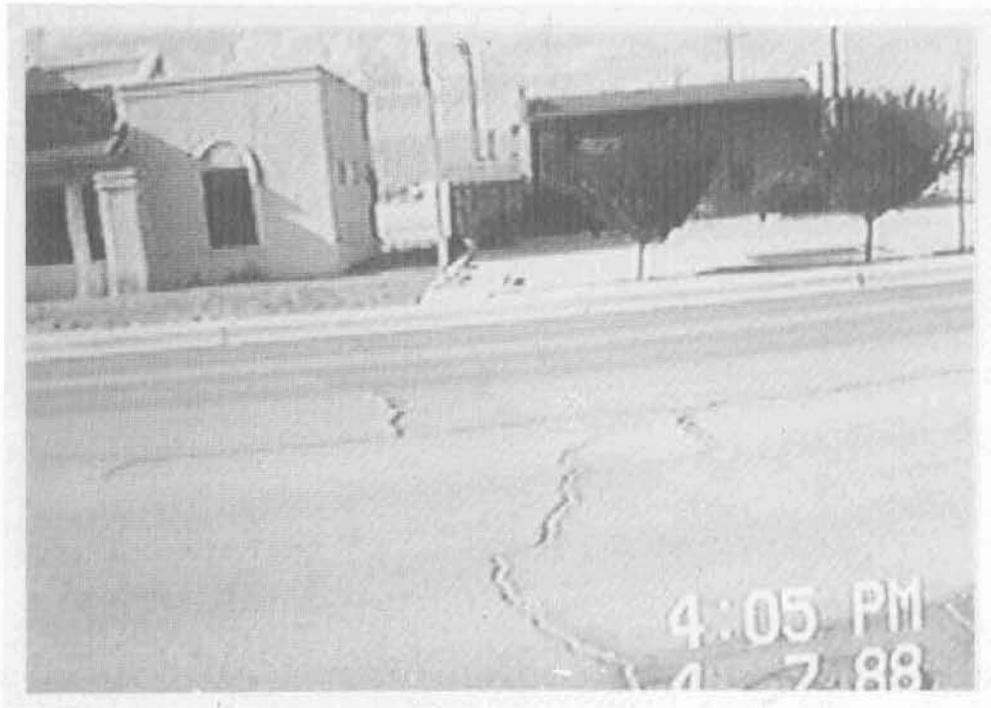
Figure 5 shows a typical transverse crack in the pavement. Most of the transverse cracks had been filled with sealant, but much of the sealant had been tracked onto the pavement. The cracks had been filled with dirt and small incompressibles. The portland cement concrete curbs, gutters, and sidewalks in the vicinity were badly cracked, as shown in Figure 6. It appears as though moisture intrusion into the subgrade may have increased the severity of the cracking.

Figure 5 Typical Transverse Crack in the Pavement.

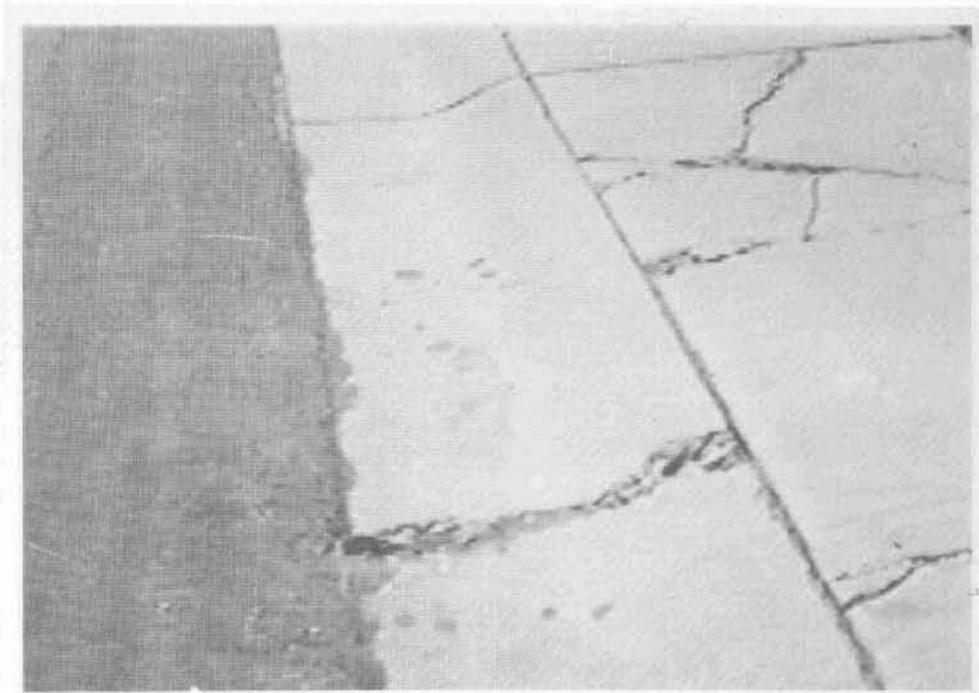
Figure 6 Typical Cracks in the Curb and Sidewalks.

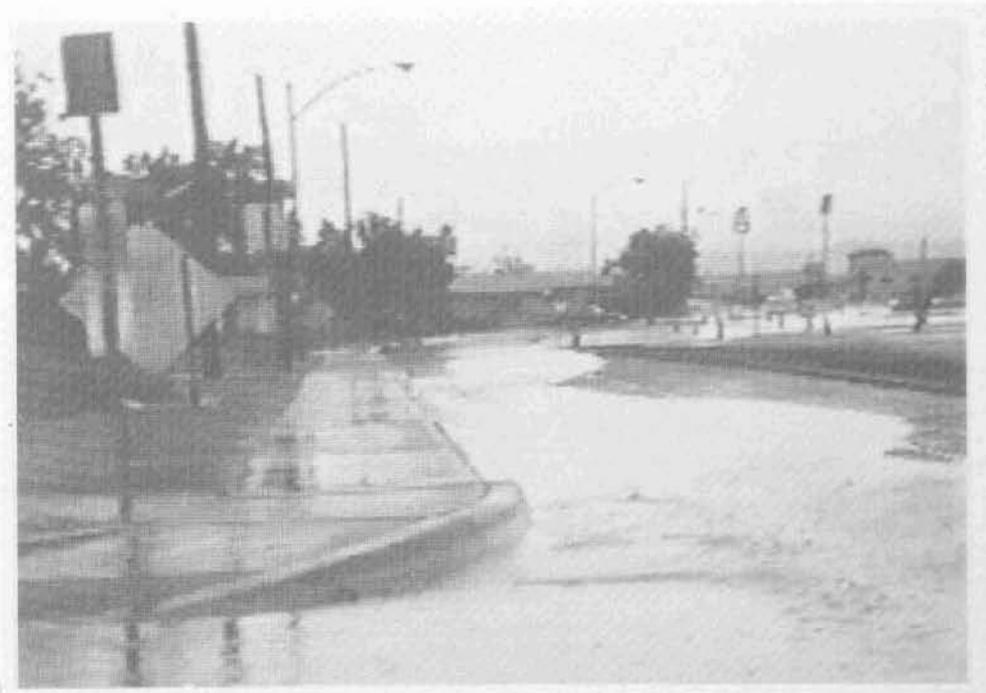
Drainage on the road was a problem, and still is. There is no provision for removing rain water from the street. As such, the water tends to settle along the curbs and gutters, migrating through cracks and joints into the base and subgrade. Figure 7 illustrates the drainage problem. Subgrade samples taken during the initial construction were determined to have a water content of 30.7 percent.

Figure 7 Gutters Filled with Runoff.

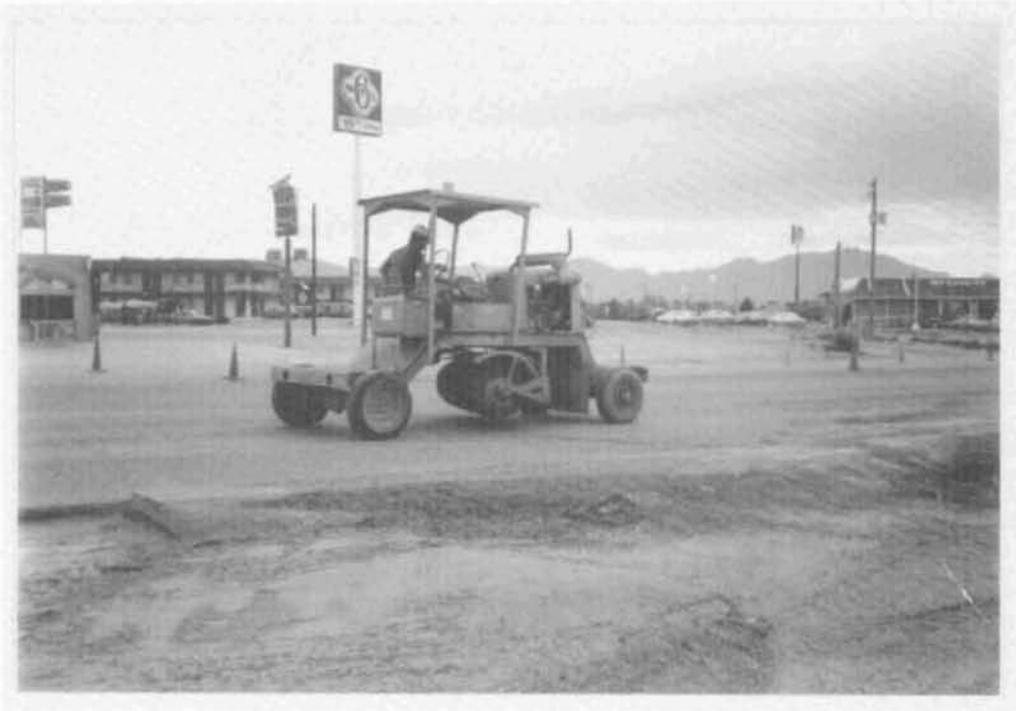
Figure 13 Power Broom Used on Project.

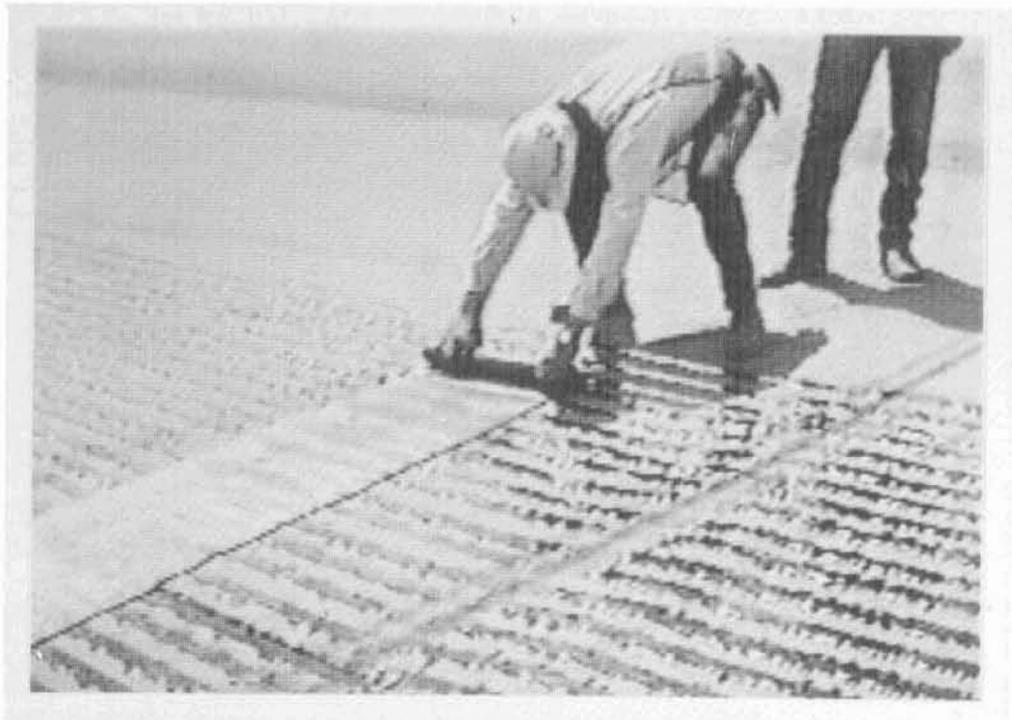
Eight transverse cracks, crossing 468 ft. of pavement, were treated with Paveprep. An additional 202' of random cracking was covered with the fabric. Paving was to be carried out by lane, and likewise so was the fabric treatment. The installation of Paveprep involved tacking the surface with AC-30, cutting and rolling out the fabric, and walking across it. The installation took place about 400 ft. ahead of the paving machine. Figure 15 shows a Paveprep installation.

Figure 15 Paveprep Installation on a Transverse Crack.

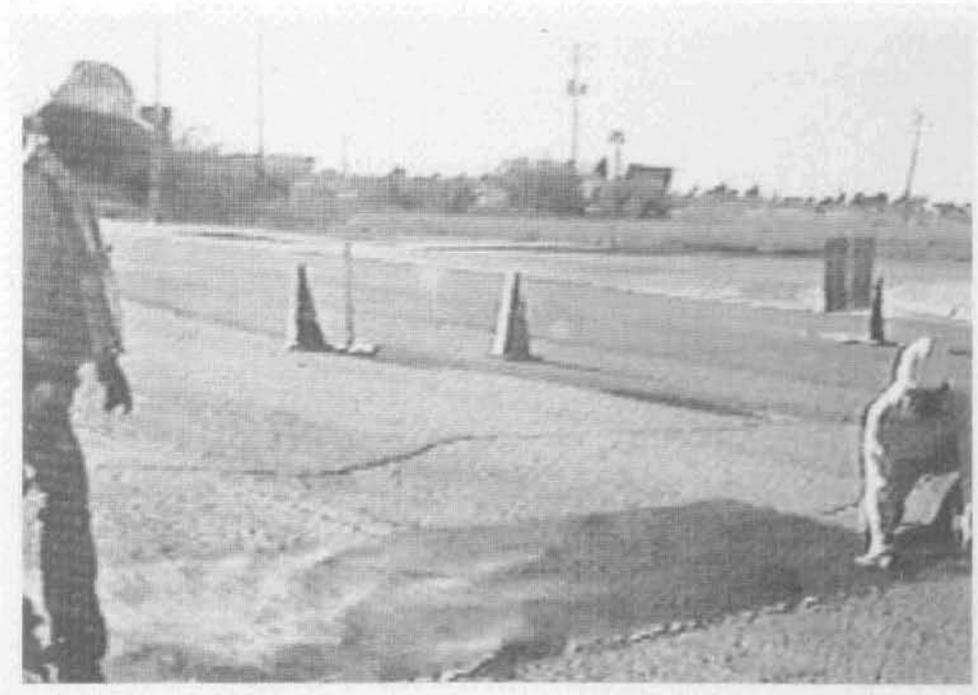
Eight transverse cracks, crossing 470 ft. of roadway, and 146 ft. of random cracking were treated with Glassgrid. Glassgrid is self-adhering, and installation consisted of cutting, laying, and rolling the fabric. A pickup truck with dual tires was used to roll the fabric. Figure 19 is a photograph of Glassgrid placed on a transverse crack.

Figure 19 Glassgrid Installed on a Transverse Crack.

The Glassgrid did not bond well to the existing surface. The boot truck, belly dump, and paving machine all pulled up the paving fabric. The bond was poorer than with the Paveprep, and in some instances the fabric was pulled completely off of the surface. Just a small amount of asphalt cement would cause the fabric to be picked up. Hot asphalt concrete was spread under equipment tires in an attempt to keep the fabric from being picked up, but this did little to help.

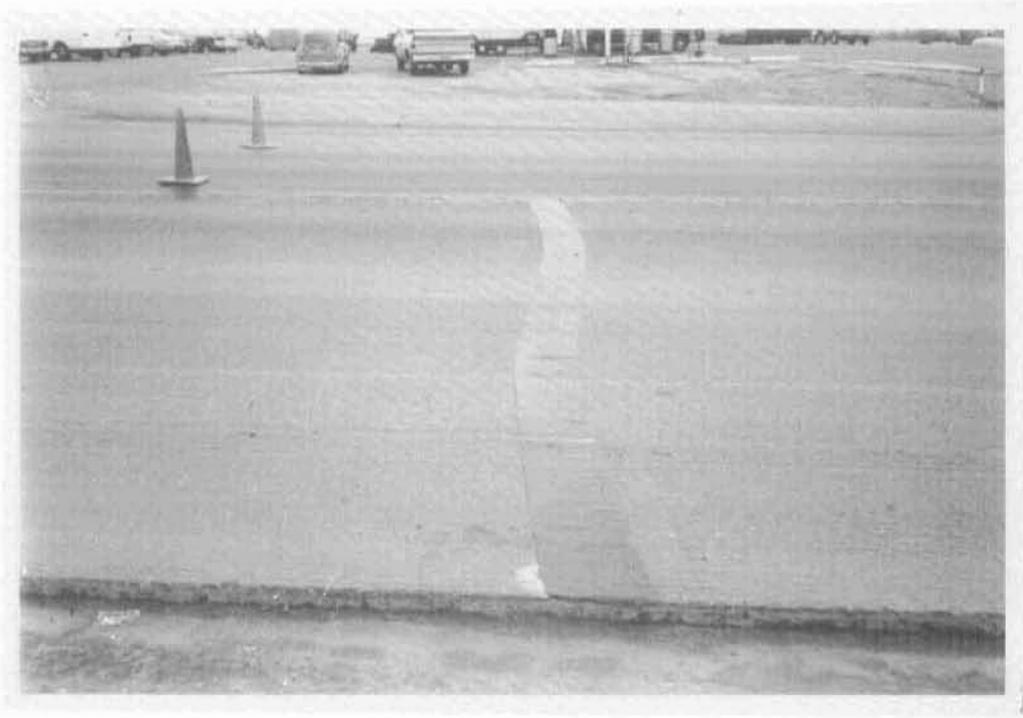
Eight transverse cracks, crossing 472 ft. of roadway, were treated with 12 in. wide Tapecoat. Also, 93 ft. of random cracks were treated with 4 in. wide Tapecoat, and 52 ft. of random cracks were treated with 12 in. wide Tapecoat. Refer to Figure 3 for locations. Like Glassgrid, Tapecoat is self-adhering, and as such the installation required cutting the material, peeling off the backing to expose the adhesive surface, and rolling the placed fabric. A pickup with dual wheels was used to roll the fabric. Figures 21 and 22 show 12 in. and 4 in. Tapecoat installations.

Figure 21 12-in. Tapecoat Placed on a Transverse Crack.

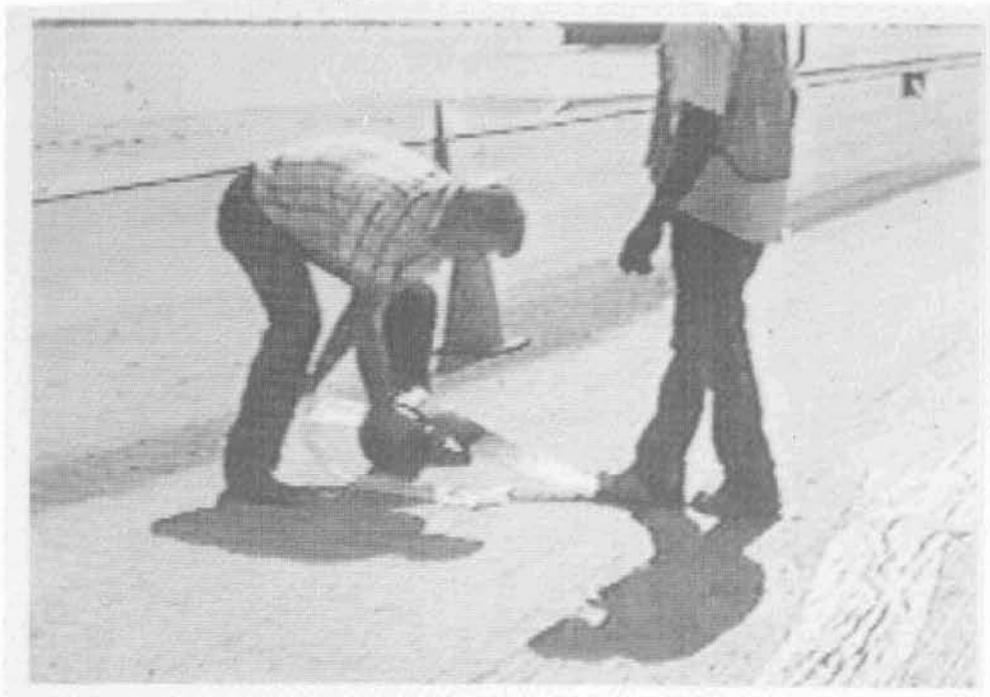
Figure 22 4-in. Tapecoat Placed on Random Cracking.

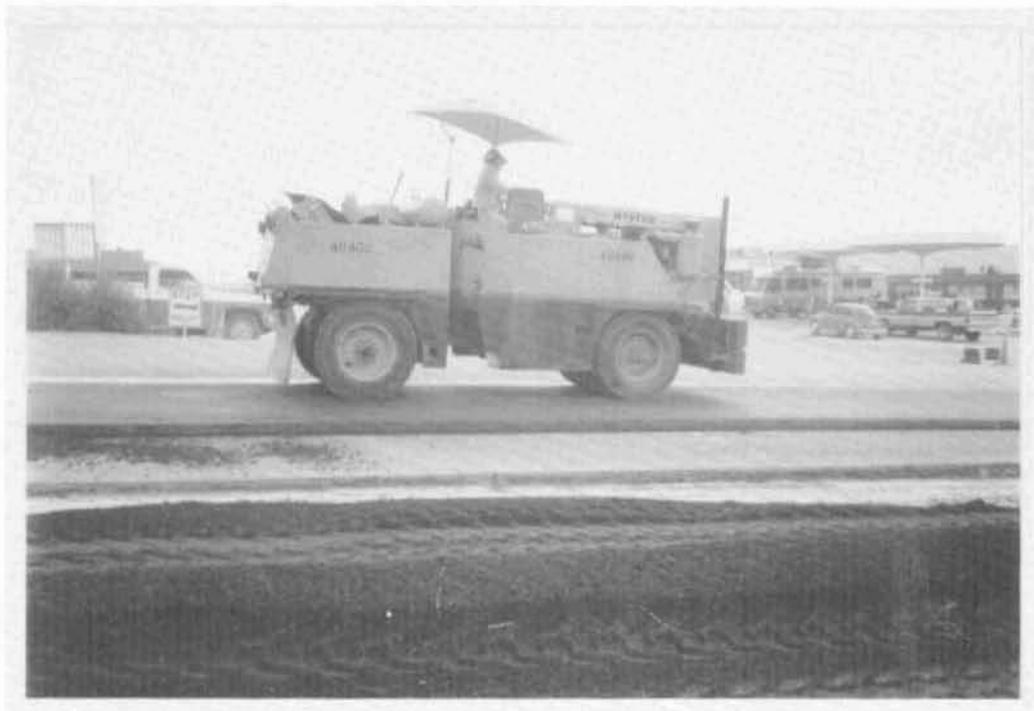
Compaction of the overlay was achieved by the use of three rollers. First a vibratory steel roller made three passes. Next a pneumatic roller made two passes. And finally, a second steel roller performed the finish rolling. Figure 26 shows the vibratory steel roller, and Figure 27 illustrates the pneumatic roller used on this project.

Figure 27 Pneumatic Roller.

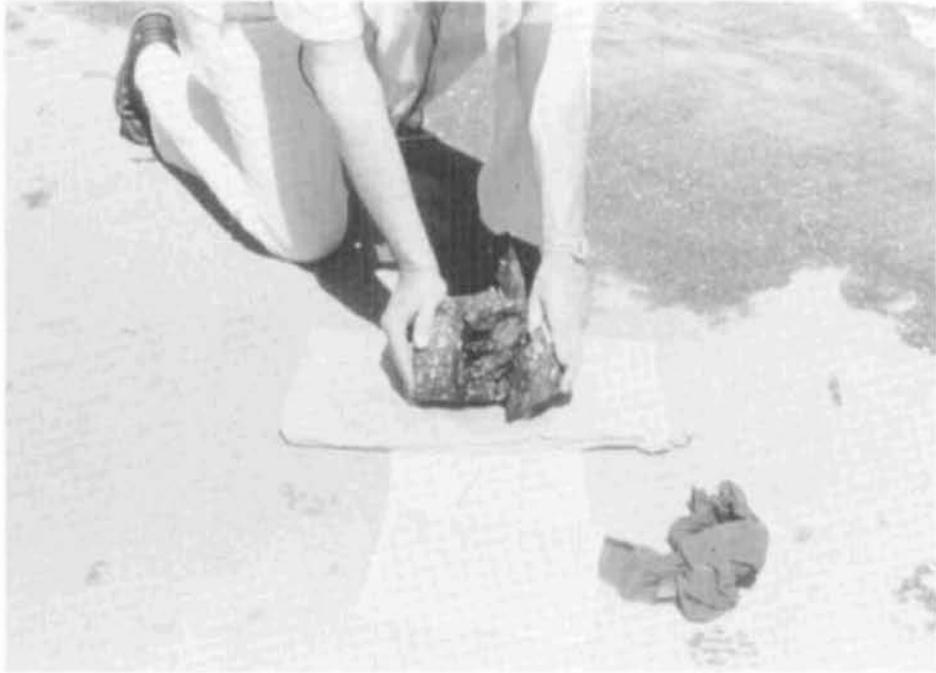
As it turned out, each of the core sample cracks was observed to have began in the original pavement and propagated through the paving fabric. As such, only two samples of each treatment were necessary. Figures 30, 31, and 32 demonstrate core samples with Paveprep, Glassgrid, and Tapecoat in place. The results of the core sampling confirmed the validity of the results of the field surface crack evaluations.

Figure 30 Core Sample of Pavement Preparation Treated Crack.

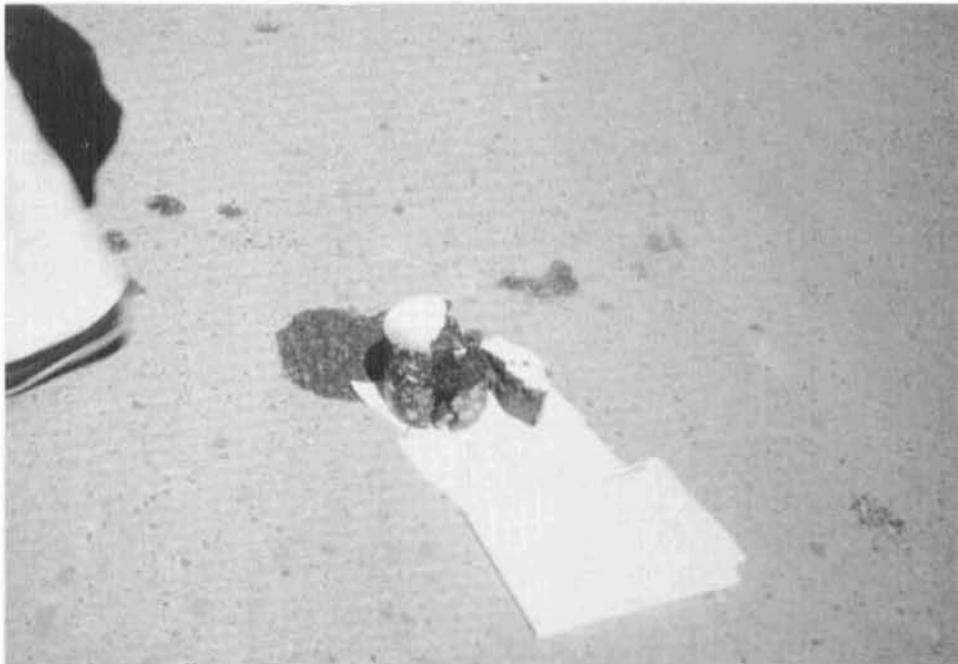
Figure 31 Core Sample of Glassgrid Treated Crack.
