# Development of an NCHRP Report 350 TL-3 New Jersey Shape 50-inch Portable Concrete Barrier

Final Report

for the  
Ohio Department of Transportation  
Office of Research and Development

State Job Number *134162*

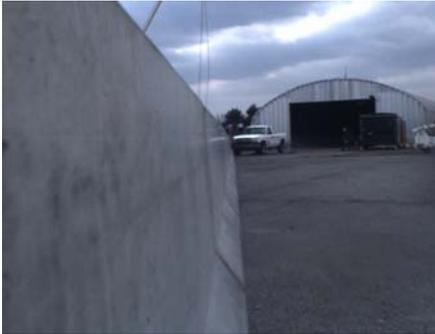
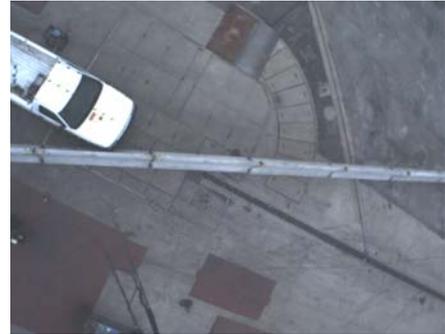
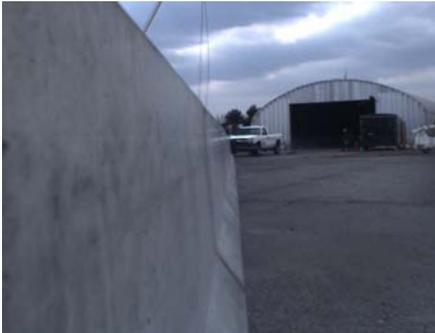
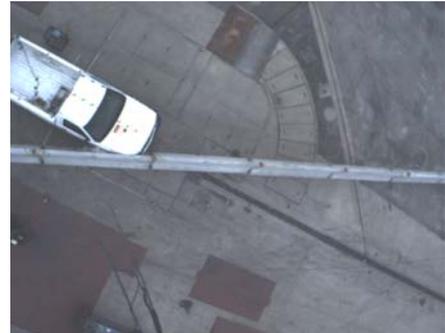
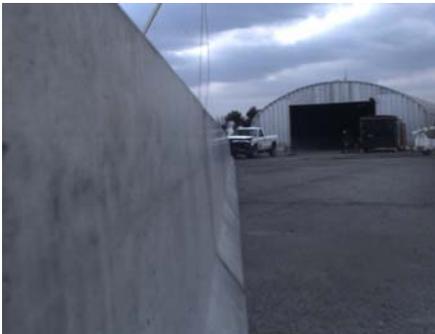
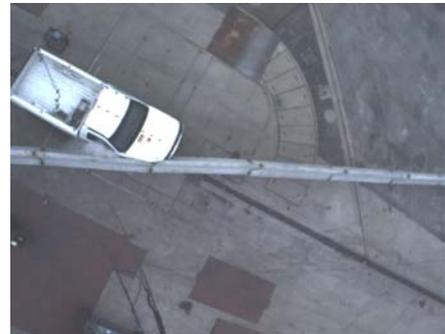
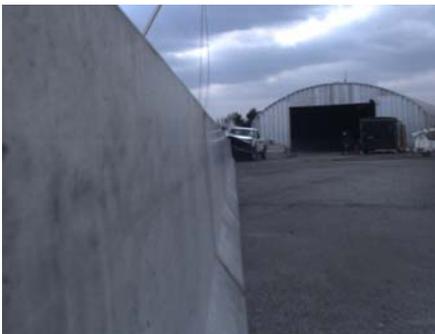
**Figure 41:** Sequential photographs for test 060412 (overhead and front views).

Sequential views of the impact event from a downstream viewpoint and an overhead viewpoint are shown in Figure 41. At approximately 32 milliseconds after initial impact (time = 0.0) the barrier began to displace laterally, away from the vehicle. At approximately 72 milliseconds, as the vehicle encountered barrier segment eight, it began to yaw counter-clockwise away from the barrier. The vehicle continued along barrier segment eight, displacing it laterally and continuing to be redirected. The vehicle's right side was in contact with the barrier at approximately 304 milliseconds and continued to be redirected as it displaced barrier segments eight, nine, and ten. The vehicle lost contact with the barrier at approximately 578 milliseconds. The vehicle came to rest upright after the impact approximately 165 ft (50.3 m) downstream from the original impact point and 6.89 ft (2.1 m) left of the barrier face.

The overall kinematics and trajectory of the vehicle were very stable. The maximum roll angle of the vehicle was 16.2 degrees and the maximum pitch angle was -10.2 degrees.

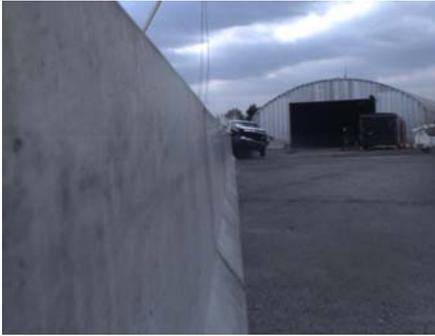
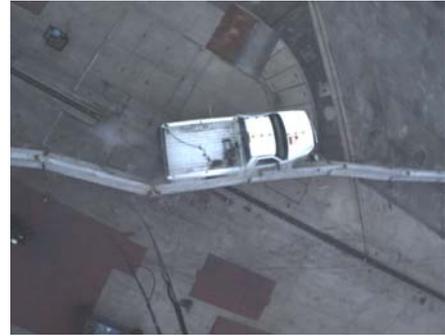
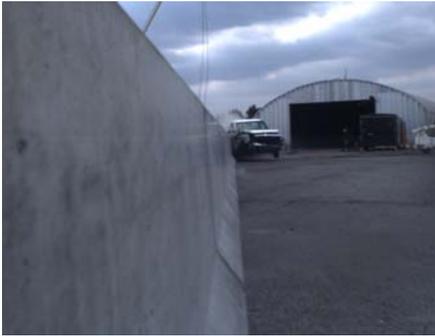
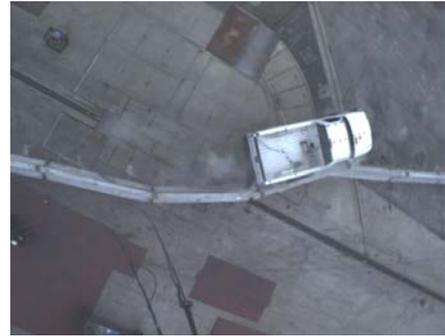
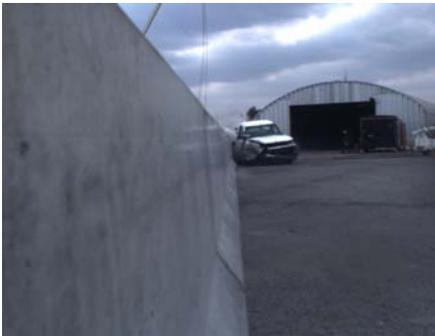
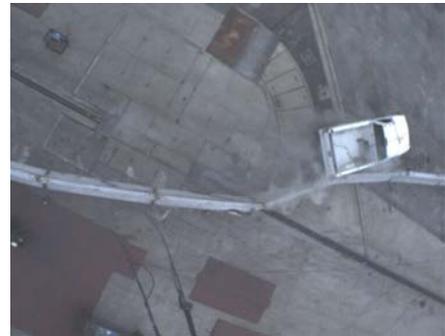
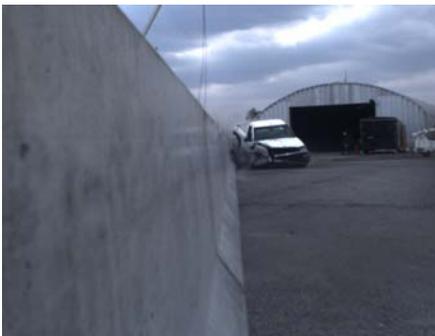
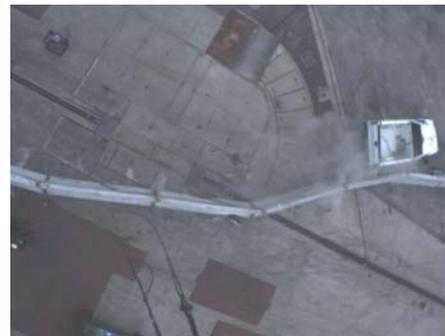
**Figure 41:** Sequential photographs for test 060412 (overhead and front views) (continued).

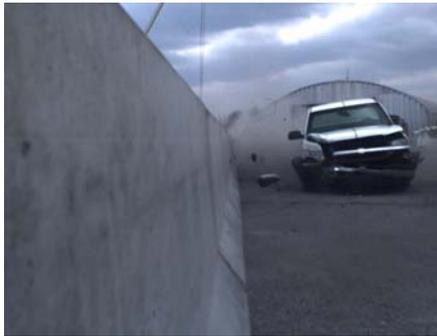
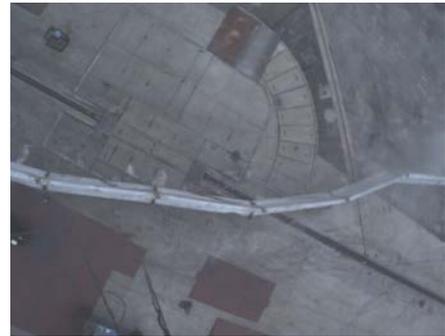
**Figure 41:** Sequential photographs for test 060412 (overhead and front views) (continued).

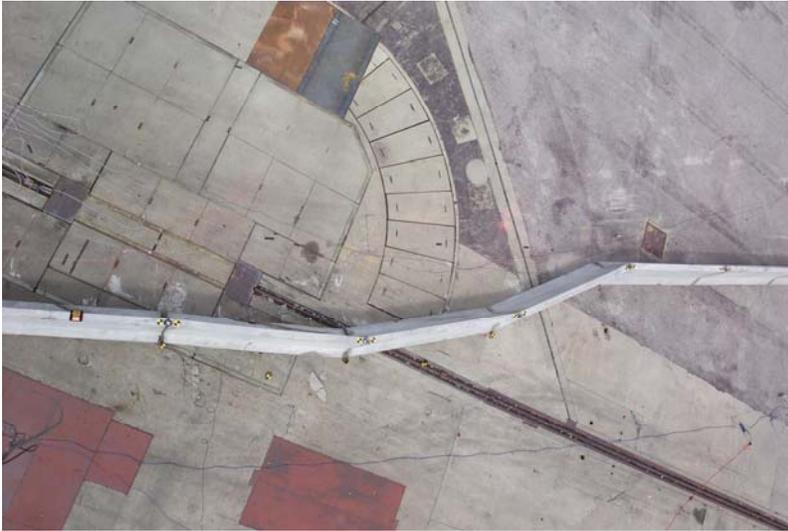
**Figure 42:** ODOT 50-inch PCB System after test 060412.

Five (5) of the seventeen sections of 50" PCB system were damaged and/or rearranged in the immediate impact zone. Individual barrier sections, numbers 7, 8, and 9 incurred noticeable damage, with portions of the concrete broken away. The connections of the PCB units sustained minimal damage as there was no noticeable deformation of the pin-and-loop connections, as shown in Figures 42 and 43. The maximum lateral deflection of the barrier was 5.15 ft (1.57 m) and the longitudinal movement of the up-stream end PCB unit was 0.83 ft (0.254 m). The schematic drawing in Figure 44 illustrates the maximum lateral displacements of the PCB segments.

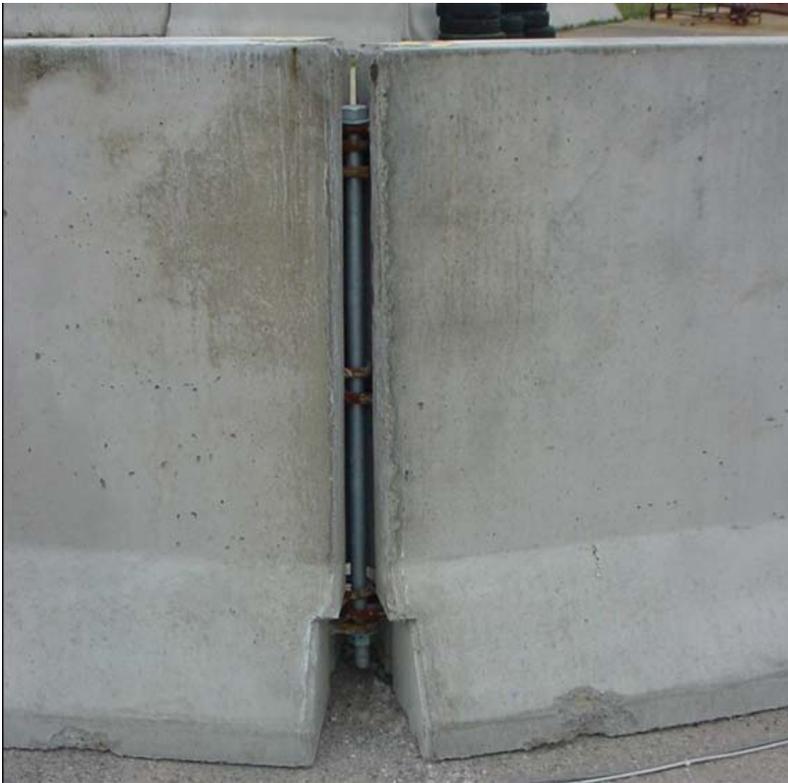
**Figure 43:** Joint connection of the PCB after test 060412 (integrity of the joints were maintained throughout the impact event).

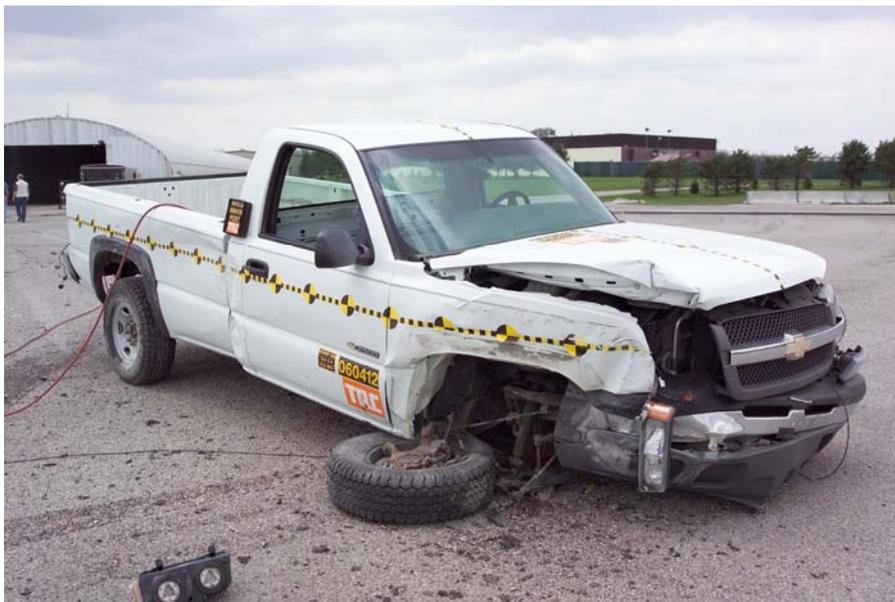
**Figure 45:** Impacting vehicle after test 060412.

Damage to the vehicle was confined to the front and right front sides as shown in Figure 45. The bumper, hood, right fender, and right front suspension were severely damaged. The left side of the vehicle was only moderately damaged. Maximum exterior crush was not measured.

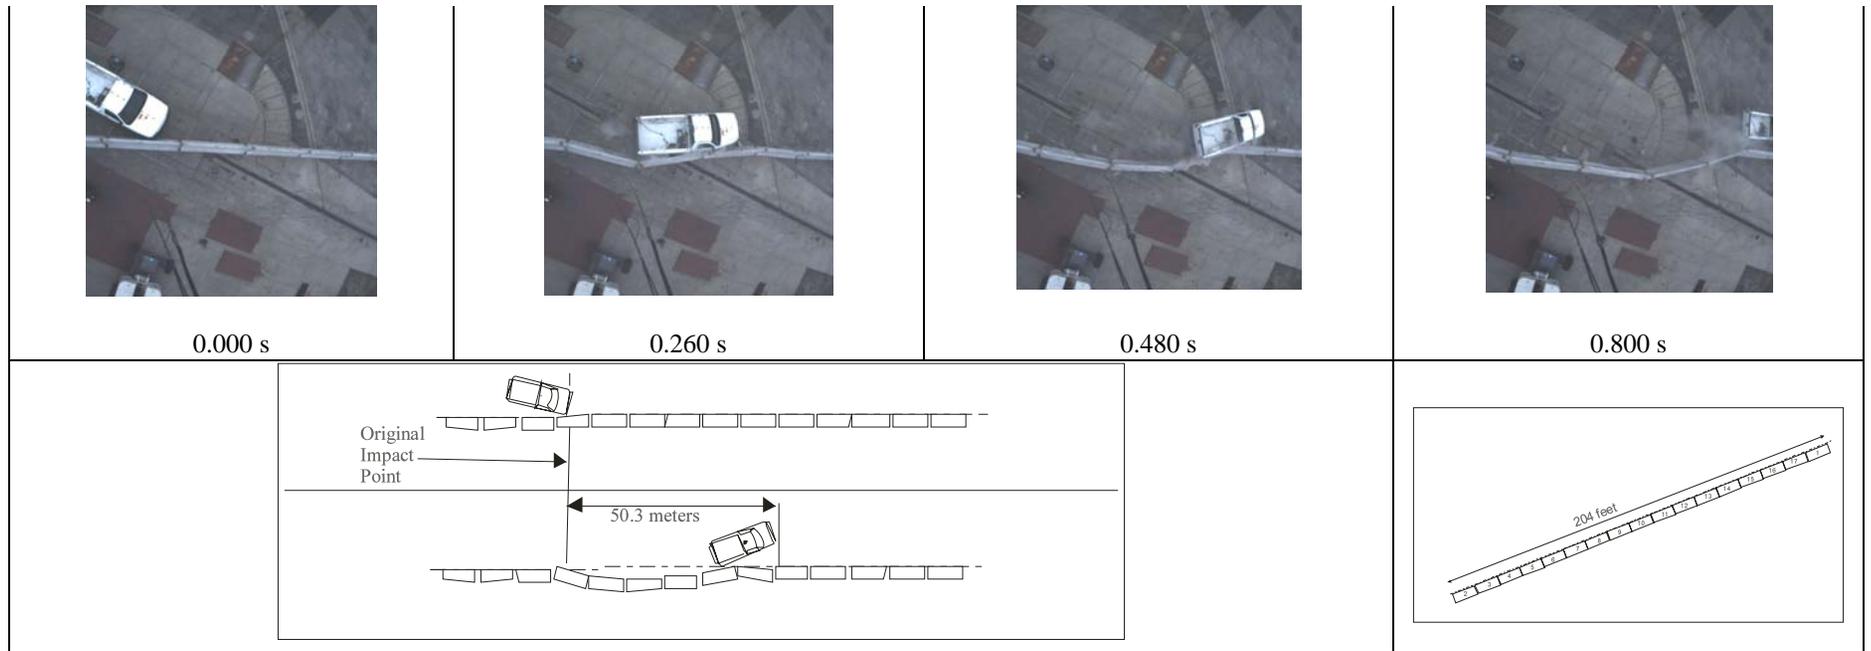
**Figure 48:** Summary report of occupant risk values from the analysis using the TRAP software in test 060412.

Test Agency	Transportation Research Center Inc. (TRC Inc.)	Impact Conditions		Test Article Deflections (m)	
Test No.	060412	Speed (km/h)	100.5	Dynamic	~1.6
Date	April 12, 2006	Angle (deg)	25.0	Permanent	~1.6
Test Article		Exit Conditions		Vehicle Damage	
Type	Longitudinal median barrier	Speed (km/h)	N/A	Exterior	
system		Angle (deg)	N/A	VDS	N/A
Name or Manufacturer	Battelle Memorial Institute	Occupant Risk Values		CDC	02FZEW3
Size and/or dimension and material of key elements	17-50" x 12' steel reinforced portable concrete barriers	Impact Velocity (m/s)		Interior	
Soil Type and Condition	N/A	x-direction	4.5	OCDI	FS0000000
Test Vehicle		y-direction	6.1	Maximum Exterior Vehicle Crush (mm)	N/A
Type	Production Model	THIV (optional)	N/A	Max. Occ. Compart. Deformation (mm)	25
Designation	2000P	Ridedown Acceleration (g's)		Post-Impact Vehicular Behavior	
Model	2003 Chevrolet 2500 Pickup truck	x-direction	5.4	Maximum Roll Angle (deg)	16.2

The acceleration time-histories of the vehicle during the event are shown in Figure 46 and the angular displacement-time histories are shown in Figure 47. Data from the accelerometer located at the center of gravity of the vehicle were collected and input into TRAP Version 2.0 to determine occupant risk factors. The data as provided directly from TRAP is presented in Figure 48.

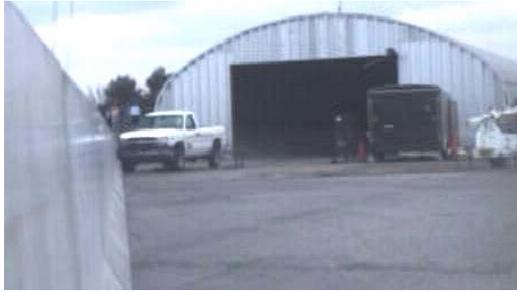
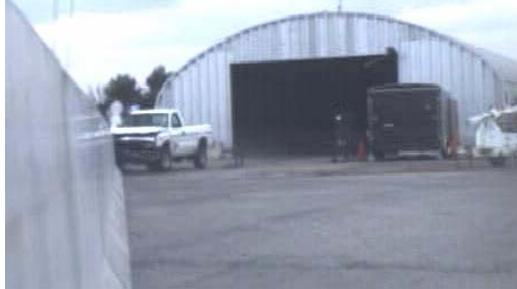
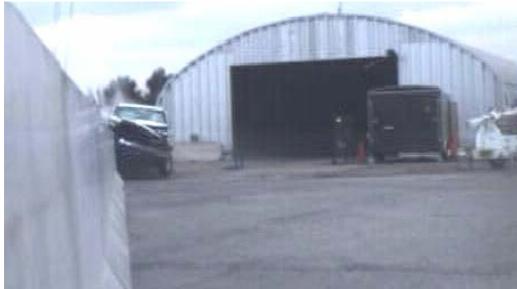
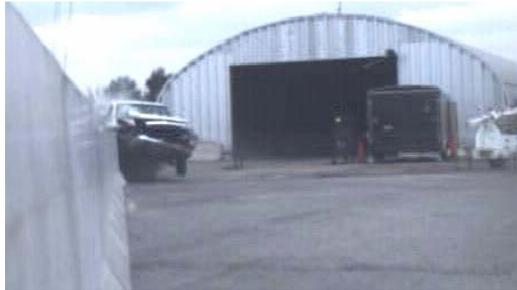
**Figure 51:** Sequential views from TRC test 060412 and the finite element analyses (case 4 and case 5) from a downstream viewpoint.

Although some differences between the F.E.A. results and test results were expected due to the differences in the F.E. vehicle model and the test vehicle (the finite element model was based on a 1996 Chevrolet C2500 vehicle and the crash test was performed with a 2003 Chevrolet C2500 vehicle), the F.E. analyses predicted the basic phenomenological behavior and crash performance of the system with reasonable accuracy. Figure 51 shows sequential views from TRC test 060412 and the finite element analyses (case 4 and case 5) from a downstream viewpoint. Figures 52 and 53 show sequential views from the test and the finite element analysis from overhead viewpoints (tight angle and wide angle views, respectively). From Figures 51 through 53, a qualitative comparison of the F.E. analyses to the full-scale test shows that the F.E. analyses accurately replicates the overall kinematic behavior of the vehicle as well as the overall deformations of the PCB system.

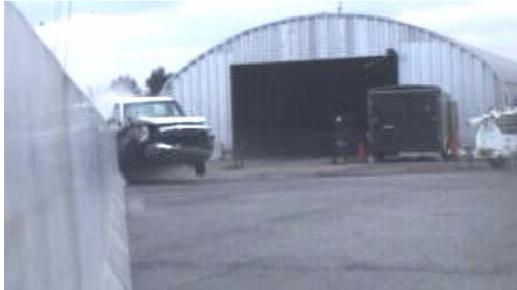
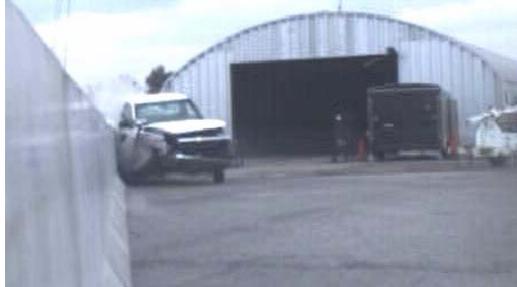
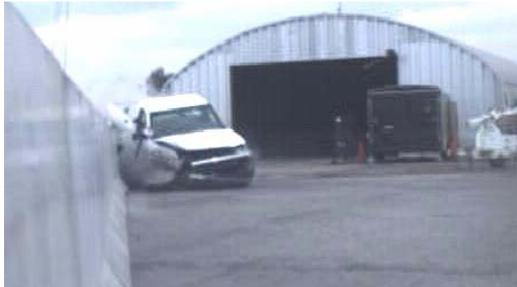
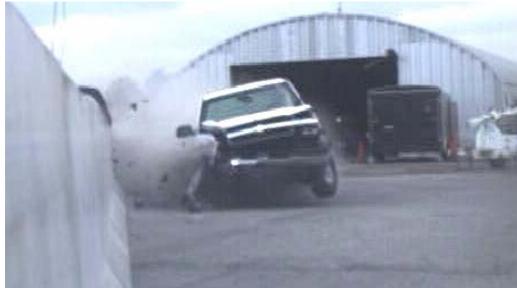
**Figure 51:** Sequential views from TRC test 060412 and the finite element analyses (case 4 and case 5) from a downstream viewpoint. (continued)

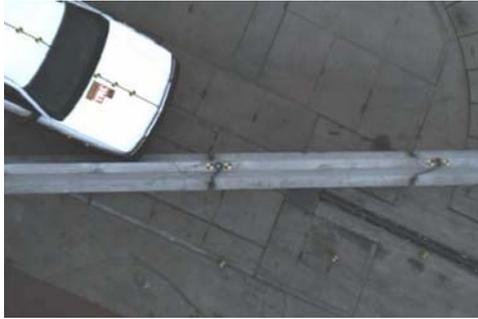
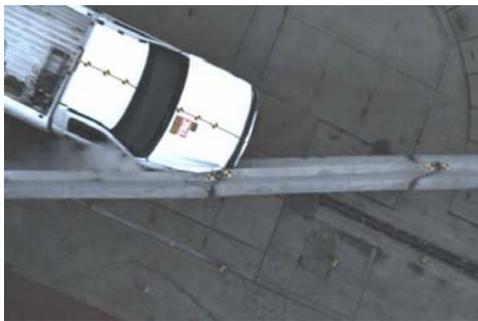
**Figure 52:** Sequential views of TRC test 060412 and the finite element analysis (case 4) from an overhead viewpoint.

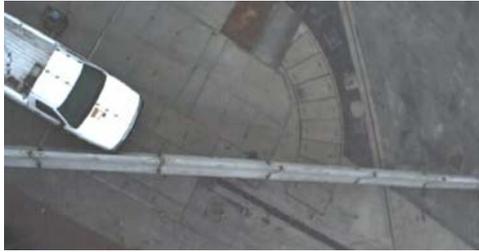
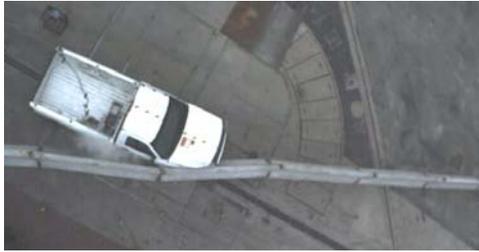
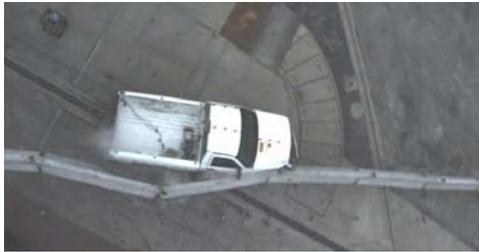
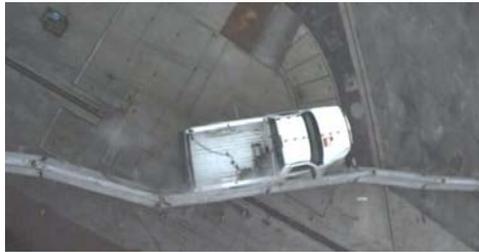
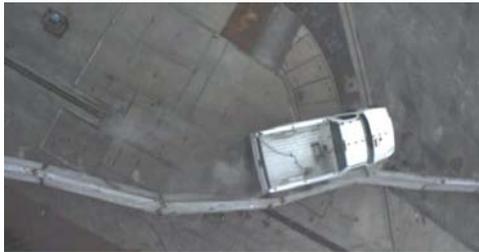
**Figure 53:** Sequential views of TRC test 060412 and the finite element analysis (case 4) from an overhead viewpoint.

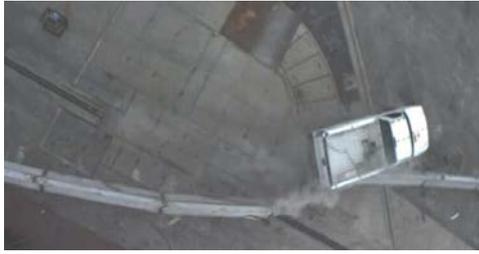
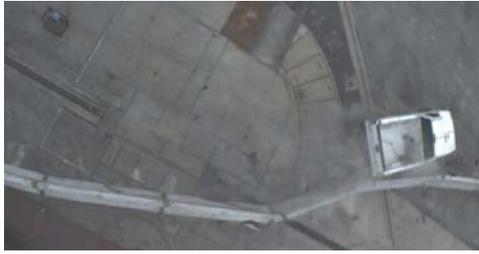
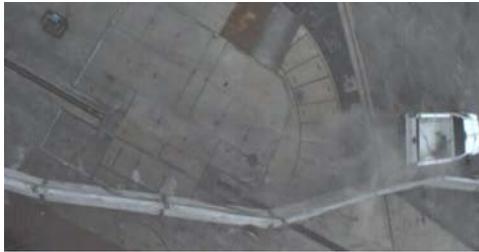
**Figure 53:** Sequential views of TRC test 060412 and the finite element analysis (case 4) from an overhead viewpoint. (continued)
