COMPARISON OF PROPERTIES OF FRESH AND HARDENED CONCRETE
IN BRIDGE DECKS

Howard H. Newlon, Jr.
Assistant State Highway Research Engineer

Virginia Highway Research Council
(A Cooperative Organization Sponsored Jointly by the Virginia
Department of Highways and the University of Virginia)

June 1971
VHRC 70-R56

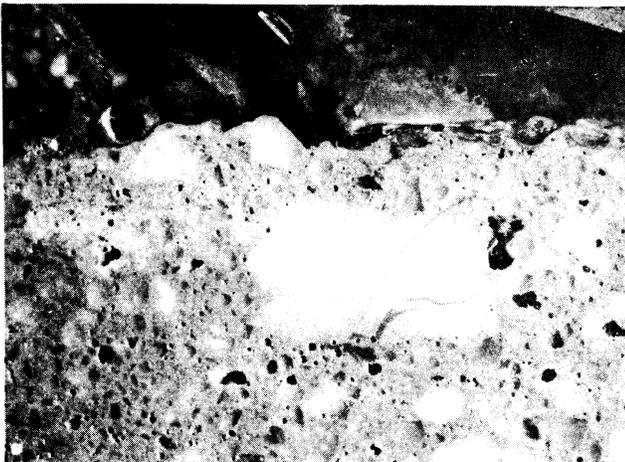
(d) Close-up of surface.

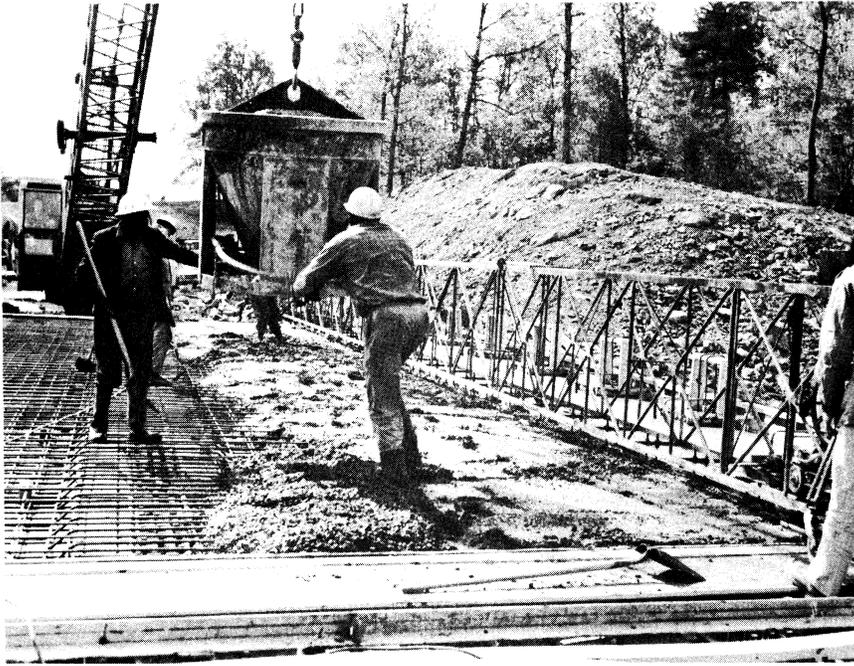
Figure 25. Concreting in progress on bridge #4 using longitudinal screed. The deflection conditions shown earlier in Figure 23 are readily visualized.

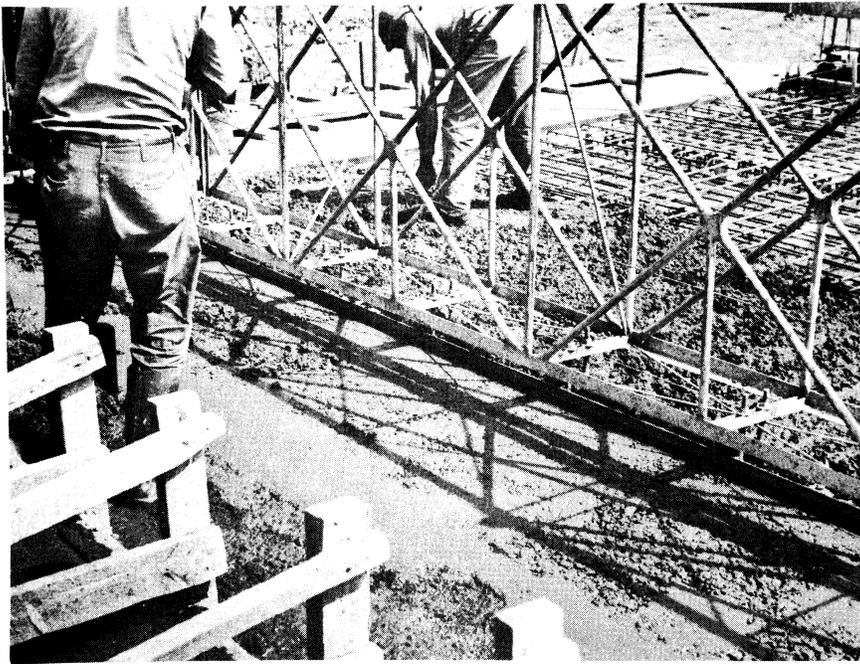
Figure 26. Evidence of stiff concrete on bridge #4.

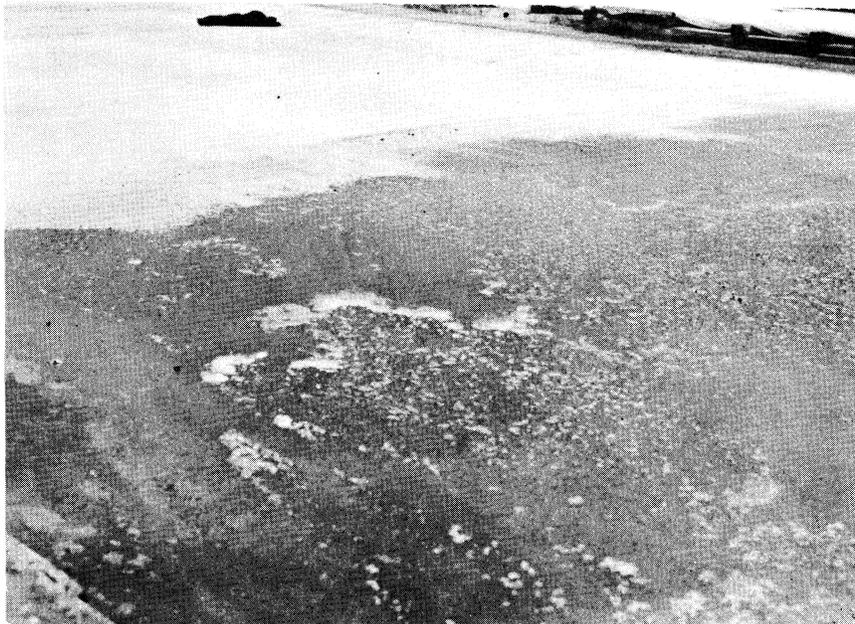
Figure 27. View of study span of bridge #5 following the rainstorm — 1963.

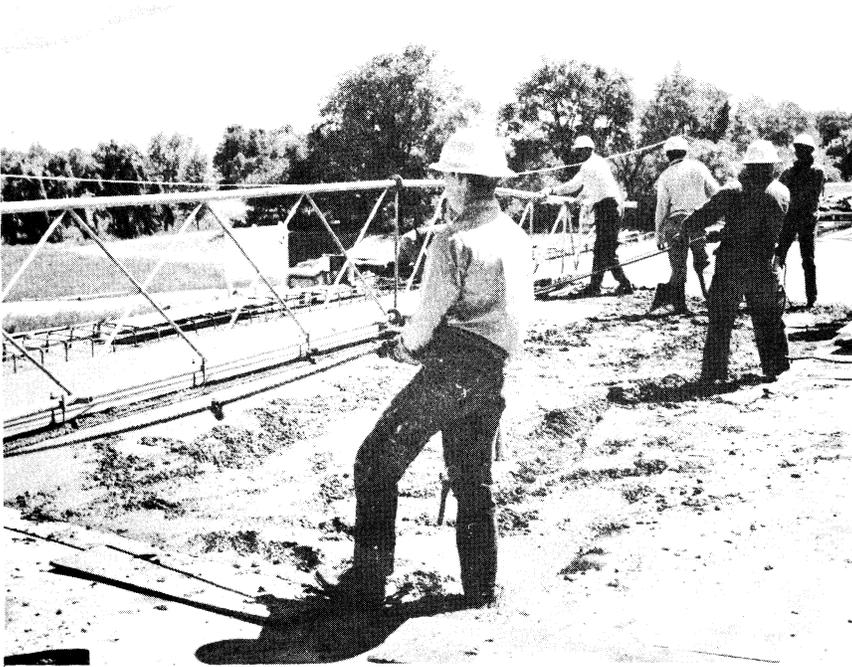
Figure A-1. Longitudinal manually operated single truss type screed.

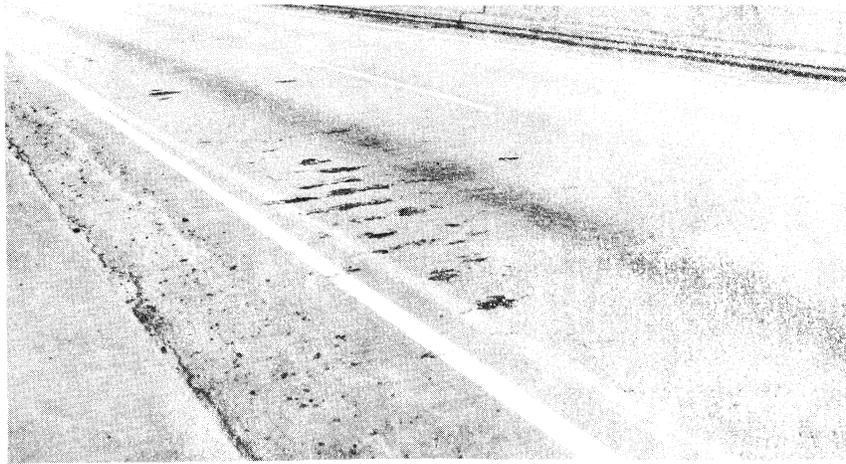
Figure C-5(a). Surface spalling.

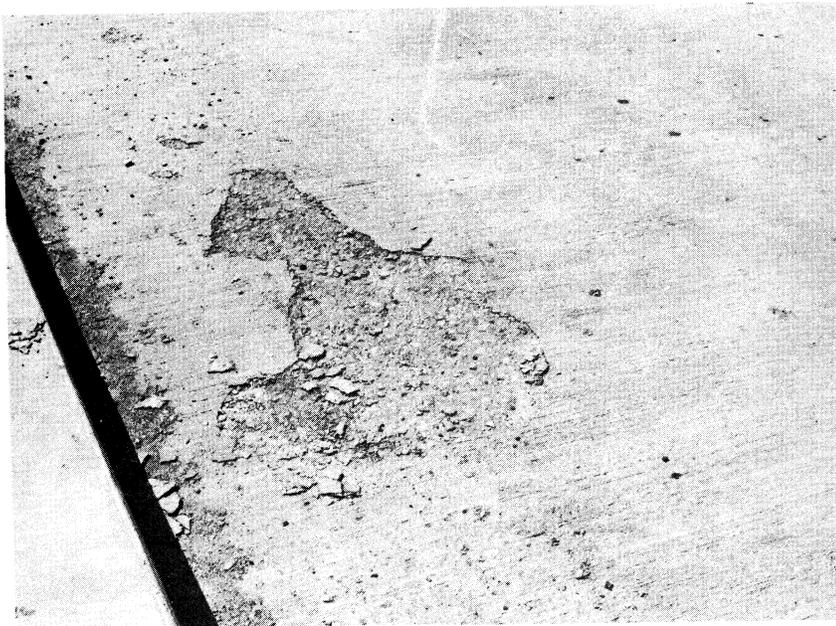
Figure C-7. Surface scaling.

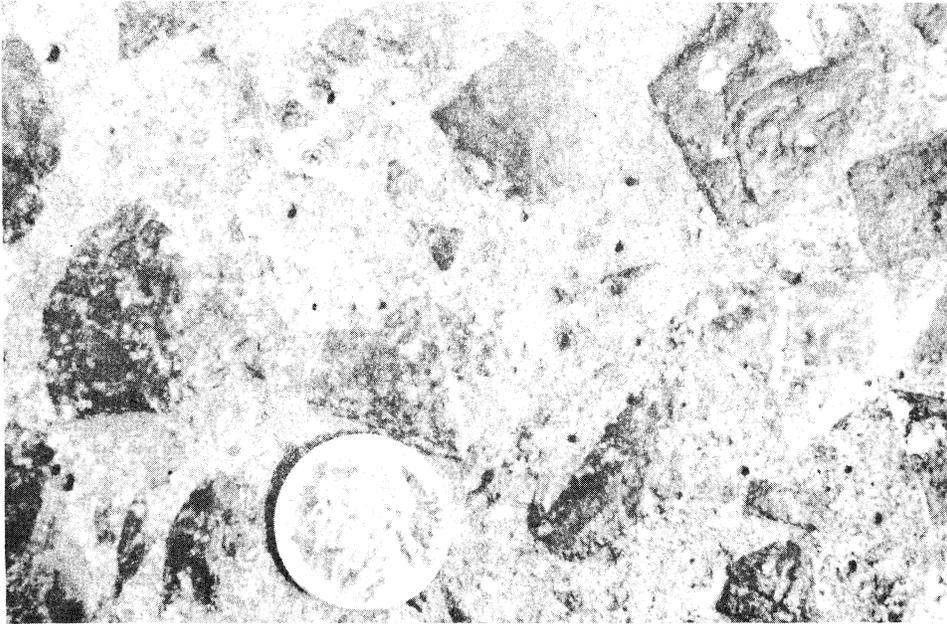
Figure C-9. Polished coarse aggregate contributes to low skid resistance.
