HEAT-CURVED GIRDERS: DEFLECTIONS AND CAMBER
LOSS DURING AND SUBSEQUENT TO BRIDGE CONSTRUCTION

M. H. Hilton
Senior Research Scientist

Virginia Highway & Transportation Research Council
(A Cooperative Organization Sponsored Jointly by the Virginia
Department of Highways & Transportation and
the University of Virginia)

September 1982
VHTRC 83-R9

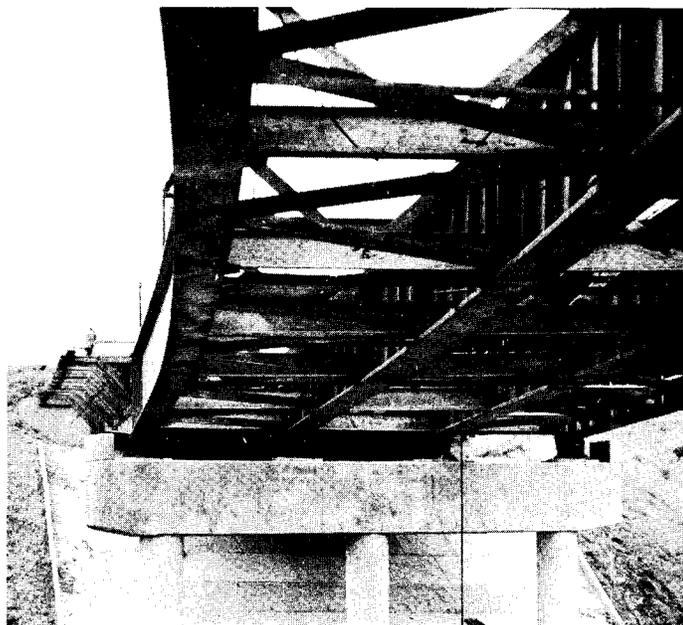
Figure 2. View of the structural steel showing curvature in the girders and the design of the diaphragms and lateral cross bracing.

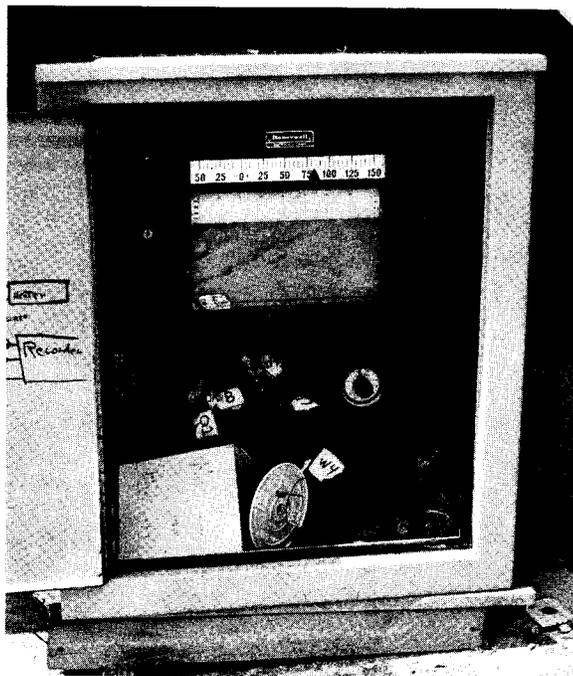
Figure 6. Honeywell recorder mounted in a steel cabinet for field use.

A 24-channel Honeywell thermocouple recorder powered by a portable generator was used to collect temperature data on the steel girders. The recorder is shown in Figure 6 mounted in a heavy steel cabinet for protection during field use. Thermocouples using a type J iron-constantan wire were placed on the top and bottom flanges of the girders at the mid-span length points. Some additional thermocouples were placed on the girders at the quarter-span length points and at some selected positions on the web of the girders as shown in Figure 3.
