INSTALLATION REPORT

EXPERIMENTAL MIXES ON RICHMOND-PETERSBURG TURNPIKE -- 1985

C. S. Hughes
Senior Research Scientist

January 1986
VHTRC 86-R26

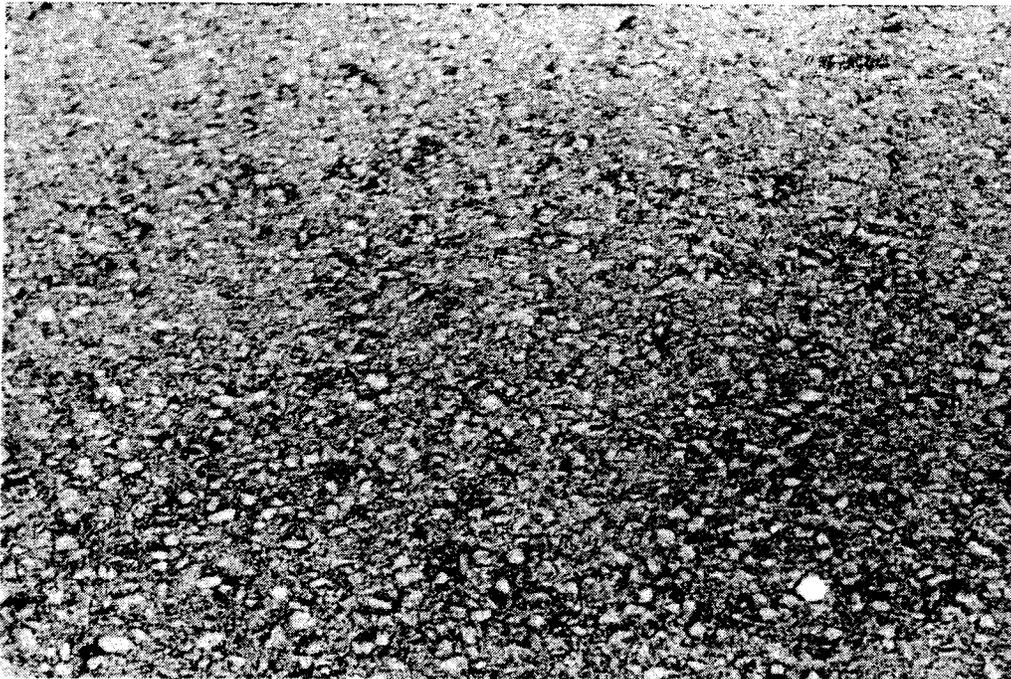
Figure 3. Coarse texture of preliminary mix.

The initial gradation used had 96% to 98% passing the 3/4-in sieve and 13% to 17% passing the No. 30 sieve. It was found that the 2% to 4% retained on the 3/4-in sieve created a coarser texture than was desirable (Figure 3), so the +3/4-in fraction of the mix was eliminated for the job mix formula used in the experimental sections. It also appeared that as the percentage of material passing the No. 30 sieve increased above 14%, the voids in mineral aggregate (VMA) decreased appreciably. This was undesirable because with a relatively low VMA, there might not be sufficient room for the asphalt and under consolidation flushing could become a problem.

The job mix formula was changed slightly to address these two potential problems. The preliminary and revised job mix gradations determined by the contractor are shown in Table 2, and Figure 4 shows the relationship between the maximum density line and the job mix formula that was used.

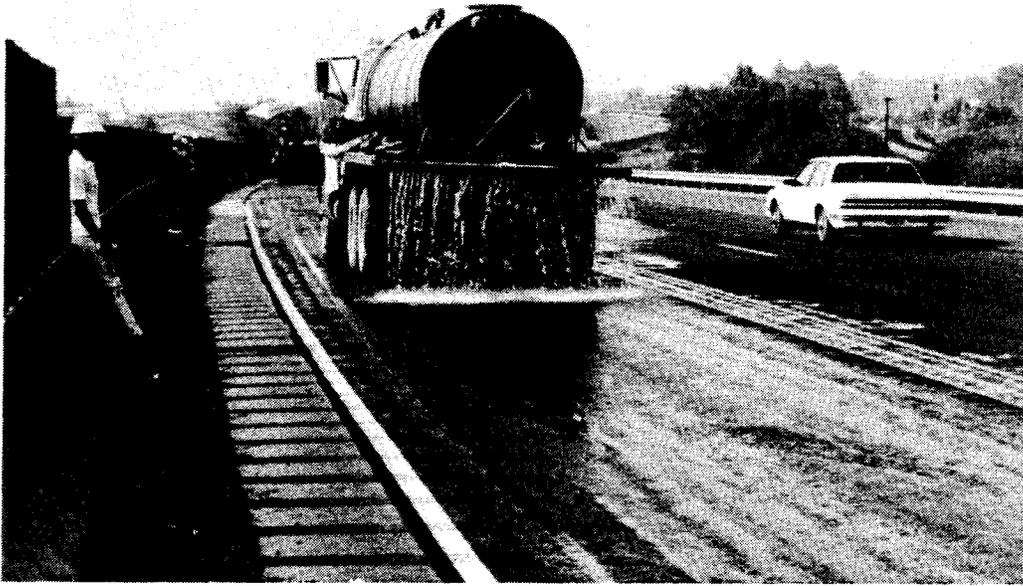
Figure 11. Water truck used to cool pavement.

Because of the relatively short distance paved daily in each lane, there was a problem in keeping the lanes closed until the overlay had cooled sufficiently to carry traffic, particularly on days with the temperature in the high 90's. A guideline of a maximum of 150°F for the surface temperature was used to determine when a lane could be opened. An infrared thermometer was effectively used to measure the surface temperature. Beginning on September 9, the second day of paving with mix #2, the surface temperature was 190°F-220°F for the last 500 ft of the paved lane after rolling was completed and the contractor was ready to open the lane to traffic. It was decided to allow the contractor to use a water truck to sprinkle the surface to reduce the temperature (Figure 11). With two passes of the water truck, the surface temperature was reduced from the 190°F-220°F range to an acceptable range of 130°F-140°F. Unfortunately, the water truck had to approach the paved lane from the hottest end so as to place water on the mix before the wheels were on the pavement. (As can be imagined, logistical problems in dealing with 30,000 vpd prevented the truck from being turned around and backing from the cool end.) The water truck did cause some rutting (Figure 12) and part of the lane had to be re-rolled (Figure 13).

However, applying water to the pavement did reduce the surface temperature sufficiently to allow the lane to be opened to traffic within a reasonable length of time.
