1. Report No. FHWA/VA-89-R24	2. Government Accession No.	3. Recipient's Catalog No.	
4. Title and Subtitle Temporary Asphalt Medians for Two-Lane, Two-Way Operation		5. Report Date March 1989

TEMPORARY ASPHALT MEDIANS FOR
TWO-LANE, TWO-WAY OPERATION

March 1989
VTRC 89-R24

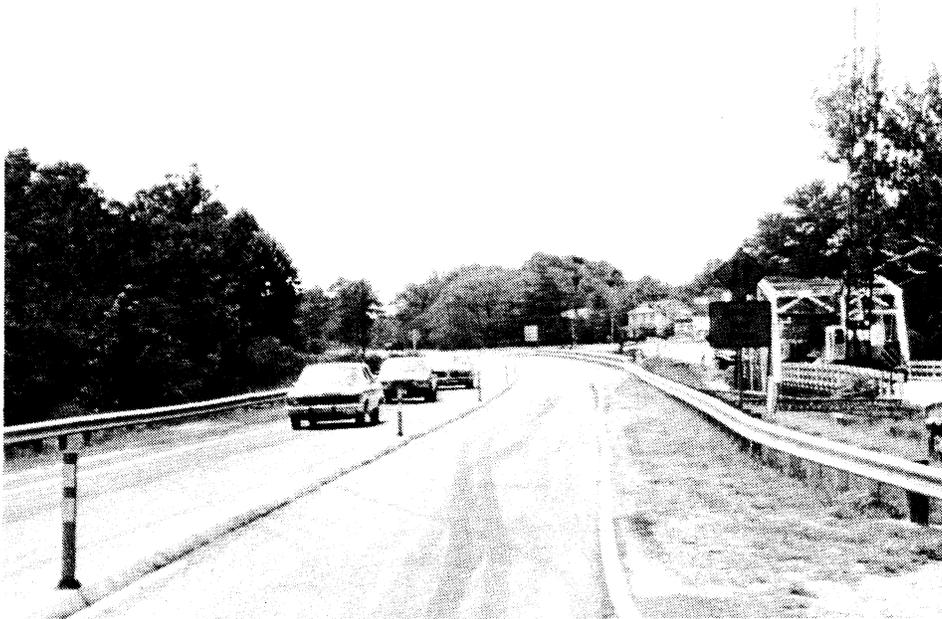
A typical temporary asphalt median (also called an island) is 12 in to 18 in wide and 4 in high, is painted with reflectorized yellow paint, and has orange tubes with reflectorized white collars mounted about 50 ft apart as shown in Figure 1 (1). The median is highly visible and provides more positive delineation than the concrete barrier, especially at night. Since the median is narrower than the barrier, it occupies less of the travel lane. Several state departments of transportation, including those of North Carolina, Florida, Ohio, and Pennsylvania, have successfully used the medians typically on roads with average daily traffic (ADT) volumes under 30,000. The medians are generally not recommended where physical separation of the opposing lanes is required or where the traffic volume is high, for example, where the ADT is above 50,000.

Figure 1. Temporary asphalt median.

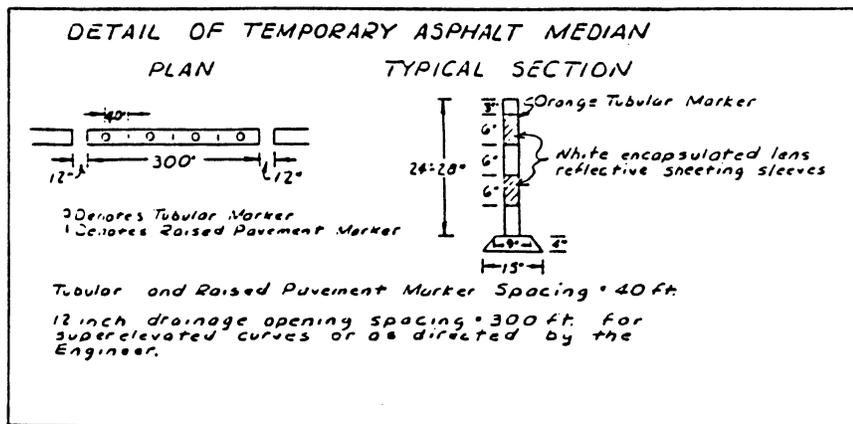
The bituminous materials shall be placed and compacted, on a clean pavement surface without using a tack coat, at the locations and to the dimensions shown in the provisions or as directed by the Engineer.

Drainage openings shall be 12 inches in length and spaced at 300 foot intervals or as directed by the Engineer.

The Department will paint the temporary asphalt median, before the Contractor installs the tubular and raised pavement markers; installation shall be in accordance with the provisions and manufacturer's recommendations.

Figure 2. VDOT special provisions.

The specifications used for the study are shown in Figure 2. These were developed based on a synthesis of the survey of state DOTs with minor revisions by VDOT personnel.

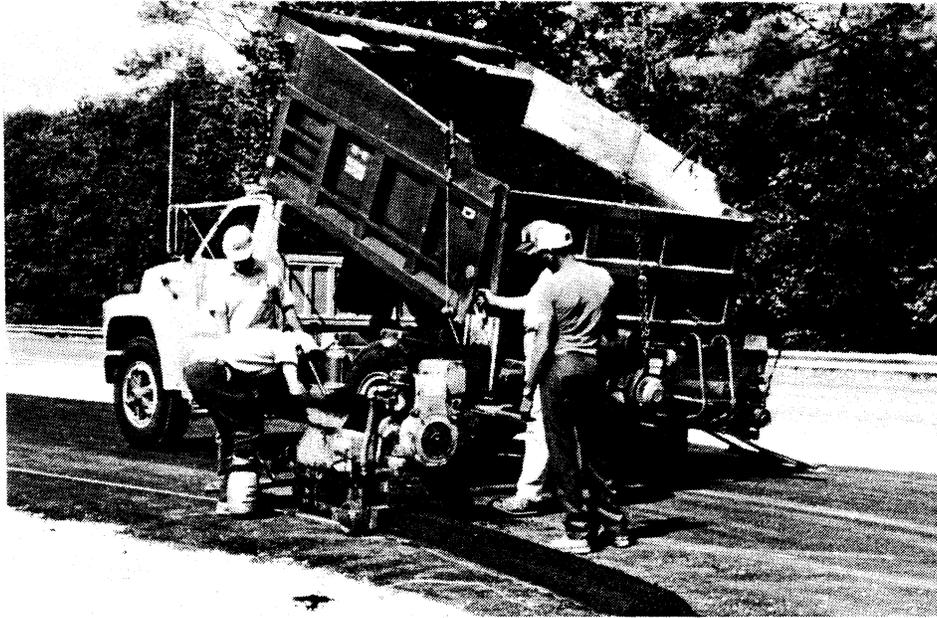
quently, on the second day, a finer, modified Type I-2 asphalt mixture was used. Four workers were involved in the median installation: (1) the curb machine guider, (2) the dump truck driver, (3) the monitor of the asphalt entering the machine, and (4) the inspector of the median and cleaner of loose asphalt (Figure 3). The asphalt median was installed at a rate of 420 ft per hr.

Figure 3. Median installation process.

Using an asphalt curbing machine, the temporary asphalt median was installed at a rate of 420 ft per hr. The concrete barrier was installed at a rate of 200 ft per hr based on a study on I-64 in Louisa County on September 1, 1987. The temporary asphalt median can be installed two times faster than the concrete barrier. Therefore, the time that traffic is exposed to installation activities is 50 percent lower for the median than the barrier. The rates are not for a complete installation since painting the median, installing markers for the median, installing warning lights on panels, and painting the temporary pavement marking adjacent to the barrier is not included. Since these are typically done concurrently with the median or barrier installation, it is expected that the additional time would be relatively small.

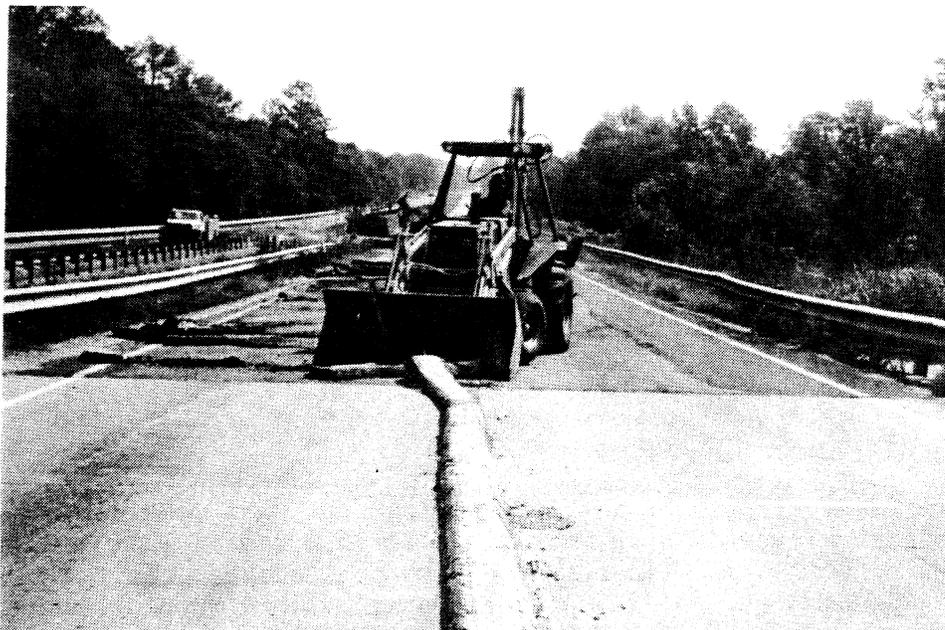
TLTWO ended on August 8, 1988, with the opening of the new westbound bridge. The median was removed on August 8 and 9, 1989, in three phases (Figure 5): (1) a front-end loader was used to push the asphalt median into a pile toward the left shoulder; (2) a tractor with a sweeper attachment swept the loose asphalt from the travel lane toward the shoulder; (3) a second front-end loader loaded the asphalt from the median onto a dump truck for transport to a storage area. During the first two phases, the second front-end loader was removing the median crossover pavement.

The median was removed under traffic conditions. The front-end loader operator moved the median out of its position and into the closed left lane during gaps in the traffic stream. The median was then pushed into piles about 500 ft apart. The average rate of removal by the loader was 606 ft per hr (with a standard deviation of 144 for four samples).

a. Front-end loader removing median.

Figure 5. Median removal.

The removal rate for the median was 606 ft per hr. It is estimated that the removal rate for the barrier is equal to the installation rate of 200 ft per hr since the procedure is reversed. If the removal rate for the median is reduced to 450 ft per hr to allow for complete removal, this will mean that the median can be removed 2-1/2 times faster than the barrier, thus reducing exposure to traffic by 60 percent.

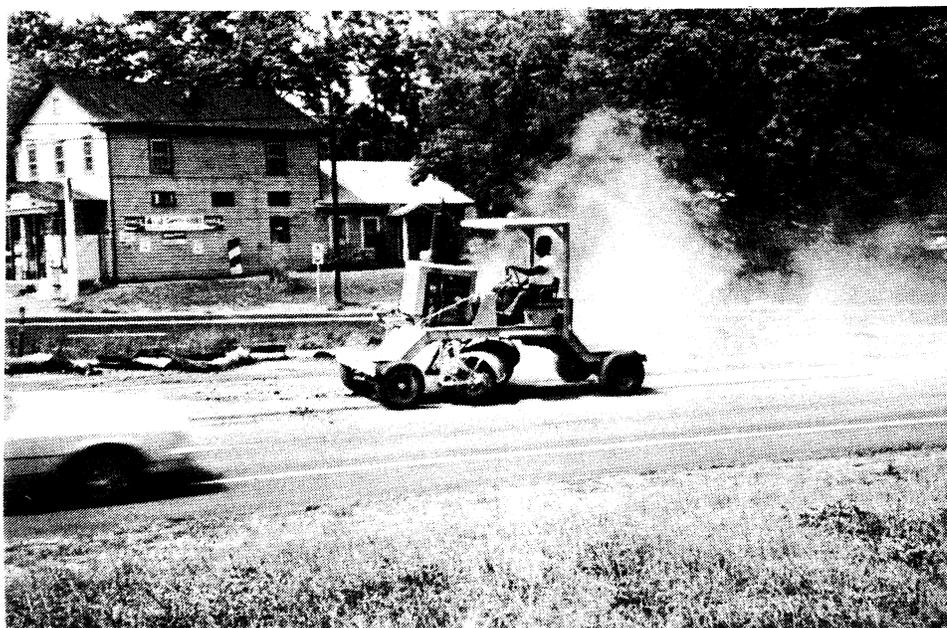
b. Sweeping loose gravel.

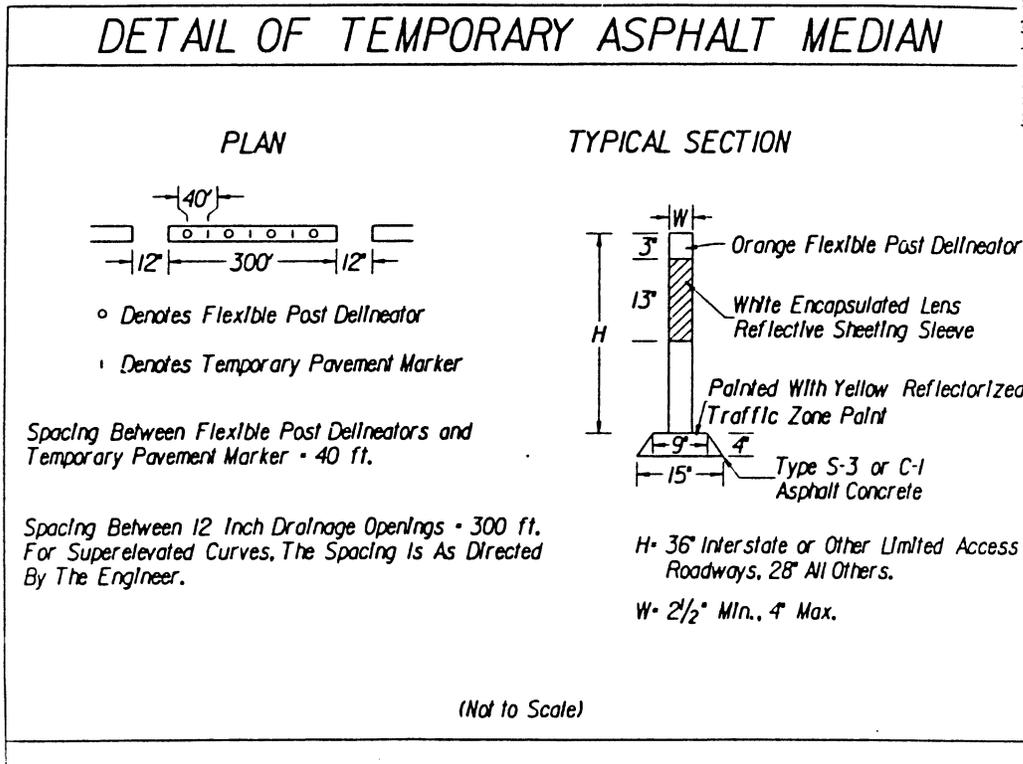
Instructional & Information Memorandum
LD-87 (D) 93.8
Sheet 7(1) (Added 5-16-88)

The VDOT's guidelines for the use of temporary asphalt medians are shown in Figure 6. The guidelines consist of two parts: general notes and a detailed drawing of the temporary asphalt median.

- Temporary asphalt medians are to be considered on two-lane, two-way temporary detours for traffic volumes between 4000 and 15,000 VPD.
- Each location is to be reviewed and have the joint approval of applicable District, Traffic Engineering and Location & Design personnel.
- Each location should use geometrics that provide an operating speed equal to that of the existing roadway, where possible, to minimize operational problems. (See Standard GS-10)
- The SEQUENCE OF CONSTRUCTION/TRAFFIC CONTROL PLAN is to include the required temporary asphalt median layout details along with the included "DETAIL OF TEMPORARY ASPHALT MEDIAN" that is available in the CADD SECTION for inclusion in the plans.
- Payment will be made under:

Figure 6. VDOT guidelines for use of a temporary asphalt median.

Considering the median for TLTWO with traffic volumes between 4,000 and 15,000 vehicles per day is restrictive when compared to other state DOTs. However, this restriction reflects VDOT's cautious approach to using the median. Although it is mostly used on four-lane divided roads, the median in TLTWO is suitable for use on four-lane undivided roads. The guidelines do not address four-lane, two-way operations (FLTWO). However, FLTWO is being used on Chippenham Parkway and, therefore, FLTWO should be mentioned in the guidelines. The decision to use the asphalt median is made on a project-by-project basis, typically using traffic analysis methods. The volume guidelines are not very useful compared to the traffic analysis. Therefore, volume guidelines may be omitted.

3. The two 6-in reflective sleeves on the tubular marker should be replaced by the option of a 13-in reflective sleeve as shown in the guidelines or a 6-in (at the top) and 4-in sleeve spaced 2 in apart. The 13-in sleeve was recommended based on a study to optimize the tubular marker design (5) while the latter option is in accordance with a recent change in the Manual on Uniform Traffic Control Devices (6).
4. The contractor should be encouraged to use efficient methods for the installation and removal of the median.
