FINAL REPORT

PREMIXED POLYMER CONCRETE OVERLAYS

Michael M. Sprinkel
Research Scientist

Virginia Transportation Research Council
(A Cooperative Organization Sponsored Jointly by the Virginia
Department of Transportation and the University of Virginia)

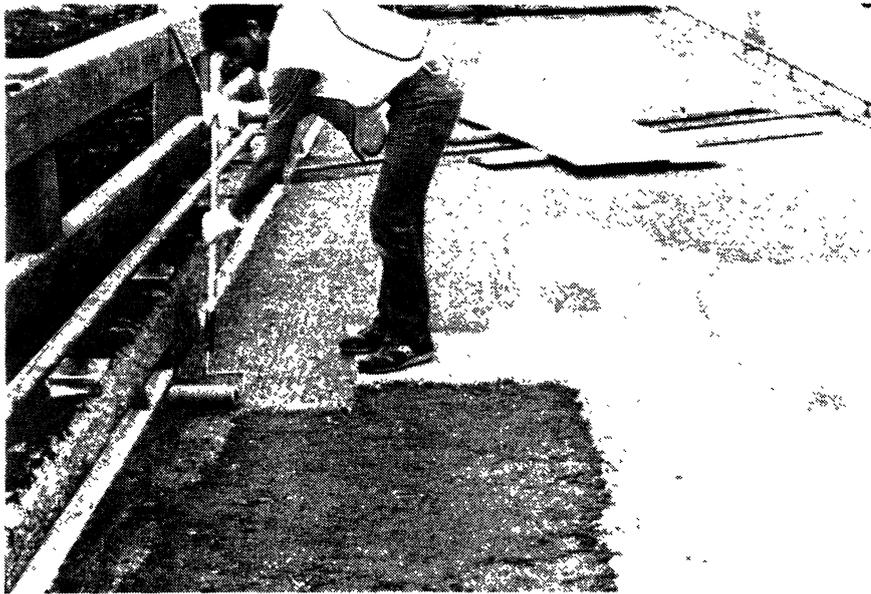
Figure 3. A one-component urethane primer is applied to the deck surface prior to placing the overlay on Rte. 340.

100-125 ft² /gal and was allowed to cure for approximately 1 to 2 hours prior to placing the overlays for installations 3 and 4 (see Figure 4). When the overlays were placed, the urethane was tack free and the polyester was gelled but sticky. No primer was used for installations 5, 6, and 7 because the primer would inhibit the conduction of current between the overlay and the base concrete. However, polyester styrene resin 2 was applied to a small strip next to the parapet for installation 7 just to see if the primer would enhance the bond strength of the overlay. The development of a conductive primer could be beneficial. Figure 5 shows one of the six continuous loops of platinum-niobium covered copper wire attached to the shotblasted surface prior to placing the conductive polymer concrete overlay on Rte. 99.

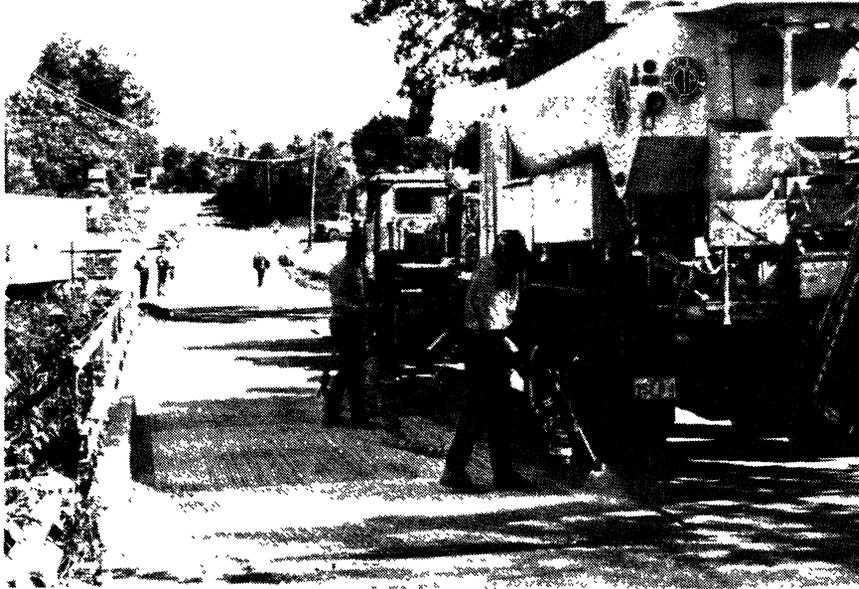
Figure 4. Polyester styrene primer is sprayed onto the deck surface prior to placing overlay on Rte. 629. Mobile concrete mixer in adjacent lane contains resin, initiator, and aggregates for overlay.

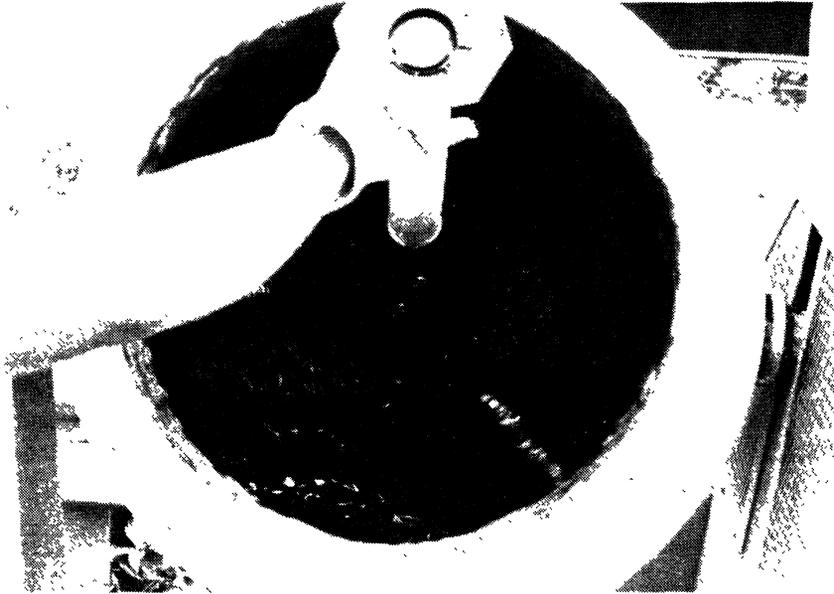
Figure 7. MEKP initiator is added to resin in a mixer.

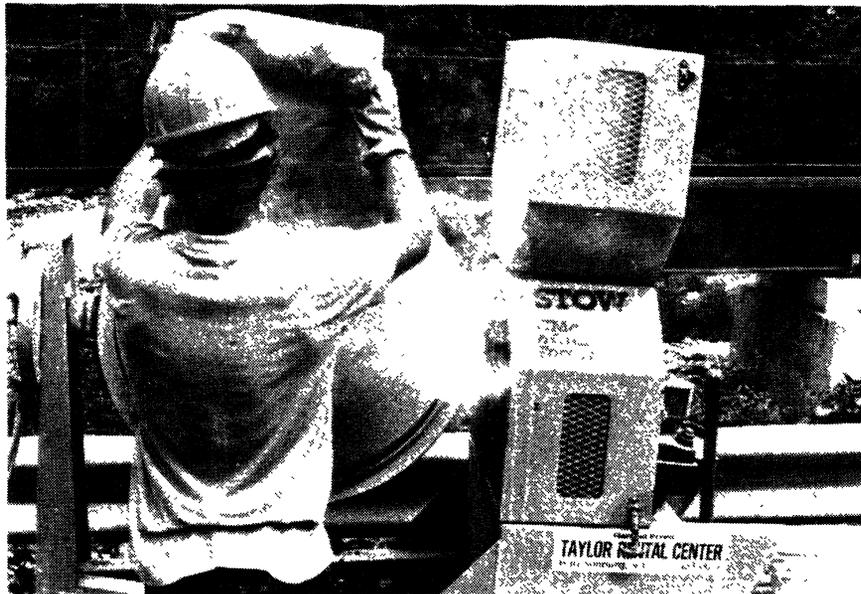
Figure 8. DOW Chemical prepackaged aggregate is added to a concrete mixer.

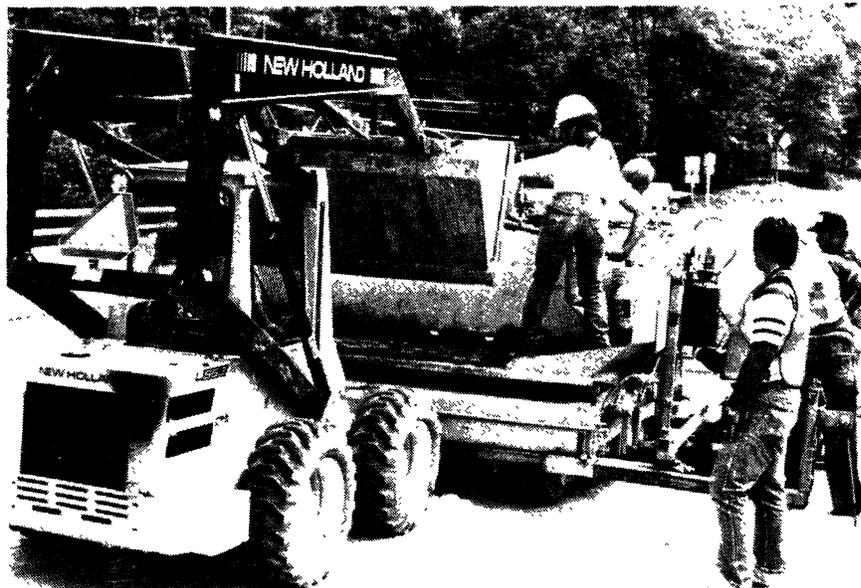
Figure 15. A front end loader deposits conductive polyester styrene concrete into the hopper of a slip form paver.
