AN EVALUATION OF DETECTABLE WARNING SURFACES FOR SIDEWALK CURB RAMPS

1. Report No. FHWA/VA-95-R31	2. Government Accession No.	3. Recipient's Catalog No.	
4. Title and Subtitle An Evaluation of Detectable Warning Surfaces for Sidewalk Curb Ramps		5. Report Date August 1995

August 1995
VTRC 95-R31

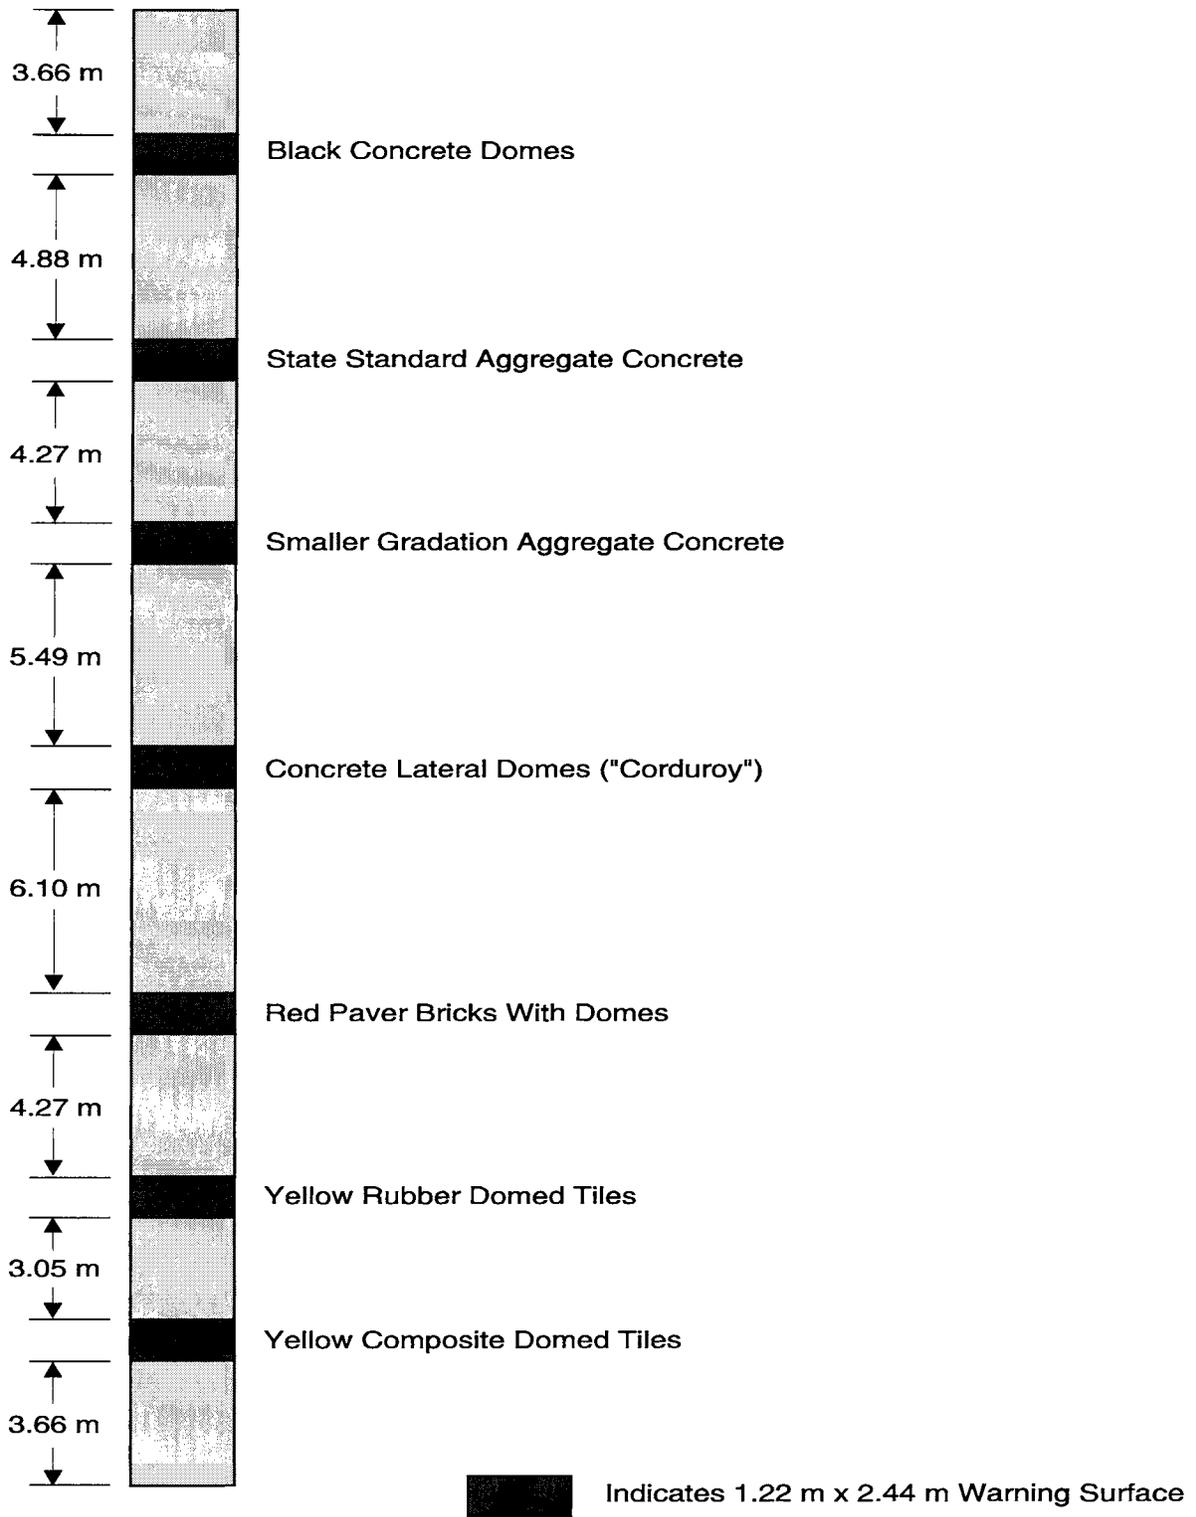
Figure 1. Test Site

The authors developed a method for testing the detectability and navigability of various warning surfaces, based on both the literature and the potential test sites at the Virginia Rehabilitation Center for the Blind (VRCB), a residential training facility in Richmond. A test site was built by installing seven 1.22 by 2.44 m (4 by 8 ft) sections of detectable warning materials in an existing straight sidewalk (Figure 1). DVH mobility trainers told the authors that 1.22-m lengths of the warning surfaces should be adequate for testing people with a variety of stride lengths. The warning surfaces were installed at varying distances from each other to minimize expectancy effects on the test results. Flat sections of warning materials were used rather than ramps to facilitate a more accurate assessment of the surfaces' detectability. DVH trainers emphasized to the authors that most of their visually impaired clients without other disabilities detect curb ramps primarily by their slope (this was later confirmed by the test subjects). By eliminating slope as a cue, the detectability of the surface alone could be better

evaluated. Other auditory and sensory cues in the testing environment were held constant as much as possible. No testing was done in wet, icy, or very cold weather, nor at dawn or dusk.

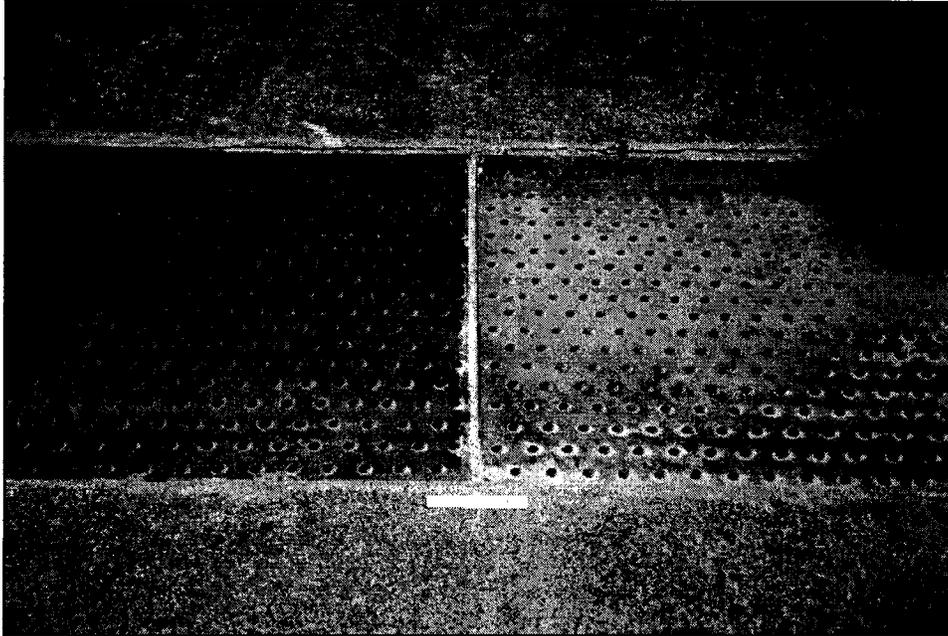
Figure 4. Precast Back Concrete Raised Truncated Domes

A number of the raised truncated domes on the black concrete and red brick surfaces also were damaged. The exact cause of this damage is unknown. According to Don Callahan, maintenance supervisor at VRCB, the only winter maintenance performed on the test sidewalk was snow blowing no more than 4 times during the (relatively harsh) winter. The snow blower was raised so that it would not touch the domes when used. It seems unlikely that routine use of the sidewalk accounts for the damage (apart from the testing, in fact, the sidewalk is infrequently used by VRCB residents). The surfaces could have been run over by skateboards or bicycles on weekends or evenings, but there is no proof of this.

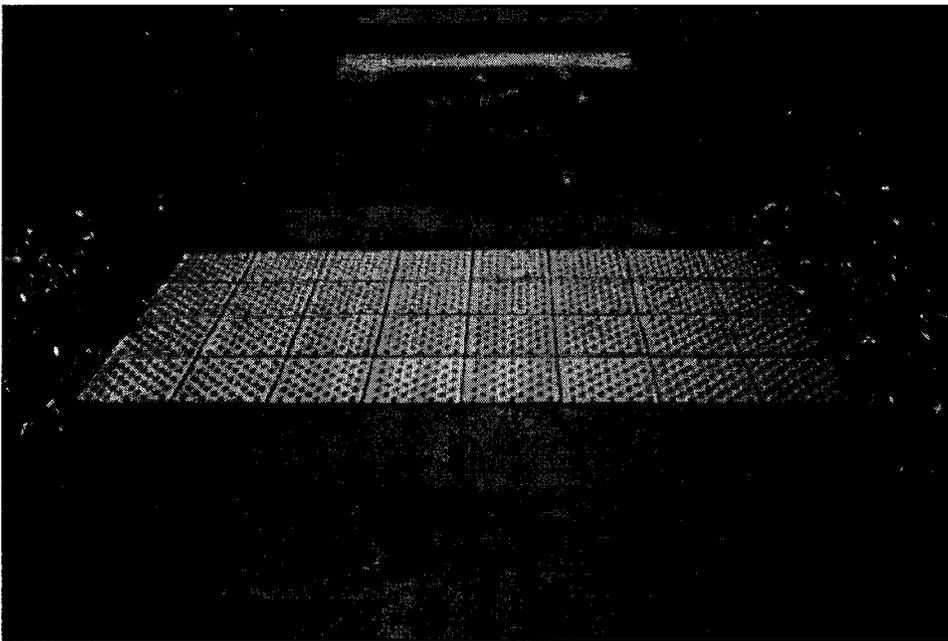
Figure 5. Yellow Rubber Pathfinder Tiles With Raised Truncated Domes

In addition, the yellow rubber domed tiles faded quite visibly between November and May. This was not unexpected, however, since the manufacturer no longer recommends the

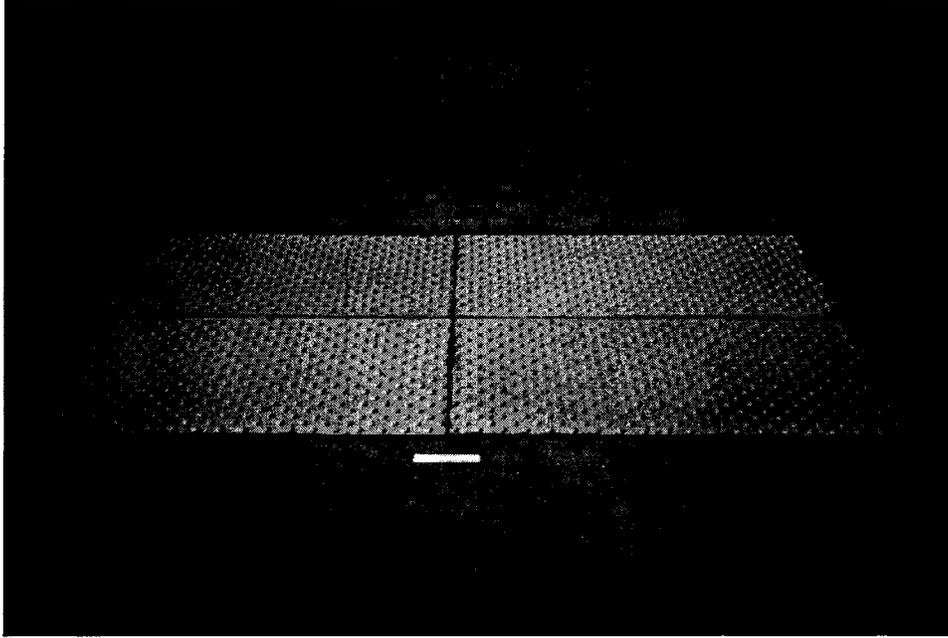
Figure 6. Yellow Composite Pathfinder Tiles

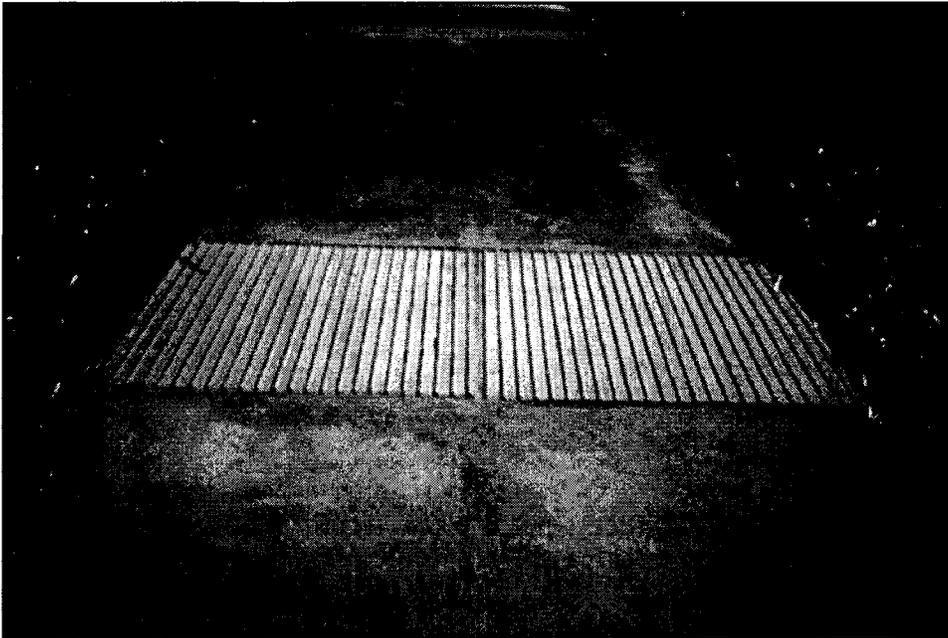
Figure 7. Precast Concrete Lateral Domes (Corduoy)

lateral domes (the corduroy surface). All six made negative comments about the lateral domes, which they said made their movement unstable or hazardous. Those who used wheelchairs complained about the wheels becoming stuck in the grooves of the lateral domed surface. The truncated domes also elicited negative comments: the domes were too high and too difficult to maneuver over. As one of those who used a wheelchair commented about the yellow composite domes, "they prevent you from going in the direction you want." These negative comments are consistent with research results and comments cited in the *Federal Register*.⁸ One participant said she would avoid any textured surface, as she preferred the curb ramps without them.

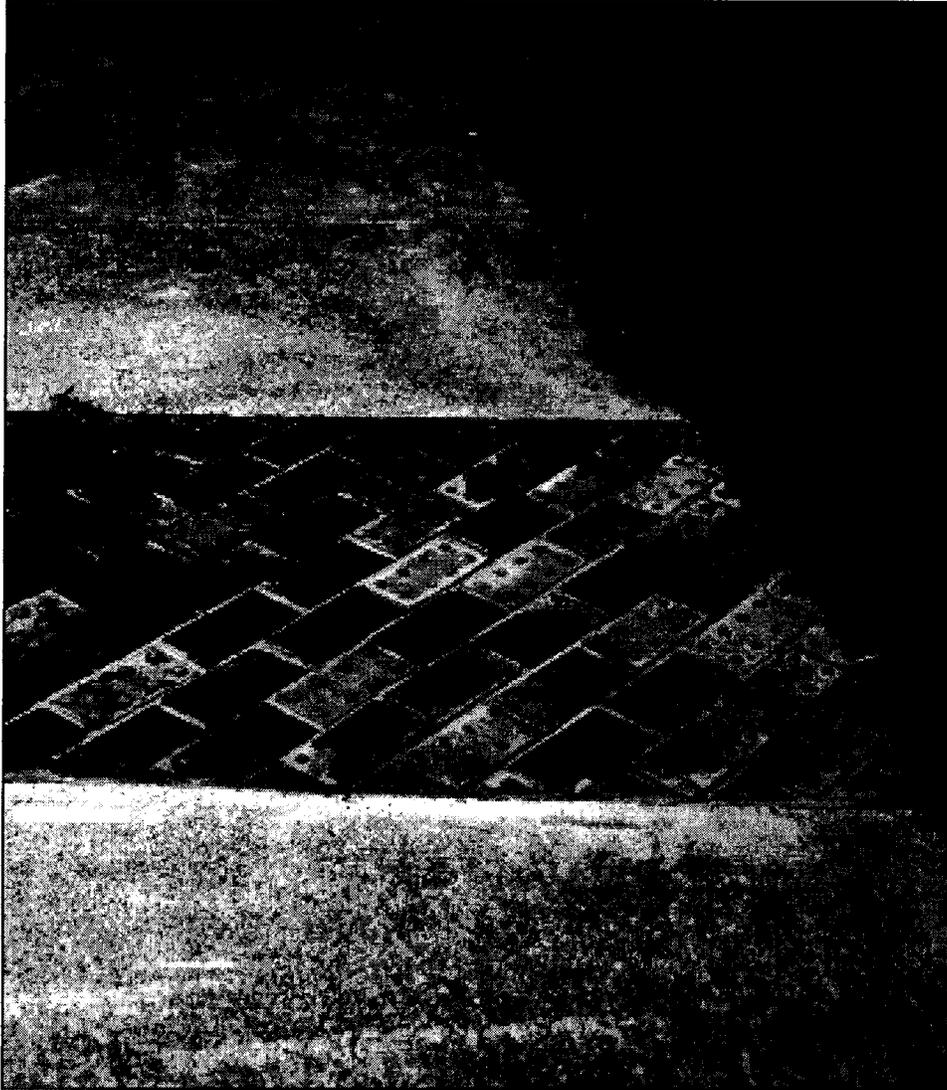
Figure 8. Red Paver Bricks With Domes
