INTERIM REPORT

**PILOT APPLICATIONS  
OF ELECTROCHEMICAL  
CHLORIDE EXTRACTION  
ON CONCRETE BRIDGE DECKS  
IN VIRGINIA**

**Charlottesville, Virginia  
May 1996**

**VTRC 96-IR3**

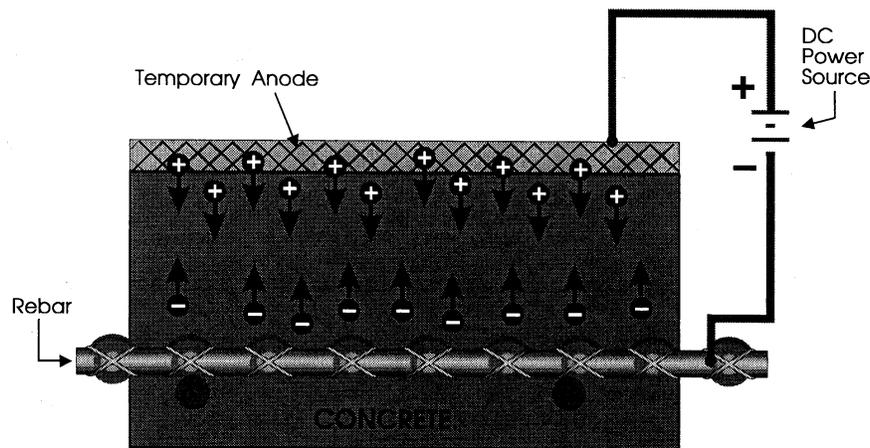
*Figure 1. Electromigration of cations and anions when an electrical field is applied between the rebars and a temporary anode on the surface of the concrete.*

The electrochemical removal of chloride from intact, contaminated concrete by electrochemical means, without excavating any concrete, has been studied since the mid-1970's. The Kansas Department of Transportation used a sacrificial copper anode to show that chloride ions can be expelled from concrete by passing a direct current between the rebars and the anode, as in cathodic protection except at considerably higher level of current.<sup>1,2</sup> In another study, Battelle Columbus Laboratories treated a total of 200 ft<sup>2</sup> of concrete on a bridge deck in Ohio with an average current density roughly between 23-28 A/m<sup>2</sup> (2.3-2.8 A/ft<sup>2</sup>), under a constant voltage of 100 V, for 12-24 hours, confirming the feasibility of electrochemical removal of chloride from concrete.<sup>3</sup> When a direct current is conducted through concrete, the relatively mobile ions (such as Cl<sup>-</sup>, OH<sup>-</sup>, Na<sup>+</sup>, K<sup>+</sup>, and Ca<sup>+</sup>) in the concrete would migrate, with each ion moving toward the electrode with the opposite charge (Figure 1). The same electromigration of ions occurs in cathodically protected concrete structures and is manifested noticeably during the first several months of operation of a new cathodic protection system by an increase in its circuit resistance.

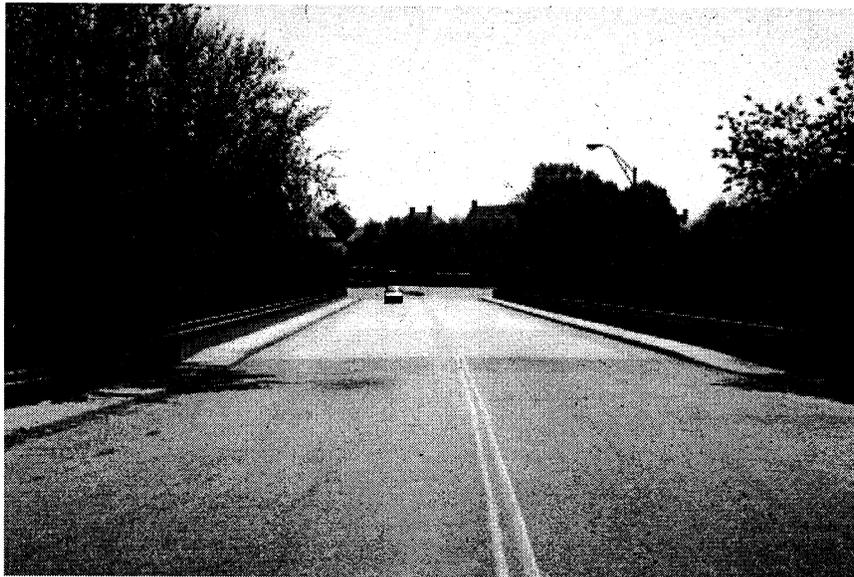
*Figure 2. The 34th Street Bridge in Arlington, Virginia.*

The bridge deck, approximately 28 years old, is on the 34th Street bridge over Interstate Route 395 in Arlington, Virginia (Figure 2). The reinforced concrete deck is 109 m (362 ft) long and 17 m (58 ft) wide, with a curb-to-curb width of 14 m (48 ft). The deck consists of five simple spans, supported by steel beams. Recent inspection of the deck spans indicated that 2 to 29% of the concrete in each span was delaminated due to rebar corrosion.<sup>11</sup> Although wide enough for four traffic lanes, the bridge carries only two lanes of traffic (eastbound and westbound). Traffic was maintained on half of the deck while the rest was subjected to conventional delamination repair and ECE treatment. Because available funds were limited and

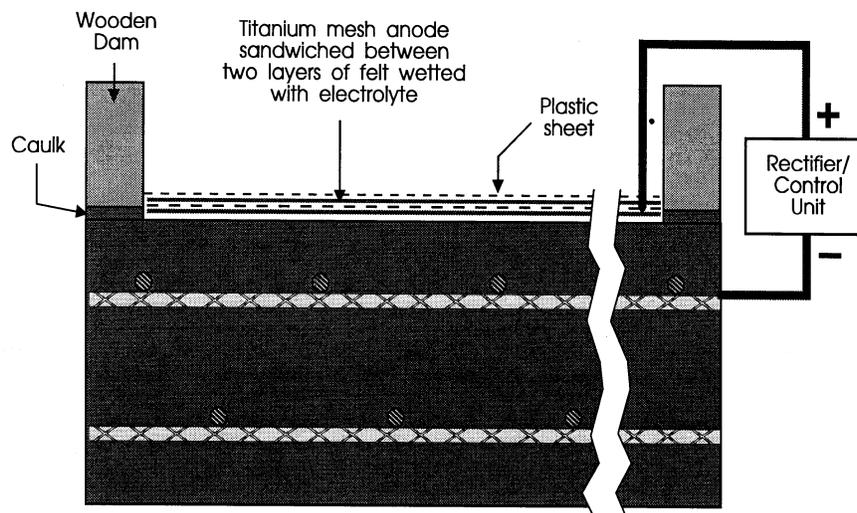
*Figure 3.*  
*treatment of*

*Setup for ECE*  
*bridge deck.*

The temporary anode system used was a layer of inert catalyzed titanium anode mesh sandwiched between two layers of synthetic felt, surrounded by a dam and kept wet by an electrolyte (Figure 3).

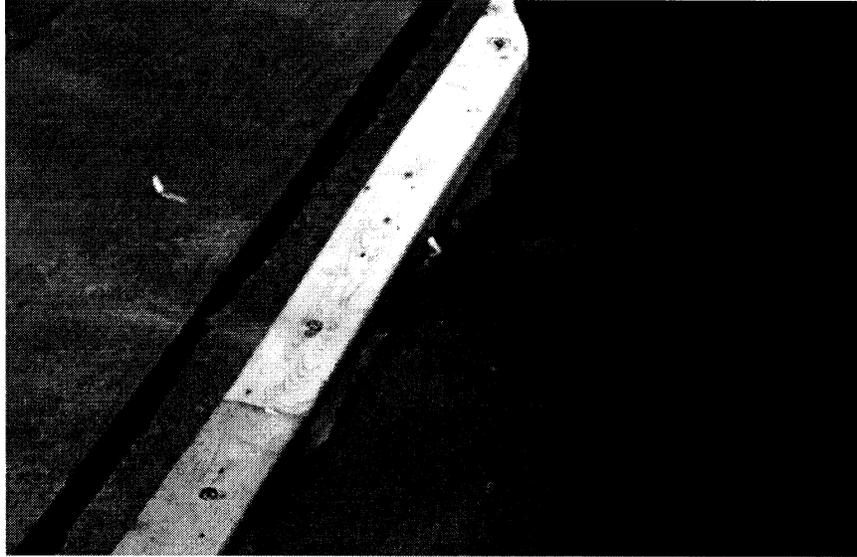
*Figure 4. Installation of ponding dam around a treatment area with wood strips and silicone caulk.*

1. Construction of a wooden dam around the area to be treated, stopping within 7 cm (3 in) of the joints. This was accomplished by securing 5 cm x 10 cm x 365 cm (2 in x 4 in x 12 ft) wood strips around the perimeter of the area with anchor bolts and applying enough silicone caulk underneath and all around the base of the wood strips to seal the edges (Figure 4).
2. Placement of a layer of 6 mm (0.25 in) thick felt over the entire area within the dam (Figure 5). The felt, which comes in width of 1.8 m (6 ft), was cut to the length of the area for longitudinal placement, from end to end of the area, with adjacent pieces overlapping by 2.5 to 5.0 cm (1 to 2 in).

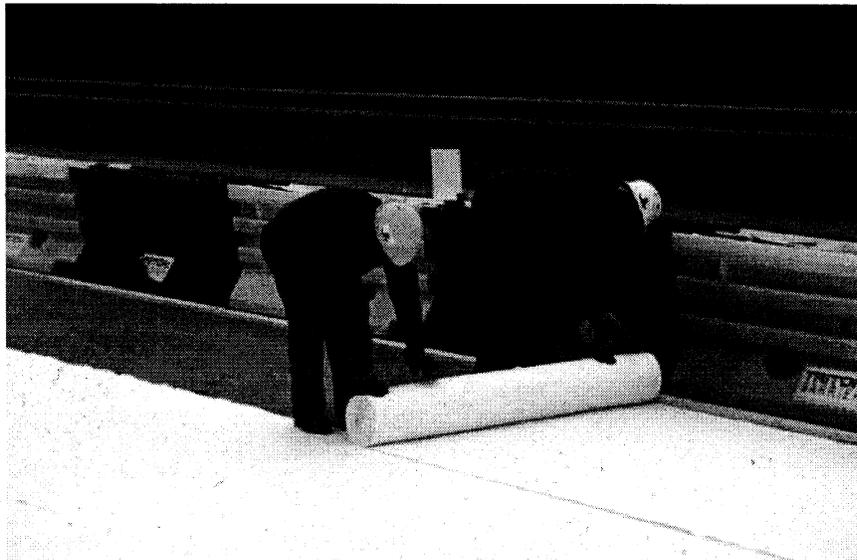
*Figure 5. Placement of the first layer of synthetic felt on the concrete within the treatment area.*

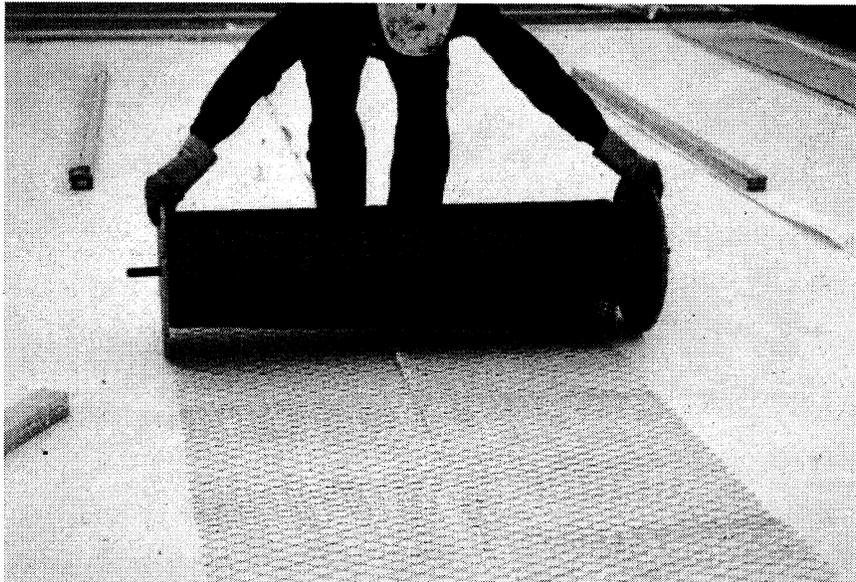
*Figure 6. A layer of 1.2 m wide titanium anode mesh being placed above the first layer of synthetic felt.*

3. Placement of a layer of titanium anode mesh (Elgard 210) over this layer of felt (Figure 6). (Any equivalent titanium anode mesh will suffice.) The anode mesh, 1.2 m (4 ft) wide, was cut to the length of the area to run continuously from end to end. Covering the entire 7.3 m (24 ft) width of the area required five full-width strips and one half-width strip of the mesh. The gap between adjacent strips was kept less than 8 to 11 cm (3 to 4 in).
4. Electric resistance welding a continuous piece of 12 mm (0.5 in) wide titanium ribbon every 0.6 to 0.9 m (2 to 3 ft), to each strip of anode mesh (Figure 7). Each ribbon was then cut to extend approximately 0.3 m (1 ft) beyond each end of the anode mesh it was connected to. (As described below, both ends of each ribbon would be connected to a rectifier.)
5. Placement of a second layer of felt over the anode mesh (Figure 8).

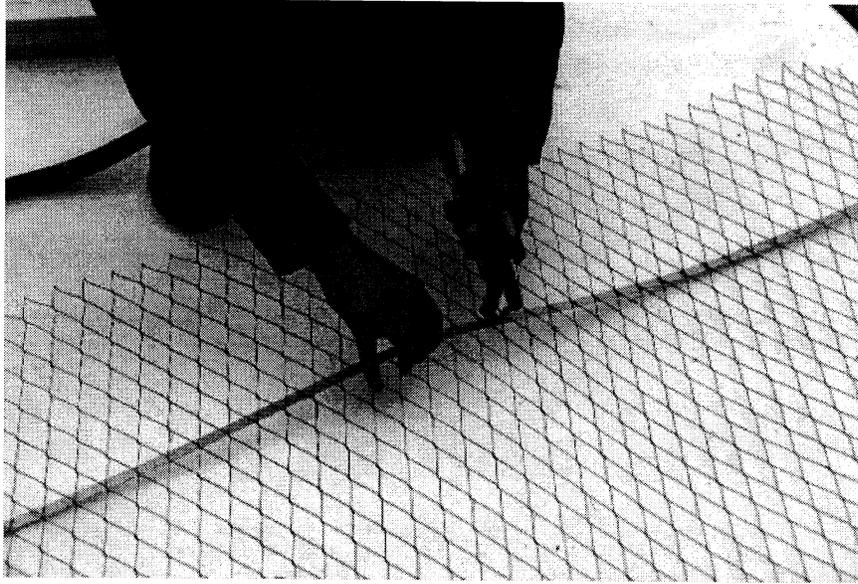
*Figure 7. A continuous piece of 12 mm wide titanium ribbon is connected by electric resistance welding to each strip of titanium anode mesh.*

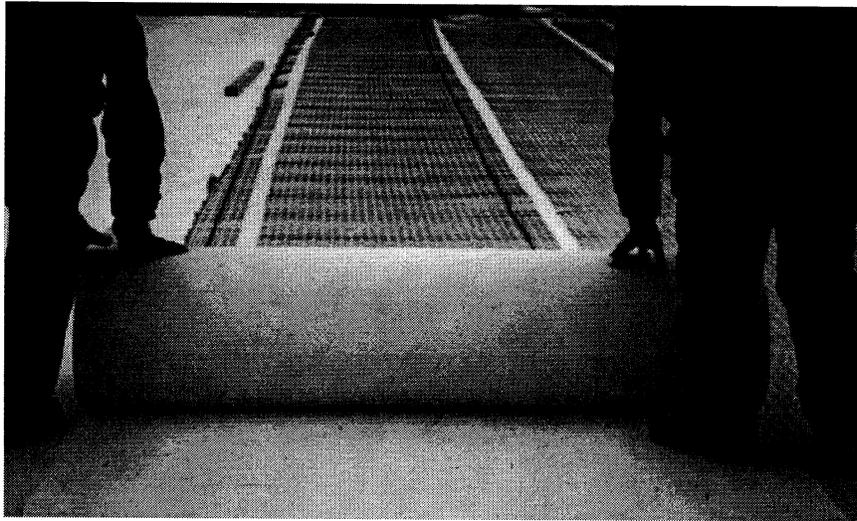
*Figure 8. Placement of a second layer of synthetic felt over the titanium mesh and the first layer of felt.*

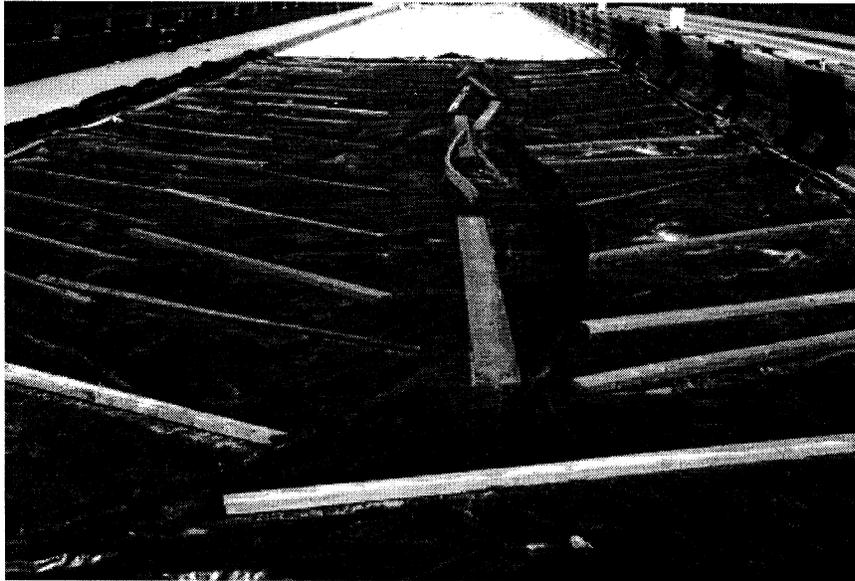
*Figure 9. Entire treatment area covered with plastic sheets, after wetting with electrolyte.*

6. Routing a soaker water hose, from the lowest corner of the treatment area, along three sides of the area. A small water pump was connected to the hose at the lowest corner to allow recirculation of the electrolyte to the entire area.
7. Wetting the entire felt/mesh/felt anode system with an electrolyte. Table 1 shows the various electrolytes used in the treated areas. As a source of  $\text{LiBO}_3$ , approximately 950 liters (250 gal) of the electrolyte Renew™, from FMC Corporation, was used in the north half of each span.
8. Covering the entire area with a thick black plastic sheet (Figure 9).

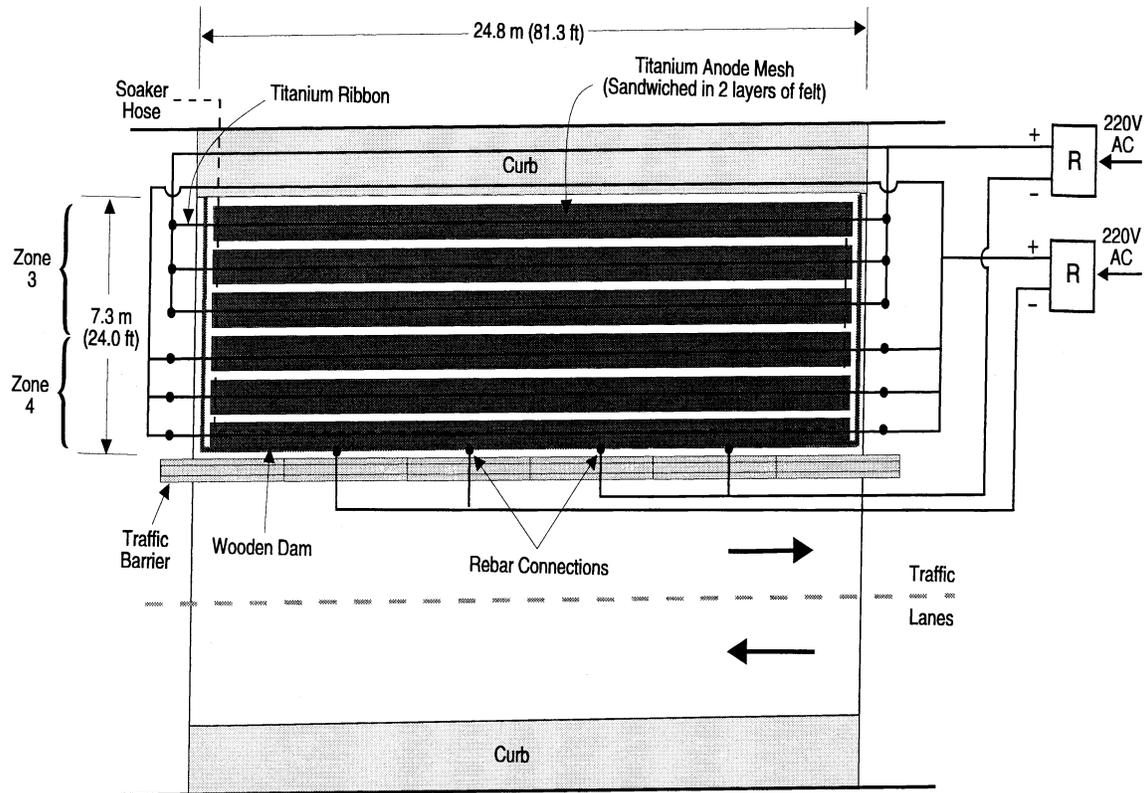
Figure 10. Plan of ECE setup for north half of span 5 (identical to other 3 areas).

1. Designating each half of each span into two zones, each with three of the six strips of titanium anode mesh (Figure 10).
2. Connection of all three strips of anode mesh in one of the zones to the positive terminal of a rectifier. This was achieved by connecting each end of the three welded titanium ribbons to the rectifier through a separate insulated copper lead wire of adequate gauge. The rectifiers required a single phase 220 V AC line. Each had a maximum output rating of 150 A at 40 V.
3. Similar connection of the second zone to a second rectifier.
4. Connection of the four ground connections in each span to the negative terminals of these rectifiers, using the same type of wires as the positive leads.

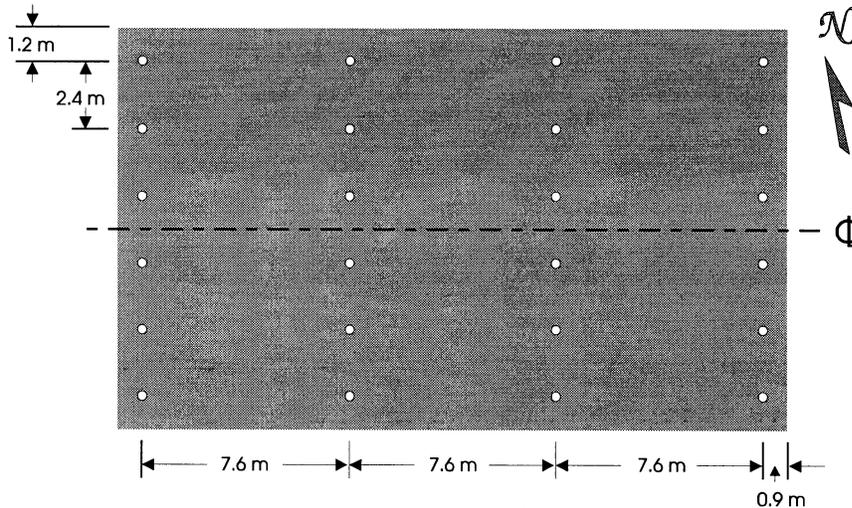
Figure 11. Grid layout of the sampling points used to conduct various pre- and post-treatment tests on the concrete of both halves (or treatment areas) of span 5. The sampling grid used for span 4 was similar.

To assess the effect of ECE treatment on the concentration of the chloride ions in the concrete, pulverized concrete samples were collected from each span, before and after treatment. The sampling points in each span were determined on a grid (Figure 11). At each point, separate concrete samples were taken at two depths from the surface: between 0.6 to 1.9 cm (0.25 to 0.75 in), and 1.9 to 3.2 cm (0.75 to 1.25 in). No samples were taken at depths below 3.2 cm (1.25 in), because the depths of the transverse rebars ranged from only 1.9 to 4.4 cm (0.90 to 1.75 in). To minimize the possible effect of the natural variability in the composition of concrete on the results, the pre- and post-treatment samples from each sampling point were collected within 1 cm (0.5 in) of each other. A potentiometric titration procedure, described elsewhere,<sup>12</sup> was used to determine the total chloride contents of all concrete samples.

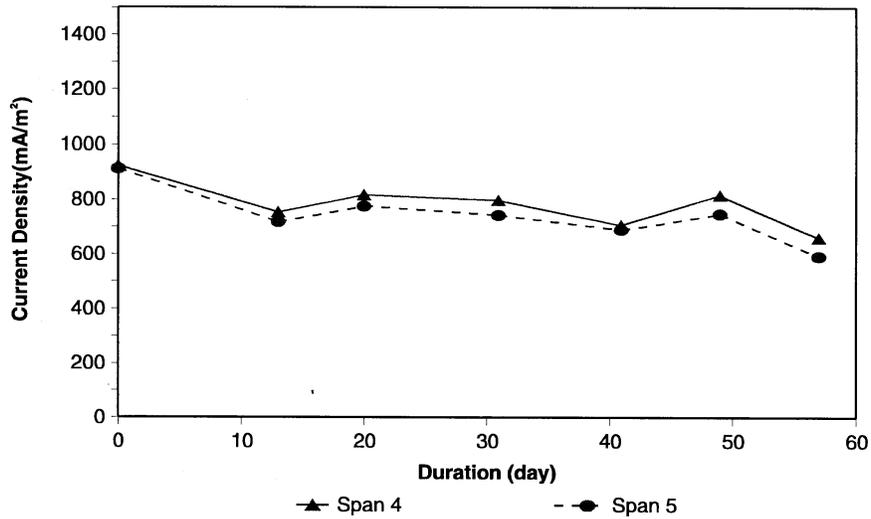
Figure 12. Density of treatment current passing through the north half of spans 4 and 5.

At the beginning of each phase of the ECE treatment of this deck, the output voltage of the rectifier for each zone was adjusted so that the total current passing through a span was less than  $1 \text{ A/m}^2$  ( $100 \text{ mA/ft}^2$ ). The voltages were in most cases kept constant throughout the entire treatment. Figures 12 and 13 show the change in the density of direct current passing through the north and south halves of both spans during treatment, which lasted for 57 or 58 days. As these illustrations show, the current passing through each area generally decreased as the treatment progressed. For example, in the north half of span 4, the current started at  $925 \text{ mA/m}^2$  ( $86.0$

mA/ft<sup>2</sup>) and ended at 662 mA/m<sub>2</sub> (61.5 mA/ft<sup>2</sup>). This decreasing trend is typical and is the net result of the electromigration of different ions of different charges into and out of the concrete. Table 2 shows a summary of various electrical parameters recorded for all areas during their treatment.

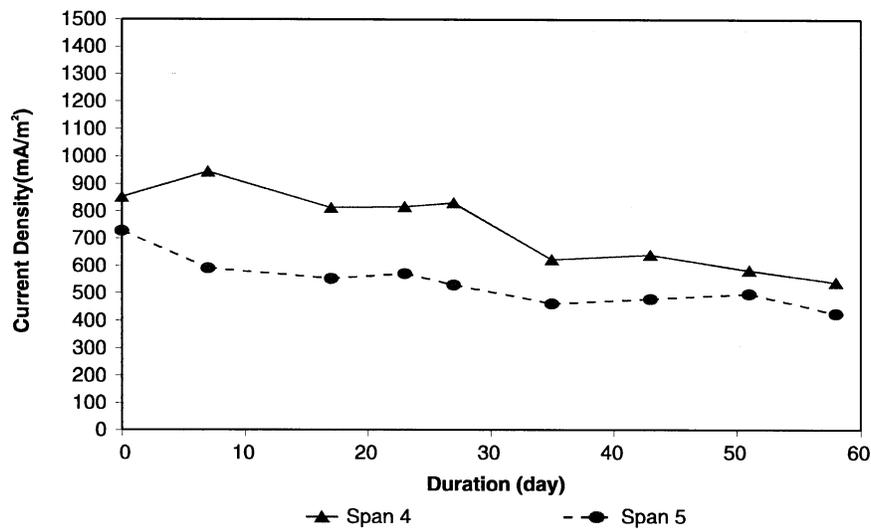
Figure 13. Density of treatment current passing through the south half of spans 4 and 5.

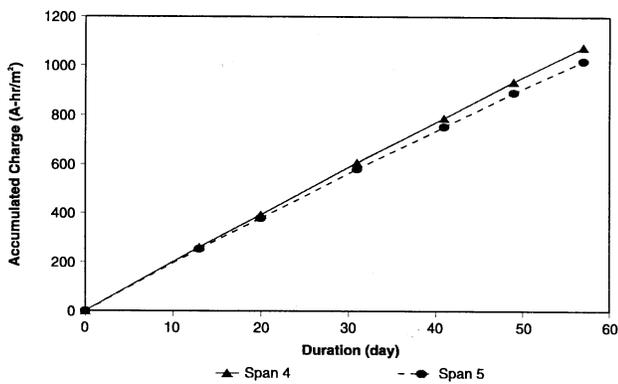
Figure 14. Estimated total electrical charges applied to the north half of span 4 and 5 at different stages of the treatment.

Figures 14 and 15 show the estimated amount of total electrical charge that passed through each area, at different stages of the treatment, as a result of the current applied. At the end of treatment, the accumulated charge varied from a low of 741 A-hr/m<sup>2</sup> (68.8 A-hr/ft<sup>2</sup>) for the south half of span 5, to a high of 1,077 A-hr/m<sup>2</sup> (100.1 A-hr/ft<sup>2</sup>) for the north half of span 4 (Table 2).

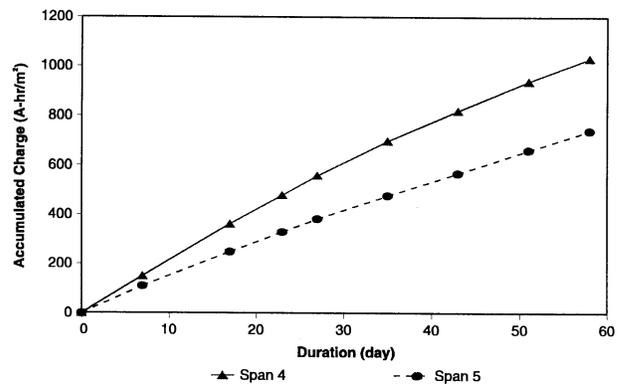
Figure 15. Estimated total electrical charges applied to the south half of span 4 and 5 at different stages of the treatment.

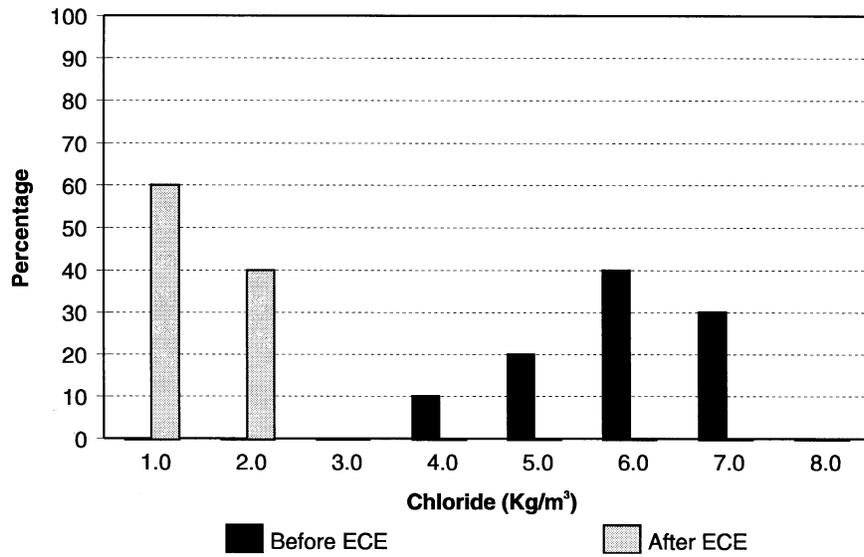
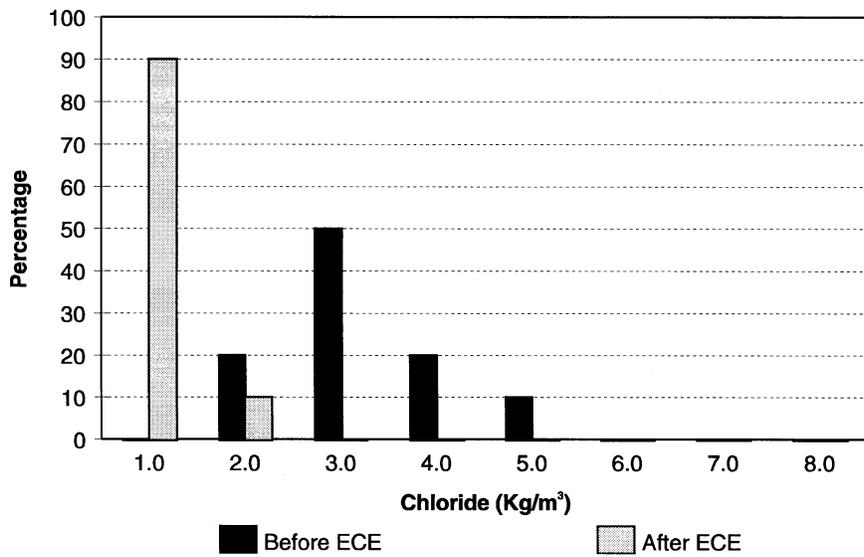
Span 4 (North Half): 0.6 - 1.9 cm

Span 4 (North Half): 1.9 - 3.2 cm

Figure 16. Change in the population distribution of chloride concentrations in the concrete of the north half of Span 4 at two different depths after ECE treatment.

Comparison of the chloride contents in the concrete of all treated areas, before and after the ECE treatment, indicates that the amount of chloride removed from the concrete closest to the surface of the deck was consistently slightly higher than the amount removed from deeper concrete (Table 4). This correlation reflects the combined effect of the strength of the electrical field and the distance of travel on the rate of outward migration of the chloride ions. The results in Table 4 also show that the treatment led to significant decreases in the concentration of chloride in the concrete samples from both depths, in all four treatment areas (Figures 16 to 19). The amount of chloride removed varied between the areas, ranging from 75.8 to 82.1% at a depth of 0.6 to 1.9 cm (0.25 to 0.75 in) and slightly lower (72.2 to 81.7%) at a depth of 1.9 to 3.2 cm (0.75 to 1.25 in). The amounts of chloride that were removed from the treated spans surpassed the maximum of 40 to 55% for very heavy treatments suggested by one of the SHRP reports.<sup>4</sup>

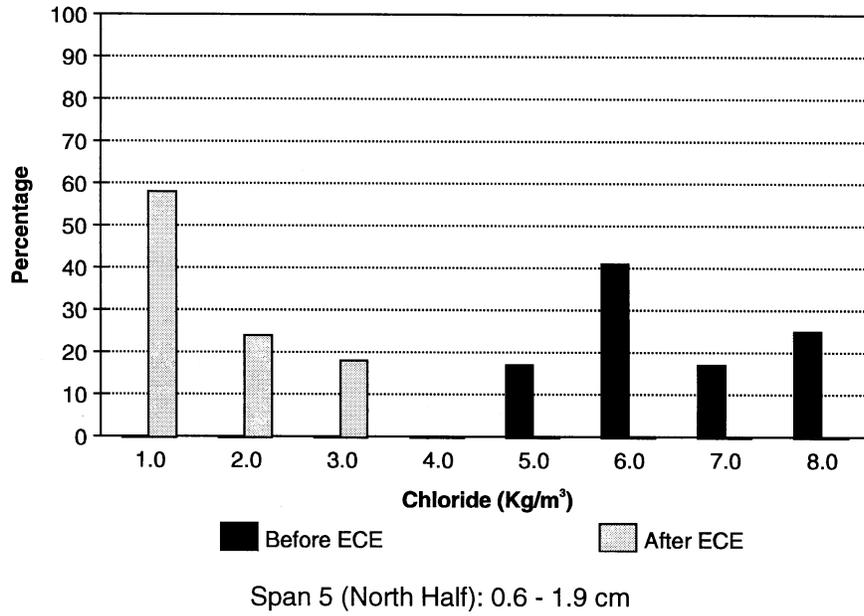
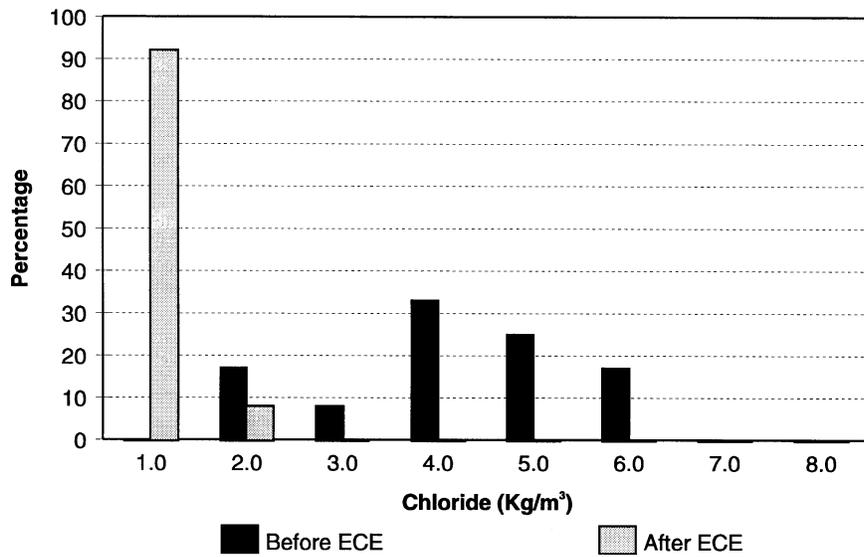
Figure 17. Change in the population distribution of chloride concentrations in the concrete of the north half of Span 5 at two different depths after ECE treatment.

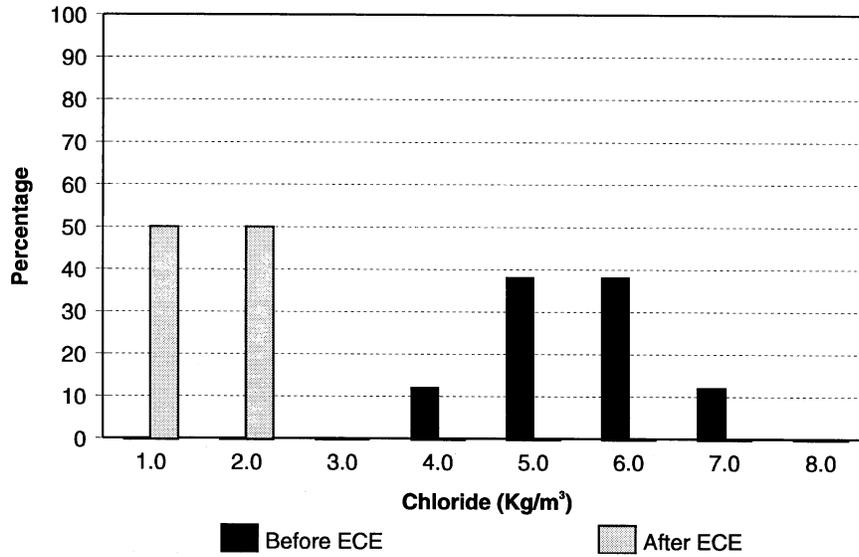
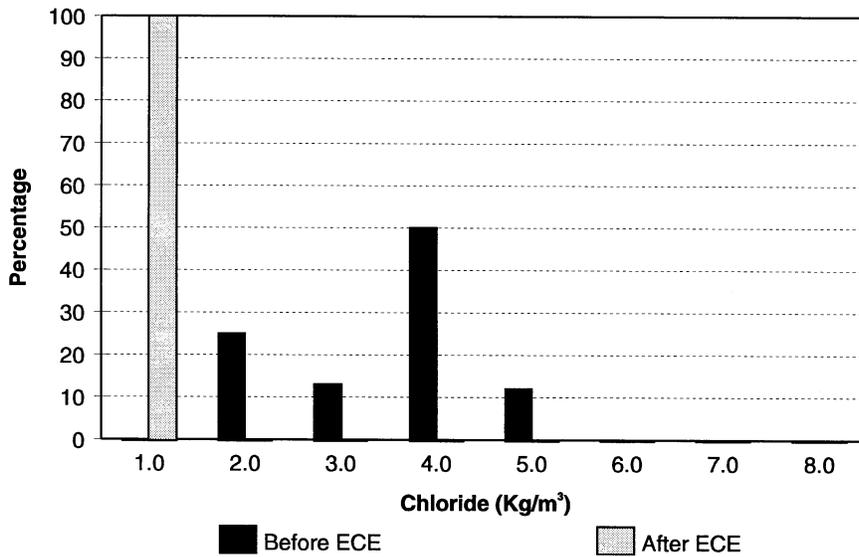
Span 4 (South Half): 0.6 - 1.9 cm

Span 4 (South Half): 1.9 - 3.2 cm

Figure 18. Change in the population distribution of chloride concentrations in the concrete of the south half of Span 4 at two different depths after ECE treatment.

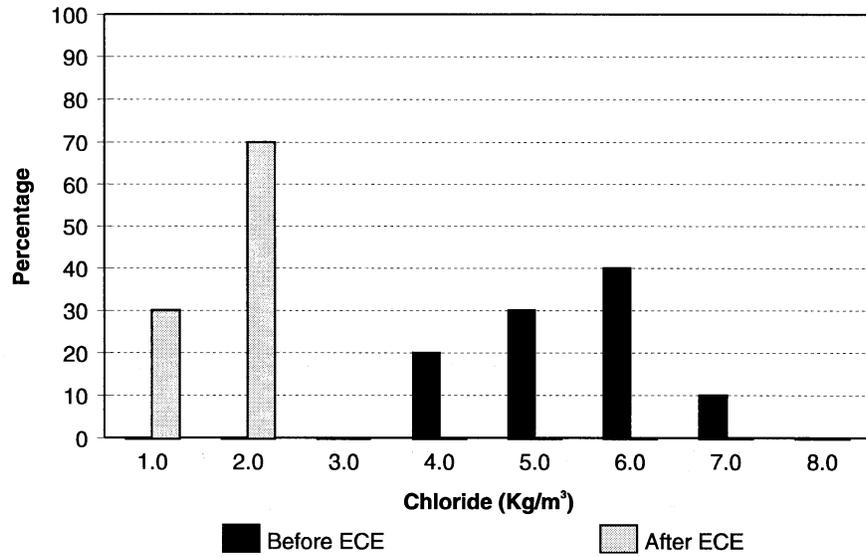
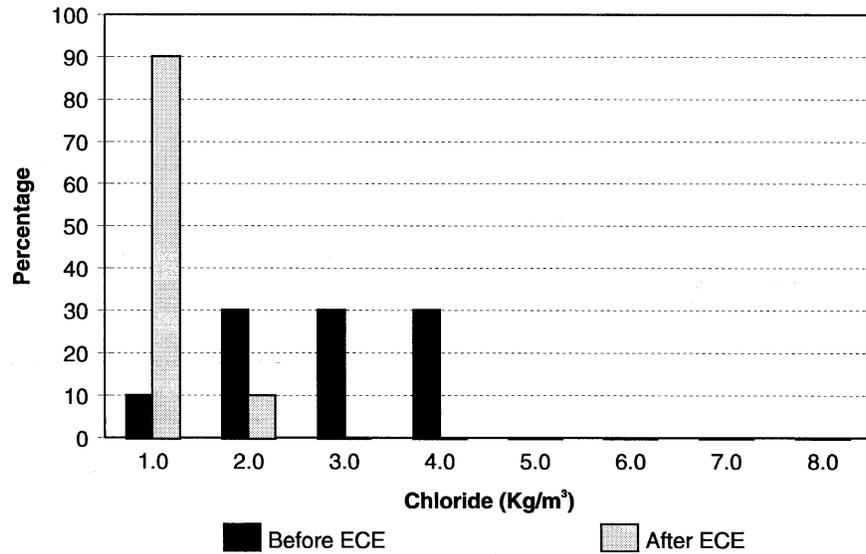
Span 5 (South Half): 0.6 - 1.9 cm

Span 5 (South Half): 1.9 - 3.2 cm

Figure 19. Change in the population distribution of chloride concentrations in the concrete of the south half of Span 5 at two different depths after ECE treatment.
