CONTRACT REPORT

**STRATEGIES FOR IMPEDIMENT REHABILITATION TO CREATE FISH PASSAGE
OPPORTUNITIES IN THE RAPPAHANNOCK RIVER BASIN**

June 2004
VTRC 04-CR2

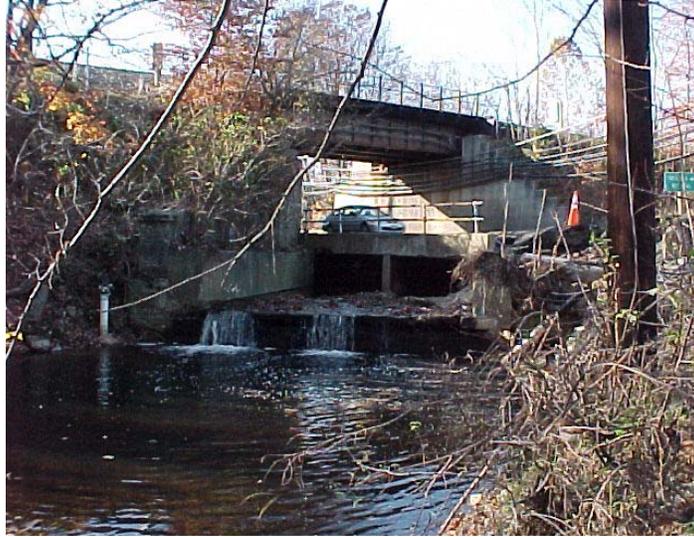
Figure 1. Claiborne Run at Rt. 218, Stafford County. Note: Road no longer functional.

This passes under Rt. 218, Stafford County, just NE of the Fredericksburg City limits. The present double box culvert is raised significantly above stream level impeding upstream movements of fishes. The placement of a fish passage structure will allow anadromous fishes such as alewife and blueback herring as well as catadromous fishes such as American eel, reach additional spawning grounds upstream of the road. In addition it will allow those resident fishes downstream access to upstream habitats, supporting a more completely connected system. (See Figure 1.)

Although Claiborne Run was our first and initially best choice for fish passage in the Rappahannock River system, we have formally abandoned the site for the passage project. Following our initial site visit, we met on-site with personnel from VA Dept. of Transportation (Brian Hawley, primary contact; Brain.Hawley@VirginiaDOT.org), VA Transportation Research Council (G. Michael Fitch; gmf8X@virginia.edu), VA Department of Game and Inland Fisheries (Alan Weaver; aweaver@dgif.state.va.us), US Fish and Wildlife Services (Dick Quinn; Dick.Quinn@fws.gov and David Sutherland; David.Sutherland@fws.gov) and consultants and engineers [Scott Cahill (watershedservices@yahoo.com) and Tim Davey and Mike Claude, Timmons Engineering (Mike.Claud@timmons.com, tim.davey@timmons.com)]. Dick Quinn (USFWS) fish passage expert provided engineering recommendations for effective installation of a proposed Alaskan steep pass structure. Additional meetings with VDOT and VDGIF personnel discussed necessary permits and potential for time of year restrictions on construction. We obtained cost and time estimates for the production of steep pass structures from local and out-of-state-manufacturers. After review of estimates, we settled on a local metal shop, Richmond Steel Inc. in Richmond to build the first two sections of steep pass for the Claiborne Run site (Figure 8).

1. The road previously crossing the stream (218) had been diverted and VDOT would no longer be maintaining the road or culvert,
2. The culvert was currently undercut necessitating further concrete repair of portions of the culvert prior to placement of the structure
3. Additional funds for repair, placement, and CSX's needs were unavailable.

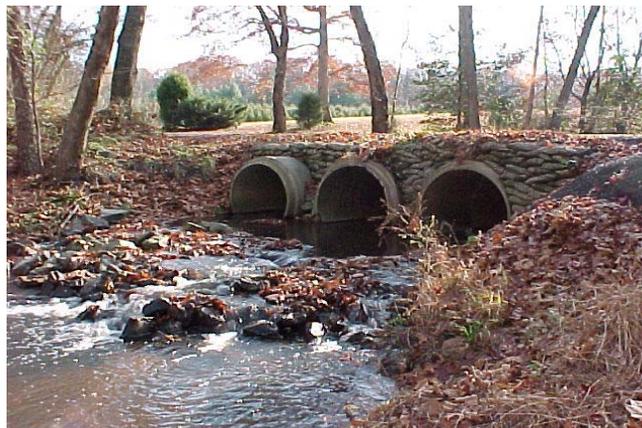
Figure 2. White Oak Run at Co. Rt. 601, Stafford County.

This is also a tributary of the Rappahannock River drainage in Stafford County, Virginia. Just prior to the confluence with Muddy Run, White Oak Run is crossed by Co. Rt. 601. At Rt. 601, a triple pipe culvert is raised sufficiently to impede anadromous fishes and resident fishes alike. A fish passage structure at this locality will also allow for the free movements of anadromous and resident fishes. (See Figure 2.)

White Oak Run (Figure 2) is presently being fitted with a pool-weir fish passage system. Water will be diverted into a single pipe culvert and the pool-weir steps will be placed in the road rubble and substrate downstream of the road culverts. Landowner permission to perform this work was obtained from Mr. Manley Turner as the written permission is archived at Virginia Commonwealth University. The upstream diversion wall will be similar to that of Figure 10.

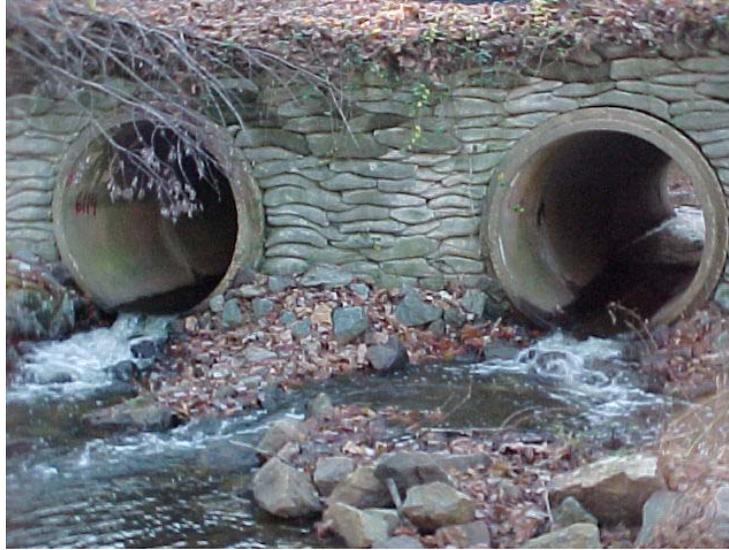
Figure 3. Ware Creek at Rte 766 (Burma Rd) Caroline County.

This is a third Rappahannock River tributary. Ware Creek runs under Co. Rt. 766 in Caroline County southwest of Fredericksburg. The drop from the culvert to the creek downstream of the culvert suggests a steep pass structure would be best at this particular site. (See Figure 3.)

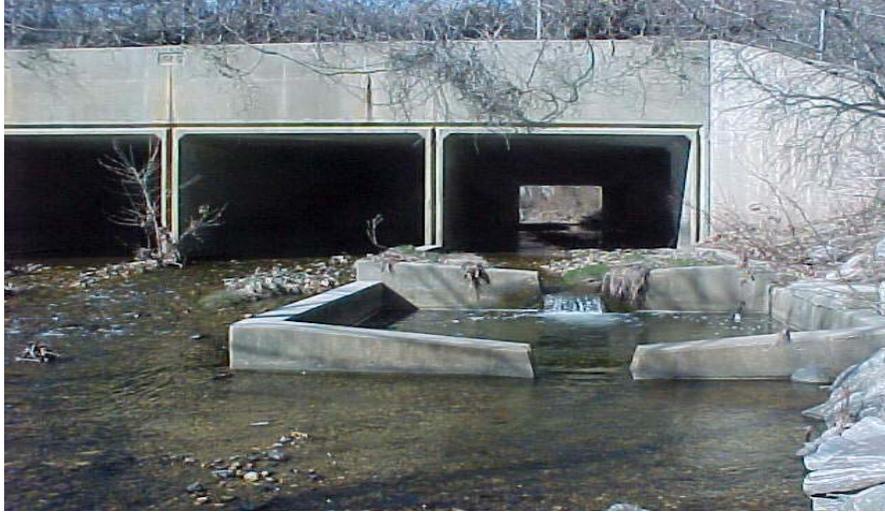
Figure 4. Paint Branch site at I-495, Prince Georges County, MD.

The fish passage at the Paint Branch site is a simple pool-weir design (Figure 4). Upstream of the large box culvert is a small diversion wall that is designed to force most of the streams flow into a single culvert. Downstream of the culvert two concrete boxes were formed (the pools) with notches cut allowing appropriate flow and depth for anadromous fishes. As one can see from the Figure 4, presently this design represents a failed system in that the intended channel has filled with sediment and gravel effectively raising the elevation above that of the remainder of the stream and hence reducing real and potential flow in the intended area. At present there is a need for heavy machinery to clean out the deposited sediments (too much for manual labor). It is unlikely that fishes will utilize this passage facility. Table 1 lists the species that were captured at the Paint Branch site in 2001 and 2004, as well as those that were marked. No marked fishes were captured above the culvert at any of the collections. No anadromous fishes were found above the culvert. Water quality parameters measured (temperature, dissolved oxygen, pH, conductivity, and salinity) were within acceptable range for anadromous fishes.

The pool-weir at Paint Branch site is obviously a failed system (Figure 4) due to a lack of required regular maintenance at this site. A different placement of the structure or, perhaps a different hydrological assessment of the site may have suggested an alteration of the passage placement. However, shifting substrates that exist in these settings and the ability of those sediments to fill constructed pool-weir systems suggests high maintenance and must be considered prior to construction. To a lesser extent the Budd's Creek Alaskan steep pass (Figure 7) requires periodic maintenance (here performed by a landowner) to clear woody debris from the structure. If not adequately removed, build up of woody debris and leaf litter may effectively clog the system rendering its passage abilities non-existent. The substrates upstream of the Sawmill Creek site are finer and thus, with ample flow in the system, are not likely to clog the pool-weir design placed therein (Figure 5).

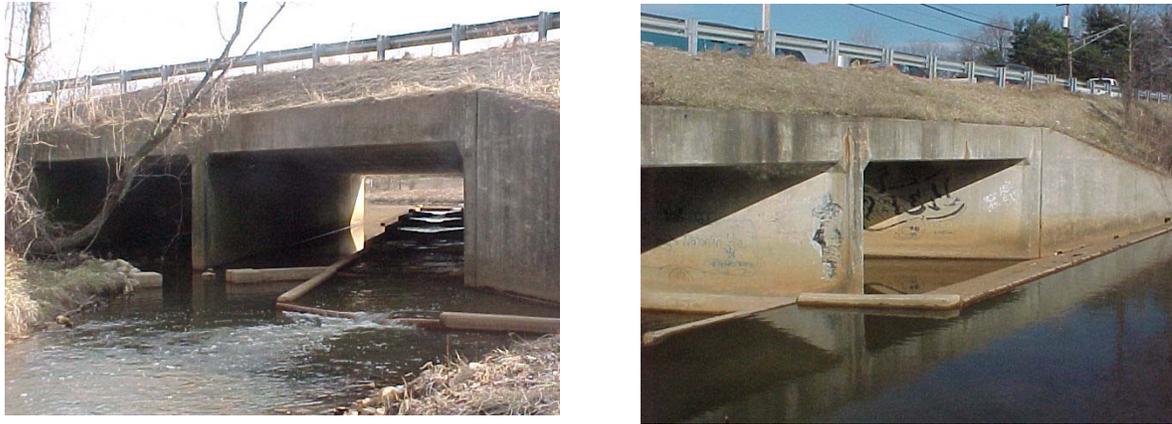
Figure 5. Sawmill Creek culvert and downstream and upstream views of the custom pool-weir fish passage.

Upstream of the large double-box culvert is a diversion wall (Figure 5; right) that is designed to force most of the streams flow into a single culvert but allow spillover when necessary. A seven-step, pool-weir raceway was developed using concrete from about 4 meters downstream of the culvert through the length of the culvert. Table 2 lists the species that were

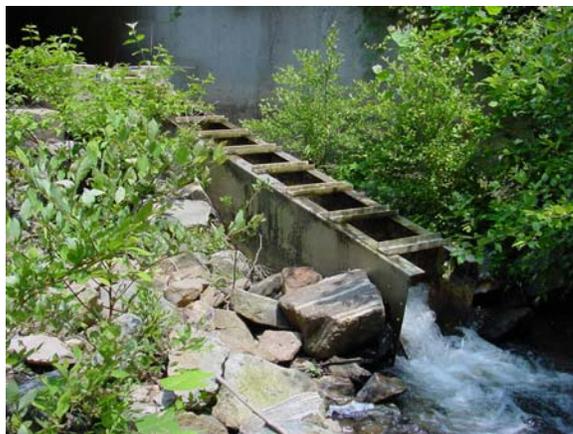
Figure 6. Hogs Hole Run fish passage at Highway 6, Charles Co., MD.

Access to this site was directly from Highway 6 or from a side road with a small development where landowners granted access. Although alewife have been found in this area (Odell et al. 1975), this site is not likely a major spawning ground. There were no anadromous fishes taken during any of the surveys here. This was largely due to insufficient water depth throughout the study area. Figure 6 represents the flow conditions at Hogs Hole Run during the 31 May 2001 survey. Although water is being diverted upstream and concentrated into the raceway leading to the Alaskan steep pass structure, insufficient depth exists to effectively allow passage of anadromous herrings. A few resident fish species were marked but none was later located upstream of the fish passage. No fish were shocked from within the structure.

We do not assess this as an indication of steep pass inefficiency but rather a situation of low water conditions and, perhaps, poor placement judgment. Although water conditions in the area were considerably higher in April 2004, water passing through the steep pass remained marginal in depth and flow. No anadromous fishes were captured (Table 3). A landowner said that the structure often gets clogged with woody debris (most frequently after storms) and that he cleans it regularly.

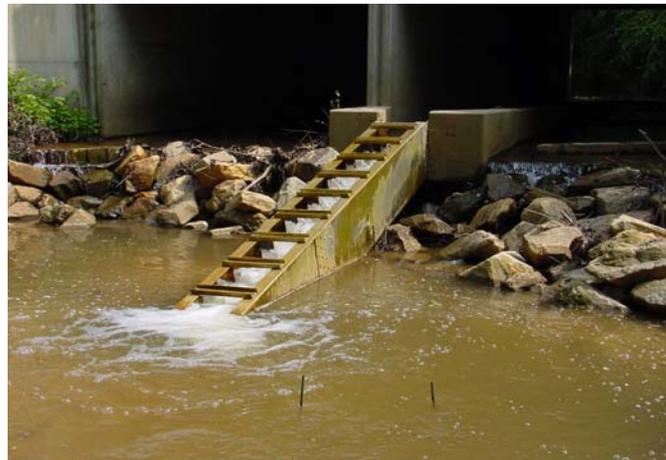
Figure 7. Budd’s Creek fish passage at Rte 234, Charles-St Mary’s Co. line, MD.

The Budd’s Creek fish passage structure (Figure 7) is located on the border of Charles and St. Mary’s Counties at Highway 234 (Budd’s Creek Road).

Fishes captured at this site are presented in Table 4. Low water conditions throughout most of the spring of 2001 made the likelihood of anadromous fish usage minimal at this site. Toward the end of the regular spawning season we collected 75 blueback herring from downstream (near the mouth) marked and transported them via aerated cooler to the site. Flooding occurred prior to the next collection and the herring were not collected again. Seven blueback herring were taken just downstream of the passage structure in April of 2004; none was collected above. The anadromous sea lamprey, however were shocked while spawning upstream of the road crossing indicating usage of the fish passage structure. One marked creek chubsucker was collected above the road indicating some use of the passage system by resident fishes. No fishes were collected inside of the steep pass but a few dusky salamanders were shocked from the structure. Some beaver activity is noted from the area in 2004.

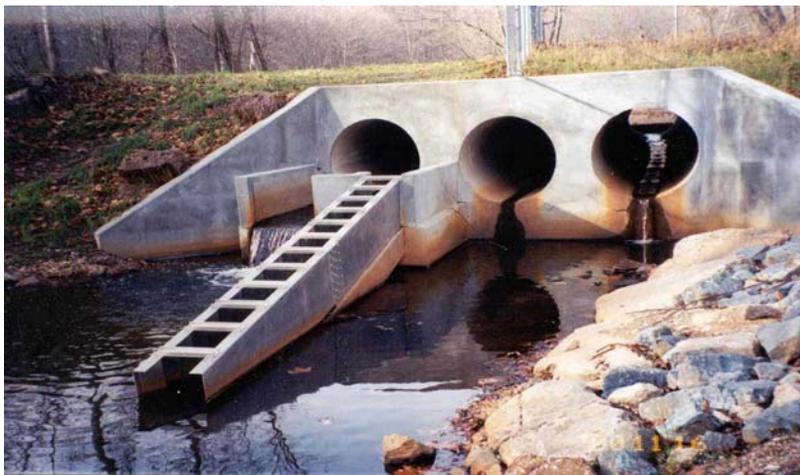
Figure 9. Steep pass design for Claiborne Run. Note adjustable gated flow wall to left of steep pass structure.

A placement similar to that in Figure 9 was designed for the Claiborne Run site and additional funds (about 40 thousand dollars) for the placement of two passage structures were obtained from the U.S. Army Corp of Engineers through The Nature Conservancy. Upon final permit and right-of-way review by VDOT personnel it was determined that considerable right-of-way in the study area was owned by CSX corporation. Initial contact was attempted with local CSX offices who directed us to the proper personnel in the Florida office. After correspondence with the Florida office we were contacted by a consulting/law firm in Philadelphia. We sent them our proposal to install an Alaskan steep pass structure and replied that a contract with us would be required to compensate their personnel for time spent reviewing the project.

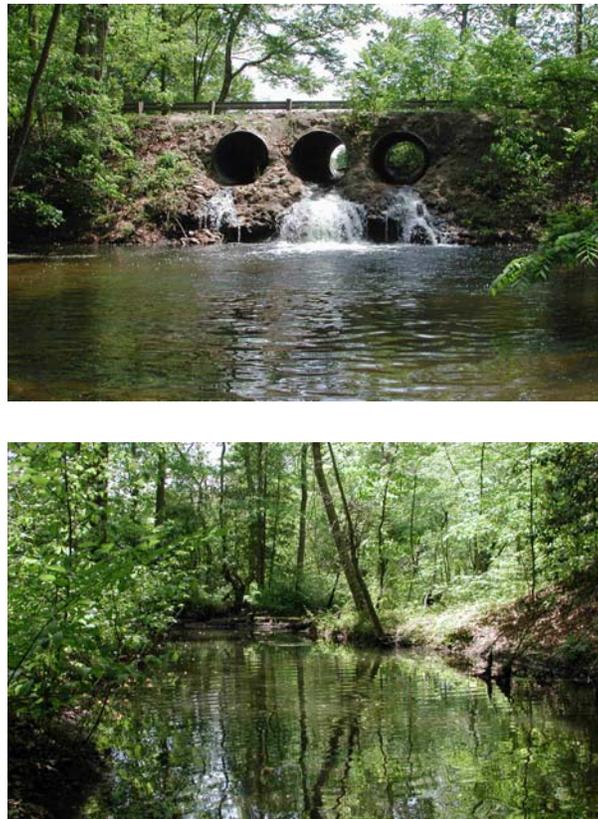
Figure 11. Carter Creek impediment, Rt. 614 Gloucester County, York drainage. Top is looking upstream toward road culverts; bottom is looking downstream from road.

An additional site in the York drainage was cited as a potential replacement for the Alaskan steep pass structures developed for the Claiborne Run site. Carter Creek at Rt. 614 in Gloucester County is impeded by culverts that empty portions of Hayes pond. We continue to work toward landowner permission for this site and will update VDGIF and VTRC as work progresses. There is some question as to the length of passage structure needed for this site and contact has been made with Alan Weaver (VDGIF) and Dick Quinn (USF&W) to address some concerns about passage at this given site. Figure 11 shows photos looking upstream toward the impediment and downstream from the impediment. This area is known to have anadromous fish runs in the spring.
