research report

An Evaluation
of the Performance of Concretes
Containing Fly Ash and Ground Slag
in Bridge Decks

September 2006
VTRC 07-R7

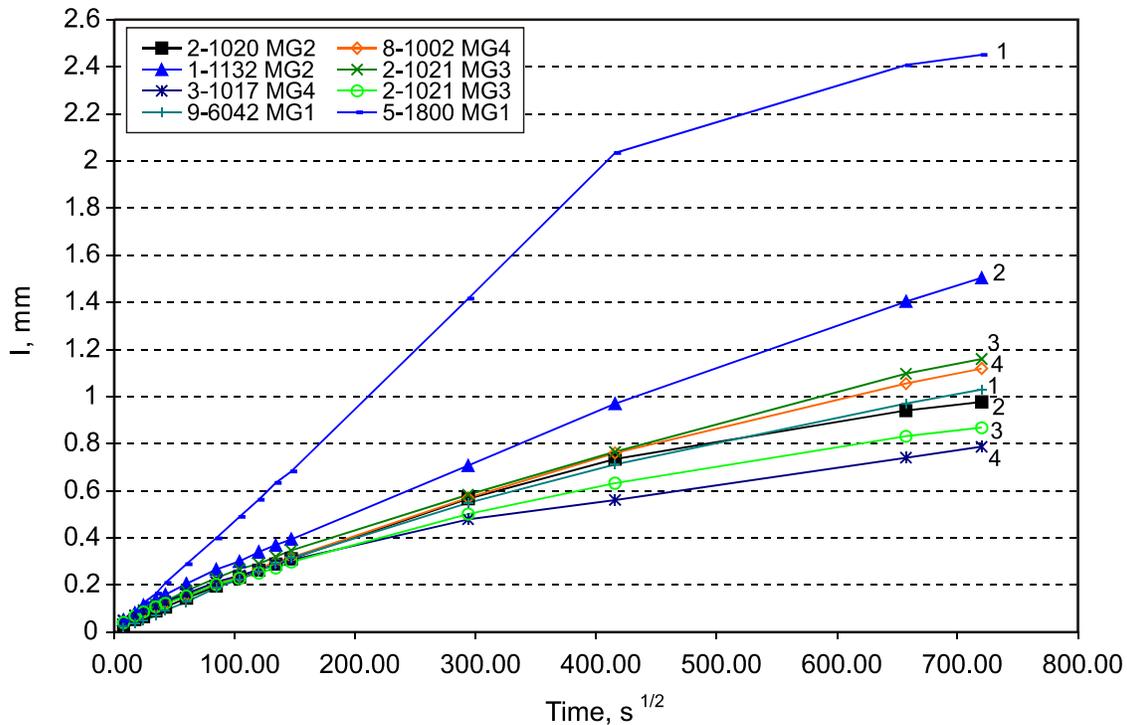
Figure 1. Graphical Example of Rate of Absorption (ASTM C 1585) Data. Materials group: 1 – PCC 0.47; 2 – PCC 0.45; 3 – fly ash; 4 – ground slag.

The average initial rate of absorption ranged from a low of 8.2 to a high of 57.8×10^{-4} mm/s^{1/2}. These values compare to a suite of 28-day laboratory concretes that exhibited values ranging from 4.8×10^{-4} mm/s^{1/2} for a 0.38 W/CM concrete with 6% silica fume by mass to 35.2×10^{-4} mm/s^{1/2} for a portland cement concrete with a 0.58 W/CM (Lane, 2006a), suggesting a broad range in concrete quality. The secondary rate of absorption values had a smaller range, from 5.8 to 24.8×10^{-4} mm/s^{1/2}. Secondary absorption rates for the laboratory concretes ranged from 2.3 to 15.3×10^{-4} mm/s^{1/2}. An example of the graphical plot of data is shown in Figure 1.

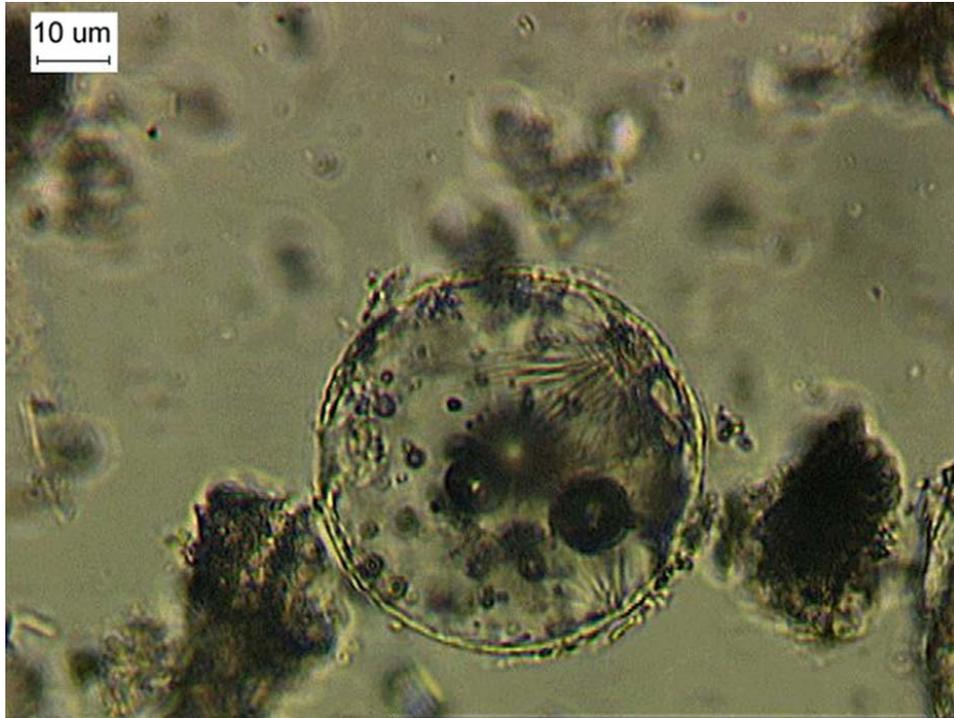
Figure 2. Fly Ash Particle in Immersion Mount of Pulverized Paste (2-1021)

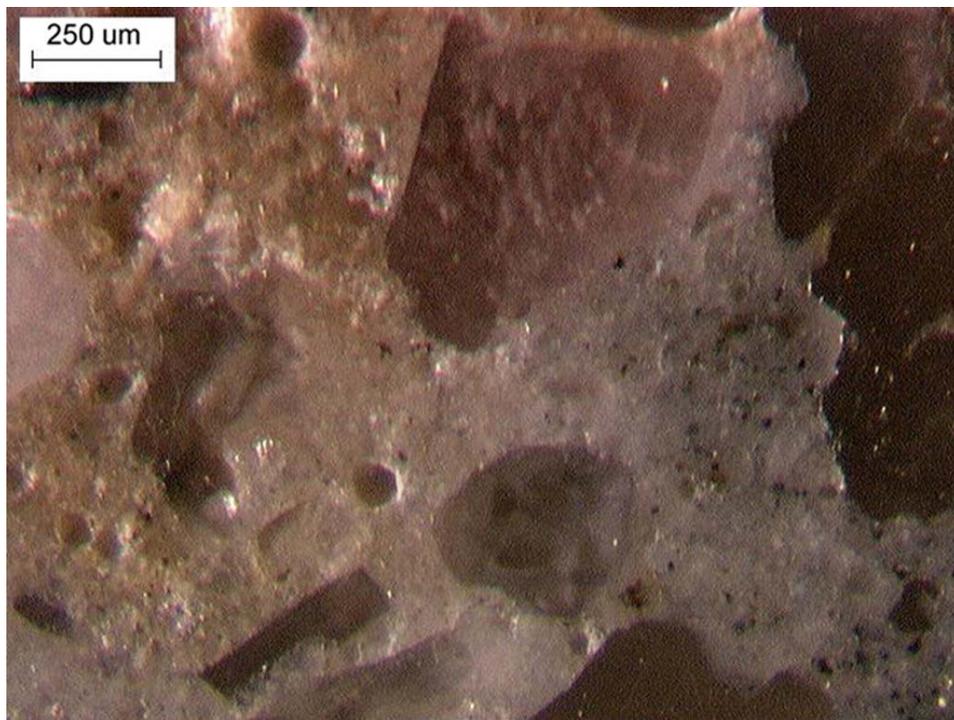
Figure 3. Small Area of Greenish Bluish Paste Adjacent to Aggregate Particle on Right Margin Is Indicative of Presence of Slag Cement (3-1000)

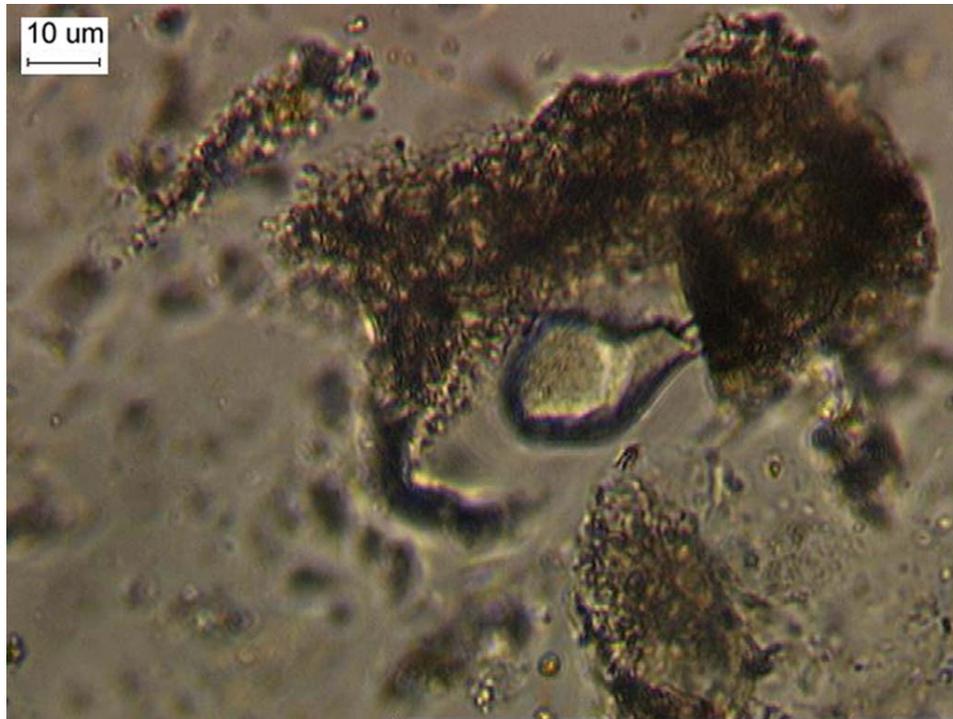
Figure 4. Unhydrated Core of Slag Particle in Immersion Mount of Pulverized Paste (9-1014)
