# Wear Resistant Pavement Study

WA-RD 657.2

Experimental Feature WA03-02

Sullivan Road to Idaho State Line, Phase I

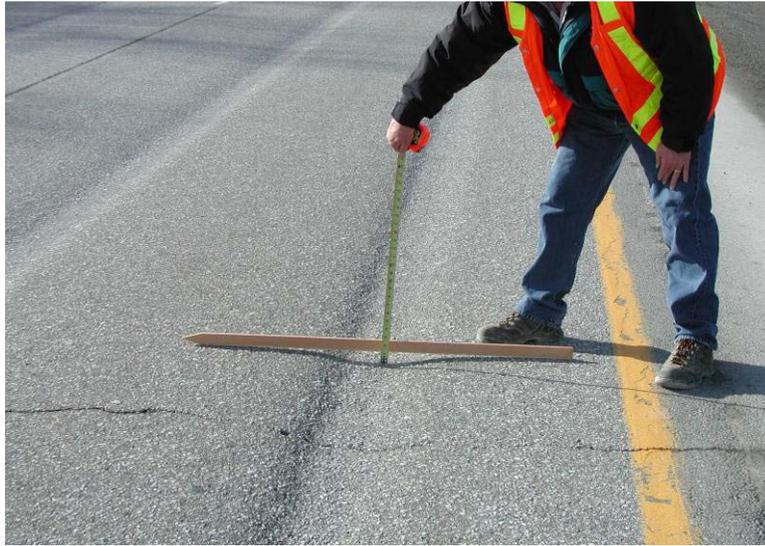
Figure 1. Studded tire wear in HMA pavement on I-90 near the Idaho border.

The primary objective of this experimental feature is to evaluate the performance of a PCC whitetopping overlay, a Modified Class D HMA overlay, and a micro/macro surfacing section in reducing studded tire wear. Studded tire wear is a problem throughout the state, but it is particularly severe in the Spokane metropolitan area as evidenced by the rutting shown in Figure 1. A survey conducted by WSDOT during the winter of 1996-1997 revealed that, on the average, 10 percent of passenger vehicles use studded tires in Western Washington and 32 percent use them in Eastern Washington. The survey also indicated that the highest stud usage was in the Spokane area at 56 percent and the lowest in the Puyallup area at 6 percent.

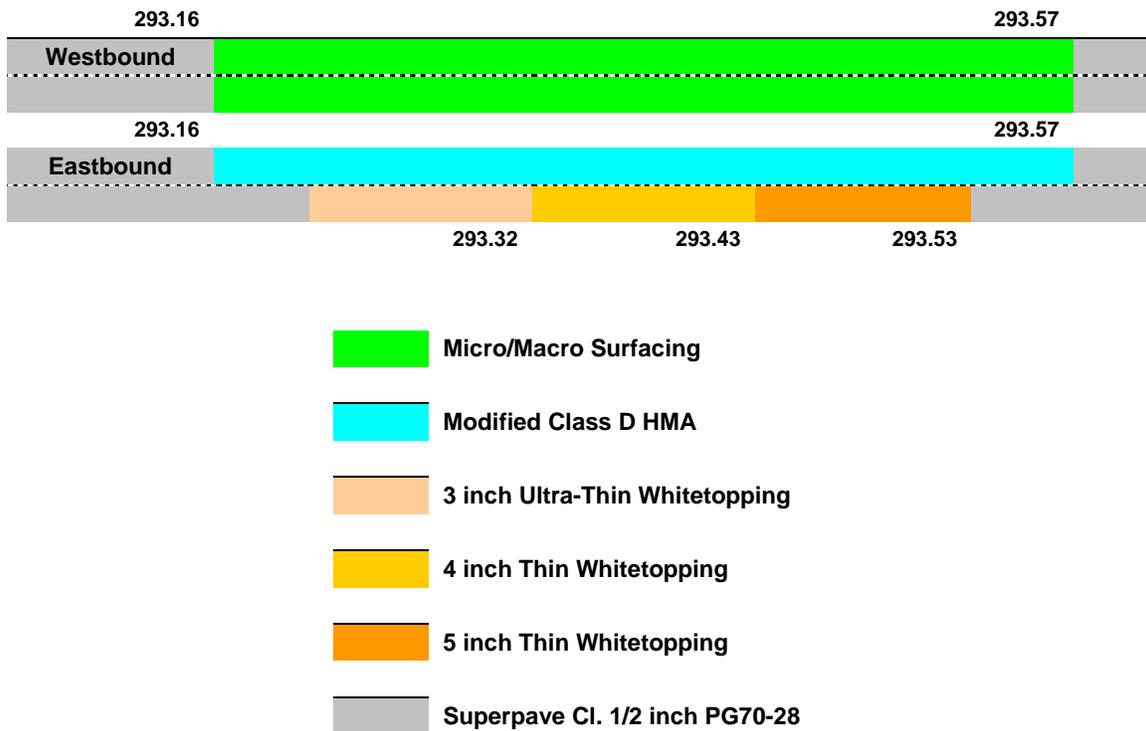
Figure 2. Location of test sections.

The experimental sections were constructed between mileposts 293.15 and 293.55. The thin and ultra-thin test sections of whitetopping were placed in the outside truck lane in the eastbound direction. The Modified Class D HMA section was placed next to the whitetopping in the inside passing lane in the eastbound direction. The micro/macro resurfacing was placed in the westbound lanes opposite the whitetopping and Modified Class D as noted in Figure 2. The control section of Superpave ½ inch HMA was used on the remainder of the contract.

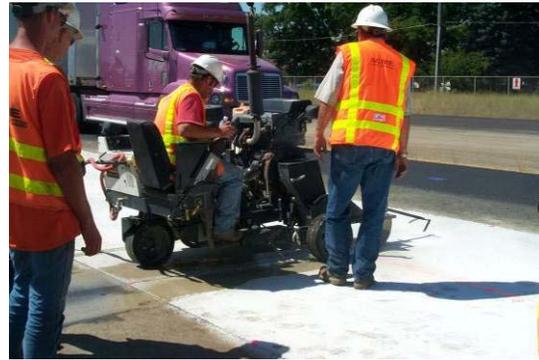
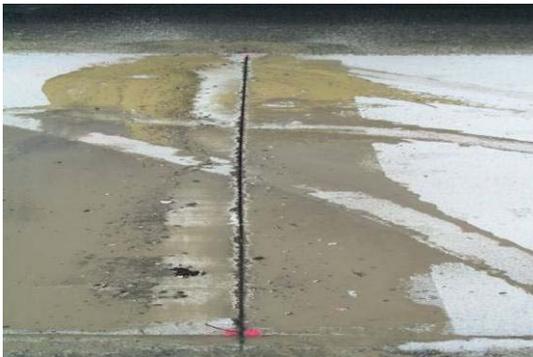
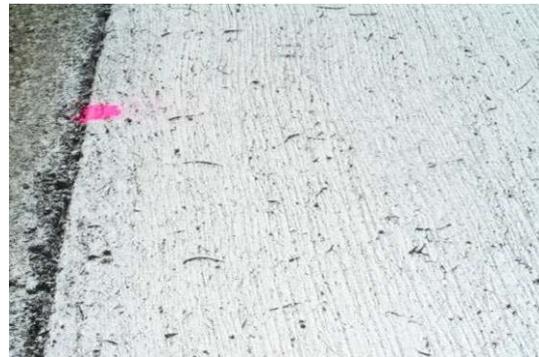
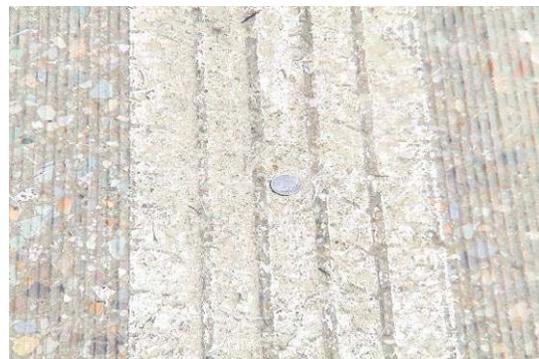
Image B. Joint sawing operation.

Image C. Spalling of joints due to tender mix or fibers or a combination of both.

Image D. Surface of whitetopping showing fiber reinforcement.

Image E. Diamond grinding to remove the ruts from the vehicle that entered the construction zone.

Image F. Ruts caused by vehicle that entered the construction zone during paving.

Figure 4. Whitetopping paving operation from curing to joint sawing and diamond grinding.

A carpet drag finish was applied to the wet concrete in two stages, one directly behind the paver, and one propelled by hand several feet behind the first stage. White curing compound was applied by a hand held spraying wand. The 5' x 6' joint pattern used for all three sections was formed by diamond sawing. The sawing began at 3:15 pm and was not completed until 10:00 pm. There were many delays in the sawing due to spalling at the joints caused by a tender mix or the embedded fibers or a combination of both. Image C of Figure 4 shows the spalling of the joints due to the sawing operation. Sealing of the joints was completed on the 20<sup>th</sup> and the sections were opened to traffic on the 22<sup>nd</sup>. Opening to traffic was delayed because cylinder breaks from the last load of concrete were at 4000 psi compressive strength. Although this converts to a flexural strength of 690 psi and would probably meet or exceed the 14 day requirement of 800 psi written into the Special Provisions (Appendix C), the Contractor elected to play it safe and not open the section to traffic. Images of the whitetopping construction sequence are shown in Figures 3 and 4.

One of the other problems encountered with the placement of the whitetopping, in addition to the spalling problems during joint sawing, was that a vehicle drove inside the traffic control and put 1/8 to 1/4 inch deep ruts in the last 100 feet of the wet mix. The Contractor diamond ground the last 100 feet to remove the tracks, see Image E of Figure 4, but the tire tracks are still visible even after the diamond grinding.

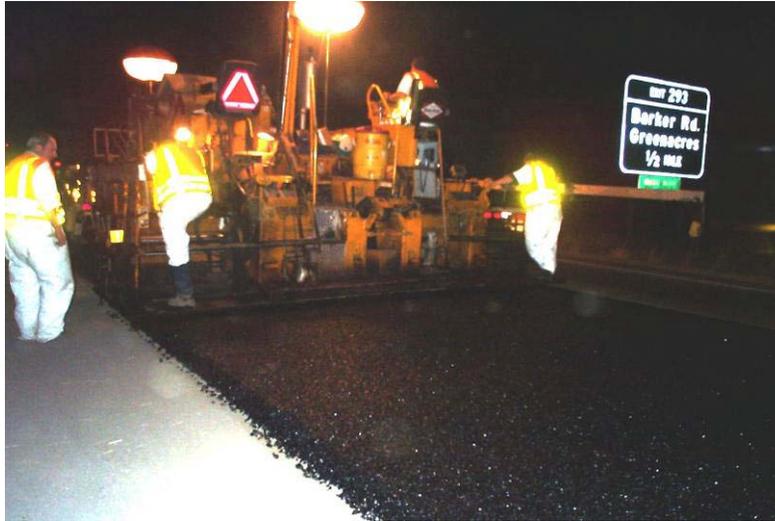
Figure 5. Paving of Modified Class D mix.

Paving of the Modified Class D followed rotomilling to remove 2 inches of the existing pavement. An equal amount of Class D mix was then inlaid on the 2,100 foot test section. One of the concerns with the compaction of open graded mixes is that they lose heat rapidly due to the additional void space that exposes more surface area to the air than a dense graded mix. This did not appear to be a problem with this overlay because the Eastern Region recommends that the Contractor use vibration during breakdown compaction. WSDOT Special Provisions state that HMA Class D shall be compacted to the satisfaction of the Engineer and they do not require the use of pneumatic rollers. Figures 5 and 6 show the placement of the Modified Class D pavement.

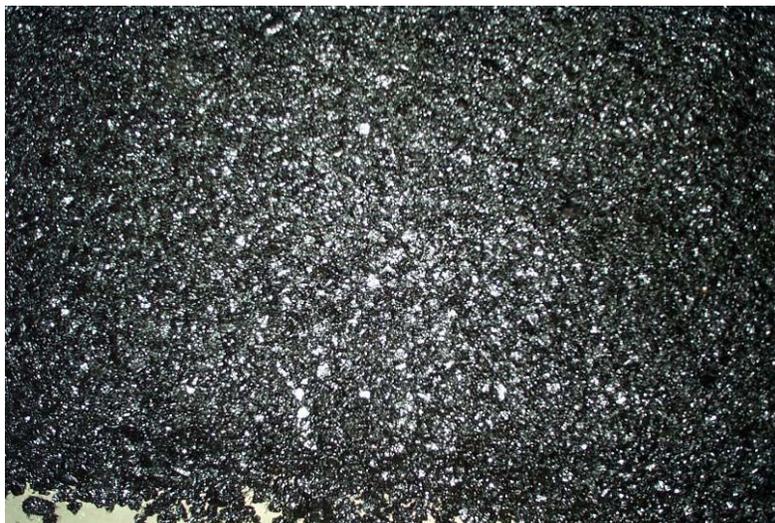
Figure 6. Close-up of Modified Class D mix.

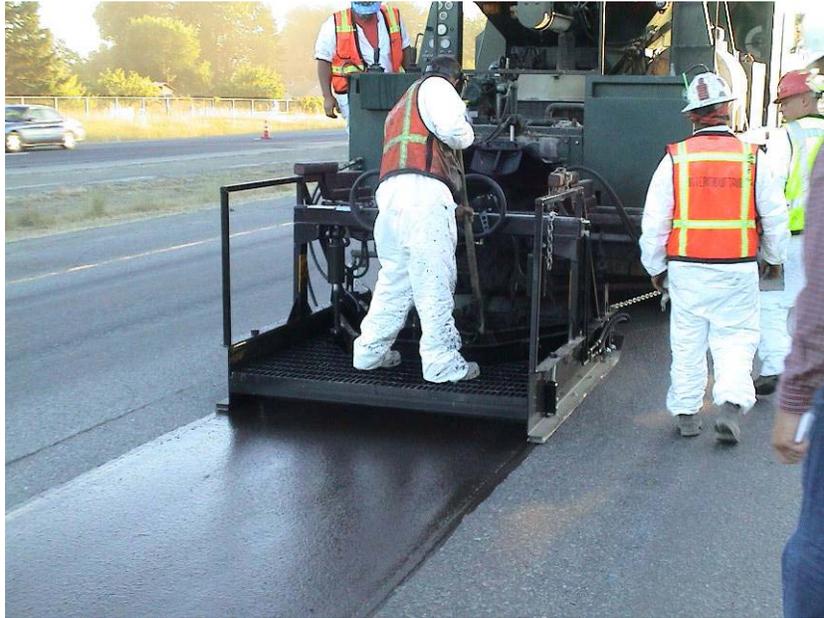
Figure 7. Micro-surfacing being applied to the rut in the left wheel path of the outside line westbound.

The application of the micro-surfacing to fill the ruts in the westbound lanes began on July 9, 2003, see Figures 7 and 8. The outside lane was completed first, but not without problems with rough joints caused by the starting and stopping of the operation and aggregate segregation problems caused by material that was left in the machine from a previous job. A lot of hand work was required to fill the ruts that were 1 ¼ inch deep throughout most of the section. This entailed men pushing squeegees behind the lay down machine to concentrate the micro-surfacing into the deep ruts in the wheel paths. Due to these difficulties a second application of micro-surfacing was placed on July 14<sup>th</sup>. The macro-surfacing was placed on August 16<sup>th</sup>. No problems were encountered with the placement of the macro-surfacing (see Figure 9).

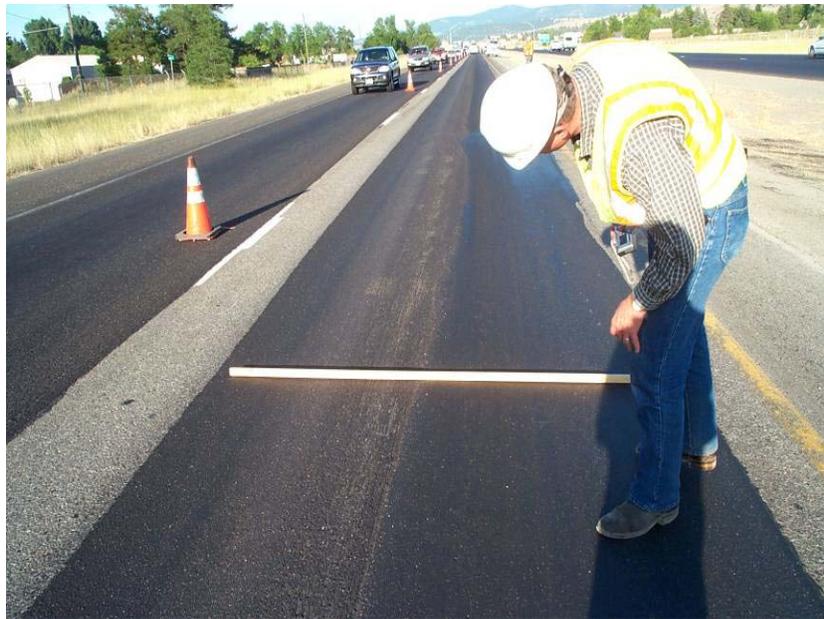
Figure 8. Micro-surfacing placed as a rut fill prior to macro-surfacing within the two westbound lanes of I-90 (MP 293.15 to MP 293.55).

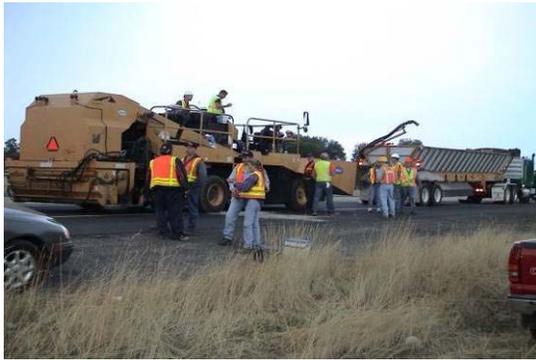
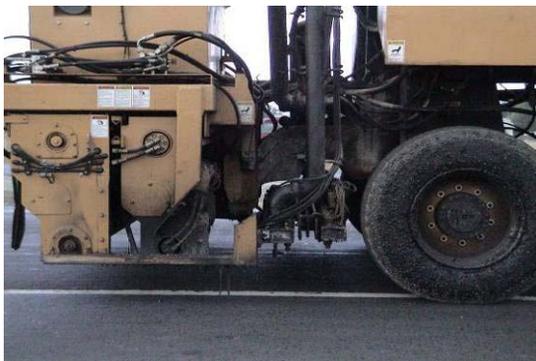
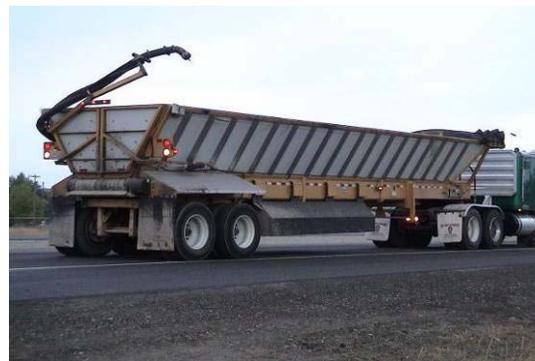
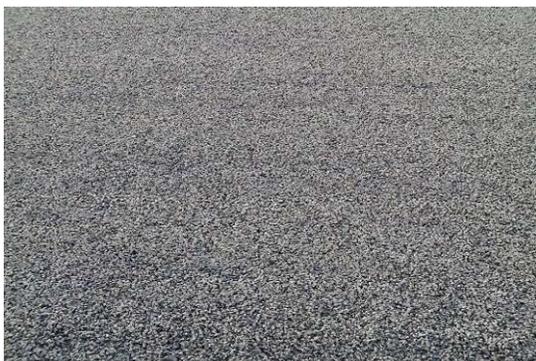
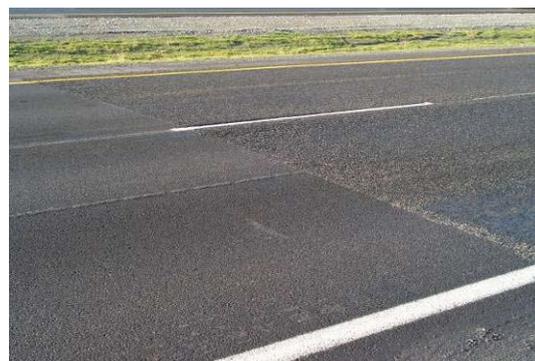
Image A. Paving train for macro-surfacing.

Image B. Macro-surfacing paver.

Image C. Paving machine showing spray bar for binder in the center of the photo. Aggregate is spread from the box behind the spray bar.

Image D. Aggregate truck with asphalt storage tank below. The hose rotates to connect to the paving machine to transfer the binder.

Image E. Completed macro-surfacing overlay.

Image F. Macro-surfacing overlay on the right and existing pavement on the left.

Figure 9. Macro surfacing paving sequence.

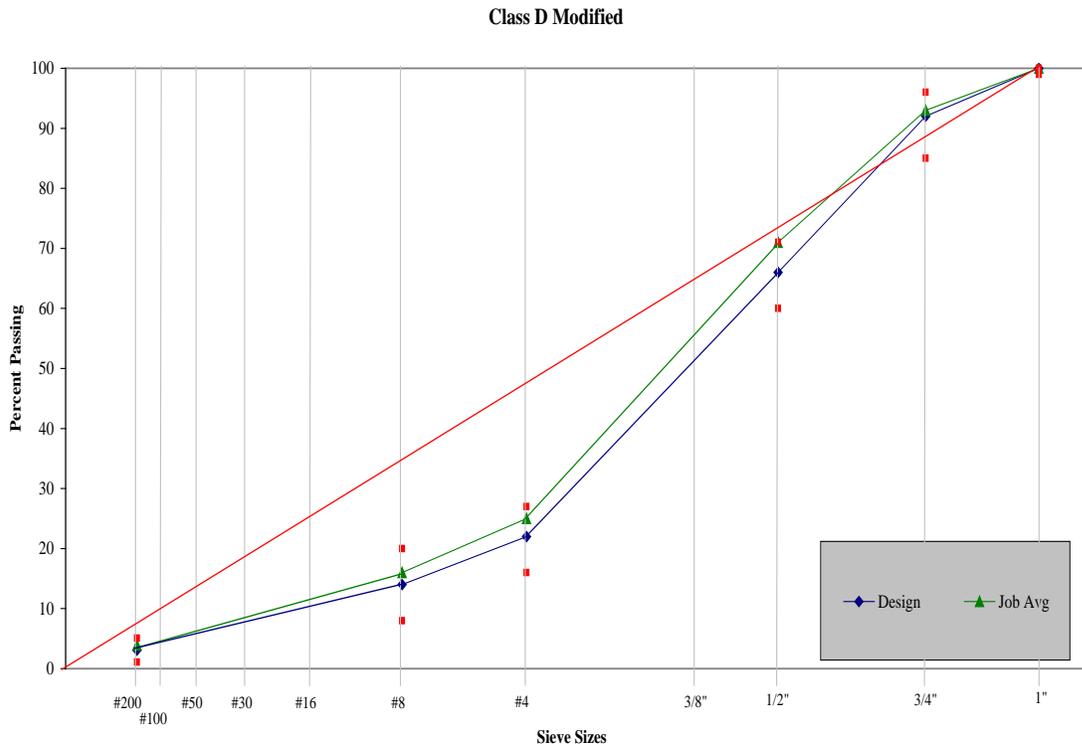
Figure 10. Modified Class D 0.45 power curve.

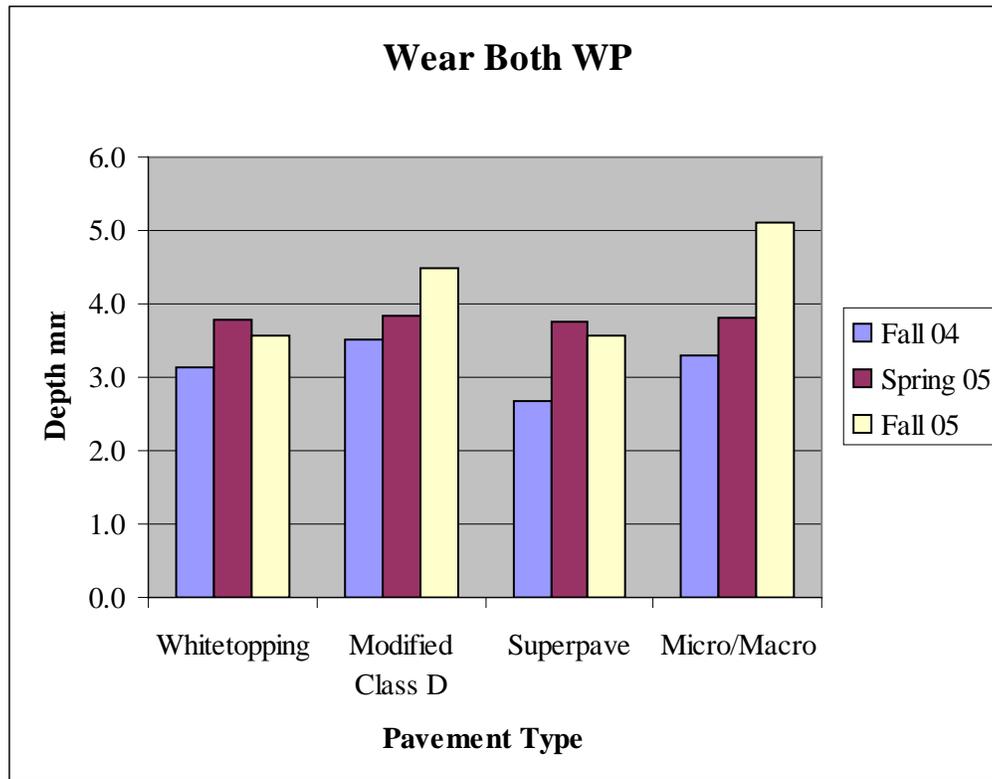
Figure 11 shows the transverse profile results from the Pathway van for the four test sections. As noted earlier measurements were taken in the fall of 2004, following construction, and again in the spring and fall of 2005. The transverse profiles show the amount of rutting or wear in the wheel paths. It is recognized that on PCC pavements the profile is showing pavement wear, whereas for the asphalt sections it may be either pavement wear or rutting or a

The rutting or wear has increased each year in all of the test sections. The micro/macro surfacing is showing the most wear or rutting at 5.1 mm and the whitetopping and Superpave at 3.6 mm with the least wear or rutting. The Modified Class D at 4.5 mm ranks at the next highest wear/rutting below the micro/macro surfacing. The most costly pavement, the whitetopping is showing the most resistance to studded tire wear and the least expensive treatment, the micro/macro surfacing, is showing the least resistance. If the rate of wear noted in the first two years is projected into the future the micro/macro-surfacing will reach 10 mm of rutting in another 1.9 years for a total life of 4 years. It is WSDOT's policy that pavements are scheduled for rehabilitation when they reach 10 mm of rutting. The whitetopping and Superpave would reach this target value in another 3.6 years for a total life of 5.6 years. The Modified Class D is expected to reach 10 mm of rutting in another 2.4 years for a total life of 4.4 years. There is no guarantee that the rate of wear is a constant value over time, therefore, these are only estimates.

Figure 11. Average rutting or wear depths for each pavement type.

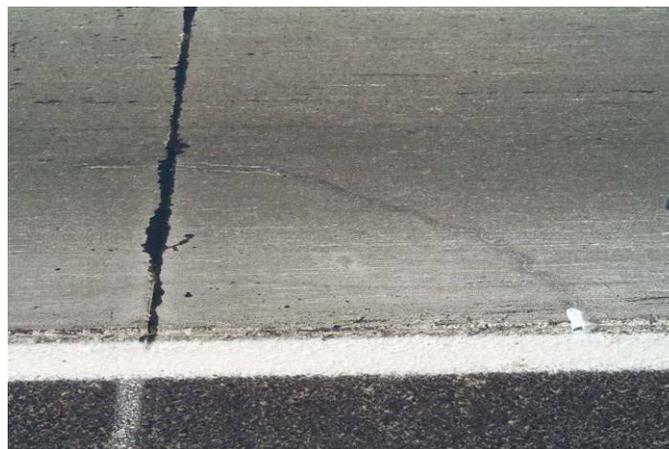
Figure 12. Typical corner crack within the 3-inch ultra thin whitetopping test section.

- 87% of the panels are cracked in the 3 inch section.
- 4% of the panels are cracked in the 4 inch section.
- 4% of the panels are cracked in the 5 inch section.

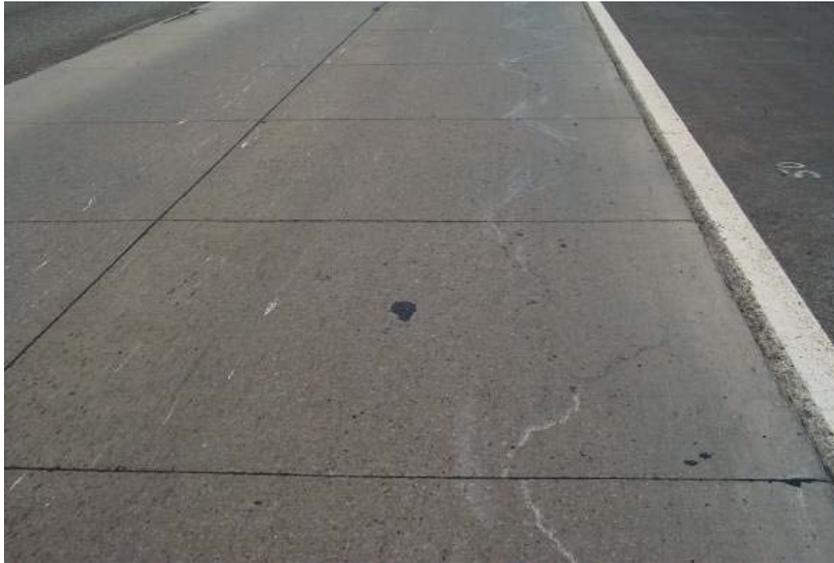
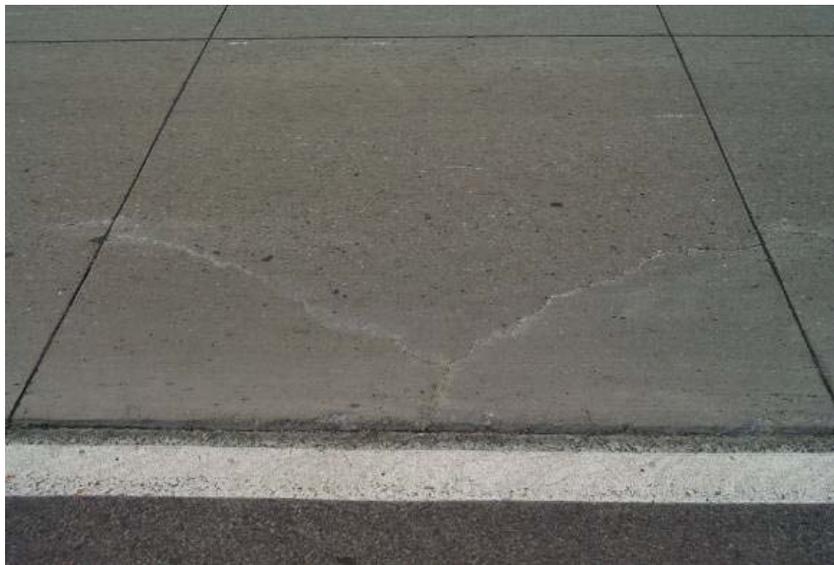
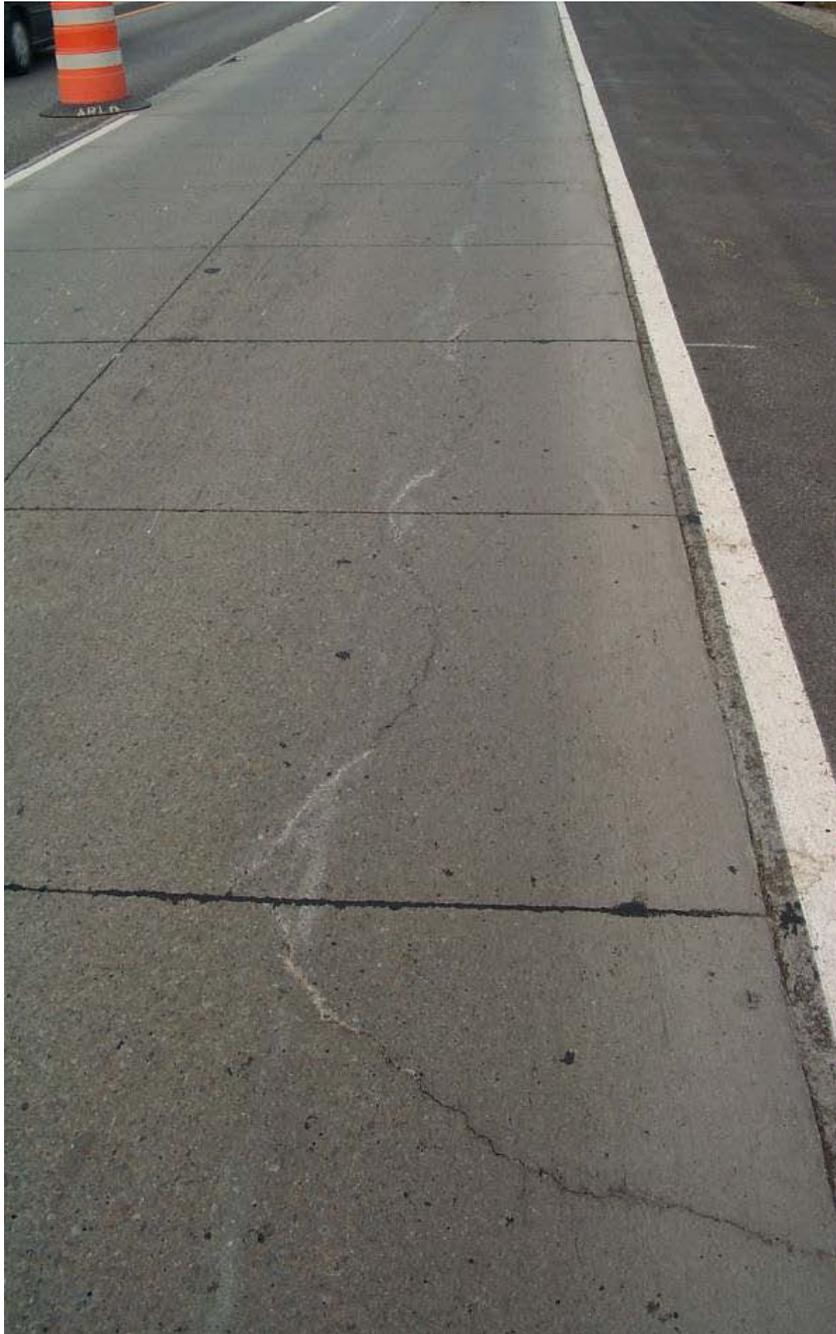
Figure 13. Intersecting corner cracking in the 3 inch ultra-thin whitetopping section. August 2004.

Figure 14. Intersecting corner cracking in the 3 inch ultra-thin whitetopping section. August 2004.

Figure 15. Longitudinal view of intersecting cracking in the 3 inch ultra-thin section. August 2004.

The white precipitate noticeable in the cracks (Figure 13, 14 and 15) was also noted in the MnROAD whitetopping sections (Burnham, 2005). There investigation revealed that the precipitate was calcium carbonate and that it was formed as a result of the carbonation of the concrete. Carbonation occurs in concrete because the calcium in the concrete is attacked by carbon dioxide and converts the calcium to calcium carbonate. The carbon dioxide enters the concrete through the water and air that enters the cracks. Normal carbonation results in a decrease of the porosity making the carbonated paste stronger which is an advantage in non-reinforced concrete.

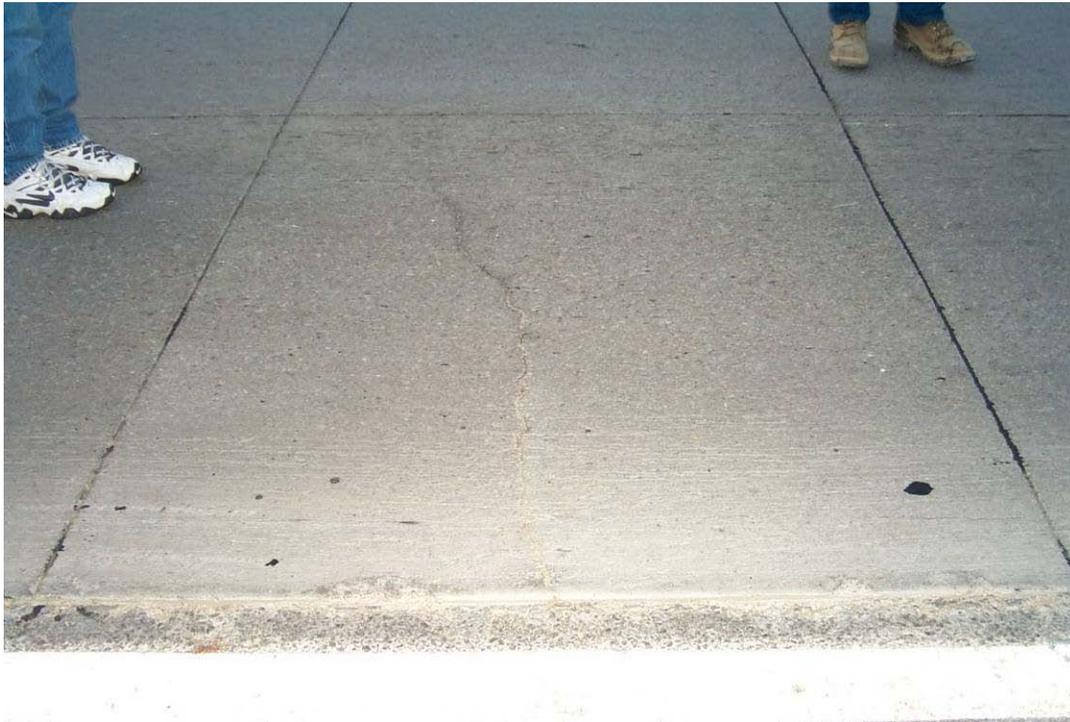
Figure 16. Mid-panel transverse crack in 5 inch test section.

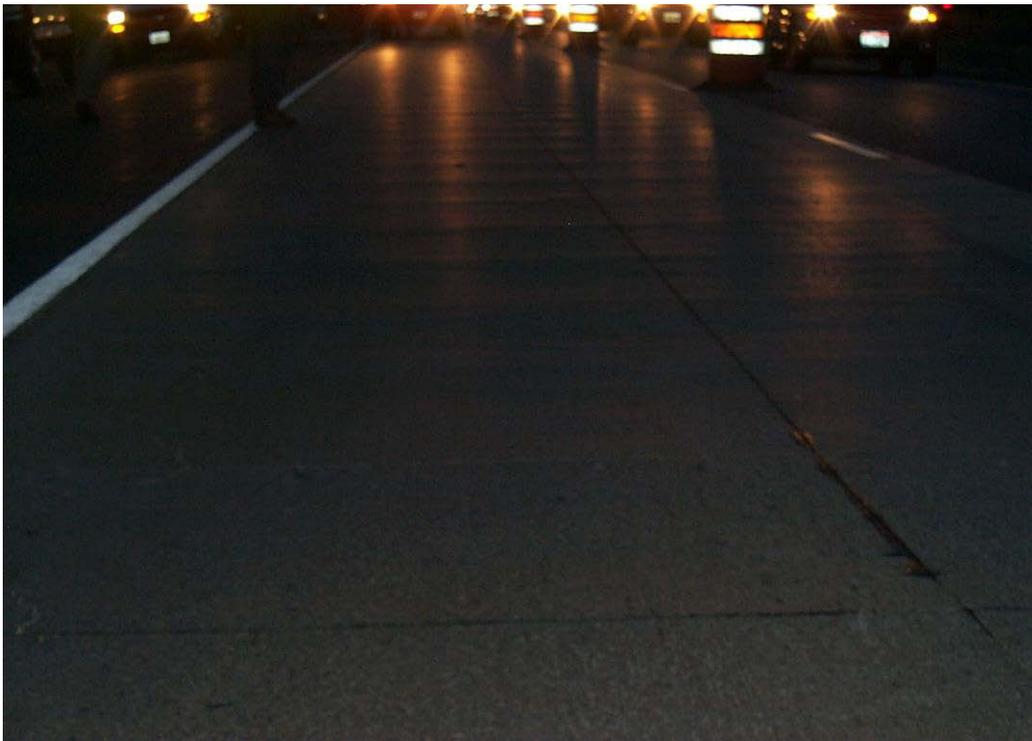
Figure 17. Night time photo of 3 inch ultra-thin whitetopping section showing curing of the panels.

1/16” in the 5 inch section. The measurements were made with a straightedge placed across each transverse joint. The cause of the curling is believed to be a moisture gradient where the top of the slab dries more rapidly than the middle and bottom of the slab. The loss of surface moisture causes the top of the slab to shrink creating a tension that curls the edges of the slab upward (Mark Snyder, personal correspondence).

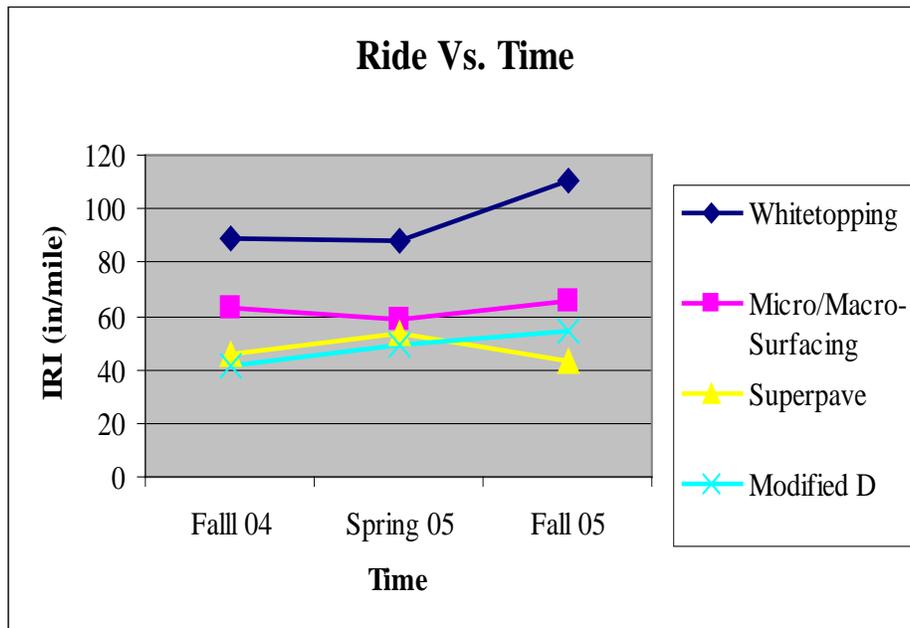
Figure 18. IRI versus time for the four pavement types.

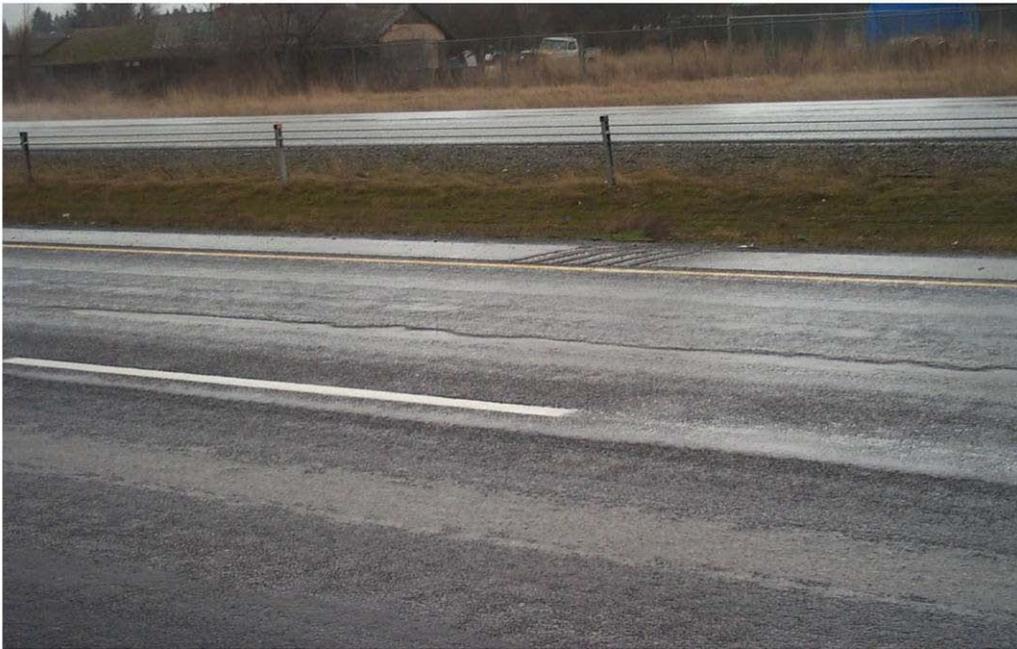
Figure 19. Delamination of the macro-surfacing. Photo taken in January 2005.

There are three areas of concern at this point in time. The first concern is with the rutting in the micro/macro-surfacing section. With the rut depth at 5.1 mm the rutting or wear is over half way to the 10 mm limit before resurfacing should be scheduled. Recent photos of the section show pop outs and delamination of the macro-surfacing adjacent to the wheel paths (see Figures 19 and 20). The life expectancy of the section may be short based on these two issues.

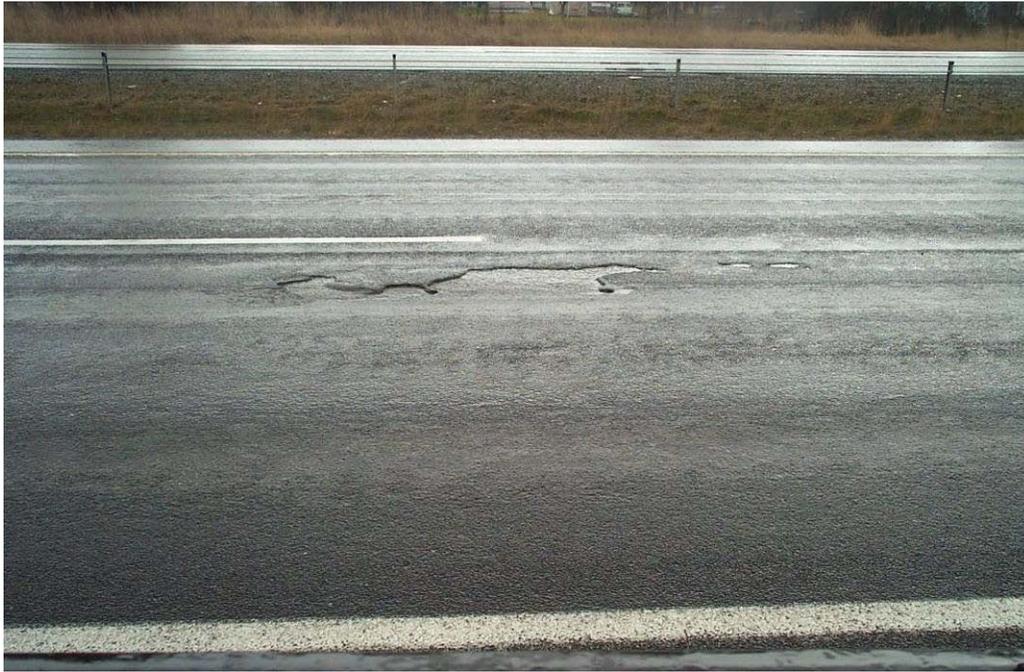
Figure 20. Pop out in the macro-surfacing. Photo taken in January 2005.

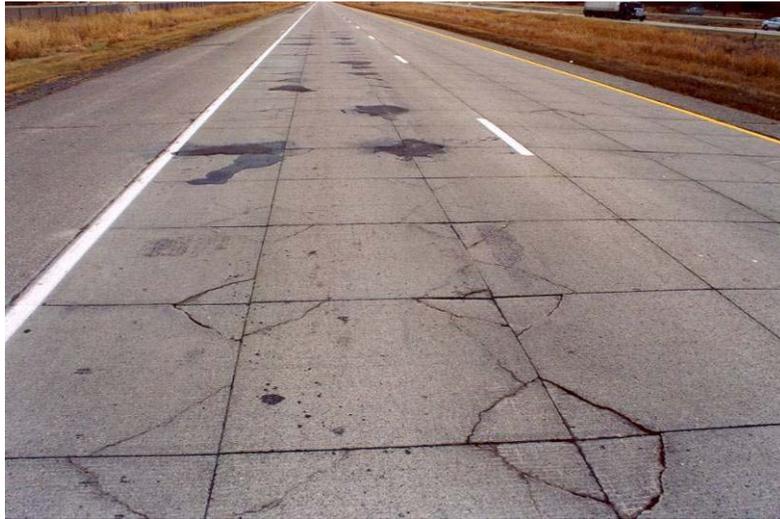
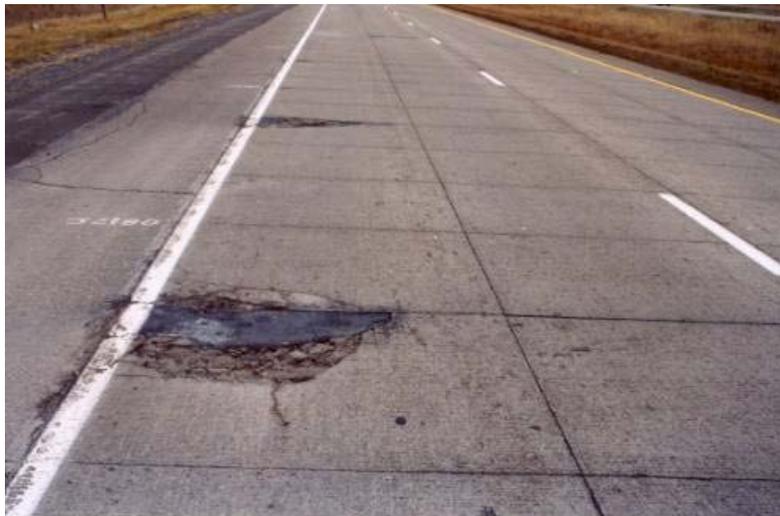
Figure 21. Corner cracking in MnROAD Test Cell 94, 3 inch whitetopping with a 4 ft by 4 ft joint spacing. Photo courtesy of Mn/DOT.

Figure 22. Cracking in MnROAD Test Cell 95, 3 inch whitetopping with a 5 ft by 6 ft joint spacing. Photo courtesy of Mn/DOT.

The second concern is the cracking in the 3 inch section of the whitetopping. The large amount of corner and longitudinal cracks that are now spalling may indicate a short life for this section of whitetopping. Minnesota DOT placed sections of 3 inch whitetopping on their MnROAD test track (Burnham, 2005). Two of the three sections had 4' by 4' joint patterns and the third had a 5' by 6' spacing. The performance of the sections with the 4' by 4' spacing was much worse than the section with the 5' by 6' spacing and this difference was primarily due to the location of the joints in the wheel paths. Figure 19 shows the driving lane of MnROAD Test Cell 94 which was one of the 3 inch sections with 4' by 4' joint spacing. Note the corner cracking at every joint intersection. With time these locations developed potholes. In contrast, the section with the larger joint spacing performed much better, due primarily because the intersections of the longitudinal and transverse joints were not located in the wheel paths. Figure 20 shows the driving lane of Test Cell 95 that was built with a 5' by 6' joint spacing. The distress is concentrated in the area near the shoulder which is similar to what we are seeing on I-90. If our section progresses in a similar manner to the MnROAD section we should expect that

some of the shoulder side corner cracked areas will continue to deteriorate and eventually require patching. Figures 21 and 22 are from the forensic report by Burnham, 2005.

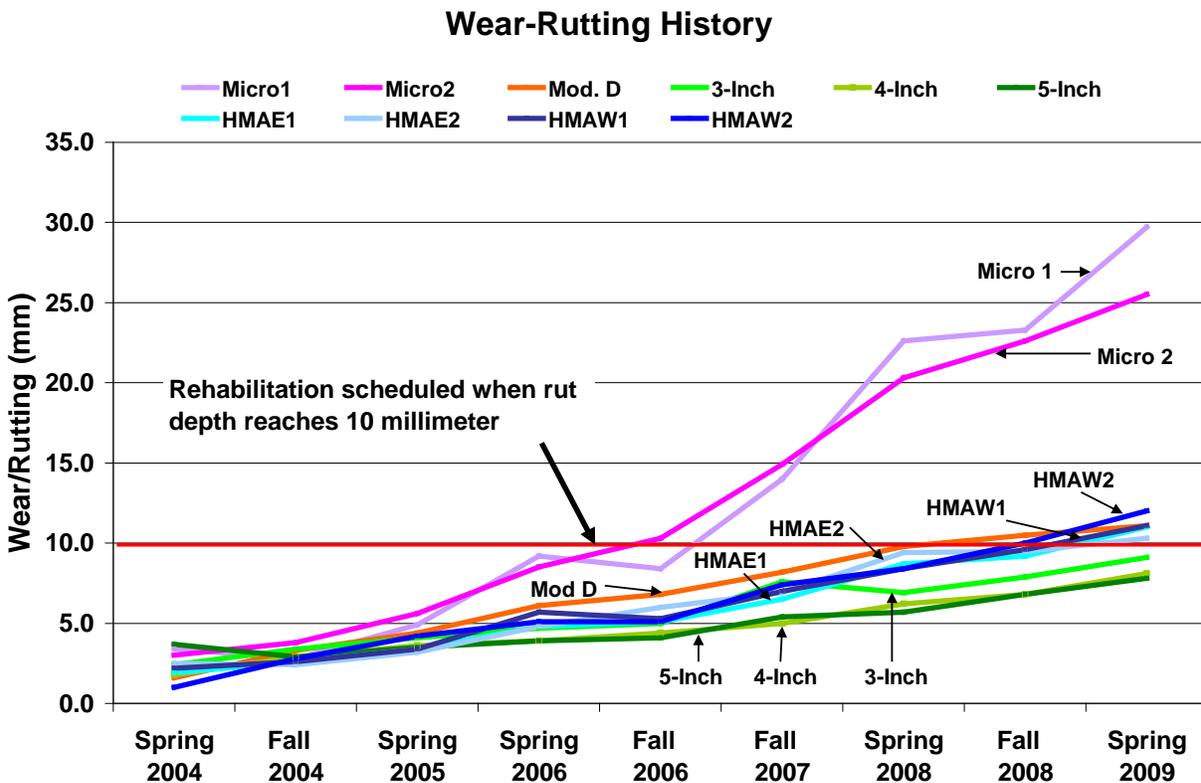
Figure 23. Wear/rutting measurements for each period of measurement.

The gradual increase in wear/rutting for all of the section except the micro/macro surfacing is illustrated in Figure 23. The micro/macro surfacing showed accelerated wear/rutting after the spring 2005 measurement. Wear/rutting reached 10 millimeters within the 5+ years of the monitoring period for all of the sections except the whitetopping. Ten millimeters is the point where the WSPMS indicates that the project should be scheduled for rehabilitation and it marks the end of the pavements service life. The micro/macro surfacing reached the 10 millimeter target in three to four years. The Modified Class D section reached the target in about 4-1/2 to five years and the Superpave Class 1/2 inch in five to 5-1/2 years. These values agree fairly closely with the prediction made in the post-construction report which indicated four years for the micro/macro surfacing, five years for the Modified Class D, and 5 to 5-1/2 years for the Superpave Class 1/2 inch.

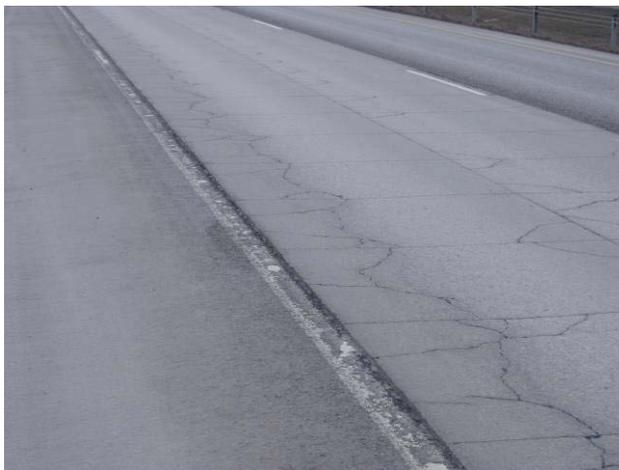
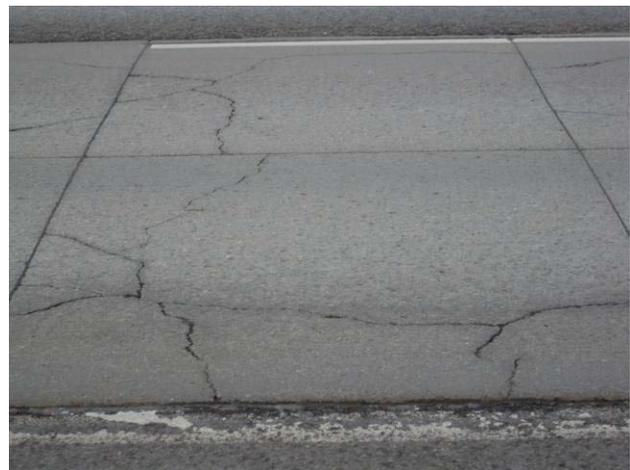
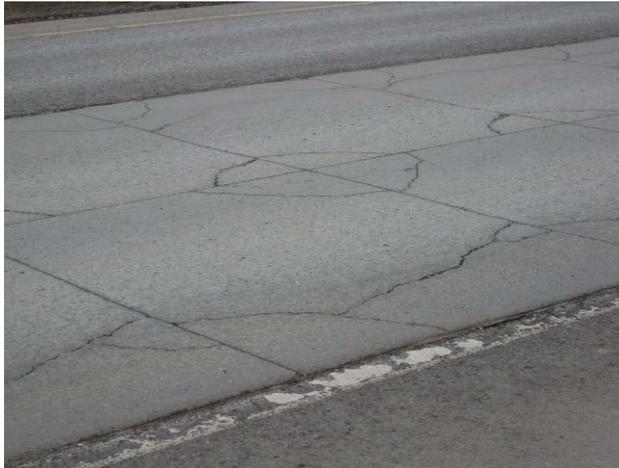
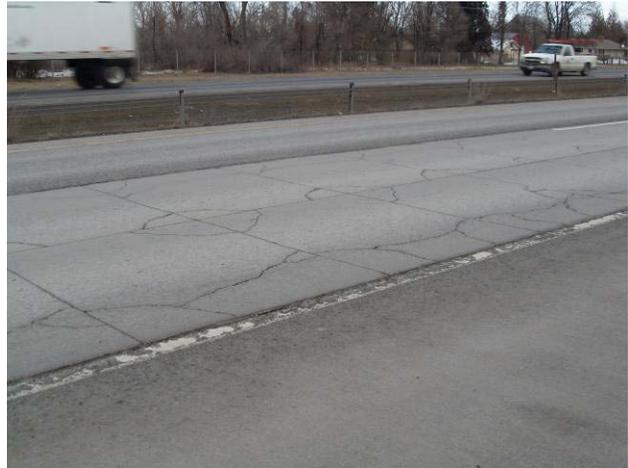
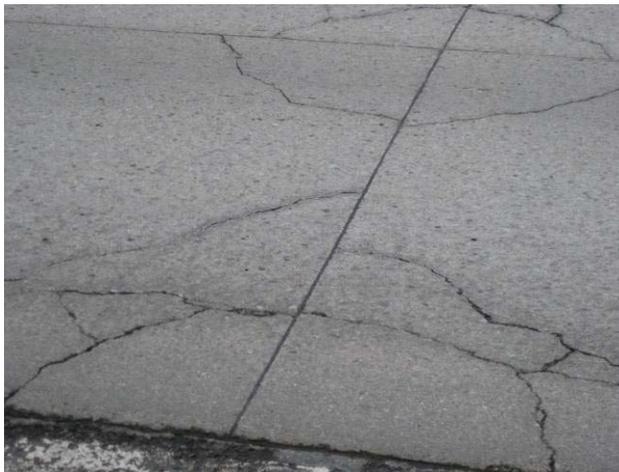
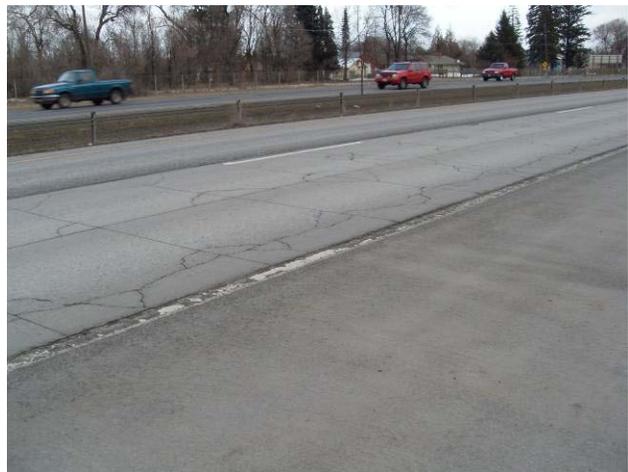
Figure 24. Multiple cracks in 3-inch section.

Figure 25. Close-up of two 5x6 ft. panels in 3-inch section.

Figure 26. Close-up of cracking in the 3-inch section.

Figure 27. Longer view of the cracking in the 3-inch section.

Figure 28. Close-up of minor spalling of the cracks in the 3-inch section.

Figure 29. Longer view of the multiple cracks in all of the panels of the 3-inch section.

Photos taken in 2009 show the extent and nature of the cracking in the 3-inch section (Figures 24-29). Minor spalling of the cracks is occurring in the wheel paths. However, the extensive deterioration of the joints experienced in the MnROAD's 3-inch section is not apparent in the I-90 project, possibly because of climatic differences (less severe winters) and the better aggregates available in Washington State.

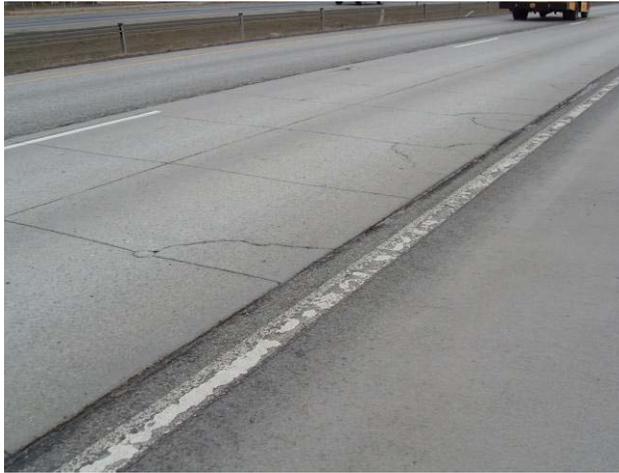
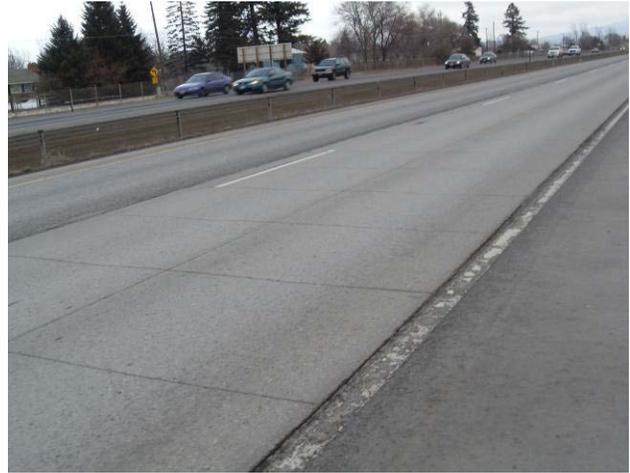
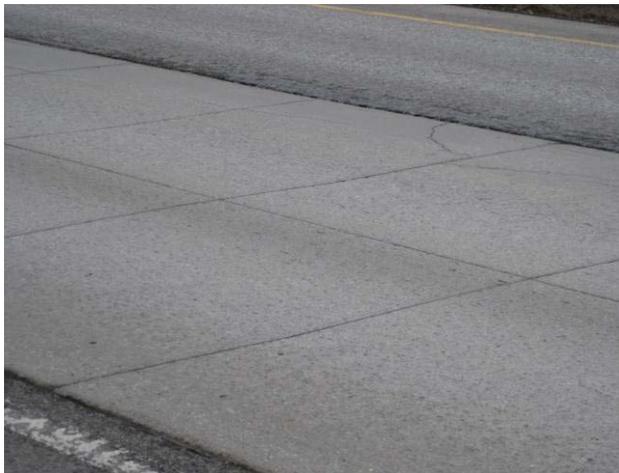
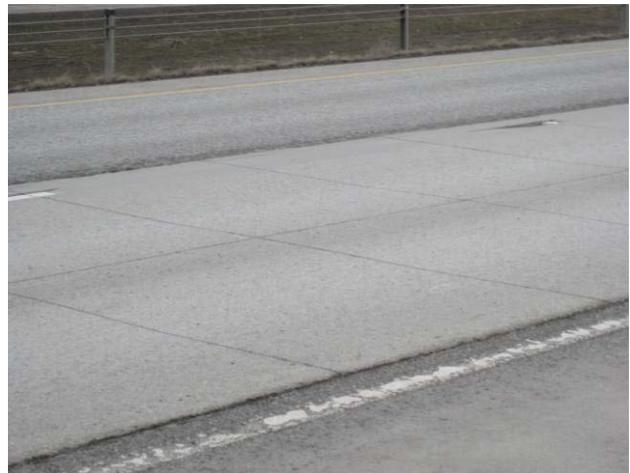
Figure 30. Corner cracking in the 4 inch section.

Figure 31. Crack free condition of most of the 4-inch section.

Figure 32. Minor corner cracking in the 4-inch section.

Figure 33. Crack free condition of most of the 4-inch section.

Photos of the cracking in the 4-inch section are shown in Figures 30 through 33. This section is showing the least distress of any of the sections with very few cracks and little to no spalling.

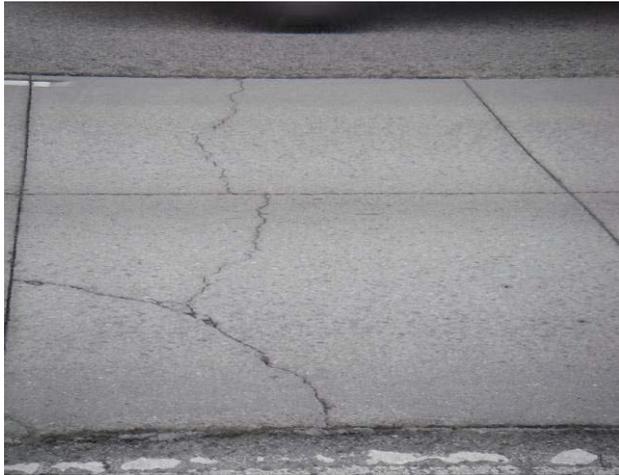
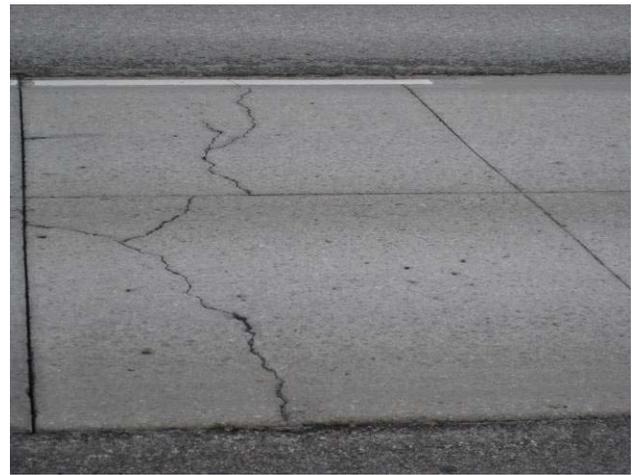
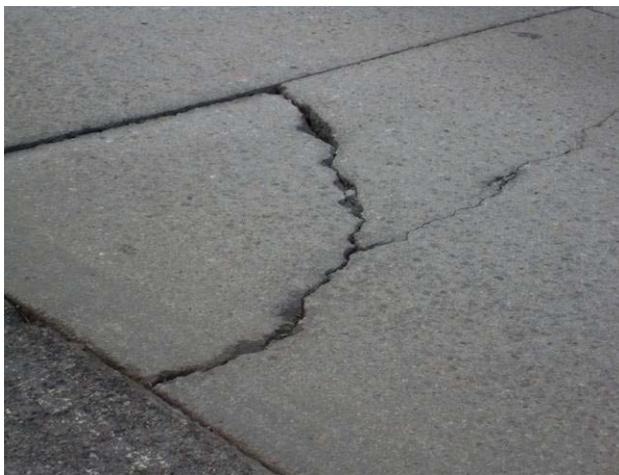
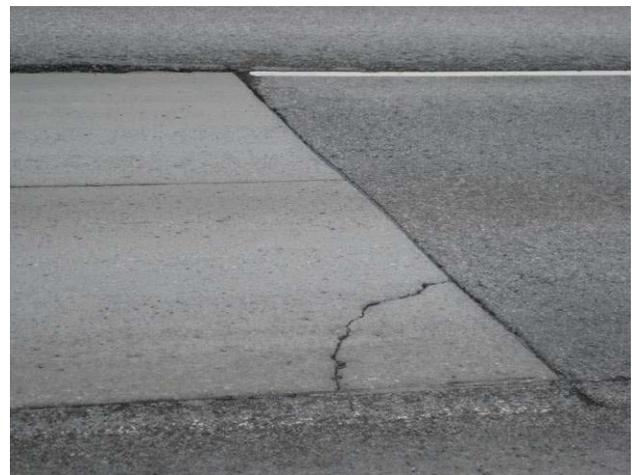
Figure 34. Spalled cracks in the 5-inch section.

Figure 35. Spalled cracks in the 5-inch section.

Figure 36. Spalled corner crack in the 5-inch section. Corner is also depressed below surface of the other panels.

Figure 37. Spalled corner crack at the end of the 5-inch section where it meets with the Superpave Class 1/2 inch.

The 5-inch section had slightly more cracks than the 4-inch section and more spalling along the cracks as shown in Figures 34-37. One of the cracked corners is depressed below the surface of the surrounding panels, indicating possible problems with the support from the underlying HMA.
