# Wear Resistant Pavement Study

WA-RD 657.2

Experimental Feature WA03-02

Sullivan Road to Idaho State Line, Phase I

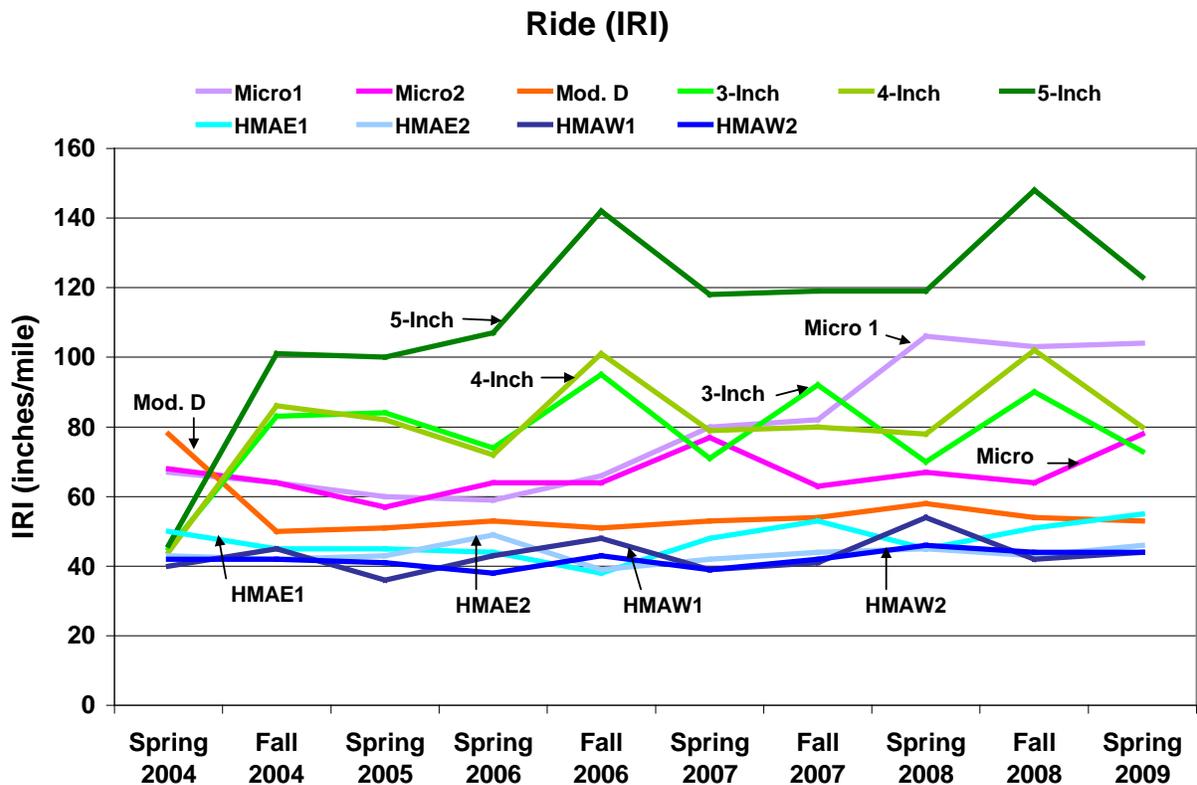
Figure 25. Historical ride readings.

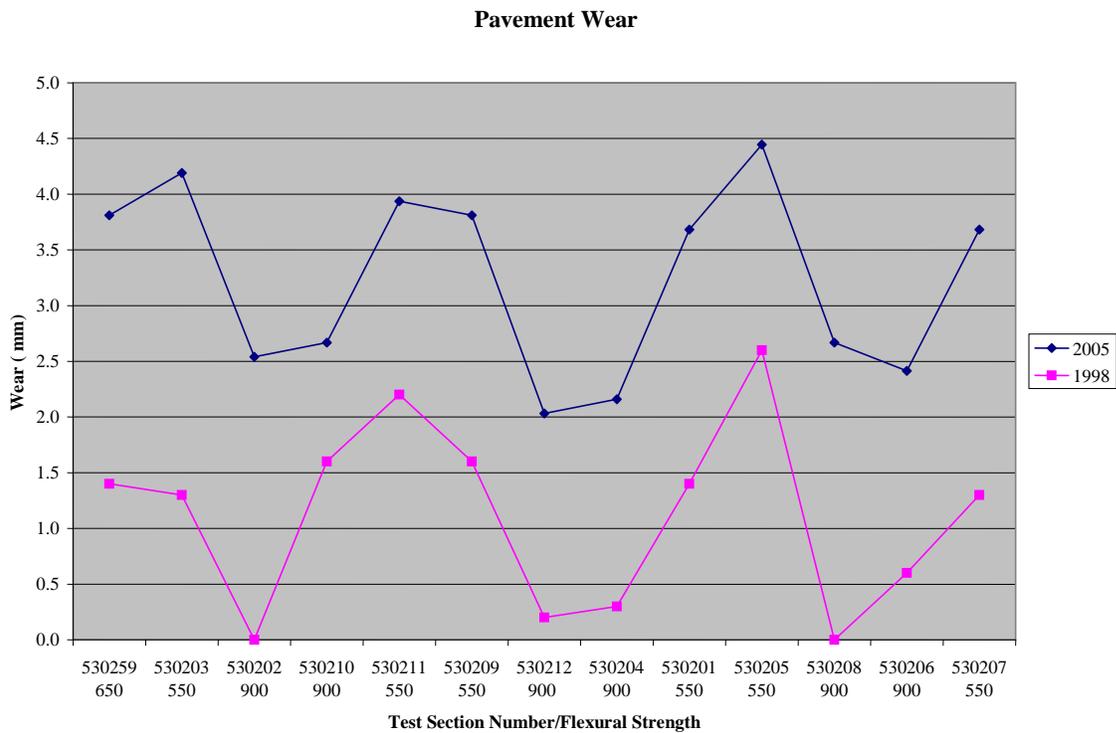
Figure 1. Pavement wear for each test section from 1998 and 2005 surveys.

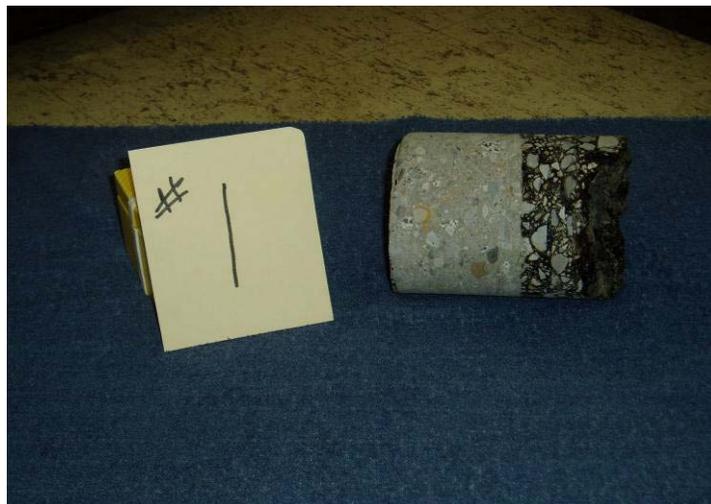
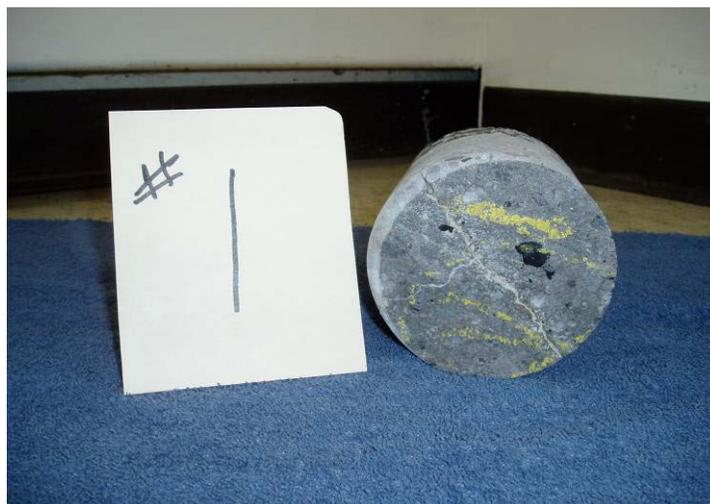
**DESCRIPTION:** 3" PCCP (Solidly Attached to HMA)  
Existing HMA Ground 0.10'

Figure 1. Side view. August 2004

Figure 2. End view showing cracks. August 2004

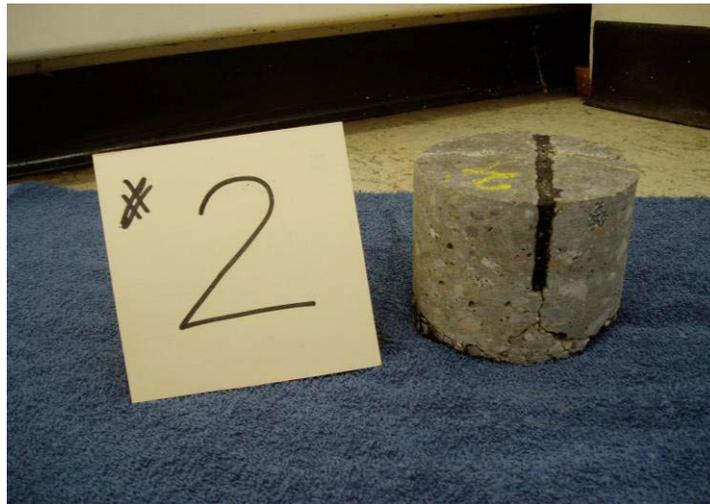
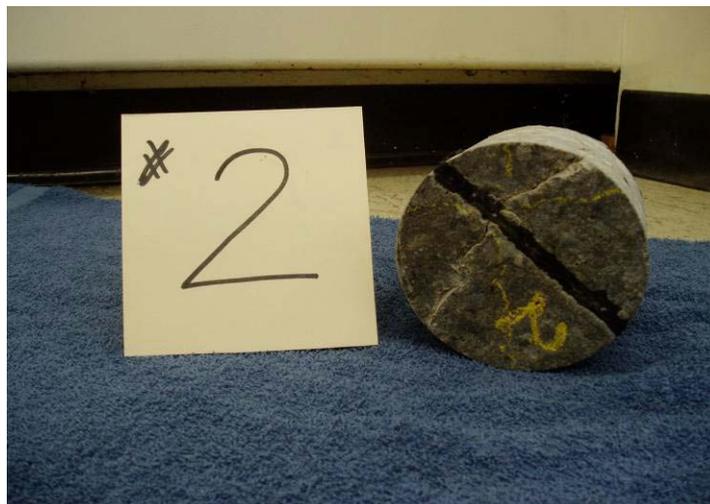
**DESCRIPTION:** 3" PCCP (Delaminated from HMA)  
Existing HMA Ground 0.10'

Figure 3. Side view showing panel joint. August 2004.

Figure 4. End view showing joint and crack. August 2004

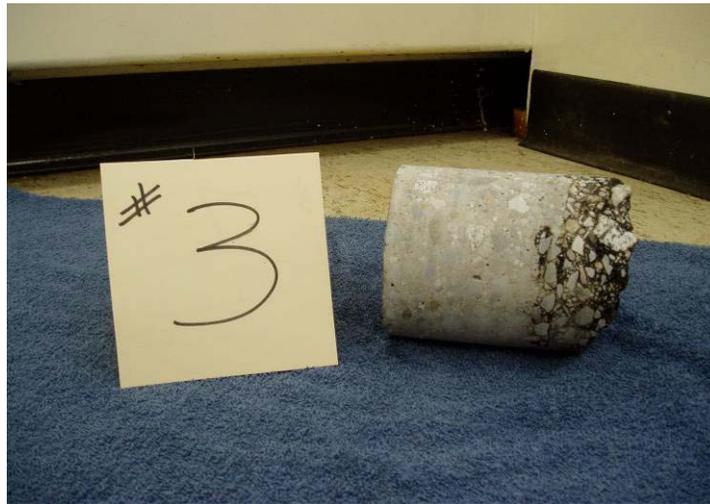
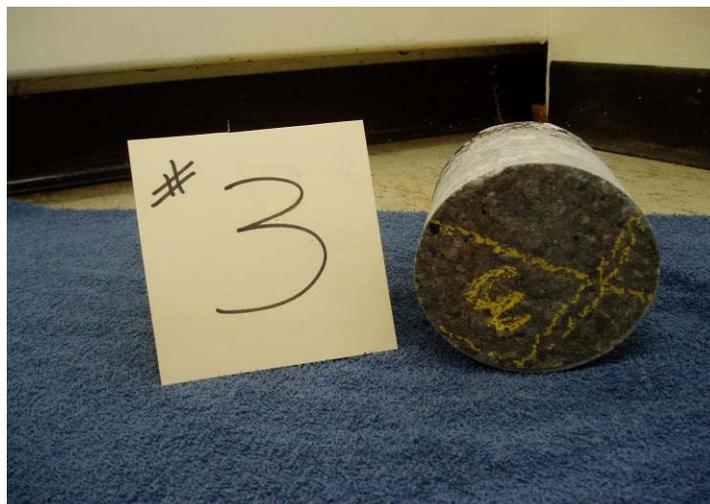
**DESCRIPTION:** 3" PCCP (Solidly Attached to HMA)  
Existing HMA Ground 0.10'

Figure 5. Side view showing whitetopping solidly attached to HMA. August 2004.

Figure 6. End view. August 2004

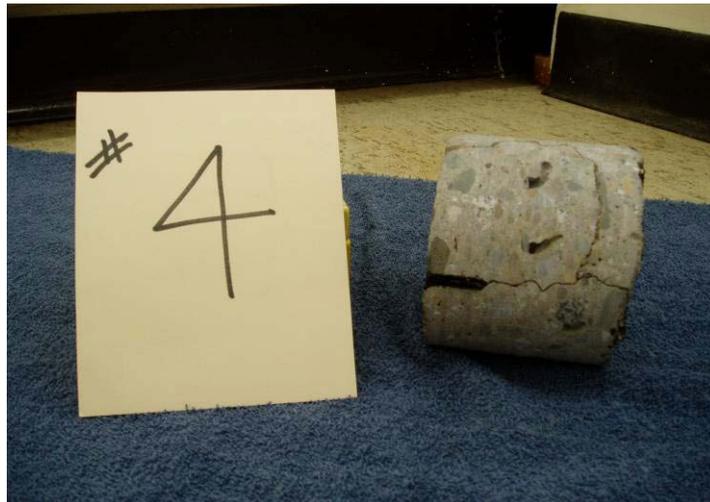
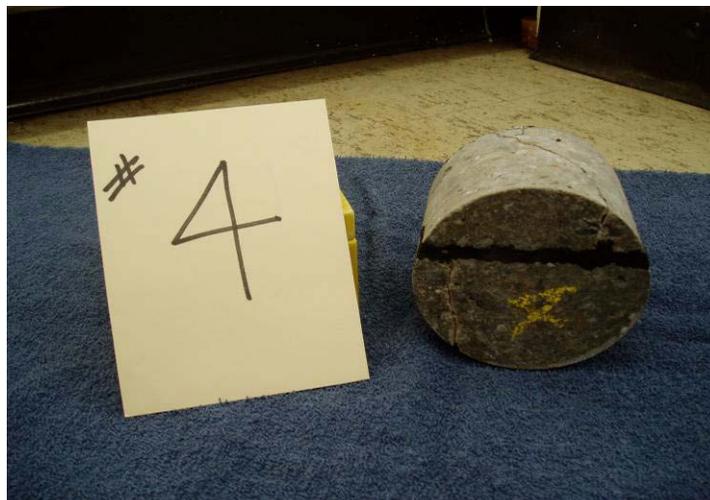
**DESCRIPTION:** 3" PCCP (Delaminated from HMA)  
Existing HMA Ground 0.10'

Figure 7. Side view showing panel joint and horizontal cracks. August 2004.

Figure 8. End view showing panel joint and cracks. August 2004

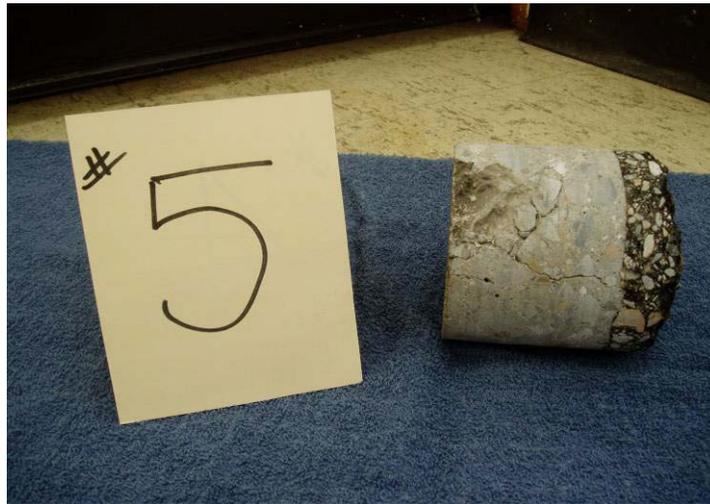
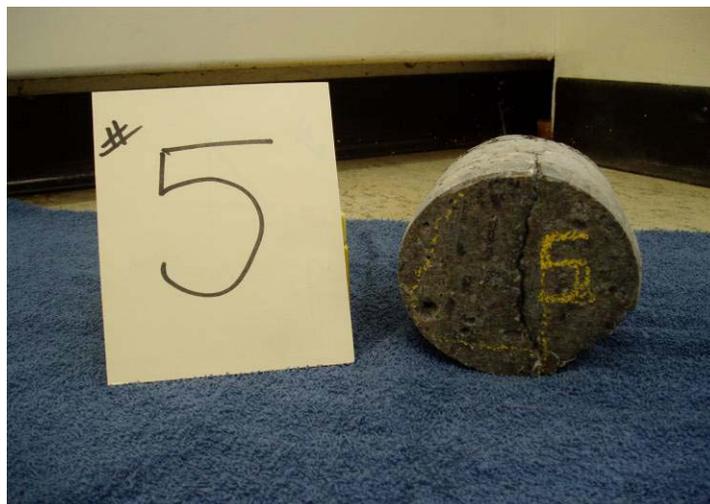
**DESCRIPTION:** 3" PCCP (Solidly Attached to HMA)  
Existing HMA Ground 0.10'

Figure 9. Side view showing cracks and solidly attached HMA. August 2004.

Figure 10. End view showing cracks. August 2004

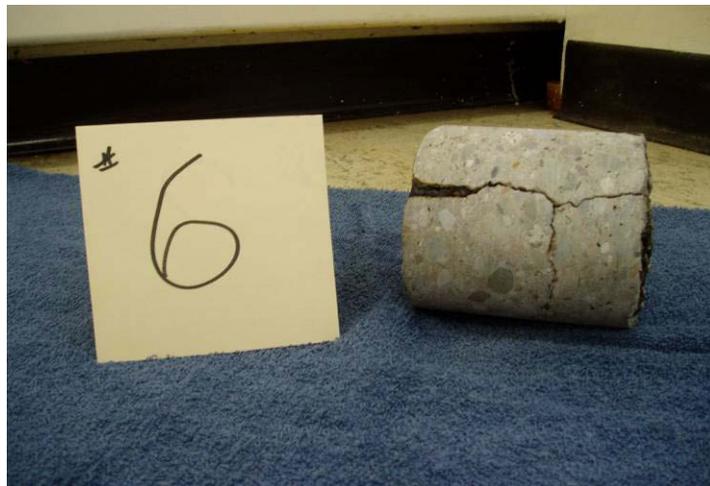
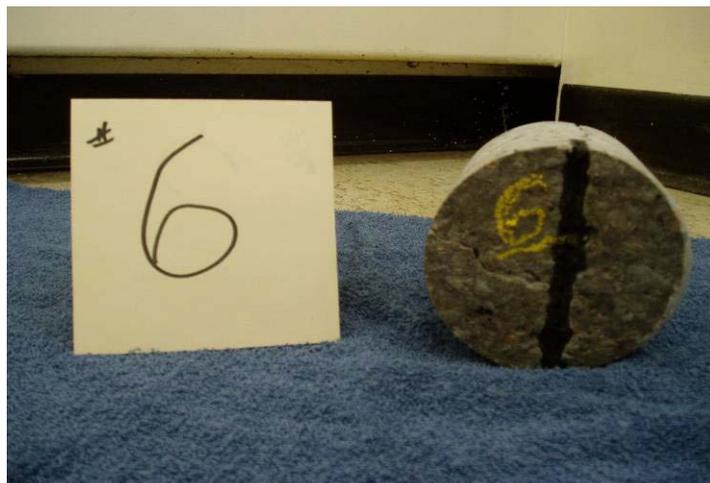
**NOTES:** HMA below PCCP stripped like CSTC, old Class E Layer that had Class D on it at one time.

Figure 11. Side view showing panel joint and cracks. 8/04

Figure 12. End view showing joint and cracks. 8/04

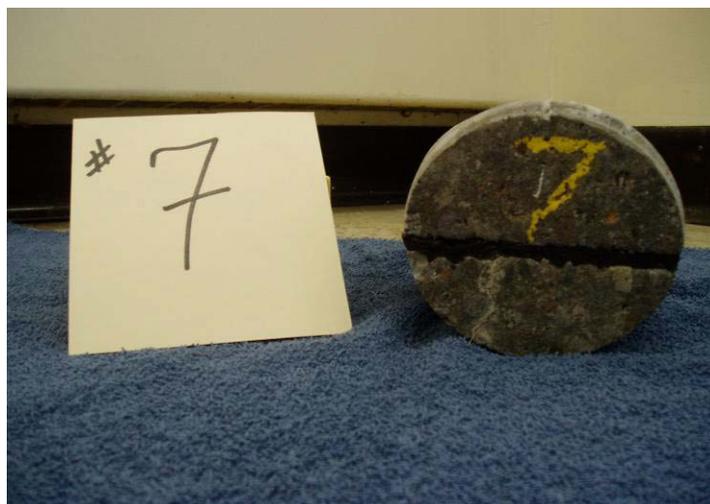
**NOTES:** Class E below from 1978, flushed out.

Figure 13. Side view showing panel joint. Aug. 2004.

Figure 14. End view showing joint and crack. Aug. 04.

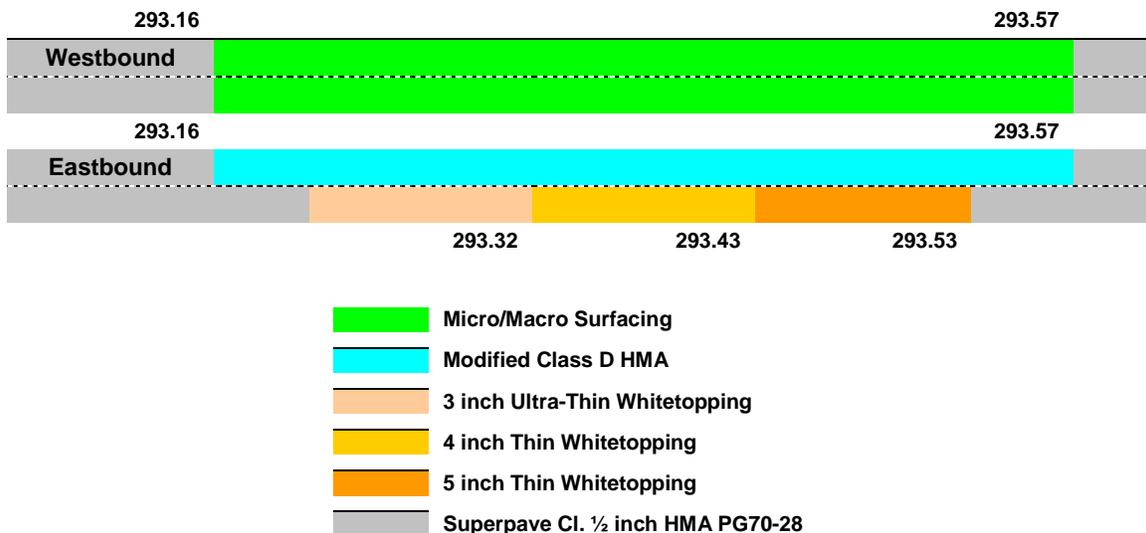
Figure 1. Location of test sections.

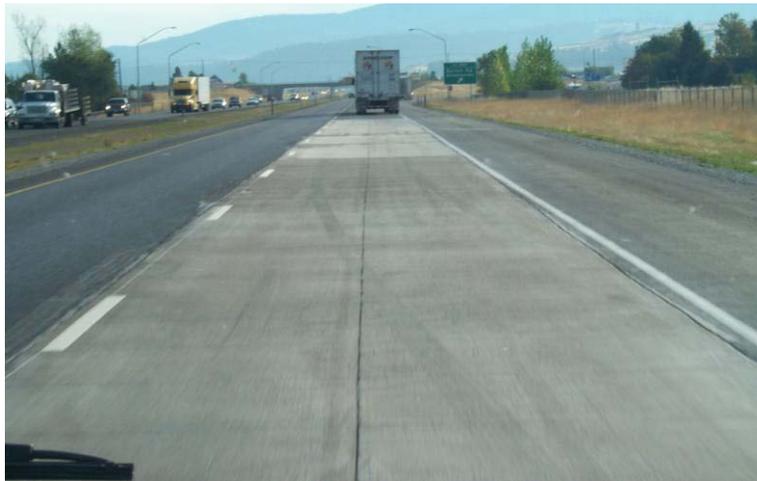
Various thicknesses of concrete were placed to study their structural capacity and performance. The ultra thin whitetopping section is 3 inches thick. The thin whitetopping sections are 4 and 5 inches thick. The concrete mix design used for the section was modified to target a higher strength pavement than traditionally used by WSDOT. The higher strength PCCP mixes appear to be more resistant to the abrasive wear of studded tires. Additionally, polyester fibers were incorporated into the mix at the rate of three pounds per cubic yard. The purpose of the polyester fibers is to hold cracks tight should they develop. Image 1 shows the whitetopping test section.

Image 1. Ultra Thin and Thin Whitetopping Test Section placed in the outside lane of eastbound I-90 (MP 293.15 to MP 293.55).

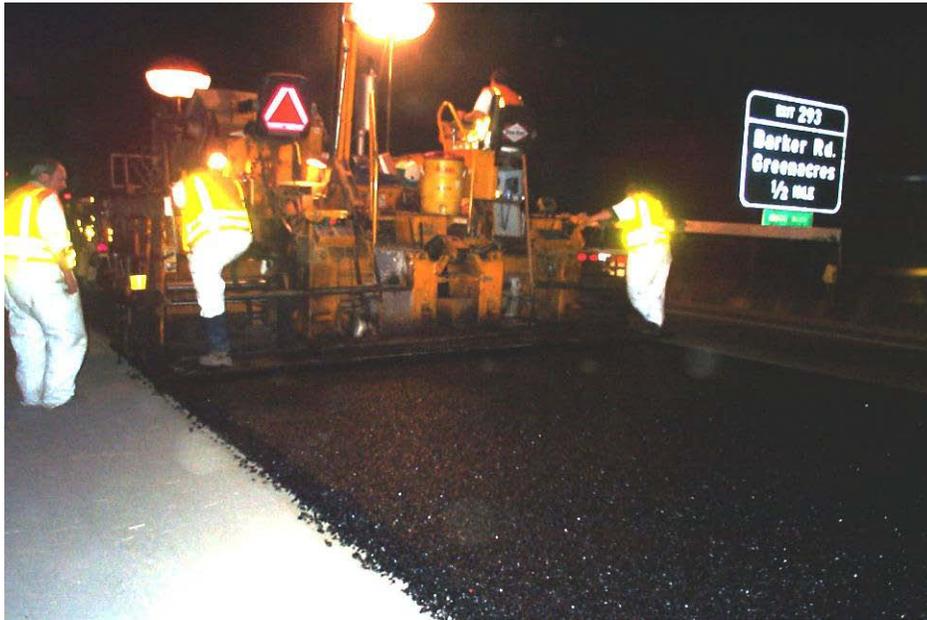
**Modified Class D** – The Modified Class D asphalt section consists of a coarser aggregate than WSDOT’s standard asphalt paving mixture. The coarser aggregate provides an aggregate skeleton that may resist load in addition to wear caused by studded tires. Modified Class D pavements have performed well in areas outside of Spokane, however, the Modified Class D asphalt has not been subjected to the high studded tire use as experienced on the experimental section. Modified Class D asphalt has an open surface texture and is typically placed two inches thick. The Modified Class D asphalt section is 1,500 feet long and is located in the inside eastbound lane. Image 2 shows placement of the Modified Class D asphalt.

Image 2. Placement of Modified Class D asphalt in the inside eastbound lane of I-90 (MP 293.15 to MP 293.55).

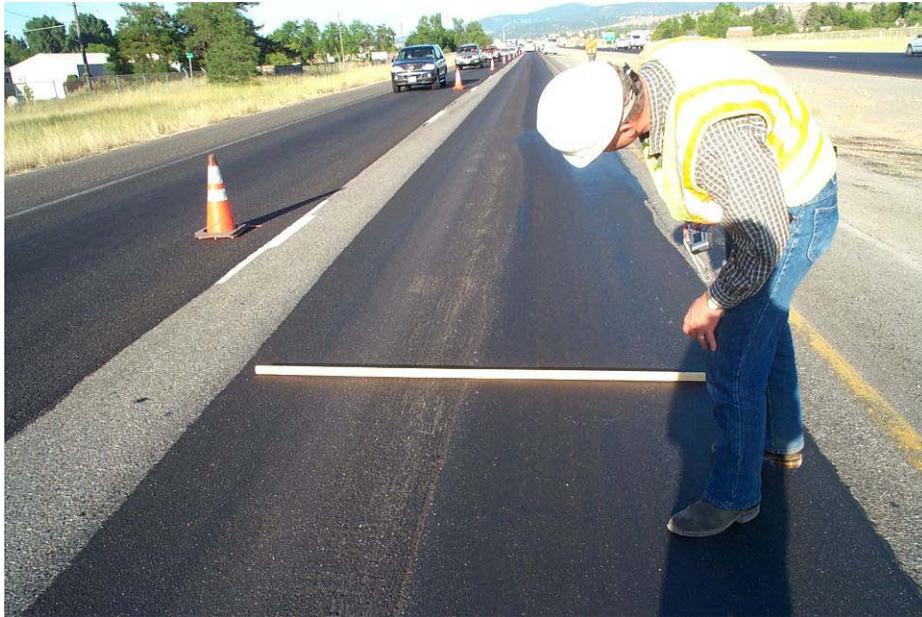
**Micro Surfacing/Macro Surfacing** – The Micro/Macro Surfacing test section first received a rut filling of the existing ruts and then a resurfacing of the roadway with a thin high quality surface treatment. Specifically, Micro-Surfacing is comprised of a mixture of finely graded high quality aggregated, asphalt, mineral filler and water. Micro-Surfacing is applied as a slurry by a specialty contractor using self-contained mixing and laying equipment. Following the rut filling (see Image 3), Macro-Surfacing is placed (see Image 4). Macro-Surfacing is a

Image 3. Micro Surfacing placed as a rut fill prior to Macro-Surfacing within the two westbound lanes of I-90 (MP 293.15 to MP 293.55).

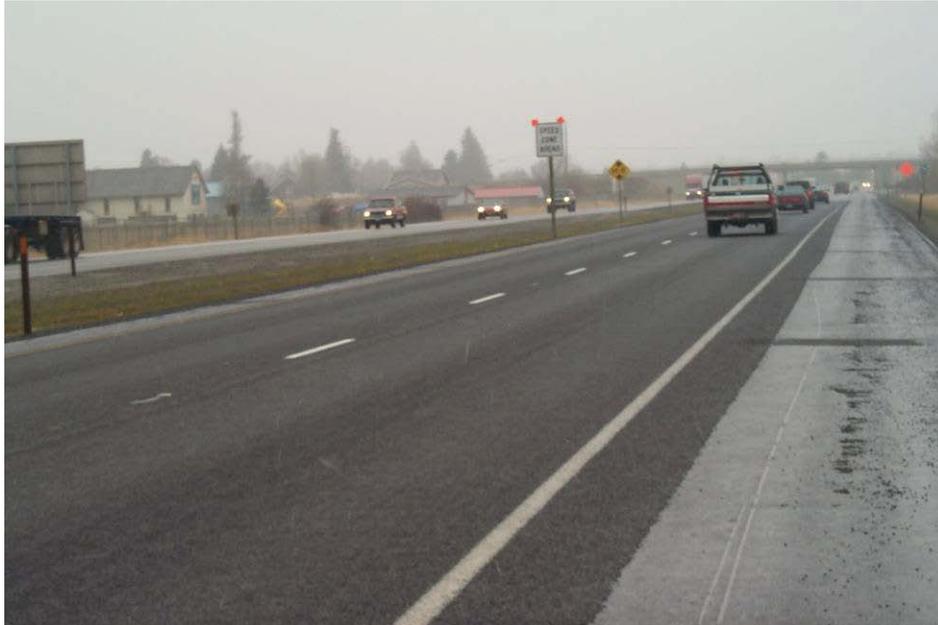
single pass surface treatment designed to place both the asphalt emulsion and the aggregate. The surface treatment is approximately ½ inch thick and consists of hard and durable aggregates bond together with a high strength asphalt emulsion binder. The Micro/Macro Surfacing test section is 1,500 feet long and is located in the both the inside and outside westbound lanes.

Image 4. Macro Surfacing Test Section placed on top of the Micro-Surfacing rut fill placed in the westbound lanes of I-90 (MP 293.15 to MP 293.55).

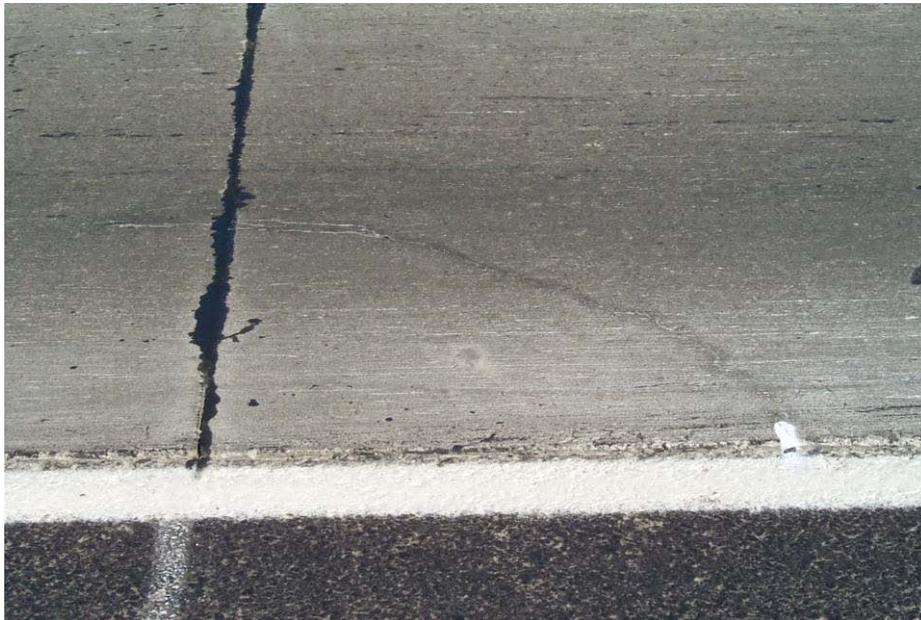
The 3 inch Ultra Thin Whitetopping section began displaying corner cracks (breaks) at the edge of the lane within three months of installation (see Image 5). Currently, the cracking is remaining tight and does not pose a performance problem on I-90. The 4 and 5 inch Thin Whitetopping sections are performing well.

Image 5. Typical corner crack within the 3-inch ultra thin whitetopping test section.

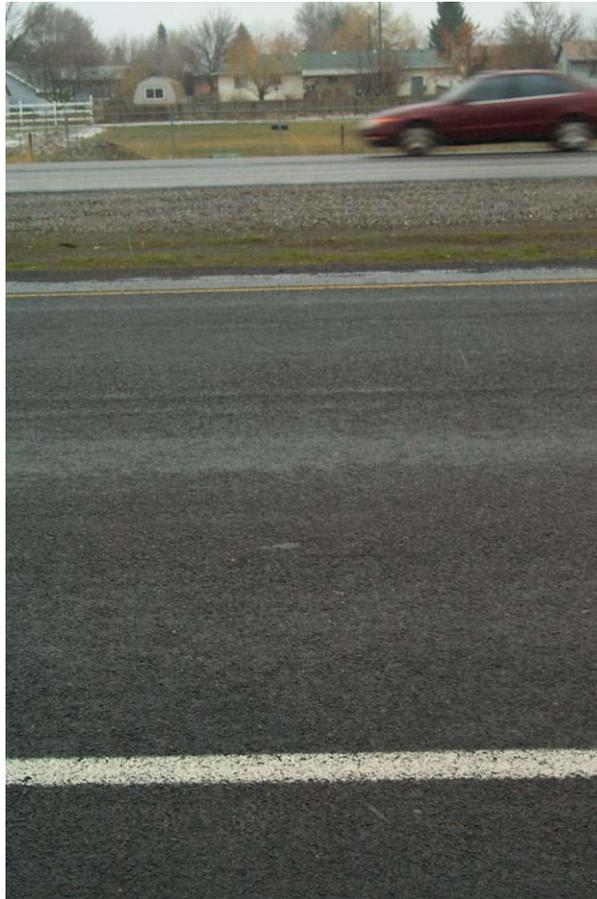
distress showing at this time is cosmetic and is not affecting the performance of the section. The surface texture is shown in Image 6.

Image 6. Surface texture of the Macro Surfacing.
