**PERFORMANCE OF ZINC ANODES FOR CATHODIC  
PROTECTION OF REINFORCED CONCRETE BRIDGES**

**Final Report**

**SPR 364**

**March 2002**

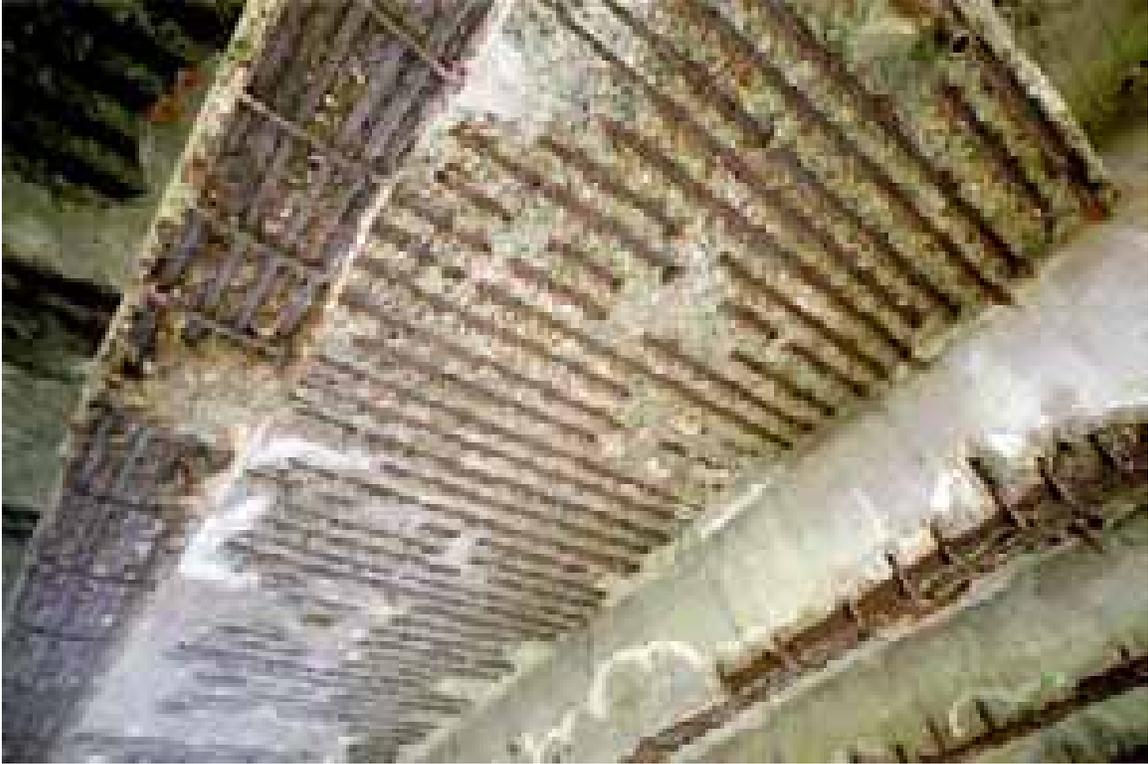
Figure 1.1: Concrete spalling from deck underside at the Big Creek Bridge prior to restoration

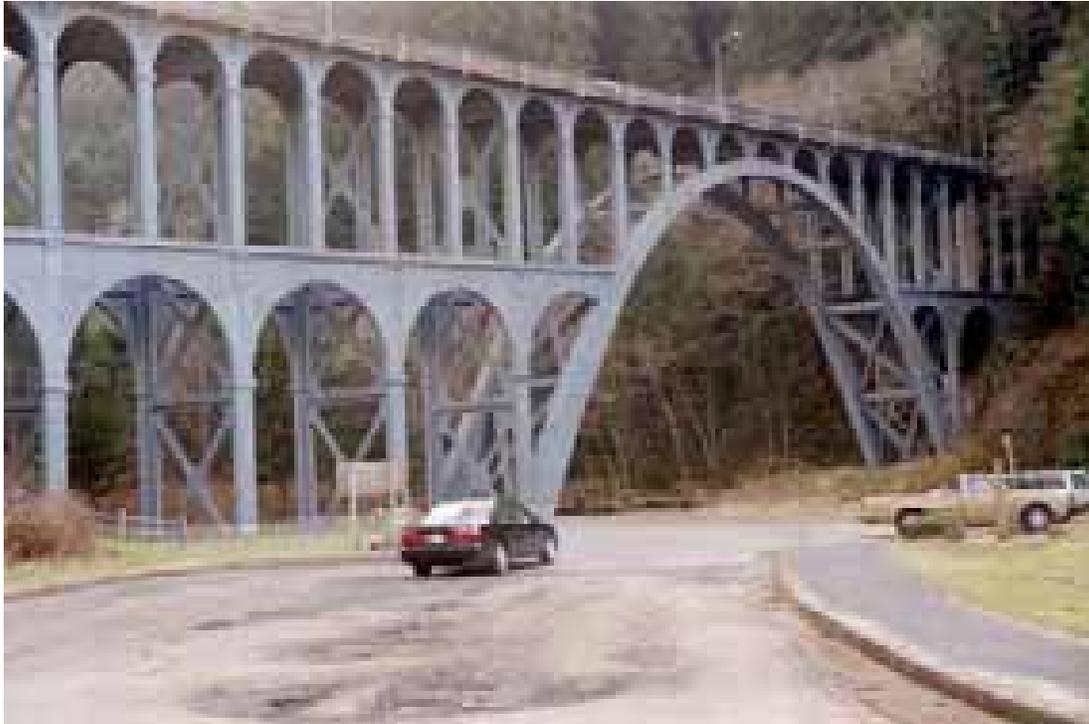
Figure 1.2: Cape Creek Bridge built in 1932 and located on the Oregon coast south of Cape Perpetua

The first Oregon Department of Transportation (DOT) impressed current CP (ICCP) system using thermal-sprayed Zn anodes was installed in 1990 to protect the Cape Creek Bridge, Figures 1.2 and 1.3. The next TS Zn anode system was installed on the Yaquina Bay Bridge arches, Figure 1.4, followed later by the south approach, Figure 1.5. The Depoe Bridge TS Zn anode project, Figure 1.6, also included one CP zone using cobalt-catalyzed thermal-sprayed titanium as the anode. The Cape Perpetua Viaduct was used for a demonstration of TS Zn and TS Aluminum-12Zinc-0.2In (AlZnIn) anodes and a Zn-hydrogel anode in a sacrificial anode CP (SACP) systems, Figure 1.7. Installation of TS Zn anodes for the Big Creek Bridge ICCP system was completed in 1998, Figure 1.8. Projects are currently underway at Rocky Creek (Ben Jones) Bridge and the Rogue River (Patterson) Bridge.

The Cape Creek Bridge is located on the Oregon coast south of Cape Perpetua, Figures 1.2 and 1.3. Oregon DOT extensively repaired the bridge in 1991 and then installed thermal sprayed Zn anodes on the surface for a multi-zone ICCP system. Some ICCP zones were converted to SACP zones following installation because of shorts between the anode and rebar. The CP system was energized in January 1992. Six 5 cm (2 in) diameter core samples were taken from the bridge in October 1995 representing both ICCP and SACP zones with Zn on both original concrete and patch concrete. Table 2.5 lists the six samples. Small sections of the cores were cut and mounted in epoxy for microanalysis.

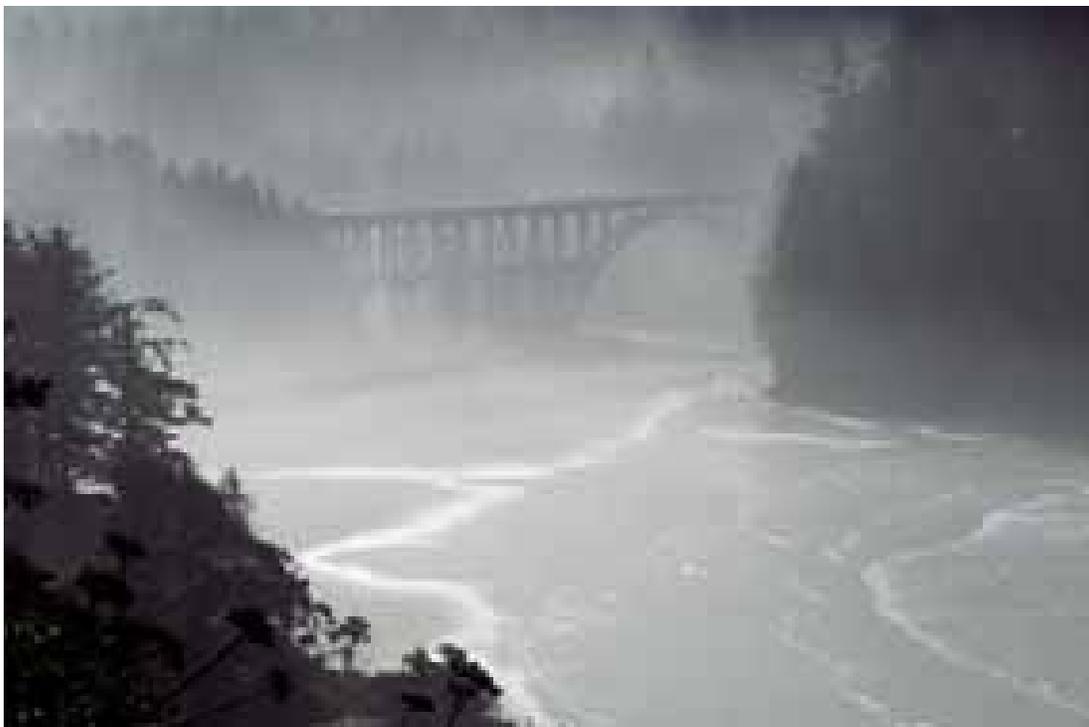
Figure 1.3: Cape Creek Bridge showing morning fog that aids the deposition of salt on the bridge surface as a precursor to chloride-induced corrosion damage

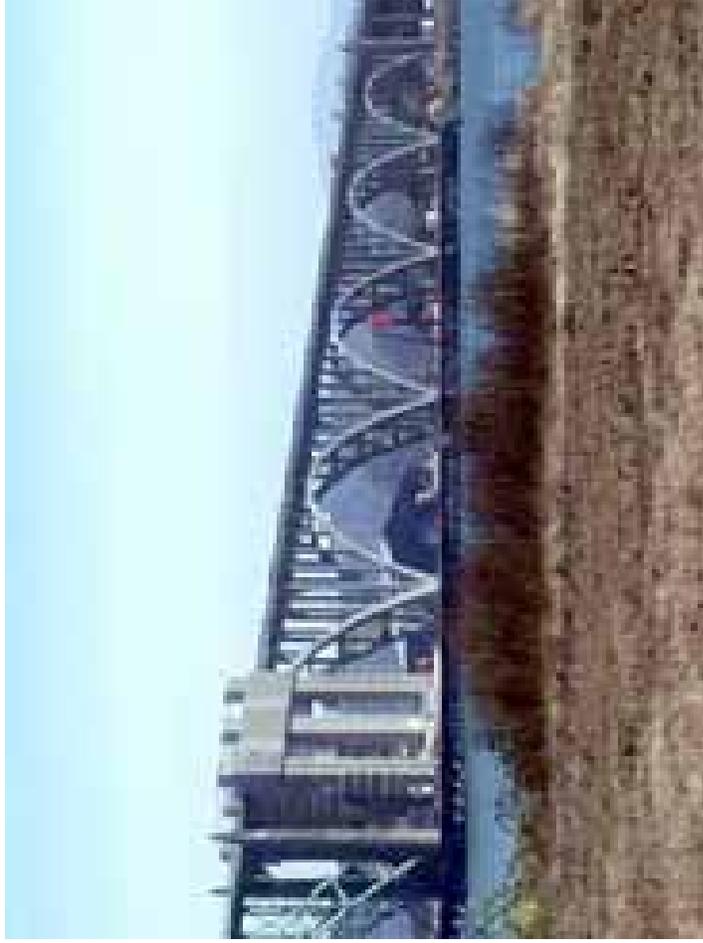
Figure 1.4: Yaquina Bay Bridge built in 1936 and located on the Oregon coast at Newport

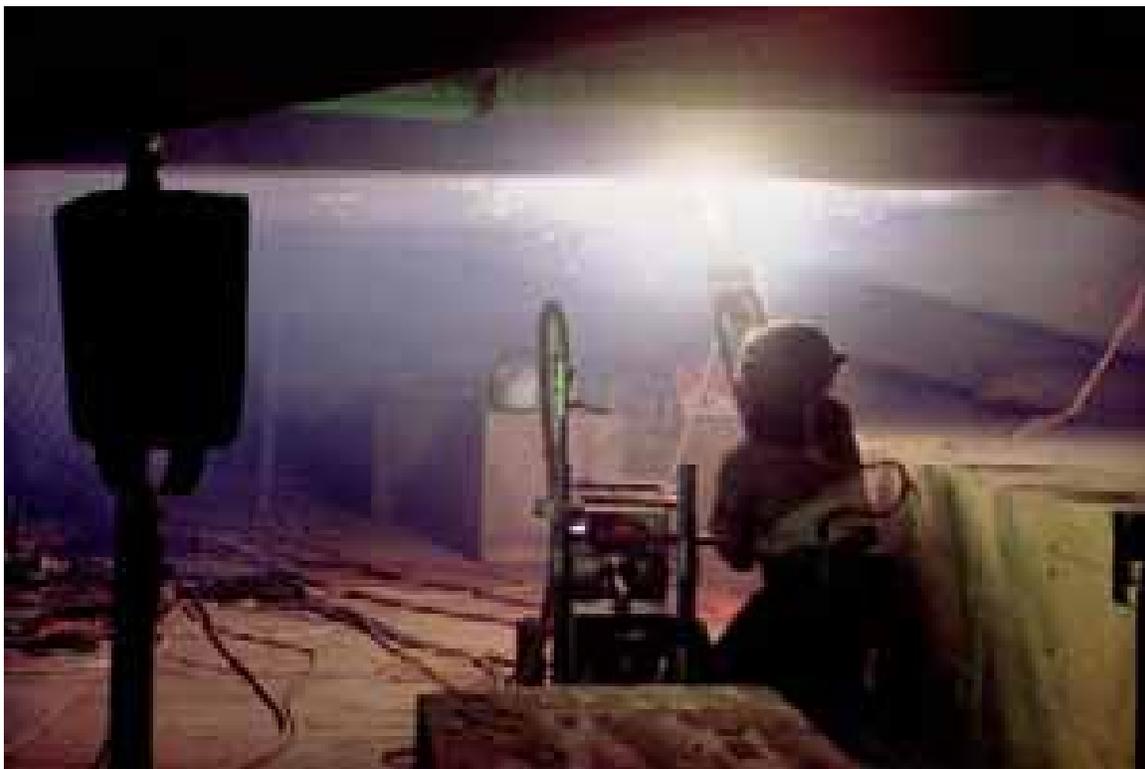
Figure 2.2: Thermal spraying Zn on a bridge substructure using the twin-wire arc-spray process

The twin-wire arc-spray process was used to apply the Zn anodes to the concrete surface (Covino, *et al.* 1995). In this process, an arc is created that melts two Zn wires that are brought into close proximity with each other. The molten Zn is then atomized into droplets by a jet of compressed gas and propelled to the concrete surface. There the droplets coalesce, penetrate into surface roughness, and then freeze into a solid layer of Zn composed of many small “splats” of Zn. The resulting coating is held in place on the concrete surface by a mechanical bond. Compressed air is typically used to atomize the molten Zn droplets and propel them to the surface. Figure 2.2 shows twin-wire arc-spray equipment being used to apply an anode to a bridge on the Oregon coast.

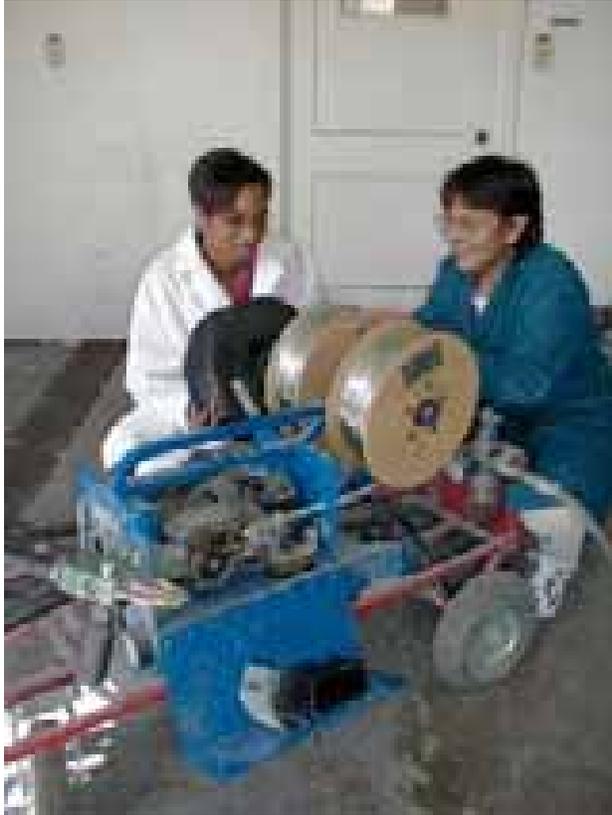
Figure 2.3: General view of twin-wire arc-spray equipment showing wire spools, the wire-feed drive, and the spray gun

The twin-wire arc-spray equipment is shown in Figure 2.3 and includes the wire feed system and spray gun or nozzle. The spray parameters were: 265 A (DC); 25 V (DC); air pressure, 0.65 MPa (105 psi); spray distance, 150 - 230 mm (6 - 9 in); spray angle, normal to surface; Zn wire

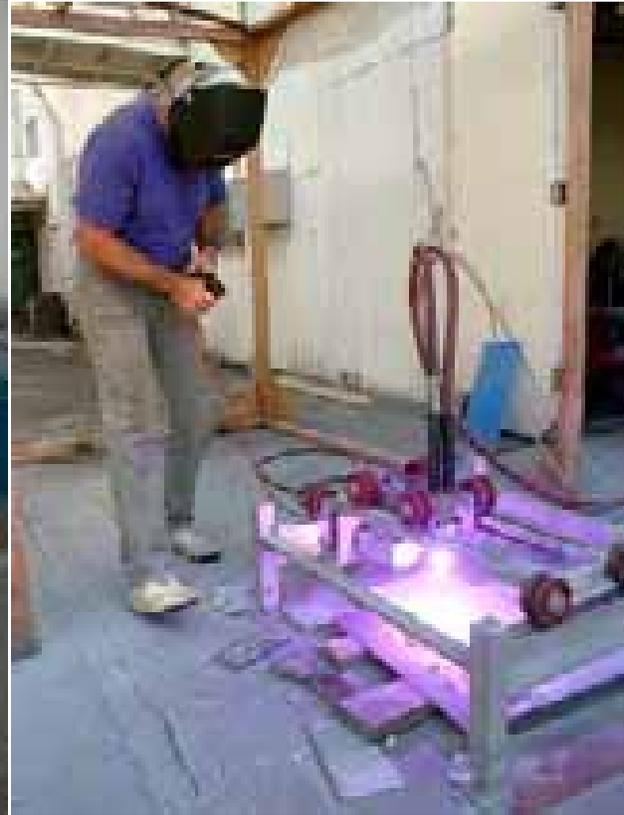
Figure 2.4: Oregon DOT robotic x-y traversing system used to apply TS Zn anode to concrete slabs

diameter, 4.8 mm (3/16-in); spray rate, 14.5 kg zinc/hr (32 lbs zinc/hr). A custom designed and constructed programmable X-Y traversing system, Figure 2.4, was used to control the movement of the spray head to obtain a uniform Zn anode coating thickness on the concrete slabs. The zinc anode typically was 0.5 mm (0.020 in) thick for the laboratory studies.

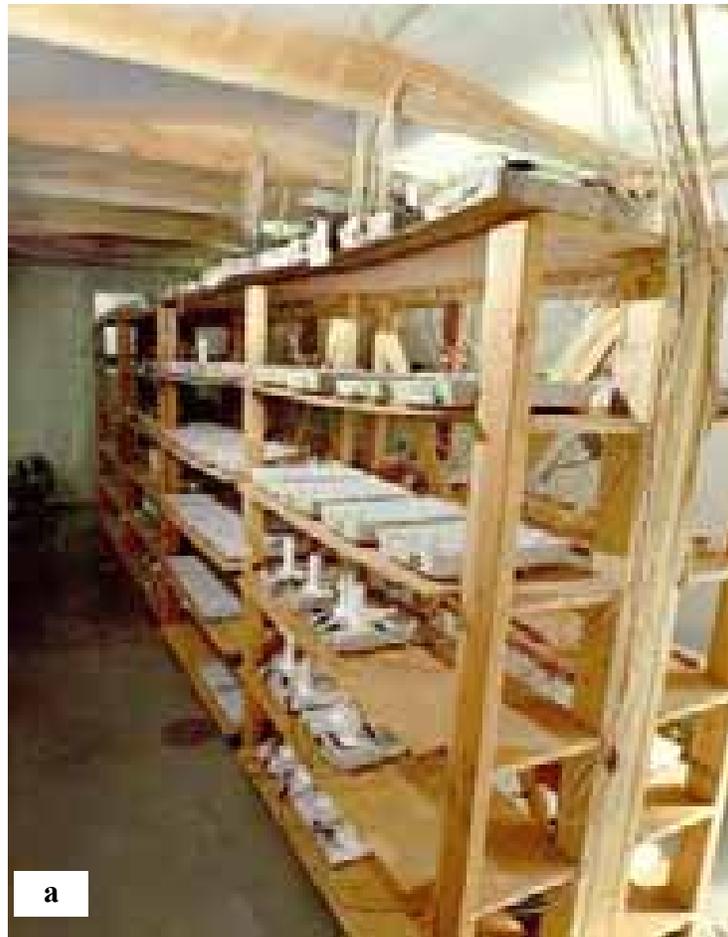
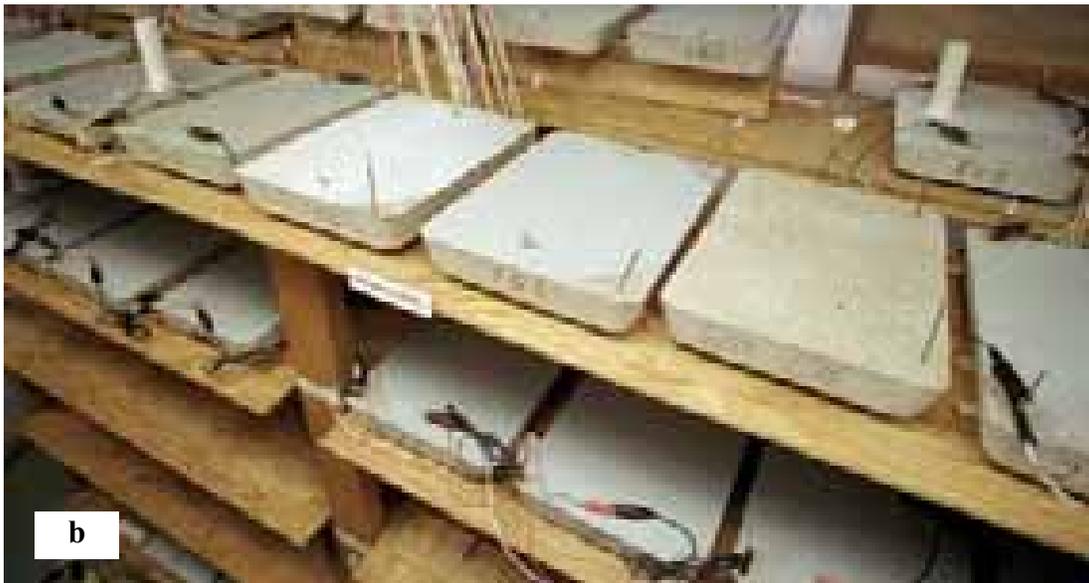
Figure 2.6: Multiple concrete slabs undergoing accelerated electrochemical aging in a controlled humidity enclosure: (a) overall view; (b) close-up of concrete slabs

Electrochemical aging of the slabs was conducted in a constant temperature-constant humidity enclosure to keep the slabs from drying out. The temperature was about 24°C (75°F) and the relative humidity varied from 80 to 85%. For purposes of electrochemical aging, the slabs were divided into several groups. Slabs in each group were wired in series, with Zn as the anode and the steel mesh as the cathode. Figure 2.6 shows concrete slabs being aged in the controlled environment enclosure. Slabs were polarized at a current density of 0.032 A/m<sup>2</sup> (3 mA/ft<sup>2</sup>) using constant current power supplies. Total voltage across each group of slabs, the impressed current, and the laboratory temperature were recorded hourly on a data acquisition system to provide long-term performance data for the zinc/concrete/steel electrochemical (CP) system. Figures 2.7 and 2.8 are flow charts that represent the organization of the first and second experiments, respectively. Slab numbers are shown in the boxes. Note that slabs with two different concentrations of NaCl in the concrete were studied in the first experiment while only one concentration was studied in the second experiment. Table 2.4 shows basically the same information and gives the total number of slabs tested for each configuration and test duration.

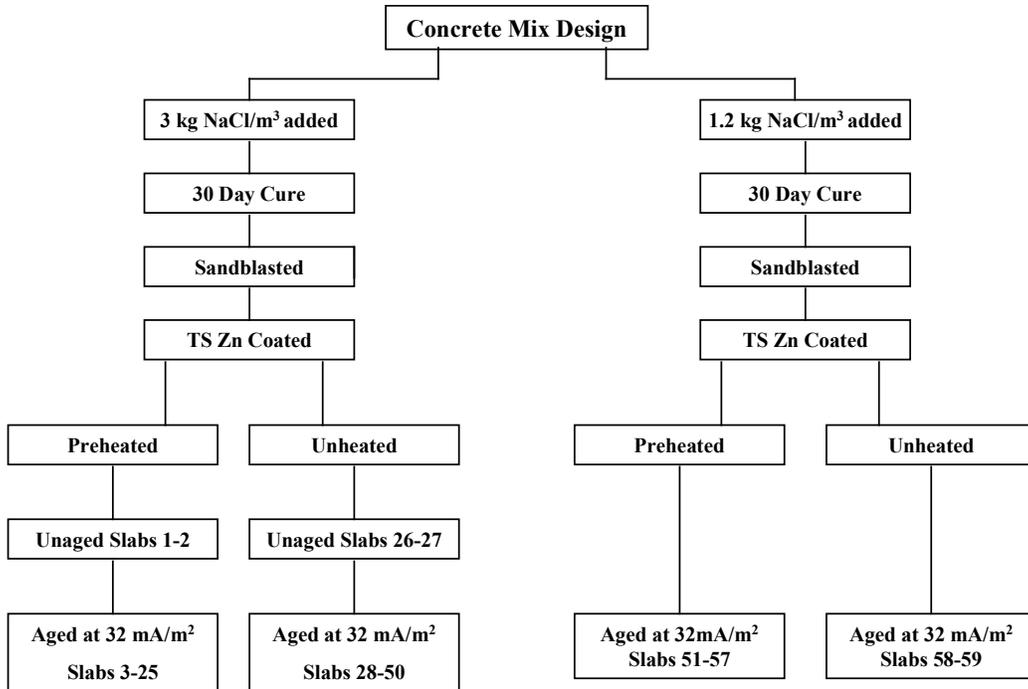
Figure 2.7: Flowchart showing the concrete slab treatments used in the first electrochemical aging experiment

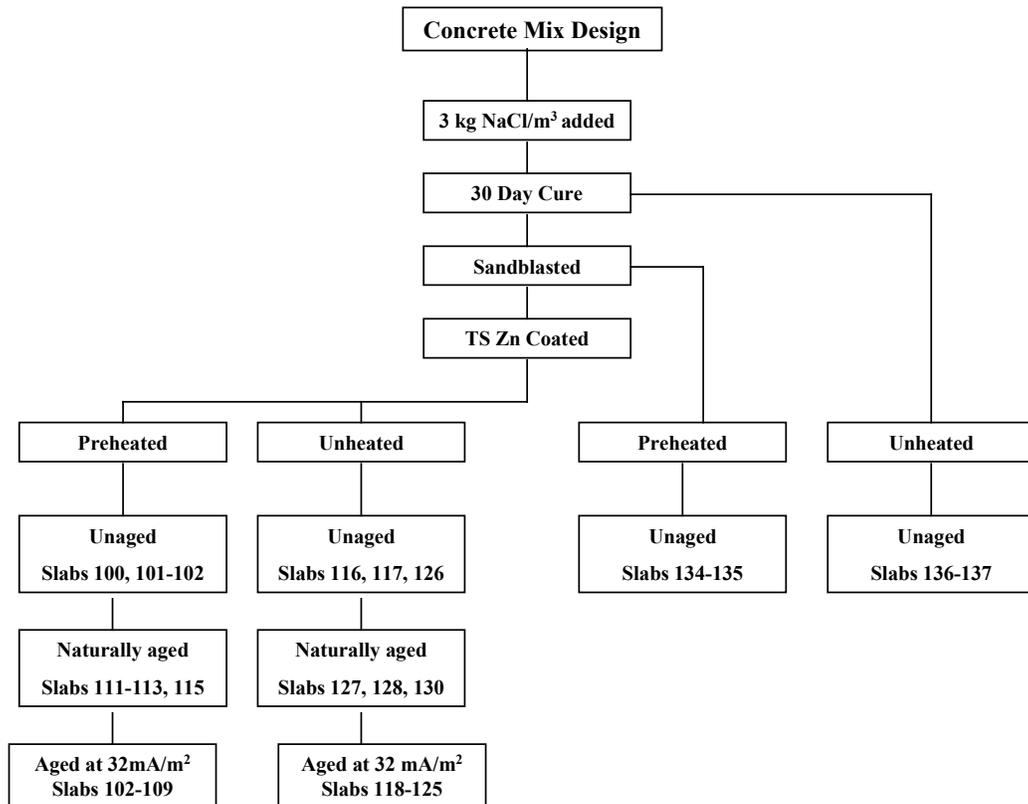
Figure 2.8: Flowchart showing the concrete slab treatments used in the second electrochemical aging experiment

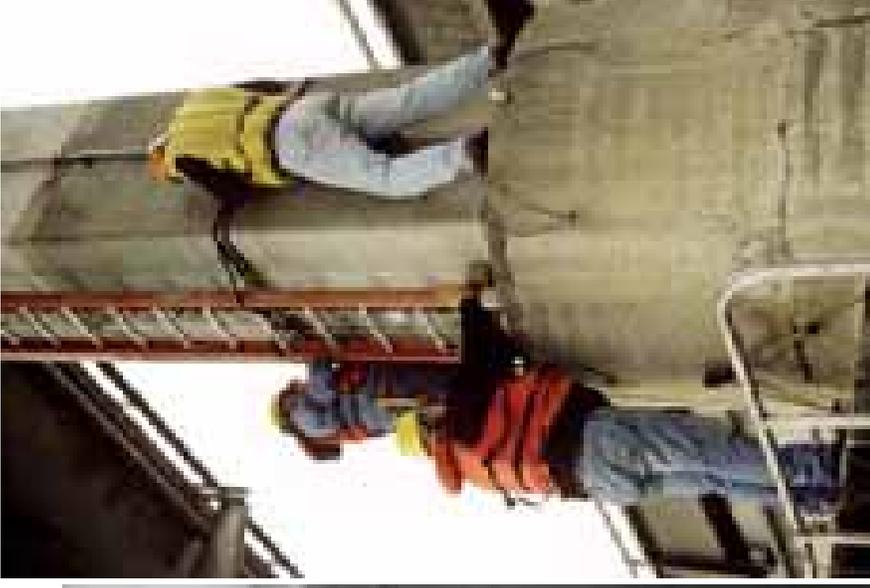
Figure 2.10: South column of pier 4, Richmond-San Rafael Bridge (CA), showing two of the four ICCP Zn anode bands (zones) and the SACP Zn anode zone on the barrel at the column base

The Richmond-San Rafael Bridge, Figure 2.9, is a major bridge in the northern half of San Francisco Bay on Route 17. The south column of pier 4, Figure 2.10, was thermal sprayed with Zn in 4 bands (zones) on May 1983. The barrel at the base of the column (on which the upper two researchers are standing) was also thermal sprayed with zinc. The Zn in each zone was applied by flame spraying to a thickness of approximately 0.22 mm (9 mils) using an oxy-acetylene flame. [However, coatings cross-sections examined by SEM and shown in this report suggest the actual coating thickness was greater, perhaps 0.37-0.49 mm (15-20 mils).] Initial bond strength of the Zn to concrete ranged from 1.0-3.4 MPa (150-500 psi) with an average value for 14 measurements of 1.93 MPa (280 psi) (*Carello, Parks and Apostolos 1989*).

Each band is 1.2 m (4 ft) in vertical height, surrounds the column, and is separated from the one above and below it by a 15.2 cm (6 in) gap. The anode on the barrel was operated galvanically. Bands 1 through 4, on the column, were operated as ICCP anodes. The low edge of band 1 is within 3 m (10 ft) of the water surface and fully exposed to the action of waves and precipitation. Band 4 is higher on the column, partially sheltered from precipitation by the roadbed immediately above it, while fully exposed to the drying effects of the wind. The CP systems were operated and the driving (or operating) voltage and system current for each anode was monitored by CALTRANS continuously for 12 years from 1983 through 1994. In May 1997, bond strength tests were performed on anode bands 1 through 4 on the north and east faces of the south column. Powder samples and 5 cm (2 in) diameter core samples were taken from bands 1, 2, and 3 on the north face of the south column and from the footer, Table 2.5. To date, the Richmond-San Rafael thermal-sprayed Zn anodes are the longest operating TS Zn anodes anywhere.

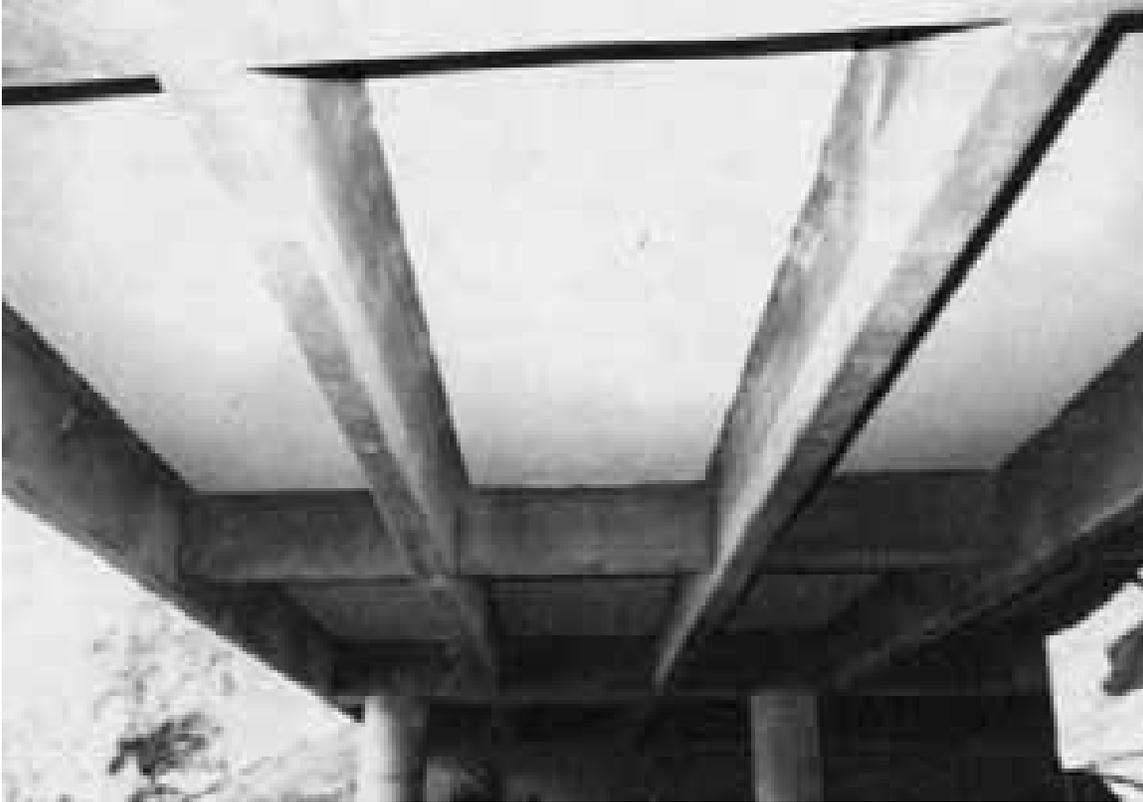
Figure 2.12: East Camino Under-crossing (CA) showing soffit areas that were thermal sprayed with Zn

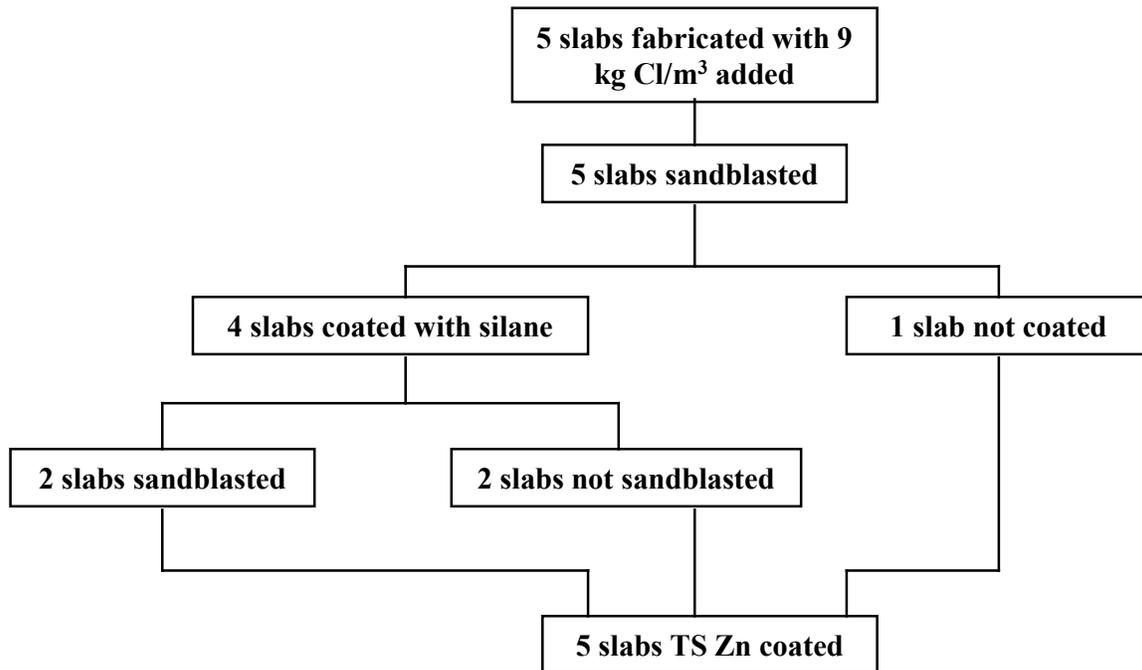
Figure 2.13: Experimental design for the CALTRANS laboratory silane study

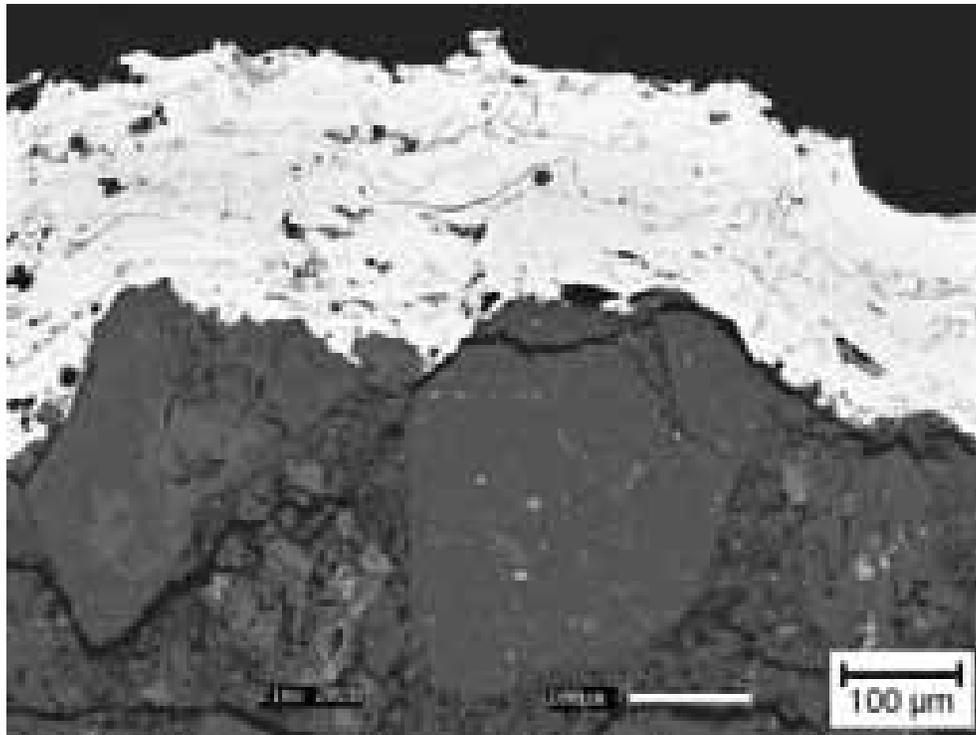
Figure 3.1: SEM photomicrograph of cross-section showing unaged TS Zn anode microstructure and anode-concrete interface for anode on concrete

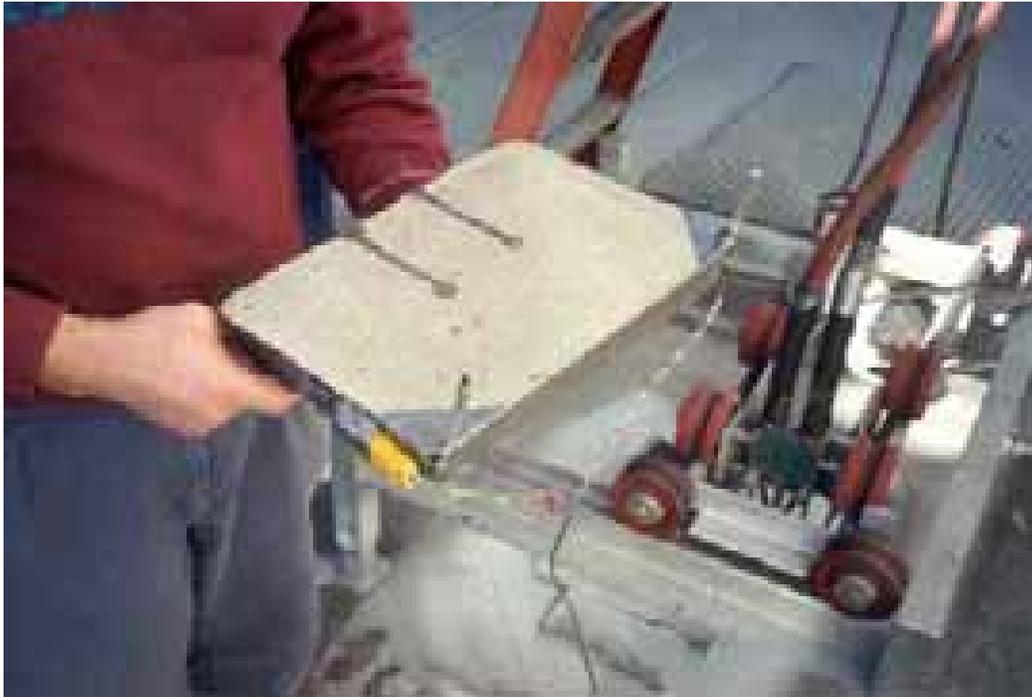
Figure 3.2: View of thermocouples attached to concrete slab for surface temperature measurements

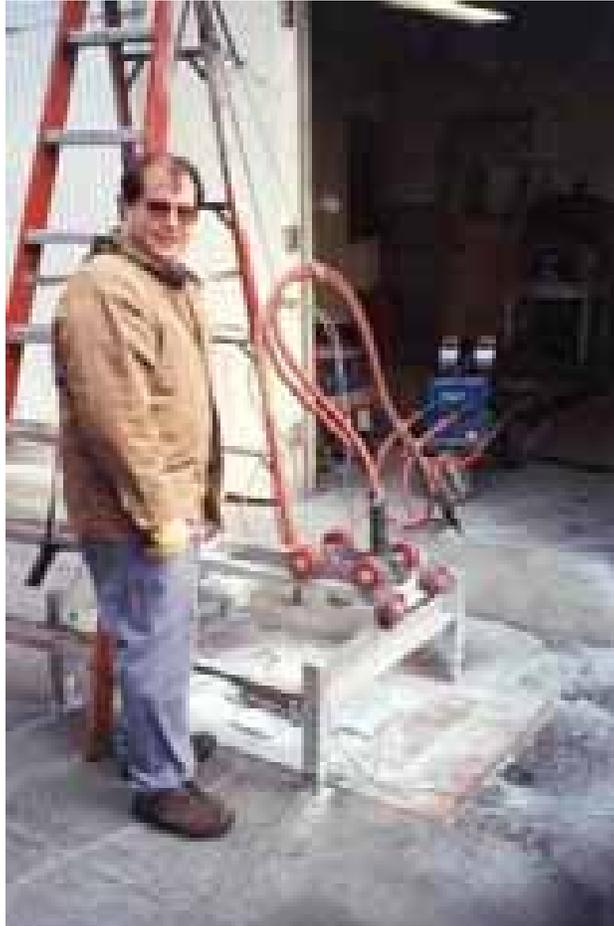
Figure 3.3: Twin-wire arc-spray equipment prior to applying TS Zn anode to concrete slab for surface temperature measurements

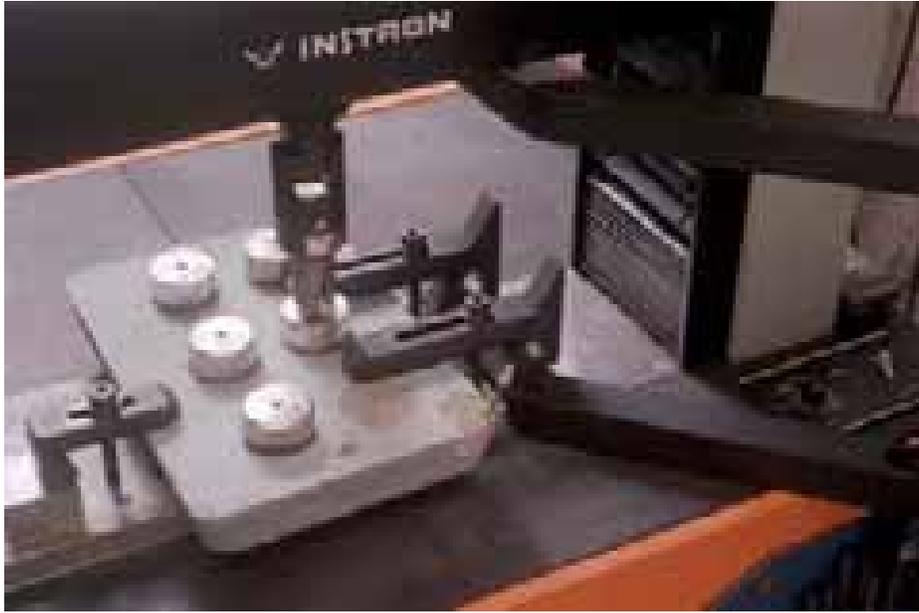
Figure 3.6: Instron universal tensile tester used to measure the bond strength of TS Zn anodes on a concrete slab; shows 5 cm diameter aluminum dollies attached to anode with epoxy

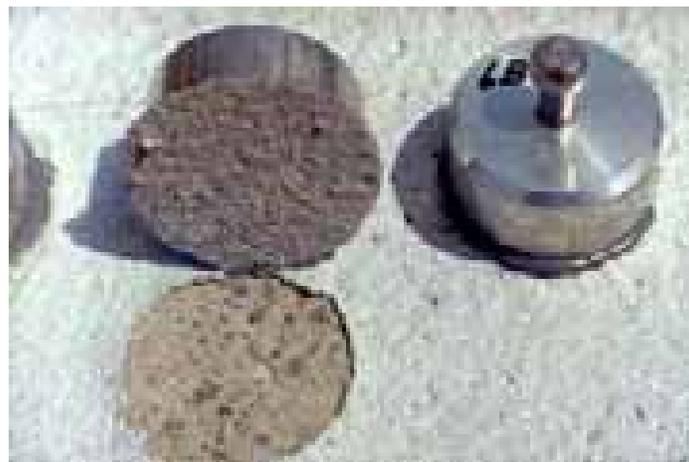
Figure 3.7: Close up of aluminum dollies used for bond strength measurements: one dolly attached and one pulled off

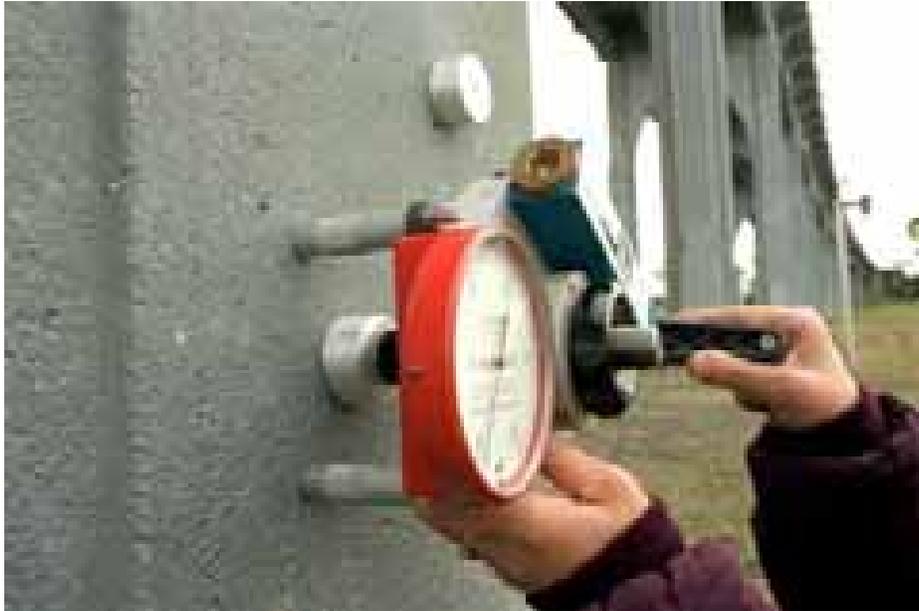
Figure 3.8: Proceq portable tester used to measure the bond strength of the TS Zn anode on concrete

Bond strength measurements on field anodes used the same dollies and adhesive as used in the laboratory but were made using a Proceq Adhesion Tester, Figure 3.8.

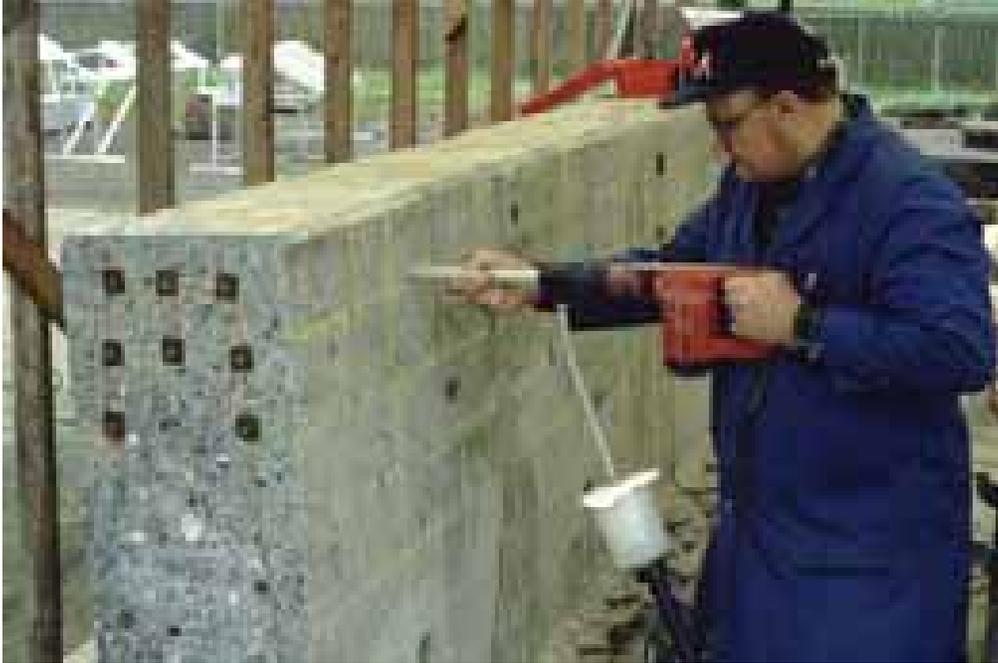
Figure 3.9: Concrete powder samples are taken from a concrete bridge beam using the Oregon DOT sampling equipment. Powder samples are analyzed to determine the salt concentration in the concrete as a function of depth in the beam.

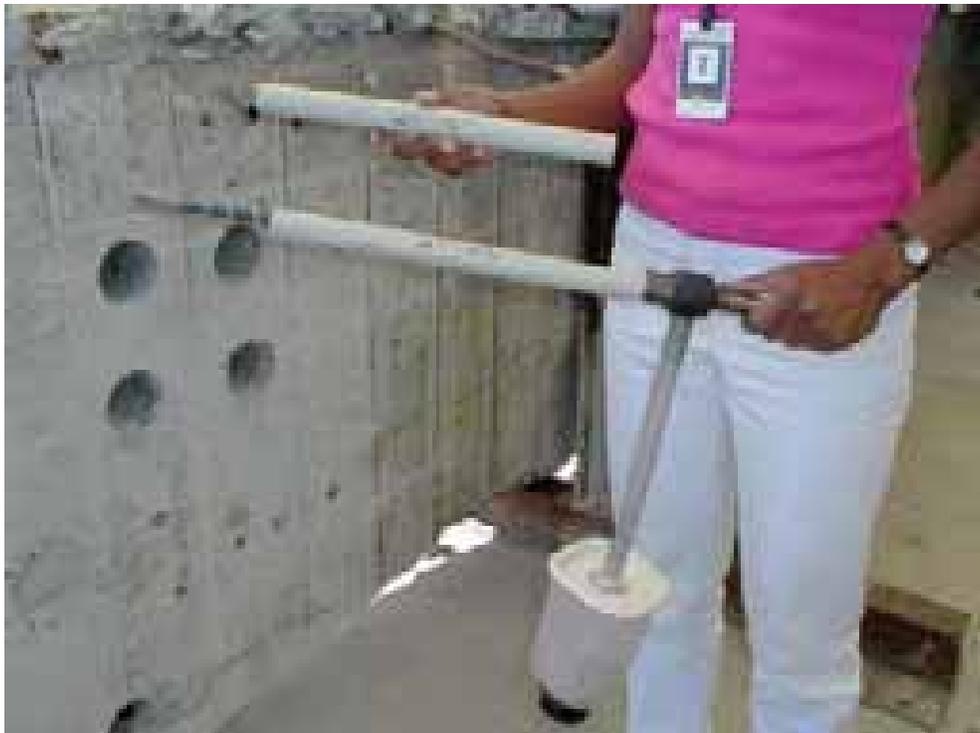
Figure 3.10: The hollow anchor drill bit, depth spacers, and vacuum filter assembly used in taking powder samples from concrete

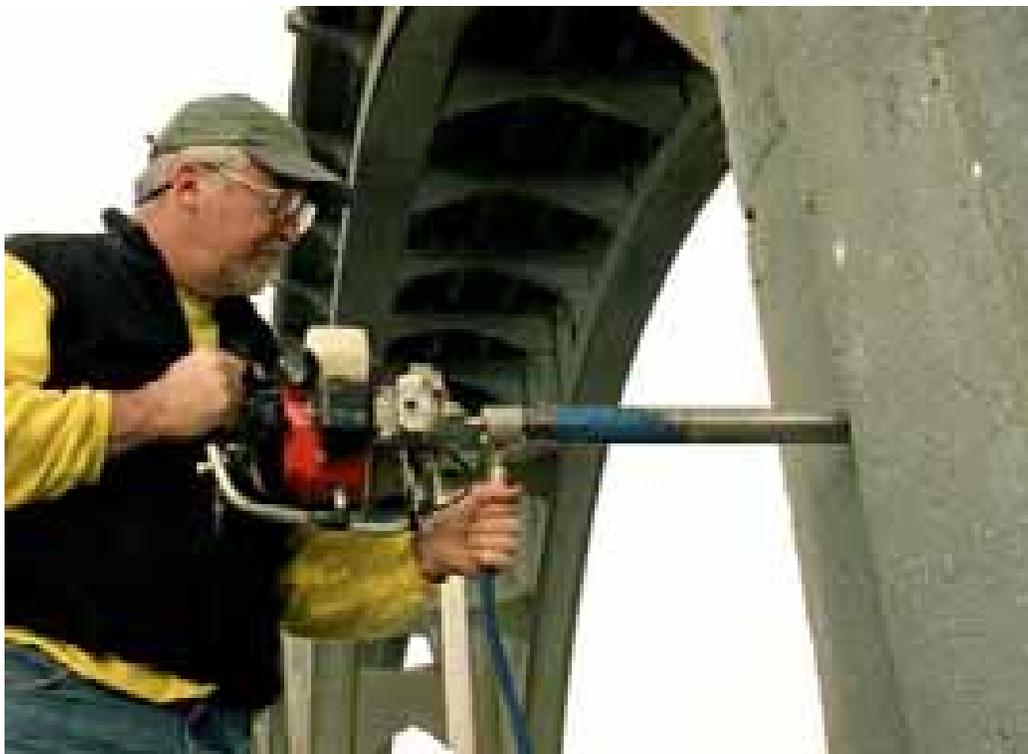
Figure 3.11: Portable gasoline-powered core drill for taking concrete core samples

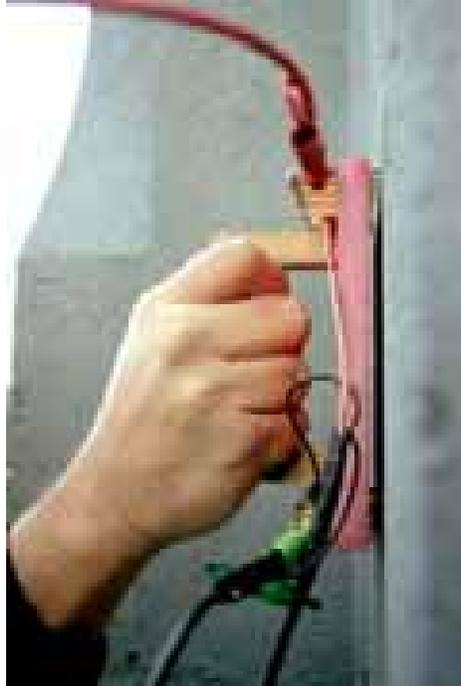
Figure 3.12: Oregon DOT resistance probe for measurement of anode coating resistivity

The dc (direct current) resistance of thermal-sprayed Zn anode coatings was measured as a function of electrochemical age. No surface preparation was required for these measurements. The probe used to make this measurement was built by the Oregon DOT (*McGill, et al. 1999*) and is shown in use on the Yaquina Bay Bridge in Newport, OR, Figure 3.12. The probe measured only the resistance of the TS anode, since the underlying concrete was orders of magnitude more resistive when dry. Resistance measurements were made on laboratory slabs before electrochemical aging and at the conclusion of the aging experiment. By knowing the anode coating thickness, the resistance can be converted into coating resistivity values.

The probe allowed for a 4-point resistance measurement that eliminated the contact resistance common to 2-point measurements. The current source, which was connected to the outer row of pins of the probe, was typically set to  $1.0 A_{dc}$ . The voltage measurement was made using a high impedance electrometer by connections to the inner pins. The probe provided accurate results requiring no corrections when the sample being measured was the same width as the probe. Anodes having a width greater than the probe introduce correctible errors as a result of additional current pathways (McGill, *et al.* 1999). The effect of these additional pathways is a reduction of the measured resistance. Anode widths more than twice the probe width, such as would be encountered with bridge CP zones, lead to a measured resistance about 60% of the true resistance.

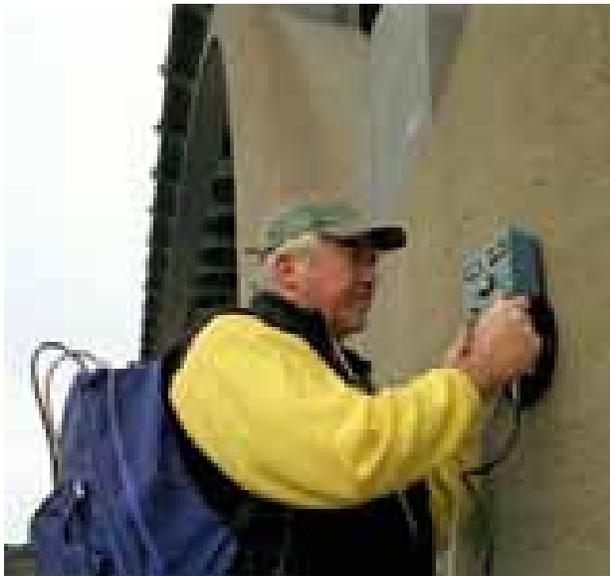
Figure 3.13: Portable surface air permeability instrument in use

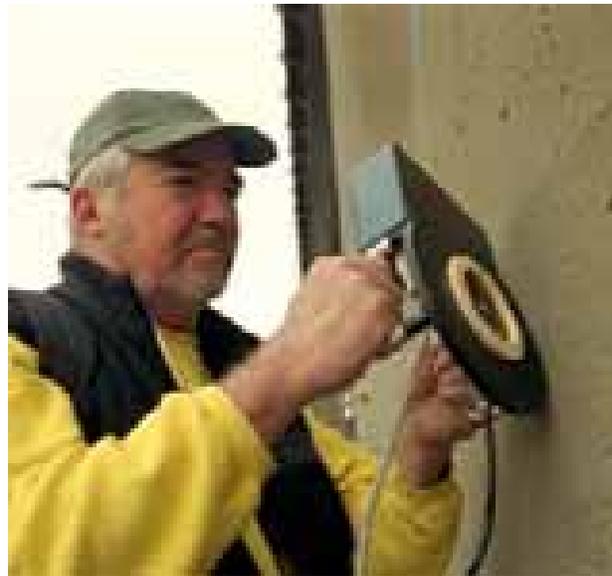
Figure 3.14: Close-up of measuring head for surface air permeability instrument showing the flexible rubber gasket that forms a vacuum seal between the measuring head and concrete surface

The permeability of the TS Zn anode to the ingress of air can be determined by a surface air permeability measurement. The instrument is based on the principle that flow of air through a surface will be higher for a surface with a higher permeability. Operation of the instrument required a vacuum of about 640 mm (25 in) Hg. Air flow was measured by a mass flowmeter. The instrumentation was available as a self-contained portable unit. Its operation is described in the “Showcase Workshop on Concrete Durability” (*U.S. FHWA-SHRP 1995*) and in SHRP-S-329, “Condition Evaluation of Concrete Bridges Relative to Reinforcement Corrosion – Volume 7: Method for Field Measurement of Concrete Permeability” (*Whiting and Cady 1993*). The instrument is shown in Figure 3.13 in use on a thermal-sprayed Zn anode CP zone on the Yaquina Bay Bridge. Figure 3.14 gives a closer view of the instrument showing the flexible rubber gasket used to form a vacuum seal between the measuring head and the bridge surface.

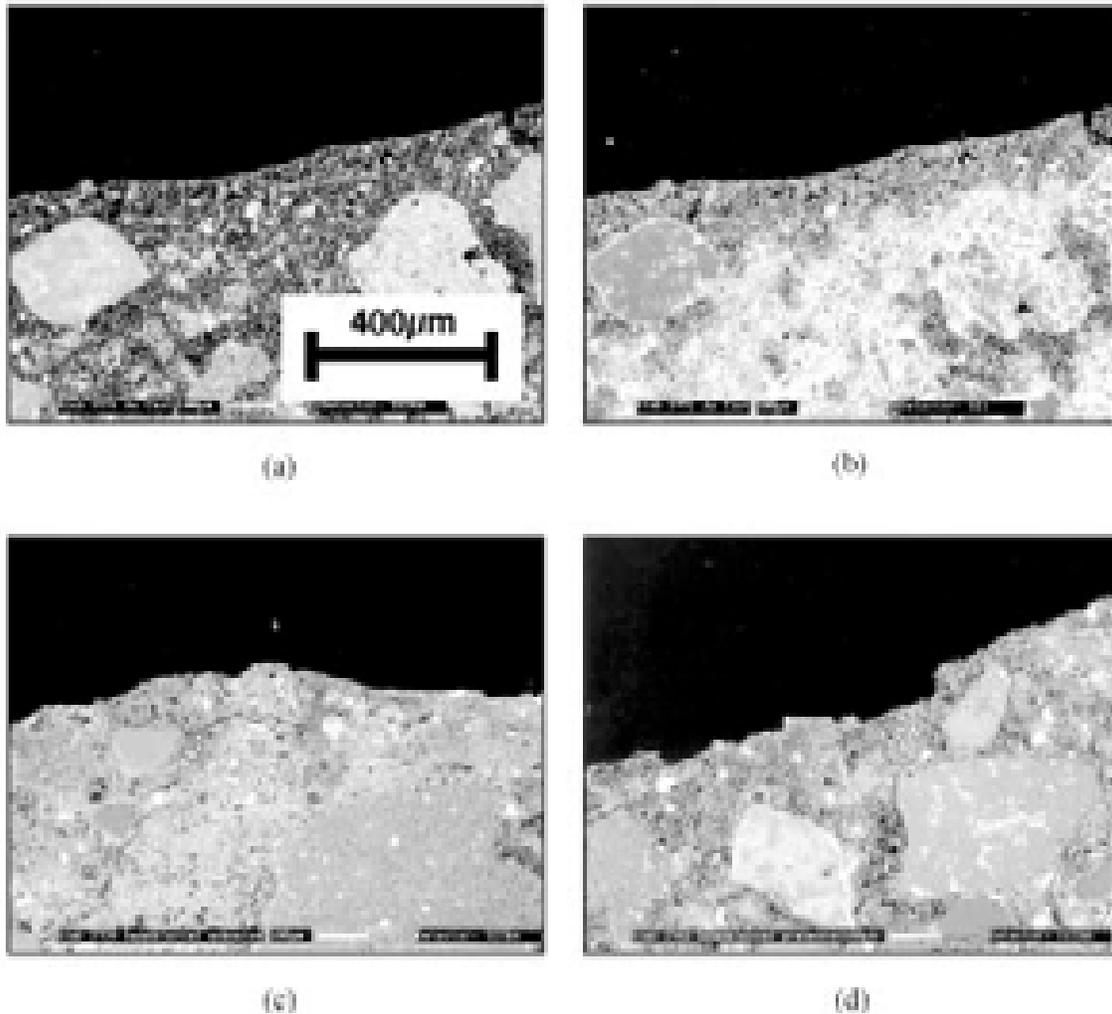
Figure 4.1: Multiple SEM photomicrographs of cross sections from uncoated slabs. (a) as cast, back scattered electron (BSE); (b) as cast, secondary electron (SE); (c) sandblasted, BSE; (d) sandblasted and preheated, BSE.

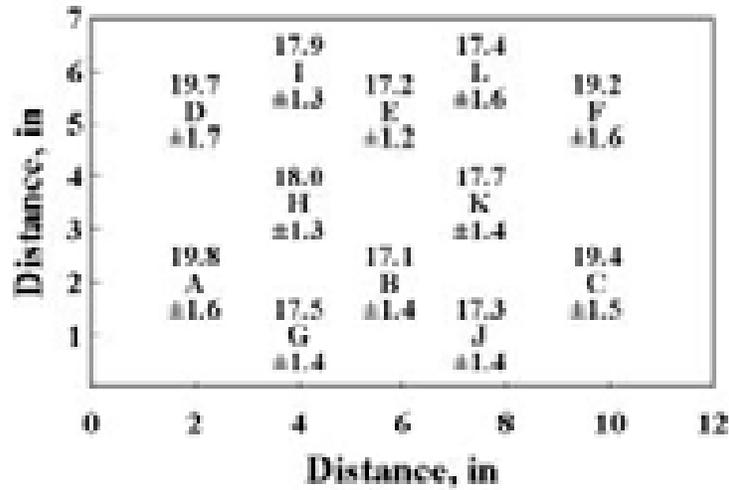
Figure 4.2: Location of measurements on 56 concrete slabs showing average and standard deviation values of TS Zn coating thickness from eddy current measurements

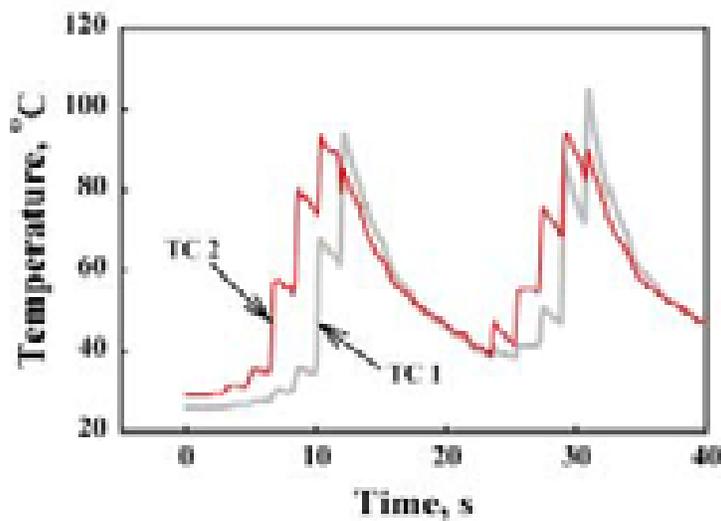
Figure 4.3: TS Zn coating surface temperature versus time for two thermocouples under the coating on the concrete slab

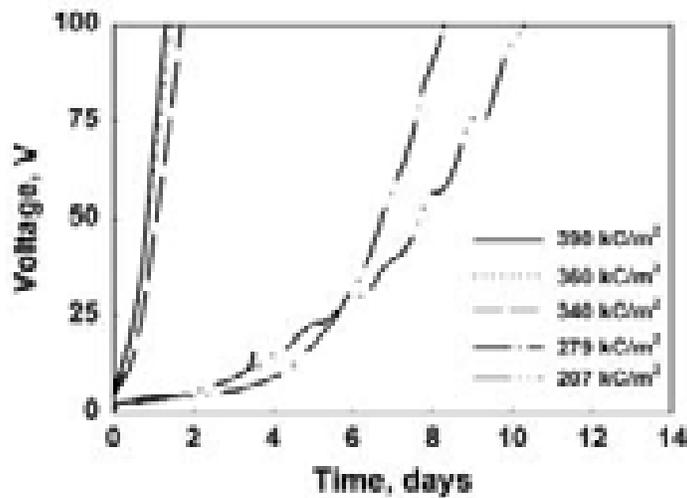
Figure 4.5: CP system voltage rise due to drying of the anode-concrete interface versus drying time for selected electrochemical ages

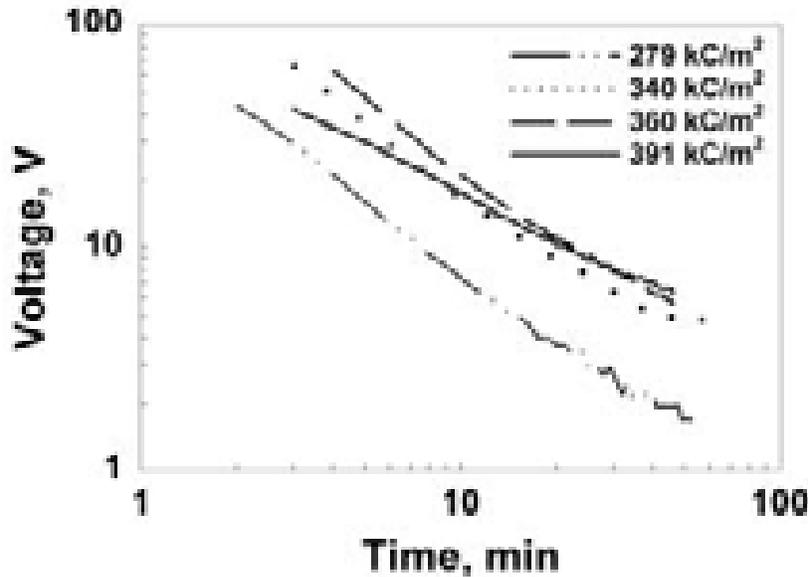
Figure 4.6: CP system voltage decay due to wetting of the anode-concrete interface versus elapsed time after wetting for selected electrochemical ages

**Table 4.1: Voltage decay parameters for TS Zn anodes on periodically-wetted concrete slabs (based on Figure 4.6)**
