**PERFORMANCE OF ZINC ANODES FOR CATHODIC  
PROTECTION OF REINFORCED CONCRETE BRIDGES**

**Final Report**

**SPR 364**

**March 2002**

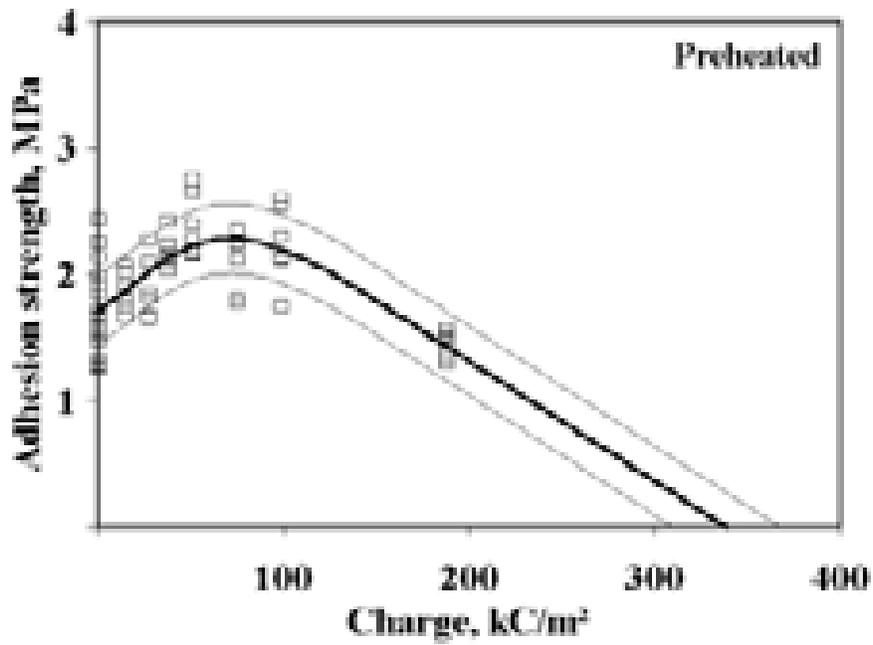
Figure 4.8a: Bond strength of the TS Zn anode on un-wetted, preheated concrete slabs versus electrochemical age

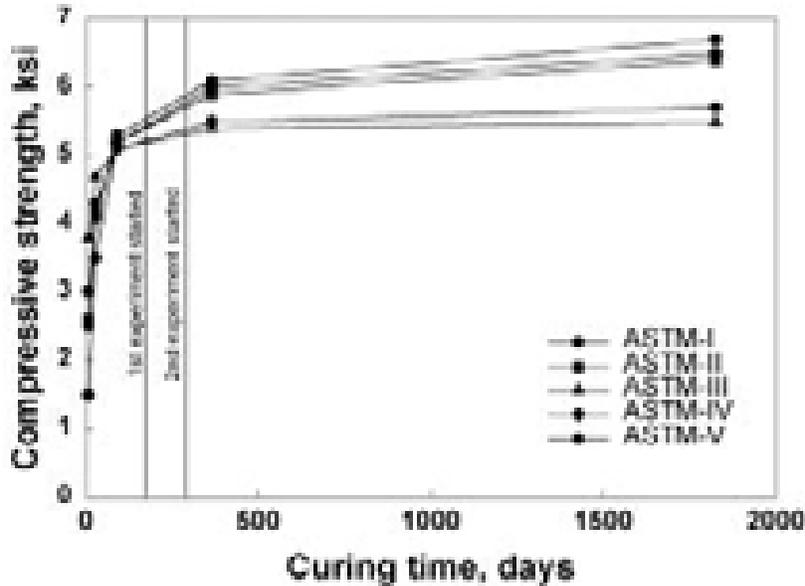
Figure 4.10: Effect of curing time on the compressive strength of five ASTM concretes

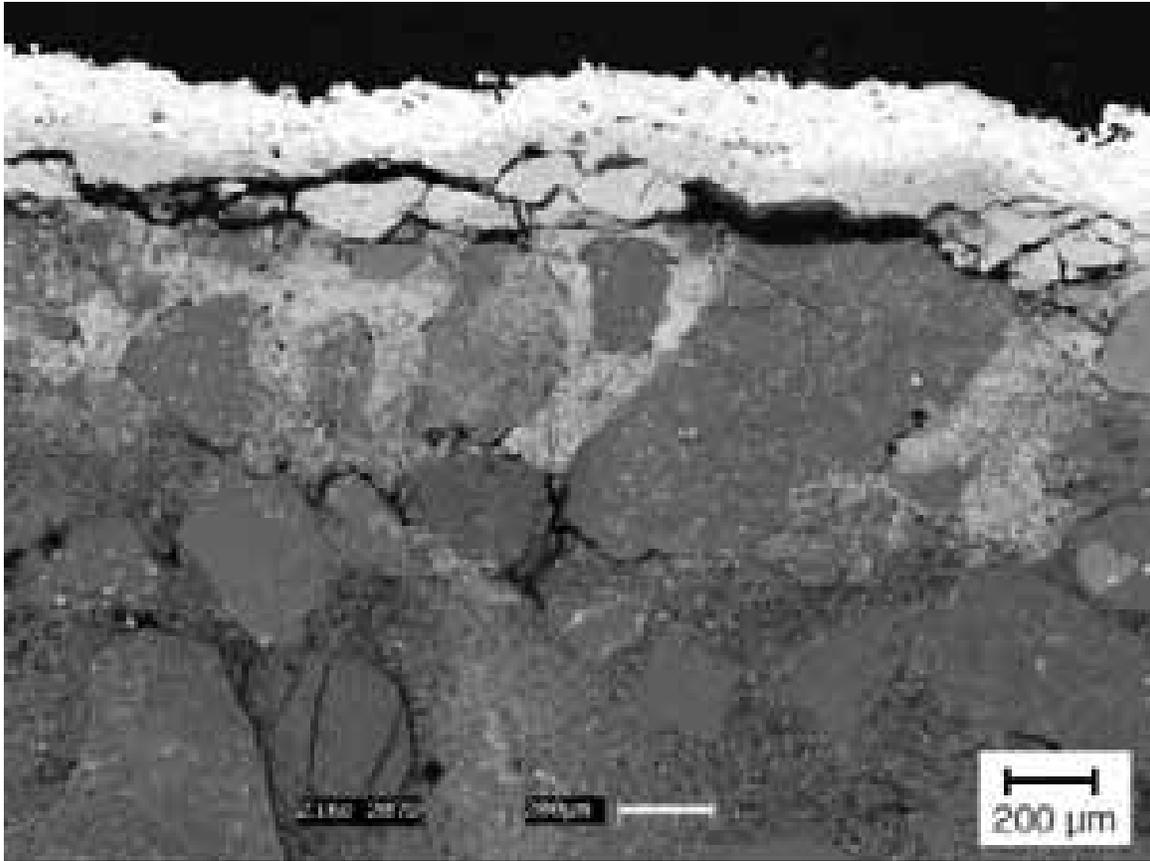
Figure 4.11: SEM photomicrograph showing cracking of periodically-wetted cement paste at the TS Zn anode-concrete interface following  $747 \text{ kC/m}^2$  aging, the equivalent of 11.0 years at  $0.0022 \text{ A/m}^2$

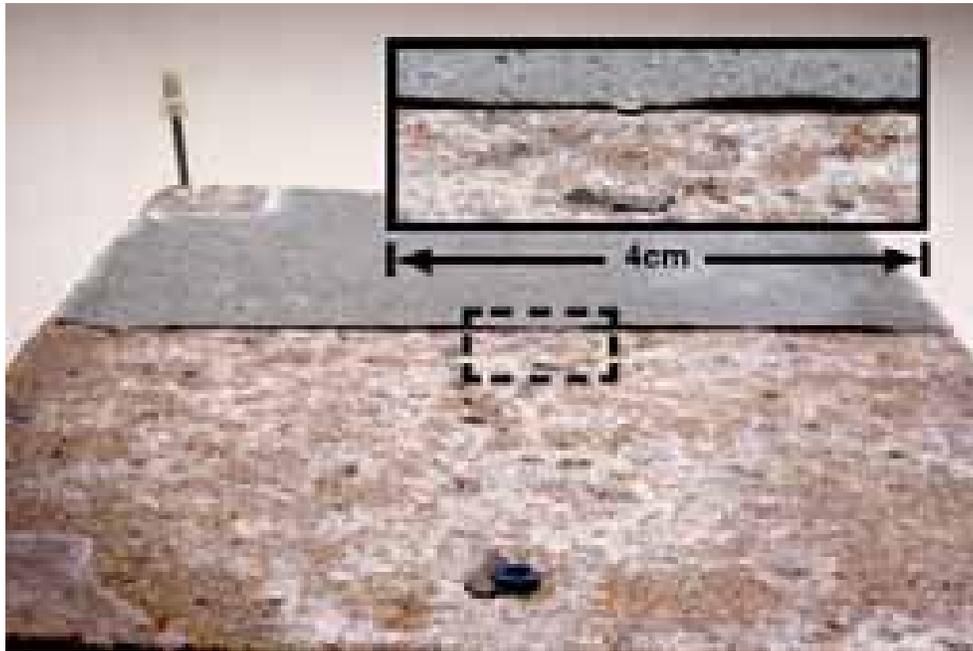
Figure 4.12: Delaminated TS Zn anode on periodically-wetted concrete slab following  $\sim 1800 \text{ kC/m}^2$  aging

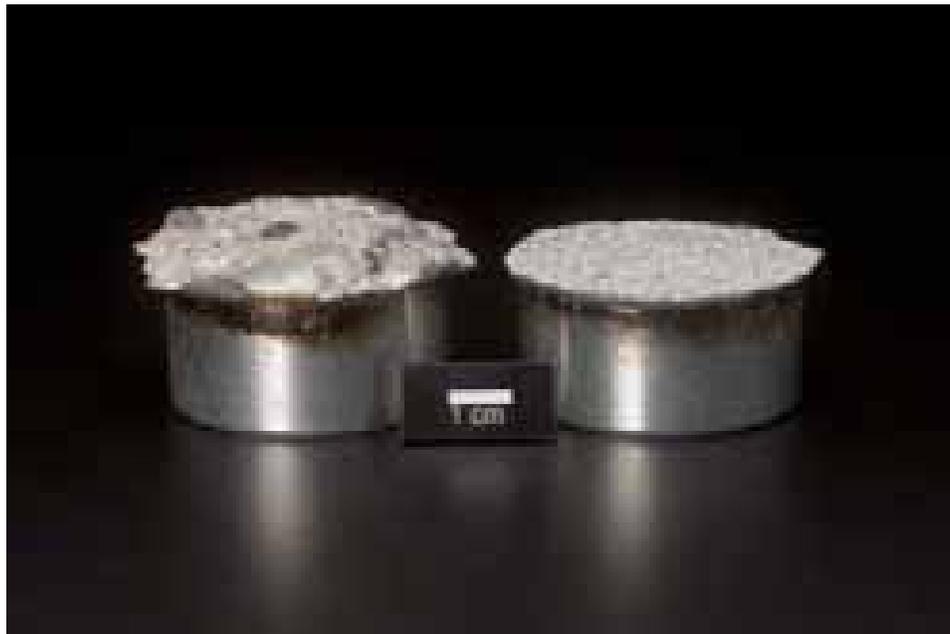
Figure 4.13: Pullout of concrete as a result of bond strength tests for bare concrete (left) and TS Zn coated concrete (right)

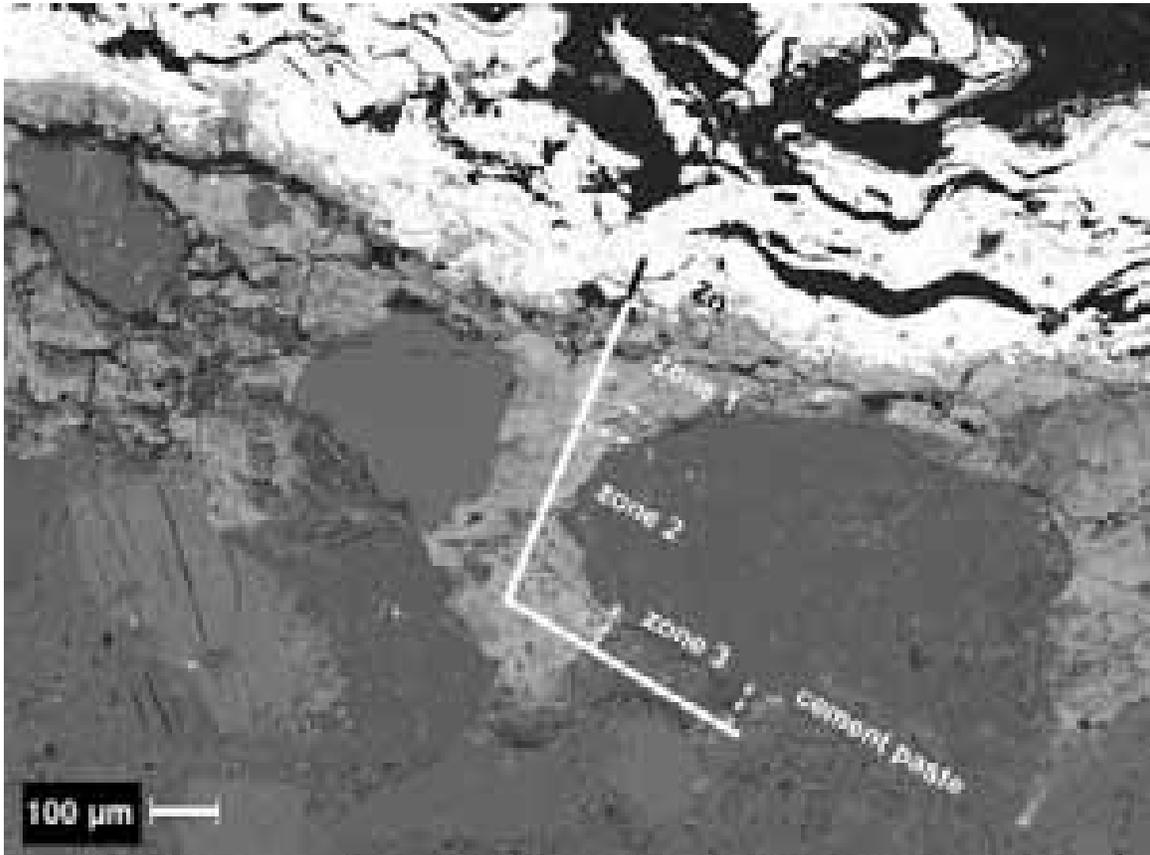
Figure 4.14: Back-scattered electron SEM photomicrograph of a cross-section of TS Zn anode on periodically-wetted concrete electrochemically aged for  $640 \text{ kC/m}^2$ , the equivalent of 9.4 years at  $0.0022 \text{ A/m}^2$ ; shows reaction zones.

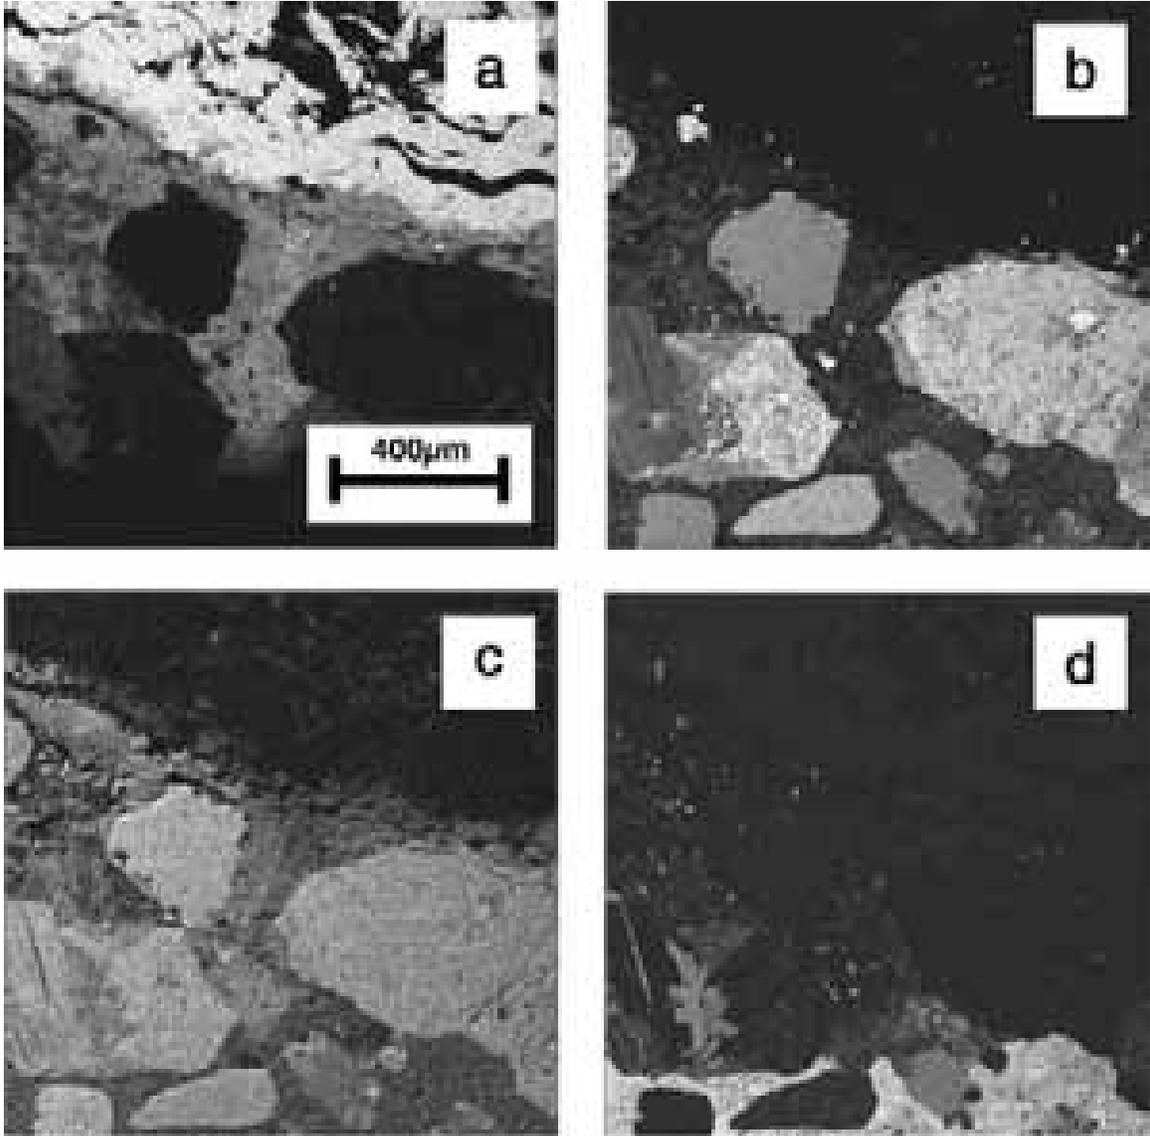
Figure 4.15: X-ray maps of elemental distributions at the Zn-concrete interface in Figure 4.14:  
 (a) Zn; (b) O; (c) Si; (d) Ca

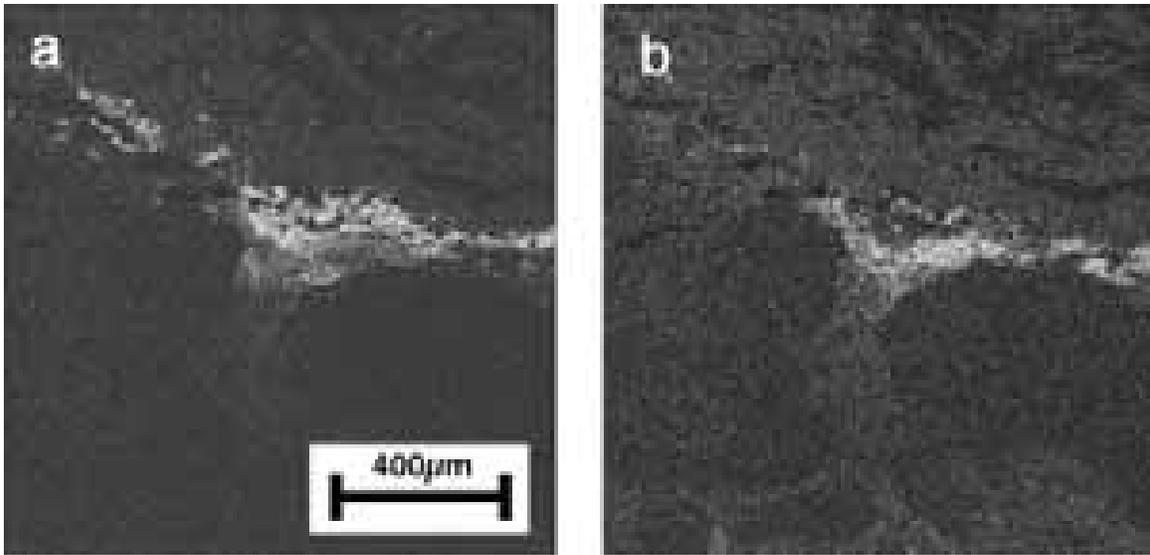
Figure 4.16: X-ray maps of elemental distributions at the Zn-concrete interface in Figure 4.14: (a) Cl; (b) S

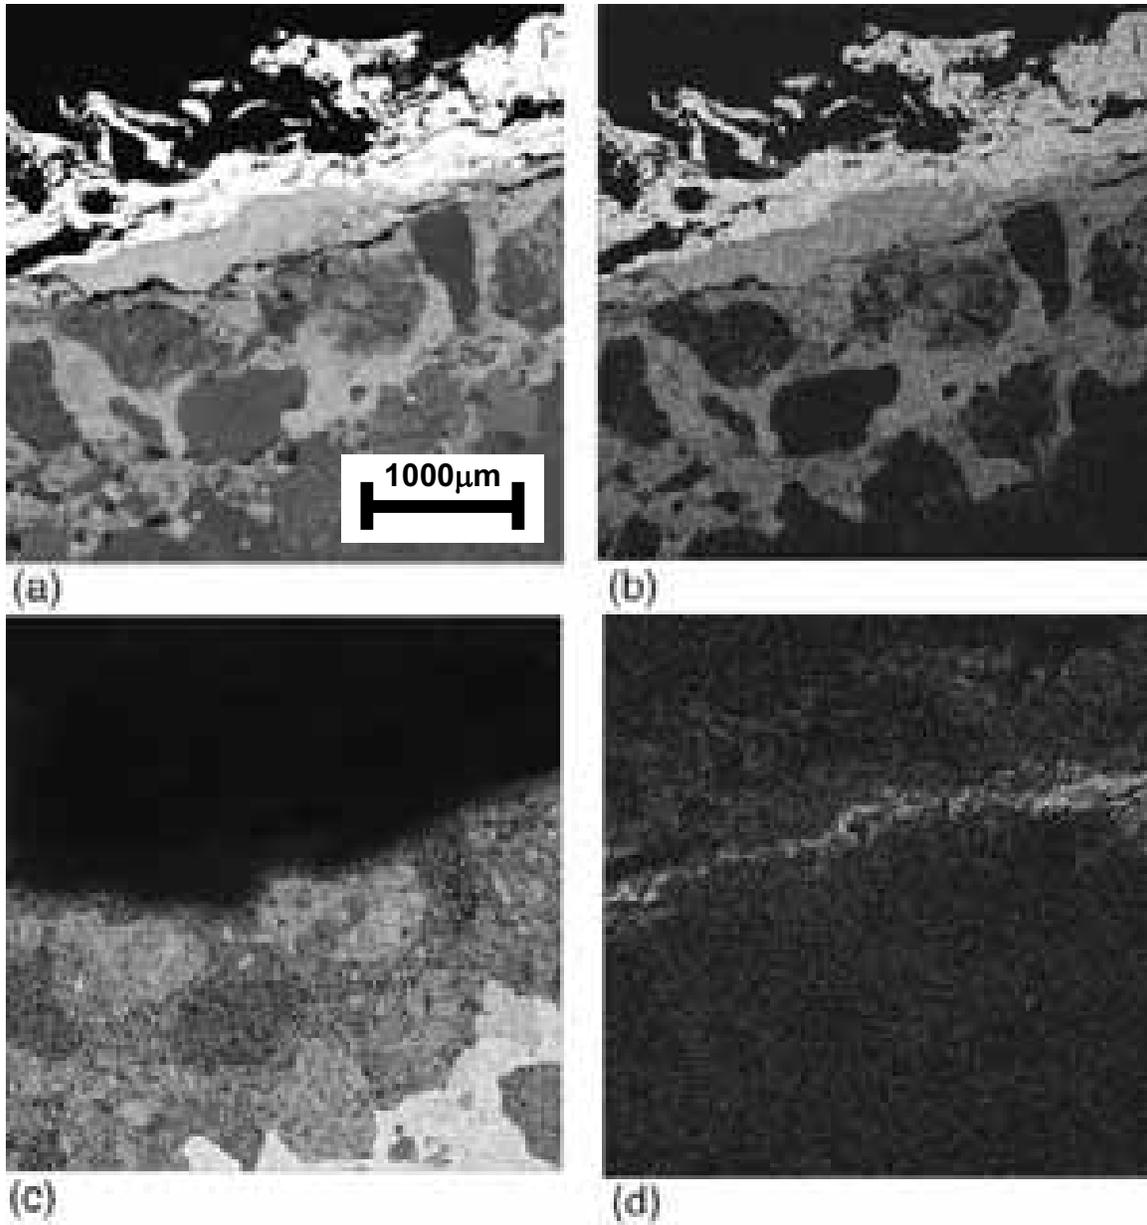
Figure 4.17: Cross-section of TS Zn anode on periodically-wetted concrete electrochemically aged for 1080  $\text{kC/m}^2$ , the equivalent of 15.9 years at  $0.0022 \text{ A/m}^2$ : (a) back-scattered electron SEM photomicrograph; and x-ray maps, (b) Zn, (c) Ca, (d) Cl

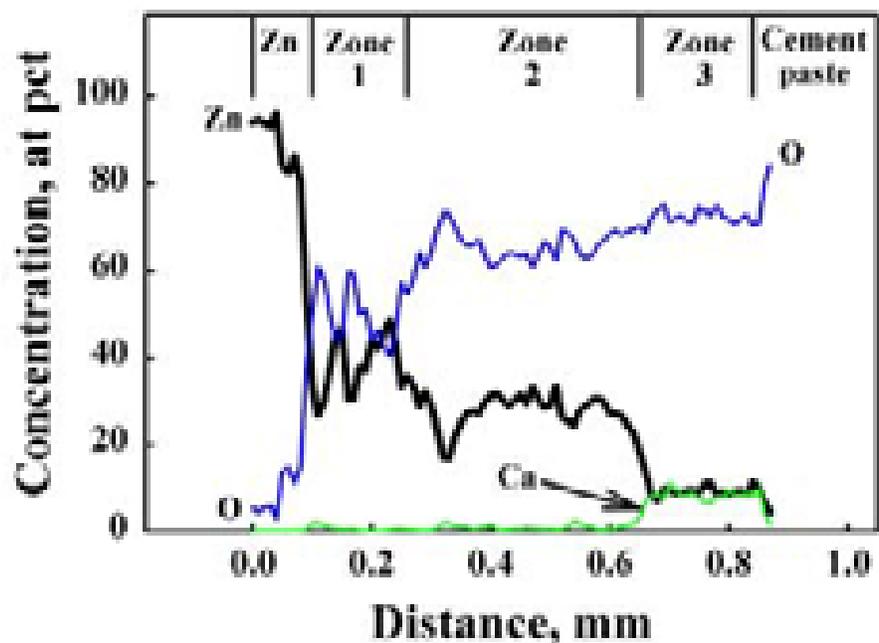
Figure 4.18: WDS concentration profiles for Zn, O, and Ca at the TS Zn anode-concrete interface in Figure 4.14

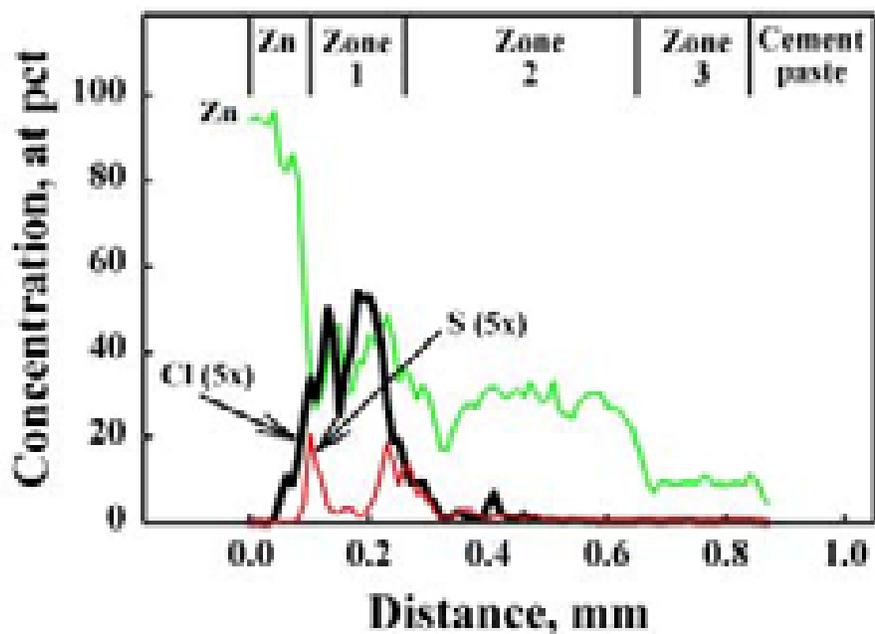
Figure 4.19: WDS concentration profiles of Zn, Cl and S at the TS Zn anode-concrete interface in Figure 4.14

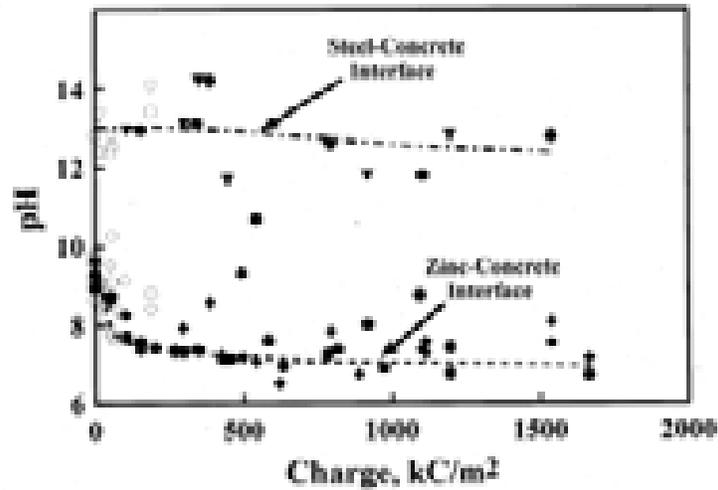
Figure 4.23: pH versus electrochemical age for TS Zn anode-concrete and steel-concrete interfaces for periodically-wetted concrete slabs

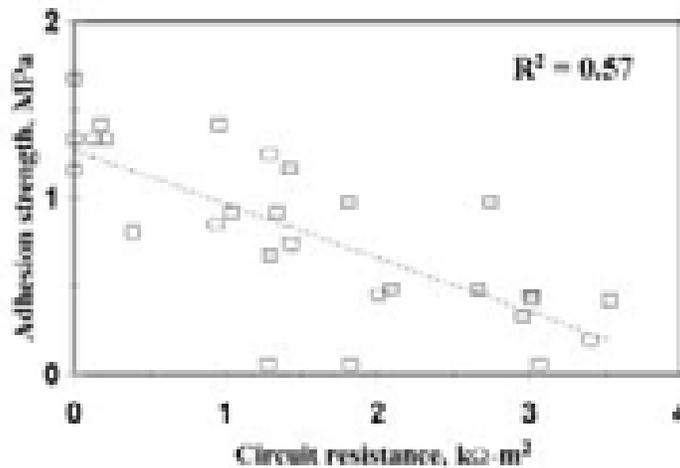
Figure 4.24: Relationship between CP system circuit resistance and TS Zn anode bond (adhesion) strength for periodically-wetted concrete slabs

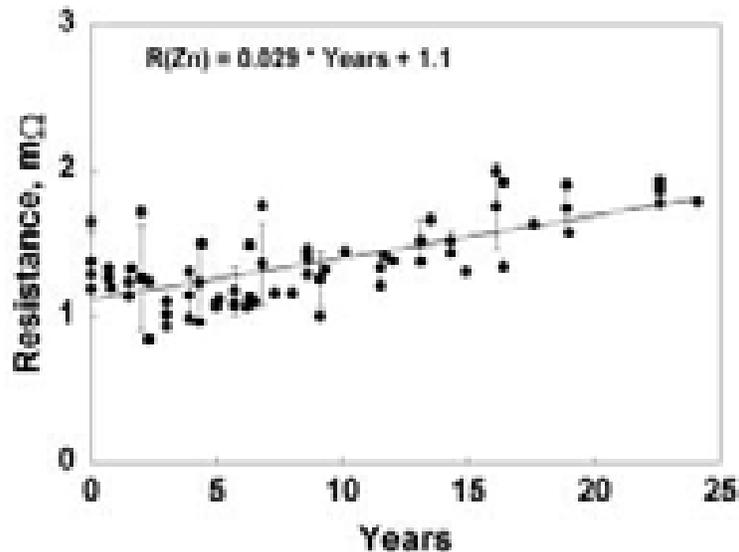
Figure 4.25: Surface resistance of TS Zn anode as a function of electrochemical age in years at 0.0022 A/m<sup>2</sup> for periodically-wetted concrete slabs

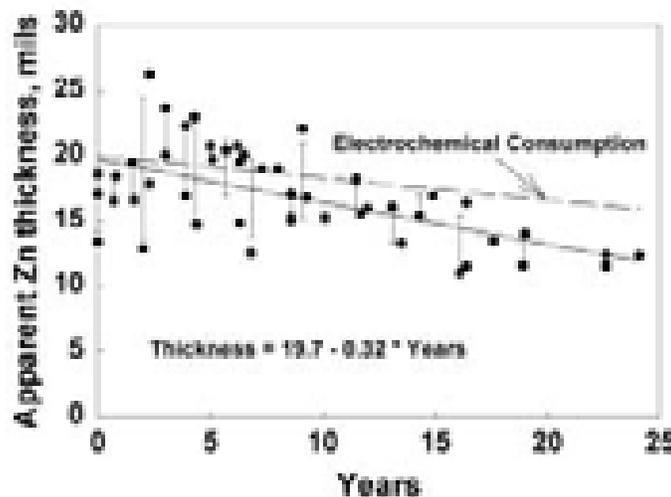
Figure 4.26: Apparent TS Zn anode thickness as a function of electrochemical age in years at  $0.0022 \text{ A/m}^2$

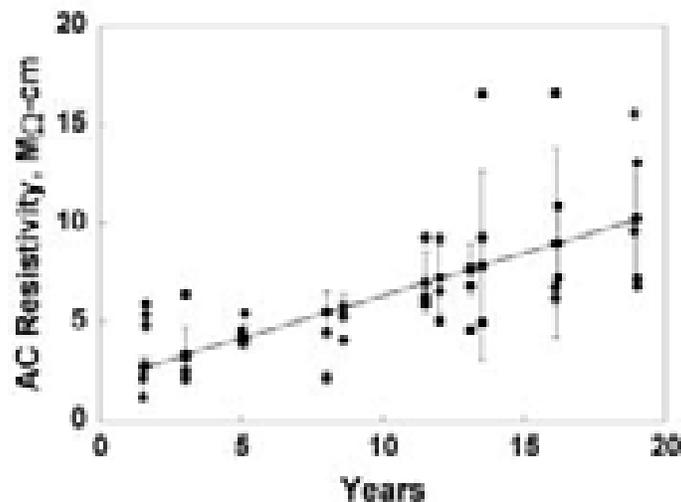
Figure 4.27: Volume average AC resistivity of material between the TS Zn anode and the steel as a function of electrochemical age in years at  $0.0022 \text{ A/m}^2$ ; average includes zinc minerals at anode, altered and unaltered concrete, and corrosion film on steel.

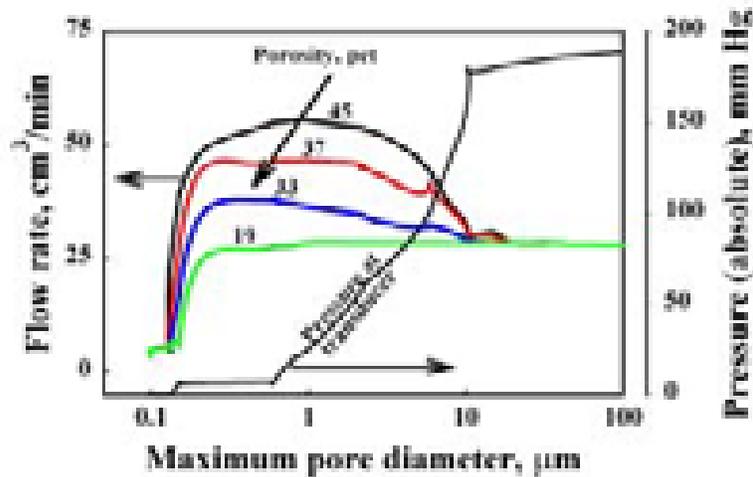
Figure 4.28: Surface air permeability determined using ceramic disc porosity standards as a function of maximum pore diameter and percent pore volume (porosity).

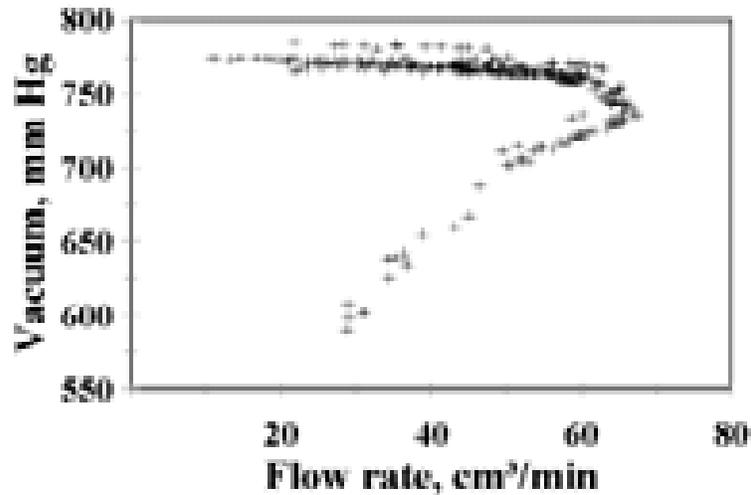
Figure 4.29: Surface air permeability vacuum pressure for TS Zn anodes on periodically-wetted concrete slabs as a function of airflow rate through the instrument

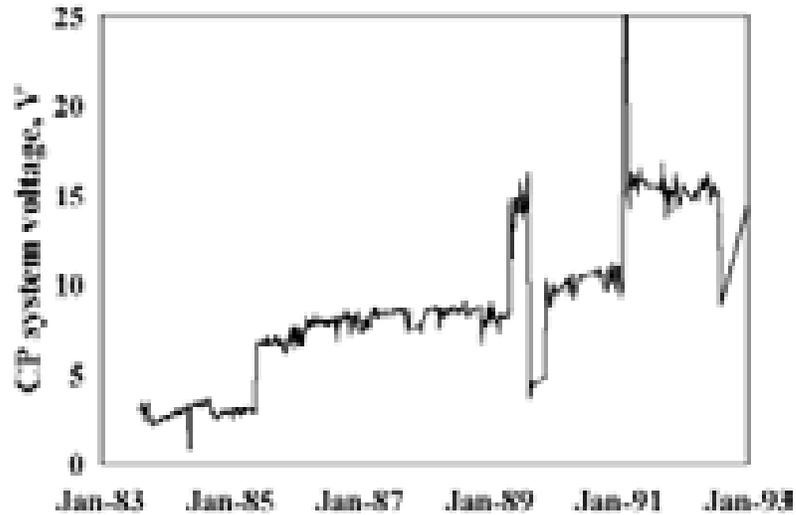
Figure 5.2: ICCP system voltage for the TS Zn bands (zones) on the south column, pier 4 of the Richmond-San Rafael Bridge (CA).

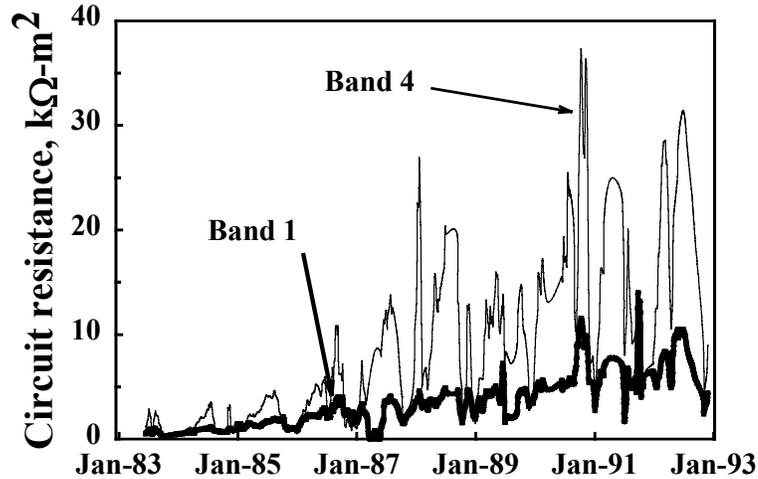
Figure 5.3: Circuit resistance as a function of time for TS Zn anode bands (zones) 1 and 4 on the south column, pier 4 of the Richmond-San Rafael Bridge

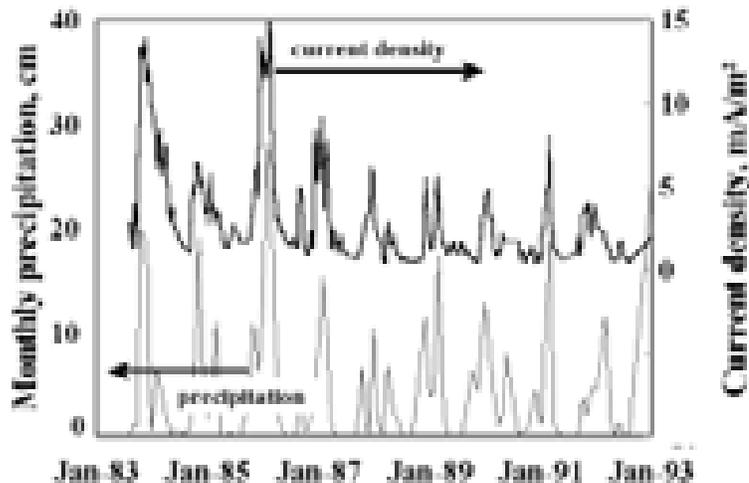
Figure 5.5: Current density and monthly precipitation as a function of time for TS Zn anode band (zones) 4 on the south column, pier 4 of the Richmond-San Rafael Bridge

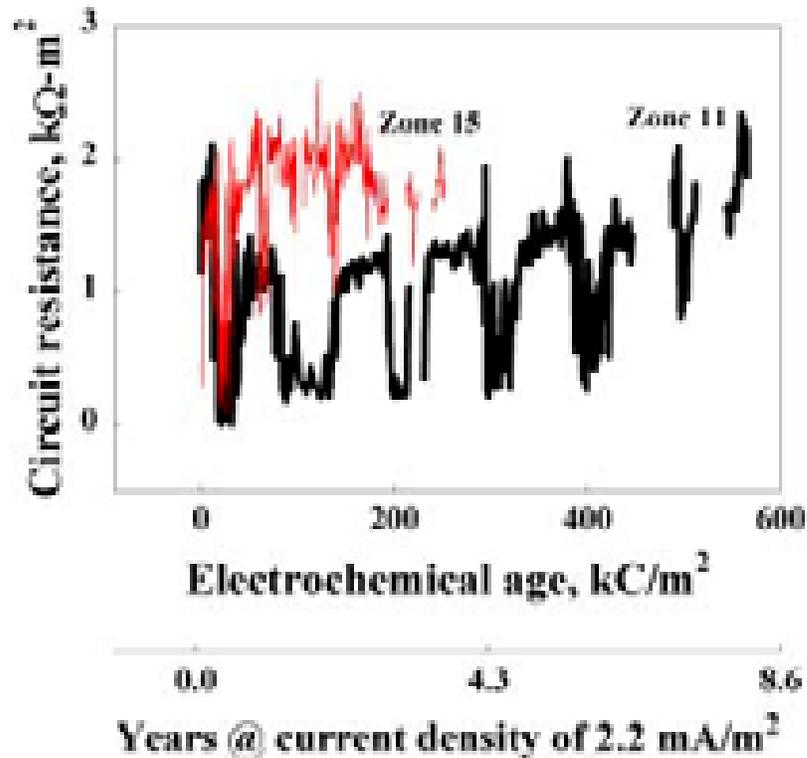
Figure 5.6: Circuit resistance as a function of TS Zn electrochemical age for ICCP zones 11 and 15 on the Cape Creek Bridge; measurements on each zone were for the same time period.

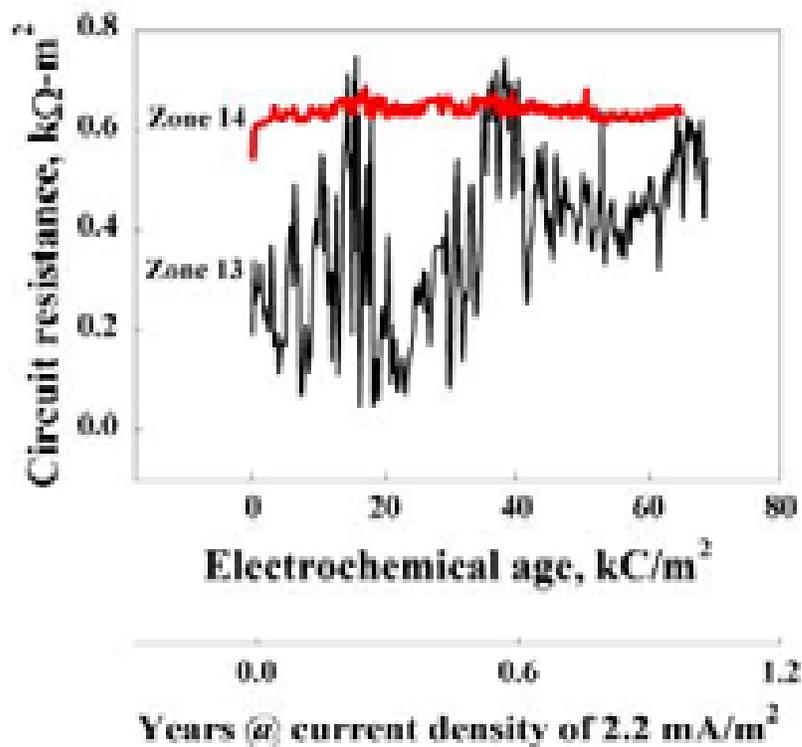
Figure 5.7: Circuit resistance as a function of electrochemical age for ICCP zones 13 (TS Zn anode) and 14 (TS Ti anode) on the Depoe Bay Bridge; measurements on each zone were for the same time period.

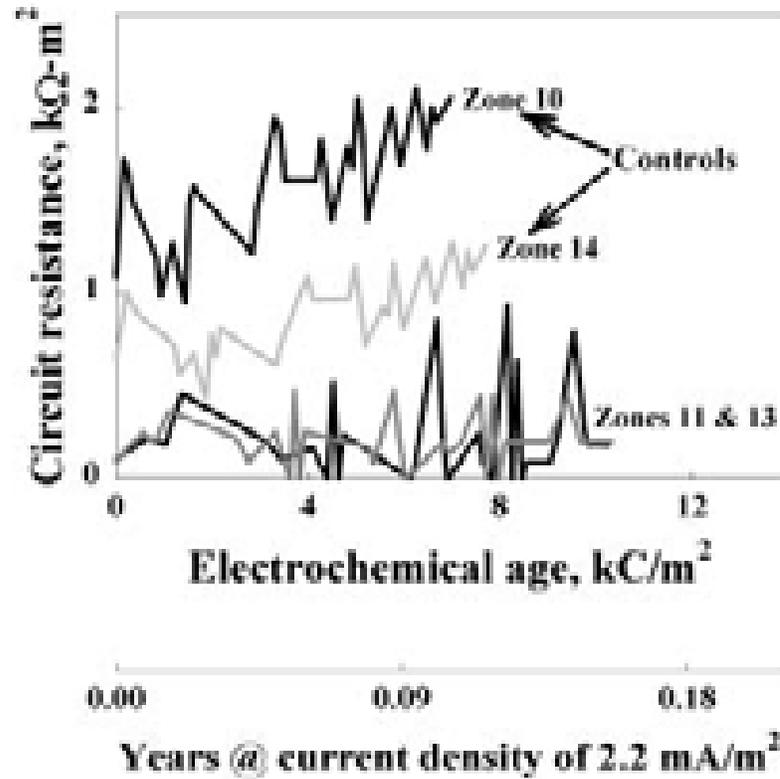
Figure 5.8: Circuit resistance as a function of TS Zn electrochemical age for humectant-treated ICCP zones 11 and 13 and control ICCP zones 10 and 14 on the Yaquina Bay Bridge; measurements on each zone were for the same time period.

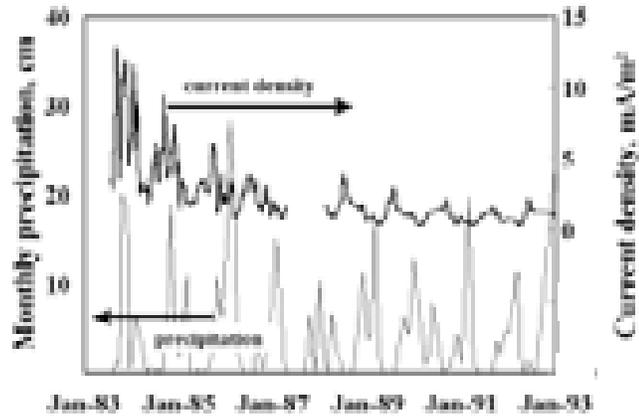
Figure 5.10: Current density and monthly precipitation as a function of time for TS Zn SACP anode on the barrel at the base of the south column, pier 4 of the Richmond-San Rafael Bridge.

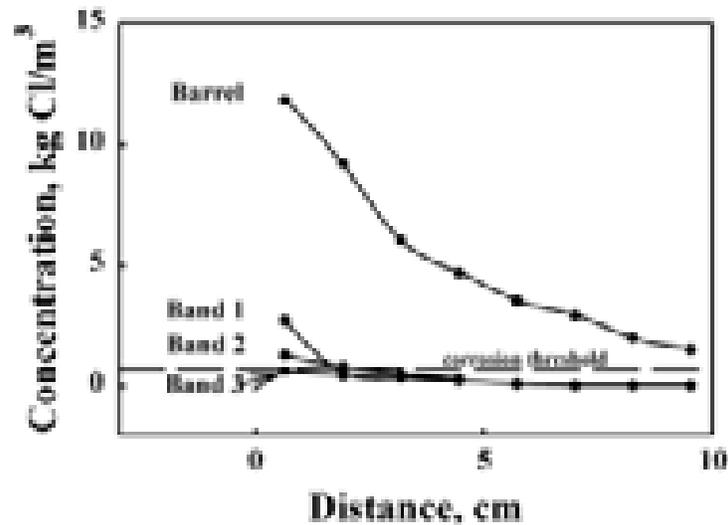
Figure 5.12: Chloride concentration profiles for TS Zn anodes on the south column, pier 4 of the Richmond-San Rafael Bridge, after ~ 10 years service.

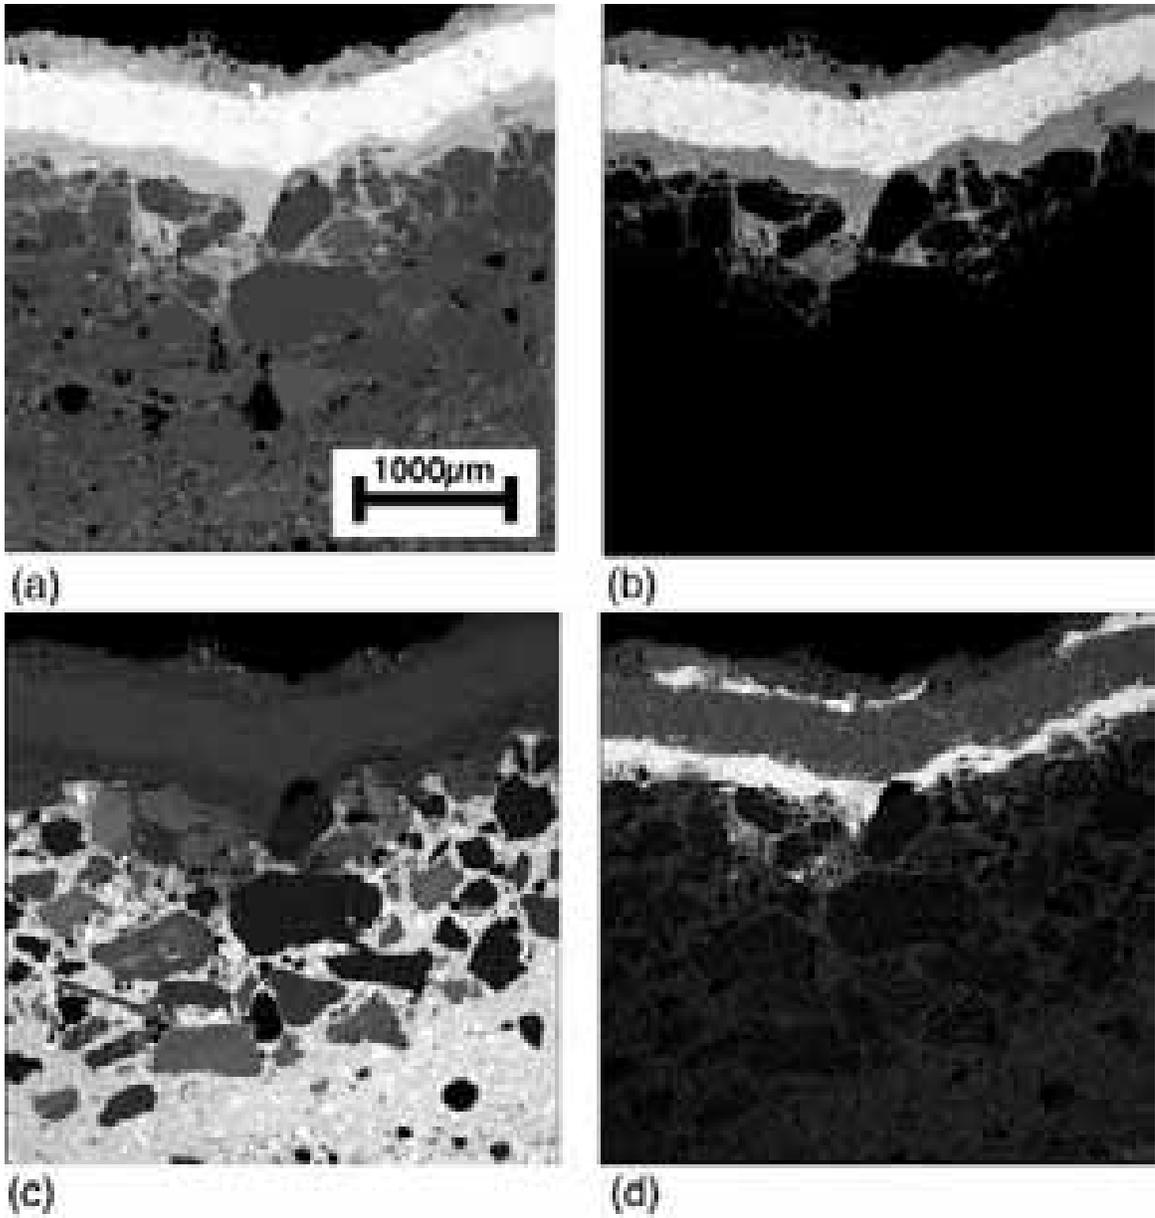
Figure 5.15: BSE photomicrograph and x-ray maps of TS Zn anode-concrete interface of Richmond-San Rafael Bridge, band 1 after aging  $\sim 1200 \text{ kC/m}^2$  service or  $\sim 10$  years service: (a) BSE photomicrograph; (b) Zn; (c) Ca; (d) Cl.

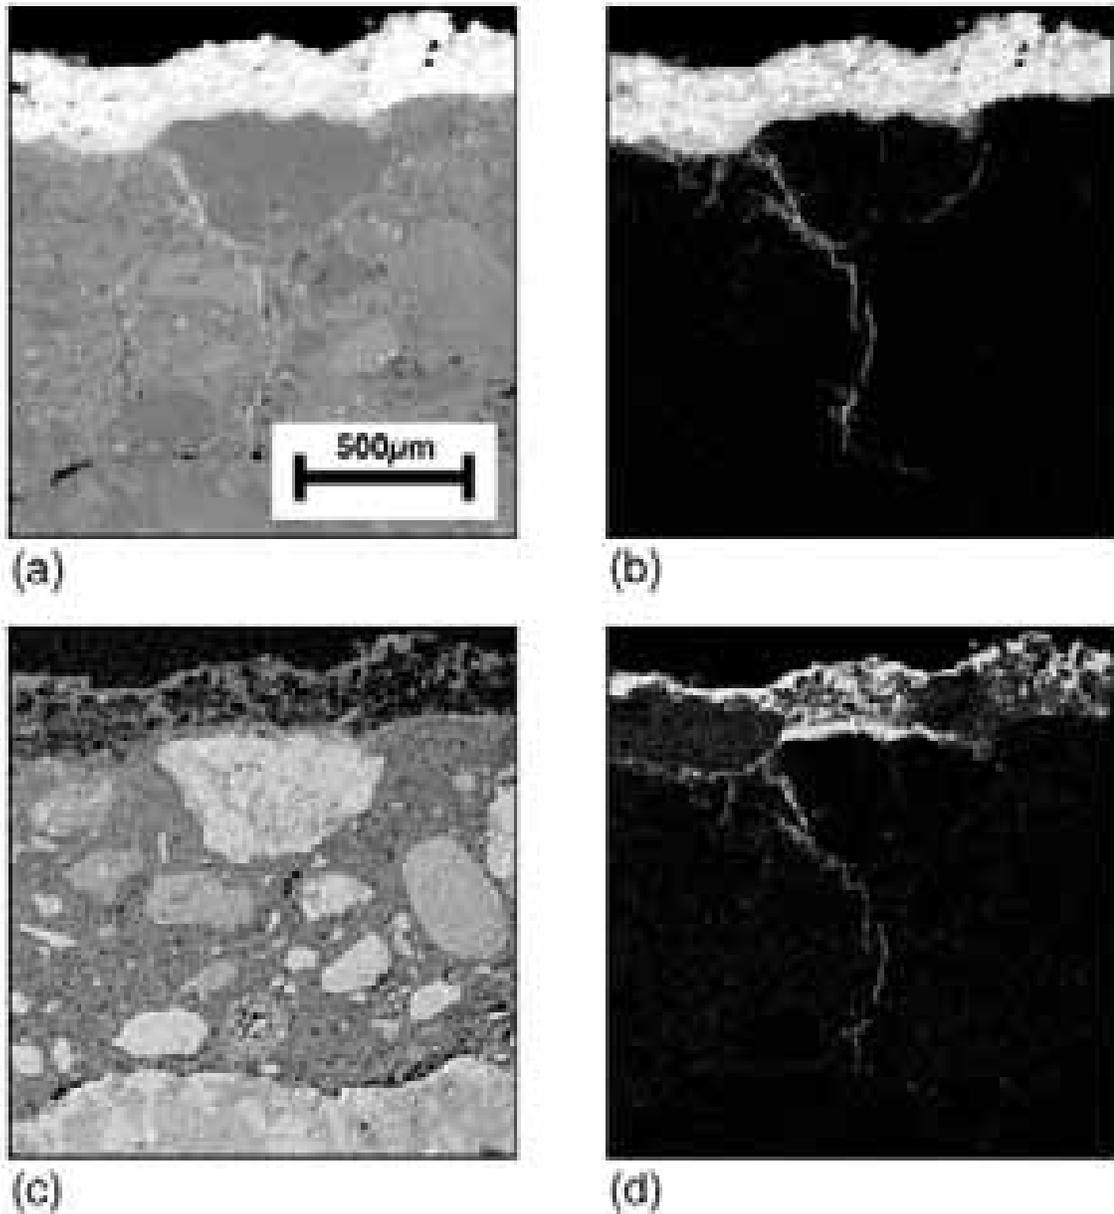
Figure 5.18: BSE photomicrograph and x-ray maps of TS Zn anode-concrete interface for concrete slab treated with silane but not sandblasted, then aged  $\sim 700 \text{ kC/m}^2$ : (a) BSE photomicrograph; (b) Zn; (c) Si; (d) Cl.

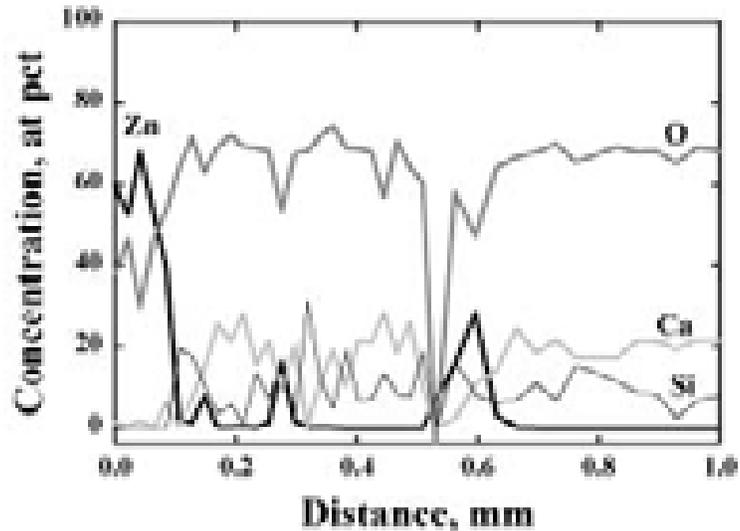
Figure 5.19: WDS line scan for Zn, O, Ca, and Si across the TS Zn anode-concrete interface for concrete slab treated with silane but not sandblasted, then aged  $\sim 700 \text{ kC/m}^2$

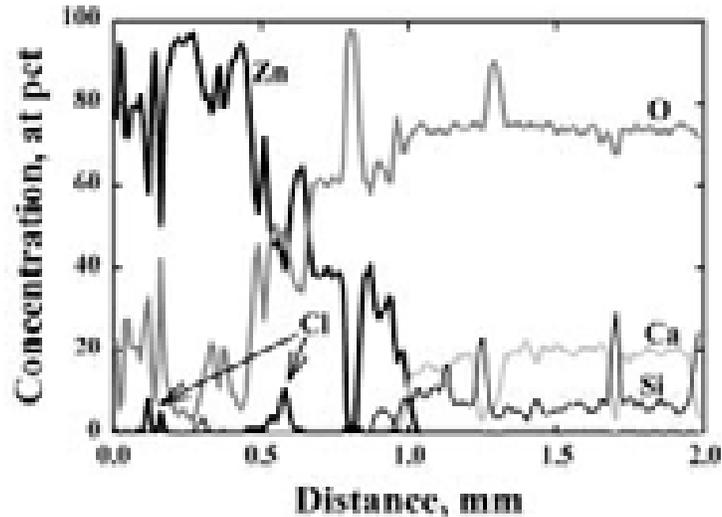
Figure 5.22: WDS line scan for Zn, O, Ca, Si, and Cl across the TS Zn anode-concrete interface for the soffit of East Camino Under-crossing aged  $\sim 330$  kC/m<sup>2</sup>.

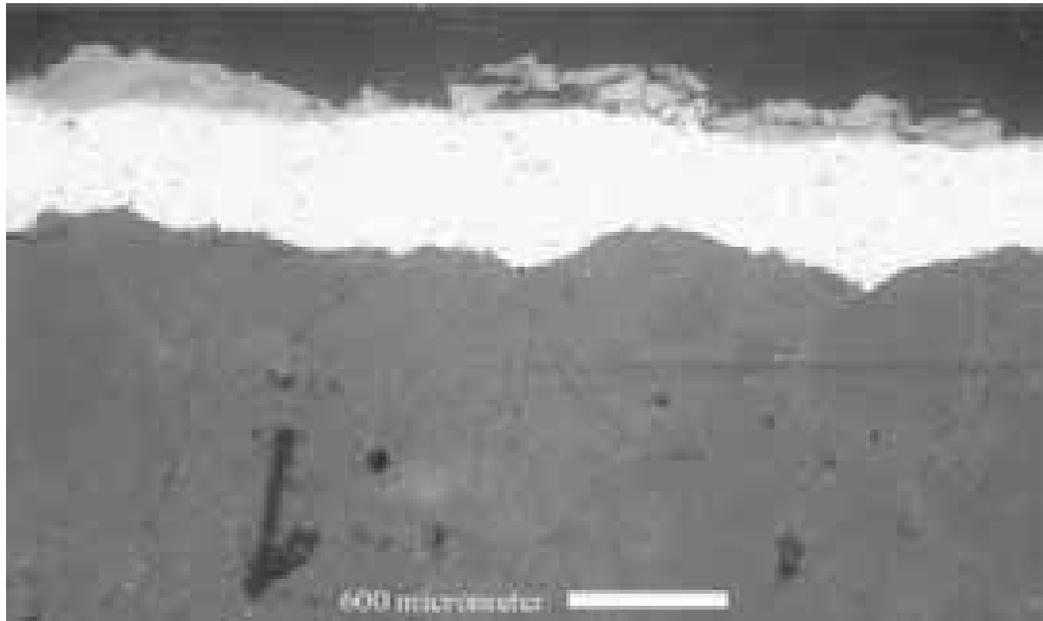
Figure 5.25: SEM photomicrograph of TS Zn anode-concrete interface for the Richmond-San Rafael Bridge SACP zone on the barrel of the south column aged  $\sim 700 \text{ kC/m}^2$  or  $\sim 10$  years service.

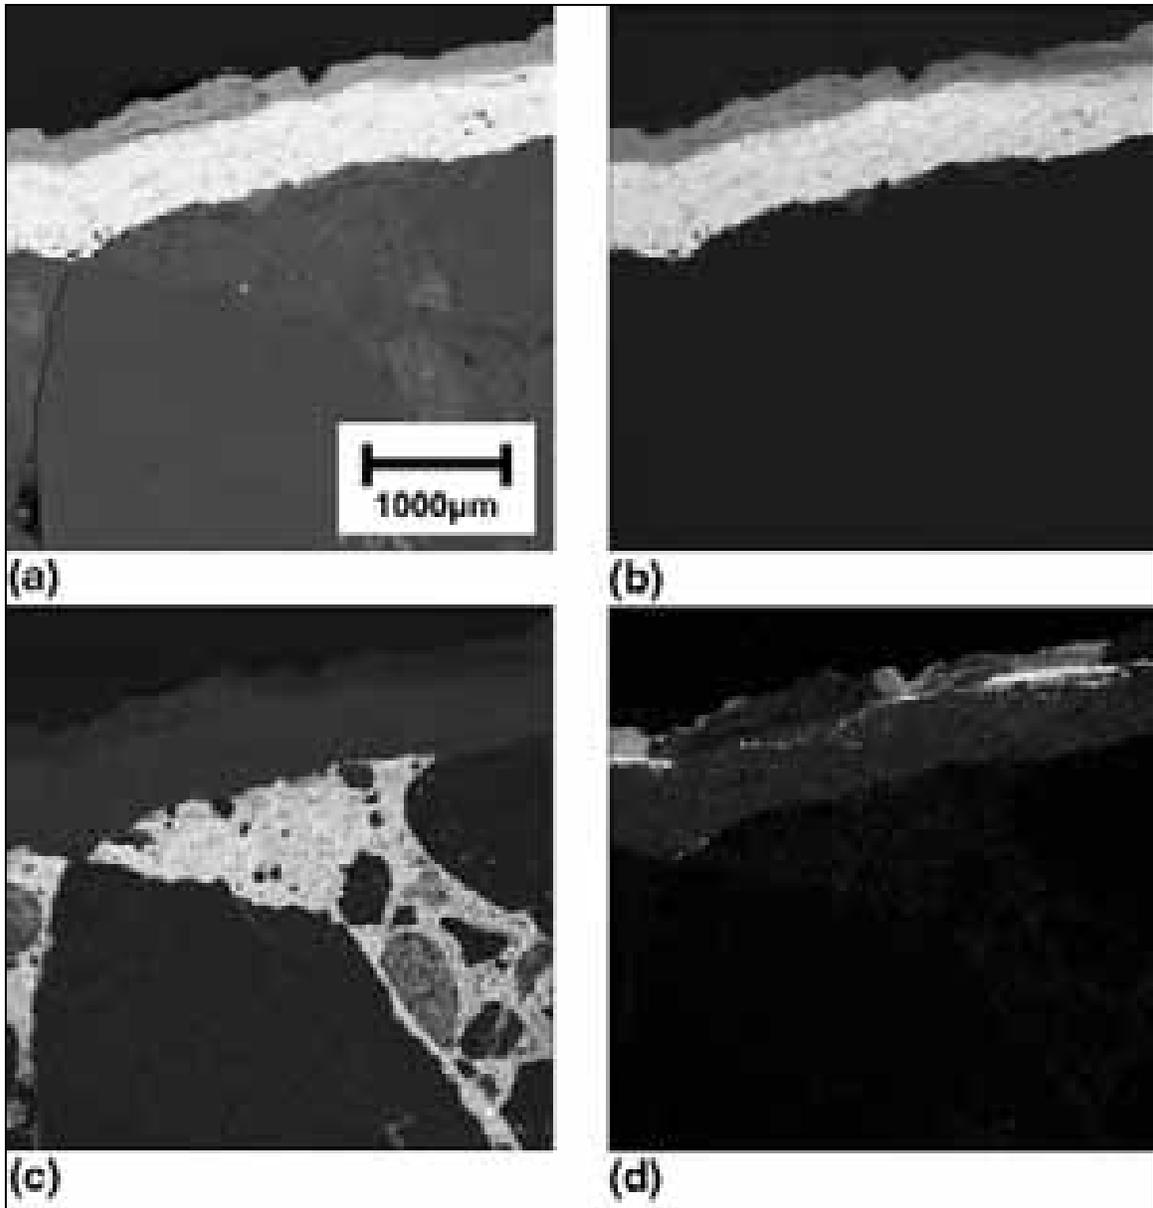
Figure 5.26: BSE photomicrograph and x-ray maps of TS Zn anode-concrete interface for the Richmond-San Rafael Bridge SACP zone on the barrel of the south column aged  $\sim 700 \text{ kC/m}^2$  or  $\sim 10$  years service: (a) BSE photomicrograph; (b) Zn; (c) Ca; (d) Cl.

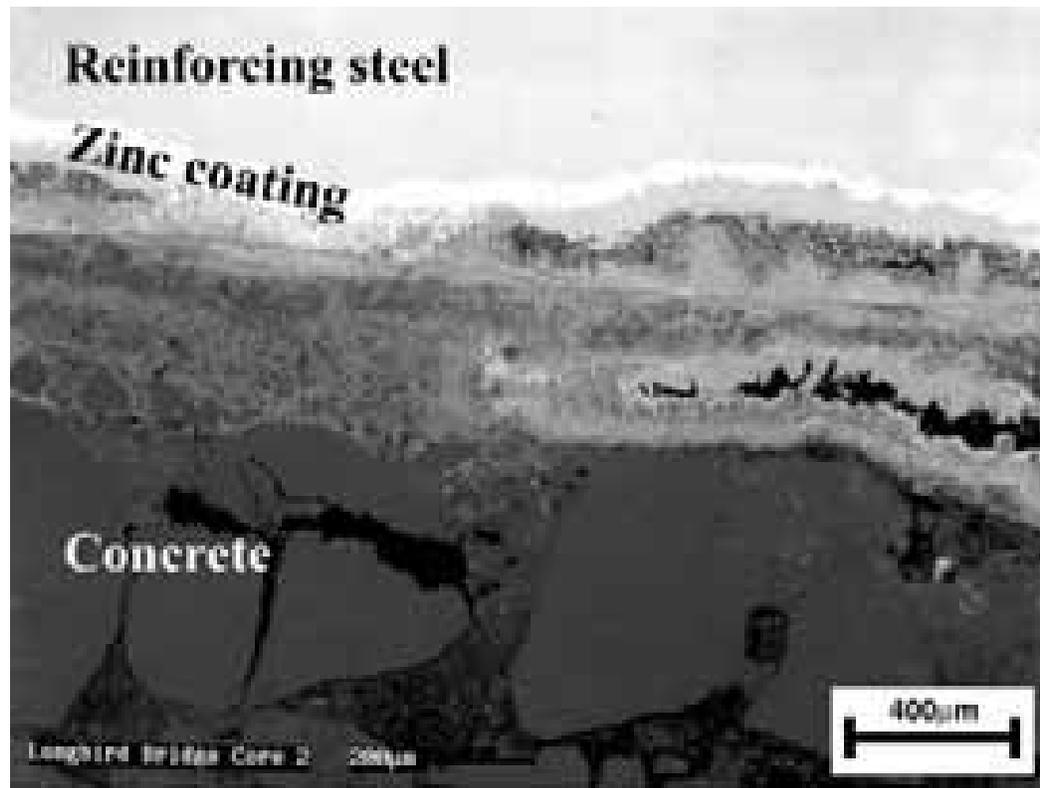
Figure 5.30: SEM photomicrograph of galvanized rebar-concrete interface from the abutment of the Longbird Bridge after 46 years service.
