**PERFORMANCE OF ZINC ANODES FOR CATHODIC  
PROTECTION OF REINFORCED CONCRETE BRIDGES**

**Final Report**

**SPR 364**

**March 2002**

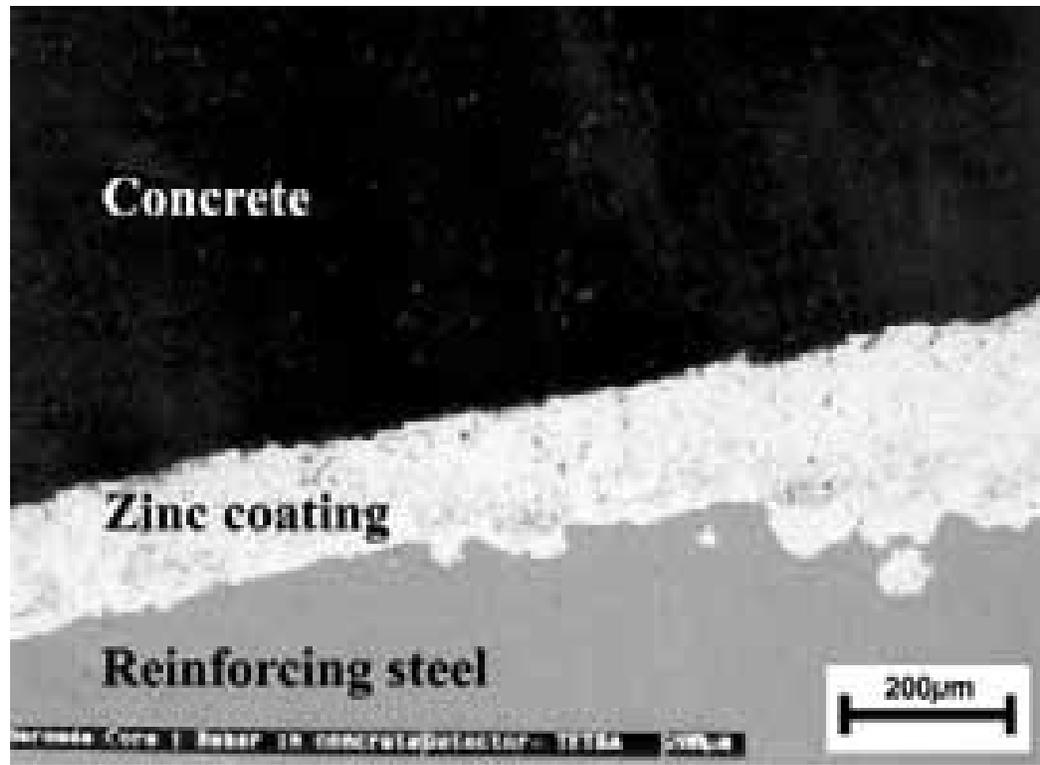
Figure 5.31: SEM photomicrograph of galvanized rebar-concrete interface from the sidewalk of the Longbird Bridge after 46 years service.

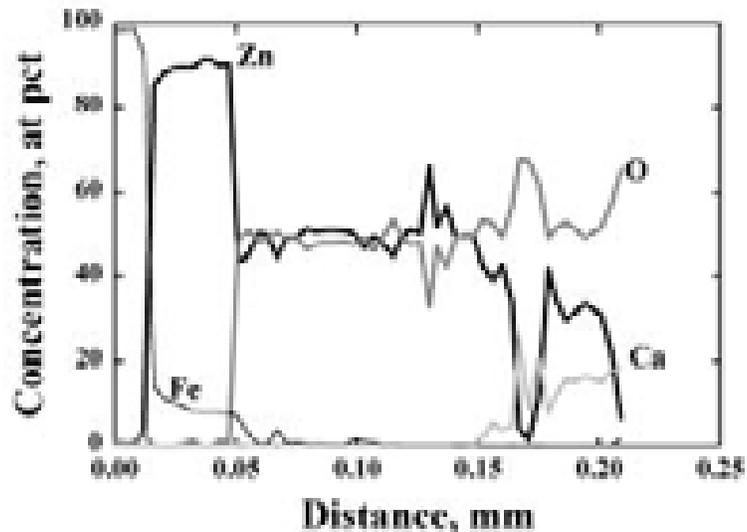
Figure 5.34: WDS line scan for Zn, Fe, O, and Ca across the galvanized rebar-concrete interface for rebar from the abutment of the Longbird Bridge after 46 years service.

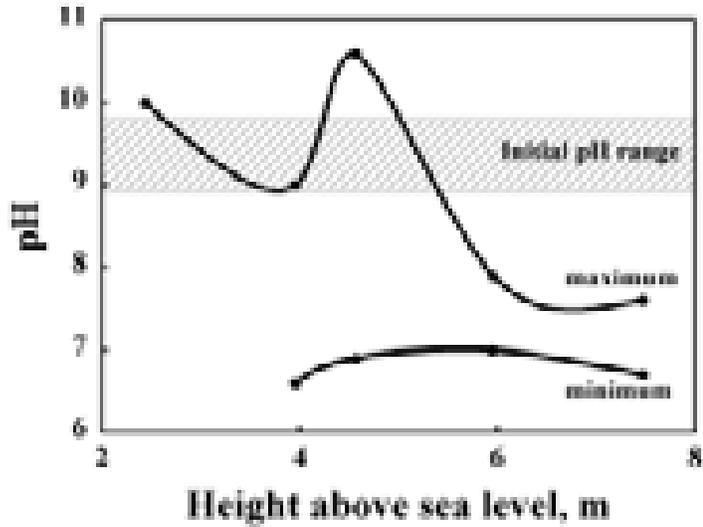
Figure 5.35: pH as a function of height above sea level for the TS Zn anode ICCP bands (zones) on the Richmond-San Rafael Bridge after ~ 10 years service.

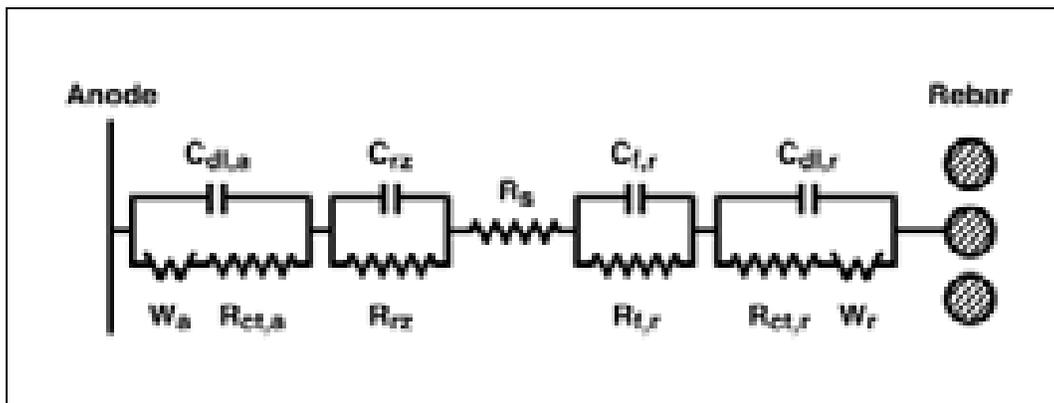
Figure 6.1: Equivalent circuit for ICCP between TS Zn anode and rebar. A Randles-circuit approximates the response of the anode-concrete and rebar-concrete interfaces.

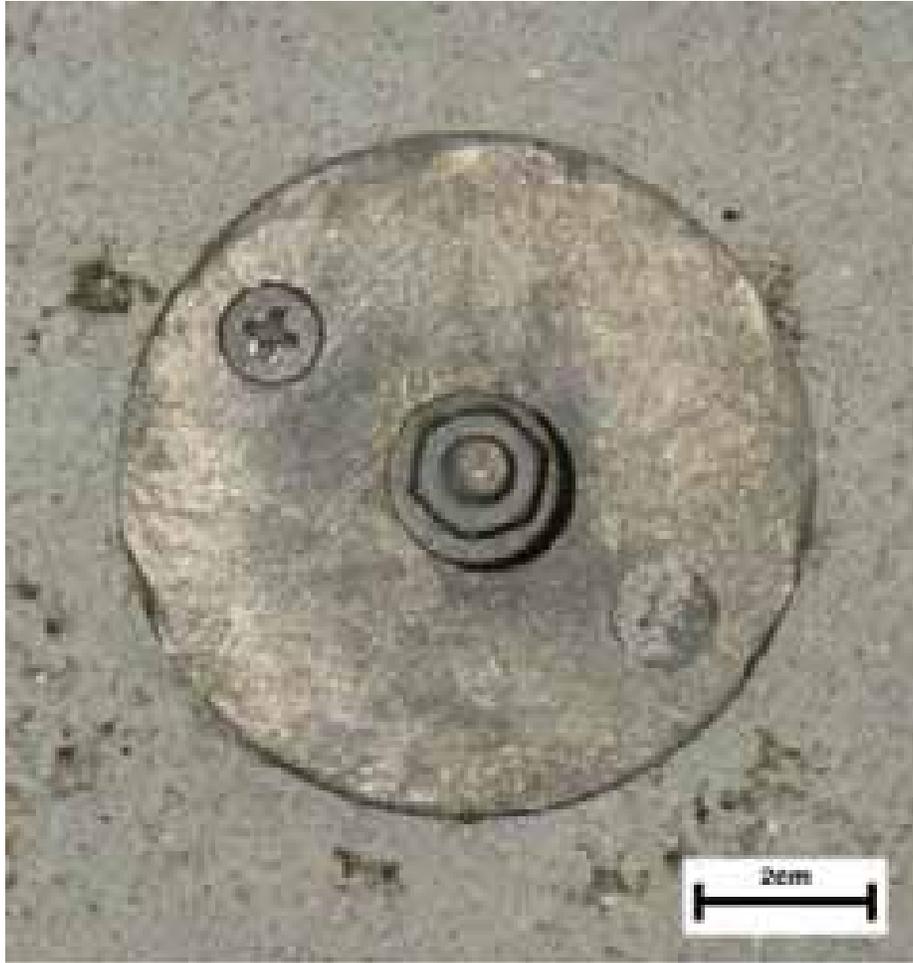
Figure E.1: Terminal plate connection prior to thermal spraying with Zn
