Executive Summary Report

Structural Evaluation of LIC-310-0396 and FAY-35-17-6.82 Box Beams with Advanced Strand Deterioration

FHWA Report Number:	FHWA/OH-2011/16
Report Publication Date:	September 2011
ODOT State Job Number:	134381
Project Duration:	41 months
Start Date:	5/1/2008
Completion Date:	10/1/2011
Total Project Funding:	\$556,429
Research Agencies:	ORITE – Ohio University, University of Cincinnati, University of Toledo
Researchers:	Eric Steinberg, Ph.D., P.E., Richard Miller, Ph.D., P.E., Douglas Nims, Ph.D., P.E., and Shad Sargand, Ph.D.
ODOT Project Manager:	Cynthia Gerst
ODOT Subject Matter Experts:	Mike Loeffler, Curtis Zigan, and Waseem Khalifa

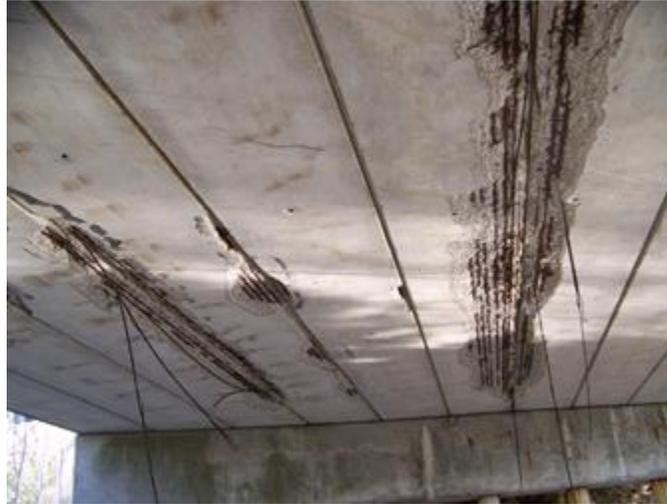
Figure 1: LIC-310-0396

The primary objective of Phase I of the study was to evaluate and determine the behavior of prestressed concrete box beams removed from LIC-310-0396 with deteriorated strands (see Figure 1). The load capacity and ductility of these beams were evaluated. Geometric and material properties of the beams were also examined. From these results, recommendations were made on rating methods and structural capacity for deteriorated box girders. The primary objective for Phase II of the study was to evaluate, test, and analyze an existing full scale damaged prestressed concrete adjacent box beam bridge in Fayette County, Ohio (FAY-35-17-6.82). This included nondestructive evaluation of the bridge, full scale destructive field testing, data analysis of the experimental testing, and analytical assessment.

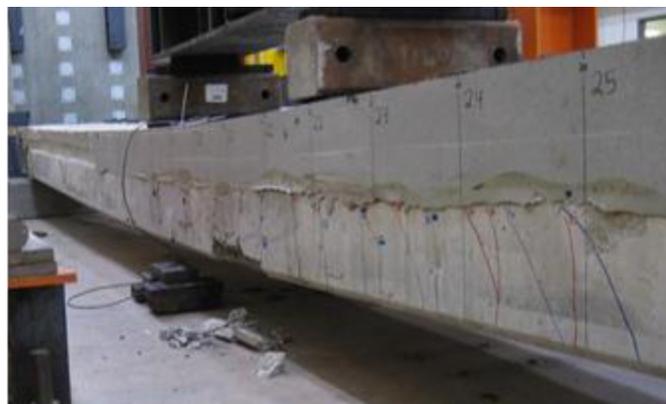
Figure 2: Destructive Testing of Beam from LIC-310-0396

In order to meet the objectives of Phase I, a variety of tasks were undertaken. The literature and related research on deteriorate box girders was reviewed to determine what had already been done. Three beams removed from LIC-310-0396 were externally inspected visually and sectioned to view the internal and cross-sectional dimensions. Nondestructive evaluation techniques were also utilized on these box beams. Samples were removed to measure chloride content within the concrete. Full scale destructive load testing of four beams with various levels of deterioration was also performed (see Figure 2). Cores were removed and tested for compressive strengths. Strands removed from the beams had various levels of deterioration and were tested for tensile capacity. Finally, the beams were assessed analytically utilizing the material property data and compared with the full scale experimental results.

The full scale load testing of the four damaged beams resulted in the following conclusions. One beam (Beam 14) had did not have any visibly corroded strands. After testing, 2 of 14 strands were found to have some corrosion. However, the beam was still able to exceed the ultimate moment capacity determined by AASHTO (Standard Specifications) calculations. For the intact beam (Beam 14), loss of prestressing force was measured at 15%. This was in reasonable agreement with the value obtained from the AASHTO LRFD Specifications (18%), but well below that predicted by the AASHTO Standard Specifications (25%). Three beams with severe damage had significantly lower capacities, but still were highly ductile. In all cases, final deflections exceeded Span/45. A conservative, but reasonable estimate of ultimate strength can be found by:

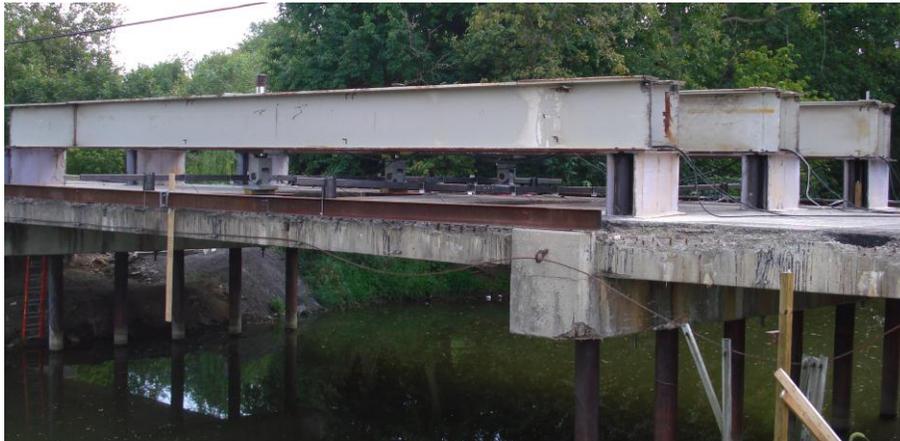
Figure 3: Destructive Testing of Center Span from FAY-35-17-6.82

In order to meet the objectives of Phase II of the study, the project involved a variety of tasks on the spans of bridge FAY-35-17-6.82. Nondestructive testing was performed and involved the use of ground penetrating radar to assess the concrete of the bridge, a magnetic method to evaluate the procedure of the method on a small portion of the bridge for prestressing strand corrosion, and truck testing to determine initial behavior of the bridge prior to destructive testing. The destructive field testing of the three span bridge involved instrumenting and testing each span individually (see Figure 3). One span was left in its existing condition to serve as a control while the two other spans were damaged to varying magnitudes prior to testing. The data from the nondestructive and destructive testing was analyzed and comparisons were made to evaluate the behavior of the spans and damage. The bridge was assessed analytically using standard design procedures, as well as with simple and complex computer software. Load rating of the bridge was also performed.

The loading of the spans during the full scale destructive testing showed that all spans were able to distribute loads across the width of the bridge. The spans were relatively symmetric in stiffness across the width of the spans as determined by loading one side and then the other side. The full scale testing showed that the East span and the Center span had nearly the same total experimental capacity even though significant damage was induced into the East span (18 out of 243 total strands cut = 7%). The West span had a lower capacity than the East or Center span, but the West span had more damage and the damage was concentrated to 3 beams (42 out of 243 total strands cut = 17%). As all spans reached their total capacity, the upper flange of

several beams crushed and the bridge failed to carry any additional load. However, all spans were still able to support and distribute load even at high total loads. In the extreme event where the load was continued to be applied well after the capacity of the bridge was reached, load was distributed across the bridge. The shear keys distributed the load among the beams and likely continued to do so even after failing due to the transverse tie bars producing friction between beams. Complete collapse did not occur until the transverse tie bars yielded and then fractured at several locations. All spans exceeded capacities determined by AASHTO Standard Specifications (>22%) and AASHTO LRFD Specifications (> 22%) when evaluating the span's total capacity as the sum of the individual capacity of the beams.
