DETERMINATION OF MINIMUM HEIGHT AND LATERAL DESIGN LOAD FOR MASH TEST LEVEL 4 BRIDGE RAILS

Test Report No. 9-1002-5

TEXAS TRANSPORTATION INSTITUTE
THE TEXAS A&M UNIVERSITY SYSTEM
COLLEGE STATION, TEXAS

Test Report 9-1002-5
Project 9-1002
Project Title: Roadside Safety Device Crash Testing Program

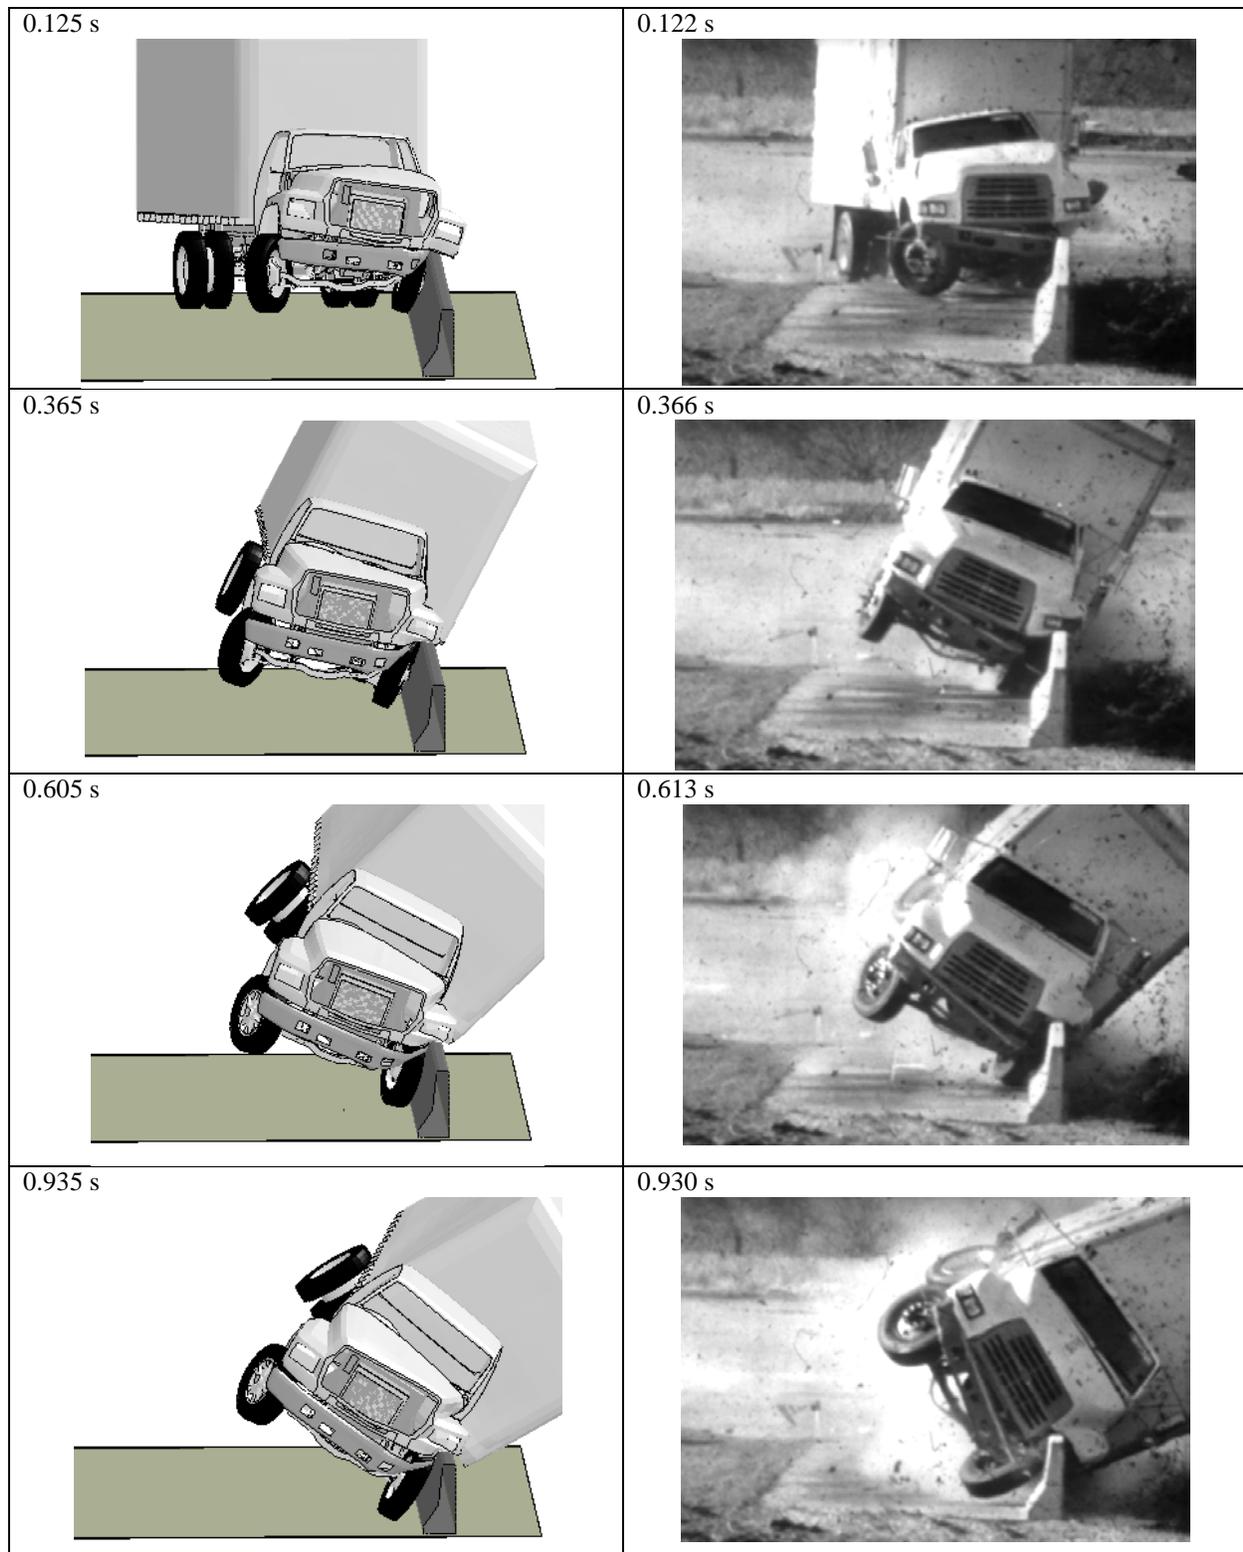
Figure 2.1. Comparison of Simulation and Crash Test Results for SUT Impact into a 32 Inch Tall NJ Barrier under MASH TL-4 Impact Conditions.

box and the chassis. The ballast shape and size, and its attachment to the vehicle were also modified to match practices and procedures at the TTI Proving Ground. After making these changes, the researchers performed an impact simulation of the modified SUT with the 32-inch NJ profile barrier using *MASH* TL-4 impact conditions. Figure 2.1 compares the simulation and crash test results.

The simulation model matched the vehicle's pitch and roll characteristics observed in the crash test reasonably well. While both simulation and test vehicles rolled over the top of the barrier, the vehicle rolled over at a faster rate in the test compared to the simulation results. With this in mind, the researchers proceeded with further analysis using the modified SUT vehicle model.

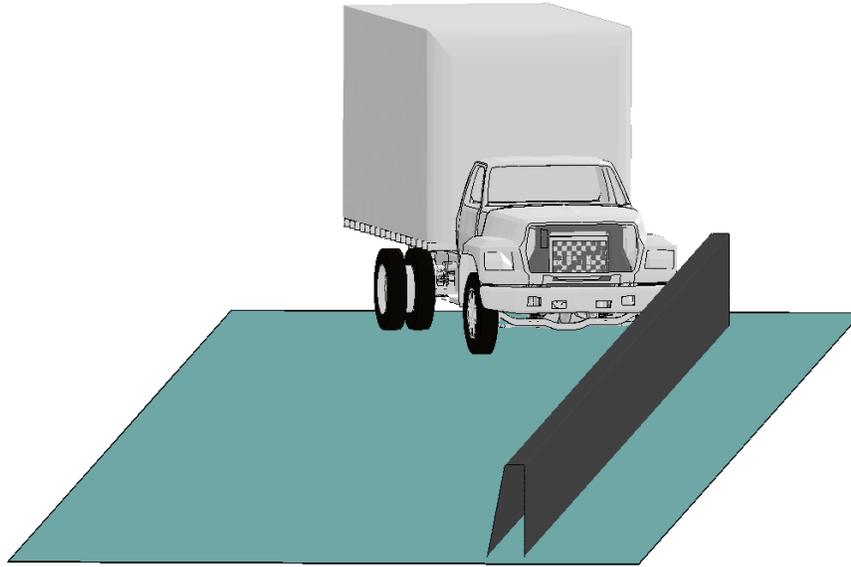
Figure 2.2. Finite Element Model of the Single Unit Truck Impacting a Rigid Single Slope Barrier under *MASH* TL-4 Impact Conditions.

The researchers investigated the effect of rail height on vehicle stability by performing finite element simulations of an SUT impacting single slope barriers of varying height. The models of the barriers were developed using rigid shell material representation. The single unit truck model impacted the barriers at a speed of 56 mi/h and an angle of 15 degrees, which are the nominal impact conditions prescribed for *MASH* test 4-12. Figure 2.2 shows the setup of a typical simulation.

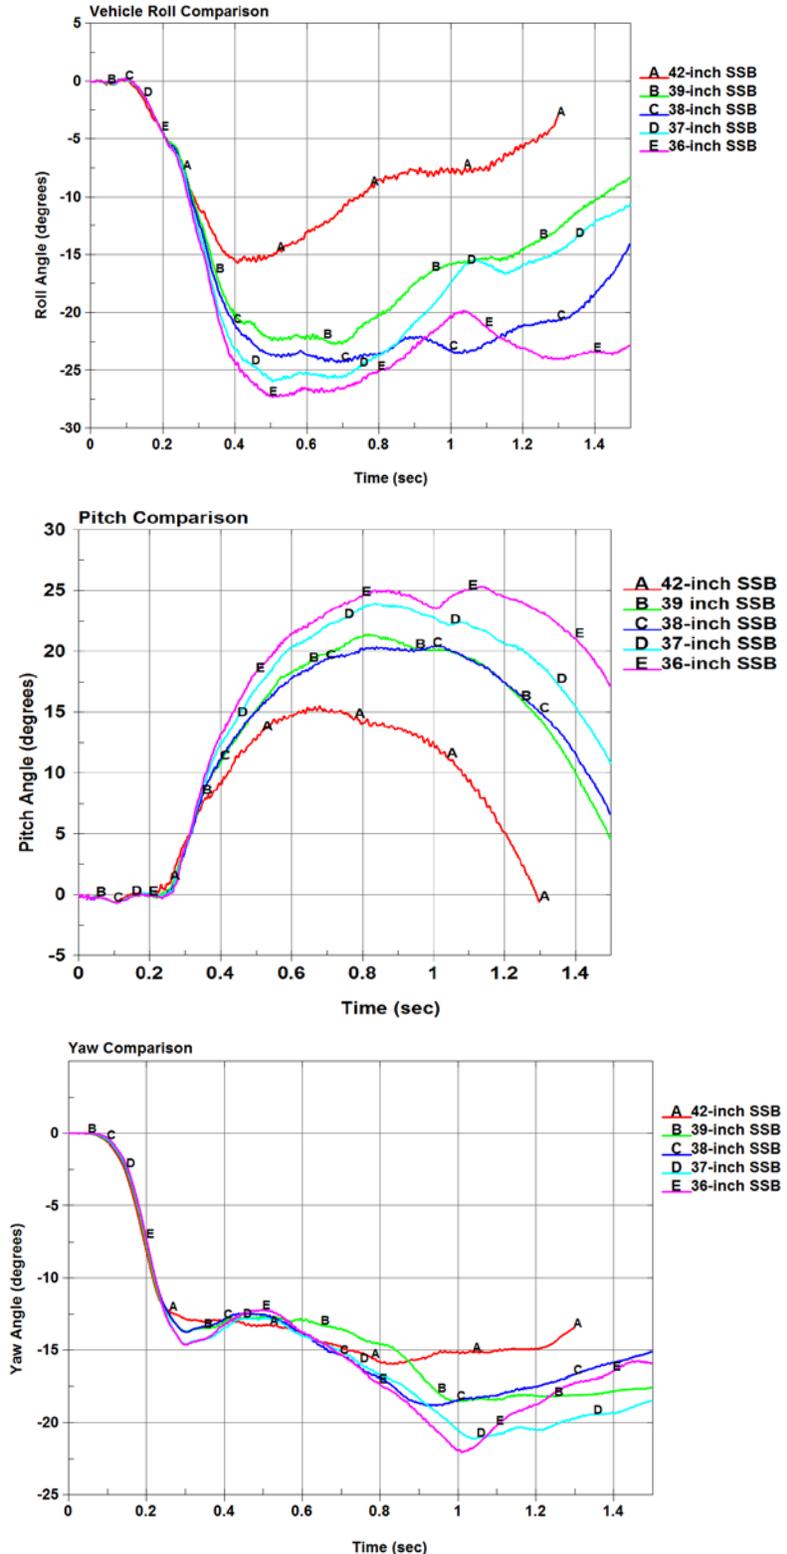
Figure 2.3. Vehicle Roll, Pitch, and Yaw Angles for MASH TL-4 Impacts into a Rigid Single Slope Barrier (SSB) with Various Rail Heights.

An initial impact simulation was performed with a 42-inch tall single slope barrier. Since *AASHTO LRFD Design Specifications* list the 42-inch rail height as the minimum for test level 5, the researchers expected the barrier to contain and redirect the SUT in a stable manner under the less severe TL-4 conditions. Having achieved successful results with the 42-inch tall barrier, the height was gradually reduced until results of the simulation indicated significant vehicular instability and likelihood of vehicle rollover. Impact simulations were performed with barrier heights of 42, 39, 38, 37, and 36 inches. Vehicle roll, pitch, and yaw angles were determined as a function of time about a point near the center of gravity of the ballast. Figure 2.3 compares these angles.

As expected, the 42-inch rail height produced the greatest vehicular stability. Although reducing the rail height to 39 inches increased the maximum roll and pitch angles of the SUT, the vehicle was still contained and redirected in a fairly stable manner.

Further reducing the rail height further increased the instability of the vehicle. At 36 inches, the maximum roll and pitch at the CG of the ballast were approximately 27 and 25 degrees, respectively. This configuration was considered marginal in terms of the vehicle's stability and propensity to roll over the barrier. With a 36-inch rail height, the cross-members of the SUT's cargo box floor are significantly above the top of the rail. Simulation results showed that at a pitch of 25 degrees, the rear impact side wheels of the SUT were near the top of the rail as the vehicle yawed into the barrier. The contact between the rear wheels and the top of the barrier (shown in Figure 2.4) helped contain the SUT and prevent the cargo box from rotating over the barrier. Results indicated that any further reduction in rail height might cause the rear axle to pass over the barrier and, therefore, further reduction in height was not recommended or analyzed. It is worth noting that slightly improved kinematic behavior was observed with 37- and 38-inch rail heights. However, since this research sought to establish a minimum height for *MASH TL-4* conditions, the 36-inch height was selected for further evaluation through a full-scale crash test.

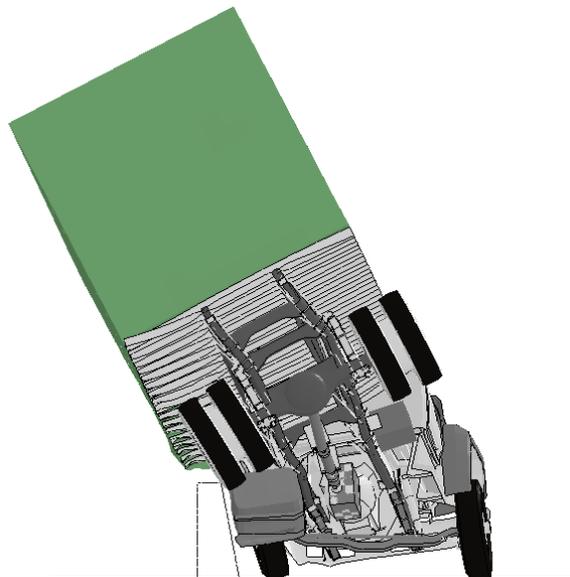
Figure 2.4. Impact of the SUT with 36-Inch Barrier (Rear View).

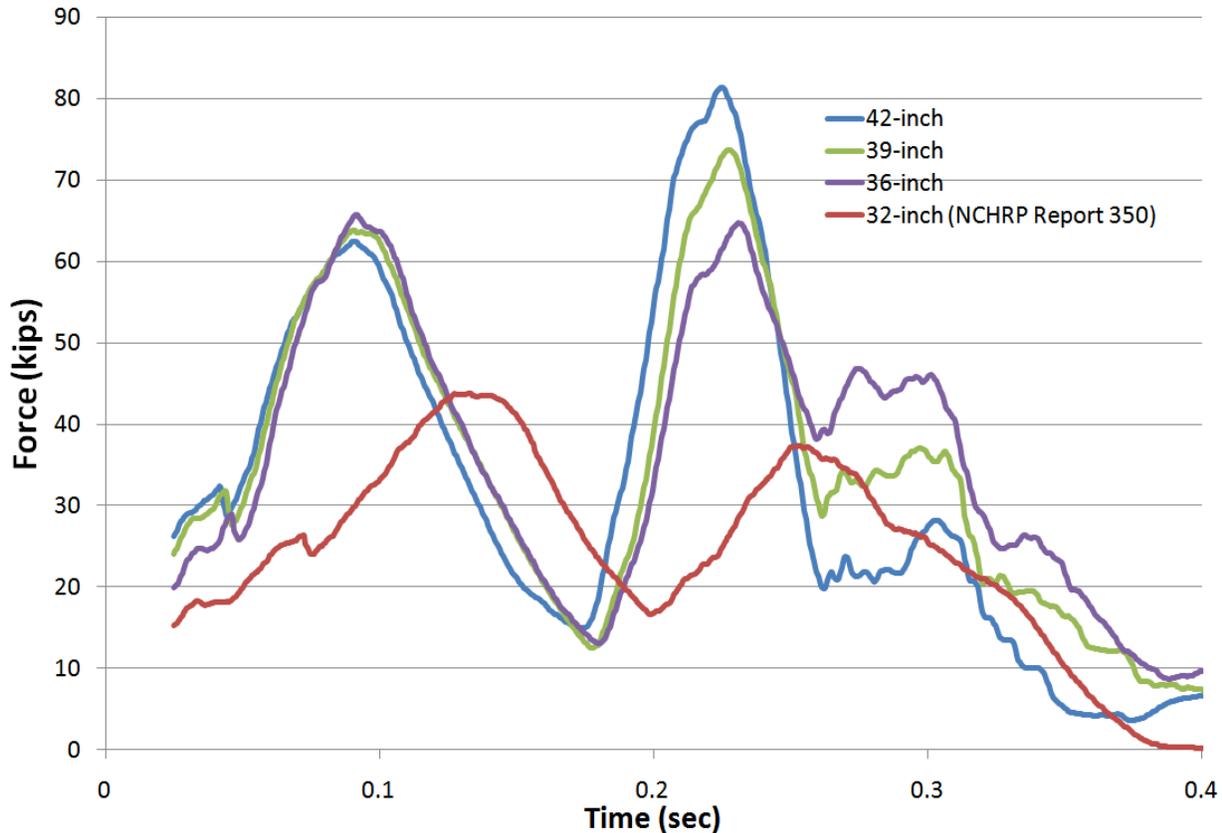
Figure 2.5. Lateral Impact Loads Resulting from Vehicle Impact with Various Rail Heights.

For each of the simulations performed, the researchers determined the lateral load applied to the barrier due to the impact. The load was calculated using LS-DYNA by summing the lateral contact forces applied to the barrier. Figure 2.5 shows the 50-millisecond moving average of the lateral force on the barrier for simulated rail heights of 42, 39, and 36 inches. The load curves each have two peaks. The first peak results from the initial impact of the vehicle's cab with the barrier. The second peak occurs at the time of the back-slap (i.e., when the rear axle contacts the barrier during redirection). The researchers also performed a simulation with a 32 inch tall rigid NJ profile barrier under *NCHRP Report 350 TL-4* impact conditions. Figure 2.5 plots the results of the lateral load from this simulation for comparison purposes.

It can be observed that the load associated with the initial contact does not vary significantly. The load associated with the back-slap increases with rail height. A contributing factor to this increase in lateral load is the interaction of the cargo box floor with the barrier. With the SUT in a static equilibrium position, the cross-members supporting the floor of the cargo box are slightly above the 42-inch rail. However, during impact, the cargo box starts to roll towards the barrier, which causes the cross-members of the cargo box floor to impact the barrier, subsequently increasing the lateral load applied to the barrier. With a 39-inch rail height, the cross-members' interaction is still significant, even though it is reduced compared to the 42 inch rail. At 36 inches, the cross members have no significant interaction with the barrier; consequently, the peak lateral load during back-slap is slightly less than the load during initial impact of the cab (i.e., the first peak). The simulation with the 32-inch rail under *NCHRP Report 350* impact conditions also did not result in contact of the cargo box floor with the rail. However, the second peak in this case, is further reduced compared to the first peak due to significant differences in the ballast of *MASH* and *NCHRP Report 350* design vehicles.

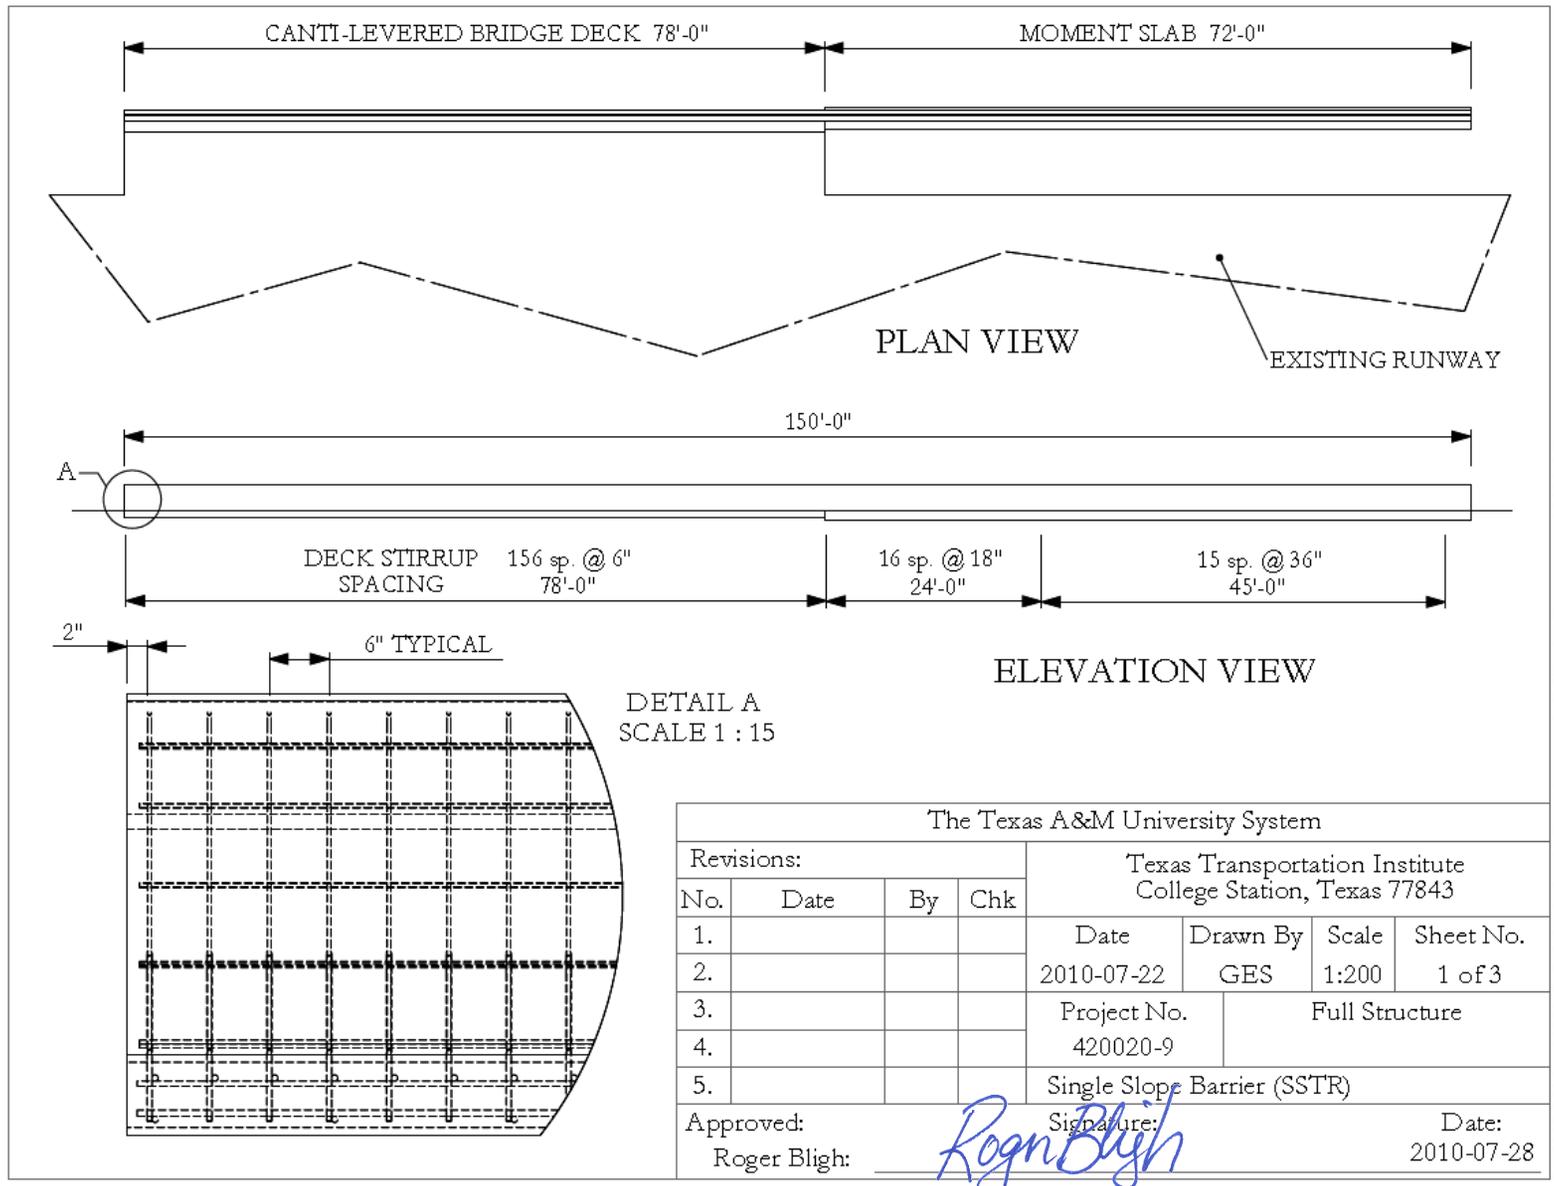
Figure 3.1. Layout of the TxDOT Single Slope Traffic Railing (SSTR).

Figures 3.1 through 3.3 show the details of the test article, Figure 3.4 has the photographs of the installation.

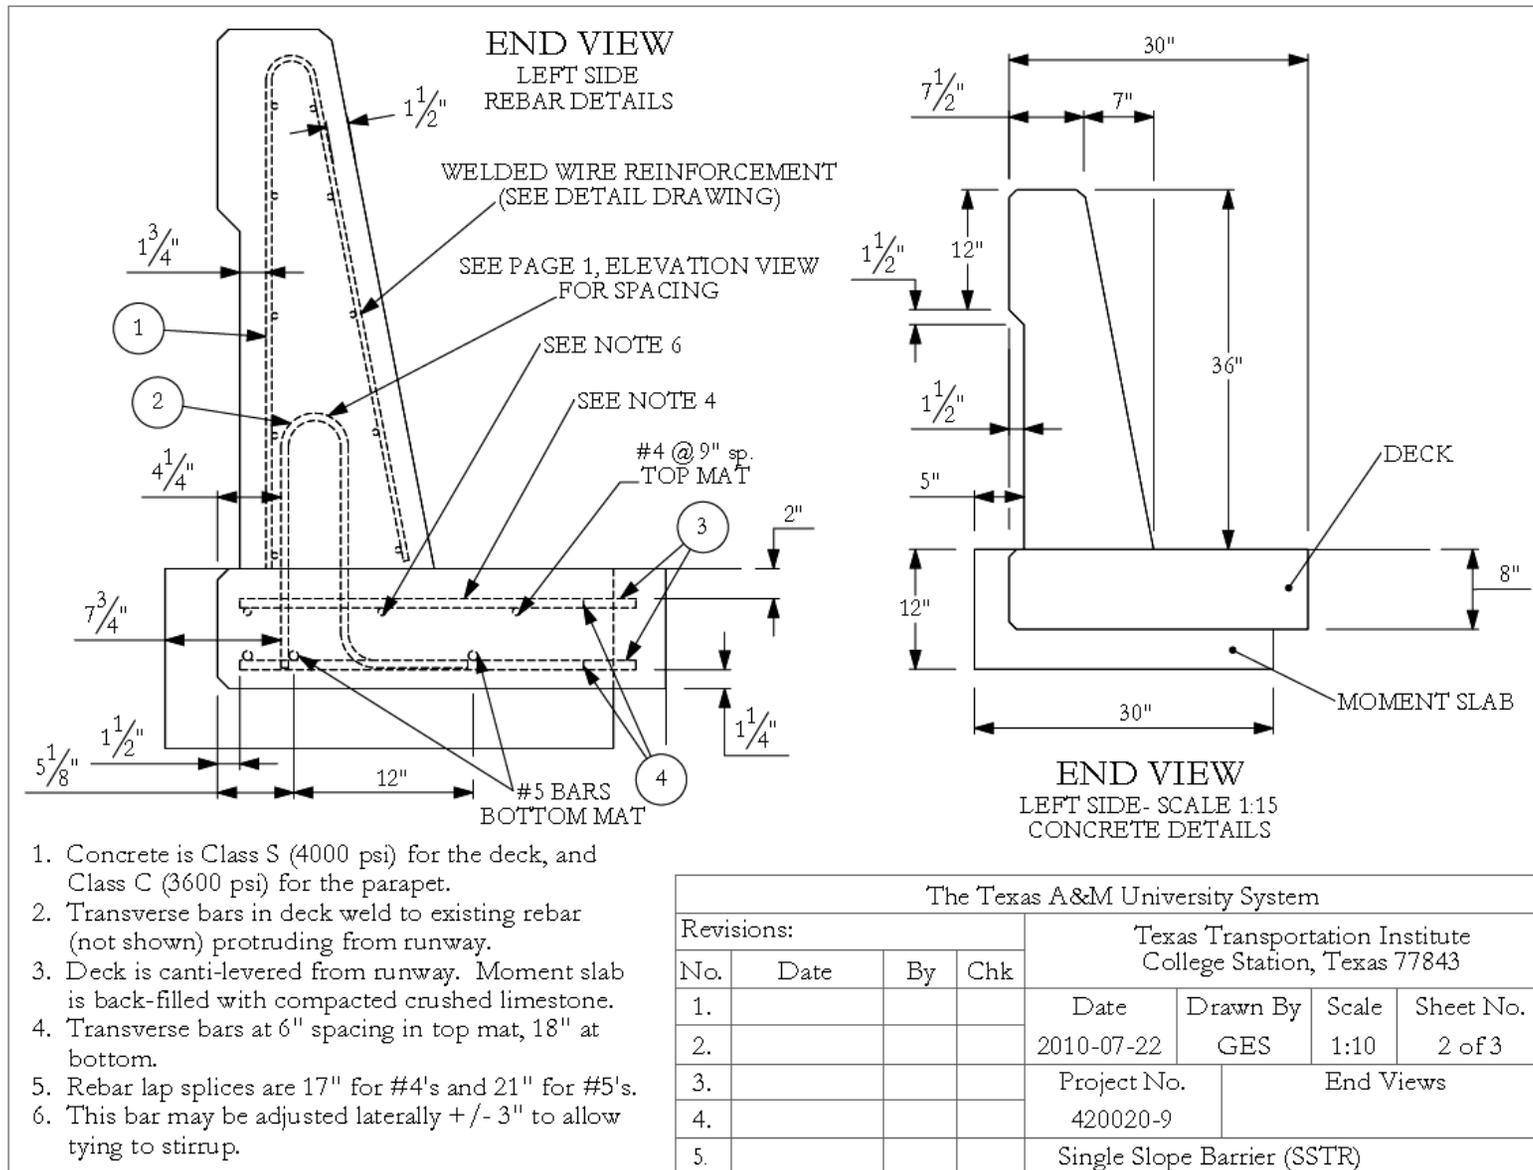
Figure 3.2. Details of the TxDOT Single Slope Traffic Railing (SSTR).

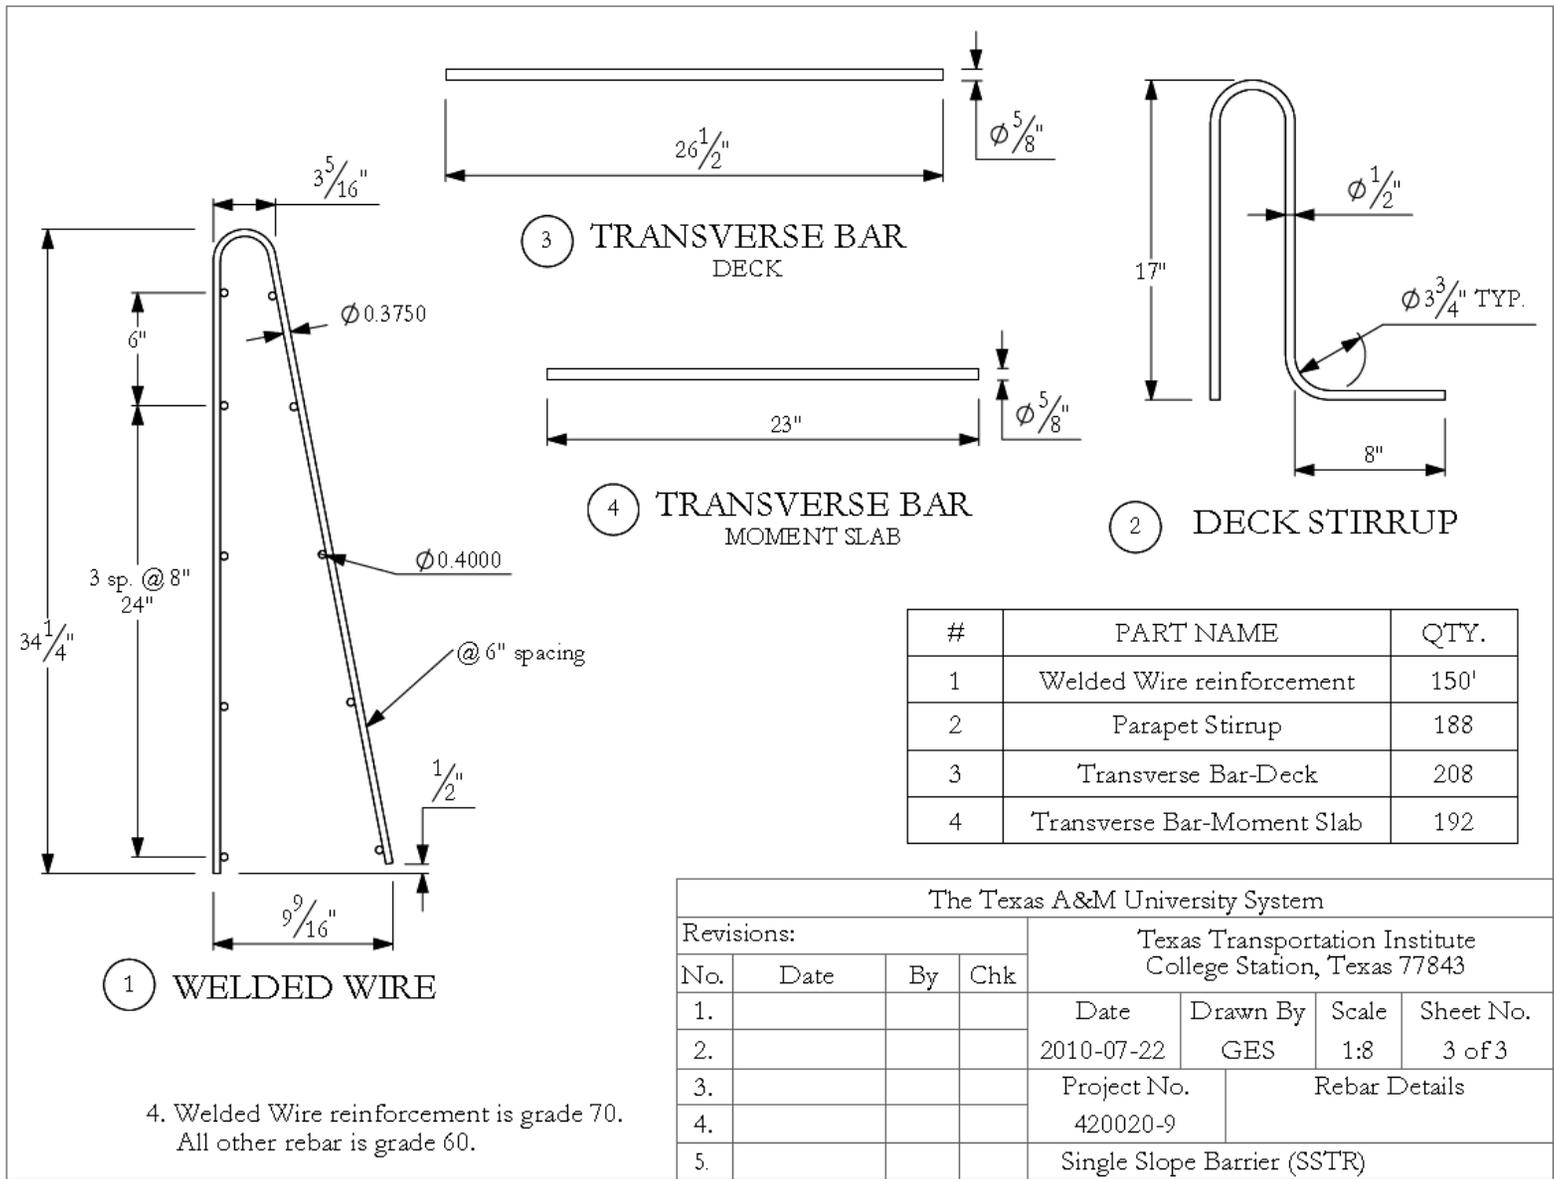
Figure 3.3. Details of the Reinforcement of the TxDOT Single Slope Traffic Railing (SSTR).

At the location of each vertical stirrup in the single-slope barrier, a 0.5-inch diameter (#4) U-shaped deck stirrup was used to connect the barrier to the underlying deck or moment slab. The U-shaped stirrup was tied to the bottom reinforcement mat of the bridge deck or moment slab and extended beyond the deck/moment slab surface.

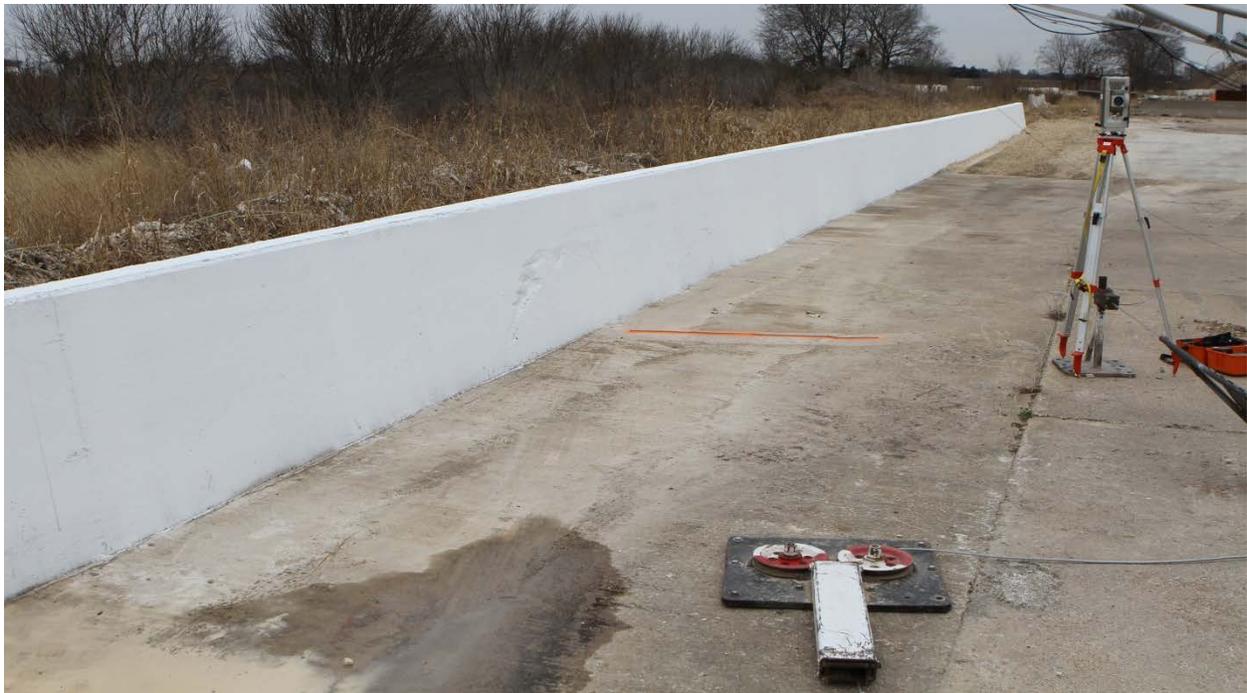
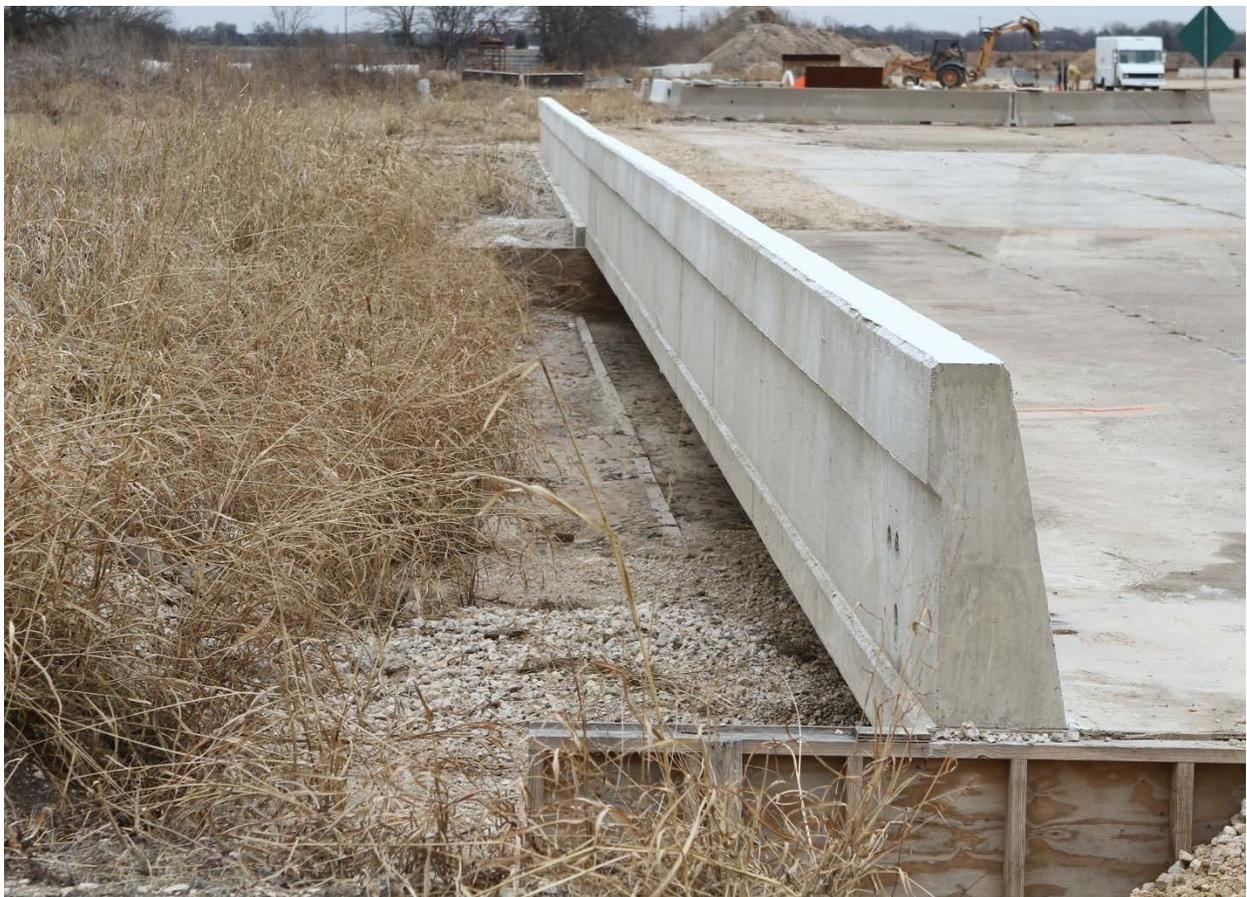
Figure 3.4. TxDOT Single Slope Traffic Railing (SSTR) before Test No. 420020-9b.

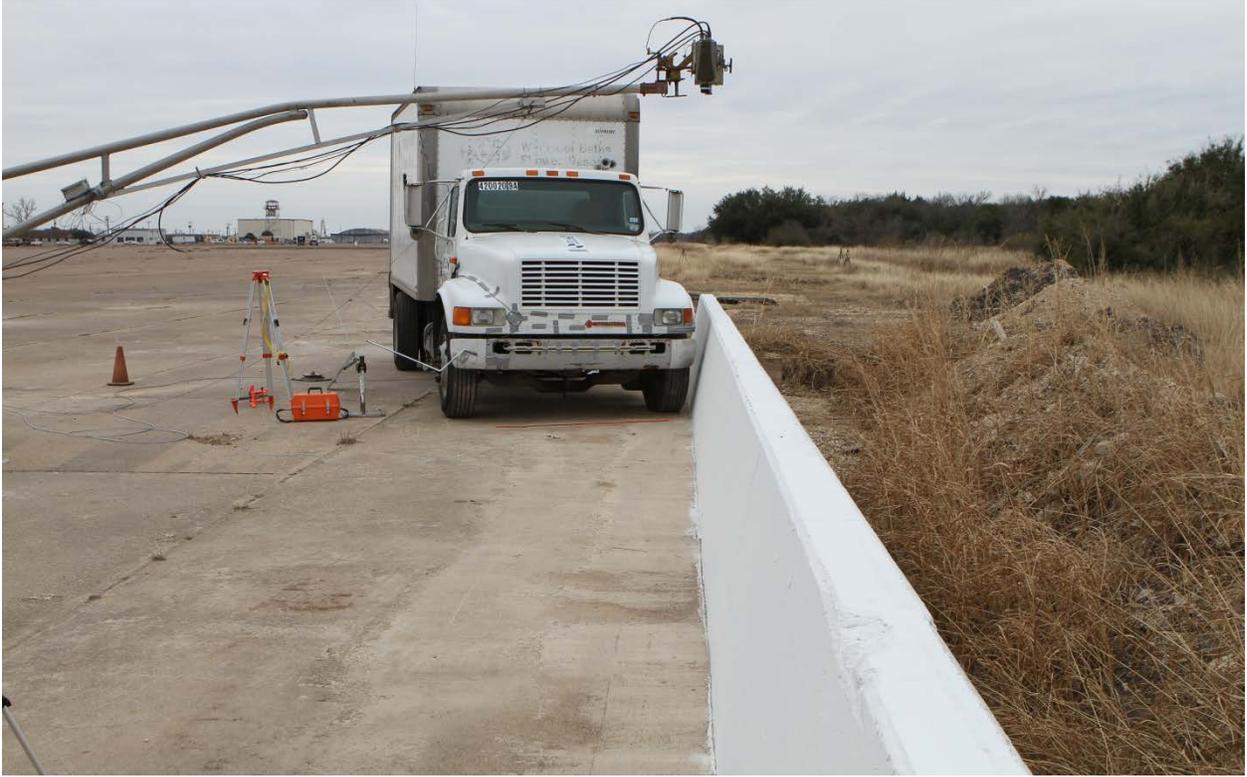
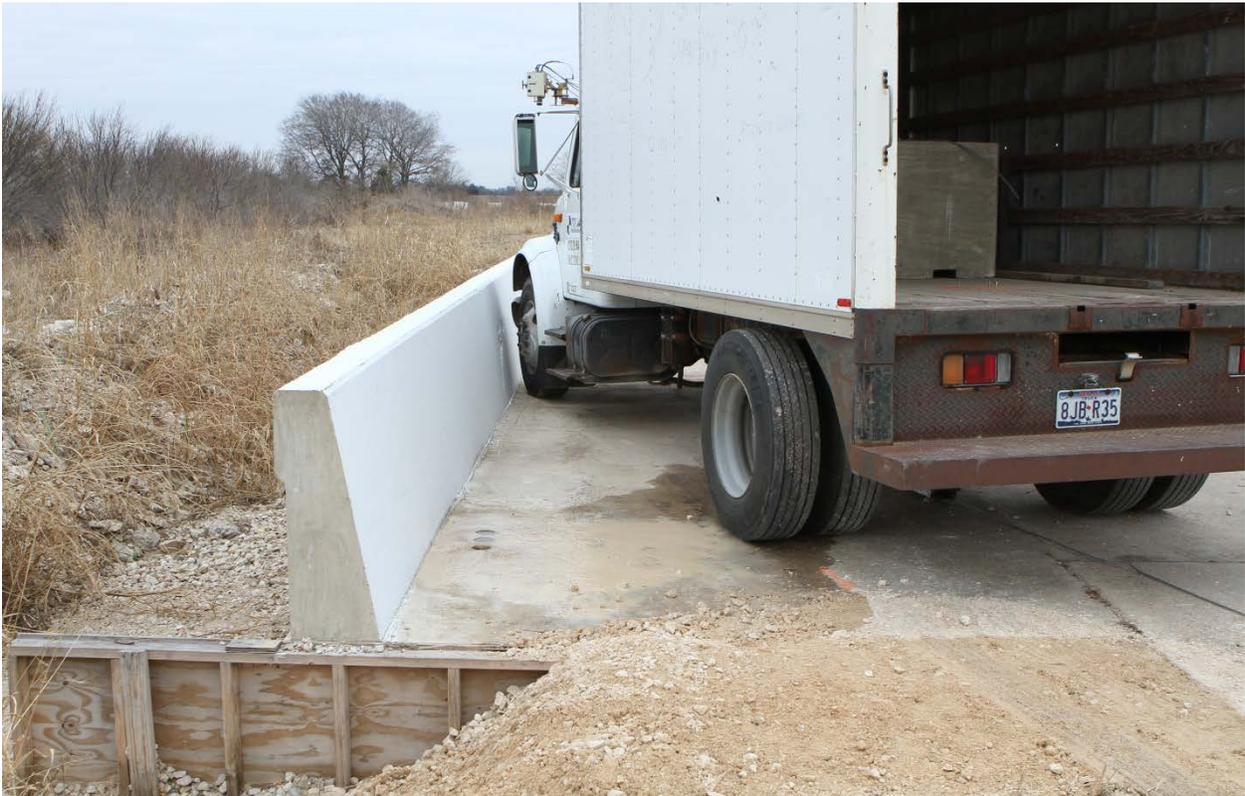
Figure 6.1. Vehicle and Installation Geometrics for Test No. 420020-9b.

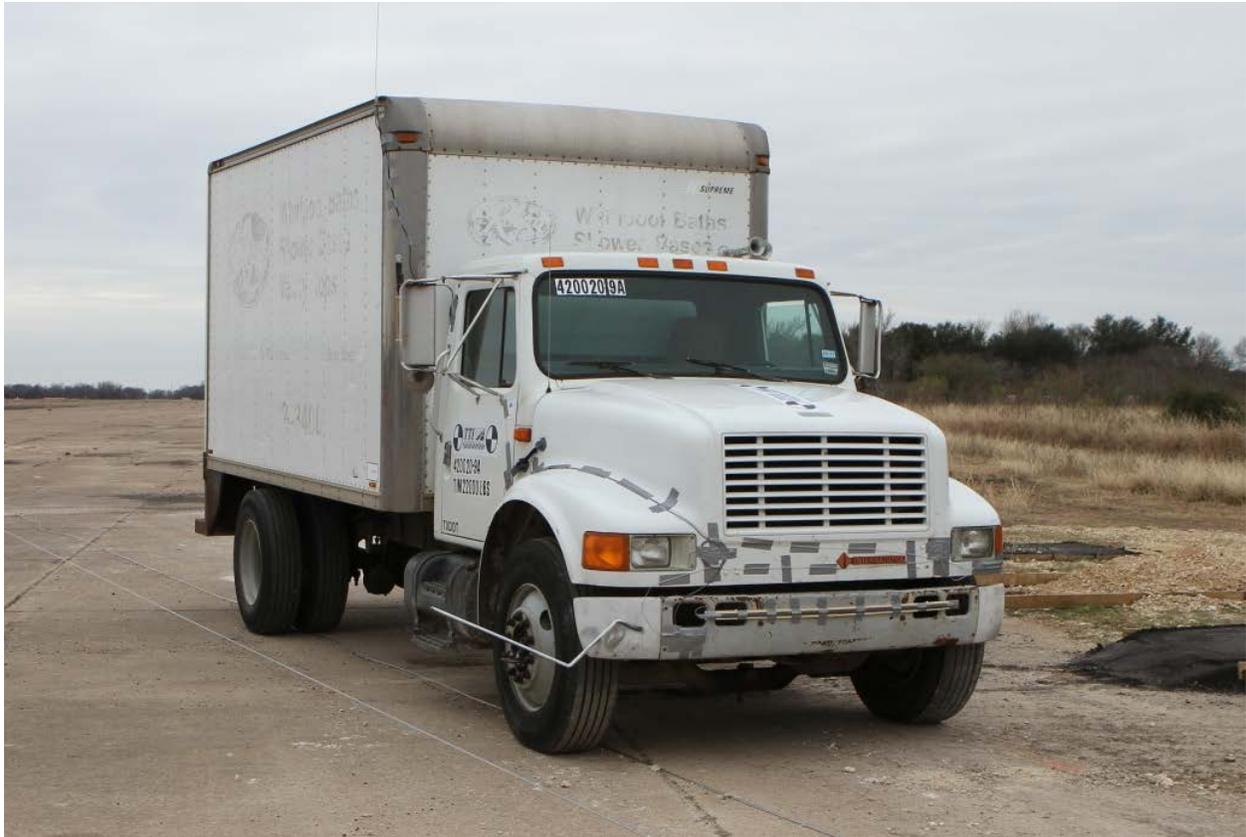
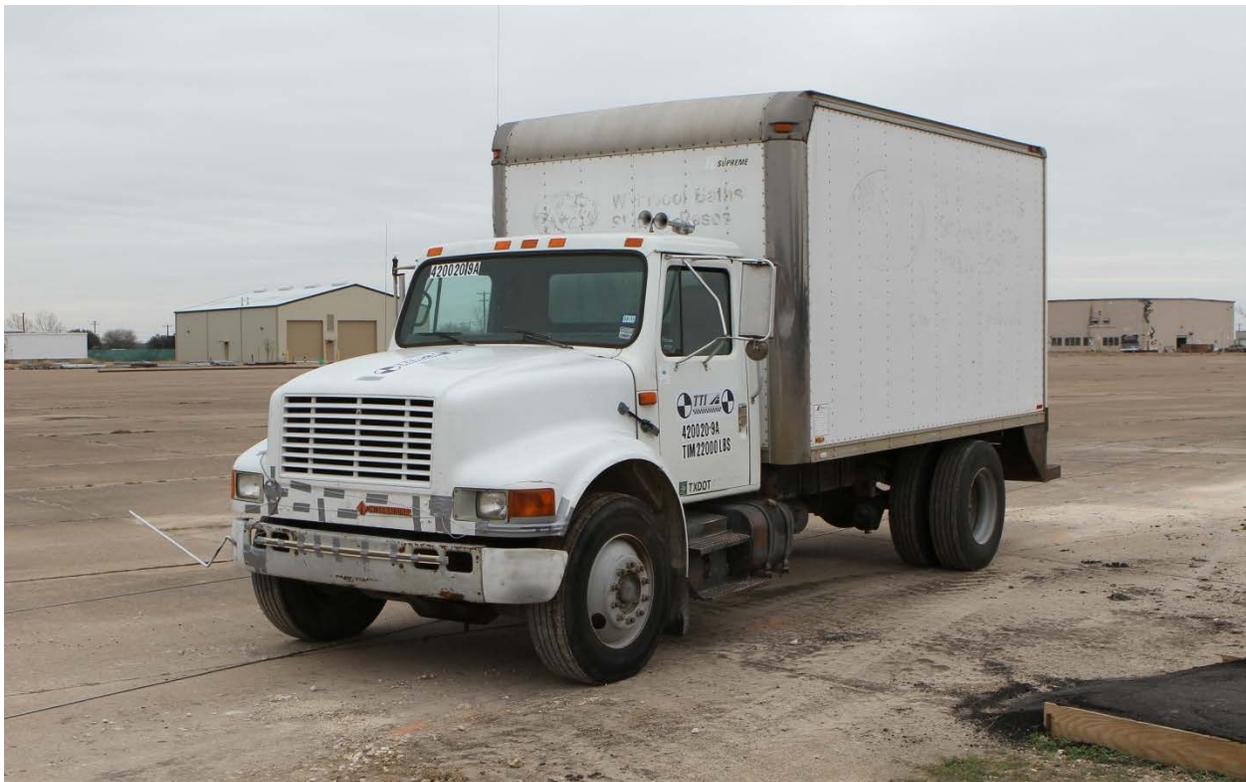
Figure 6.2. Vehicle before Test No. 420020-9b.

A 1991 International 4700 single-unit box-van truck, shown in Figures 6.1 and 6.2, was used for the crash test. Test inertia weight of the vehicle was 22,150 lb, and its gross static weight was 22,150 lb. The height to the lower edge of the vehicle bumper was 19.0 inches, and the height to the upper edge of the bumper was 30.5 inches. Table C1 in Appendix C gives additional dimensions and information on the vehicle. The vehicle was directed into the installation using the cable reverse tow and guidance system, and was released to be free-wheeling and unrestrained just prior to impact.

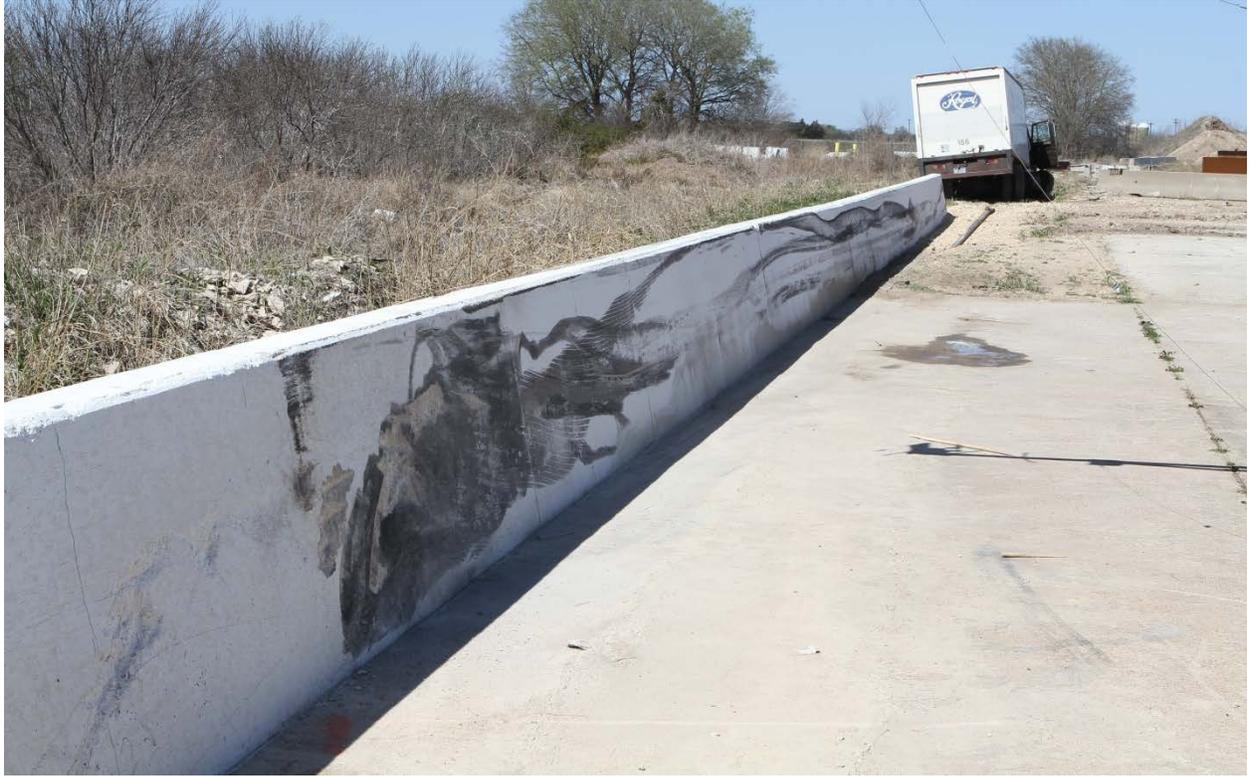
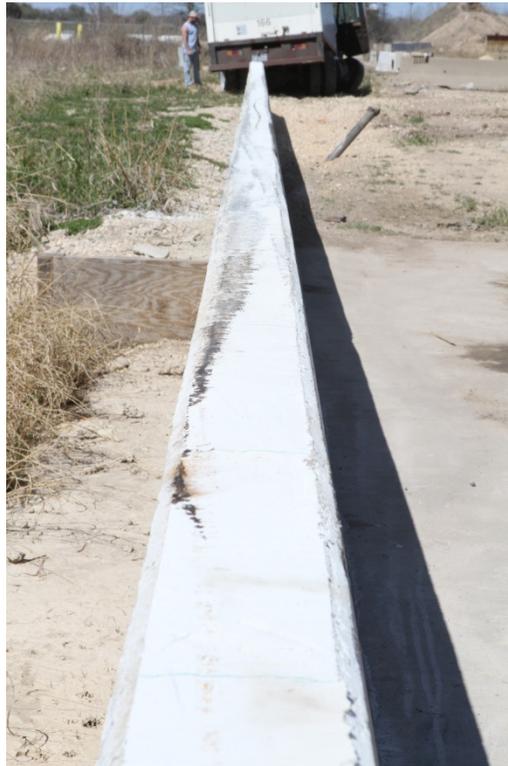
Figure 6.3. After Impact Vehicle Position for Test No. 420020-9b.

Figures 6.3 and 6.4 show damage to the barrier, which was cosmetic in nature. Tire marks and gouges were evident on the traffic face of the barrier. No new cracks in the concrete were noted. The barrier did not need repair after the impact.

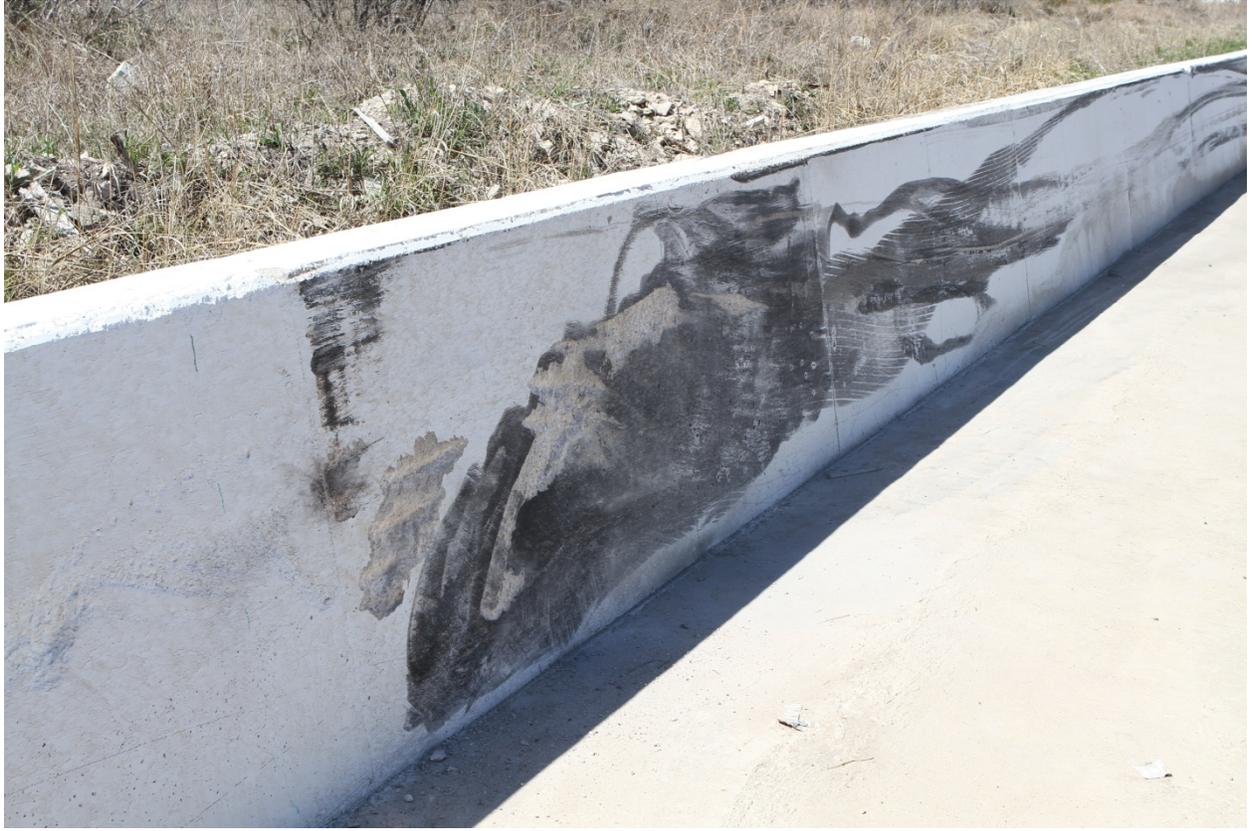
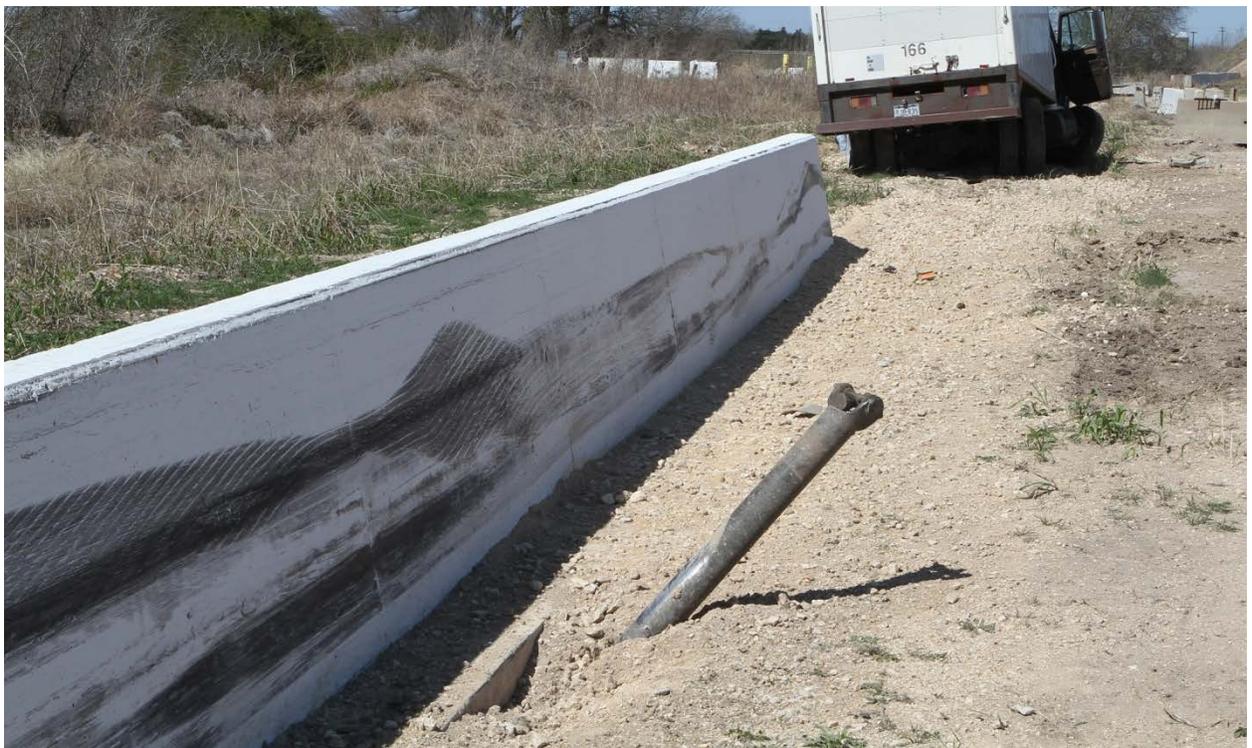
Figure 6.4. Installation After Test No. 420020-9b.
