DETERMINATION OF MINIMUM HEIGHT AND LATERAL DESIGN LOAD FOR MASH TEST LEVEL 4 BRIDGE RAILS

Test Report No. 9-1002-5

TEXAS TRANSPORTATION INSTITUTE
THE TEXAS A&M UNIVERSITY SYSTEM
COLLEGE STATION, TEXAS

Test Report 9-1002-5
Project 9-1002
Project Title: Roadside Safety Device Crash Testing Program

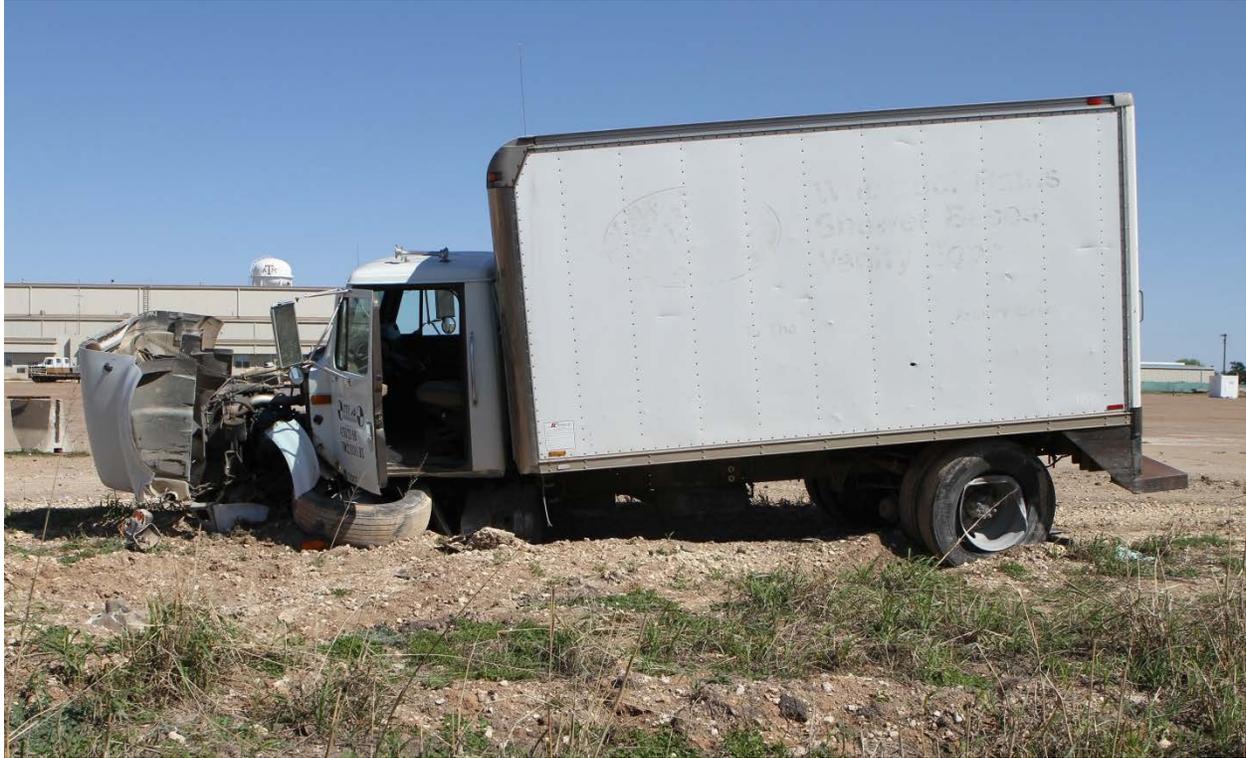
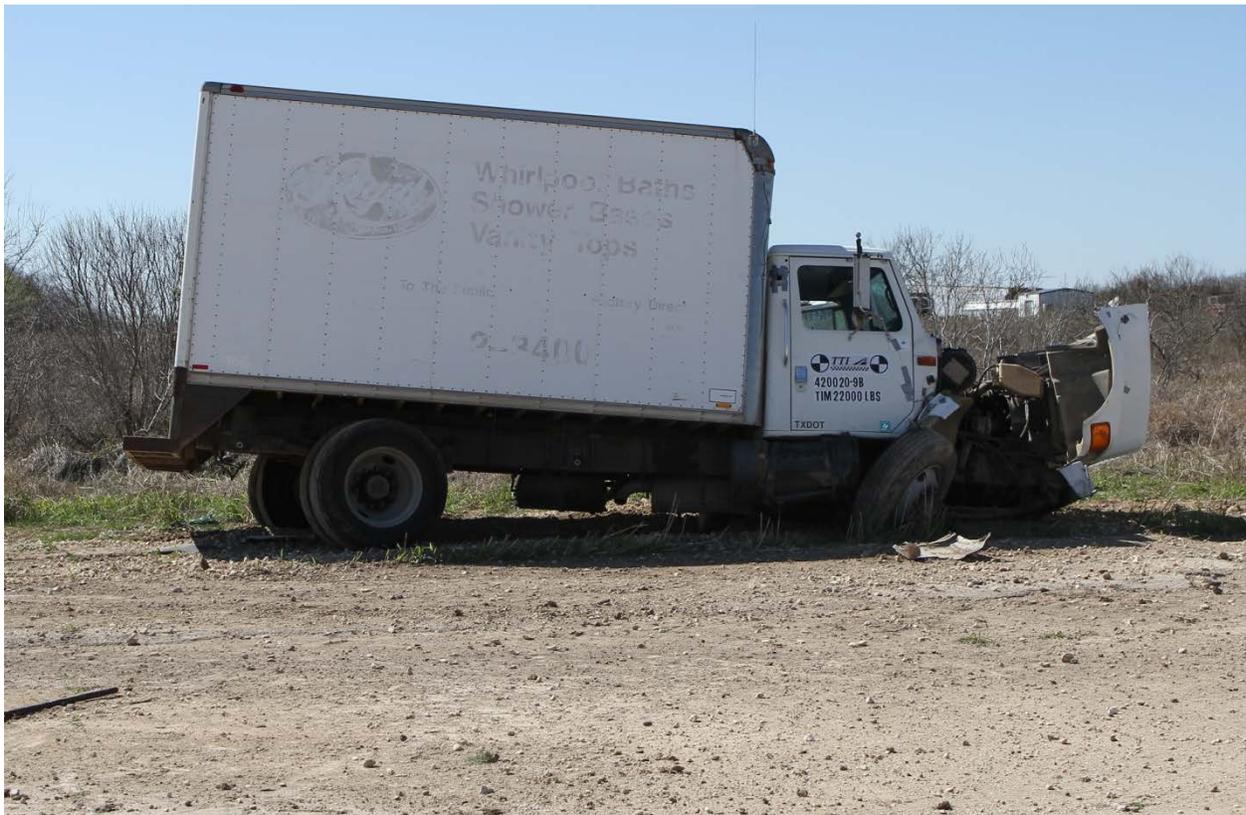
Figure 6.5. Vehicle After Test No. 420020-9b.

The 10000S vehicle sustained damage to the front left side (see Figure 6.5). The left frame rail, front axle, front U-bolts and springs, front tie rod, steering rod, left rear U-bolts and springs, and the drive shaft were all deformed. Also damaged were the front bumper, hood, left and right front tires and wheel rims, right and left fuel tanks, and left rear outer tire and wheel rim. Maximum crush of the exterior of the vehicle was approximately 12.0 inches. No notable occupant compartment deformation occurred. Figure 6.6 shows photographs of the interior of the vehicle.

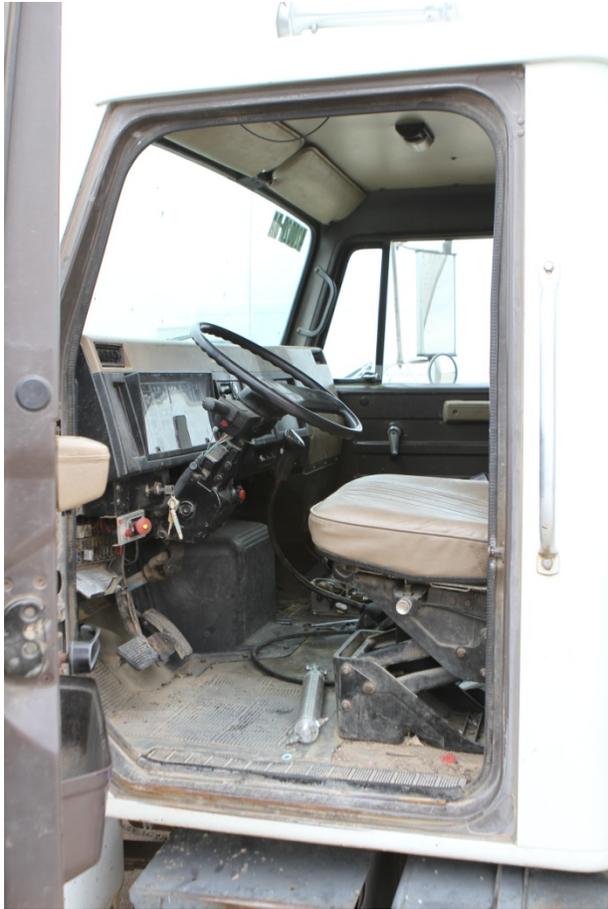
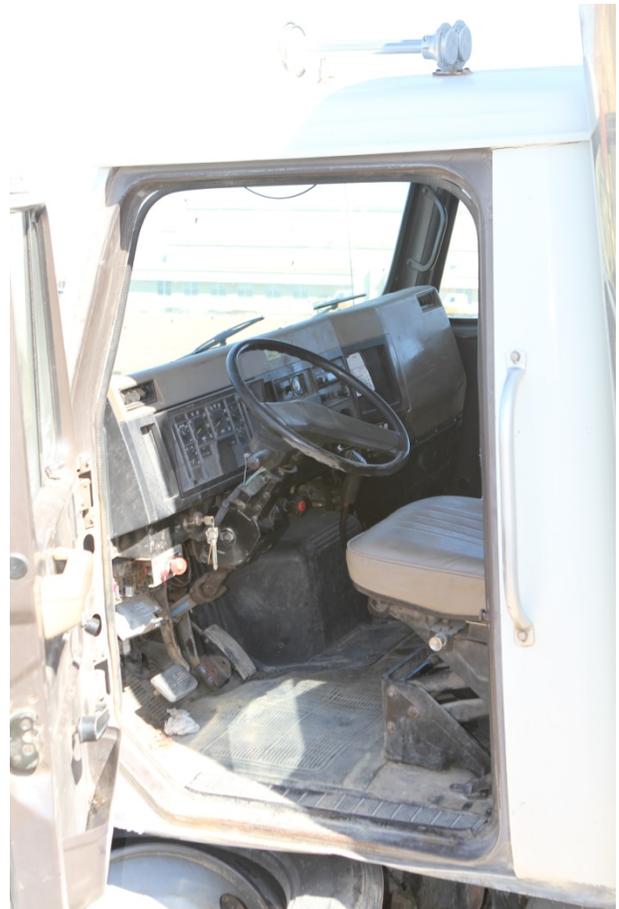
Before Test

After Test

Figure 6.6. Interior of Vehicle for Test No. 420020-9b.

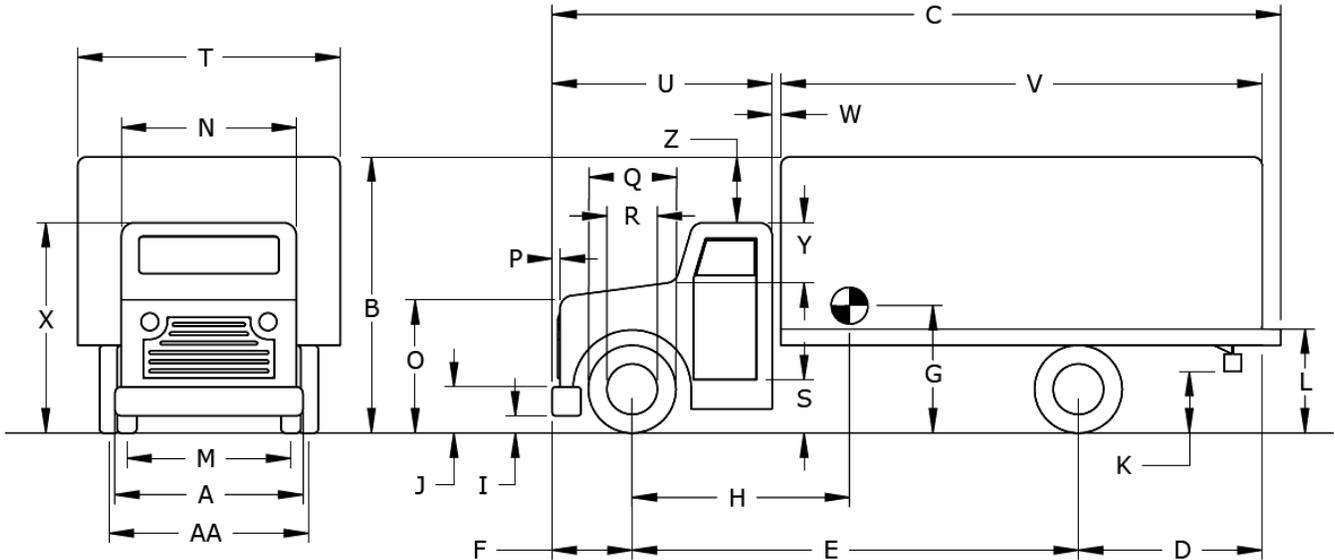
Vehicle Geometry: inches

A Front Bumper Width: <u>95.25</u>	J Front Bumper Top: <u>30.50</u>	S Bottom Door Height: <u>39.25</u>
B Overall Height: <u>133.00</u>	K Rear Bumper Bottom: <u>27.50</u>	T Overall Width: <u>95.00</u>
C Overall Length: <u>274.00</u>	L Rear Frame Top: <u>48.00</u>	U Cab Length: <u>97.00</u>
D Rear Overhang: <u>56.00</u>	M Front Track Width: <u>80.50</u>	V Trailer/Box Length: <u>173.50</u>
E Wheel Base: <u>187.50</u>	N Roof Width: <u>73.00</u>	W Gap Width: <u>1.00</u>
F Front Overhang: <u>30.50</u>	O Hood Height: <u>61.50</u>	X Overall Front Height: <u>96.00</u>
G C.G. Height: _____	P Bumper Extension: <u>2.00</u>	Y Roof-Hood Distance: <u>26.50</u>
H C.G. Horizontal Distance: <u>103.87</u>	Q Front Tire Width: <u>39.50</u>	Z Roof-Box Height Difference: <u>33.50</u>
I Front Bumper Bottom: <u>19.00</u>	R Front Wheel Width: <u>23.50</u>	AA Rear Track Width: <u>80.50</u>

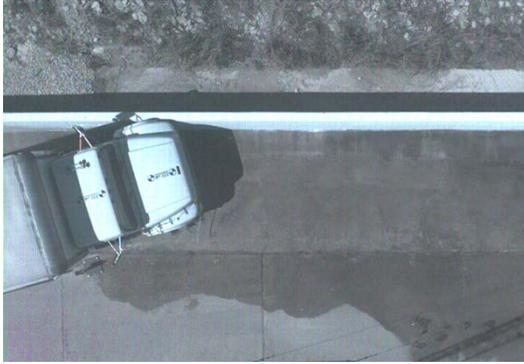
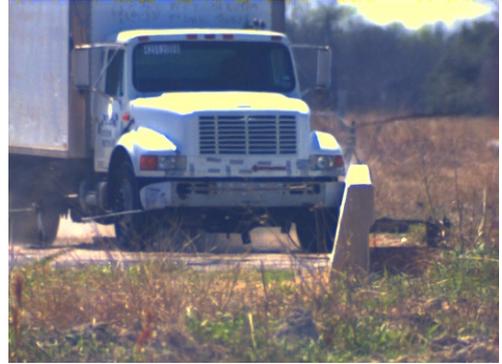
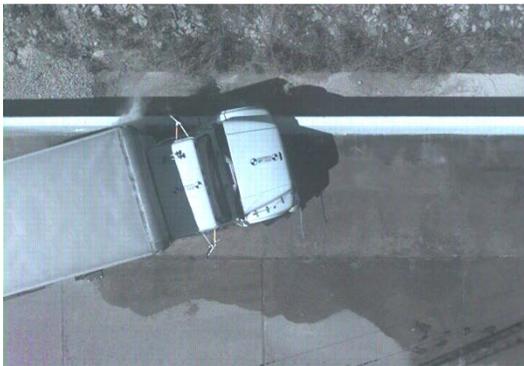
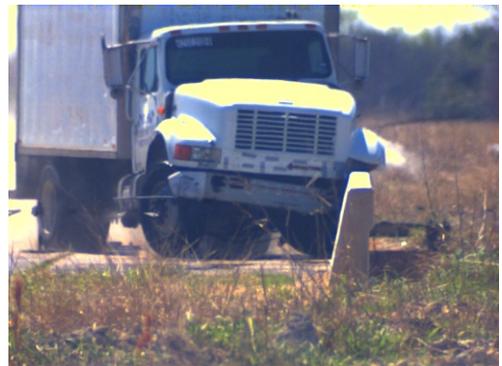
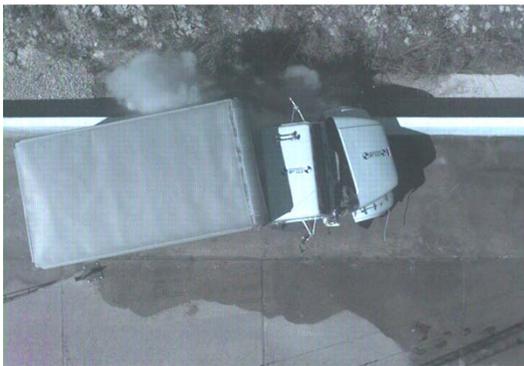
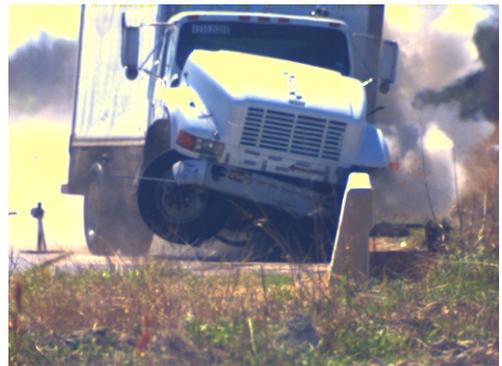
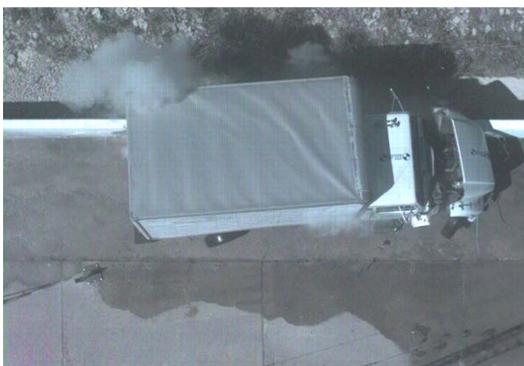
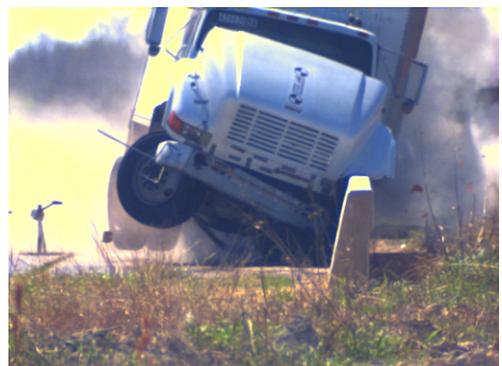
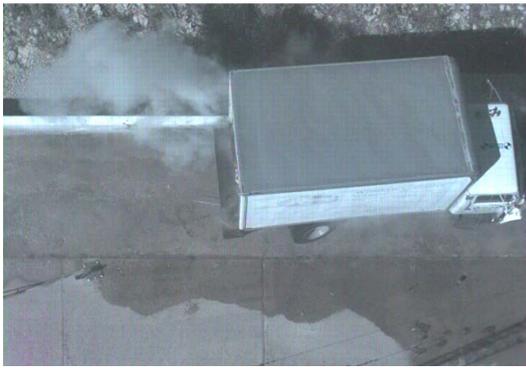
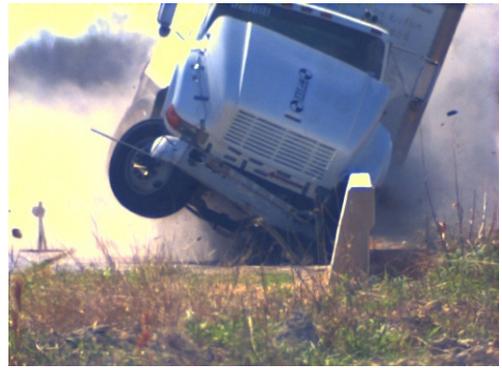
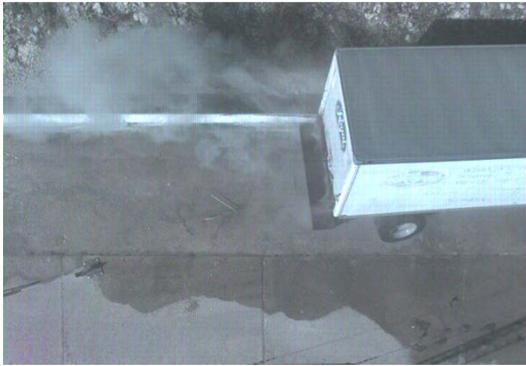
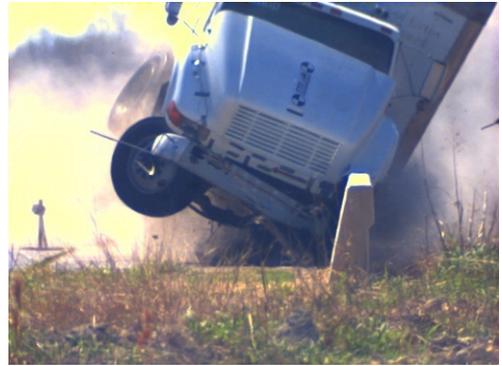
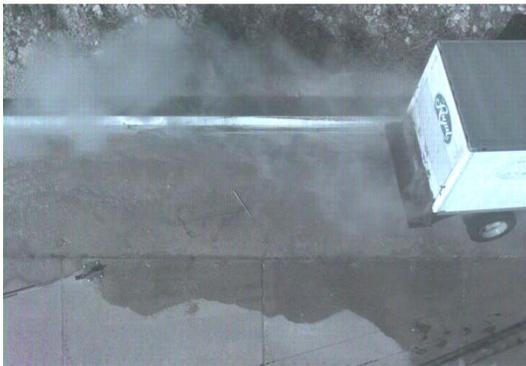
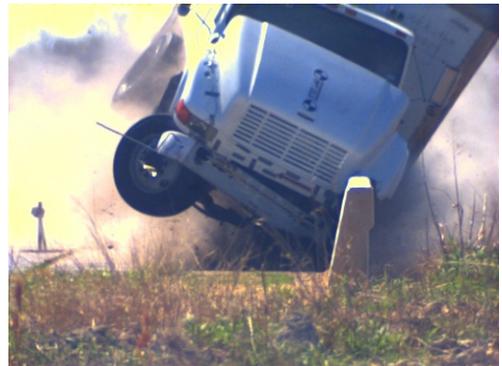
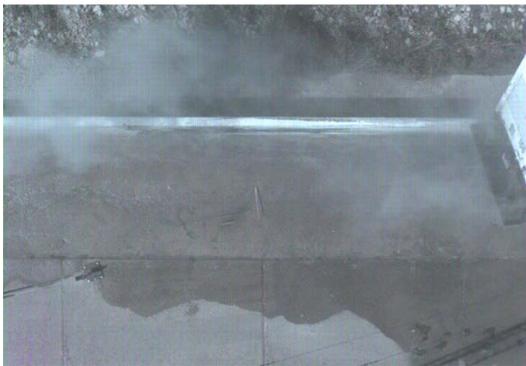
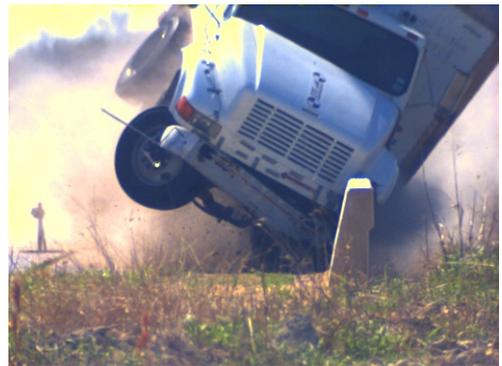
**Figure D1. Sequential Photographs for Test No. 420020-9b
(Overhead and Frontal Views).**

The 1991 International 4700 single-unit box-van truck, traveling at an impact speed of 57.2 mi/h, impacted the SSTR 24 ft downstream of the upstream end at an impact angle of 16.1 degrees. Shortly after contact, the bumper began to deform, and at 0.015 s, the driver's side front tire and wheel lost contact with the ground surface. The vehicle began to redirect at 0.029 s, and the tire and wheel on the front passenger side lost contact with the ground surface at 0.091 s. At 0.099 s, the front driver's side tire blew out, and at 0.230 s, the rear passenger's side tire and wheel lost contact with the ground surface. The rear of the box contacted the barrier at 0.244 s. At 0.264 s, the vehicle was traveling parallel with the barrier at a speed of 49.1 mi/h. The vehicle lost contact with the barrier at an exit speed and angle of 48.0 mi/h and 1.0 degrees, respectively. The vehicle continued to ride along the traffic face of the barrier and rode off the end. At 3.3 s after impact, the brakes on the vehicle were applied and the vehicle subsequently came to rest 185 ft downstream of the point of impact. Figures 6.1 and 6.2 in Appendix D show sequential photographs of the test period.

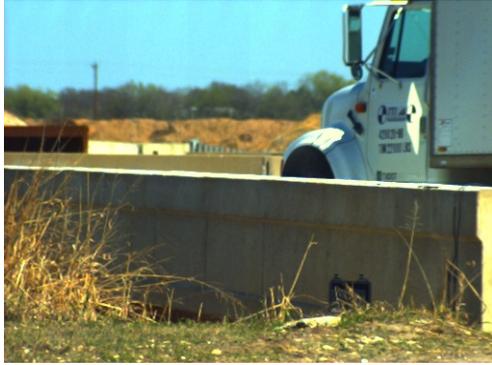
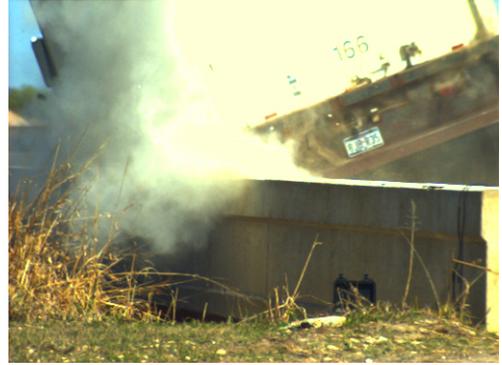
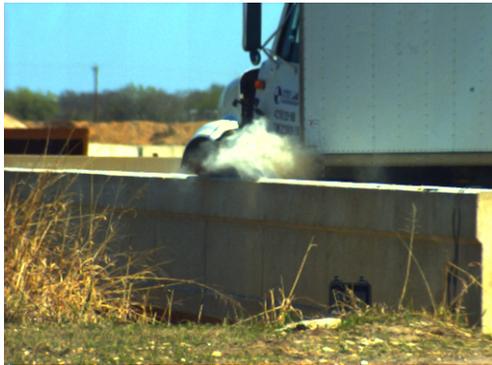
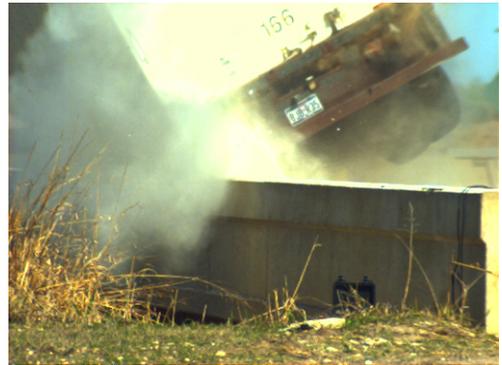
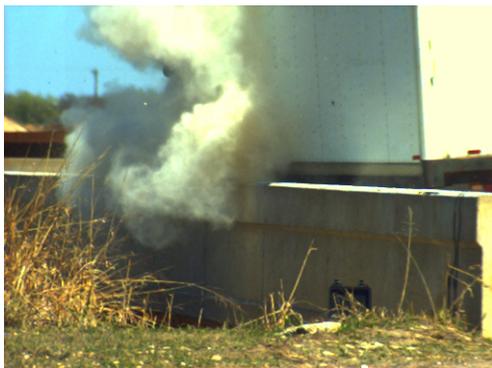
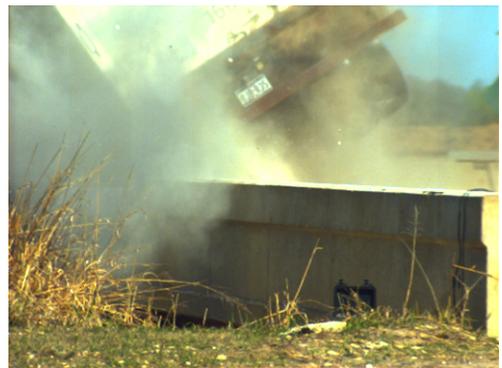
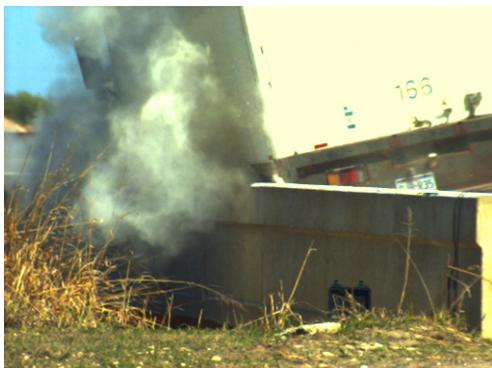
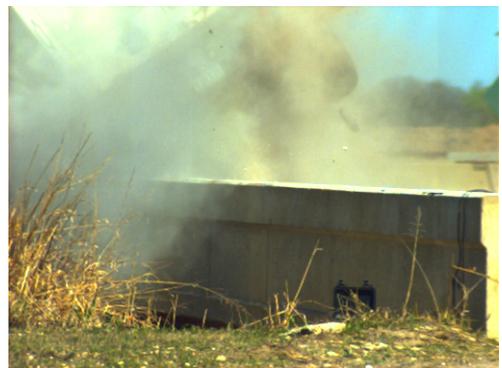
Figure D2. Sequential Photographs for Test No. 420020-9b (Rear View).

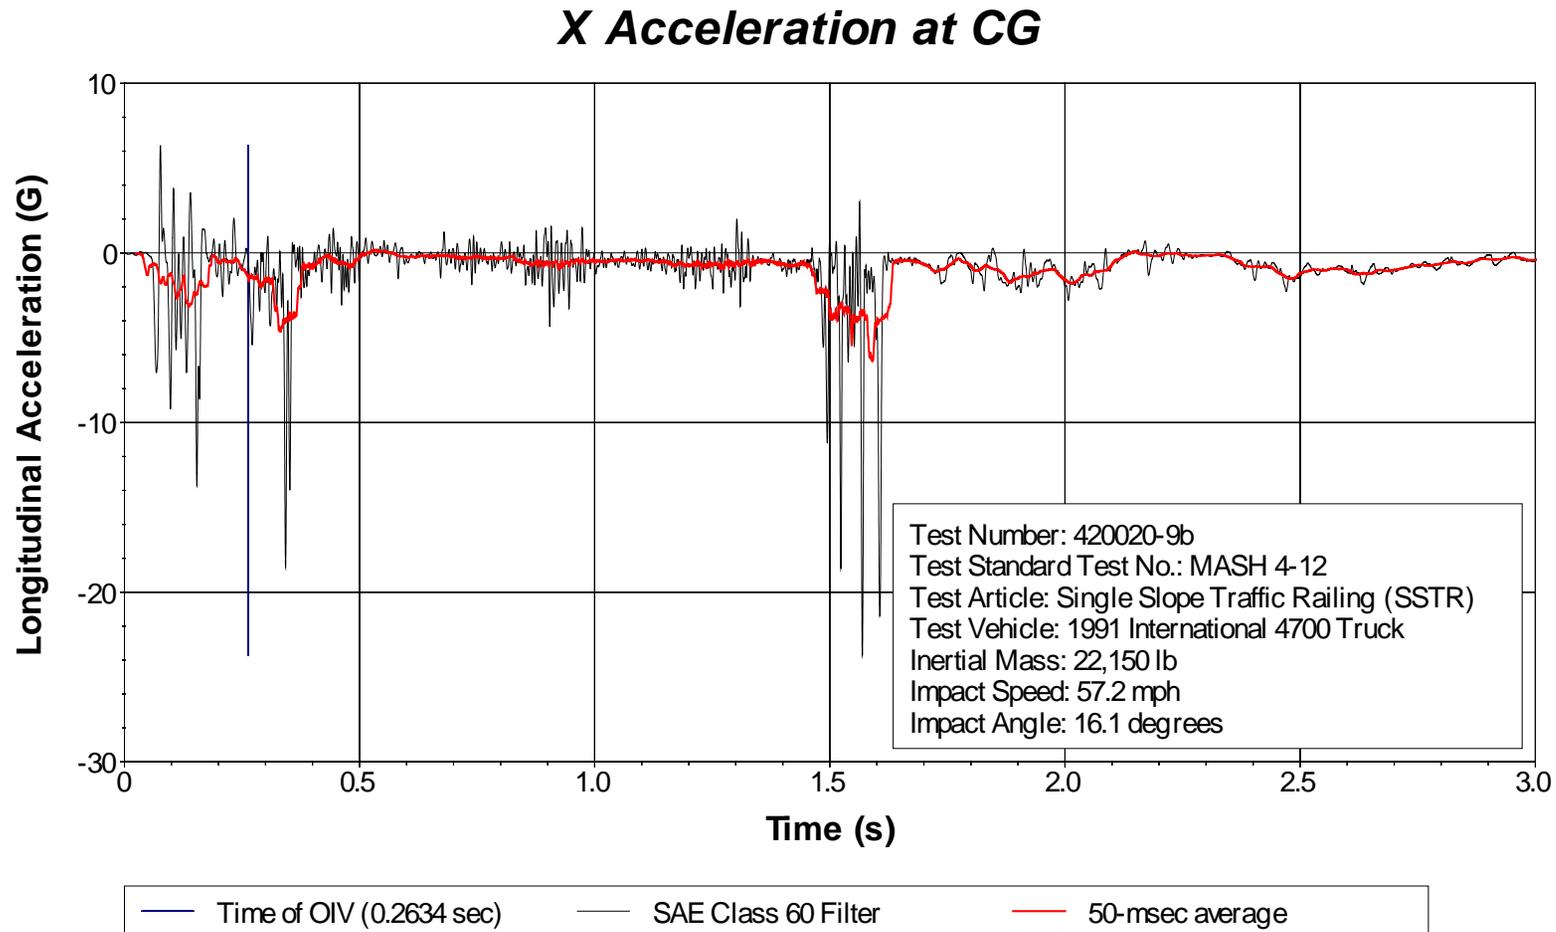
**Figure E1. Vehicle Longitudinal Accelerometer Trace for Test No. 420020-9b
(Accelerometer Located at Center of Gravity).**

Data from the accelerometer, located at the vehicle center of gravity, were digitized for evaluation of occupant risk for information purposes. In the longitudinal direction, the occupant impact velocity was 9.2 ft/s at 0.263 s, the highest 0.010 s occupant ridedown acceleration was 13.7 Gs from 1.602 to 1.612 s, and the maximum 0.050-s average acceleration was -6.4 Gs between 1.565 and 1.615 s. In the lateral direction, the occupant impact velocity was 11.5 ft/s at 0.263 s, the highest 0.010 s occupant ridedown acceleration was 9.0 Gs from 1.605 to 1.615 s, and the maximum 0.050 s average was 4.5 Gs between 1.566 and 1.616 s. Theoretical Head Impact Velocity (THIV) was 16.8 km/h or 4.7 m/s at 0.257 s; Post-Impact Head Decelerations (PHD) was 15.7 Gs between 1.602 and 1.612 s; and Acceleration Severity Index (ASI) was 2.42 between 1.566 and 1.616 s. Figure 6.7 summarizes these data and other pertinent information from the test. Vehicle angular displacements were not obtained due to a hardware malfunction. Appendix E, Figures E1 through E6, presents vehicle accelerations versus time traces.

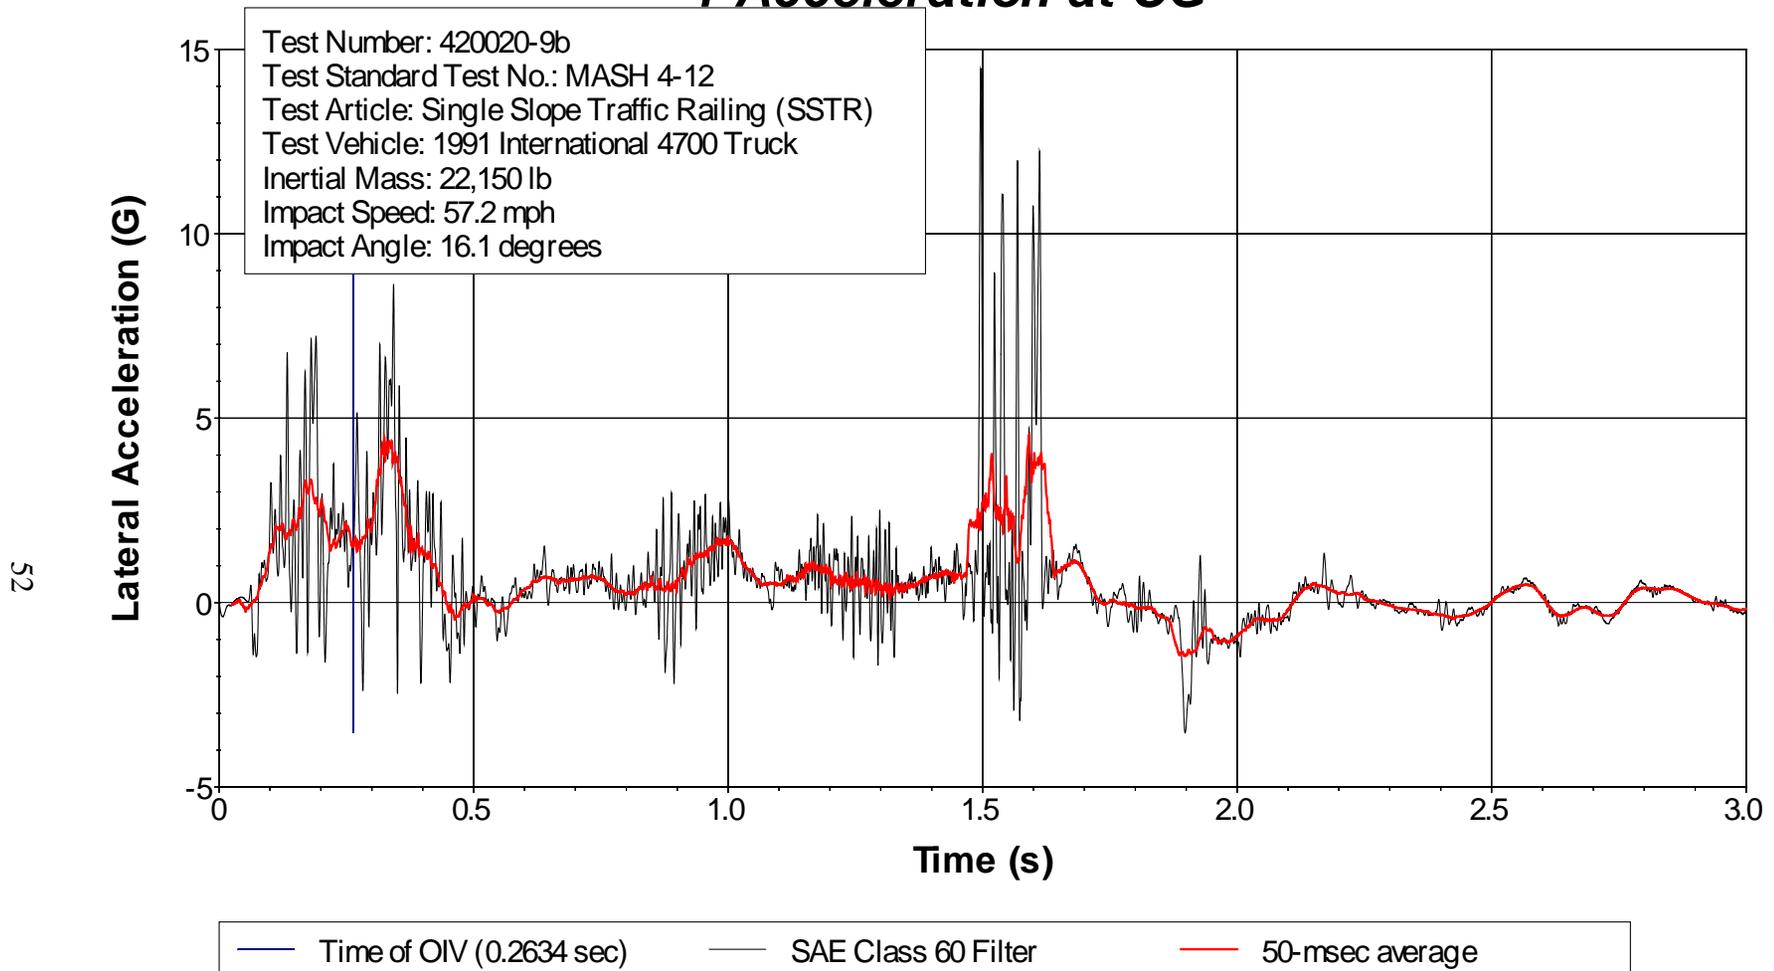
**Figure E2. Vehicle Lateral Accelerometer Trace for Test No. 420020-9b
(Accelerometer Located at Center of Gravity).**

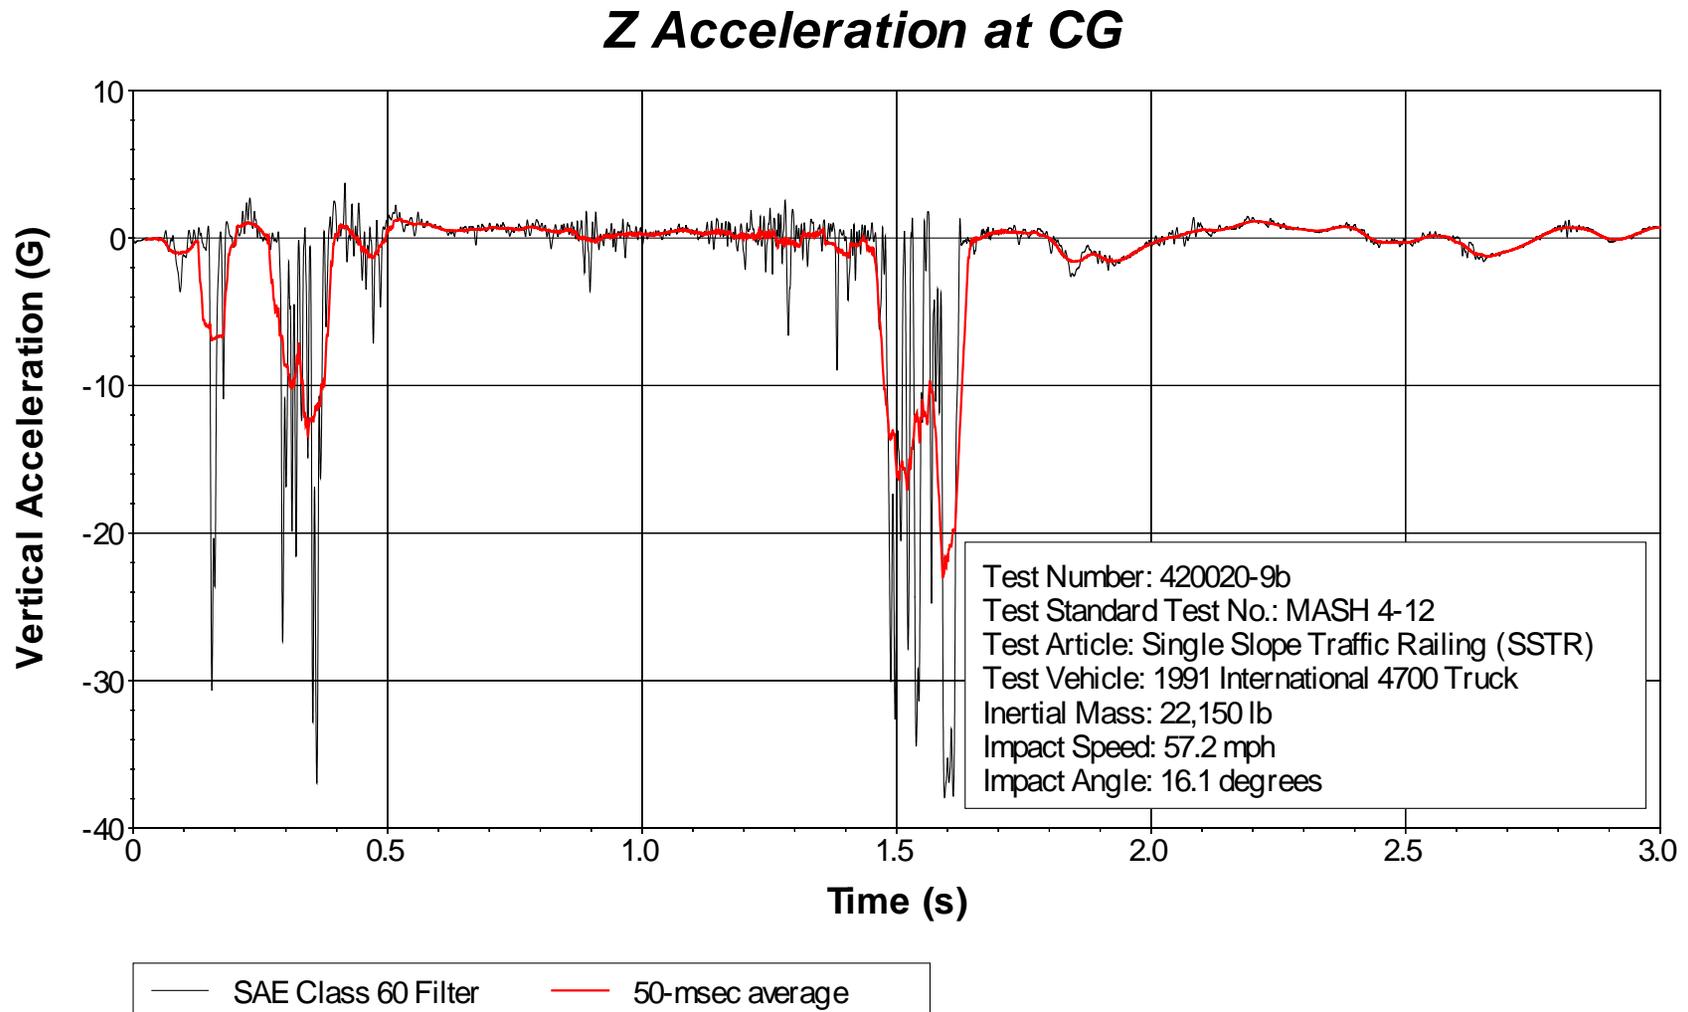
**Figure E3. Vehicle Vertical Accelerometer Trace for Test No. 420020-9b
(Accelerometer Located at Center of Gravity).**

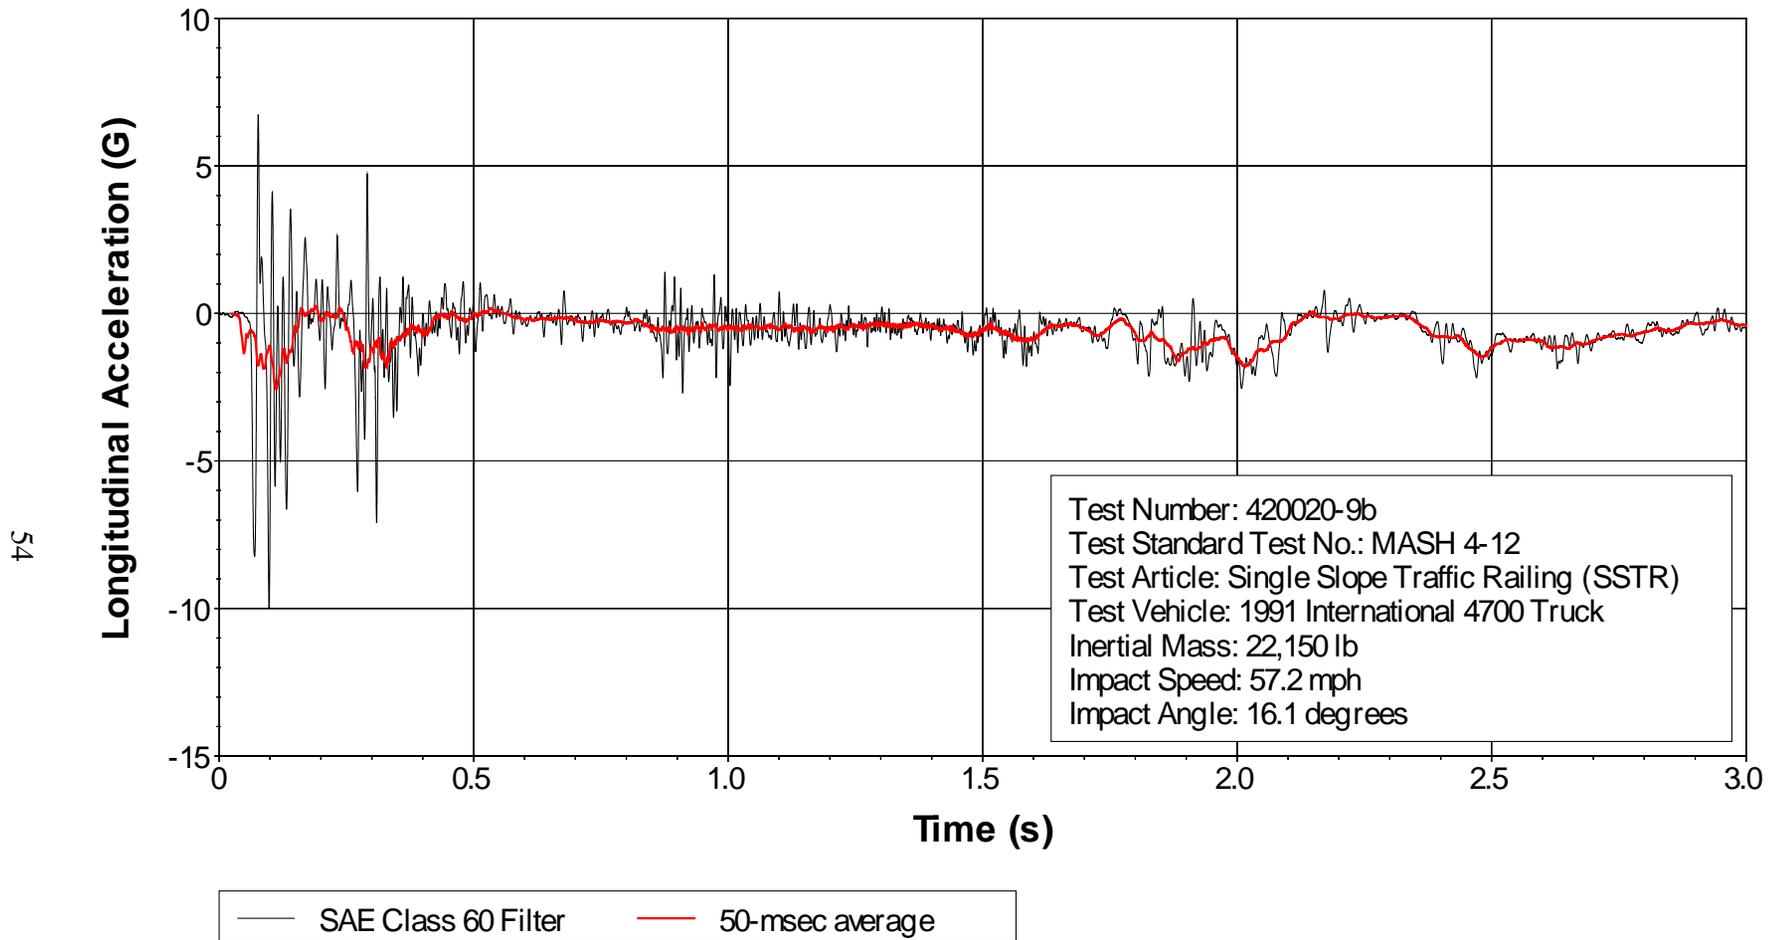
**Figure E4. Vehicle Longitudinal Accelerometer Trace for Test No. 420020-9b
(Accelerometer Located over Rear Axle).**

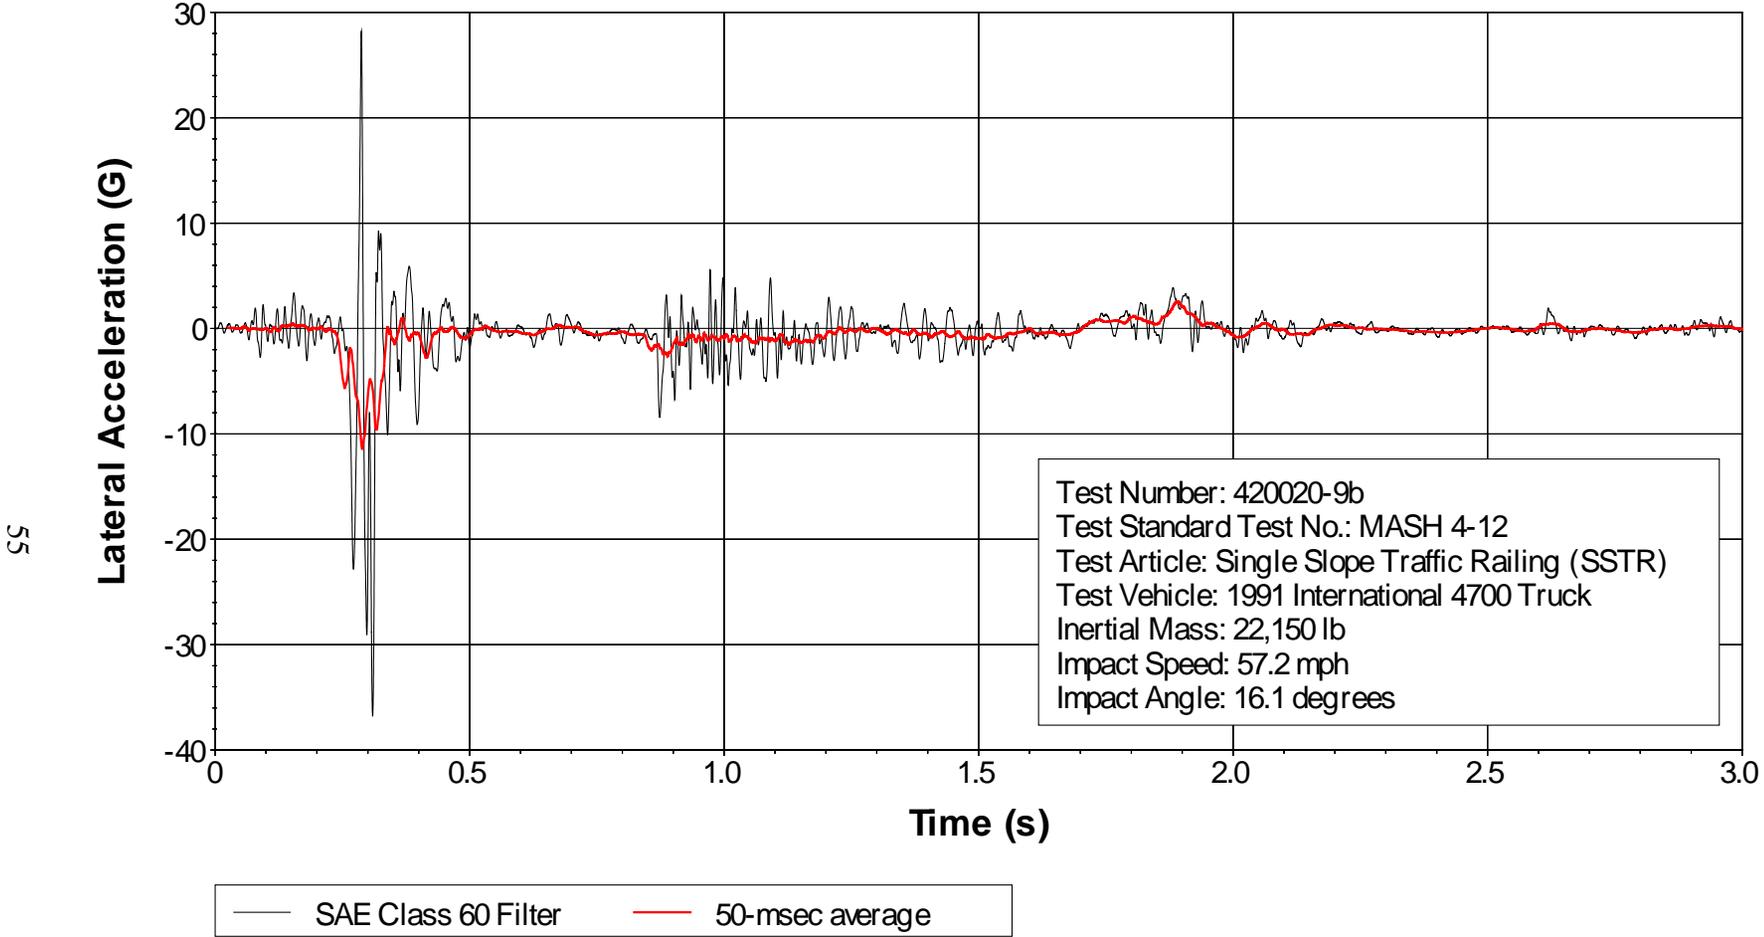
Figure E5. Vehicle Lateral Accelerometer Trace for Test No. 420020-9b (Accelerometer Located over Rear Axle).

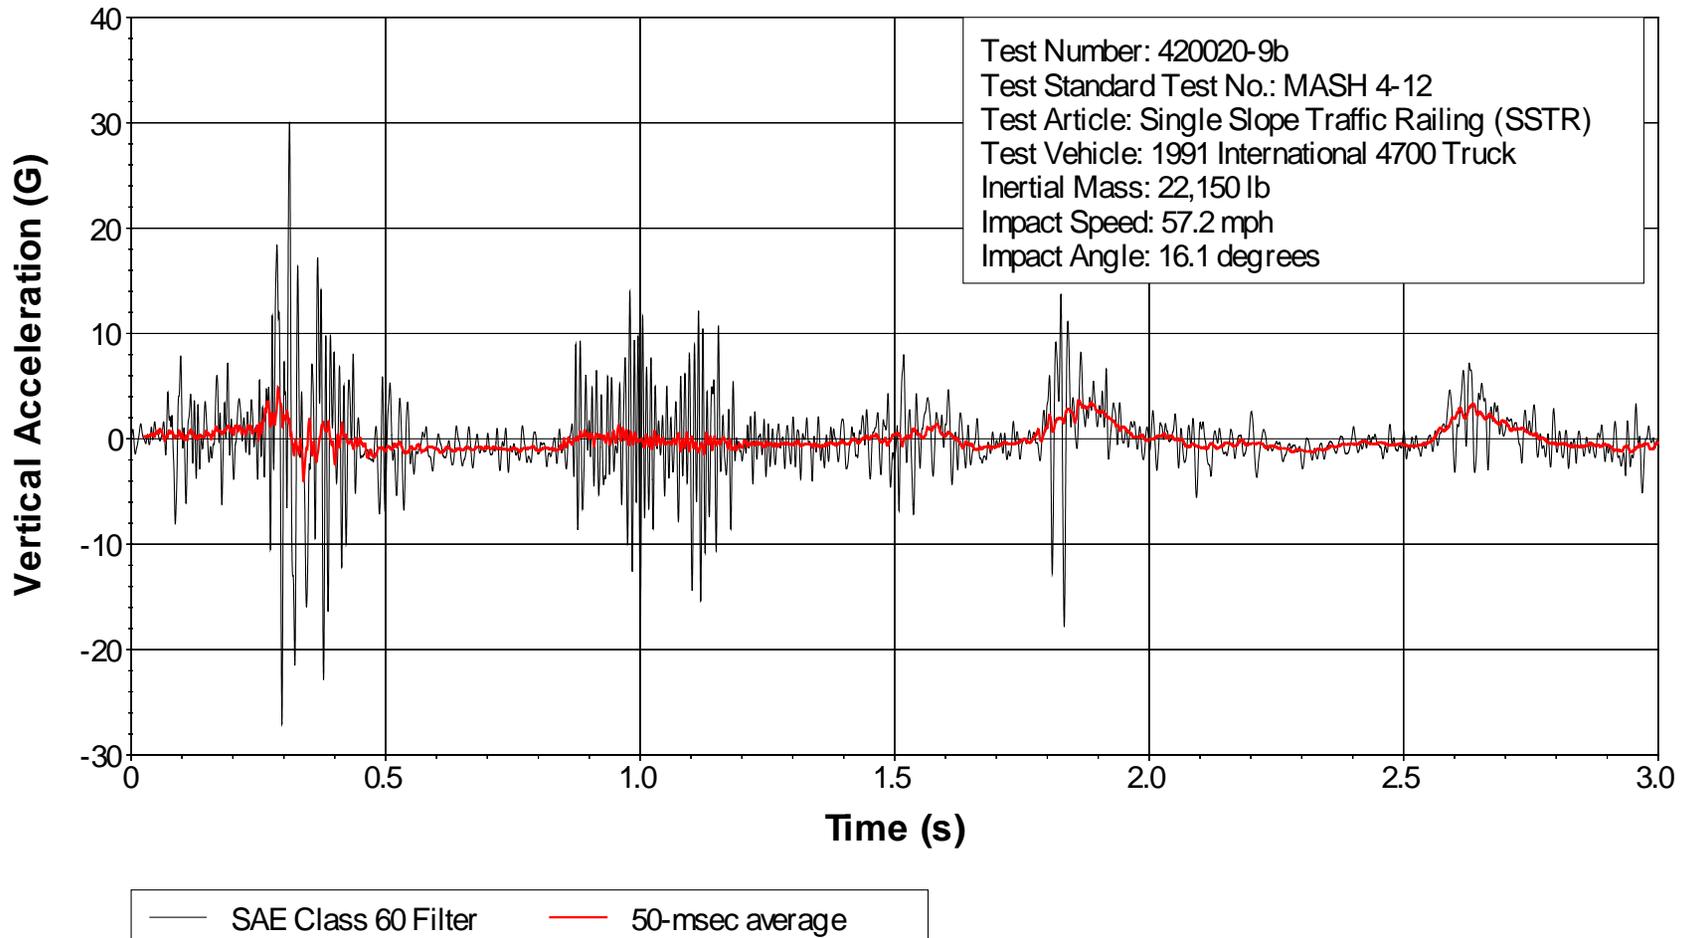
Figure E6. Vehicle Vertical Accelerometer Trace for Test No. 420020-9b
(Accelerometer Located over Rear Axle).
