Precast Concrete Elements for Accelerated Bridge Construction

Volume 3. Laboratory Testing, Field Testing, and Evaluation of a Precast Concrete Bridge: Black Hawk County

Final Report
January 2009

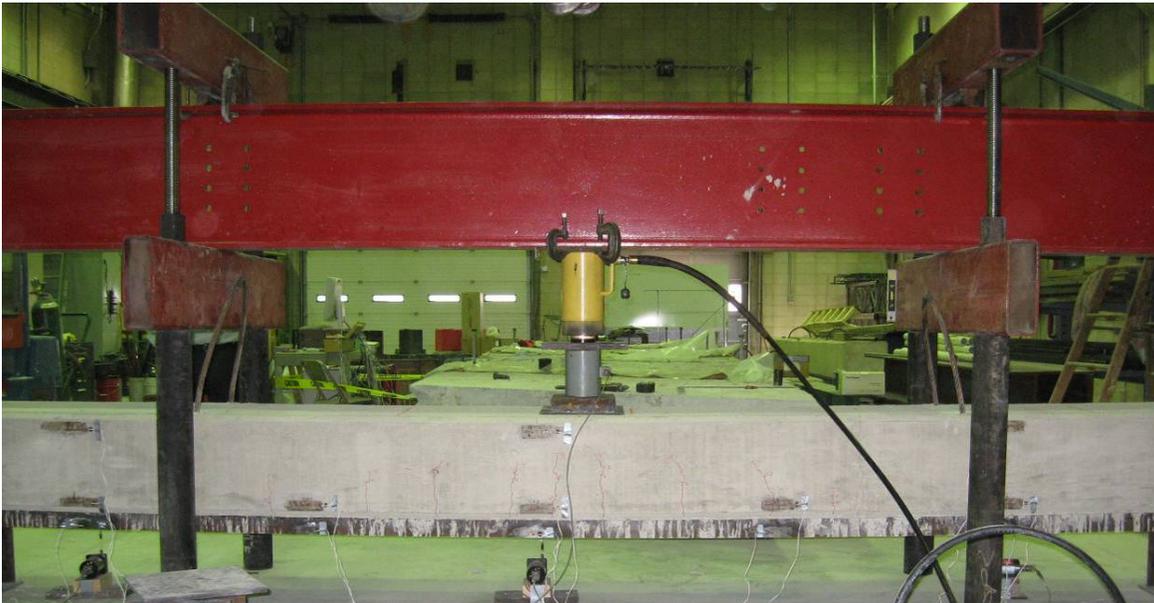
Cap 2 was tested for positive bending strength in the same manner as Cap 1. Two piles were used for supports, spaced at 15'-6''. A single point load was applied at the midspan of the abutment cap to produce positive bending as shown in Figure 2.9. A negative strength bending test was not performed on Cap 2 as the abutment cap was failed during the positive strength bending test.

a) Strength test dimensions

b) Photograph of test

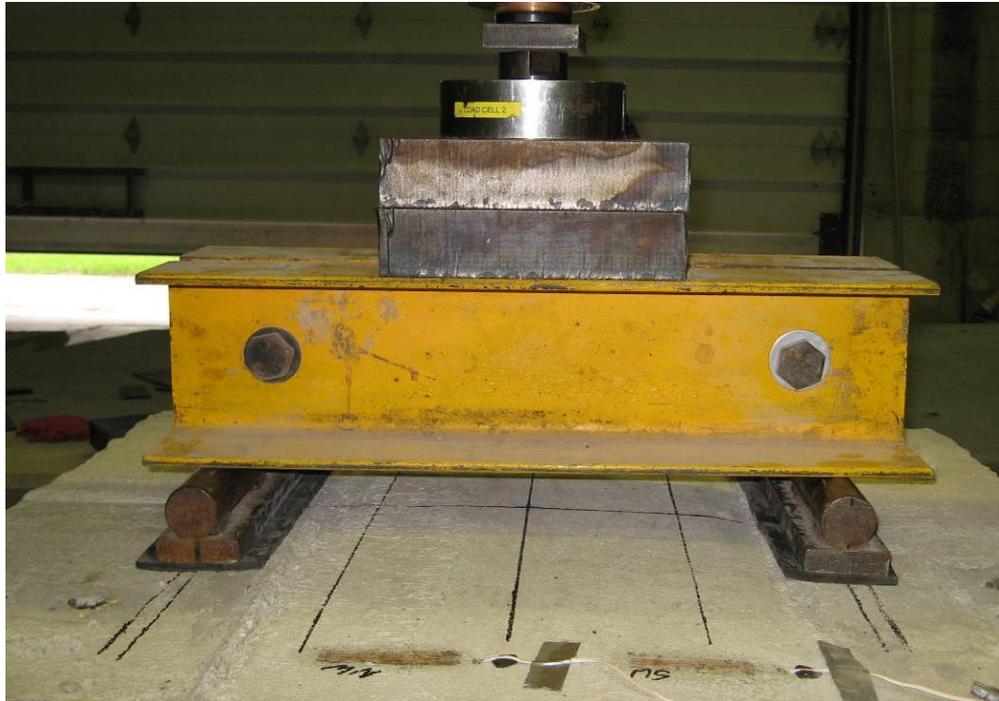
Figure 2.31. Ultimate load test set-up

After a specimen was loaded at all five load positions, the specimen was set-up for ultimate load testing. To load the specimen at two locations, a beam was used to span the distance between the load points shown in Figure 2.31. By loading the midpoint of the span of the load beam, equal force was applied at each load position. Force was applied until failure of the specimen occurred. Strain and deflection data were recorded at 1000 pound increments. After failure, the broken specimen was examined, removed from the testing area, and then the next specimen was set in place.
