Road Safety Audit for the Intersection of US 59 and IA 9 in Osceola County, Iowa

Final Report
March 2012

ROAD SAFETY AUDIT FOR THE INTERSECTION OF US 59 AND IA 9 IN OSCEOLA COUNTY, IOWA

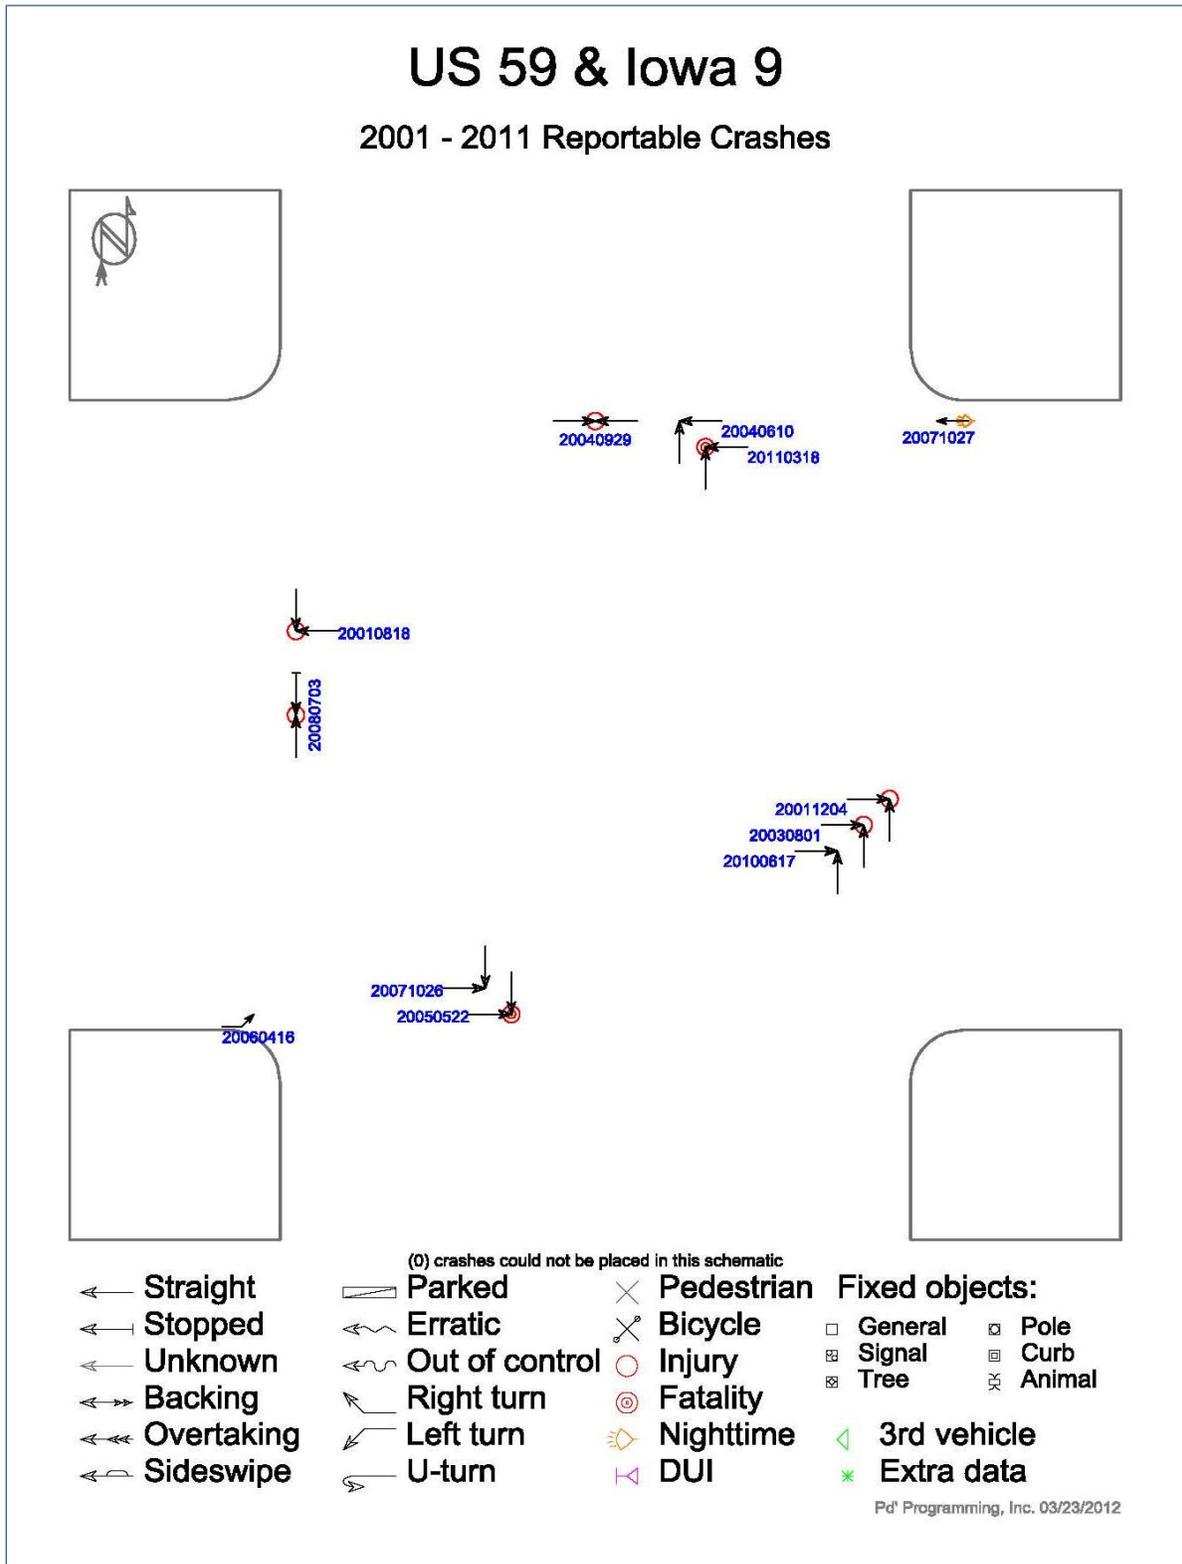
Figure B.1. 2001-2011 US 59 and IA 9 intersection crash diagram

A total of 12 crashes were recorded over the analysis period, with two fatalities, two with major injuries, three with minor injuries, two with possible injuries, and three with property only damages. The major cause of seven crashes was failure to yield the right of way from a stop sign and all other crash causes totaled only one each.

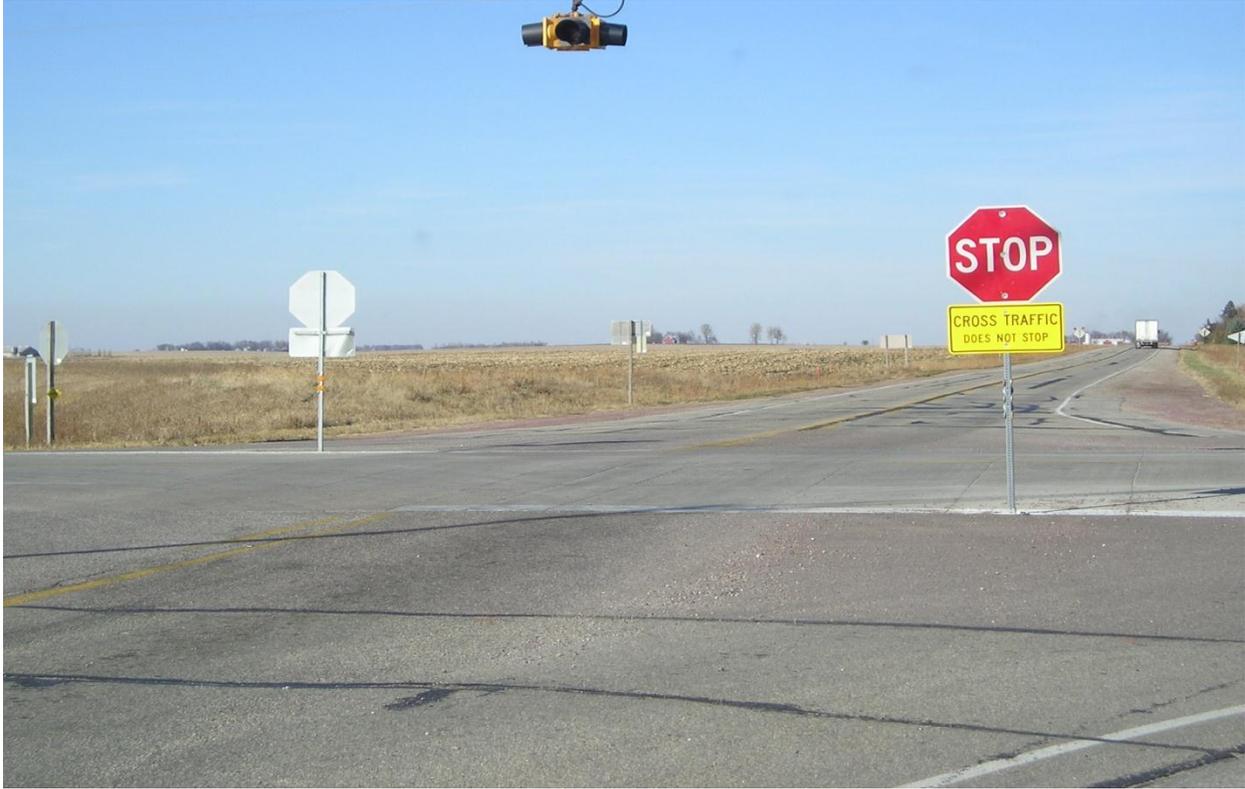
Figure D.5. Existing Stop signs and overhead beacons

Also suggested was replacement of the overhead mounted flashing beacons (shown in Figure D.5) with red flashing beacons on the Stop signs only. This procedure was found to be more effective in a recent Minnesota study, given drivers waiting at the Stop signs may assume that vehicles approaching from right angles may also be required to stop (3). (Overhead beacons were also observed at other intersections in District 3 and these locations should be reviewed for crash history.)

1. Remove the existing overhead flashing beacons and replace with flashing red beacons mounted over the Stop signs on the US 59 approaches. In addition to improving effectiveness, this step would also result in the removal of several utility poles and span wires, which would improve visibility and eliminate some roadside obstacles.

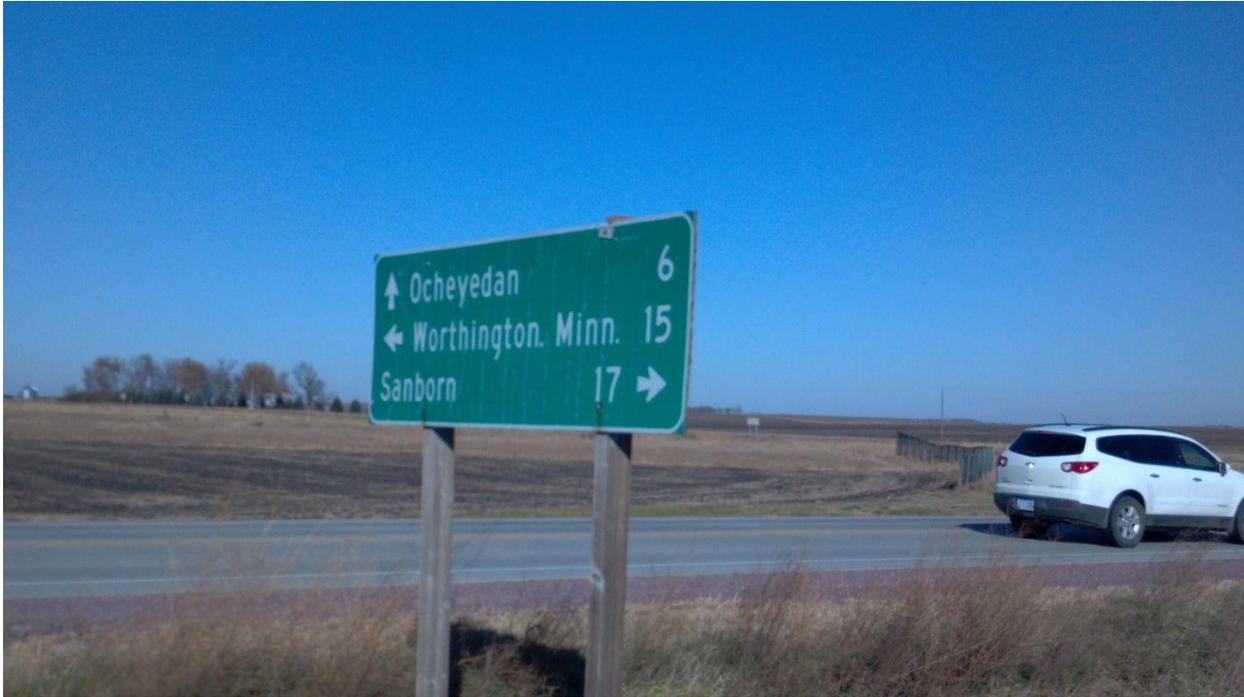
Figure D.9. Destination guide sign on eastbound IA 9

Some of the guide signs advising drivers of destinations appeared to be in poor condition and should be considered for replacement (Figure D.9). However, route markers appeared to be in excellent condition (Figure D.12).

2. Review the condition of all signs in the area of the intersection and replace as needed according to retroreflectivity performance, installation date, and current sheeting condition, with special attention to the destination sign on the eastbound IA 9 approach leg. These improvements may prove especially beneficial in advising drivers on IA 9 of the location of the US 59 intersection after removal of the overhead beacons described in option 1 above.

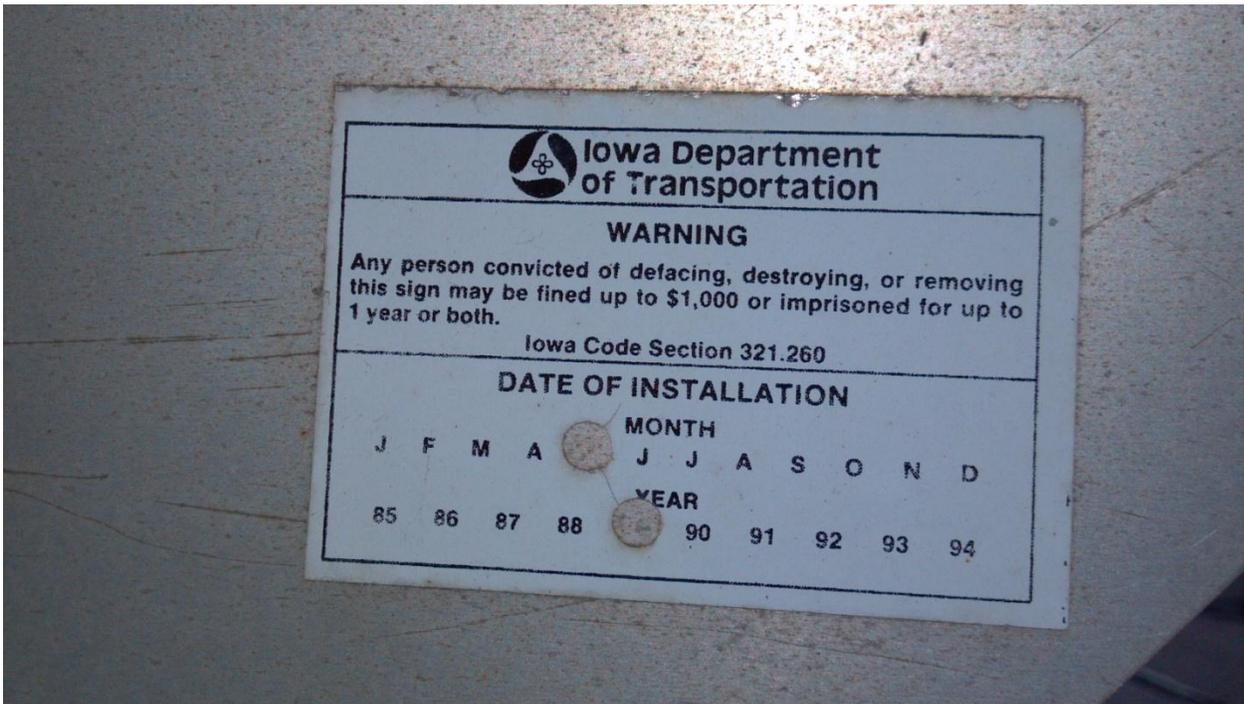
Figure D.10. Installation date sticker on existing sign

It was observed that a shadow from the adjacent intersection lighting pole was cast across the northbound Stop sign at the time of the review. Cross Traffic Does Not Stop plaques with fluorescent yellow sheeting were mounted below some of the Stop signs. All of these signs appeared in good condition, although the installation date for some signs indicated an extensive service life (some of approximately 20 years).

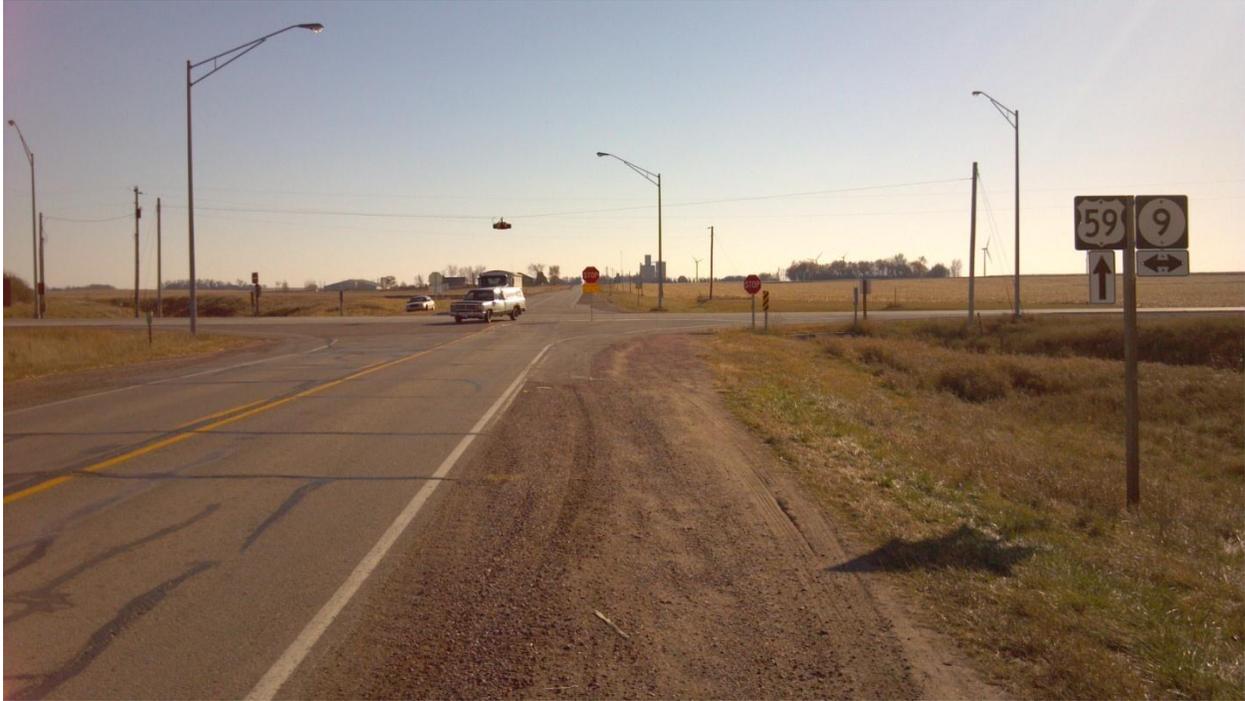
Figure D.11. Truck parking evidence on granular shoulder

Evidence of semi-tractor trailer parking along the US 59 shoulders near the intersection was observed, although the crash records did not indicate any direct safety hazards due to this practice, possibly due to greatly-reduced traffic volumes at night in this area.

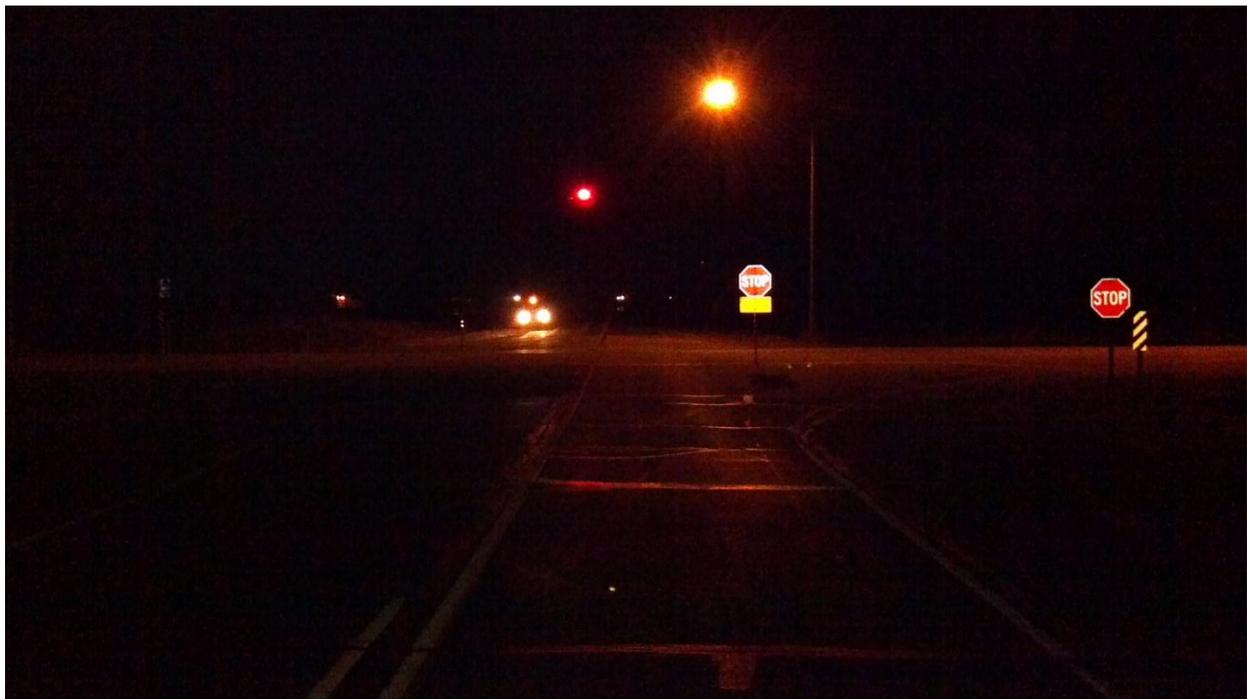
Figure D.14. Nighttime view of intersection

Traffic volume was higher than expected, particularly for large commercial vehicles, and compliance with existing traffic controls was good. However, some of the lamps in the intersection lighting were burned out and should be replaced.

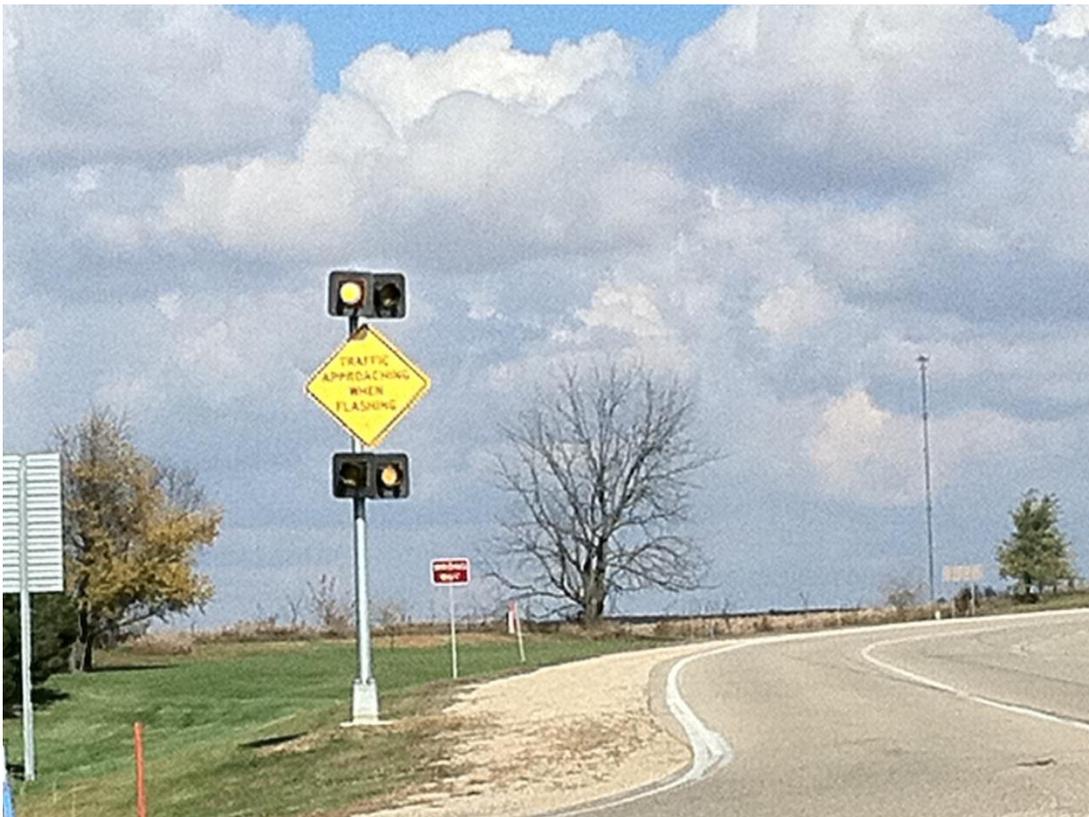
Figure D.16. Activated warning sign advising of approaching traffic on US 151 at Anamosa, Iowa

Suggestions for addressing safety issues at this intersection will include elements of all feasible alternatives. Installation of activated approaching traffic warning signs (as shown on US 151 at Anamosa, Iowa in Figure D.16) could also be considered a reactive option to possibly reduce failure to yield from Stop sign crashes. Proactive options might include replacement of the overhead beacons with flashing beacons mounted on the Stop signs, possibly supplemented with advance warning signs on IA 9 advising of entering truck traffic or a similar message.
