FRA/Volpe Center Trespass Prevention Research Study

**2011 National Highway-Rail Grade
Crossing Safety Training Conference**

Trespass Prevention Research Study

FRA/Volpe Field Site Investigation – West Palm Beach TriRail Station

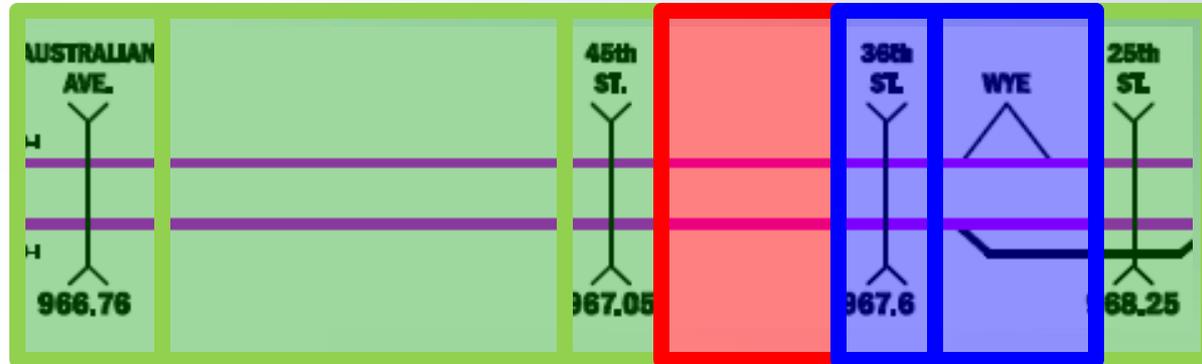
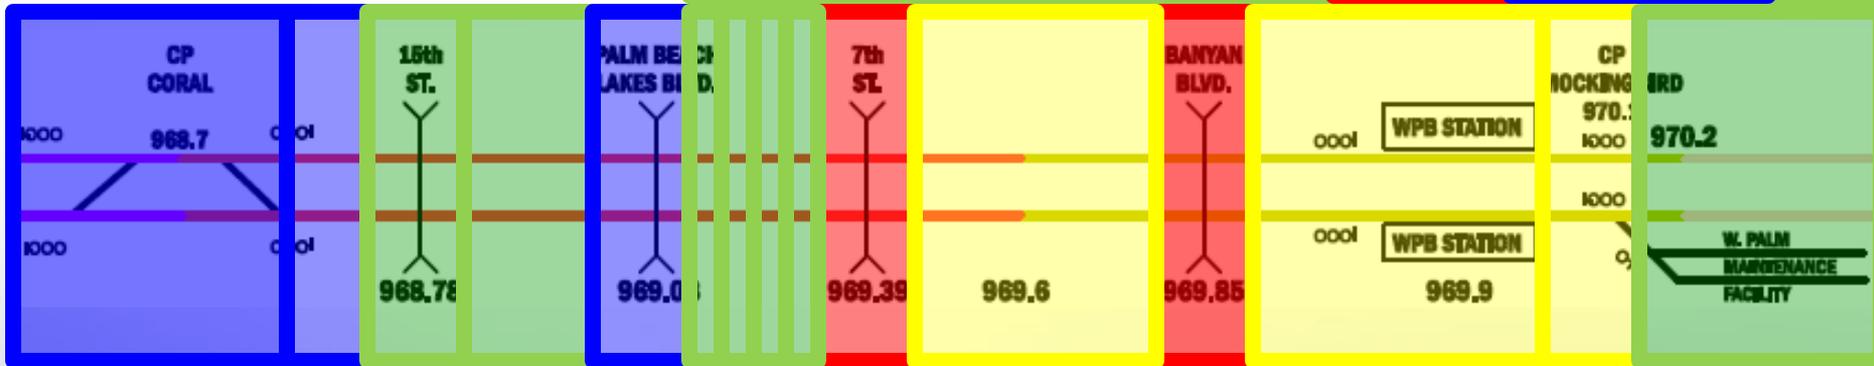
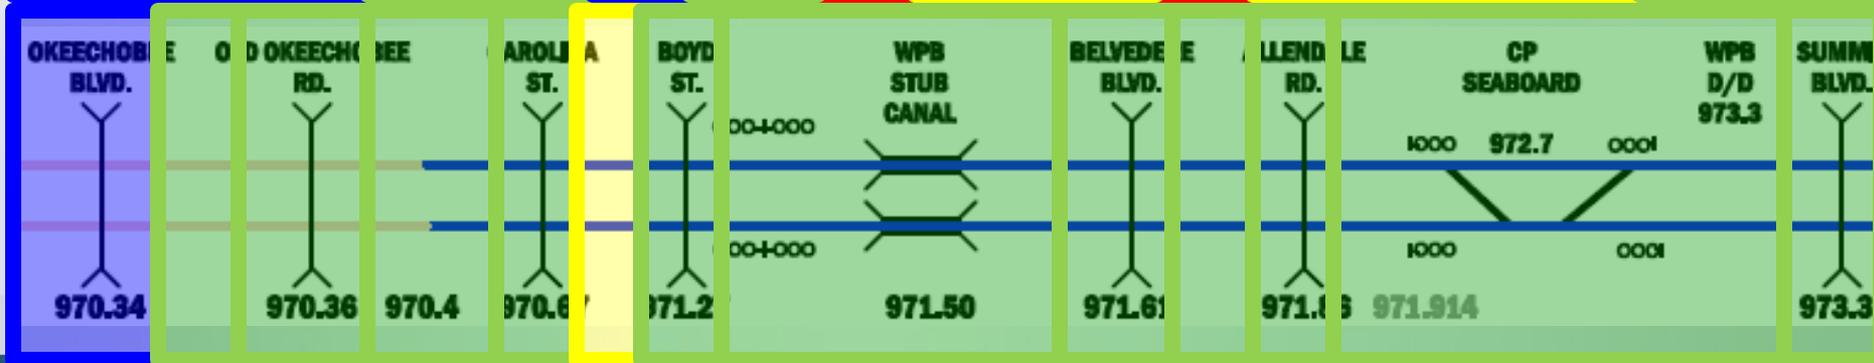
Trespass Location Severity Analysis (TLSA)

- A (high risk):
- B (medium risk):
- C (low risk):
- D (negligible risk):

- A (high risk):** PS \geq 20 3 locations
- B (medium risk):** $10 \leq$ PS $<$ 20 4 locations
- C (low risk):** $5 \leq$ PS $<$ 10 6 locations
- D (negligible risk):** PS $<$ 5 21 locations

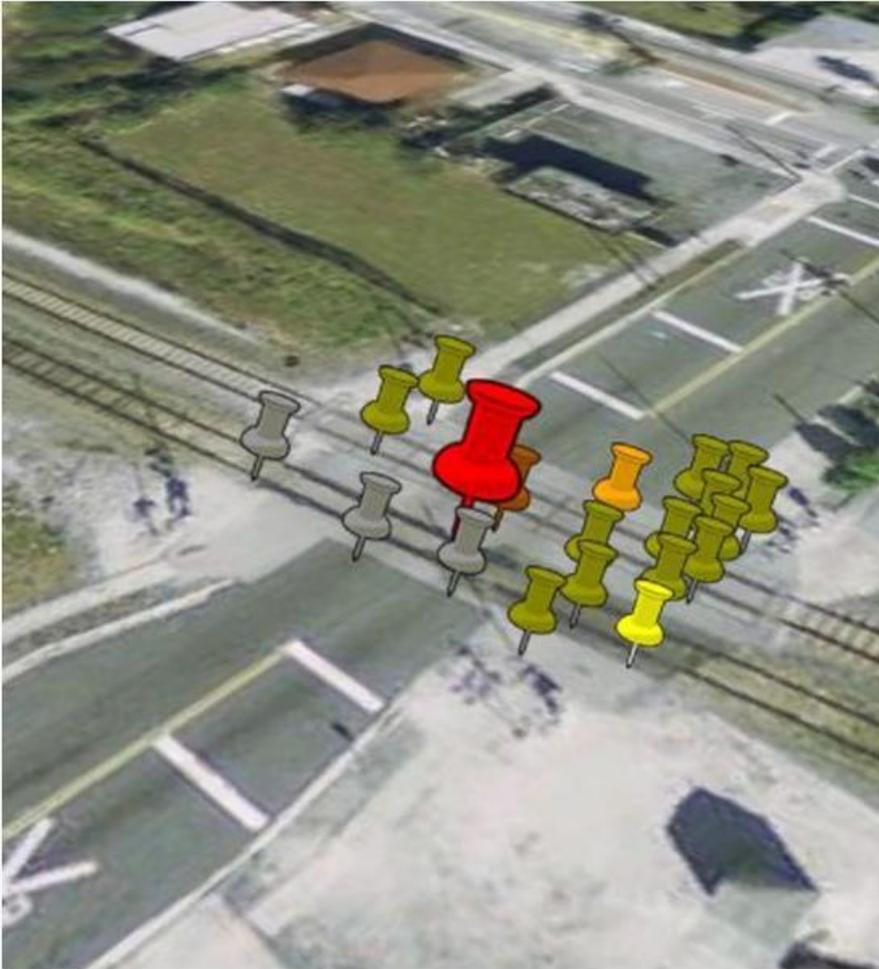
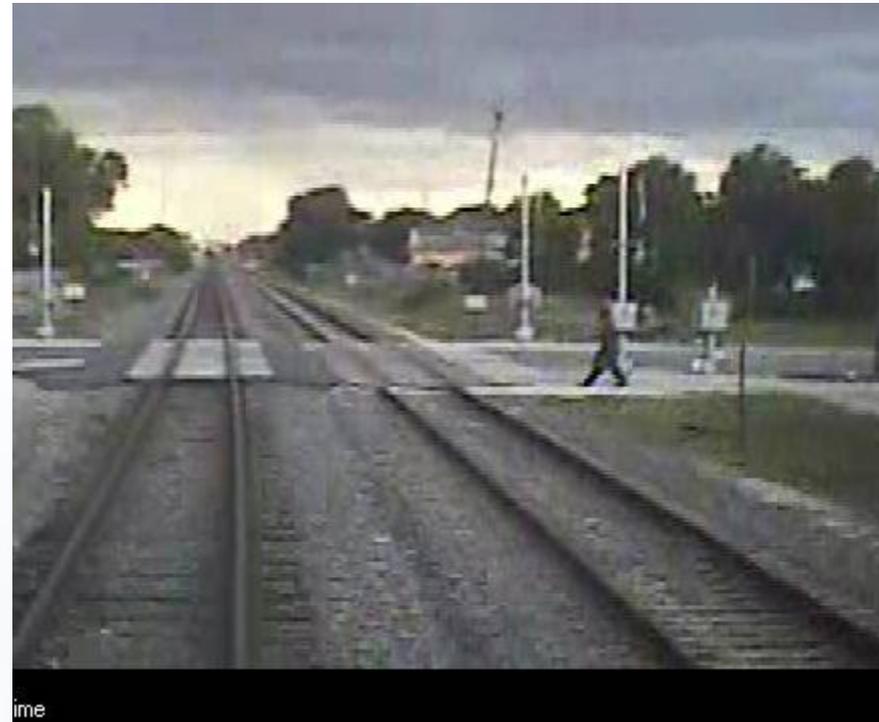
TLSA – 7th Street Crossing

- 1 fatality
- 1 suicide
- 1 attempted suicide
- 14 trespass events (locomotive video)
- Risk Class A (high risk)**

Location ID: A16
Description: 7th Street
Priority Score: 34
(Risk Class A, high risk)

- 1 fatality (12/04/07)
- 1 suicide (09/22/05)
- 1 attempted suicide (03/24/06)
- Tr-Rail locomotive video - 14 trespass events (03/05/10-07/05/10)
- 3 trespass events noted via Veolia reports (04/07/10-04/19/10)

Existing Conditions: As an active highway-rail grade crossing, the 7th street grade crossing (location A16) features numerous active and passive vehicle and pedestrian traffic control devices. The crossing is secured by a four-quadrant gate with accompanying pedestrian gates. West of the grade crossing along 7th street, a number of traffic calming devices are in use including chicanes and bulb outs. A standard 5ft tall chain-link fence lines the ROW to the north and south on the west side of the intersection.

Trespass characteristics: Events at A16 typically involve pedestrians violating the pedestrian gates at the crossing. North of the grade crossing, at the closed crossings of 8th, 9th, and 10th streets, worn trails leading through fenced or missing sections of fencing serve as clear indicators of pedestrian trespass activity. Footpaths along the ROW are visible, indicating that pedestrians also walk alongside the tracks to reach points north and south of the crossing.

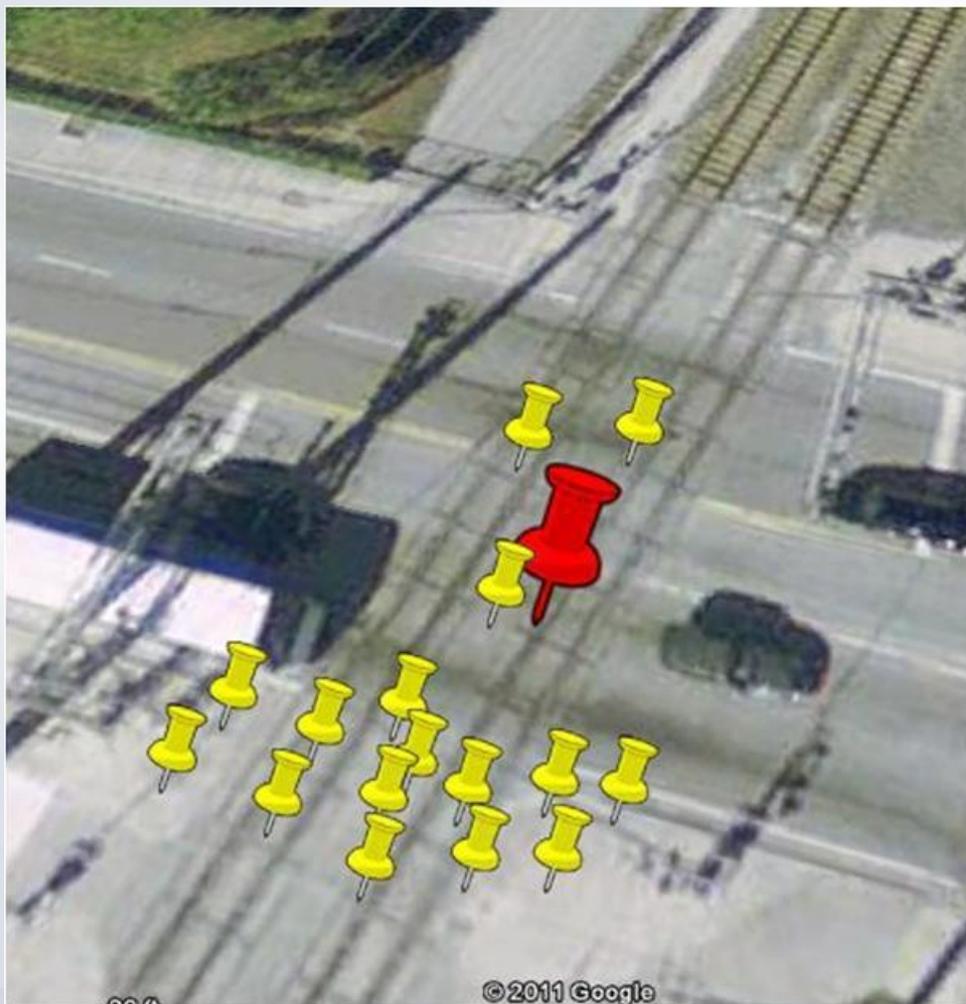
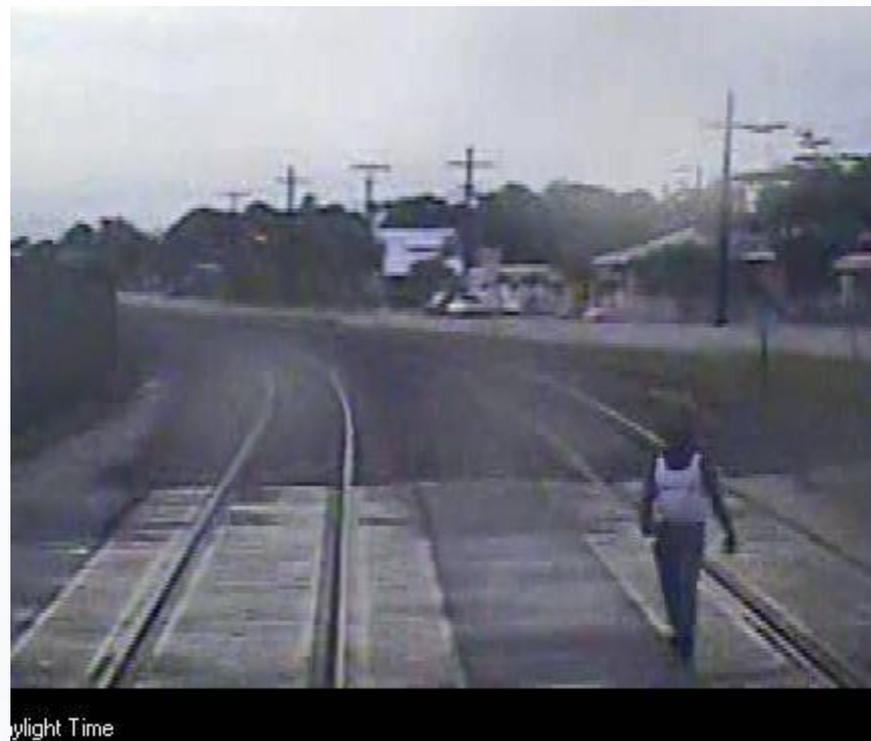
TLSA – Banyan Blvd Crossing

1 fatality

16 trespass events (locomotive video)

Risk Class A (high risk)

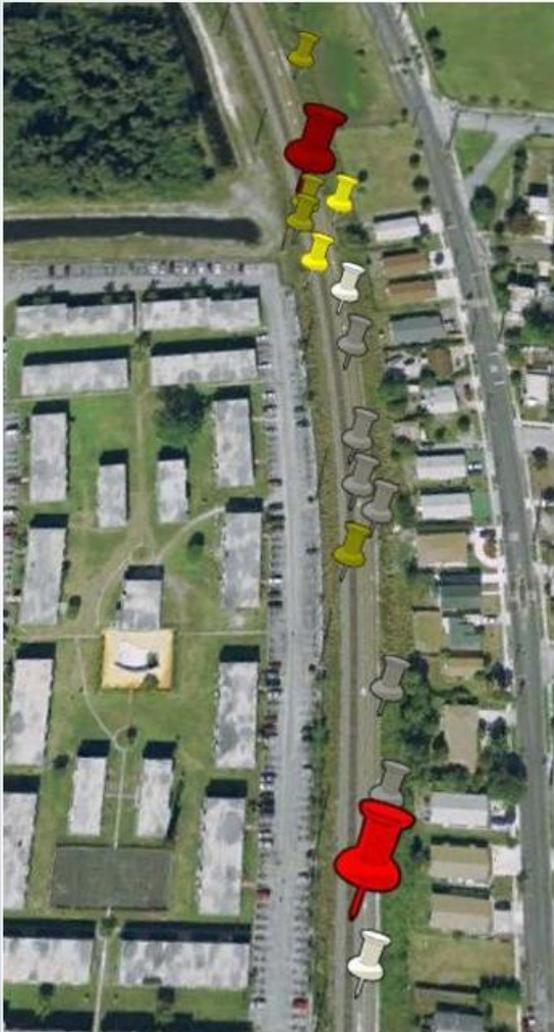
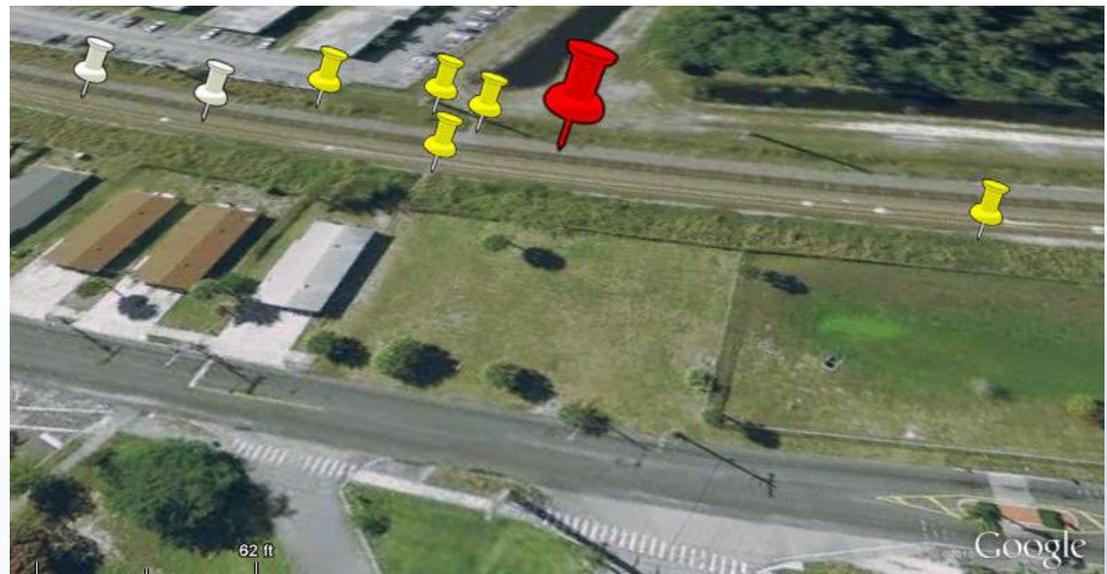
TLSA – ROW between 45th and 36th

2 fatalities

14 trespass events

- 7 within 100 ft of end of canal
- All 7 between 2:14 PM and 6:03 PM
- Northmore Elementary School (and playground) on East side

Risk Class A (high risk)

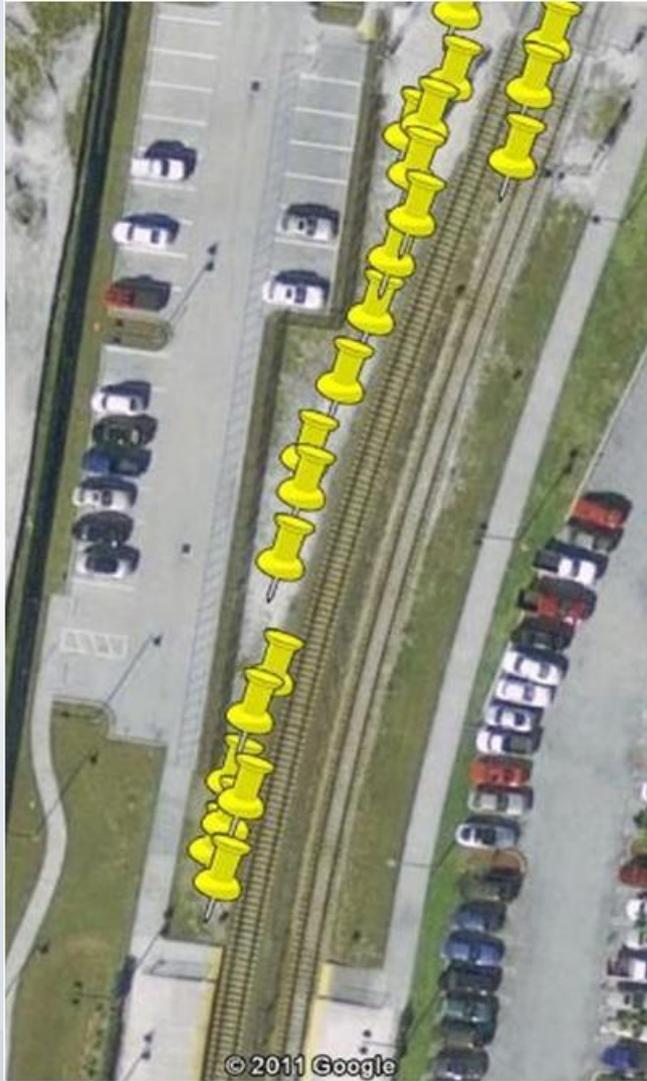
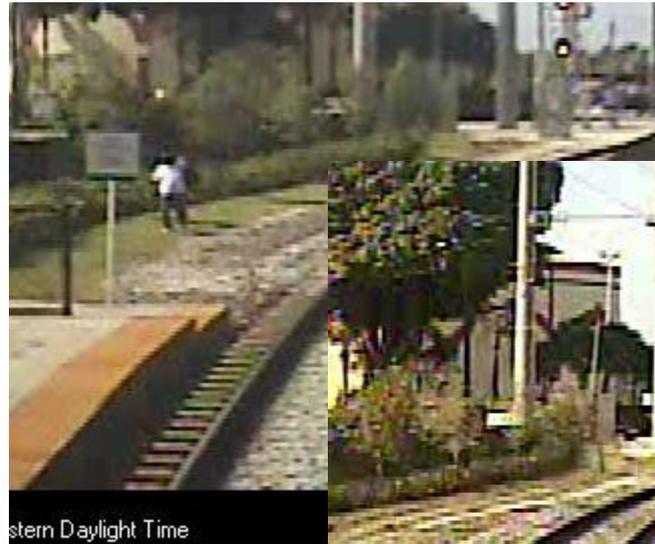
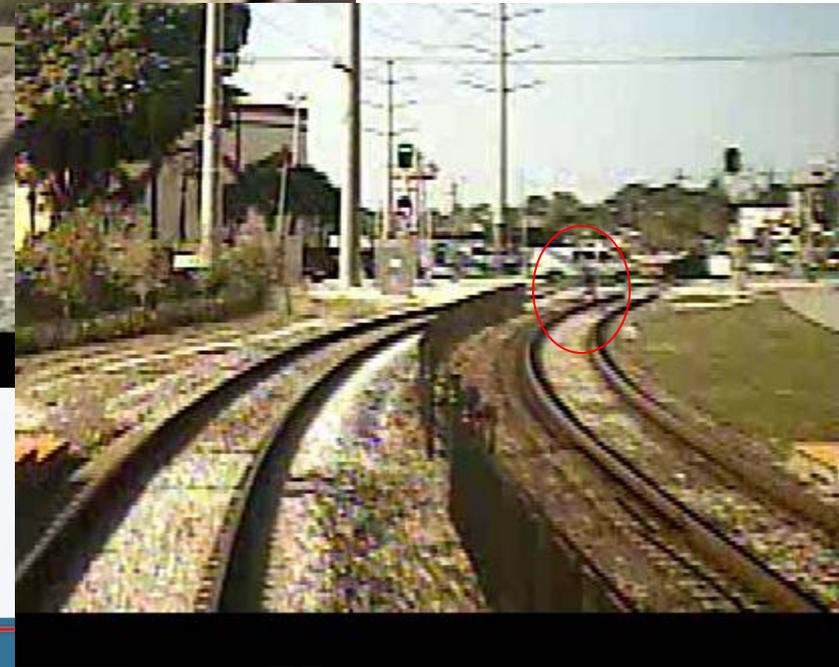
TLSA – ROW between Banyan Blvd and WPB Station

1 attempted suicide (unsure of exact location)
22 trespass events (locomotive video)
Risk Class B (medium risk)

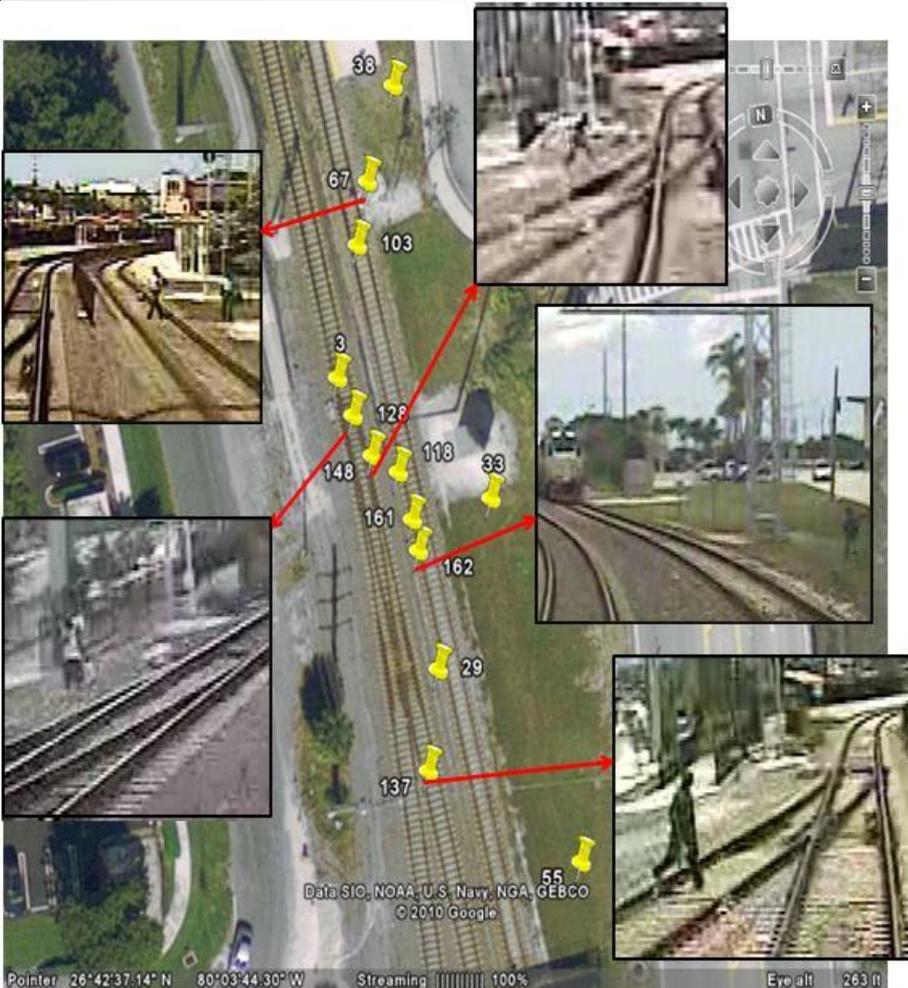
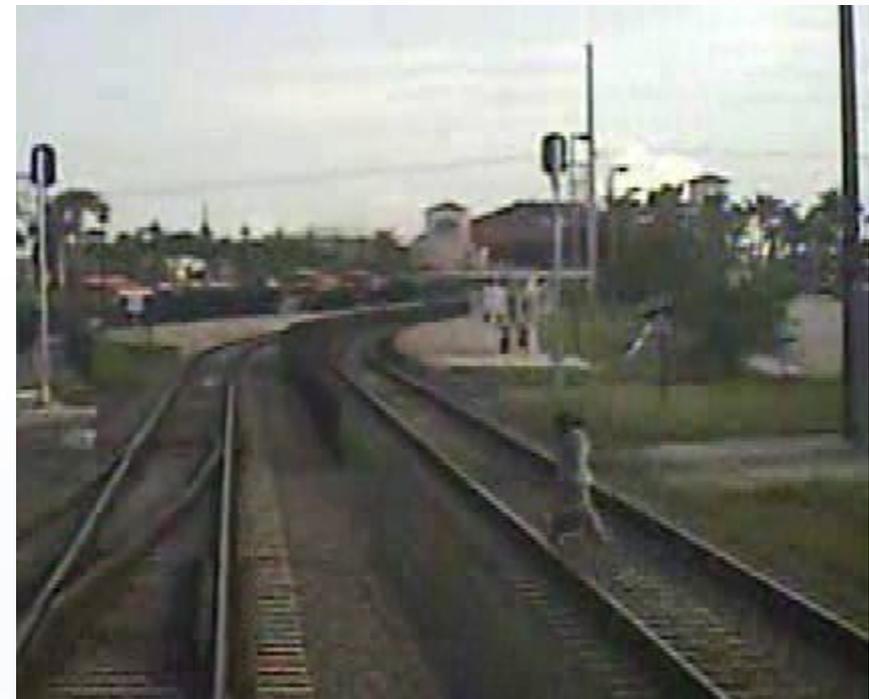
TLSA – CP Mockingbird

13 trespass events (locomotive video)

- All involved trespassers crossing the tracks

Risk Class B (medium risk)
