Testing of New Bridge Rail and Transition Designs

Volume X: Appendix I

42-in (1.07-m) Concrete Parapet Bridge

PUBLICATION NO. FHWA-RD-93-067

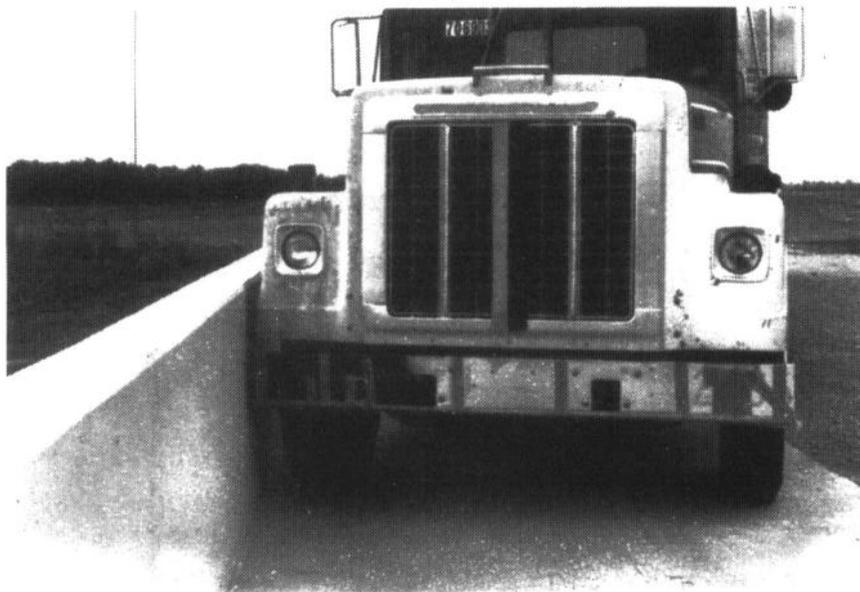
Figure 2. Vehicle/parapet geometrics before test 7069-13.

A 1979 International Transtar 4200 tractor with a 1977 Pullman van-trailer shown in figures 2 and 3 was directed into the 42-in (1.07-m) concrete parapet (figure 4) using a remote control guidance system. Test inertia mass of the vehicle was 27,690 lb (12 571 kg), and its gross static mass was 50,050 lb (22 723 kg). The height to the lower edge of the vehicle bumper was 20.5 in (521 mm), and the distance to the top of the bumper was 30.5 in (775 mm). Other dimensions and information on the test vehicle are given in figures 5 through 7. The vehicle was free-wheeling and unrestrained just prior to impact.

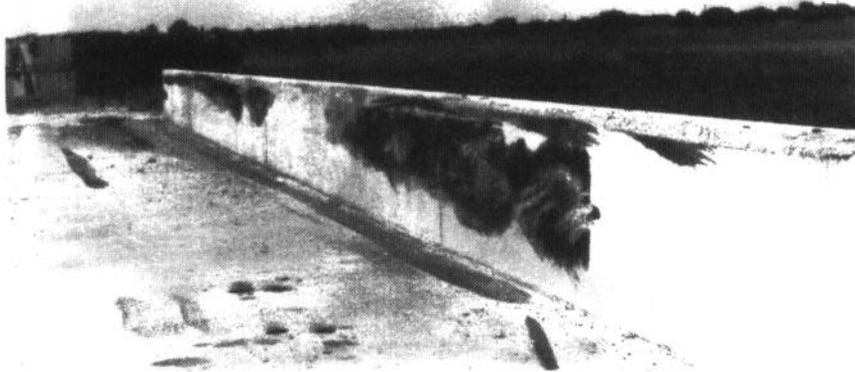
Figure 8. 42-in (1.07-m) concrete parapet after test 7069-13.

The parapet received cosmetic damage and some scraping and gouging. As shown in figure 8, there were tire marks on the parapet from just before the impact point extending a total of 85 ft (26 m) along the face. There was also a piece of the top beam of the parapet chipped off.

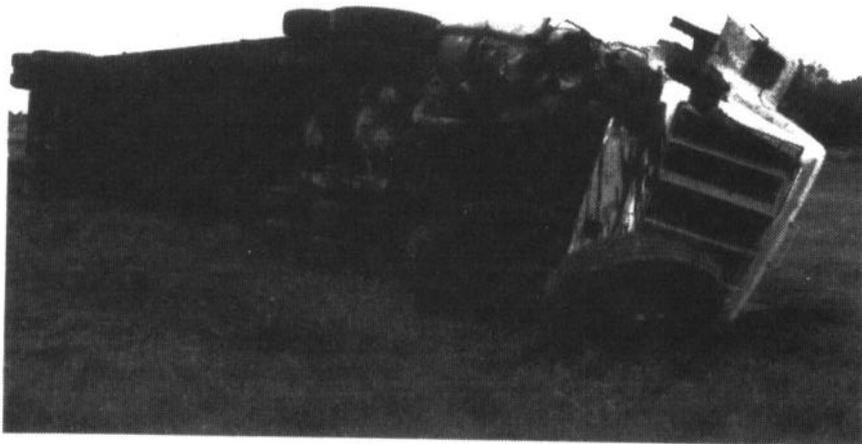
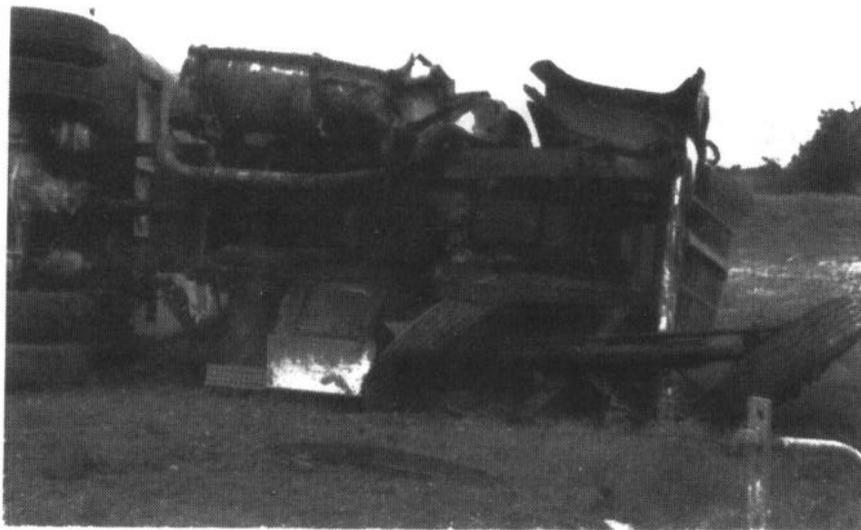
Figure 9. Vehicle after test 7069-13.

The vehicle sustained extensive damage to the right side as shown in figure 9. Maximum crush at the right front corner at bumper height was 18.0 in (457 mm). There was damage to the front axle, Pittman arm, U-bolts, front leaf springs and bolts, front shock mounts, air brake lines, right fuel cell, left rear spring pin and clamp, and exhaust pipe. The cab and left door were bent.

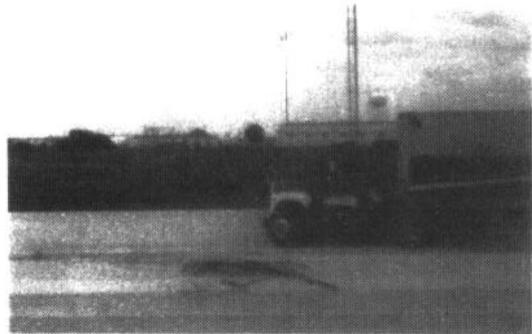
Figure 11. Sequential photographs for test 7069-13.

The speed of the vehicle at impact was 51.4 mi/h (82.7 km/h), and the angle of impact was 16.2 degrees. The vehicle impacted the parapet at 24 ft (7.3 m) from the upstream end. At approximately 0.010 s after impact the right front wheel contacted the parapet, and the left front wheel became airborne at 0.135 s. The right front corner of the trailer contacted the parapet at about 0.178 s. The tractor began to redirect at 0.178 s, and the trailer began to redirect at 0.280 s. The rear wheels of the tractor lost contact with the pavement at 0.285 s, and the left rear wheels of the trailer became airborne at 0.349 s. The left side of the tractor remained airborne until 0.417 s when the left front wheel touched down. The right rear trailer wheels contacted the parapet at about 0.684 s. The vehicle attained maximum roll to the right at about 1.165 s and began to roll left. The vehicle rode against the parapet and off the end. The brakes were applied, and the vehicle came to rest on its left side approximately 181 ft (55 m) downstream from the point of impact.

Sequential photographs of the test are shown in figures 11 and 12. Vehicular angular displacements are displayed in figure 13. Vehicular accelerations versus time traces filtered with SAE J211 filters are presented in figures 14 through 22. These data were further analyzed to obtain 0.050-s average accelerations versus time. The maximum 0.050-s averages at the tractor c.g. were -3.3g (longitudinal) and 3.7g (lateral).
