Low Visibility Operations/Surface Movement Guidance and Control System (LVO/SMGCS) Chart Usability: An Examination of Flightcrew Position Awareness in Homogeneous 300 ft/75 m RVR Conditions

Final Report—September 2014

DOT-VNTSC-FAA-14-14

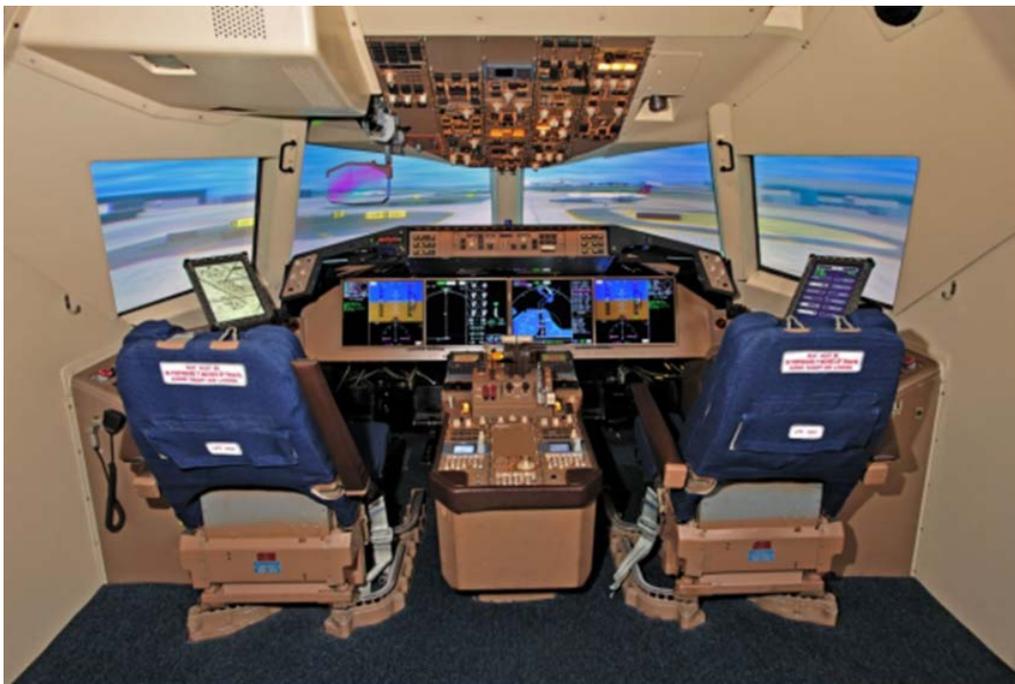
Figure 1. NASA Langley Research Flight Deck (RFD)

The research was conducted in the NASA Langley Research Center Research Flight Deck (RFD) simulator with motion (Figure 1). The full-motion RFD simulated a state-of-the-art NextGen transport aircraft. The flight deck had hydraulic-actuated sidestick controllers for the flight controls. Approaches and landings were conducted using an autoland/autopilot capability, so flightcrew performance would not be affected if flightcrews were not familiar with the use of sidestick controllers. A collimated out-the-window scene was produced by an Evans and Sutherland Image Generator graphics system, providing approximately 200 degrees horizontal by 40 degrees vertical field-of-view at 26 pixels per degree.

The cab was populated with flight instrumentation and pilot controls, including the overhead subsystem panels, to replicate standard aircraft systems. Surface maneuvering was effected through a standard tiller for the PF (left seat). The RFD was configured to mimic the instrument panel of current state-of-the-art aircraft, with four 10.5 inch (26.67 cm) vertical by 13.25 inch (33.66 cm) horizontal, 1280 x 1024 pixel resolution, color displays tiled across the instrument panel. Also, the RFD included a Mode Control Panel (MCP), Flight Management System (FMS), and Control Display Units (CDU). The simulator was also equipped with an Electronic Flight Bag (EFB), auxiliary displays above and on either side of the glareshield, and a HUD (as shown below in Figure 1), but these were not powered on or used during the studies. Unlike a real flight deck, the RFD did not have a designated area for the flightcrew to place their charts which possibly prohibited flightcrews from easily taking notes and recording ATC clearances.

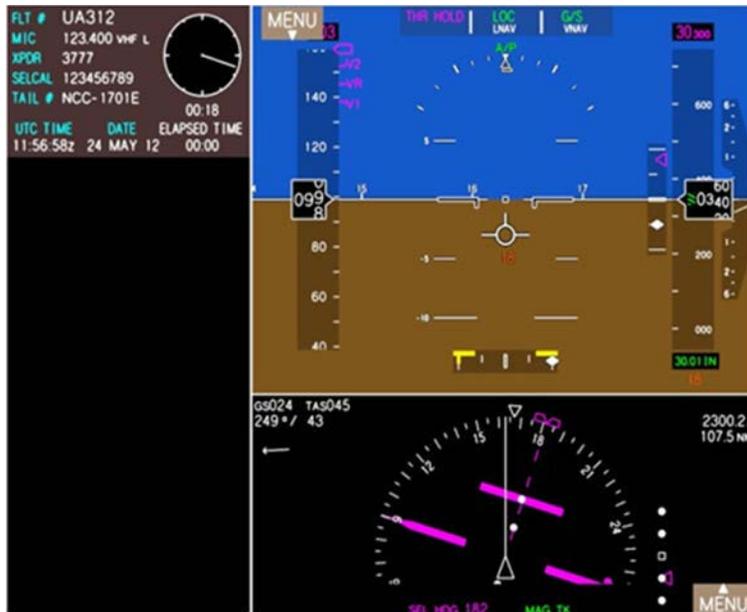
Figure 2. Pilot Flying (PF) Primary Flight Display (PFD)

Four large form-factor panel displays presented traditional glass displays heads-down; from left to right on the flight deck, these displays were the PF primary flight display (PFD; Figure 2), the PF navigation display (ND) with Engine Indication and Crew Alerting System (EICAS; Figure 3), the PM ND (Figure 4), and the PM PFD (Figure 5). Each panel display (10.5 inch/26.67 cm vertical x 13.25 inch/33.66 cm horizontal), when viewed from 25 inches (63.5 cm), subtended an angular area of 24 degrees (vertical) by 30 degrees (horizontal). The flight deck also included overhead panels, MCP, FMS, and CDU.

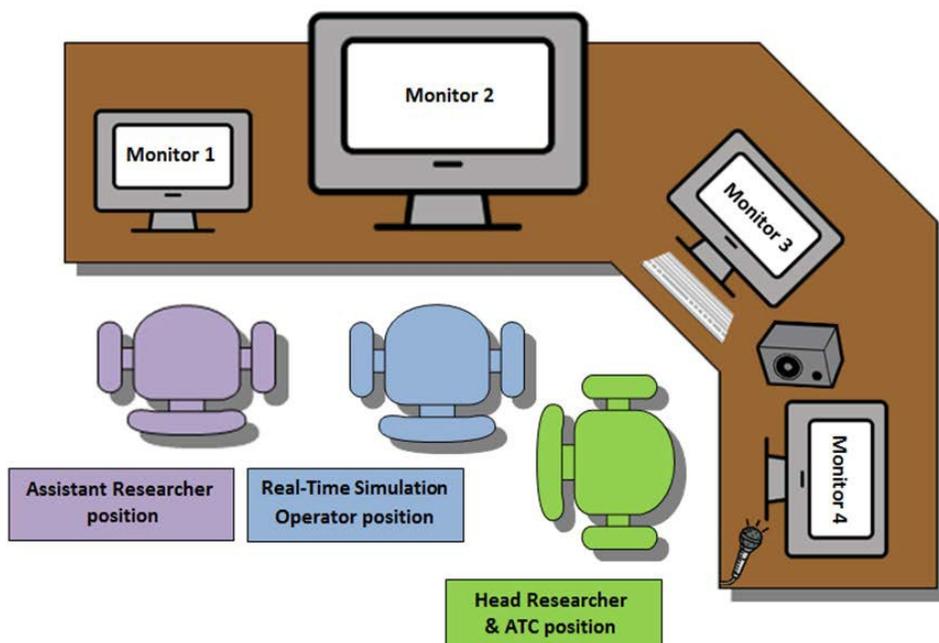
Figure 6. Control Room Layout

NASA Langley and the Volpe Center researchers monitored the research studies from a control room, which was remotely located from the simulator. Activities included loading the research scenarios and providing live ATC communications as needed (e.g., when pilots deviated from the scripted scenarios). The layout of the control room is depicted in Figure 6.

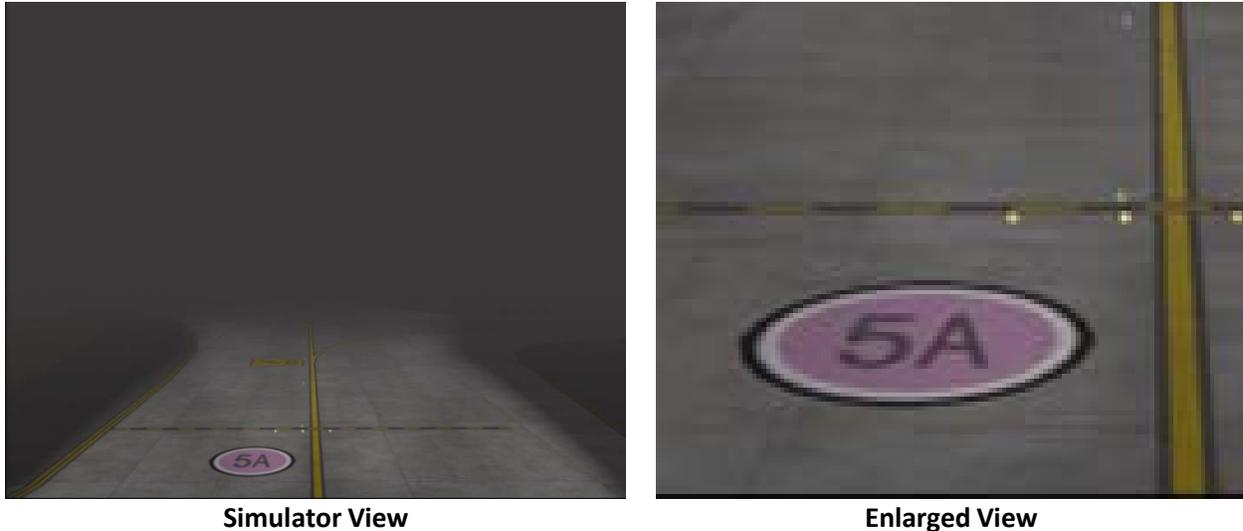
Figure 8. Example of an "Enhanced" Geographic Position Marking (GPM)

The image on the left shows a flightcrew’s out-the-window view of an “enhanced” geographic position marking (GPM) from the simulator at night in homogeneous RVR 300 ft/75 m conditions. The image on the right shows an enlarged view of the same “enhanced” GPM.

- Enhancements to GPM size and shape were examined by observing flightcrew actions during a scenario which showed “enhanced” GPMs out-the-window and comparing those flightcrew actions to a scenario that showed “traditional” GPMs. An example of an “enhanced” GPM is shown in Figure 8. “Enhanced” GPMs were larger than standard GPMs (18 x 12.5 ft/5.49 x 3.81 m) and were oval; compared to standard 9-ft (2.74 m) circular GPMs. Note that the depiction of GPMs on the charts was not changed to reflect the size and shape of the “enhanced” GPMs.

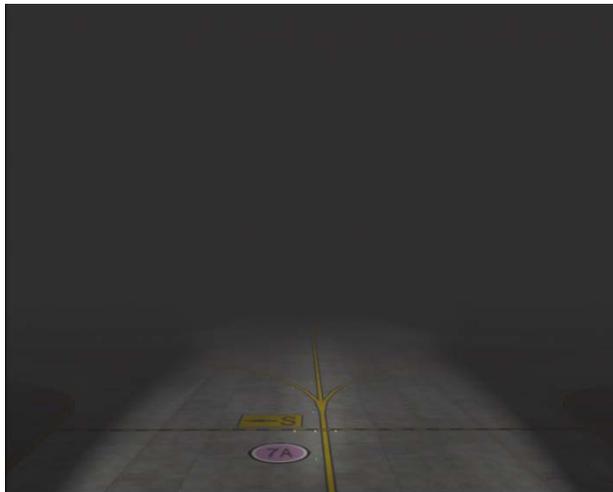
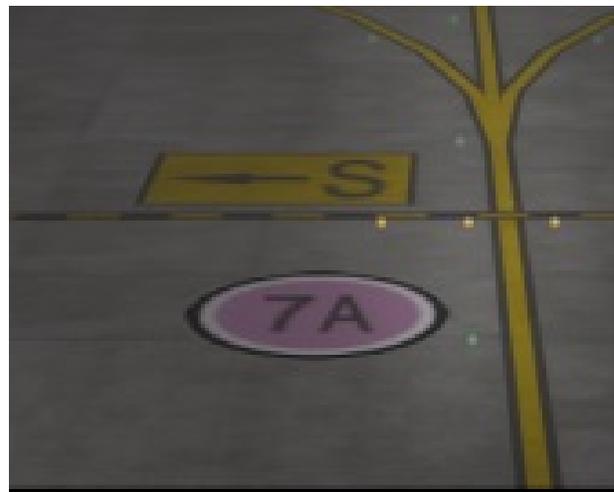
The image on the left shows a flightcrew's out-the-window view of an "enhanced" taxiway marking from the simulator at night in homogeneous RVR 300 ft/75 m conditions. The image on the right shows an enlarged view of the same "enhanced" taxiway marking.

- The depiction of surface-painted taxiway identifiers was examined by observing flightcrew actions during a scenario which supplemented taxiway signs with “enhanced” taxiway identifiers on the airport surface. An example of an “enhanced” taxiway identifier is shown in Figure 9. The “enhanced” taxiway identifiers were depicted as a yellow box encompassing the taxiway identifier and an arrow pointing in the direction of the taxiway. Note that the depiction of taxiway identifiers was not changed on the charts; that is, the charts depicted standard taxiway identifiers, not “enhanced” taxiway identifiers.

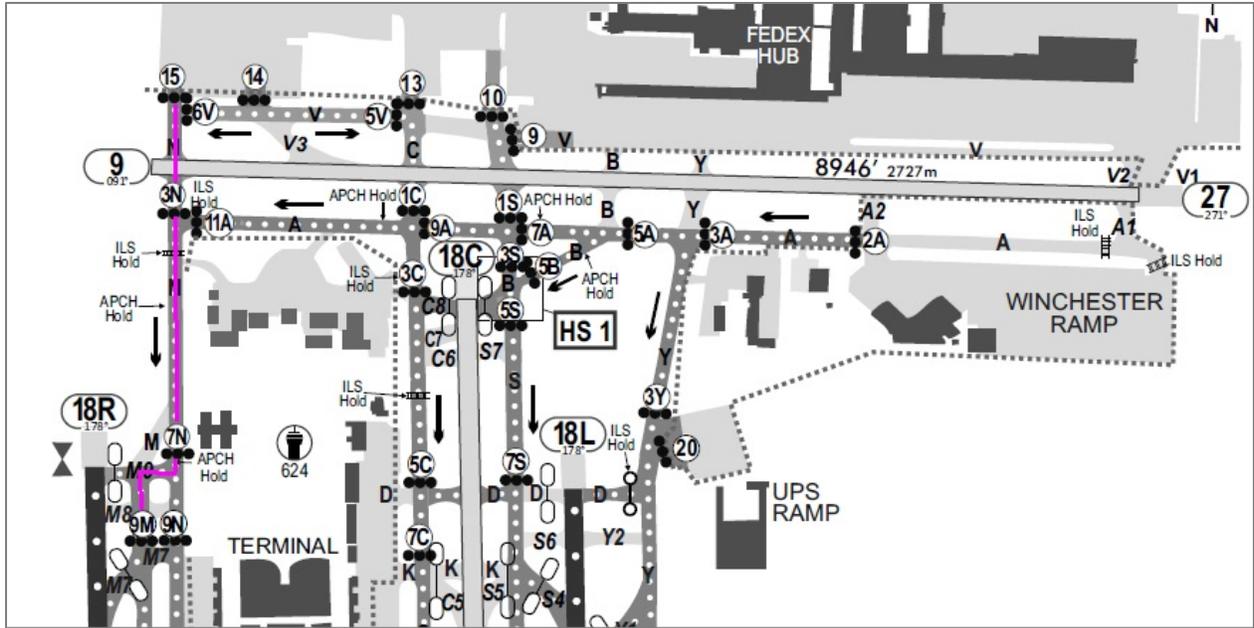
Figure 11. Planned Route for Scenario 2

Scenario 2 was a departure scenario, as depicted in Figure 11. The ATC instructions provided during the second portion of this scenario were deliberately created to use similar-sounding GPM and taxiway names to examine the effect of this similarity on flightcrews' position awareness. Additionally, the taxi route used for this scenario took flightcrews through an ILS hold line and an approach hold to examine flightcrews' knowledge of procedures for ILS hold lines and approach holds in LVO/SMGCS conditions. The scenario began at GPM 15 (FedEx Ramp) and ended at GPM 9M. The taxi clearance (not ATC clearance protocol compliant) provided to the flightcrew was "*taxi to runway 36 Left via November, Mike 9, Mike; hold short spot 7 November; report passing taxiway Alpha; you're cleared to cross runway 9.*" This clearance should have been given in two parts to be fully compliant.

The average taxi speed throughout this scenario was 8.37 kt ($SD = 1.18$) and the average total taxi time was 6 minutes 10 seconds.

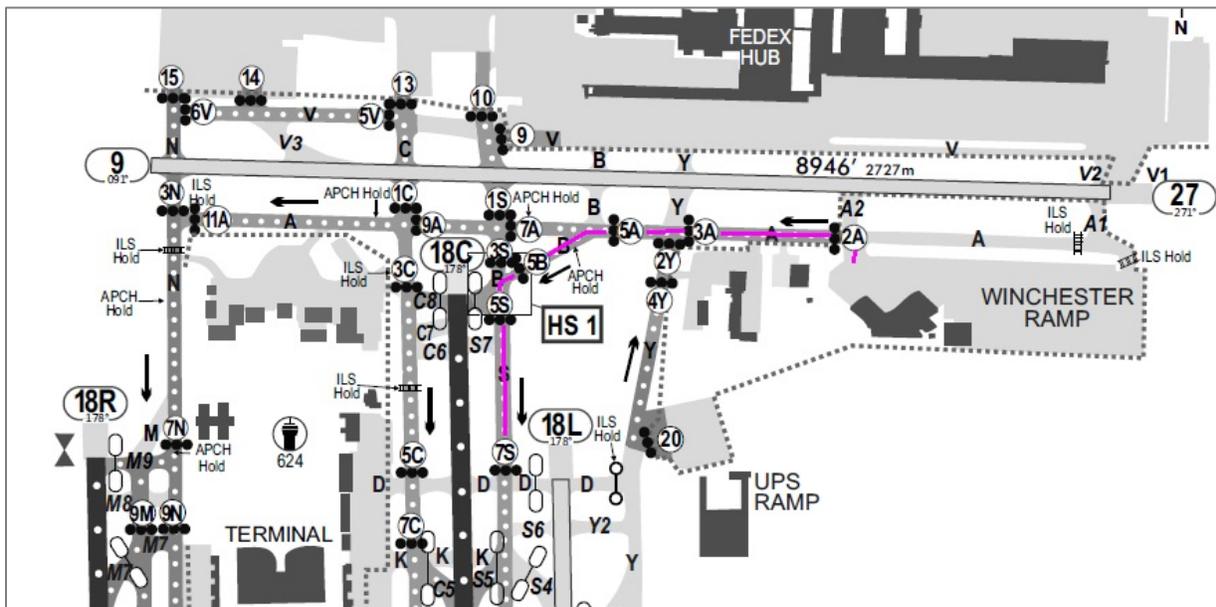
Figure 12. Planned Route for Scenario 3

Scenario 3 was a departure scenario, as depicted in Figure 12. This scenario was designed to examine flightcrews’ use of the detailed hot spot pages provided with the FAA prototype LVO/SMGCS chart (see Appendix B). The scenario began at the Winchester Ramp and ended at taxiway S7 on taxiway Sierra. The taxi clearance provided to the flightcrew was “taxi to runway 36 Center via Alpha, Bravo, Sierra, Romeo; call passing taxiway Yankee.” This clearance is compliant with ATC clearance protocols.

The average taxi speed throughout this scenario was 6.68 kt ($SD = 1.16$) and the average total taxi time was 6 minutes 37 seconds.

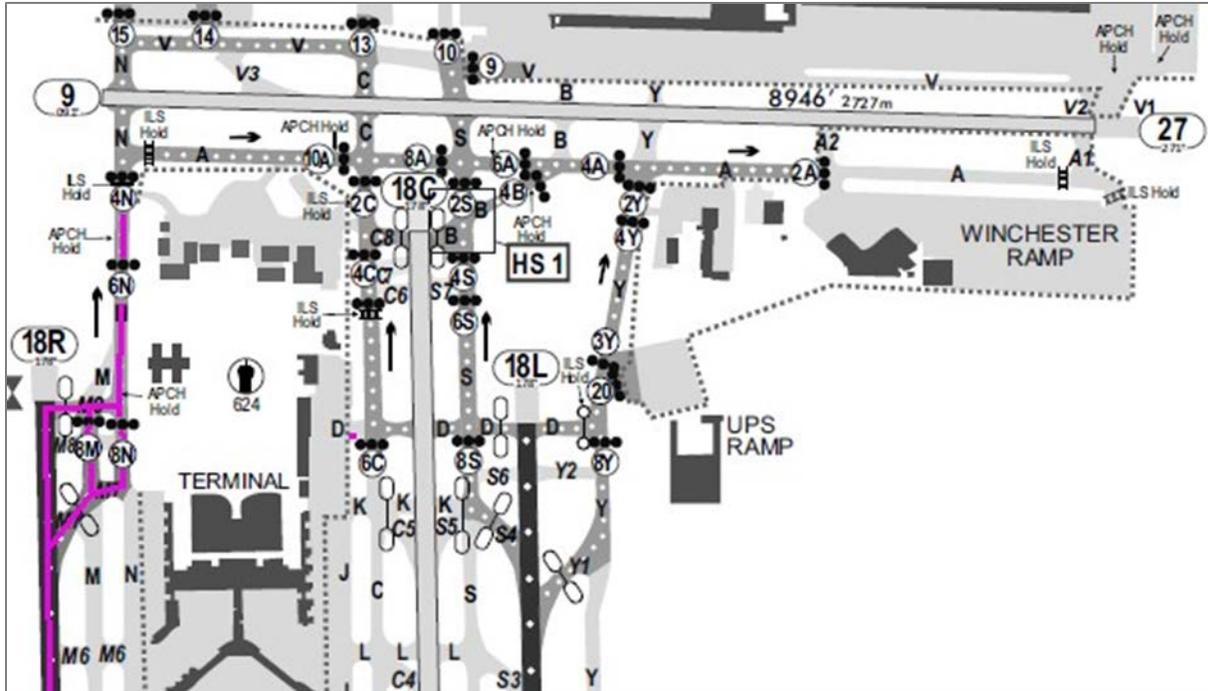
Figure 13. Planned Route for Scenario 4

Scenario 4 was an arrival scenario, as depicted in Figure 13. The scenario started 1,000 ft (304.8 m) HAT and ended at GPM 4N. The landing clearance provided to the flightcrew was "*cleared to land runway 36 Left; call ground and hold at the first GPM after clearing the runway for further clearance.*" This clearance was not compliant with ATC clearance protocols, and was designed so that the FAA could examine how flightcrews operated in landing conditions where multiple runway exits were possible if not specified by ATC. In actual practice ATC would have told flightcrews which taxiway to exit 36L on, or to exit at the runway end.

The average taxi speed throughout this scenario 8.38 kt ($SD = 2.12$) and the average total taxi time was 4 minutes 41 seconds.

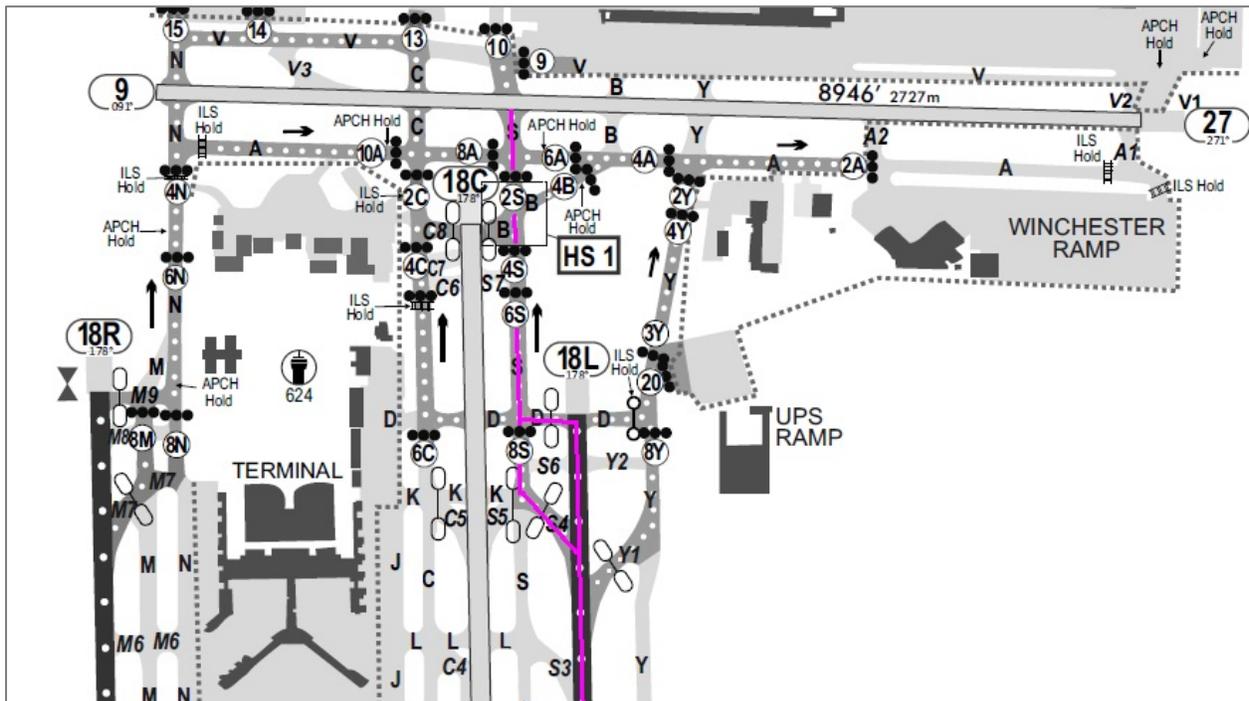
Figure 15. Planned Route for Scenario 6

Scenario 6 was an arrival scenario, as depicted in Figure 15. The scenario started 1,000 ft (304.8 m) HAT and ended at runway 9/27. The landing clearance provided to the flightcrew was "cleared to land runway 36 Right, exit to the west; hold at and report first GPM on Sierra." To be properly ATC clearance protocol compliant this clearance should have included specific instructions on which taxiway the crew was to use exiting the runway, or to taxi off at the runway end.

The average taxi speed throughout this scenario was 9.97 kt ($SD = 1.00$) and the average total taxi time was 4 minutes 12 seconds.

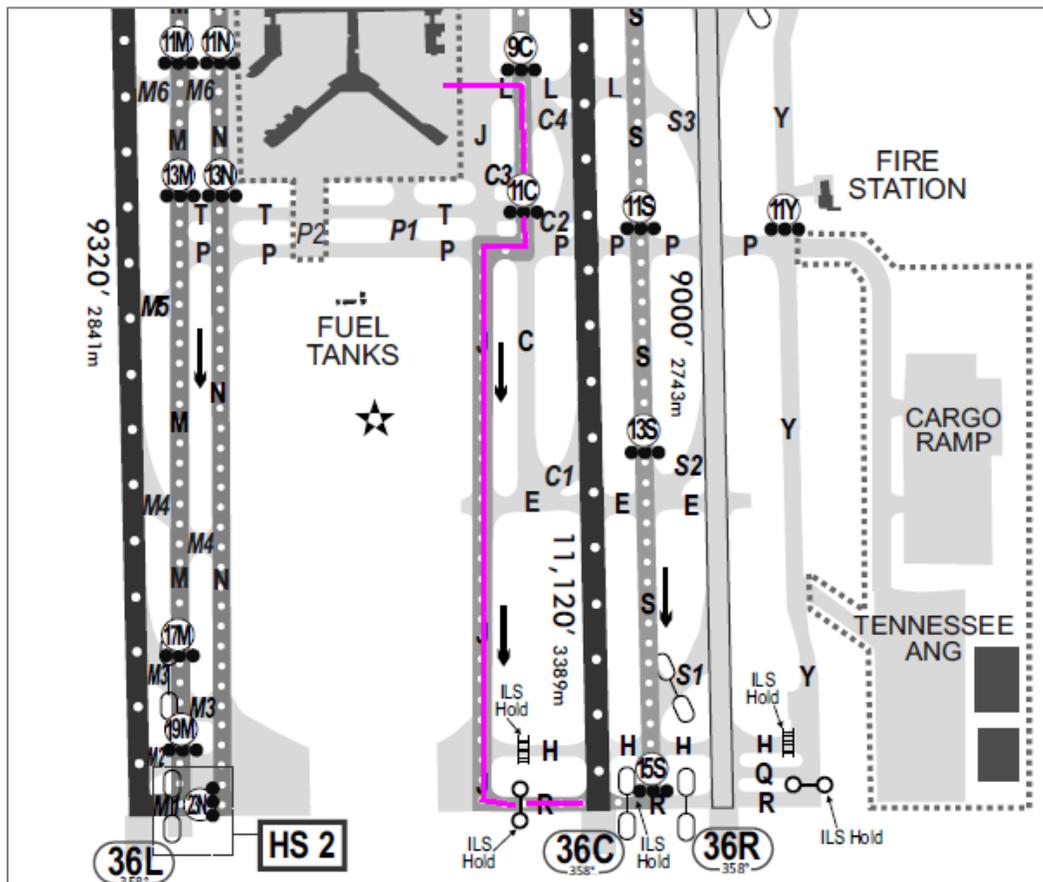
Figure 16. Planned Route for Scenario 7

Scenario 7 was a departure scenario, as depicted in Figure 16. This scenario was designed to gather data on how pilots taxi when no GPMs are depicted. Note that the scenario route contained no GPMs for 5,000 ft (1,524 m) of taxiway.

The scenario began on the Terminal Ramp and ended at runway 36C. The taxi clearance provided to the flightcrew was “taxi to Runway 36 Center via Lima, Charlie, Papa, Juliet, Romeo.” This clearance was given in compliance with ATC clearance protocols.

The average taxi speed throughout this scenario was 10.91 kt ($SD = 2.18$) and the average total taxi time was 6 minutes 11 seconds. On average, PFs spent 72% ($SD = 17$) of their time heads-up (out-the-window) during this scenario, and PMs spent 62% ($SD = 16$) of their time heads-up.

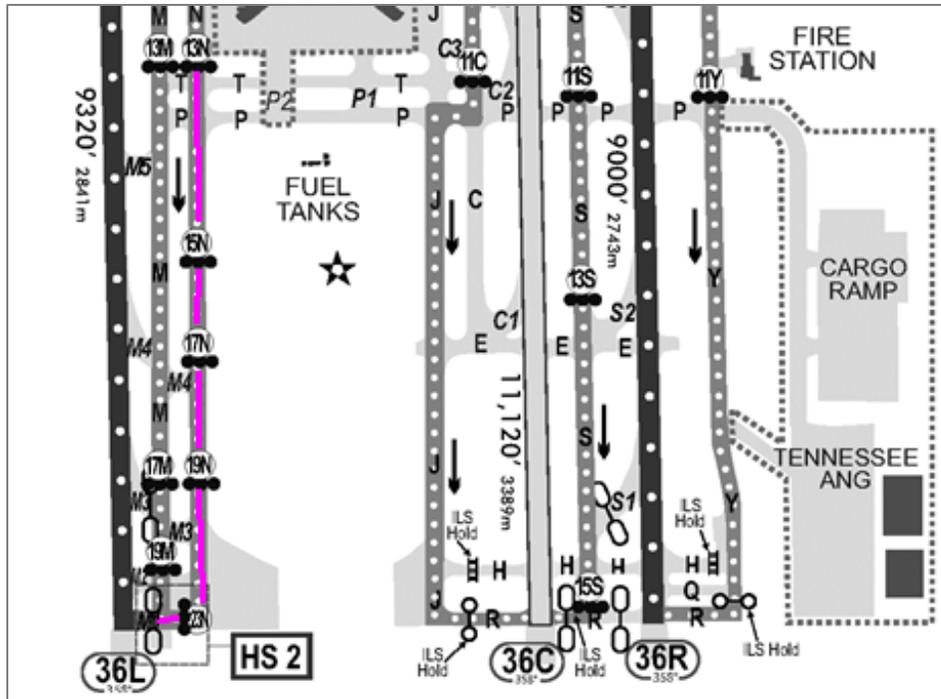
Figure 17. Planned Route for Scenario 8

Scenario 8 was a departure scenario, as depicted in Figure 17. This scenario was designed to look at the effects of GPM spacing. Three GPMs were added along the route—15N, 17N, and 19N—and to the chart. However, the first two flightcrews did not have the charts depicting the extra GPMs so their data were not included, resulting in data for only ten flightcrews.

The scenario began at GPM 13N and ended at runway 36L. The taxi clearance provided to the flightcrew was "*continue taxi to runway 36 Left.*" This clearance was given in compliance with ATC clearance protocols.

The average taxi speed throughout this scenario was 11.53 kt ($SD = 1.58$), and the average total taxi time was 5 minutes 8 seconds. On average, PFs spent 75% ($SD = 10$) of their time heads-up during this scenario, and PMs spent 58% ($SD = 16$) of their time heads-up.

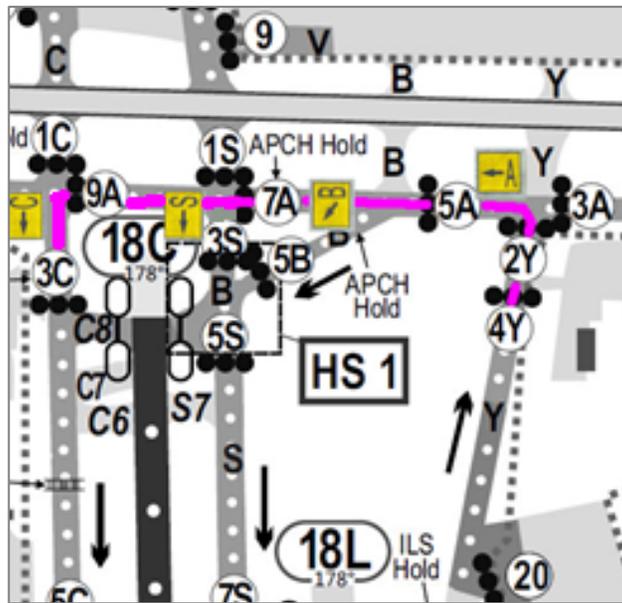
Scenario 9 was a departure scenario, as depicted in Figure 18. This scenario was designed to look at the effects of “enhanced” GPMs and “enhanced” taxiway identifiers added as additional ground markings. Compared to standard GPMs, the “enhanced” GPMs (see Figure 8) were designed to be larger in size and were oval instead of circular. In this scenario, enhanced GPMs replaced standard GPMs on the simulated airport surface, but no changes were made to the symbol shapes on the chart. The “enhanced” taxiway ground marking identifiers (see Figure 9) were pavement markings shown as yellow rectangles drawn around the taxiway identifier, with an arrow pointing in the direction of the taxiway. These additional “enhanced” taxiway ground marking identifiers were shown on the simulated airport surface—in addition to the standard taxiway signs—at the intersections of all taxiways in the scenario (taxiways A, B, S, and C). The locations of the enhanced taxiway identifiers are shown in Figure 18, but note that they were not depicted on the chart flightcrews used for this scenario.

Scenario 9 started at GPM 4Y on the UPS Ramp and ended at GPM 3C. The taxi clearance provided to the flightcrew was “*taxi to runway 36 Center via Yankee, Alpha, Charlie, Papa, Juliet, Romeo; hold at and report spot 3 Charlie.*” The clearance should have been provided in two parts to be ATC clearance protocol compliant.

1) The four “enhanced” taxiway signs were painted on Yankee; proceeding up Yankee, the Alpha taxiway marking with left pointing arrow was on Yankee taxiway left of the centerline just prior to where the centerline directed the left turn onto Alpha. All the other airport markings were done according to the same protocol.

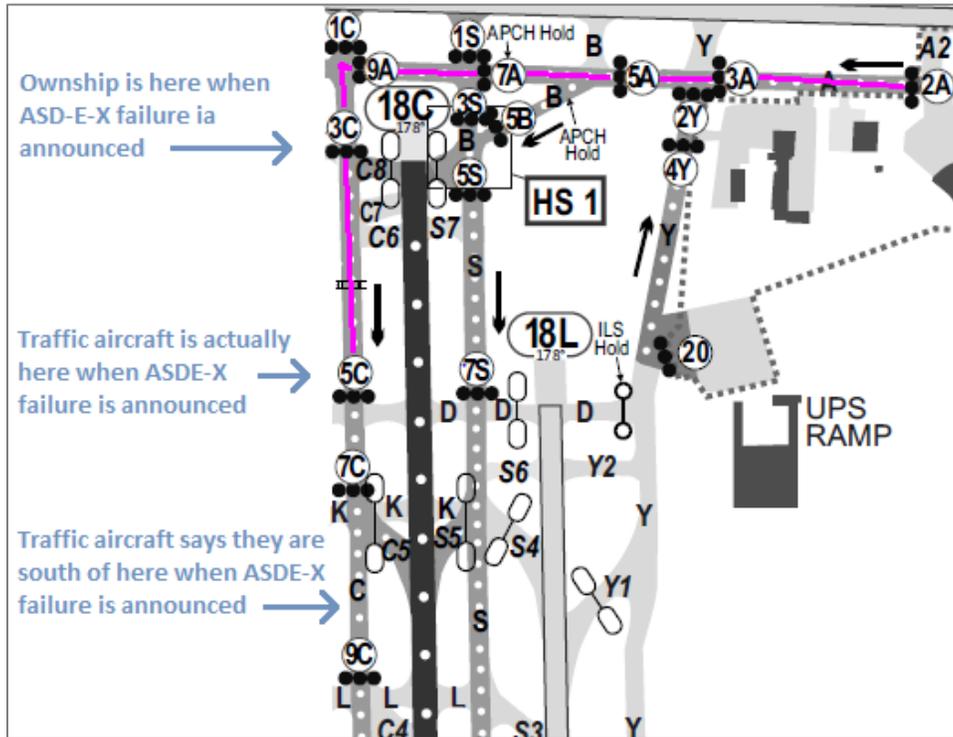
Figure 19. Planned Route for Scenario 10

The scenario began with the ownship aircraft holding at GPM 2A on taxiway A and the traffic aircraft also on taxiway A but ahead of ownship aircraft, west of GPM 2A. ATC cleared the traffic aircraft to “*taxi to*

runway 36 Center via Alpha, Charlie, Papa, Juliet, Romeo." One minute later, ATC gave the same clearance to the ownship aircraft, adding that they should "hold at spot 3 Charlie."

The average taxi speed between the start of this scenario and GPM 3C where the ASDE-X failure occurred was 11.84 kt ($SD = 1.66$). Flightcrews took an average total of 3 minutes 57 seconds to taxi to GPM 3C. After flightcrews were cleared to continue taxiing following the ASDE-X failure, seven flightcrews continued taxiing (five flightcrews held to check on the traffic aircraft location). The seven flightcrews who continued to taxi did so at an average speed of 5.87 kt ($SD = 2.11$). On average, PFs spent 77% ($SD = 16$) of their time heads-up during this scenario, and PMs spent 63% ($SD = 19$) of their time heads-up.
