Transit Vehicle-to-Infrastructure (V2I) Applications: Near Term Research and Development

Transit Bus-Pedestrian/Cyclist Crossing
Safety Application: Operational Concept

Final Report — June 2014

Publication Number: FHWA-JPO-14-129

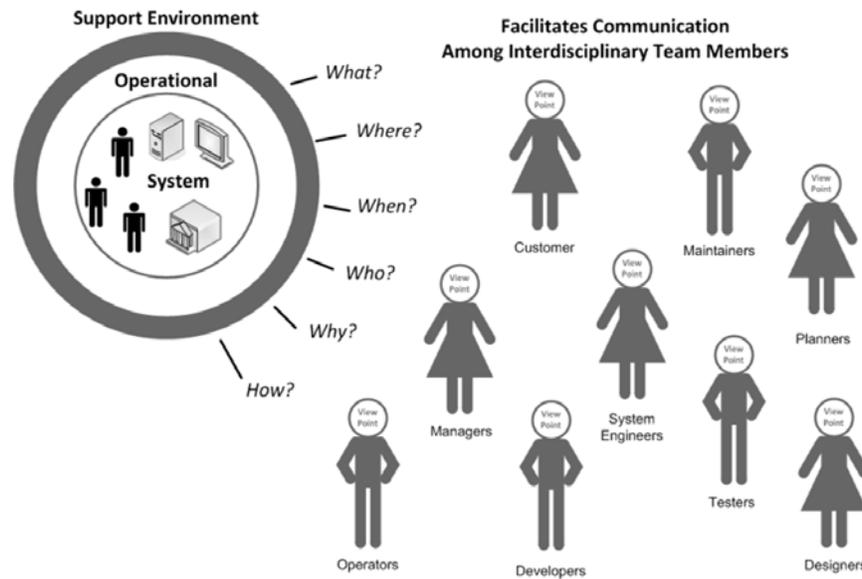
Figure 1-1: Conceptual Representation of the Operational Concept Document (Source: USDOT, adapted from ANSI/AIAA's "Guide for the Preparation of Operational Concept Documents" ANSI/AIAA G-043-1992)

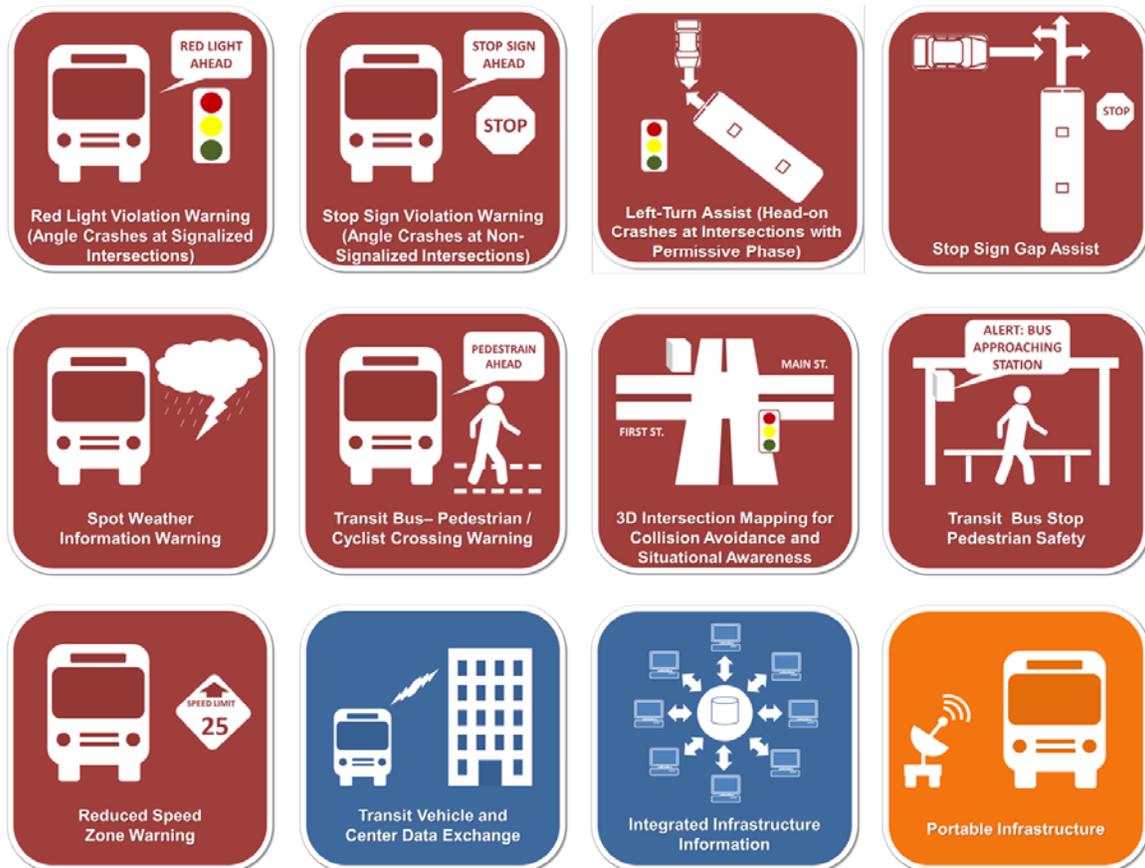
Figure 2-1: Transit V2I Applications (Source: USDOT, 2014).

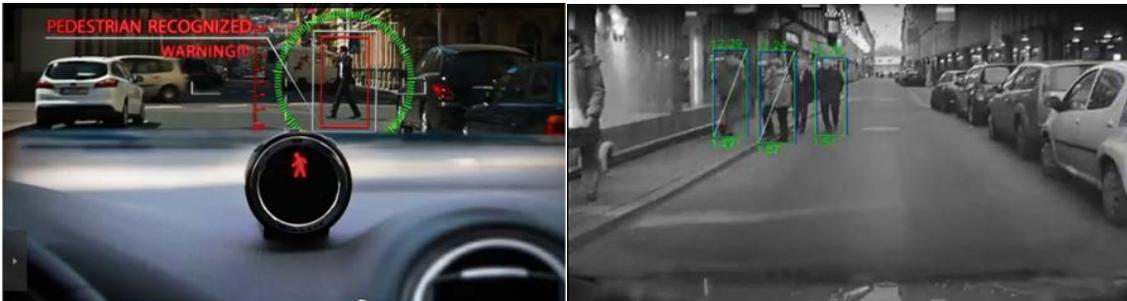
Both static and moving pedestrians can be detected to a range of around 30 meters using Video Graphics Array (VGA) resolution imagers. As higher resolution imagers become available range will scale with imager resolution, making detection ranges of up to 60 meters feasible. Mobileye’s first production for Pedestrian detection systems was in 2009 on a range of industrial powered vehicles where 8 EyeQ2 based monocular cameras provide a 360 degree all-round pedestrian detection system to a range of 15 meters and will warn the vehicle operator via Audio/Visual warnings of pedestrian in the vehicles path. The Mobileye system has been installed on 150 transit buses in Israel.⁶

Figure 3-1: Mobileye's Pedestrian Detection System (Source: Mobileye)⁶

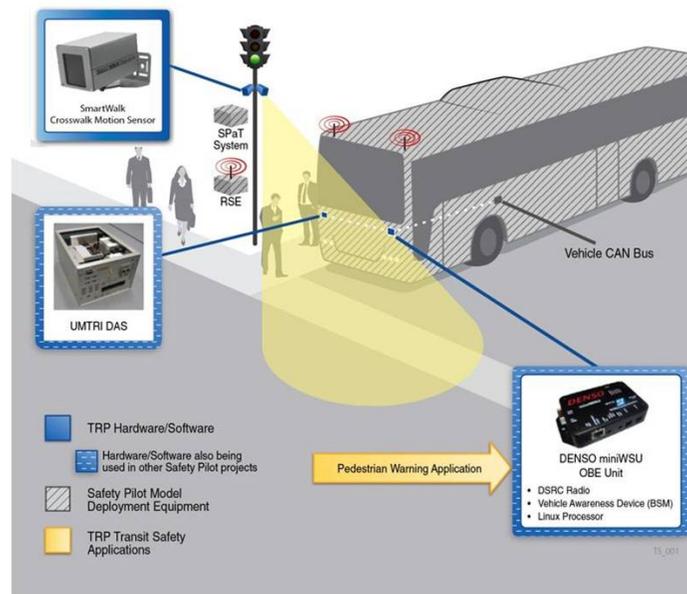
PDS have also been designed for infrastructure. These systems are primarily used as a mechanism to supplement or replace pedestrian calls to the traffic signal controller as initiated via a push button located near the intersection⁷. These Pedestrian Detection systems use infrared, microwave or video detection systems, as well as pressure-sensitive mats, to activate a call. The need for these additional technologies emerged as approaches to better accommodate mobility-impaired pedestrians were identified. These same technologies also help improve the intersection safety for pedestrians who choose not to use the existing call buttons. A microwave Doppler pedestrian detector was recently used as part of the Transit Retrofit Package (TRP) for the USDOT's Connected Vehicle Safety Pilot. The SmartWalk™ XP sensor was used to detect the presence of a pedestrian in the crosswalk, as depicted in Figure 3-2.

Figure 3-2: Illustration of the Pedestrian Warning Application from the TRP with All Hardware Components (Source: *Transit Retrofit Package ConOps*, 2012)

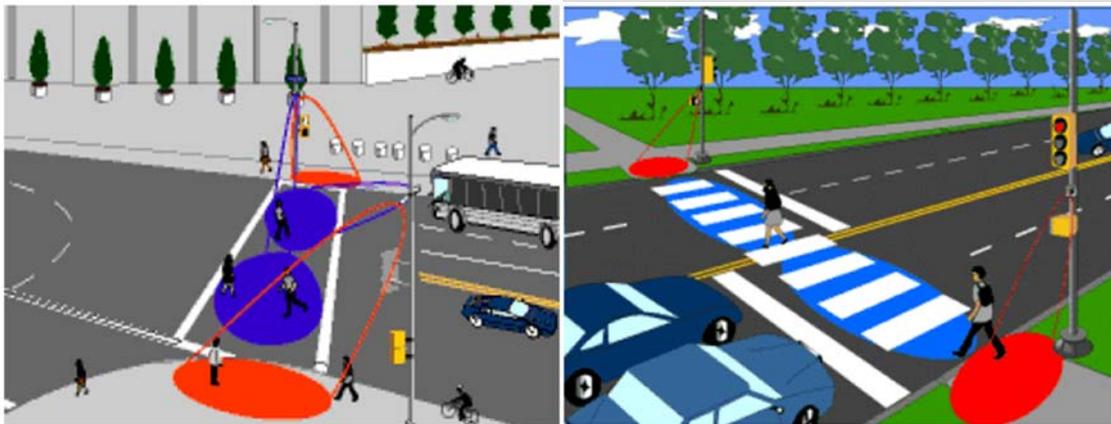
Regardless of type of APD technologies used, the targeted zones for pedestrian detection near crosswalks generally fall into two categories: detection zones on/near sidewalks/curbs, and detection zones within crosswalks, as shown in Figure 3-3.

Figure 3-3: Placement of Automated Pedestrian Detection Devices and Detection Zones at Intersection and Mid-block Crosswalk Locations (Source: FHWA, 2006¹³)

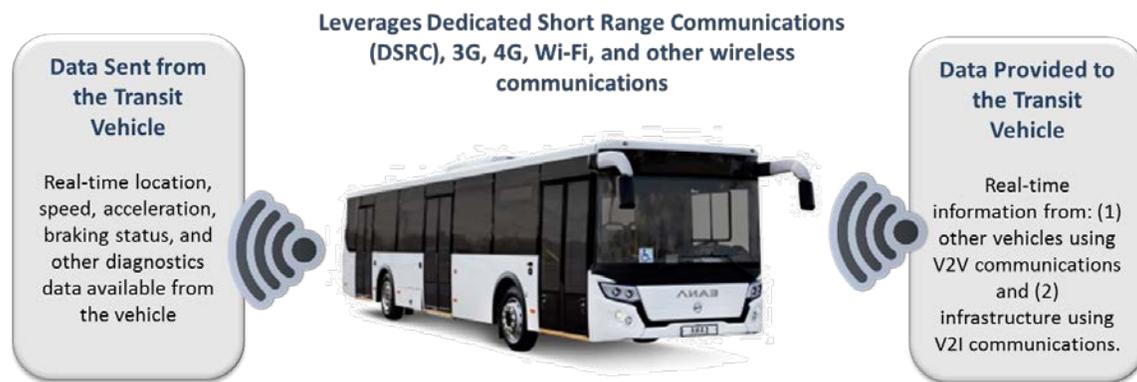
Connected vehicle technologies offer tremendous promise for safety improvements. Connected vehicle technologies function using a V2V and V2I data communications platform that, like the Internet, supports numerous applications, both public and private. This wireless communications platform provides the foundation to integrate data from the infrastructure (e.g., traffic signals) with data from the vehicle (e.g., position, speed, brake status). For this particular transit safety application, V2I communications offer an environment rich in vehicle and infrastructure data that can be used by applications residing in the motor bus to provide drivers with alerts to avoid collisions with pedestrians and cyclists in a crossing at intersection or mid-block locations.

Figure 4-1. A Connected Transit Vehicle (Source: USDOT, 2014)

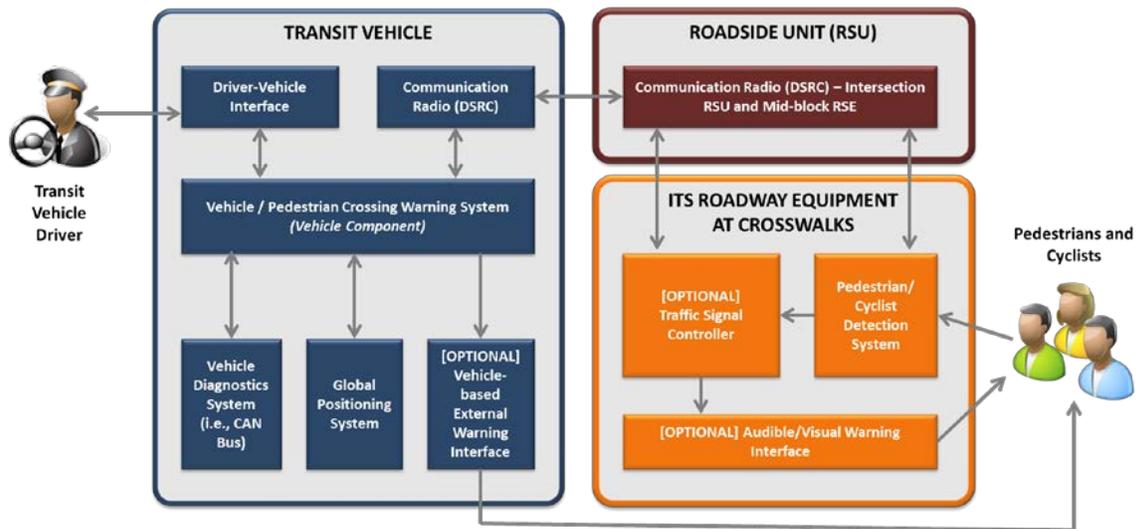
Figure 5-1: Transit Bus-Pedestrian/Cyclist Crossing Safety Application (Source: USDOT, 2014)

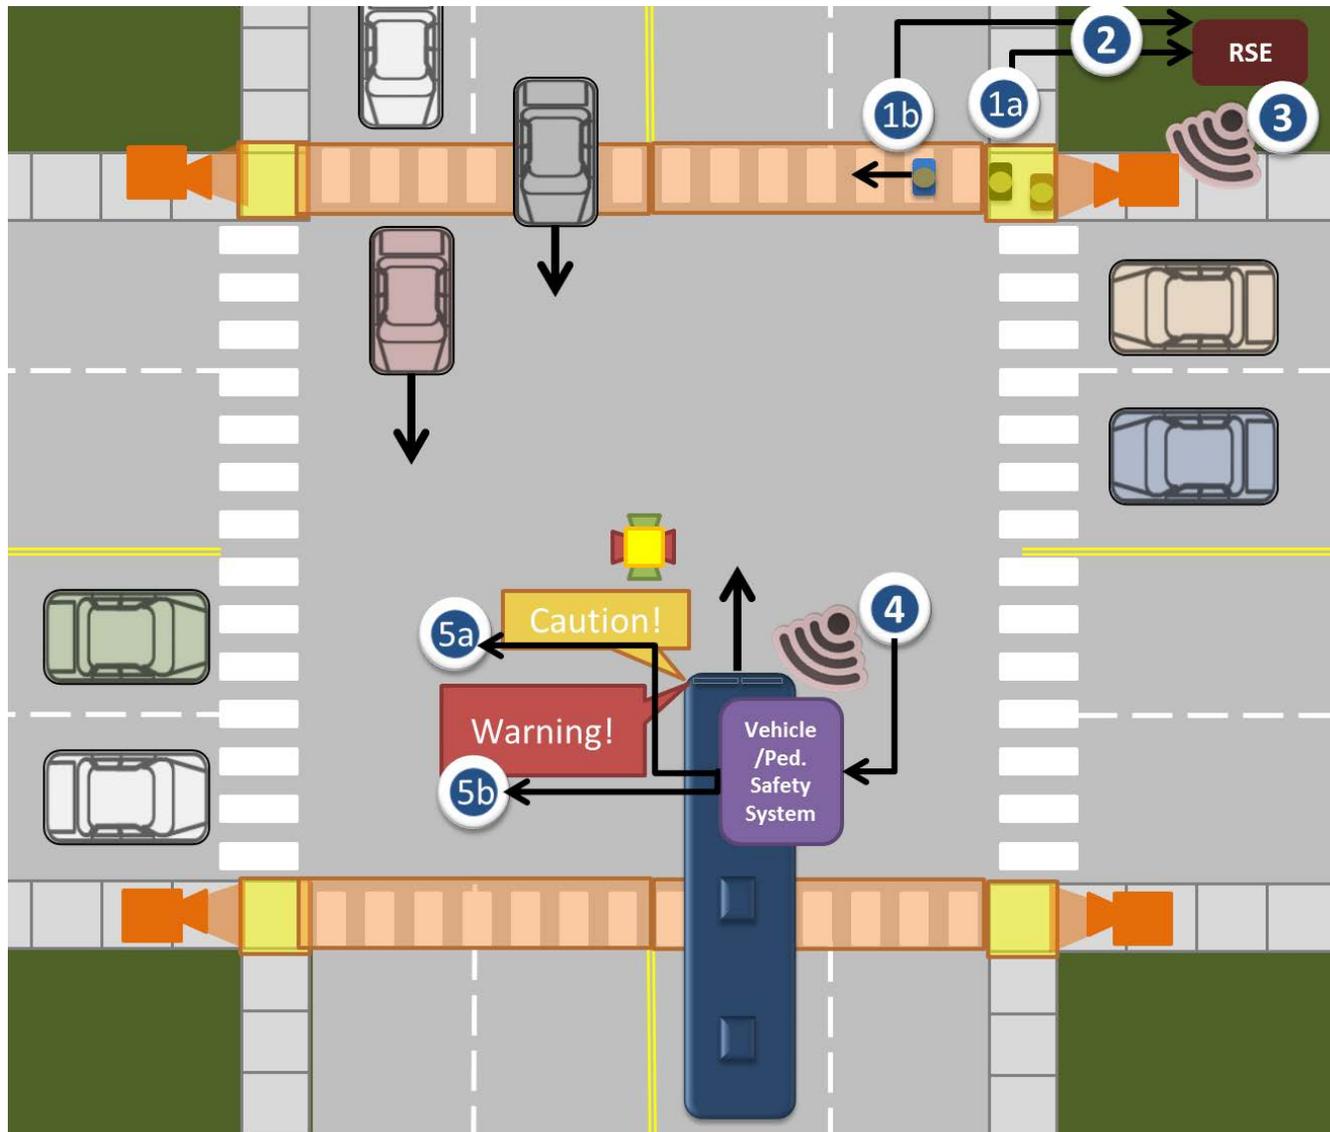
- 5b) Based on trajectory data obtained from the CAN bus and GPS; intersection geometry obtained from the MAP message; and signal phasing and pedestrian presence information obtained from the SPaT message, the Vehicle/Pedestrian Safety Warning System determines that the Transit Vehicle is going to cross the crosswalk where a pedestrian is being detected and continuously monitored. The Vehicle/Pedestrian Safety Warning System sends an audible and/or visual warning, including an indication of ordinal risk level to the driver via the DVI to warn the driver that there is a pedestrian crossing the path of the bus.

- 6) The application repeats this process until the Transit Vehicle has passed beyond the crosswalk.

Figure 6-1: Scenario 1 - Signalized Intersection, Bus Traveling Straight (Source: USDOT, 2014)

- **Scenario 1:** This scenario describes a motor bus approaching a signalized intersection that it will be traveling straight through. Pedestrian detection infrastructure detects the presence of a pedestrian in a crosswalk that the motor bus will be crossing. A roadside unit (RSU) broadcasts the pedestrian detection information through DSRC, where it is received by the motor bus OBE. The application processes the message and other relevant data to provide the motor bus driver with an alert of a potential conflict with a pedestrian in the roadway.

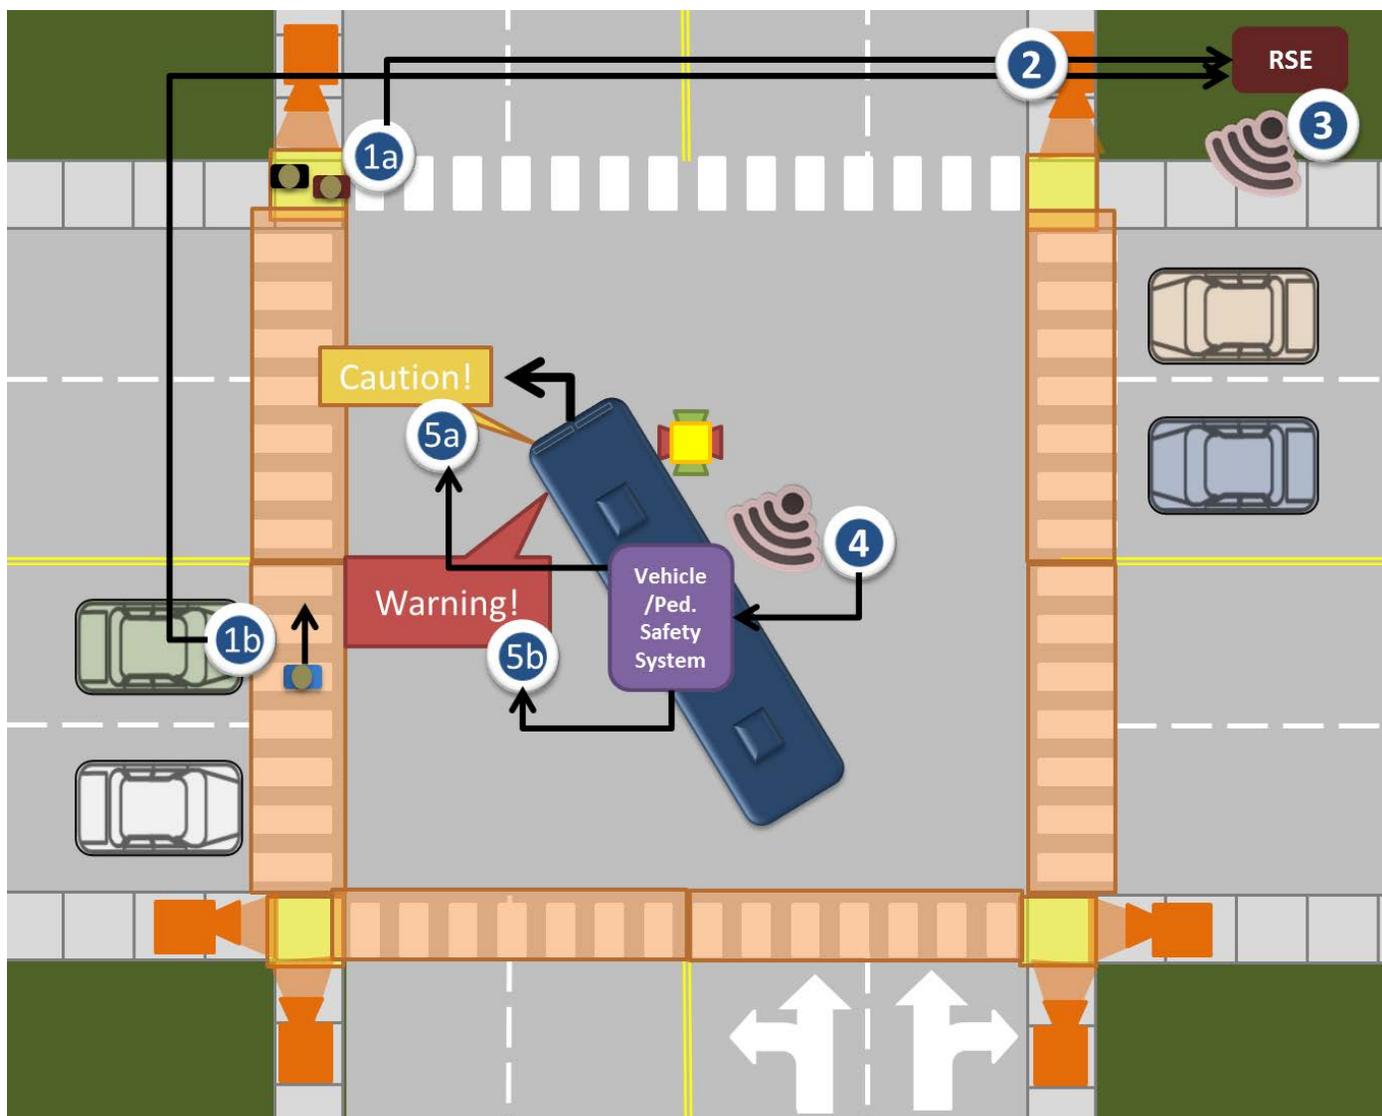
Flow of Events. The flow of events, corresponding to Figure 6-2, where the bus is turning left, is included below. It should be noted that similar flow of events also applies when the bus is turning right.

- 5b) Based on trajectory data obtained from the CAN bus and GPS; intersection geometry obtained from the MAP message; and signal phasing and pedestrian presence information obtained from the SPaT message, the Vehicle/Pedestrian Safety Warning System determines that the Transit Vehicle is going to cross the crosswalk where a pedestrian is being detected and continuously monitored. The Vehicle/Pedestrian Safety Warning System sends an audible and/or visual warning, including an indication of ordinal risk level to the driver via the DVI to warn the driver that there is a pedestrian crossing the path of the bus.

- 6) The application repeats this process until the Transit Vehicle has passed beyond the crosswalk.

Figure 6-2: Scenario 2 - Signalized Intersection, Bus Turning (Source: USDOT, 2014)

- **Scenario 2:** This scenario describes a motor bus approaching a signalized intersection where it will be turning. Pedestrian detection infrastructure detects the presence of a pedestrian in a crosswalk that the motor bus will be crossing. A RSU broadcasts the pedestrian detection information through DSRC, where it is received by the motor bus OBE. The application processes the message and other relevant data to provide the motor bus driver with an alert of a potential conflict with a pedestrian in the roadway.

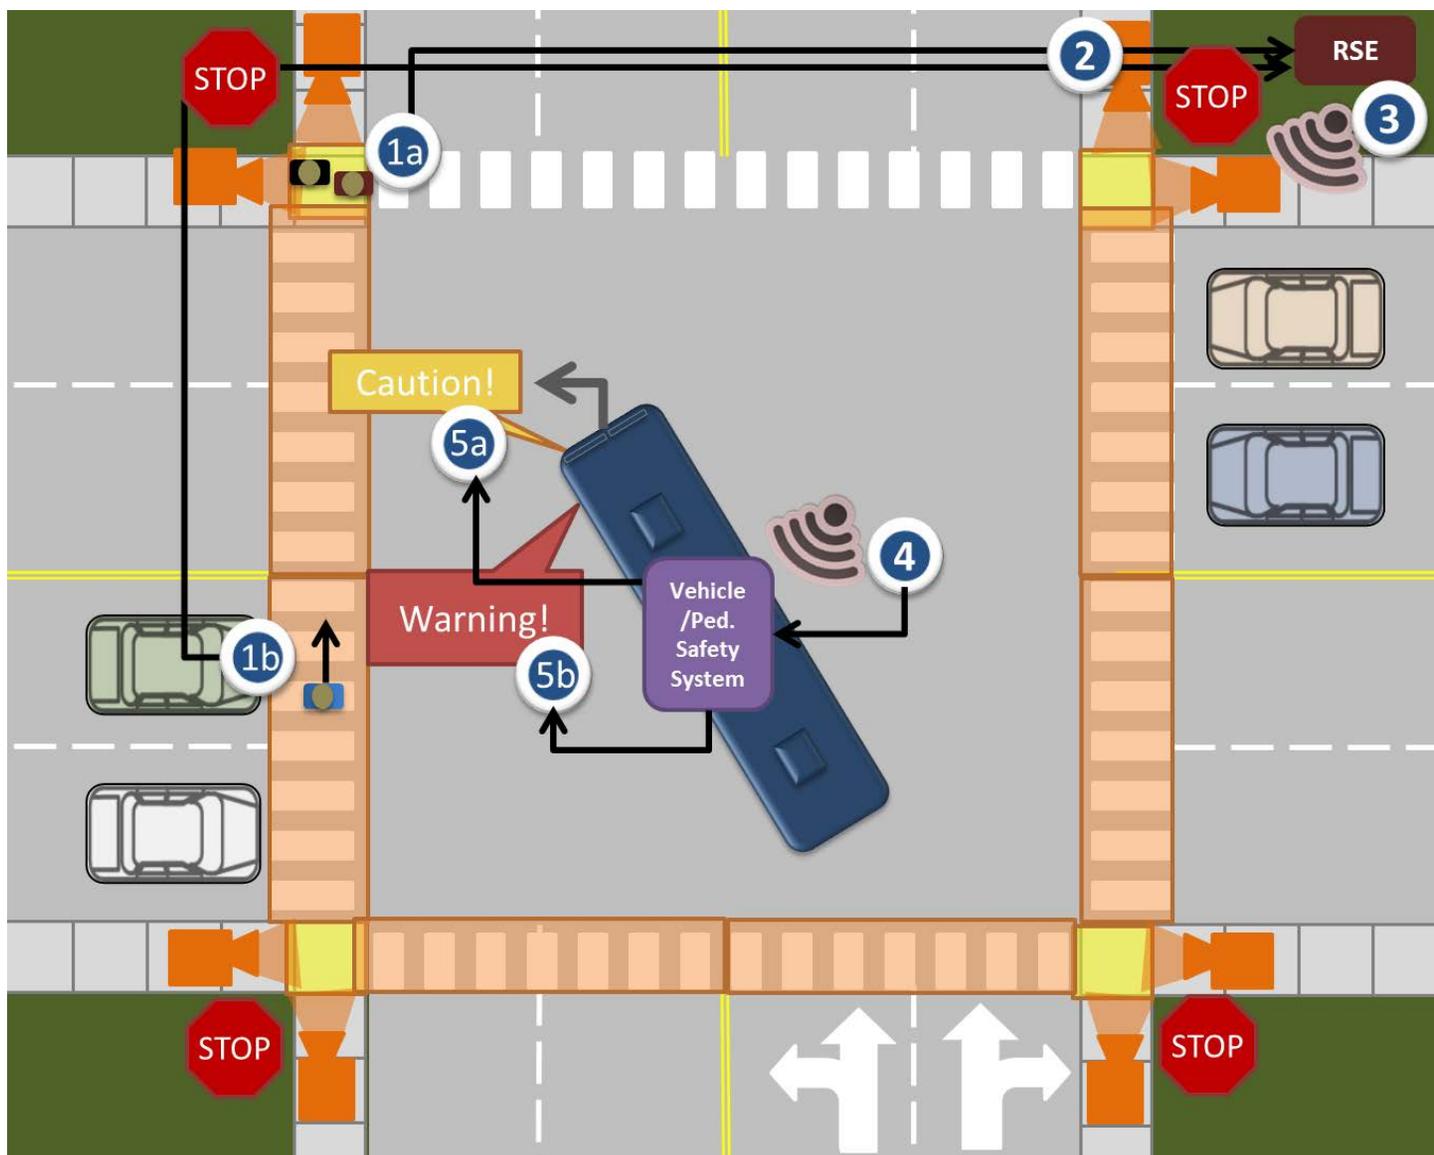
- 5b)** Based on trajectory data obtained from the CAN bus and GPS, intersection geometry obtained from the MAP message, and pedestrian presence information obtained from the TIM message, the Vehicle/Pedestrian Safety Warning System determines that the Transit Vehicle is going to cross the crosswalk where there is a pedestrian detected. The Vehicle/Pedestrian Safety Warning System sends an audible and/or visual warning to the driver via the DVI to warn the driver that there is a pedestrian crossing the path of the bus.

- 6)** The application repeats this process until the Transit Vehicle has passed beyond the crosswalk.

Figure 6-4: Scenario 4 - Unsignalized Intersection, Bus Turning (Source: USDOT, 2014)

- **Scenario 4:** This scenario describes a motor bus turning at an unsignalized intersection. Pedestrian detection infrastructure detects the presence of a pedestrian in a crosswalk that the motor bus will be crossing. A RSU broadcasts the pedestrian detection information through DSRC, where it is received by the motor bus OBE. The application processes the message and other relevant data to provide the motor bus driver with an alert of a potential conflict with a pedestrian in the roadway.

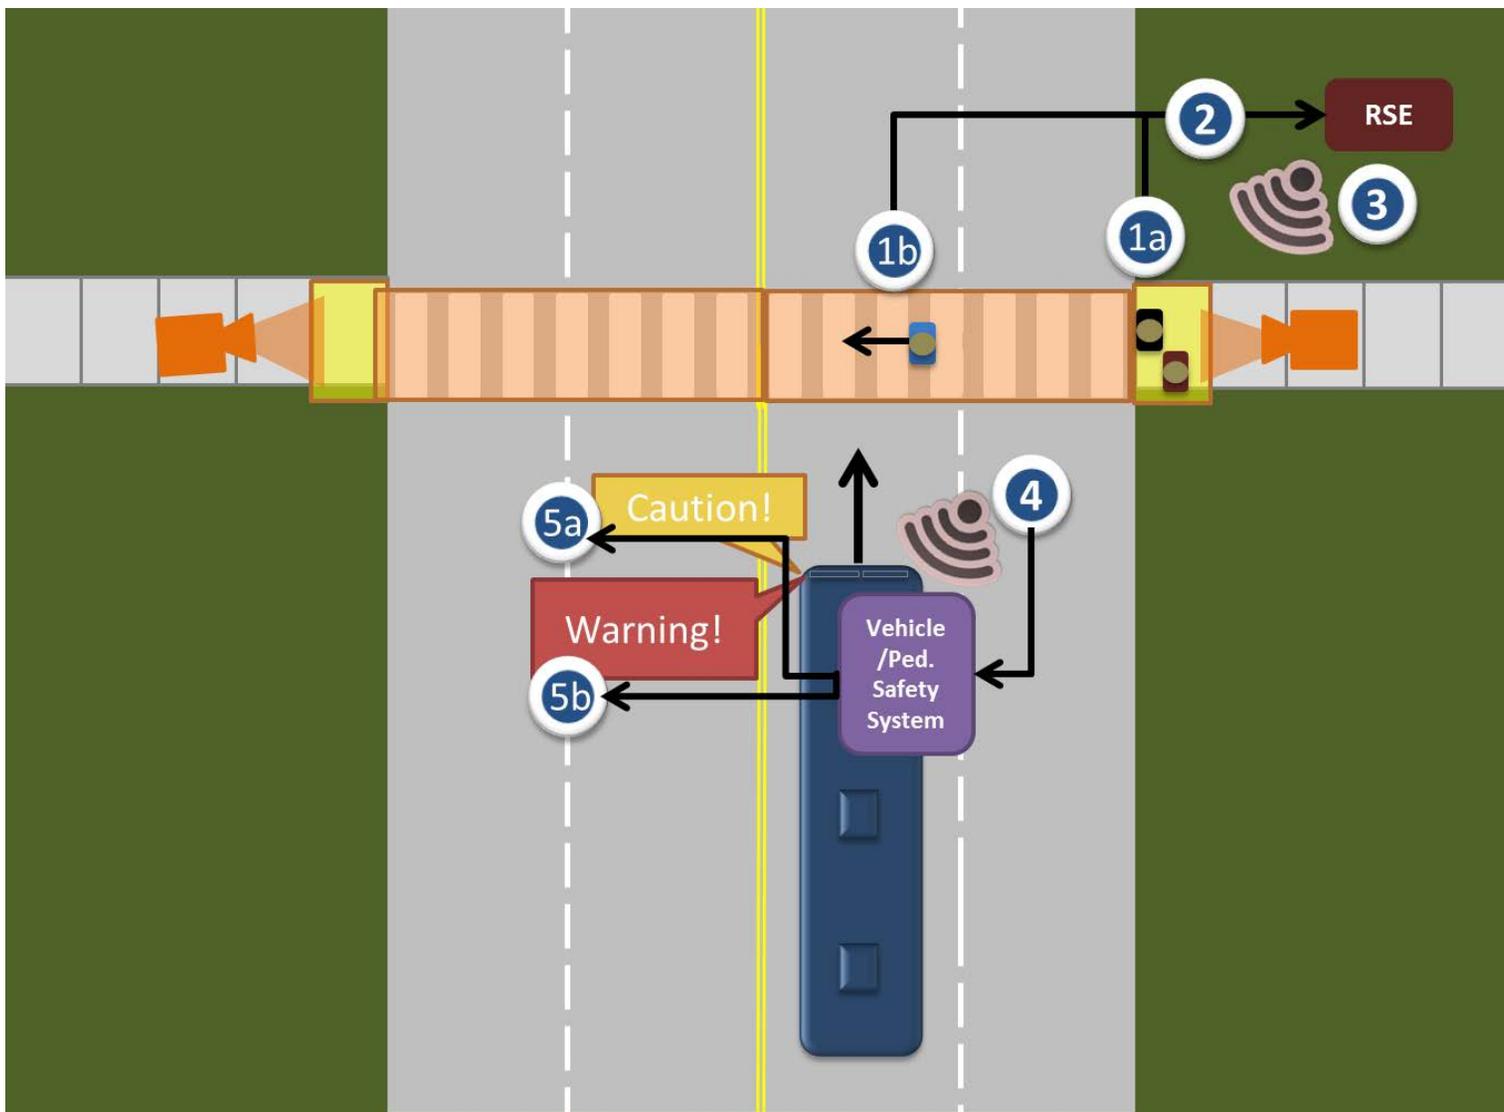
- 5b)** Based on trajectory data obtained from the CAN bus and GPS, intersection geometry obtained from the MAP message, and pedestrian presence information obtained from the TIM message, the Vehicle/Pedestrian Safety Warning System determines that the Transit Vehicle is going to cross the crosswalk where there is a pedestrian detected. The Vehicle/Pedestrian Safety Warning System sends an audible and/or visual warning to the driver via the DVI to warn the driver that there is a pedestrian crossing the path of the bus.

- 6)** The application repeats this process until the Transit Vehicle has passed beyond the crosswalk.

Figure 6-5: Scenario 5 - Bus at a Mid-Block Crossing (Source: USDOT, 2014)

- **Scenario 5:** This scenario describes a motor bus traveling towards an unsignalized, mid-block pedestrian crossing. Pedestrian detection infrastructure detects the presence of a pedestrian in the crosswalk that the motor bus will be crossing. A RSU broadcasts the pedestrian detection information through DSRC, where it is received by the motor bus
