Transit Safety Retrofit Package Development

Final Report

Final Report — July 30, 2014

FHWA-JPO-14-142

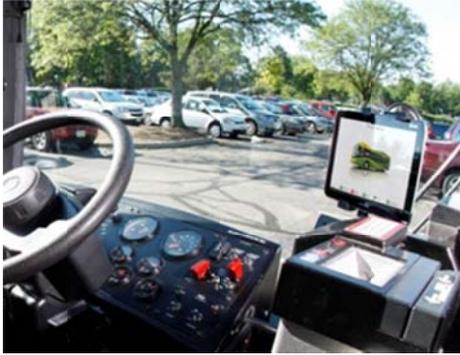
Figure 3-6. IVD

The IVD provides visual and aural alerts to the Transit Vehicle driver for the five safety applications. The IVD performs the computations for the two new safety applications – PCW and VTRW. The IVD is based on a Samsung Galaxy Tab™ computer. This item is a commercial-off-the-shelf (COTS) product, and is equipped with IEEE 802.11 a/b/g/n Wi-Fi® to support communications with the WSU. The mounting of the IVD, shown in Figure 3-6, allows the Transit Vehicle driver to view the display while not obstructing the driver's field of view.

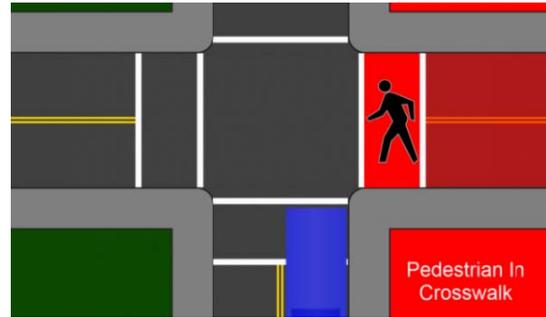
Figure 3-15. PCW Warning Display Screen

The User Interface depicts the appropriate display for the Transit Vehicle driver depending on if an alert is present. The following figures (Figure 3-15 through Figure 3-17) depict a set of sample alert screens that the IVD may depict to the Transit Vehicle driver. Not all permutations of alert types and levels are shown.

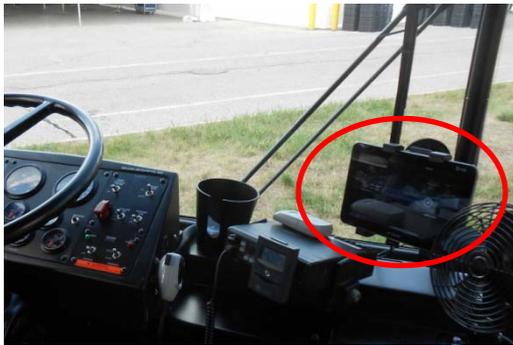
Figure 3-21. IVD Location

The IVD (circled) was mounted using a flexible arm mount as shown in Figure 3-21.

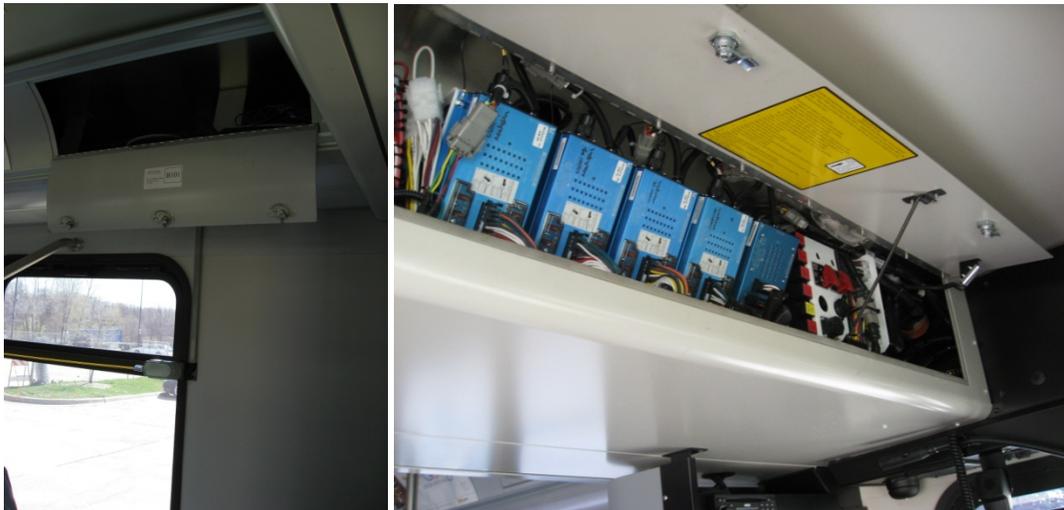
Power to the IVD was routed upward along the central windshield column to an overhead compartment behind the driver's head and behind the vehicle electronics compartment (Figure 3-22) to the DC/DC Converter.

DSRC Antenna 1 is a “whip” style antenna that was mounted on the driver side mirror in the upward position, as shown in Figure 3-25 (left). A “whip” style antenna was selected so that BSMs can be transmitted to and received from a DSRC-equipped vehicle traveling behind the transit vehicle or on the left of the transit vehicle. An antenna mounting bracket was fabricated to allow mounting onto the driver side mirror mounting arm. The antenna cable was routed behind molding and into the battery compartment. From the battery compartment, the antenna cable was routed to the overhead compartment shown in Figure 3-22 (above) and connected to the On-Board DSRC unit.

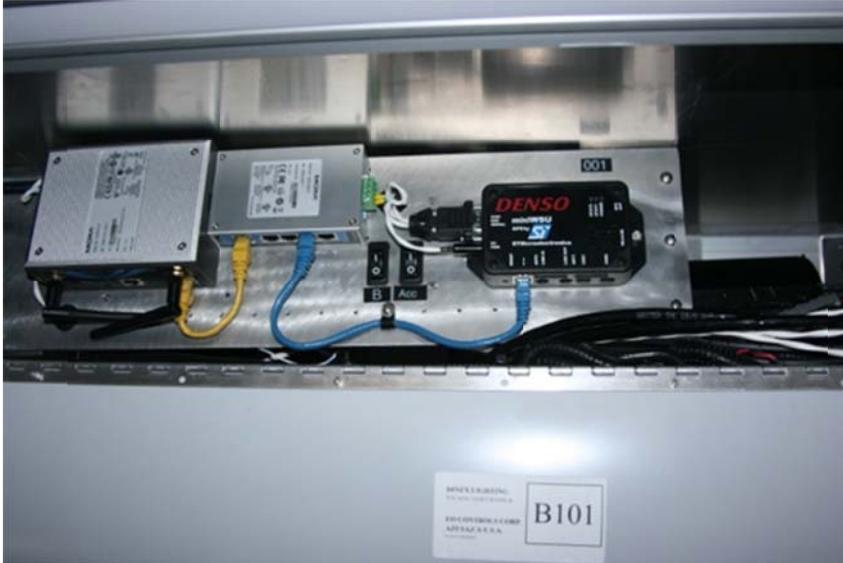
The On-Board DSRC, DC/DC Converter, Wireless Ethernet Router, and Interim Data Storage (together comprising the TRP Plate Assembly) were installed in the overhead compartment as shown in Figure 3-23.

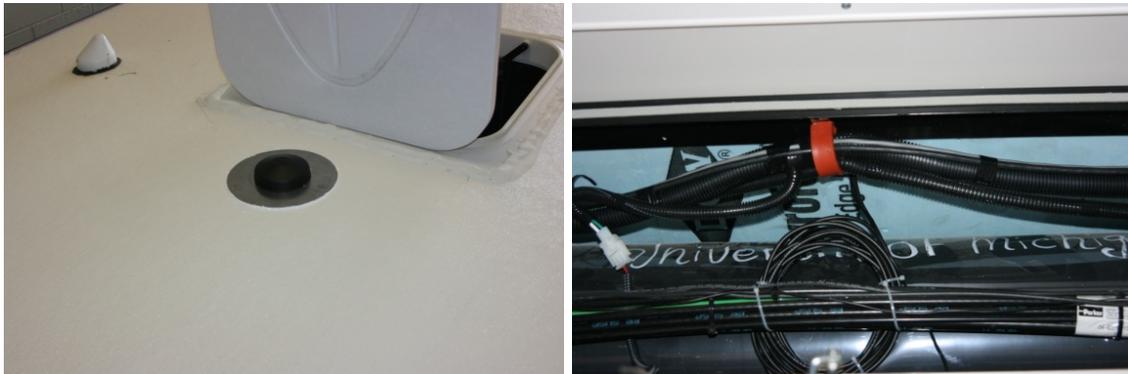
The following pictures (Figure 3-26) show an exterior picture of the completed installation, and an interior view of the completed installation.

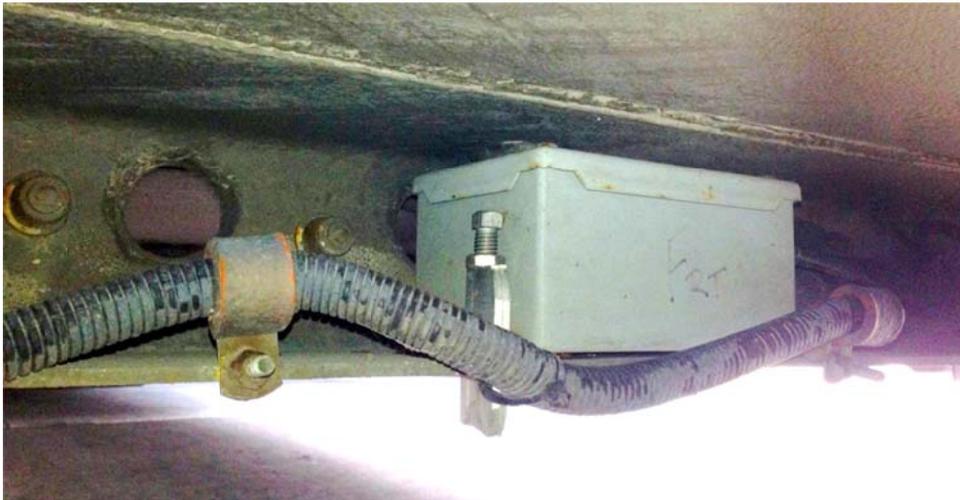
The sensor cluster continuously measures yaw rate and lateral and longitudinal acceleration, and provides those data to the DAS and the miniWSU via the TRP project CAN bus. The sensor cluster is a production unit from a Tier 1 supplier, and is installed in a watertight enclosure and attached to the underside of the integrated chassis/body of the bus as shown in Figure 3-36. The size of the enclosure is approximately 6" x 4" x 3". Various installation configurations were investigated, and this installation was selected as the best compromise between the goals of minimizing sprung-mass coupling effects that occur when mounting on the body (e.g., body roll appearing as lateral acceleration) and avoiding the confounding effects of axle shimmy for an axle-mounted system. The figure shows the cluster enclosure is mounted behind a frame channel for added protection. The sensor cluster is powered directly from the vehicle via switched power.

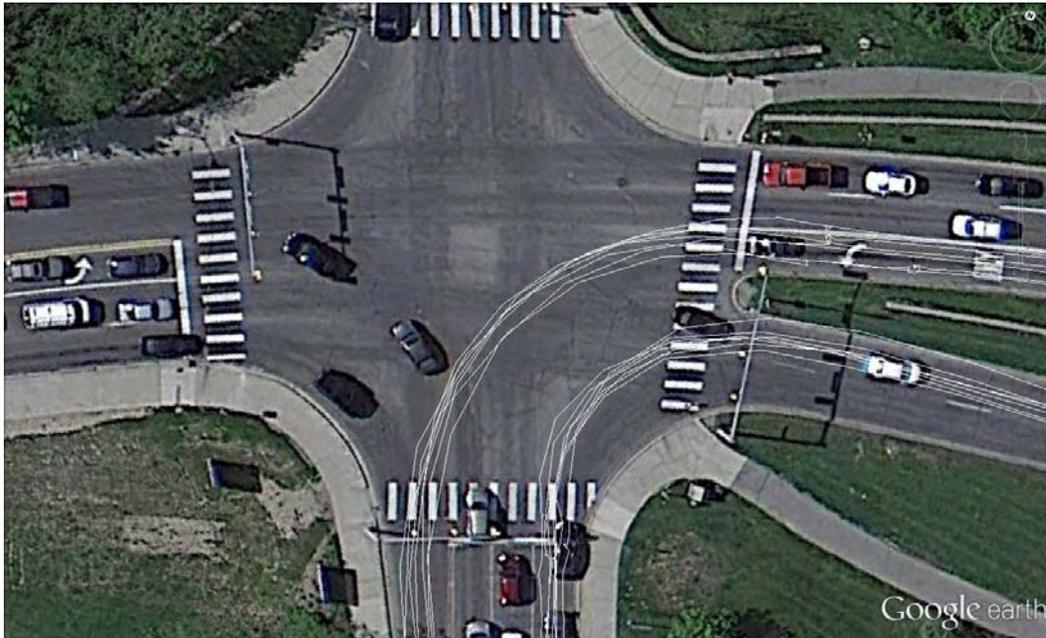
Figure 3-55. Bus Traces at Fuller Avenue and Medical Center Drive

Figure 3-55 below shows multiple bus locational traces through the instrumented PCW intersection at Fuller Avenue and Medical Center Drive. The bus traversed the intersection 14 times: 7 times turning left from westbound Fuller Avenue to southbound Medical Center Drive, and 7 times turning right from northbound Medical Center Drive to eastbound Fuller Avenue.

Although the WAAS specification requires a positional accuracy of better than 7.6 meters in both lateral and vertical measurements, vendor claims and actual measurements typically demonstrate a WAAS accuracy of 1.5 meters or better in both directions. A typical traffic lane is ~3.5 meters wide. The specified WAAS accuracy would be insufficient to support TRP needs. The measured and claim accuracy should support TRP needs. In practice, the WAAS-enabled GPS supported TRP needs a majority of the time, but remained a source of TRP error.

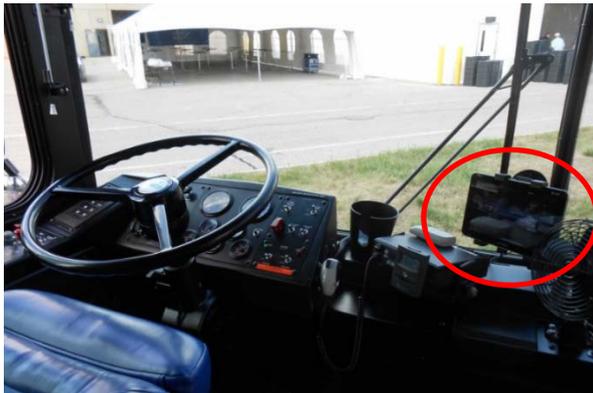
Figure 3-56. Final IVD Location

The IVD position was relocated to be closer to the driver. It was moved from the immediate right of the center bar of the front window, to the immediate left of the center bar of the front window, as shown in Figure 3-56, Final IVD Location¹³. This change was driven by driver feedback and is intended to improve the IVD and increase driver acceptance.

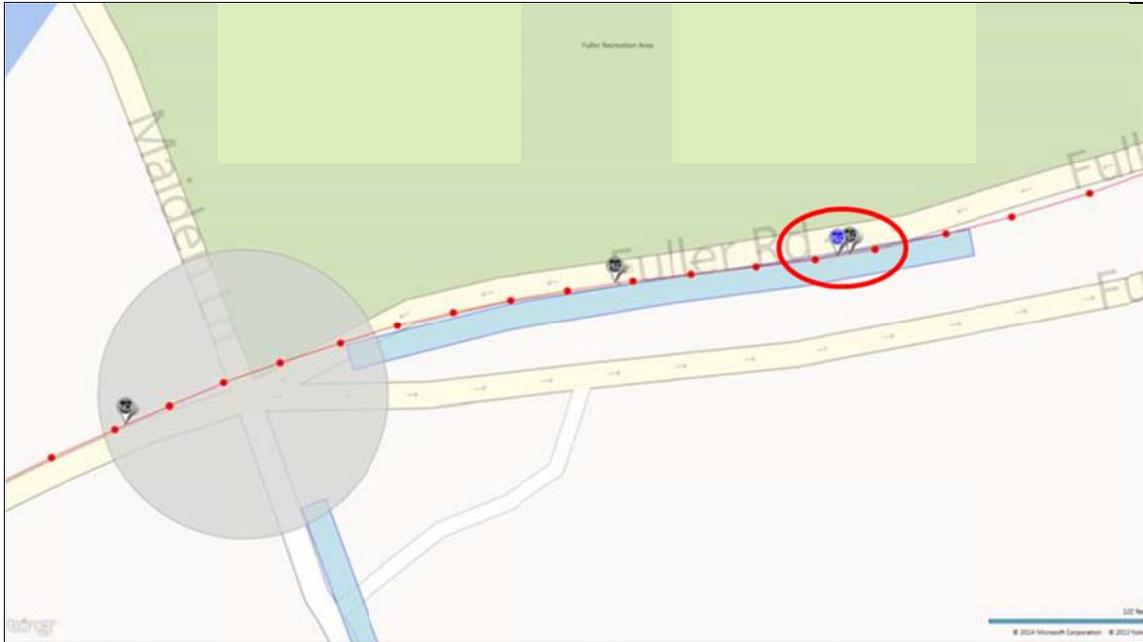
Figure 3-66. Bus Path Not Through Crosswalk (GPS Inaccuracy)

Figure 3-66 shows an actual case where the reported GPS position of the bus dipped into the left turn lane long enough to lock on to the lane, when the bus was actually in the straight lane. The blue region is the PCW-defined turn lane. The bus path is shown in red. Each point is a GPS-reported bus position at one-second intervals. The GPS position is actually received at one tenth second intervals; therefore, half the distance between points in the figure dipping into the blue region would result in the PCW application locking on to the turn lane, thus enabling PCW alerts. The circled region shows where lane-lock occurred, followed by the invalid alert.

Scenario 2: For the redeployment, with the removal of Lane 7 (straight lane) as PCW-enabled, the lane determination algorithm was modified to “favor” the turn lanes to diminish the possibility of introducing missed alerts (see Section 4.2.3). As a result, a bus can actually be located in a straight lane with its GPS-reported position in the outer region of the straight lane, and the TRP system will determine the bus is in the turn lane. In this scenario, even though the GPS-reported position is within the bounds of the lane the bus is actually in, such false alerts are attributed to GPS Inaccuracy since the PCW algorithm as designed is necessary to accommodate GPS error, favoring false alerts over missed alerts.
