Effects of Deicing/Anti-Icing Chemicals (DIAICs) on Rubberized Asphalt Pavements

SPR-617

September 2014

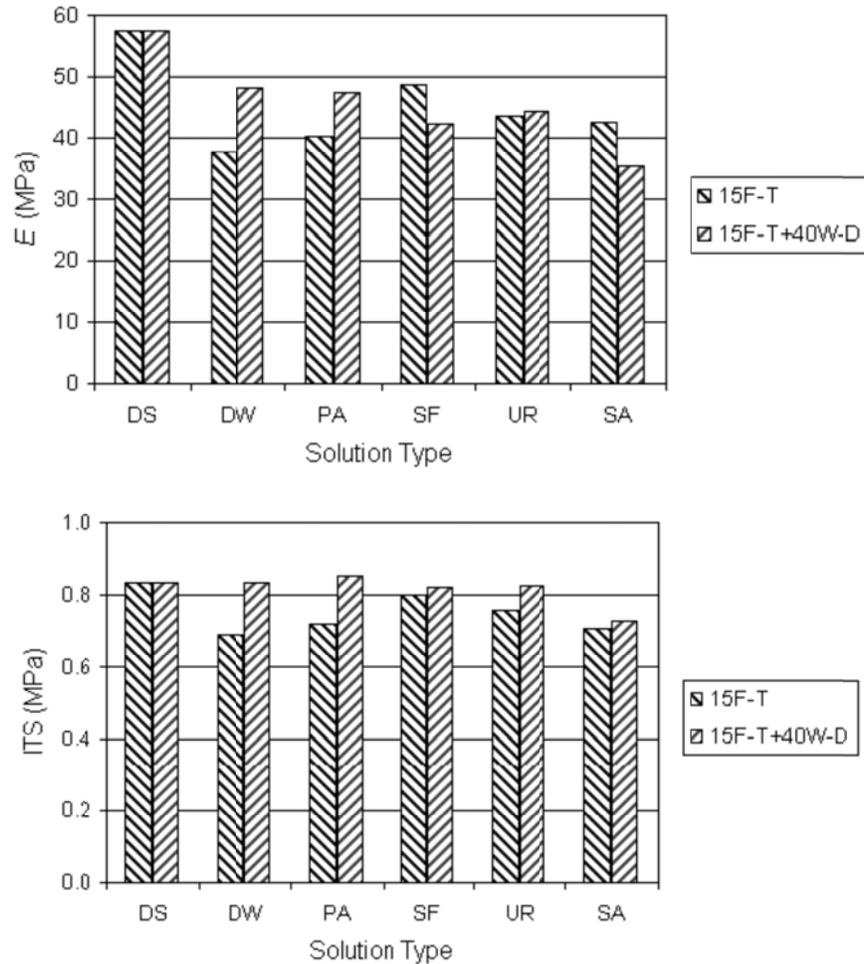
DS = dry specimen; DW = distilled water; PA = potassium acetate; SF = sodium formate; UR = urea; SA = sodium acetate.

Figure 1. Effect of Different DIAIC Solutions on Indirect Tensile Strength (Farha et al. 2002, Figure 6)

Phase 3 was similar to Phase 2, except that only 15 freeze-thaw cycles were conducted, followed by 40 wet-dry cycles at 104° F. As shown in Figure 1, ITS decreased after the 15 freeze-thaw cycles, but recovered after the wet-dry cycles. The trend is less clear for elastic modulus. While the modulus of all the specimens decreased following freeze-thaw cycling, it recovered substantially in some cases. Penetration of extracted binder increased for some specimens following freeze-thaw cycling. In the cases where penetration increased, it recovered fully after the wet-dry cycles. No significant change in the gradation of extracted aggregate was observed.

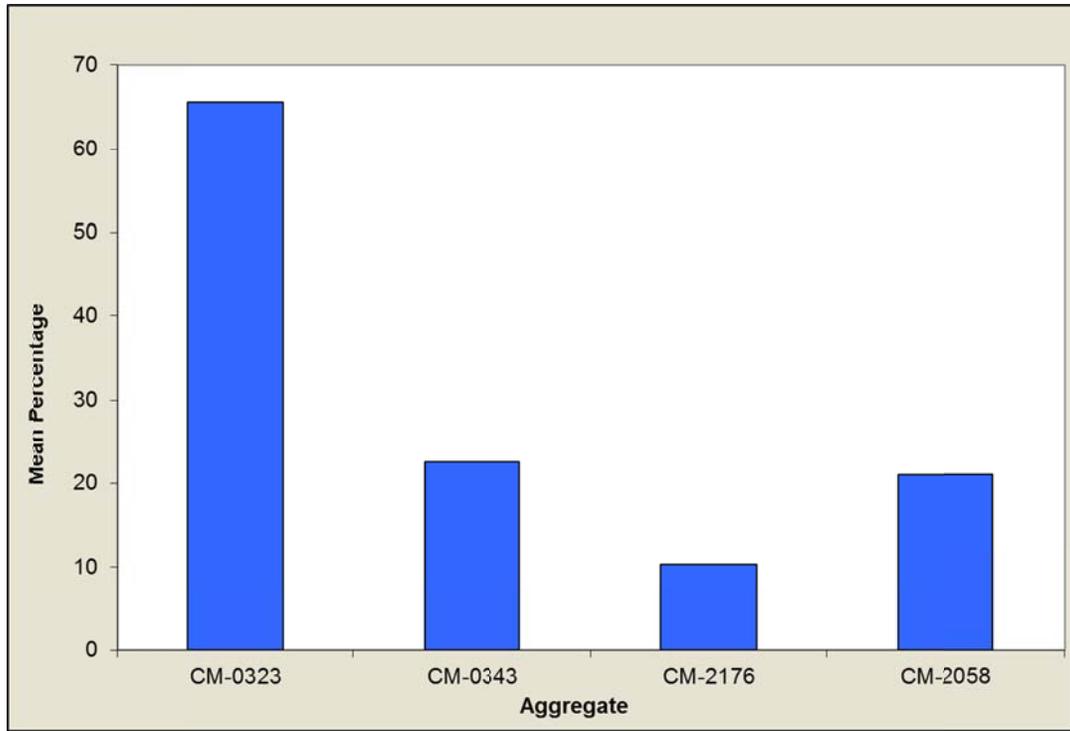
Figure 2. Percentage of Material Stripped by Aggregate Source

The percentage of stripped material differed significantly across the different aggregate types (see Figure 2). Source CM-0323 was significantly more susceptible to moisture damage than the other three sources, with an average of 65.6 percent of the aggregate stripped. Source CM-2176 had the best results, with an average of 10.3 percent stripped.

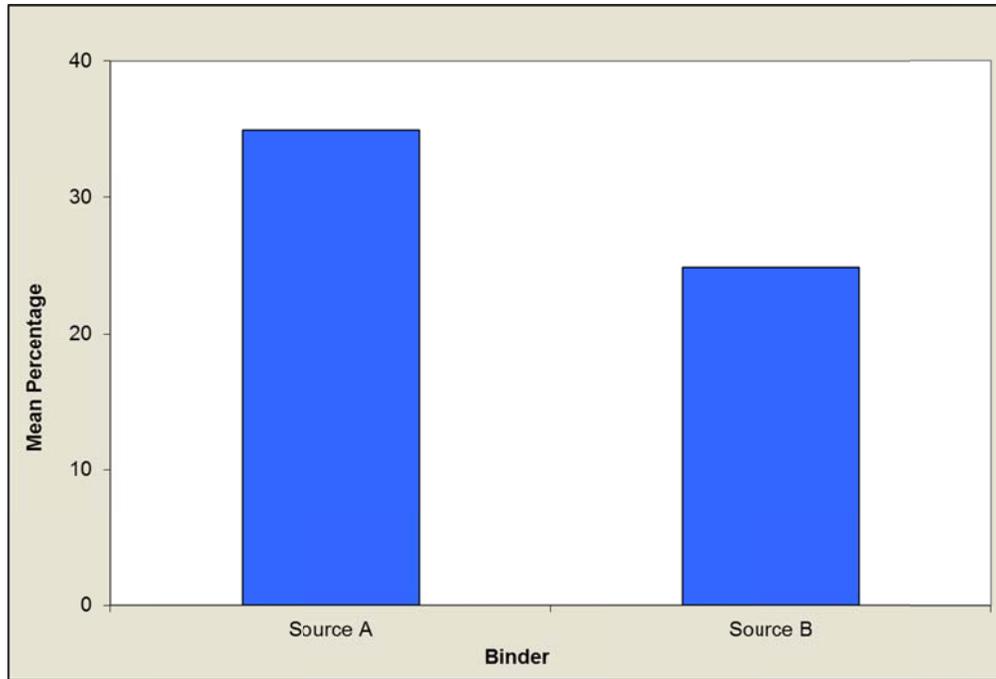
Note: The Source A binder contained 20 percent crumb rubber; the Source B binder contained 22.7 percent crumb rubber.

Figure 3. Percentage of Material Stripped by Binder Source

The analysis also showed that mixtures containing the binder blend from Source A had significantly higher moisture susceptibility (on average 10.1 percent higher than mixtures containing the binder blend from Source B, as shown in Figure 3). This was expected, because in general the Source A blend had lower viscosity than the Source B blend. The lower viscosity can be attributed to the lower crumb rubber content; the PG 58-22 binder made with the Source A blend contained 20 percent crumb rubber, while the PG 58-22 binder made with the Source B blend contained 22.7 percent crumb rubber. As reported in the literature, stiffer binders and polymer-modified binders are more resistant to DIAIC-related damage.

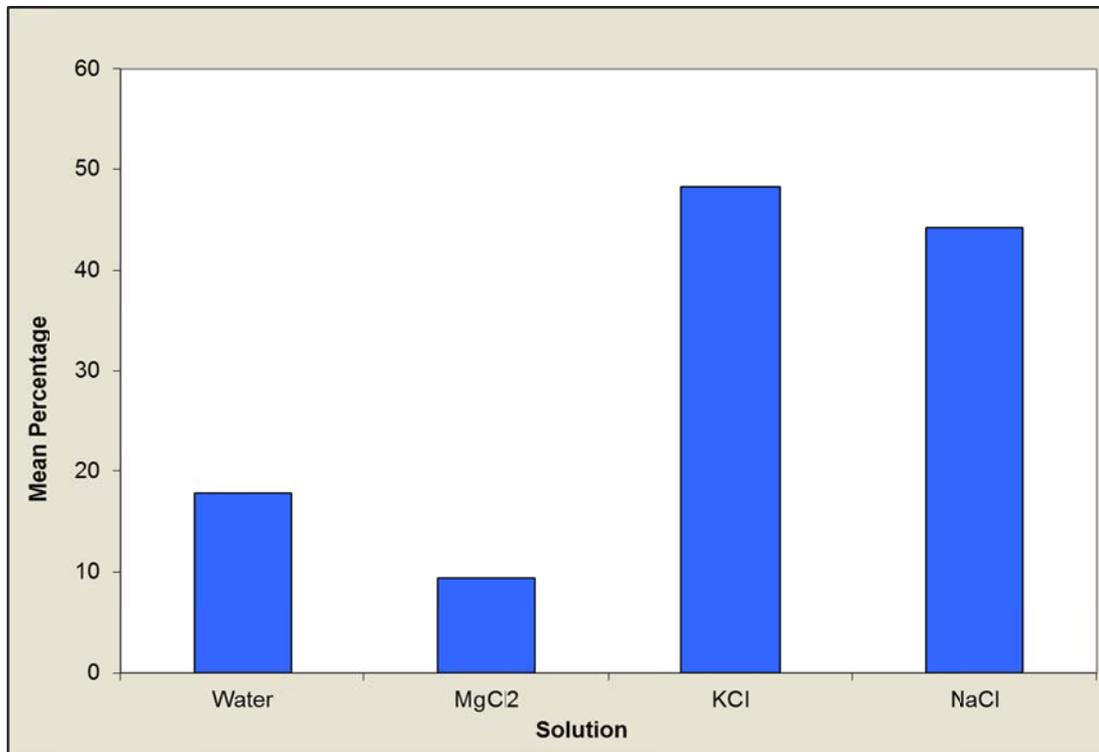
Figure 4. Percentage of Material Stripped by Type of DIAIC

The potassium chloride and sodium chloride solutions caused significantly more moisture damage to the rubberized asphalt mixtures than the other two solutions (see Figure 4). The least amount of stripping was obtained with the magnesium chloride solution, which (unexpectedly) caused less damage than the control solution of distilled water.

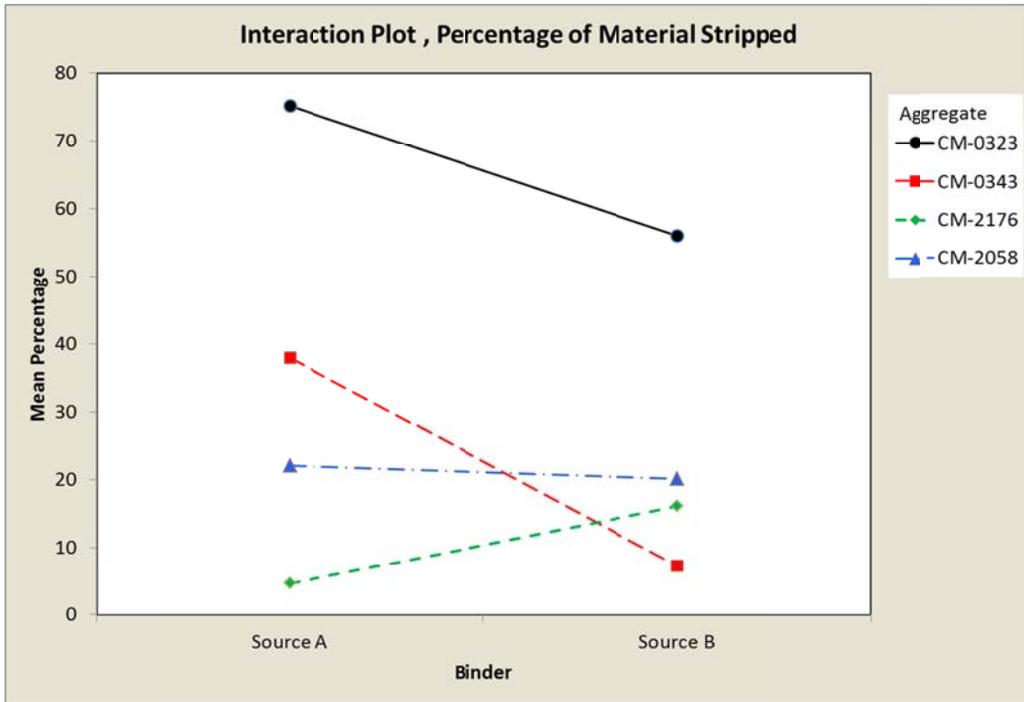
Figure 5. Interaction Between Aggregate Source and Binder Blend

For example, the percentage of stripped material varied for a particular binder blend depending on the aggregate source used (see Figure 5). Only the CM-2058 aggregate did not show a significant difference in results across binder blends. The CM-0323 aggregate showed a particularly high percentage of stripped material regardless of the binder blend used. Regarding the interaction of aggregate type and DIAIC solution, the CM-2176 aggregate was the least influenced by the type of DIAIC solution (see Figure 6). On the other hand, the percentage of stripped material varied greatly with the solution type when the CM-0323 aggregate was tested.

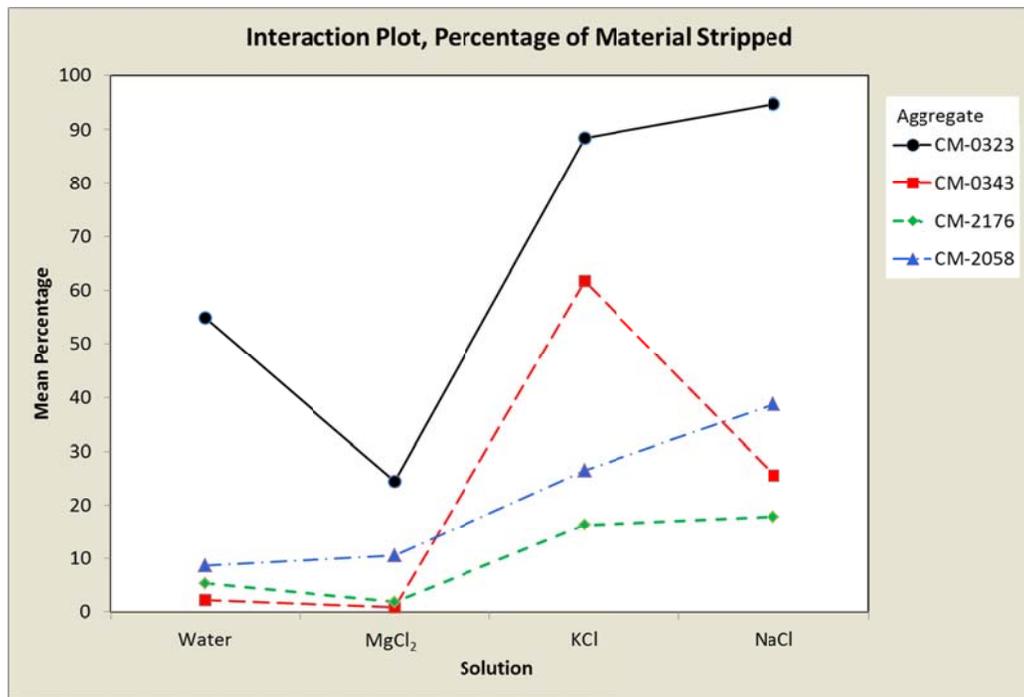
Figure 6. Interaction Between Aggregate Source and Type of DIAIC Solution

Figures 5 through 7 illustrate the interactions among the different factors. As indicated by the analysis of variance discussed earlier, the interaction terms are highly significant. This means that the differences in the levels of one factor depend on the levels of the other factors.

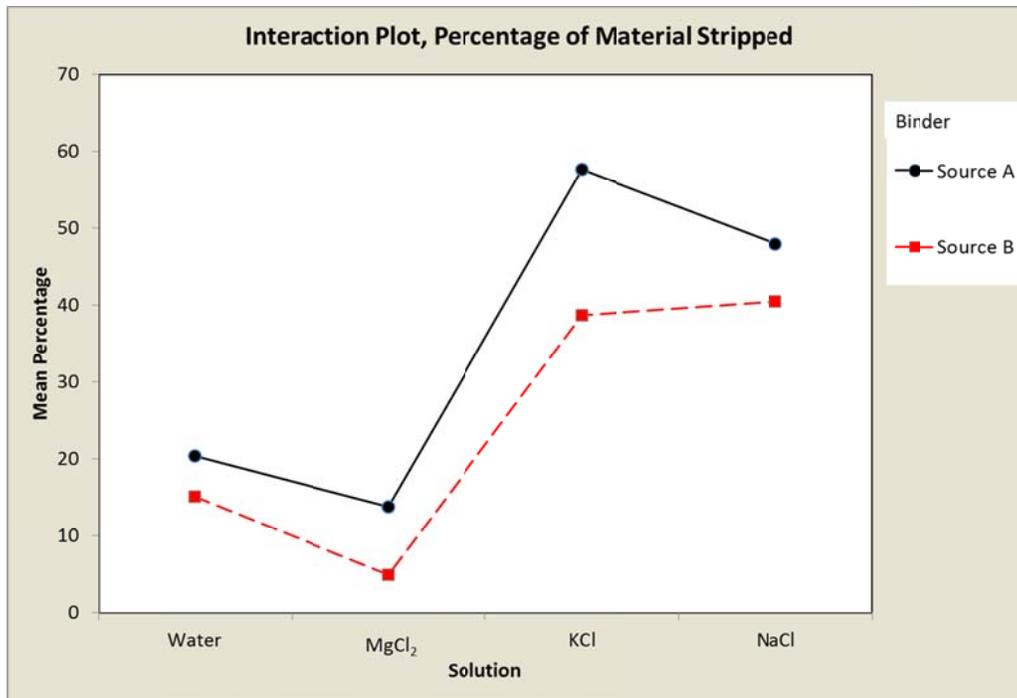
Figure 7. Interaction Between Binder Blend and Type of DIAIC Solution

The interaction between binder blend and DIAIC solution type was also analyzed (see Figure 7). Both binder blends showed a large variation in the percentage of stripped material when different DIAIC solutions were used. However, two trends clearly stand out. Regardless of the binder blend, a lower percentage of stripped material was observed when water and magnesium chloride solutions were used than when potassium chloride and sodium chloride solutions were used.

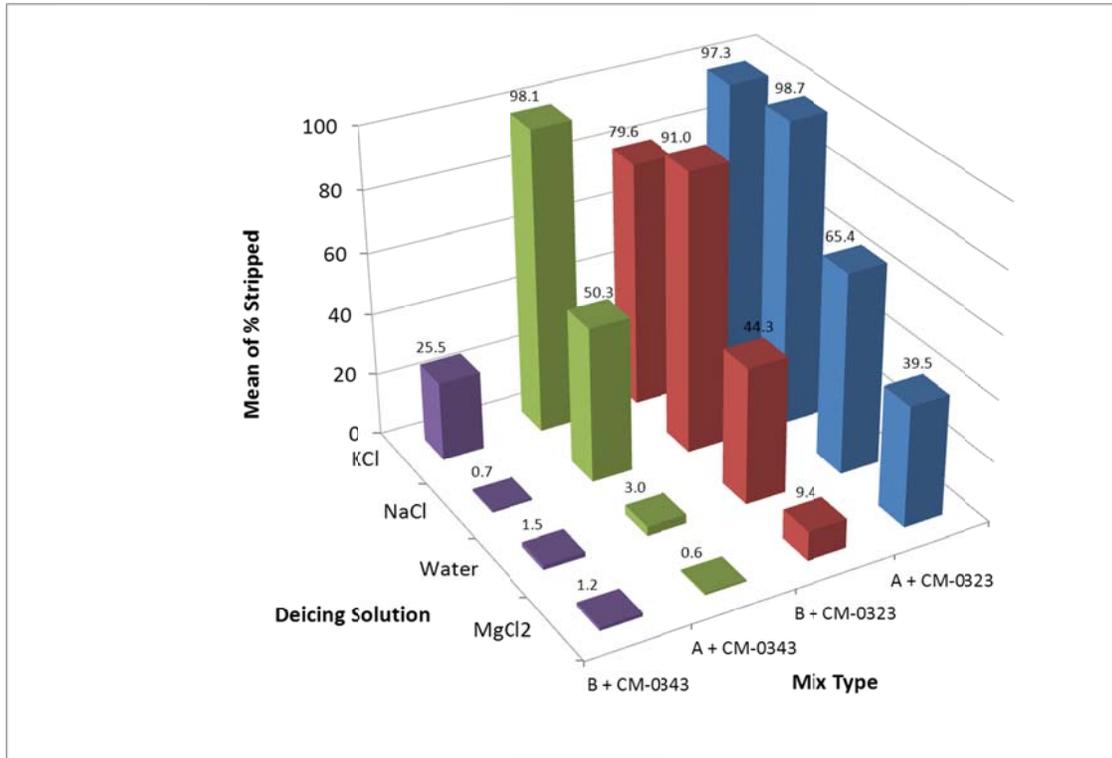
Figure 8. Percentage of Material Stripped by DIAIC Type (CM-0343 and CM-0323 Mixes)

Figure 8 shows the percentages of stripped material for four mix combinations (aggregates CM-0343 and CM-0323 blended with Source A and B binders) and the four DIAIC solutions. The mixes made with aggregate CM-0323 demonstrated the highest moisture damage potential. Stripping levels were especially high when the mixes were conditioned in the potassium chloride and sodium chloride solutions (an average of 91.7 percent stripped material). Stripping decreased when CM-0323 mixes were conditioned in the magnesium chloride solution or in water. In addition, the mixes containing CM-0323 aggregate exhibited a high level of stripping not only when they were conditioned with potassium and sodium chloride solutions, but also when they were conditioned with water. This reveals that these mixes also had high moisture susceptibility. As mentioned earlier, mixes blended with the Source B binder exhibited less stripping. For CM-0343 mixes, stripping levels were very high regardless of which binder was used, which might imply that the CM-0343 aggregate is more hydrophilic than the other aggregates used in this study. On the other hand, mixes composed of CM-0343 aggregate showed lower percentages of stripping than CM-0323 mixes in general. The exceptions were when the Source A binder was mixed with CM-0343 and conditioned in the potassium chloride and sodium chloride solutions (percentages of stripped material were 98.1 percent and 50.3 percent, respectively). This also shows that using a stiffer binder (the Source B binder in this experiment) can help decrease stripping levels.

Finally, surprisingly, stripping levels were higher when the mixes were conditioned in water than when they were conditioned in the magnesium chloride solution.

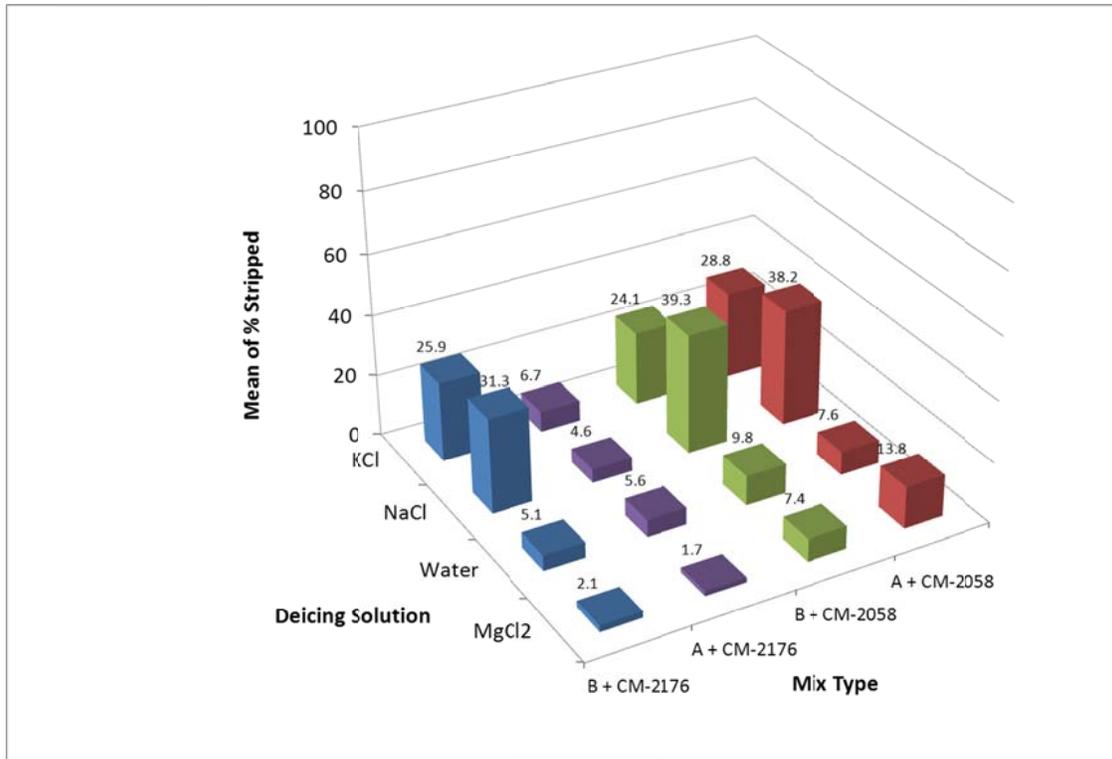
Figure 9. Percentage of Material Stripped by DIAIC Type (CM-2176 and CM-2058 Mixes)

Figure 9 shows the percentages of stripped material for the remaining four mix combinations (aggregates CM-2176 and CM-2058 blended with Source A and B binders) and the four DIAIC solutions. Stripping levels were much lower for these mixes than for the four mixes shown in Figure 8. For these four mixes, the highest stripping level was 39.3 percent; this occurred when the mix made with the CM-2058 aggregate and the Source B binder blend was conditioned in the sodium chloride solution. The lowest stripping level was 1.7 percent, yielded by the combination of CM-2176 aggregate and Source A binder conditioned in the magnesium chloride solution. As in Figure 8, two groups were still distinct from each other: Mixes conditioned in the potassium and sodium chloride solutions had higher stripping levels (an average of 25 percent stripped material) than mixes conditioned in the water and magnesium chloride solutions (an average of 6.6 percent stripped material). The benefit of using a stiffer binder was not significant for these four mixes.

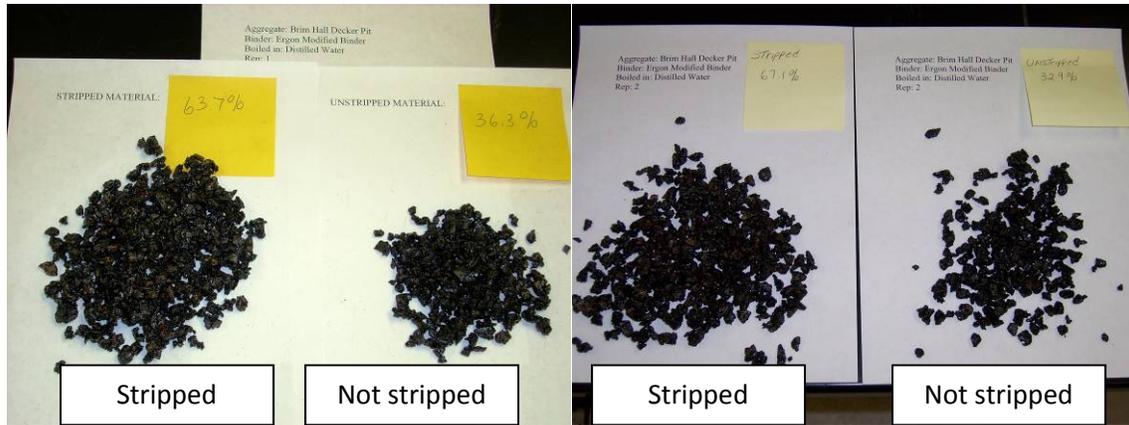
Source A Binder

Distilled Water

Replicate 1—63.7% Stripped

Replicate 2—67.1% Stripped

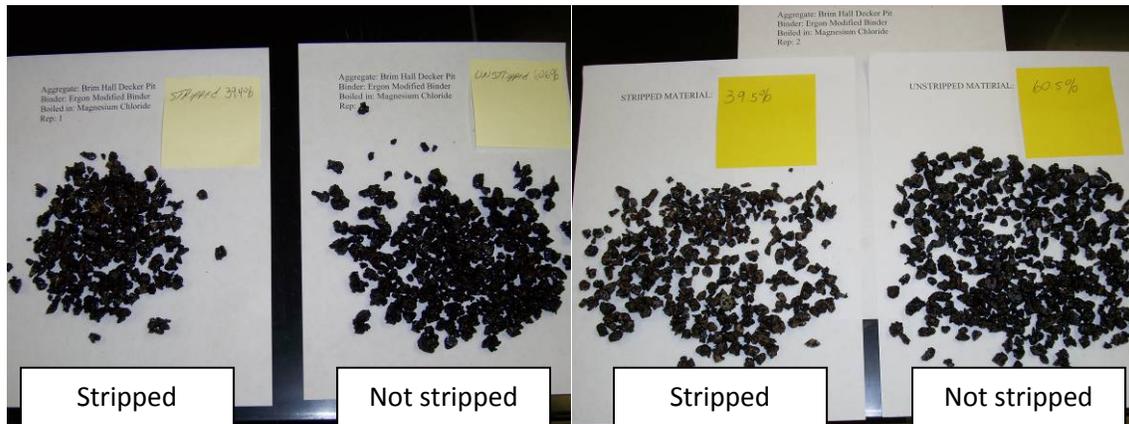
Source A Binder

Magnesium Chloride

Replicate 1—39.4% Stripped

Replicate 2—39.5% Stripped

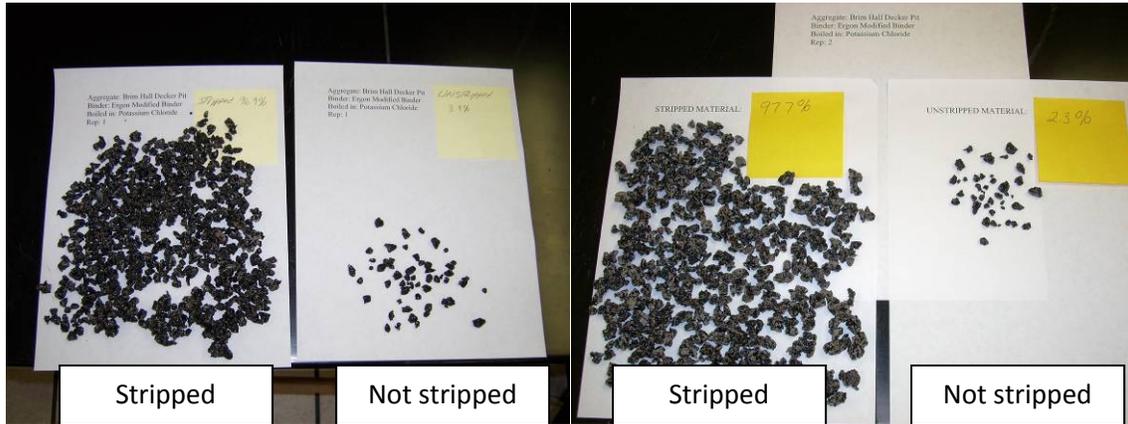
Source A Binder

Potassium Chloride

Replicate 1—96.9% Stripped

Replicate 2—97.7% Stripped

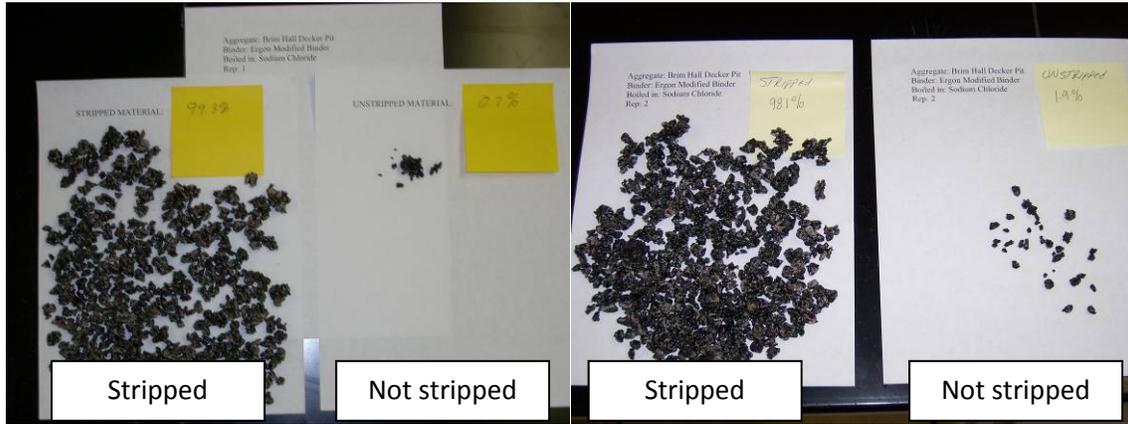
Source A Binder

Sodium Chloride

Replicate 1—99.3% Stripped

Replicate 2—98.1% Stripped

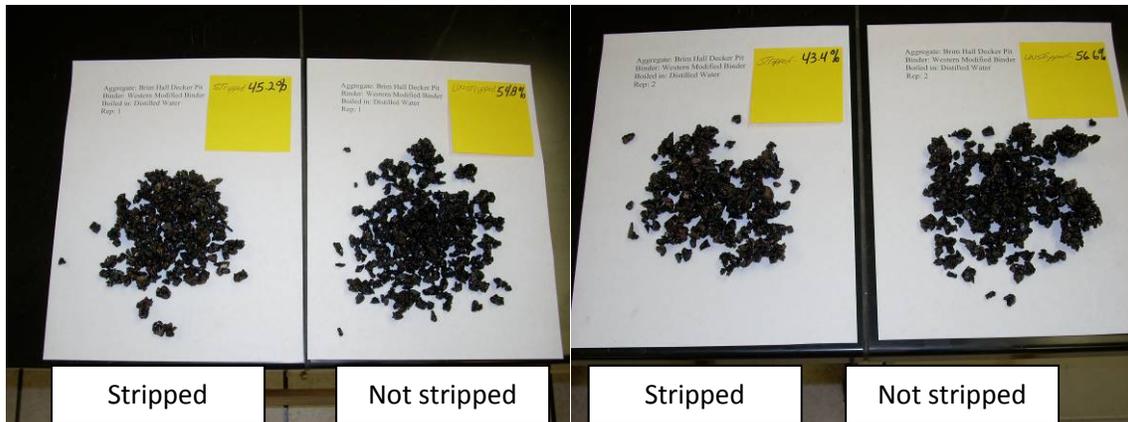
Source B Binder

Distilled Water

Replicate 1—45.2% Stripped

Replicate 2—43.4% Stripped

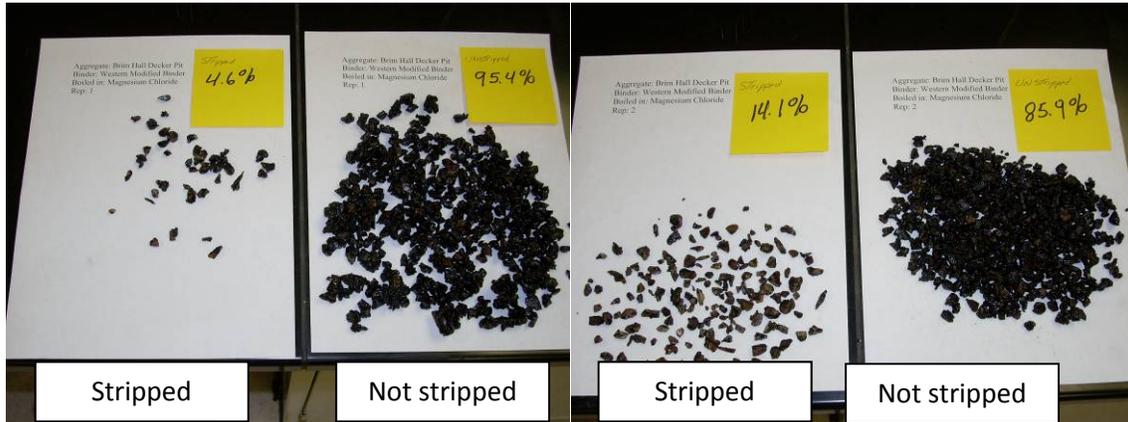
Source B Binder

Magnesium Chloride

Replicate 1—4.6% Stripped

Replicate 2—14.1% Stripped

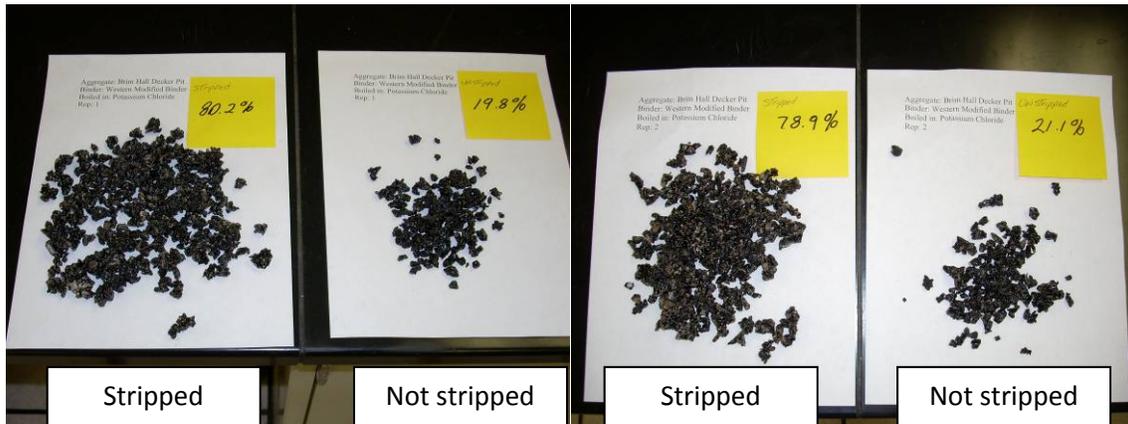
Source B Binder

Potassium Chloride

Replicate 1—80.2% Stripped

Replicate 2—78.9% Stripped

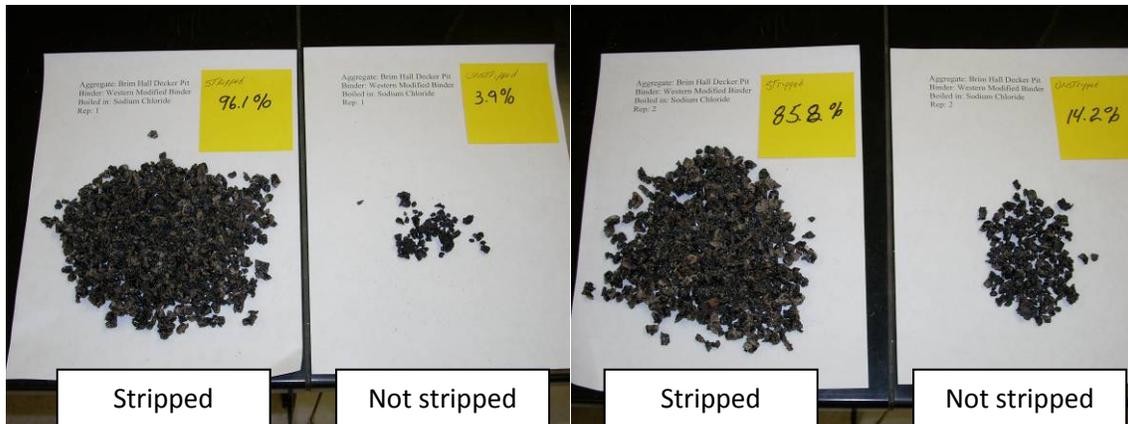
Source B Binder

Sodium Chloride

Replicate 1—96.1% Stripped

Replicate 2—85.8% Stripped

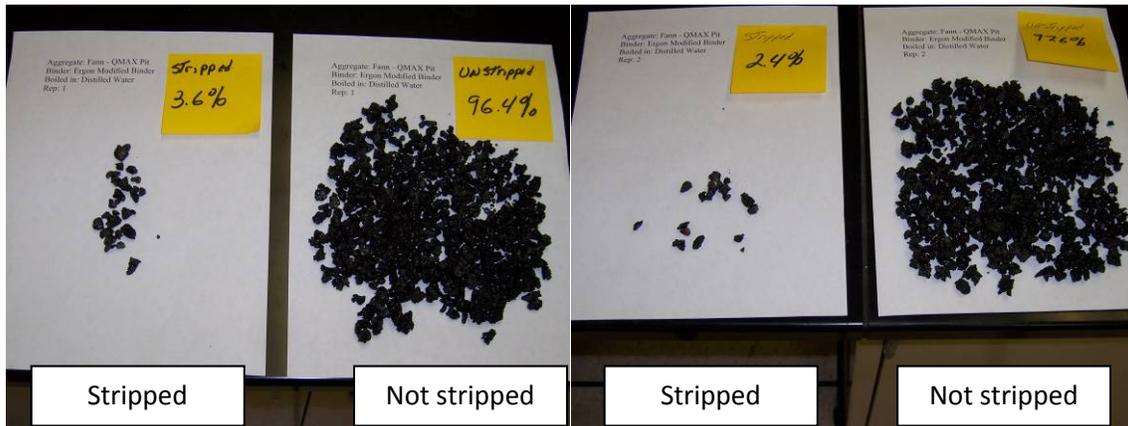
Source A Binder

Distilled Water

Replicate 1—3.6% Stripped

Replicate 2—2.4% Stripped

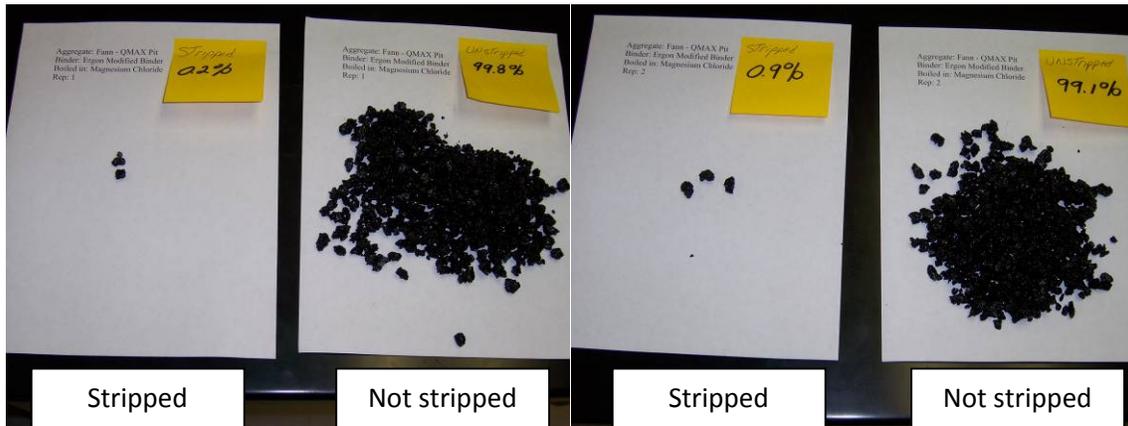
Source A Binder

Magnesium Chloride

Replicate 1—0.2% Stripped

Replicate 2—0.9% Stripped

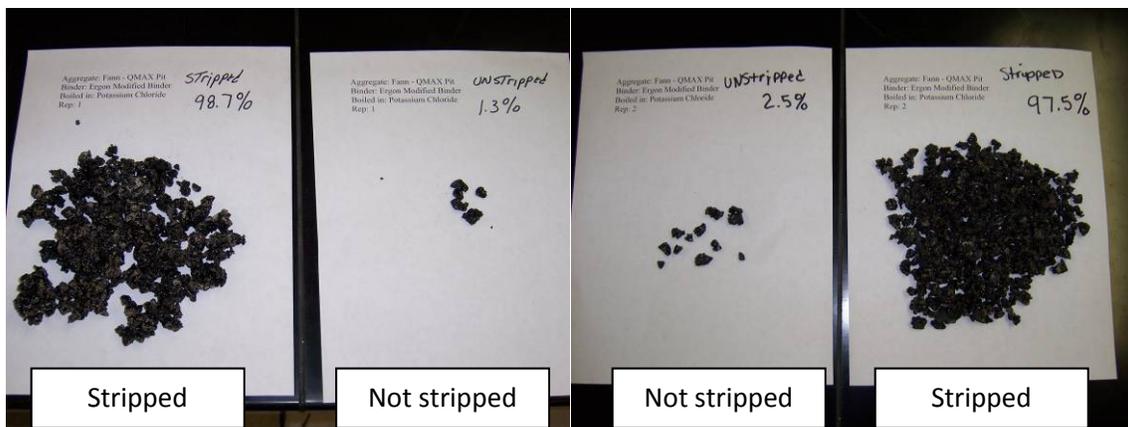
Source A Binder

Potassium Chloride

Replicate 1—98.7% Stripped

Replicate 2—97.5% Stripped

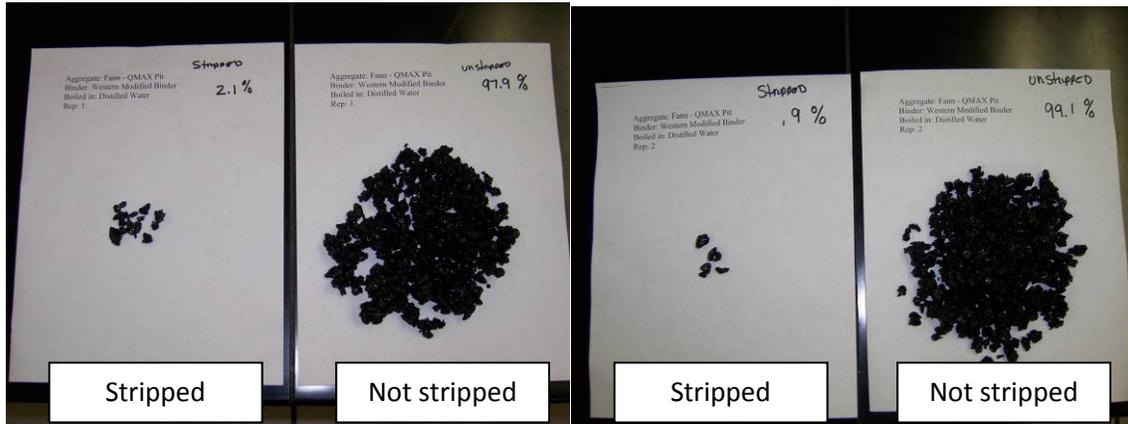
Source B Binder

Distilled Water

Replicate 1—2.1% Stripped

Replicate 2—0.9% Stripped

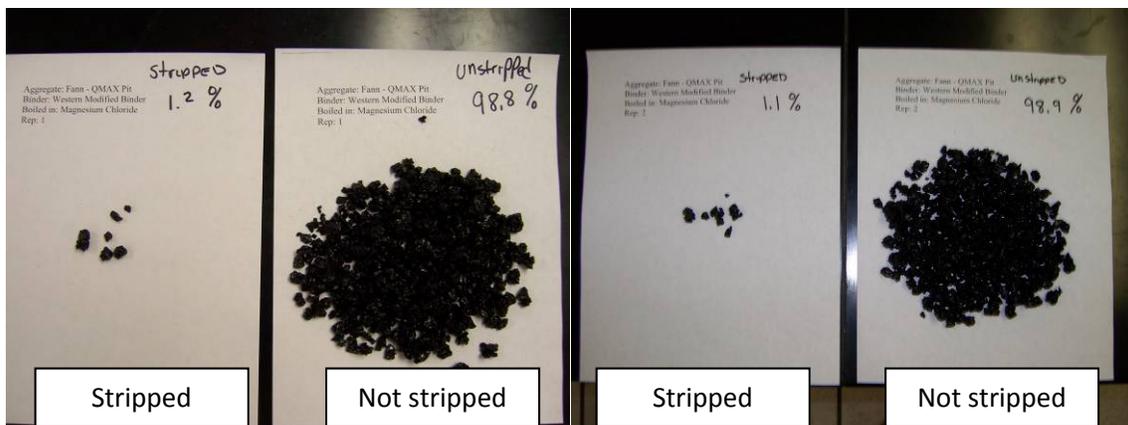
Source B Binder

Magnesium Chloride

Replicate 1—1.2% Stripped

Replicate 2—1.1% Stripped

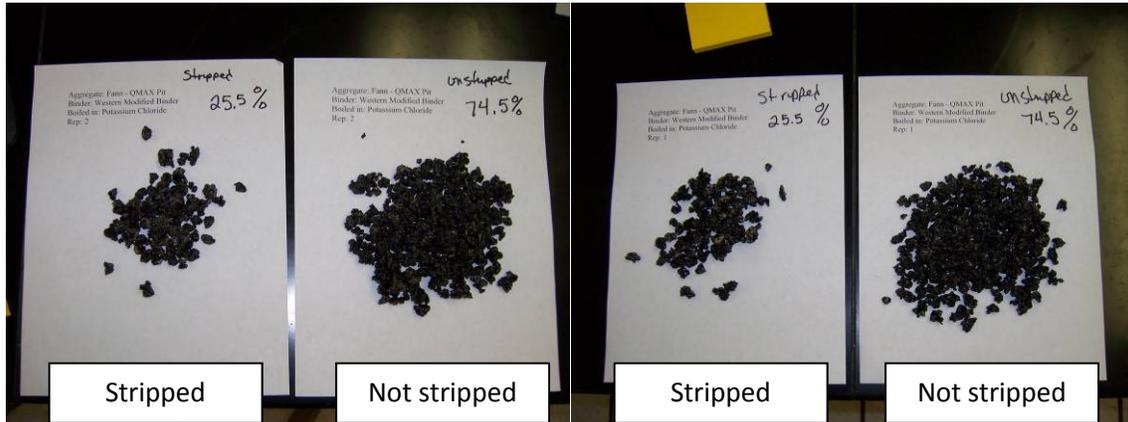
Source B Binder

Potassium Chloride

Replicate 1—25.5% Stripped

Replicate 2—25.5% Stripped

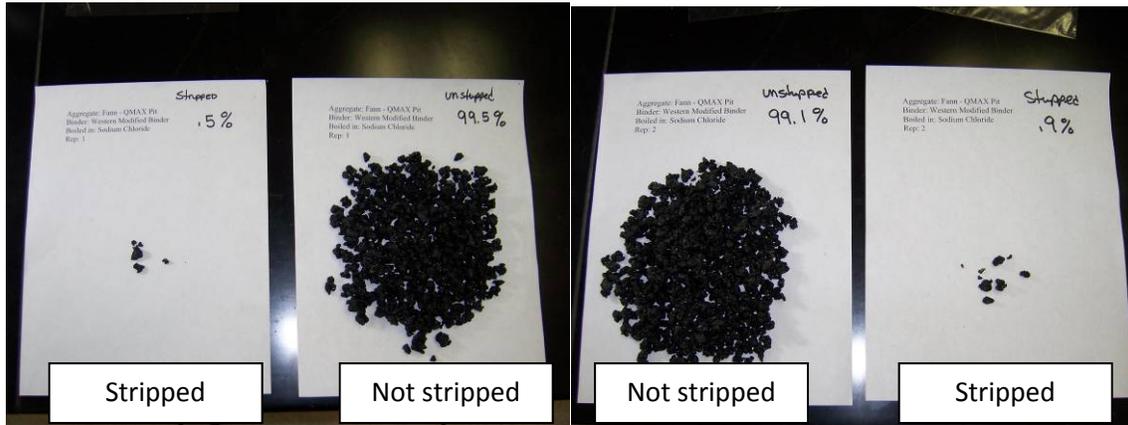
Source B Binder

Sodium Chloride

Replicate 1—0.5% Stripped

Replicate 2—0.9% Stripped

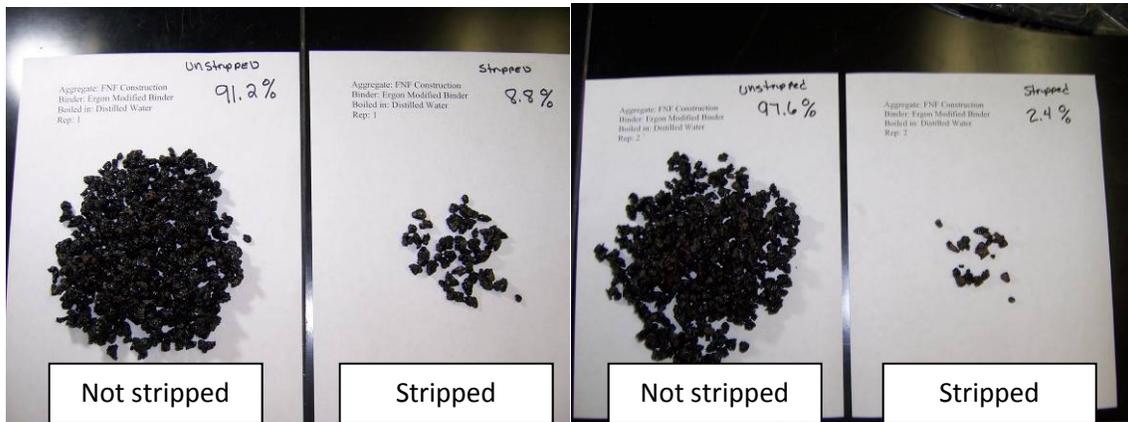
Source A Binder

Distilled Water

Replicate 1—8.8% Stripped

Replicate 2—2.4% Stripped

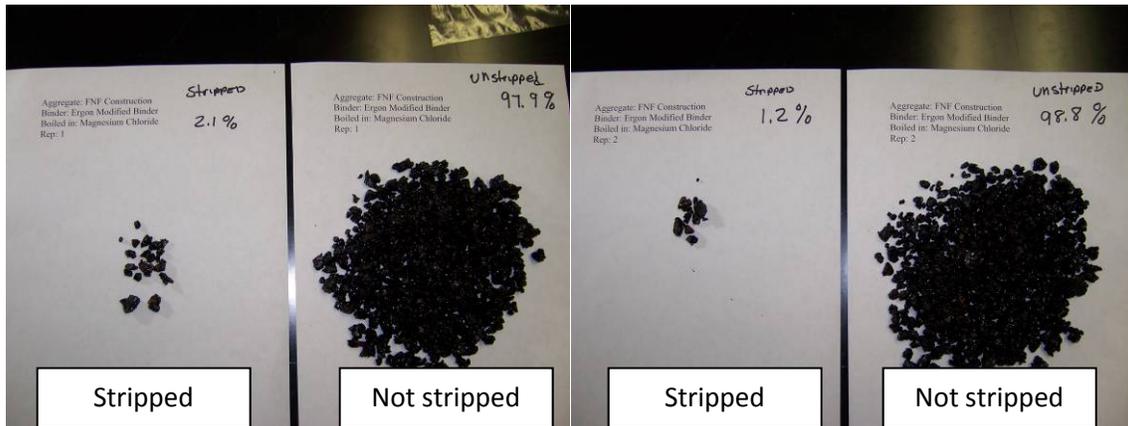
Source A Binder

Magnesium Chloride

Replicate 1—2.1% Stripped

Replicate 2—1.2% Stripped

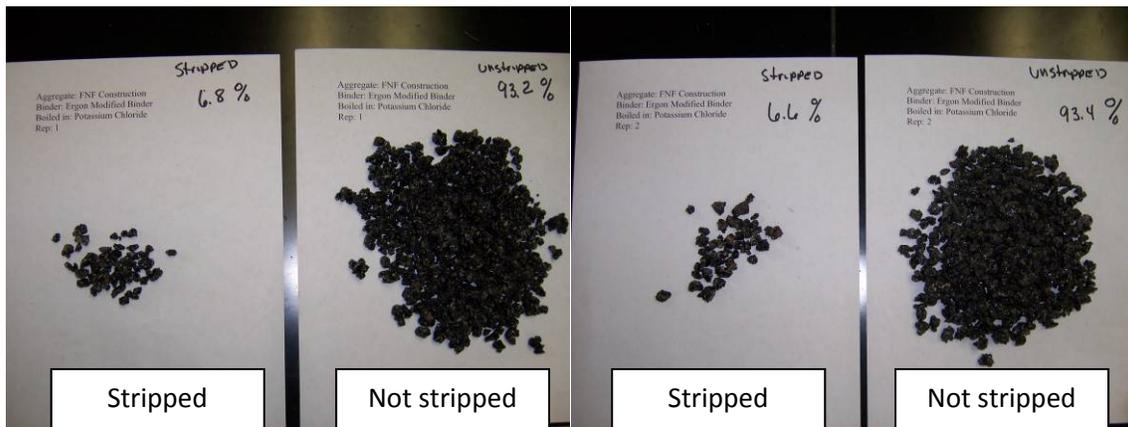
Source A Binder

Potassium Chloride

Replicate 1—6.8% Stripped

Replicate 2—6.6% Stripped

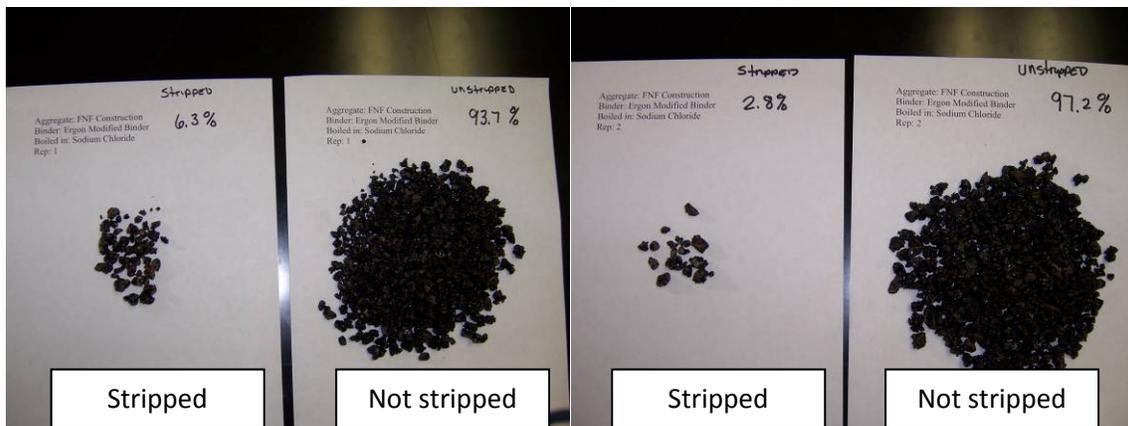
Source A Binder

Sodium Chloride

Replicate 1—6.3% Stripped

Replicate 2—2.8% Stripped

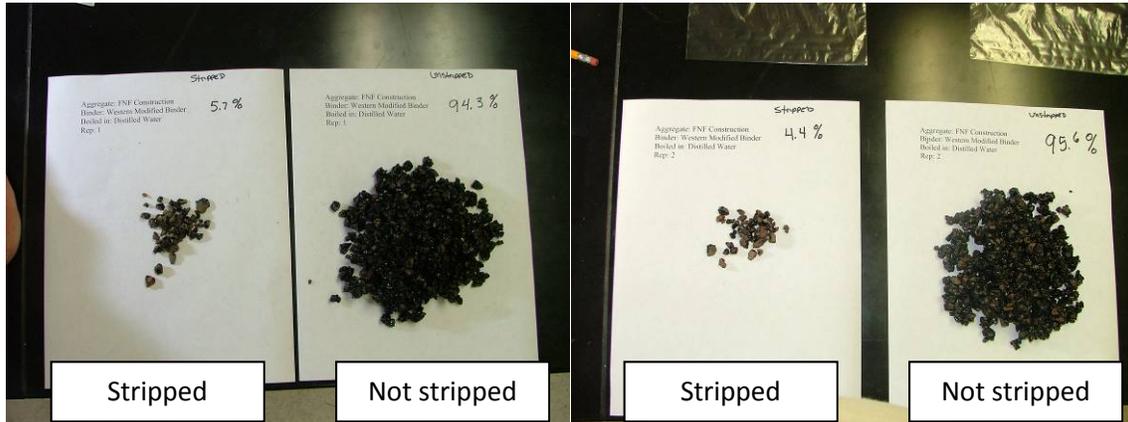
Source B Binder

Distilled Water

Replicate 1—5.7% Stripped

Replicate 2—4.4% Stripped

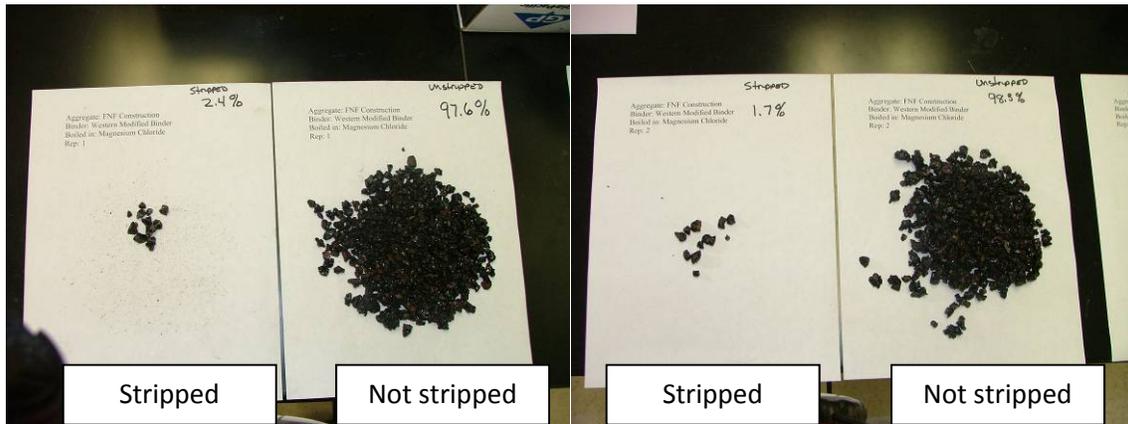
Source B Binder

Magnesium Chloride

Replicate 1—2.4% Stripped

Replicate 2—1.7% Stripped

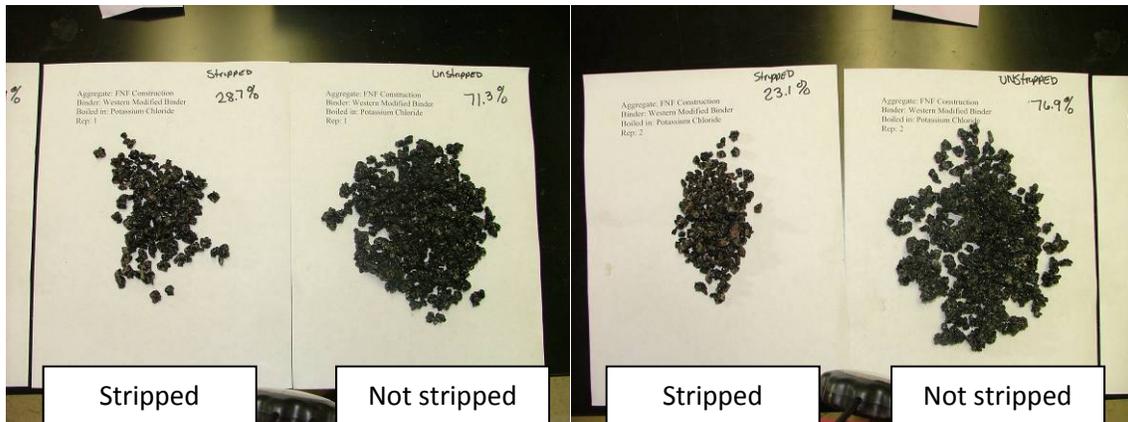
Source B Binder

Potassium Chloride

Replicate 1—28.7% Stripped

Replicate 2—23.1% Stripped

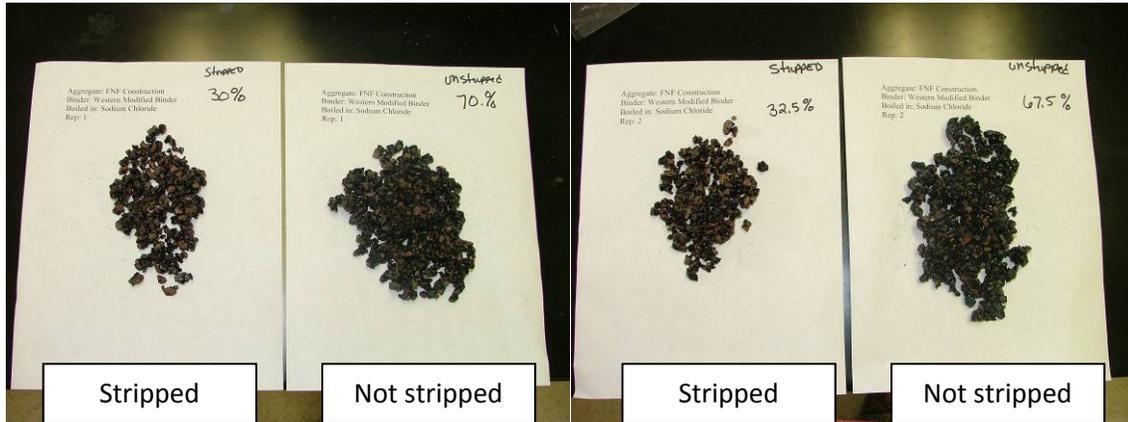
Source B Binder

Sodium Chloride

Replicate 1—30.0% Stripped

Replicate 2—32.5% Stripped

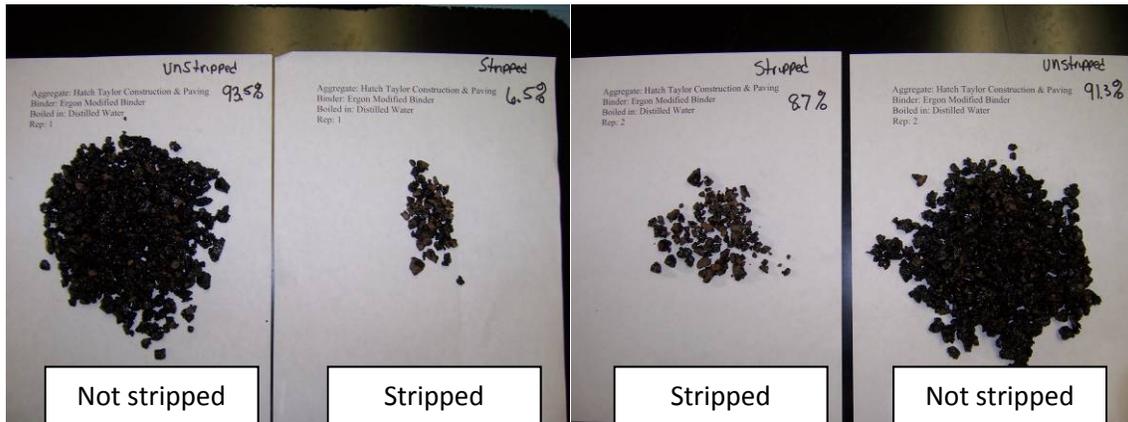
Source A Binder

Distilled Water

Replicate 1—6.5% Stripped

Replicate 2—8.7% Stripped

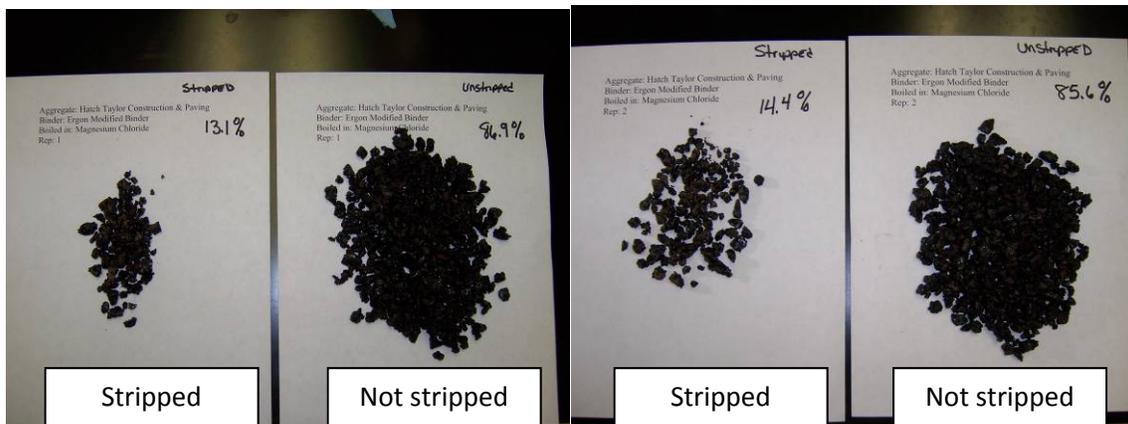
Source A Binder

Magnesium Chloride

Replicate 1—13.1% Stripped

Replicate 2—14.4% Stripped

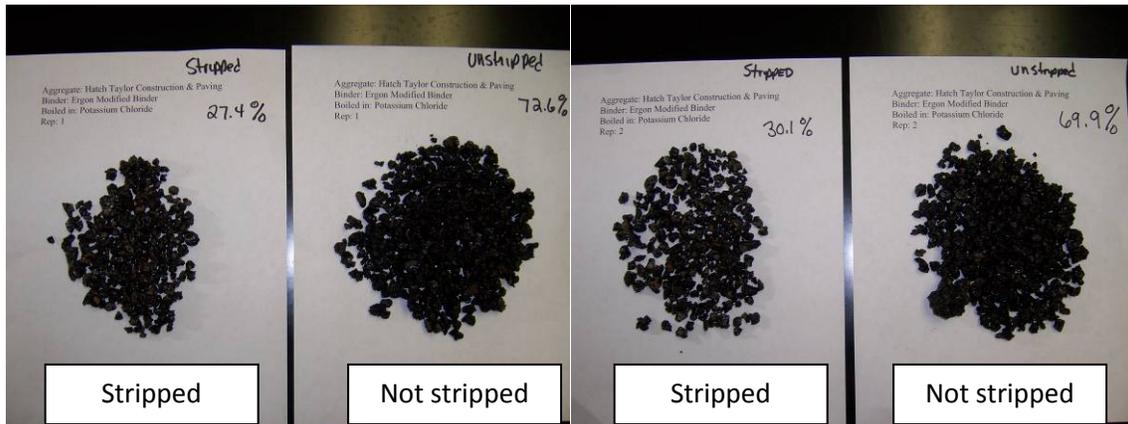
Source A Binder

Potassium Chloride

Replicate 1—27.4% Stripped

Replicate 2—30.1% Stripped

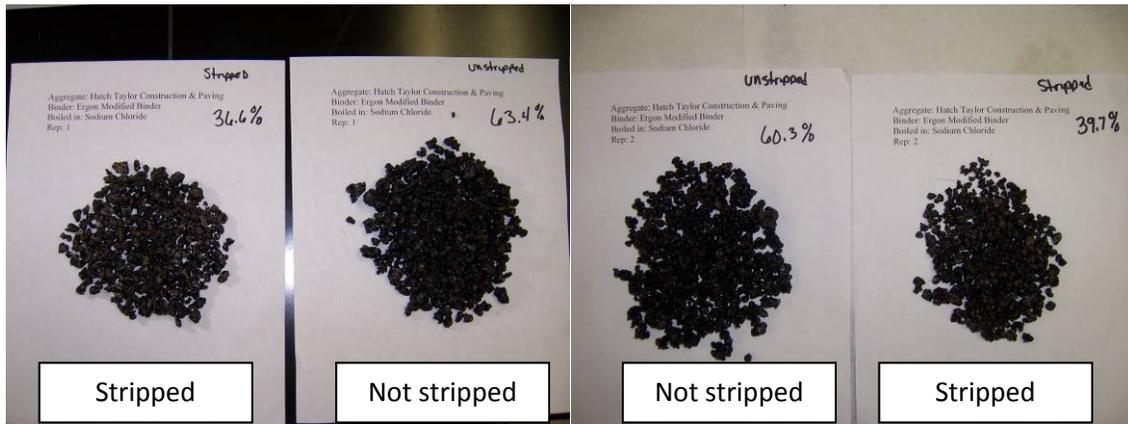
Source A Binder

Sodium Chloride

Replicate 1—36.6% Stripped

Replicate 2—39.7% Stripped

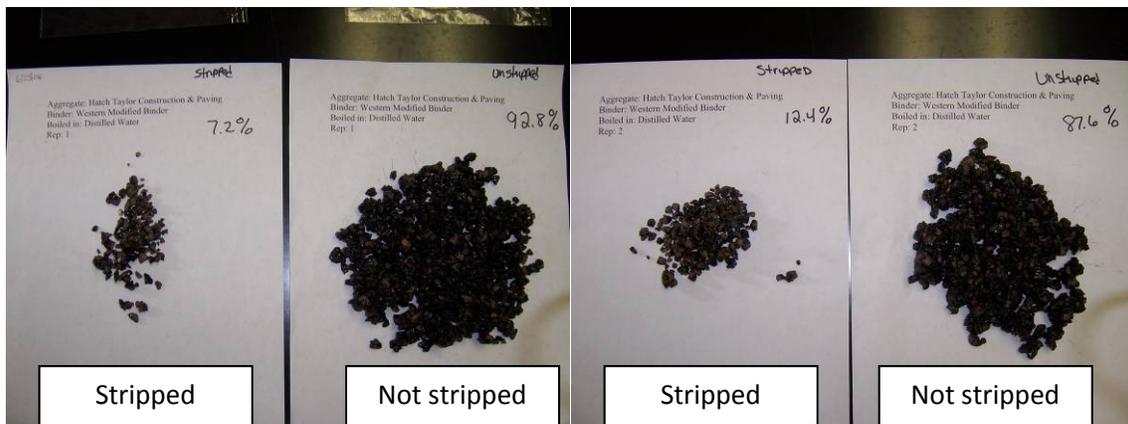
Source B Binder

Distilled Water

Replicate 1—7.2% Stripped

Replicate 2—12.4% Stripped
