Effects of Deicing/Anti-Icing Chemicals (DIAICs) on Rubberized Asphalt Pavements

SPR-617

September 2014

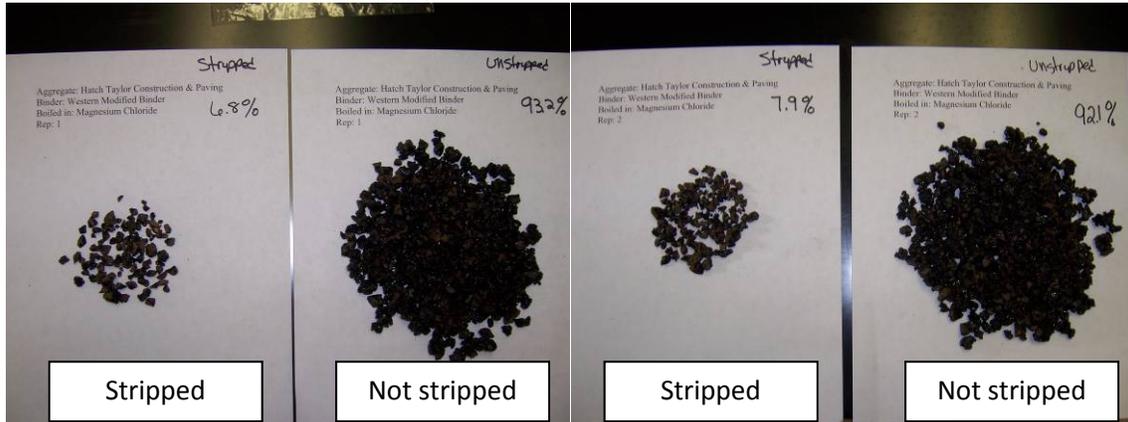
Source B Binder

Magnesium Chloride

Replicate 1—6.8% Stripped

Replicate 2—7.9% Stripped

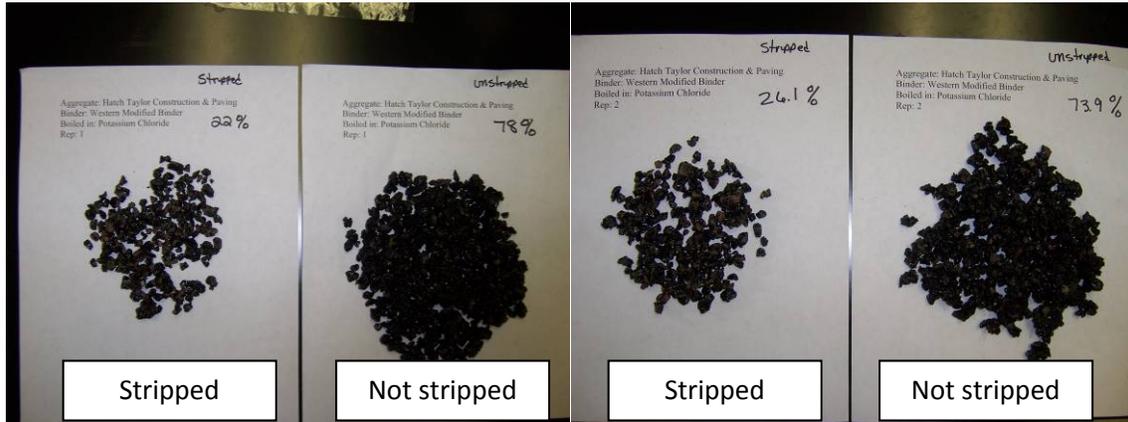
Source B Binder

Potassium Chloride

Replicate 1—22.0% Stripped

Replicate 2—26.1% Stripped

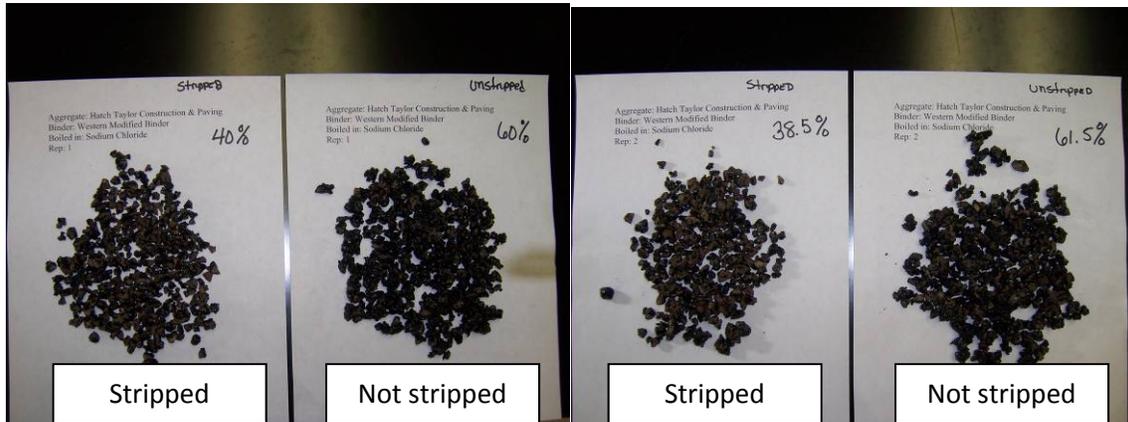
Source B Binder

Sodium Chloride

Replicate 1—40.0% Stripped

Replicate 2—38.5% Stripped
