**Federal Railroad
Administration**

Load Environment of Rail Joint Bars – Phase III Assessment of the Effects of Installation and Maintenance Practices

1. AGENCY USE ONLY (Leave blank)		2. REPORT DATE August 2015		1. AGENCY USE ONLY (Leave blank) August 2014
4. TITLE AND SUBTITLE Load Environment of Rail Joint Bars – Phase III Assessment of the Effects of Installation and Maintenance Practices			5. FUNDING NUMBERS Contract DTFR53-11-D-00008 Task Order 306

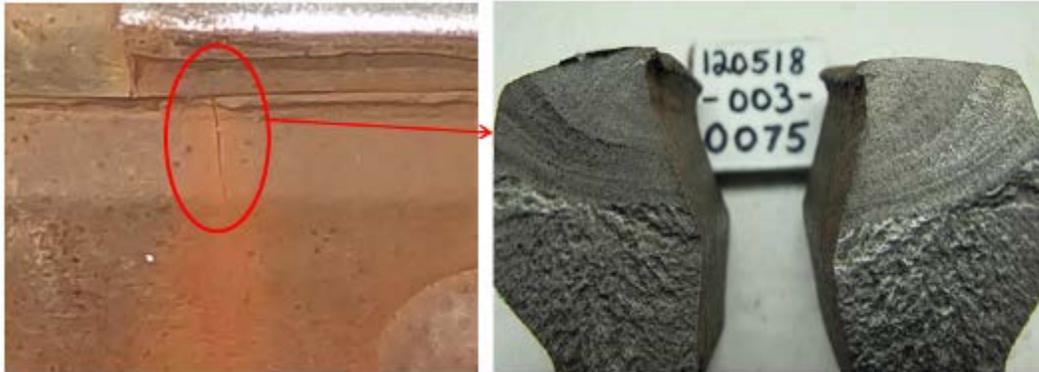
Figure 1. Top Center Crack

Top Center Crack: This type of crack initiates on the top of the joint bar, apparently at the location where the rail ends come into contact with the joint bar. Gouges from the railhead that dig into the joint bar and metal flow are associated with this type of crack. Figure 1 shows photographs of a crack at the top of the joint bar both before and after the bar was broken to expose the fracture surfaces. The mating fracture surfaces exhibit macroscopically visible ridges, sometimes referred to as clamshell or beach marks, which are characteristic of metal fatigue. Evidence of metal flow at the top of the bar can also be seen in the photograph on the right-hand side.

Crack initiation at the top center of the joint bar is likely the result of notching due to continued cyclical contact with the end of the railhead under passing loads. Surface hardening of joint bars, which is intended to improve the resistance to notching in areas of contact between the railhead and the top of the joint bar, was found to be ineffective. A comparison of hardened and unhardened joint bars HAL operations revealed that both resulted in metal flow at the top of

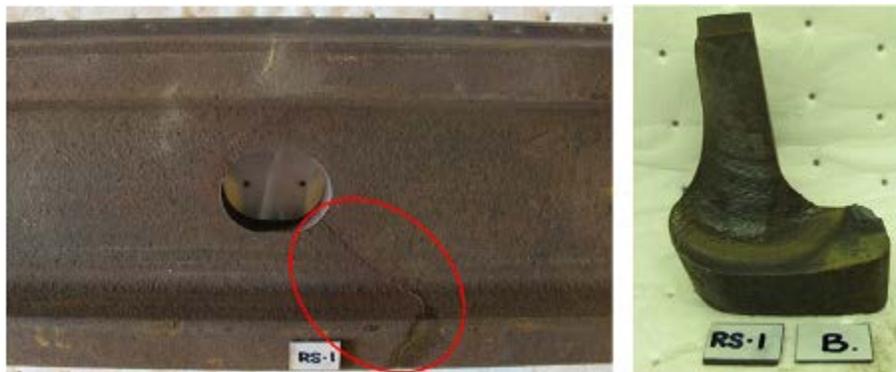
Figure 2. Joint Bar Bolt Hole Crack

Joint Bar Bolt Hole Crack: Cracks may be initiated at the rough spots on the inside of bolt holes that are produced from hot punching. In other words, the stress concentration that causes this type of crack is from the fabrication or manufacturing process rather than applied wheel loading. Such cracks appear to propagate toward the bottom or top of the joint bar at an angle. Figure 2 shows photographs of a joint bar bolt hole before and after the bar was broken to expose the fracture surfaces.

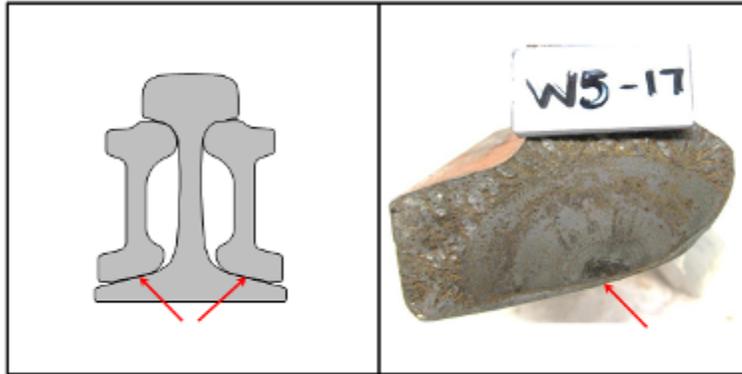
Figure 3. Bottom Center Crack

Bottom Center Crack: This type of crack starts from the bottom center where the joint bar makes contact with the rail base. Figure 3 also shows clamshell marks on the fracture surface of this type of crack, indicating that metal fatigue is the likely mechanism for crack initiation.

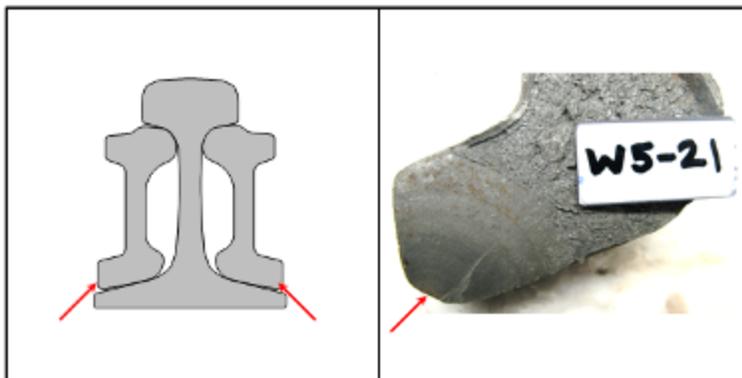
Figure 4. Bottom Edge Crack

Bottom Edge Crack: This type of crack starts at the bottom edge of the joint bar. Figure 4 shows the fracture surface of this type of crack, which exhibits the beach marks that are indicative of metal fatigue. Moreover, the bottom edge location on the joint bar, which appears to be the place where the crack was initiated, coincides with the location of maximum tensile bending stress due to passing wheels.

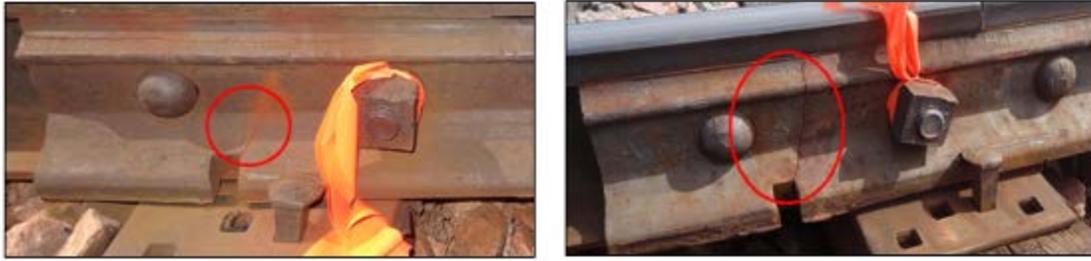
Figure 5. Quarter Crack and Quarter Break

Quarter Crack/Quarter Break: The quarter crack or break is commonly found in older types of angle bars that are longer manufactured. These angle bars have a long toe with square or rectangular holes to accommodate spikes. The corners of these spike holes are locations of high stress concentration, which leads to crack formation. Photographs of quarter defects are shown in Figure 5. The photograph on the left-hand side shows a crack emanating from the spike hole. The photograph on the right-hand side of the figure shows a crack that has propagated through the entire width of the bar, and in this case is called a quarter break.

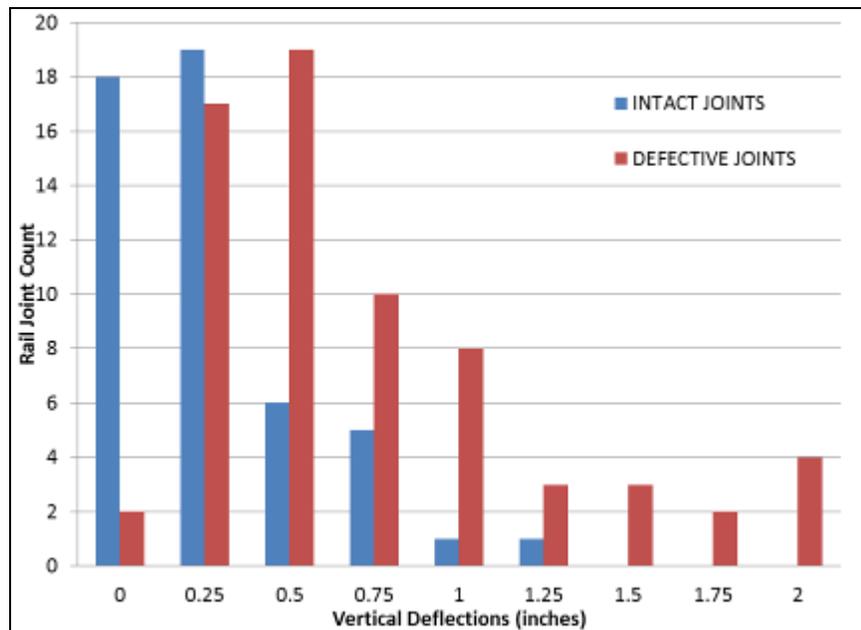
Figure 6. Distribution of Vertical Deflections for Intact and Defective Rail Joints

A review of the data collected from the field surveys and rail joints at FAST revealed that vertical deflection at the rail joint has a significant statistical correlation with intact and failed rail joints. Figure 6 shows the distribution of vertical deflections for intact and failed rail joints. Vertical deflections are grouped into ¼-in bins ranging between zero and 2 in. For example, the vertical deflections between zero and 0.24 in were measured at 20 joint locations; 18 at intact locations and two at defective or failed locations. The figure shows measurements from a total of 118 joint locations; 50 intact locations and 68 failed locations. Vertical deflections of 1.5 in or greater were measured at nine joint locations, all of which had defective or failed joint bars. Moreover, the figure shows more defective or failed joints than intact ones when the vertical deflections are ½ in or greater. At deflections less than ½ in, intact joints outnumber the failed ones.

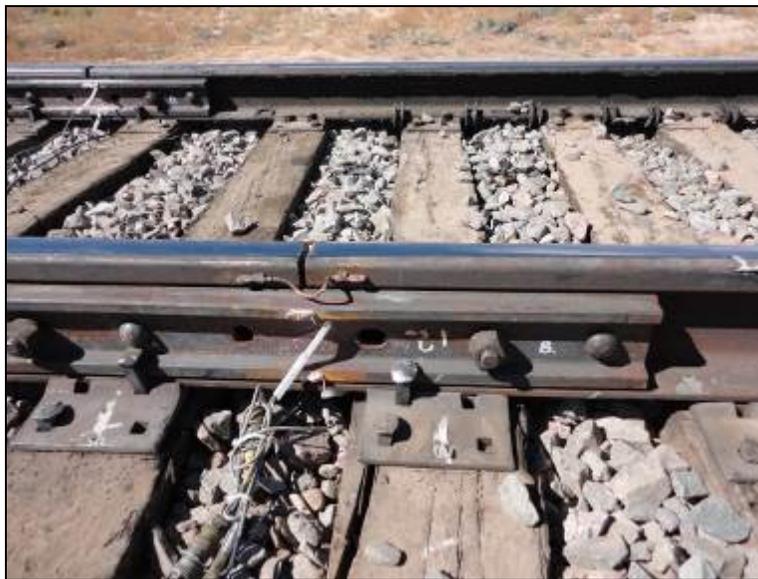
Figure 7. Installation of the Joint Bars in the Test Zone at FAST

Four standard joint bars, taken from Phase I of this study [1], were used in this investigation. Artificial notches that were approximately 0.12 in deep were machined into two of the joint bars at the top and bottom of the joint bar, as indicated in Figure 2. These joint bars were then installed in suspension (with the joints between the cross-ties) on a 5-degree curve section of track at FAST that had its ballast undercut before testing. The undercut ballast extended approximately five ties in length on either side of the joint bars (Figure 8). The two notched joint bars were grouped together on the outside (high) rail while the unnotched bars were grouped together on the inside (low) rail.

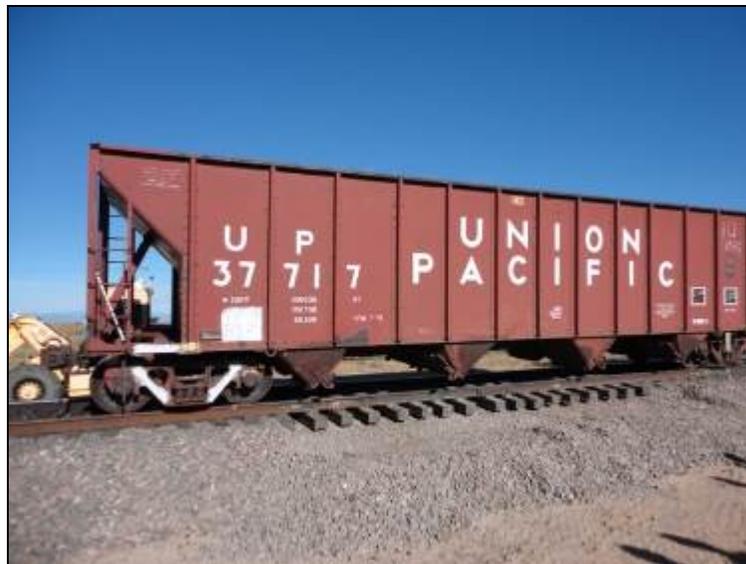
Figure 9. Placement of the Loaded Freight Car in the Test Zone

Before tamping, top-of-rail (TOR) elevations were taken over the test zone and on 20 crossties on either side of the rail joints. TOR elevations were taken with and without a static load of a freight car (approximately 315,000 lb), as Figure 9 shows. Then, the ballast was replaced and tamped before another set of elevation measurements was taken under identical conditions (i.e., with and without the static load of a loaded freight car).

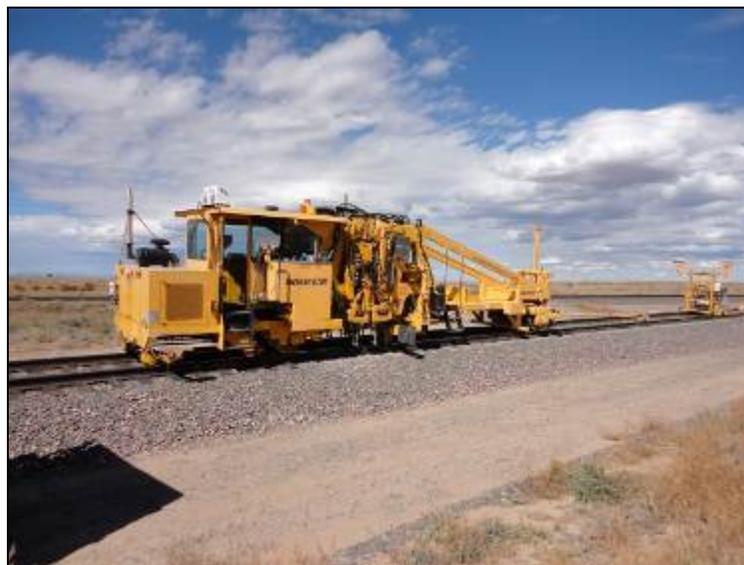
Figure 11. Tamper Used to Complete Surfacing Operations at FAST for this Study

Bending circuits were placed at two locations on each joint bar: top and bottom along the centerline (Figure 10). Bending strains were collected on all four of the joint bars while the track was lifted to a height typically observed during regular track surfacing operations. The tamper (Figure 11) ran through the test location and performed normal surface and lining operations,

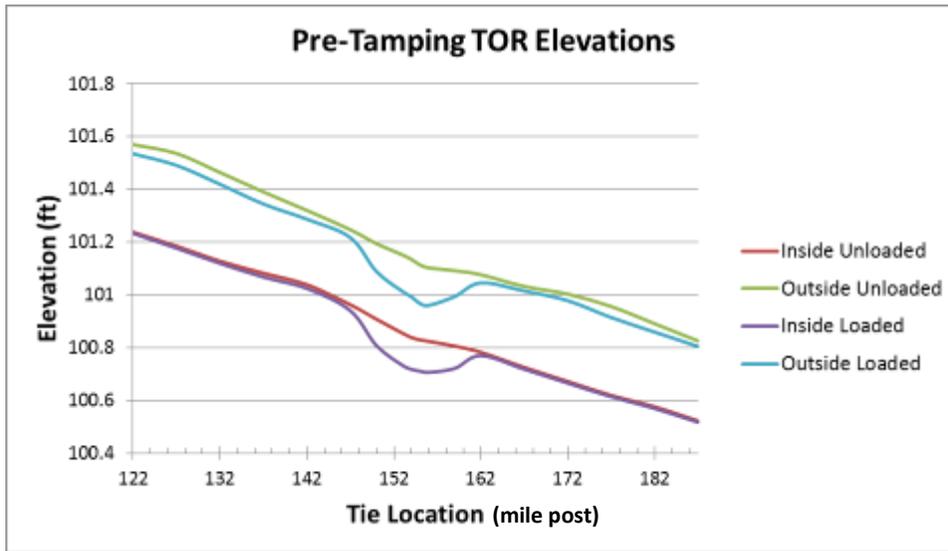
Figure 12. Plot of the Pre-Tamping TOR Elevations for the Test Zone, for both Loaded and Unloaded Scenarios

Figure 12 shows the results of the TOR elevations before tamping operations for both loaded and unloaded scenarios, while Figure 13 shows the corresponding results after tamping operations for the loaded and unloaded scenarios.

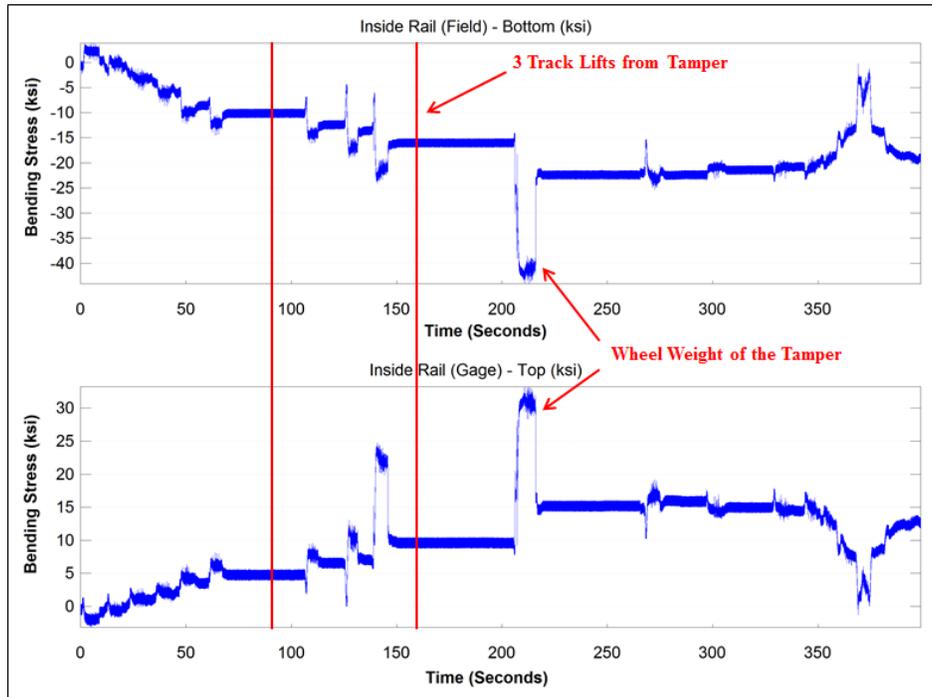
Figure 14. Stripcharts Presenting the Bending Stresses for Two of the Four Joint Bars

Bending strains were collected before, during, and after the tamping of the ballast underneath the test section at FAST. During the lifting, the top of the joint bar primarily experienced tension while the bottom of the joint bar experienced compression, as Figure 14 shows (which presents the strain output for two joint bars during surfacing). In general, the maximum bending stresses observed during the testing occurred while under the load of the tamper wheel, which notably exceeded the stress experienced by the joint bars due to the lifting of the track.

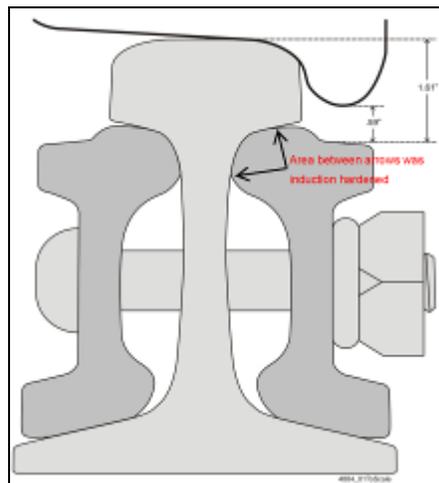
Figure 15. Locations of the Induction Hardened Areas on the Joint Bars

For this project, two joint bars were induction hardened to reduce the wear at the joint bar and rail interface. The joint bars were induction hardened in the areas shown in Figure 15 to a depth of approximately 1 in. The induction heat treatment was applied only to the middle 16 inches of each bar because that area is in contact with the bottom of the railhead. The joint bars selected had an initial hardness of approximately 300 Brinell Hardness Number (BHN). The desired hardness in the hardened section is between 410 and 450 BHN.

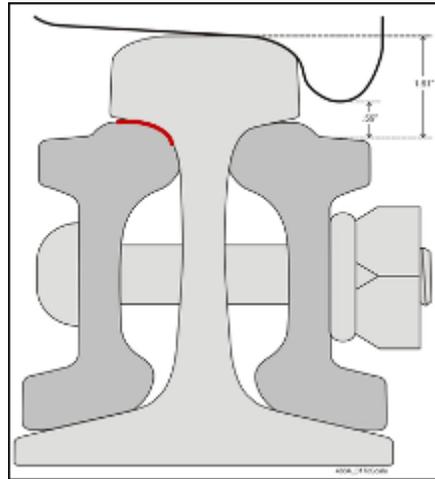
Figure 16. Diagram Noting the Location of Longitudinal Profile Measurements

A set of six measurement locations were established on two sets of standard joint bars (i.e., a pair of post-hardened bars and a pair of untreated bars). These locations (red area in Figure 16 and close-up photograph in Figure 17) allow for pre- and post-test comparisons to determine if there was a reduction in metal flow, which could potentially aid in the preservation of bolt torque in revenue service.

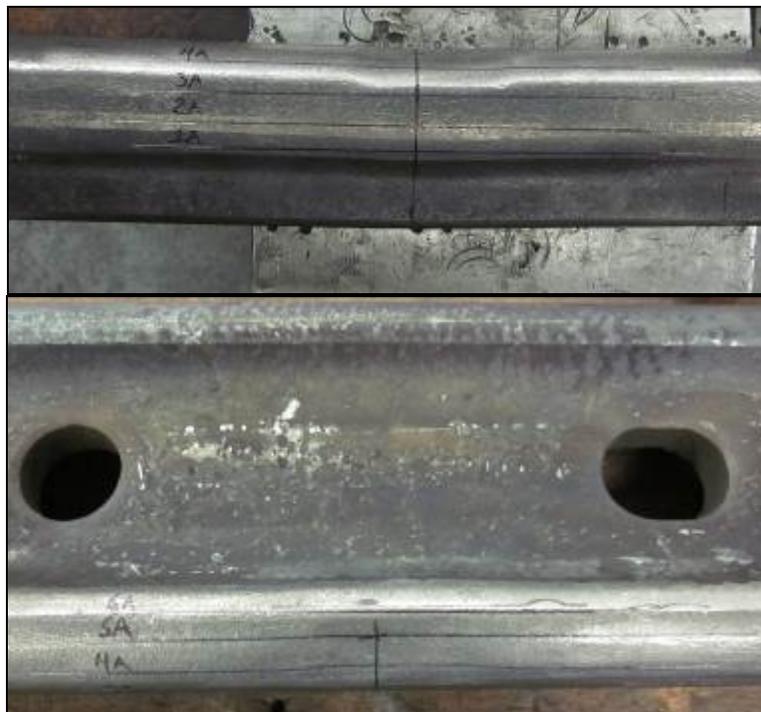
Figure 17. Longitudinal Profile Measurement Locations at the Top of a Test Joint Bar

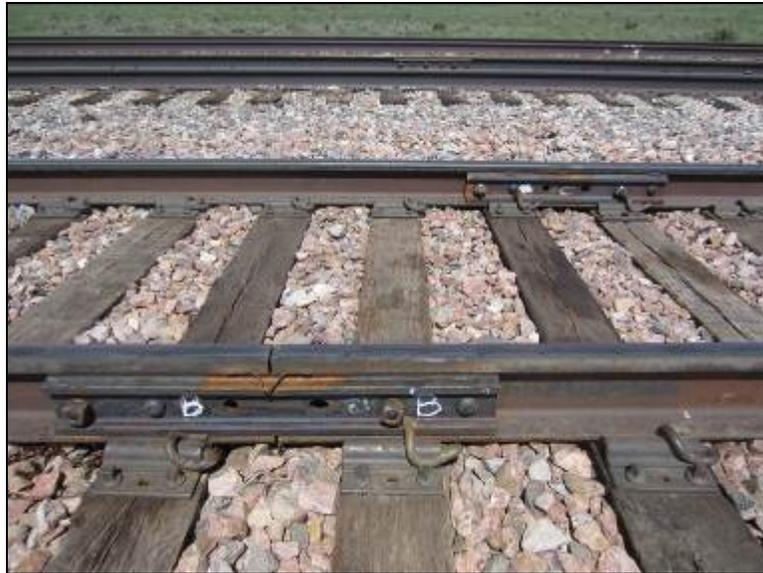
Figure 18. Installation of Standard and Post-Hardened Joint Bars at FAST

Before installation, baseline longitudinal profile measurements were taken on all four of the joint bars with a portable electronic profile measurement device. Next, the joint bars were installed in suspension on a tangent section of track at FAST and subjected to 55 MGT of HAL traffic over the course of five months. The two post-hardened joint bars were installed on the field side of the outside and inside rails, while the untreated bars were installed on the gage side of the rails. Four bolts were installed on each set of joint bars, as Figure 18 shows, and tightened to 600 ft-lb of torque. A second and final set of measurements were gathered after the joint bars were removed from the track.

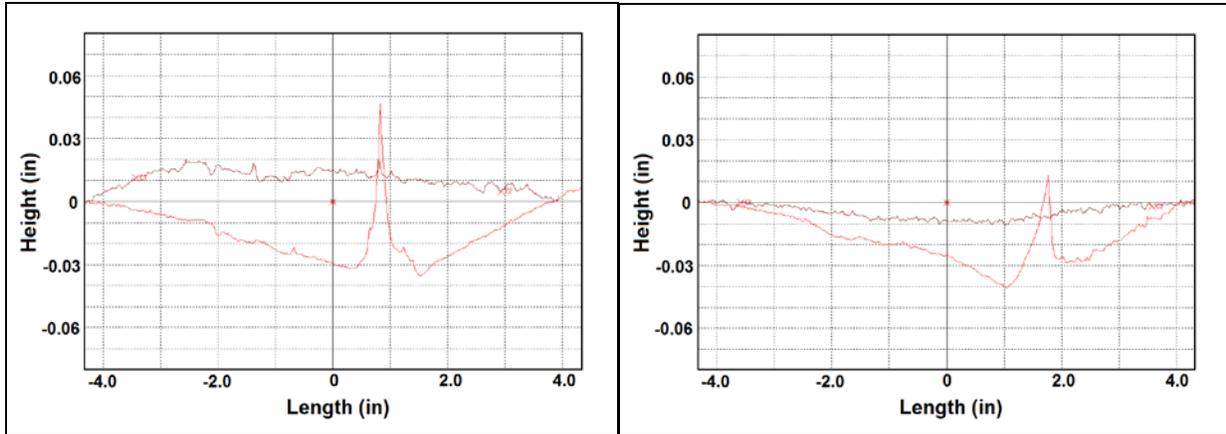
Figure 19. Pre- and Post-Test Longitudinal Profiles for an Untreated (left) and a Post-Hardened (right) Joint Bar

After 55 MGT was accumulated at FAST, the joint bars were removed. Longitudinal profiles of the joint bars were taken and compared against the profiles made at the start of testing. The comparison revealed a buildup of metal flow adjacent to the easement at the top of the joint bars; there were differing amounts of metal flow between each of the joint bars, but there did not appear to be a distinguishable difference between the joint bars treated with the induction hardening process and the untreated joint bars. Figure 19 shows the longitudinal profiles in the area of metal flow for all of the test joint bars, while Figure 20 shows photographs of the metal flow areas (outlined in red) for an untreated and a post-hardened joint bar.

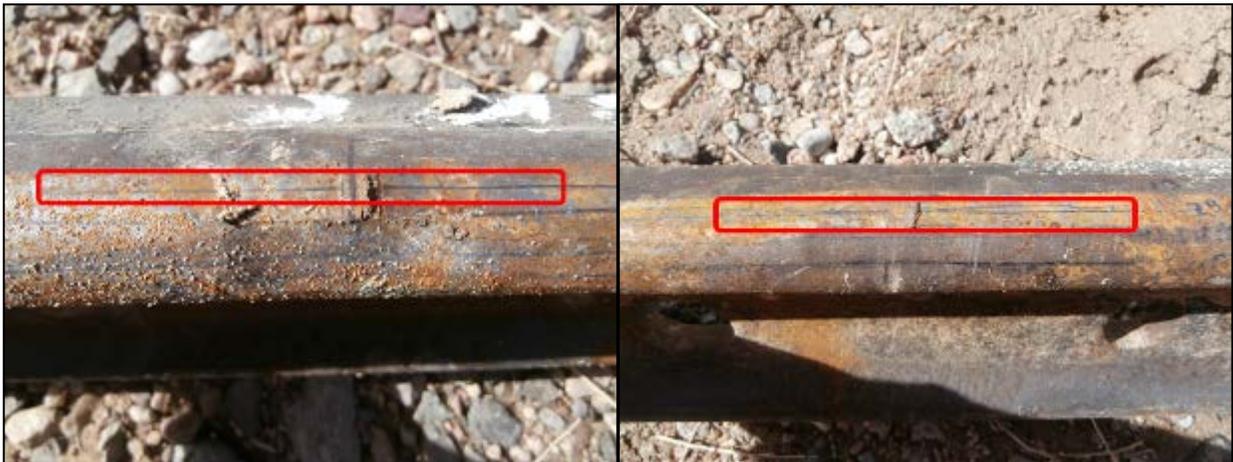
Figure 20. Post-Test Metal Flow for an Untreated (left) and a Post-Hardened (right) Joint Bar

Results have been interpreted qualitatively, because the permanent bending of the joint bar did not allow for an adequate reference that could provide accurate quantitative information on the amount of material accumulated adjacent to the easement. Photos taken following the joint bar's removal from the track (see Figure 20) show contact was primarily focused in the area on top of the joint bar, just above the easement, where the bottom of the railhead makes contact with the top of the joint bar. The easement is partially filled with material from areas outside the easement, leading to more contact with the railhead. This condition is most likely the result of higher contact forces adjacent to the easement, which were also observed in the FEA (see Section 7). Bolt torque loss would accelerate this condition by amplifying the bending, resulting in more contact with the railhead.

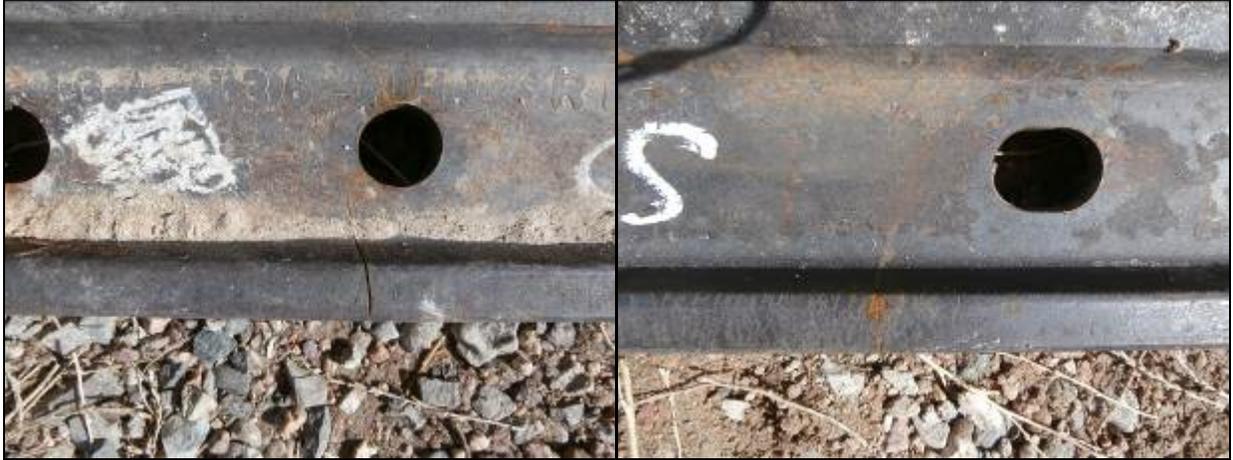
Figure 21. Fatigue Cracking in an Untreated (left) and a Post-Hardened (right) Joint Bar

During the in-track testing, cracks began to form on an untreated and a post-hardened joint bar (Figure 21), which emanated from the bottoms of the joint bars and progressed upward (under the center-left bolt hole in the untreated bar and at the midsection in the post-hardened bar). Both joint bars were removed from track before the cracks reached the bolt holes.

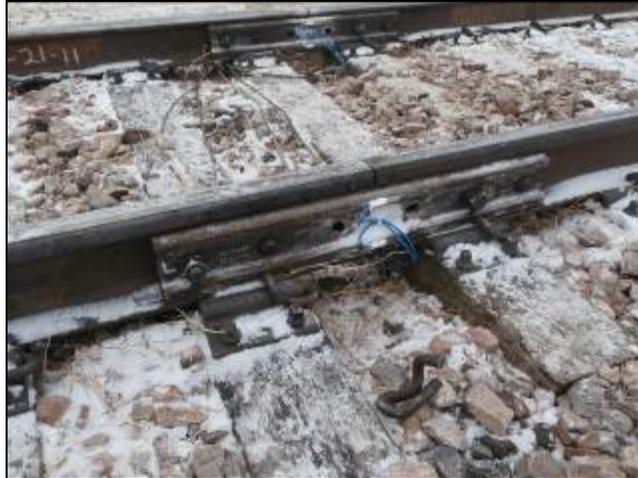
Figure 22. Installation of Instrumented Joints Bars at FAST

Four standard 132-pound joint bars were instrumented with strain gages along the central axis (recall Figure 10). These joint bars were then installed in suspension on a tangent section of track at FAST (see Figure 22), joining the parent rails with two short plugs, one on each rail (i.e., outside and inside). Both joints were located across from one another, offset by two crossties. These short plugs were joined to the adjacent parent rail, using the test bars on the west end and standard bars on the east end of each plug. This configuration allowed the gap to be easily adjusted for the differing gap sizes, as per the requirements of testing. The gap was maintained using rail anchors to prevent movement of the plug rail underneath the test train consist. An IWS, with a static wheel load of 39,000 lb, was used to gather data on the vertical impact forces at each of the joints. Sampled at 1200 Hz and filtered at 100 Hz, the IWS allows for the continuous measurement of wheel/rail forces at the interface, namely vertical, lateral, and longitudinal forces with a valid upper frequency of approximately 600 Hz. Wheel/rail forces and bending strain data (with a sampling rate of 512 Hz) were collected from both pairs of joints for 0-, $\frac{1}{2}$ -, and 1-in gaps at 10, 25, and 45 mph (clockwise (CW) and counterclockwise (CCW) movements). It should be noted, however, that due to the winter weather conditions at the time of testing, the gap could not be fully closed for the 0-in test runs, resulting in a gap approximately $\frac{1}{8}$ -in wide.

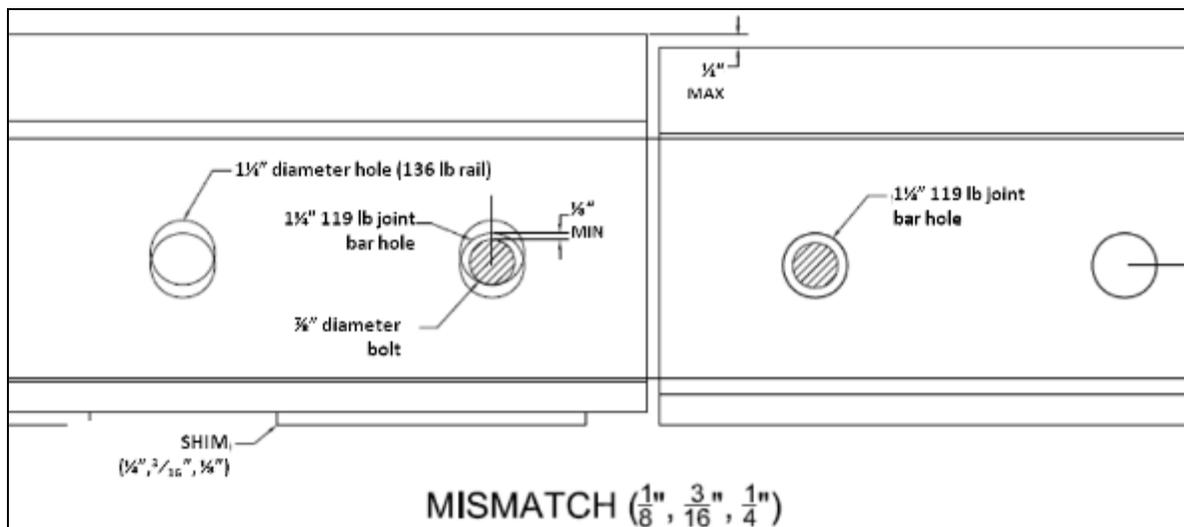
Figure 23. Plan View of an Example Railhead Mismatch Test Setup (1/2 in)

An identical approach was used to evaluate the bending stresses and vertical impact forces for differing railhead mismatch configurations. Four standard 119-pound joint bars were instrumented with setups that were identical to the bars used in testing rail gaps and installed at the same locations, which placed the joint bars across from one another and offset by two cross-ties. The gap was maintained at $\frac{1}{4}$ in using rail anchors on the plug rail. Shim plates were used to adjust the height of the parent rail to the mismatch sizes outlined in the test plan (i.e., $\frac{1}{4}$ -, $\frac{3}{16}$ -, $\frac{1}{8}$ -, and 0-in mismatches). Figure 23 is a plan view of this setup. IWS and bending strain data was collected from both pairs of joint bars at 10 and 25 mph for the $\frac{1}{4}$ - and $\frac{3}{16}$ -in mismatches, respectively, and at 45 mph for 0- and $\frac{1}{8}$ -in mismatches (CW and CCW movements).

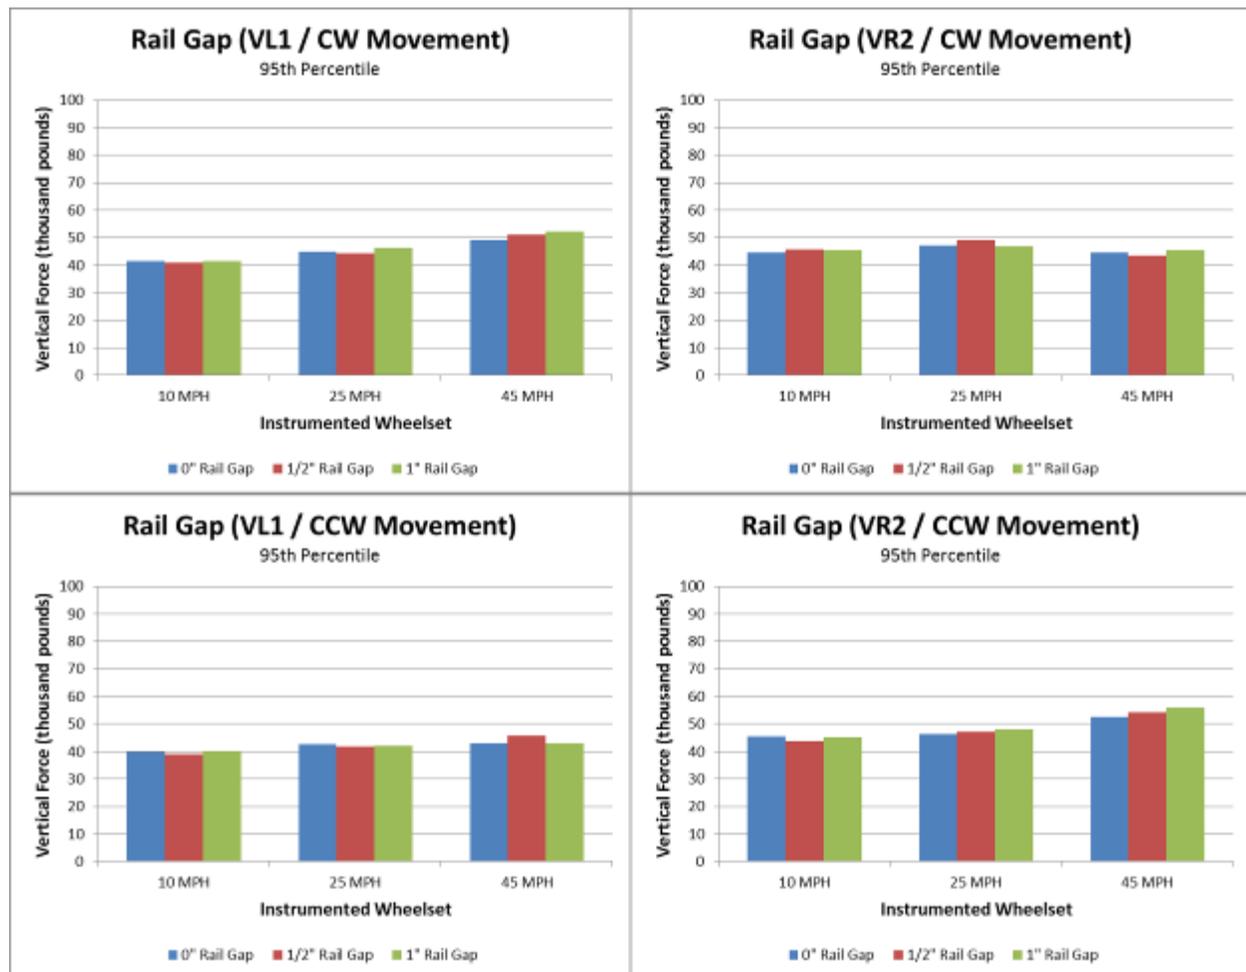
Figure 24. Plots of the 95th Percentile for IWS Vertical Wheel Force Data (Rail Gaps)

Figure 24 shows plots of the 95th percentile of the vertical force responses, gathered over a range of 30 ft (an offset of 15 ft on either side of each rail joint was used) and collected on the differing rail gaps, namely left wheel of axle #1 (VL1) and right wheel of axle #2 (VR2). From the results collected by the IWS at the location of the two sets of joint bars, there appears to be a relationship between speed of the train consist through the test zone and the vertical force response (i.e., increased speed results in an increased vertical wheel force). However, it does not appear that there is a consistent difference between CW and CCW movements. Figure 25 is a time history of the IWS vertical wheel force data, which does not show distinguishing patterns that separate the test zone from the remainder of the section at FAST. The vertical wheel forces within the test zone do not appear to differ significantly from those in the surrounding track.

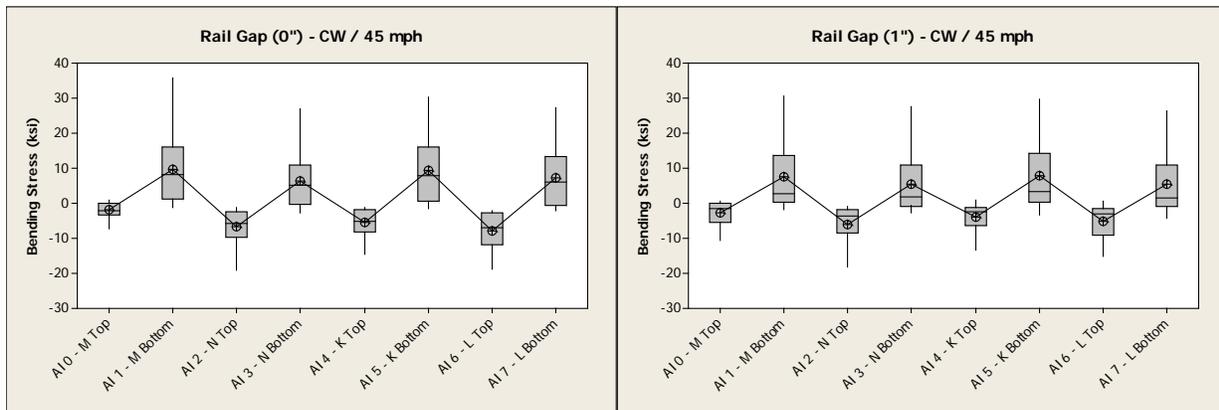
Figure 28. Box Plots of the Bending Stresses under the IWS for Each Circuit (Rail Gap)

Although, it does appear that the distributions of each vary slightly between the two configurations; while the smaller gaps are more normally distributed between the 25th and 75th percentiles, those with larger gaps tend to be skewed toward higher states of either compression or tension, depending on the location of the strain gage.

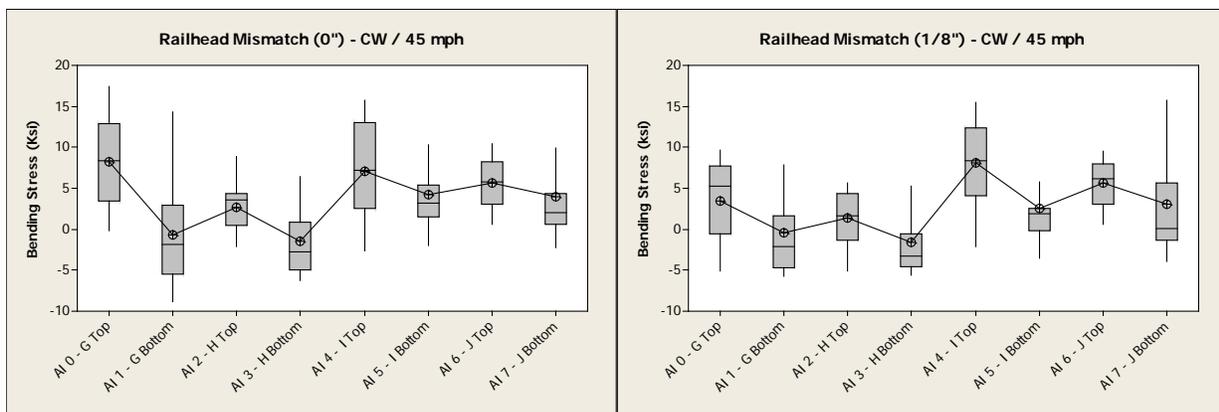
Figure 29. Box Plots of the Bending Stresses under the IWS for Each Circuit (Railhead Mismatch)

By comparison, the bending stresses in rail joints with varying railhead mismatches differ greatly from those in joints with gaps. As Figure 29 shows, even though the bending stress are notably below 20,000 pounds per square inch for both compressive and tensile states, the joints bars are dominantly in compression under the passage of the 39,000-pound wheel loads.

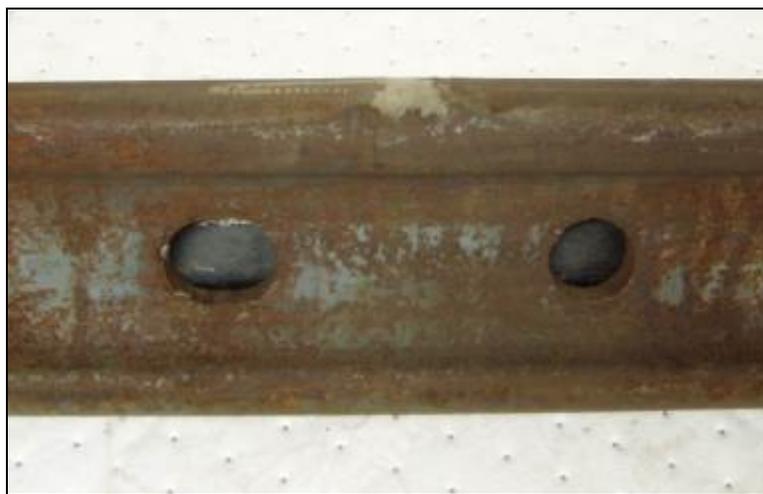
Figure 30. Area of Interest/Stress Concentration Location

One hundred samples were collected from both revenue service and at TTC (80 joint bars were temporarily donated by a western railroad and 20 were collected from onsite trackage at TTC). Information on material flow and hardness was collected on all samples, then TTCI's NDE team performed computed radiography on all samples and determined whether there was a correlation between the metal flow and propagation of fatigue cracking. The inspection area of the joint bars focused on high-stress concentration locations between the center bolt holes and the head of the joint bar (Figure 30).

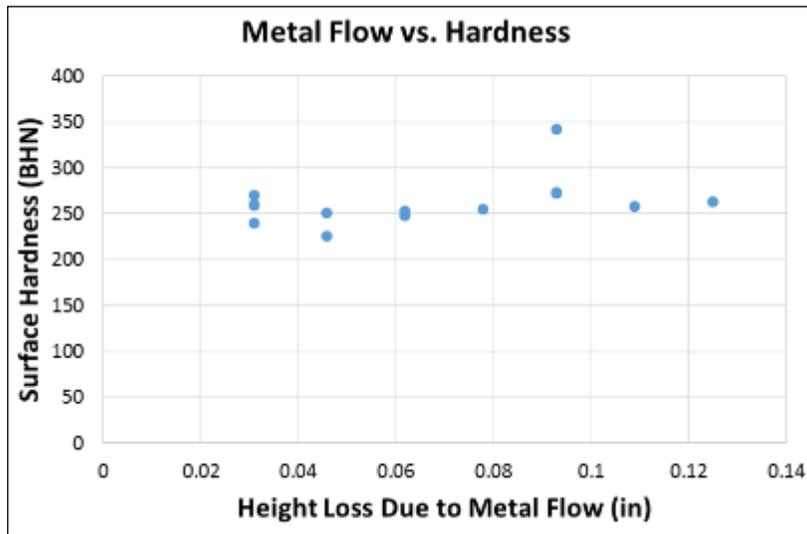
Figure 31. Plot of the Height Loss Due to Metal Flow against Surface Hardness

There was little correlation between joint bar surface hardness and metal flow depth at the top center of joint bars, as Figure 31 shows. Surface hardness was used as a proxy for the presence of a notch (stress raiser) likely to cause joint bar cracking, because too few joint bar samples had cracking. The lack of hardness and flow depth correlation suggests that a simple measure of flow depth cannot yet be used to reject joint bars from re-using them in track. A larger sample of joint bars, including more cracked bars, is needed to reach a definitive conclusion.

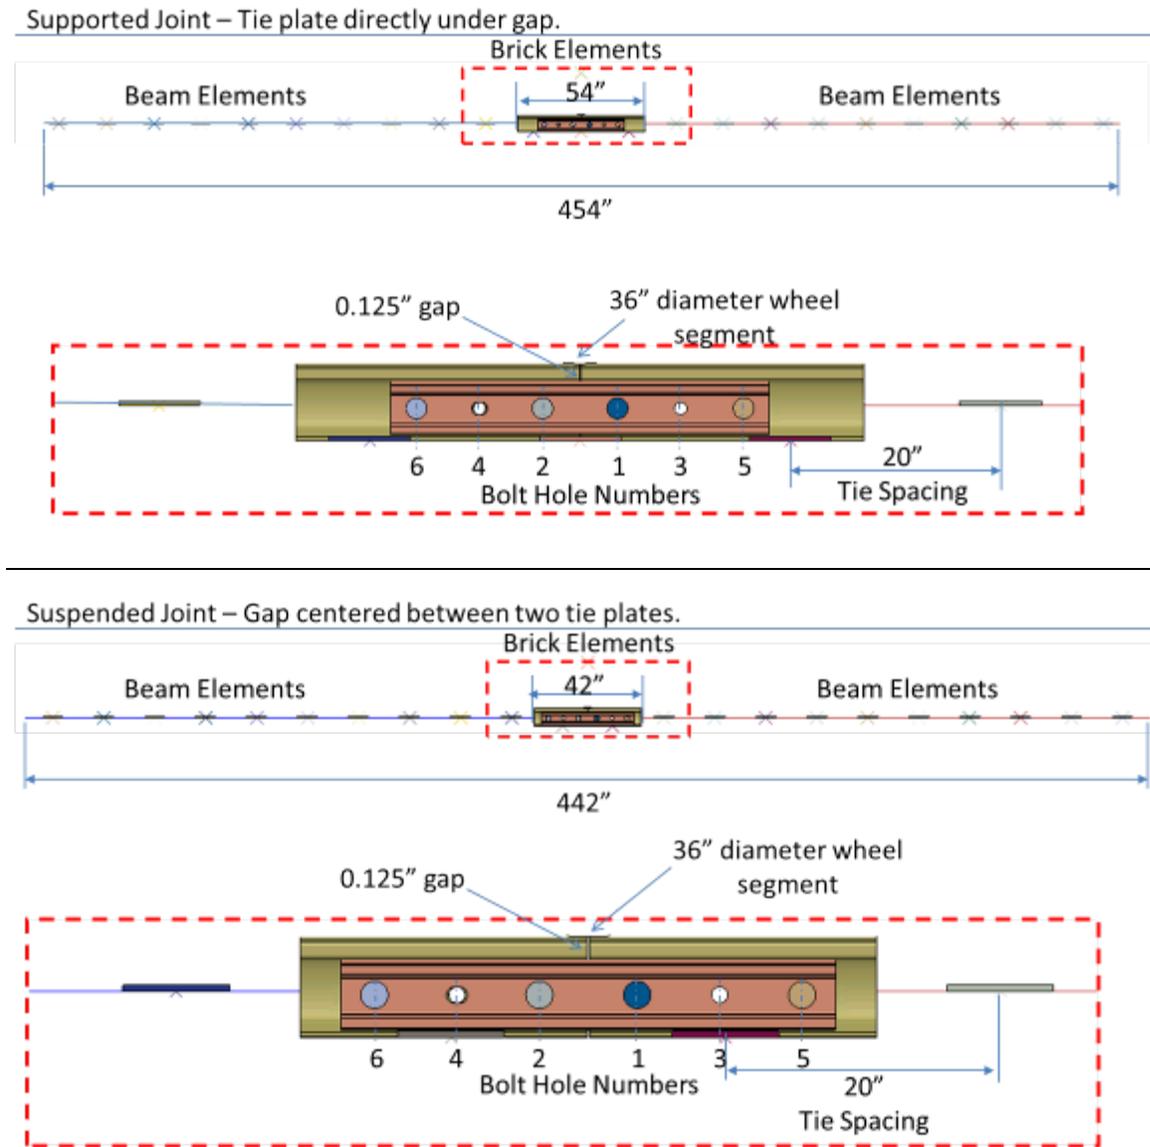
Figure 32. Finite Element Model Setup for Supported and Suspended Joints

Figure 32 shows schematic diagrams for the setup of two finite element models used for present analyses; one for a supported joint in which a cross-tie is located at the center of the joint and another for a suspended joint in which the span of the joint rail joint is centered between two cross-ties. In both models, brick elements are used to represent the rail and joint components (e.g., joint bar and bolts) in the vicinity of the joint, while beam elements are used to represent the rail away from the joint.

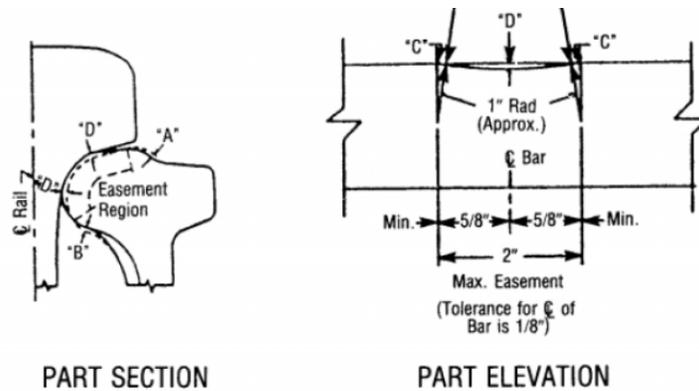
Figure 33. Recommended Head Easement for Head-Free Joint Bars [6]

Observations from the field surveys indicate that the most common type of defect found in standard joint bars is crack at the top center of the bar [3]. As discussed in Section 2, metallurgical analysis of the fracture surfaces suggests that this type of cracking is caused by metal fatigue. Another factor that contributes to cracking at the top of the joint bar is thought to be a lack of easement. In the context of joint bars, an easement is a recessed portion or depression in the bar, presumably intended to reduce the possibility of rail end contact with the top of the joint bar. Figure 33 shows the AREMA recommendation for easement in head-free joint bars [6]. If the joint bar does not have an easement, or if the easement is not properly aligned, knife-edge contact between the rail ends and the top of the bar can create an area of localized stress concentration (which can cause fatigue crack initiation).

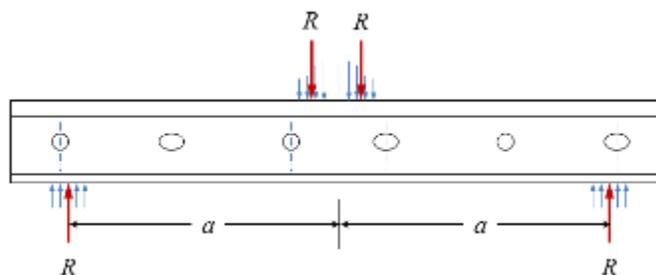
Figure 34. Joint Bar Reactions under Positive Bending

The effect of easement was examined by the FEA, which determined the locations of contact between rail and joint bar and estimated the relative magnitude of contact forces and pressures acting on the bar and the rail. Figure 34 shows a free-body diagram of the forces acting on a joint bar under a positive bending moment. The distance between the two distributions of pressure on the top of the joint bar are intended to represent the location where the rail ends do not contact the joint bar due to the easement. Moreover, the schematic shows the anticipated pressure distributions acting on a joint bar.

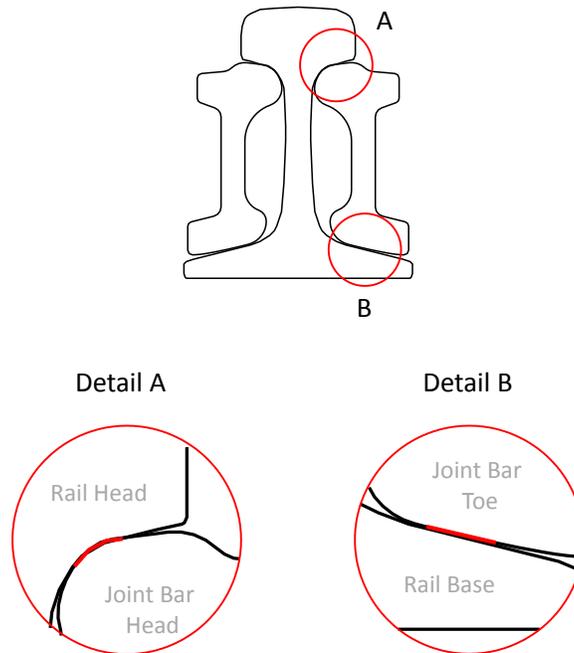
Figure 35. Potential Locations for Contact between Rail and Joint Bar

Figure 35 is a schematic of the rail joint cross section that shows two locations where contact between the rail and the joint bar are likely to occur. Moreover, these locations have been identified in Section 2 as potential locations to develop or initiate cracks at the top and bottom of a joint bar.

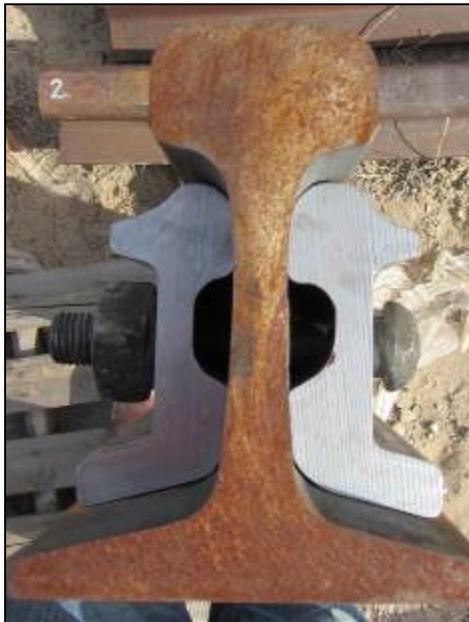
Figure 36. Example Prototype Joint Bar Design

A nonproprietary example of these designs is shown in Figure 36 [8]. The bar provides for more contact area with the rail in the web and corner fillets. Figure 37 compares the rail contact areas of the standard and new design joint bars. This larger area is intended to increase longitudinal load carry capacity before allowing rail slippage. The cross section also allows for an easement at the top of the bar. This is intended to reduce the gouging seen on the tops of some current bars from which joint bar cracking is known to occur. This design also claims to reduce bar stresses near bolt holes by improving bar support in this area.
