Conclusions from the Investigation of Deterioration of Joints in Concrete Pavements

**Final Report
February 2016**

Federal Highway Administration (FHWA) Transportation Pooled Fund TPF-5(224): FHWA, Colorado, Indiana, Iowa (lead state), Michigan, Minnesota, New York, South Dakota, Wisconsin, American Concrete Pavement Association, Iowa Concrete Paving Association, Portland Cement Association

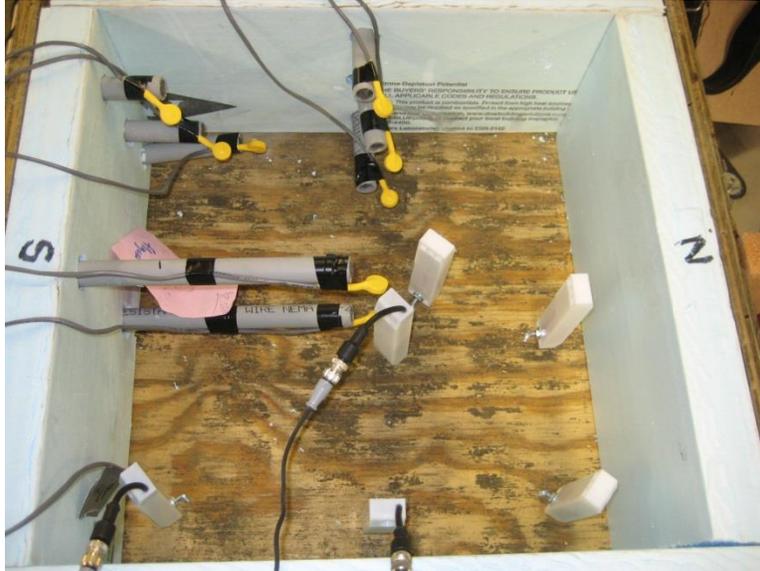
Figure 1. Temperature and humidity sensor layout

The instrumentation layout is shown in Figure 1 and Figure 2.

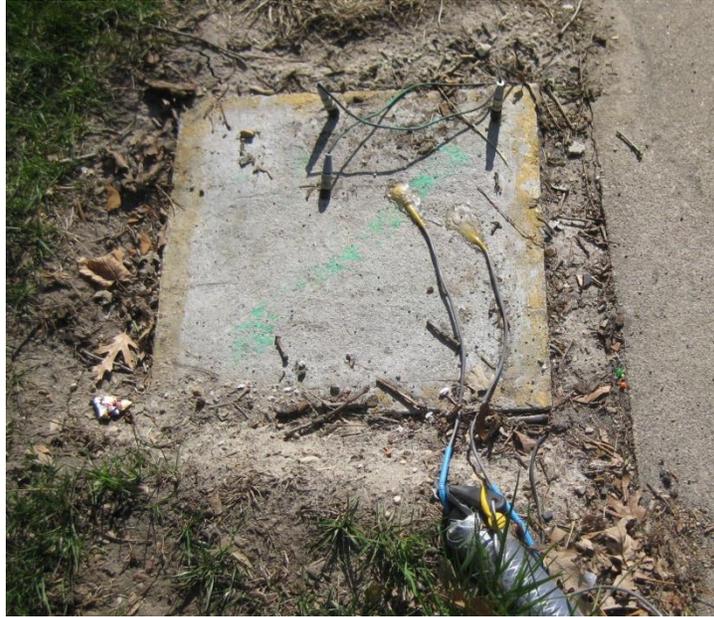
Figure 3. Instrumented slab buried in the ground next to a residential driveway

The slab was cast in early October, moist cured for two weeks, and then placed into a freezer before being placed into the ground when aged one month (Figure 3).

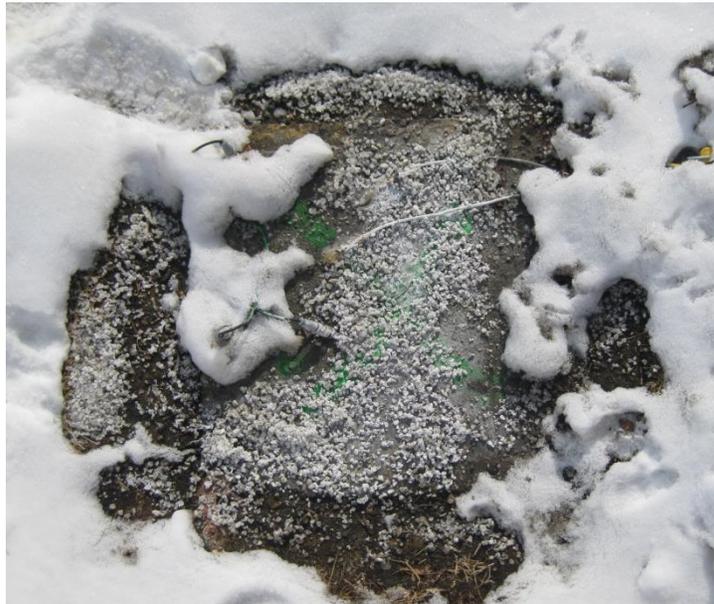
Figure 4. Sodium chloride applied on the top of the slab during a snow event

Sodium chloride was applied to the top of the slab during snow events, as shown in Figure 4.

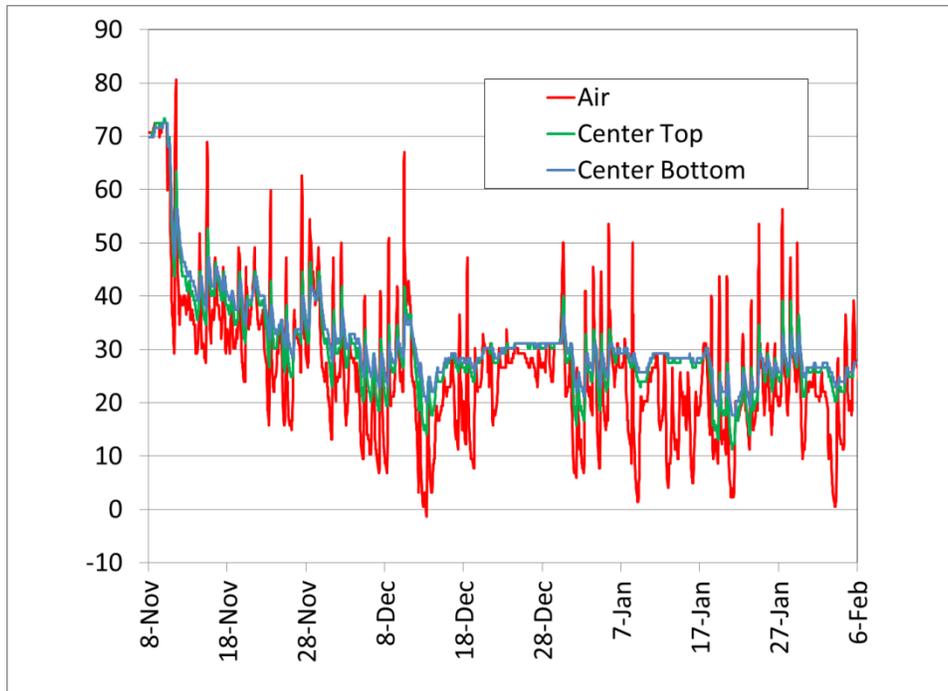
Figure 5. Temperature measurement from the center of the slab

Temperature data were recorded every 15 minutes for four months. Figures 5 through 8 illustrate the data collected over the four-month period.

Observations from the plots above indicate the following:

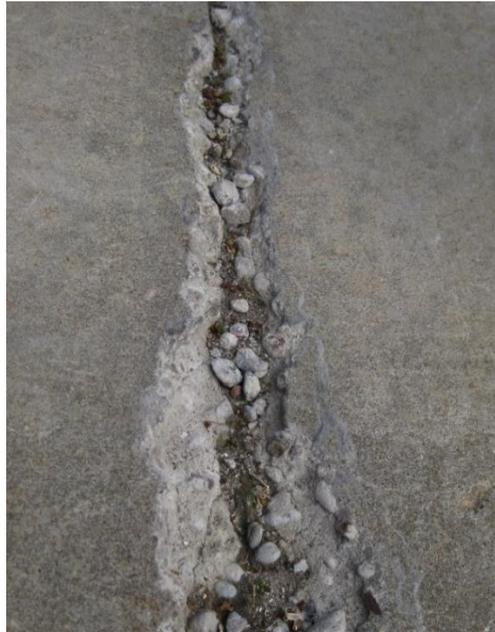
Figure 9. Field observation of joint deterioration, including exposed aggregates left behind

The aim of the experimental work was to test whether dissolution was occurring at the ITZ. This was considered likely because of the common observation in the field that aggregate particles were being cleanly separated from the paste, as shown in Figure 9.

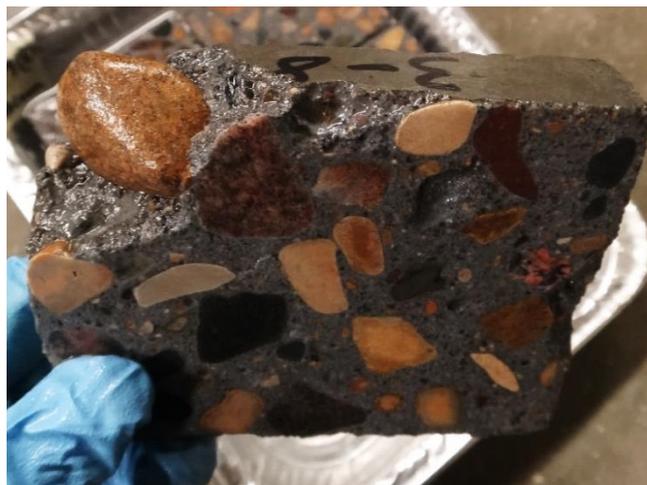
Figure 10. Laboratory sample exposed in 3% NaCl solution, showing cleanly exposed aggregate

Laboratory test results on samples that exposed the ITZ yielded similar observations as in the field (Figure 10).

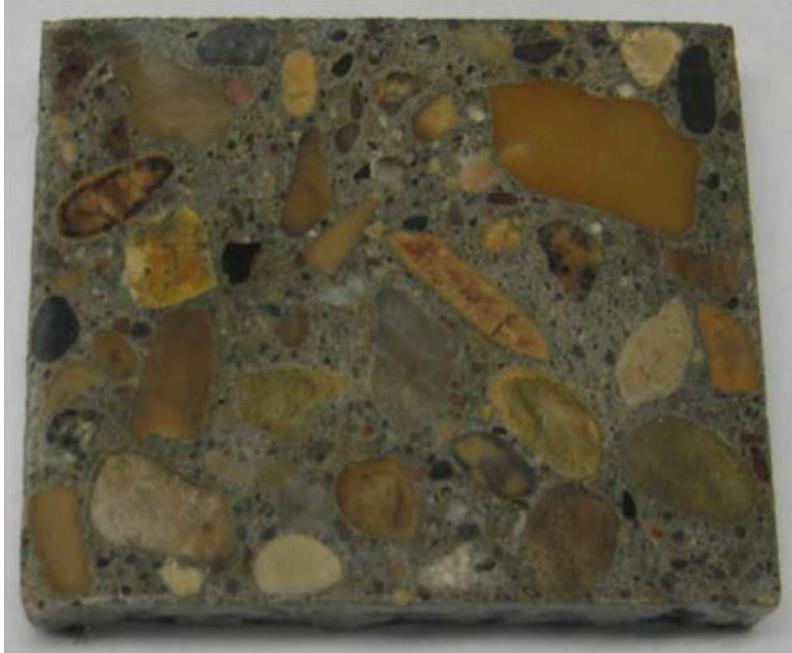
Figure 11. Saw cut slice sample with a thickness of 1/2 inch

Concrete was mixed in accordance with ASTM C192 and cast into 4 by 3 by 16 inch beams. The beams were cured in a fog room for 28 days before they were cut by diamond saw into 1/2-inch thick slices (Figure 11).

The slices were deliberately thin to ensure that some aggregate particles were exposed on both faces of the slice.

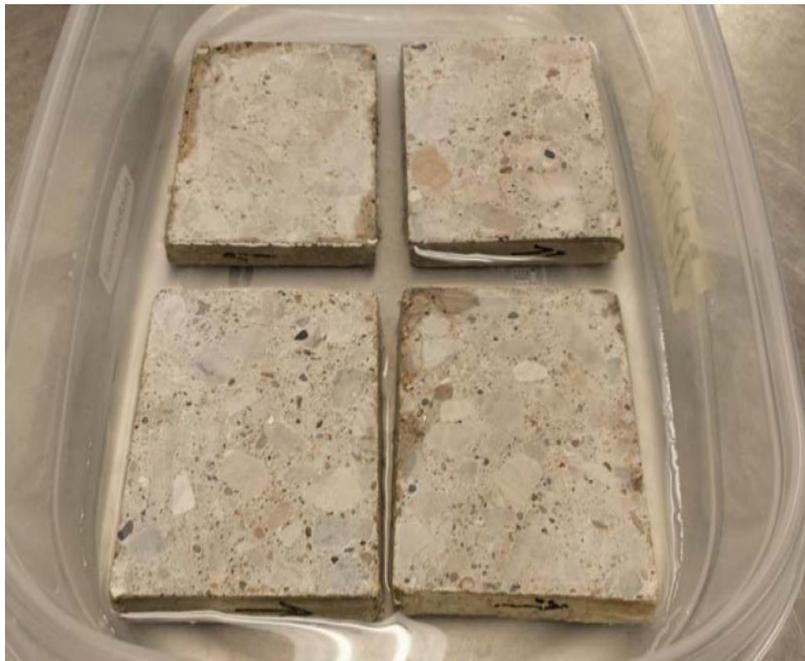
Figure 12. Samples partially immersed in liquid while stored at 40°F

The slices were partially immersed, sawn face down, in a 1/4 inch layer of test liquid comprising either water, 3% NaCl, or 3% MgCl₂ at a constant 40°F (Figure 12).

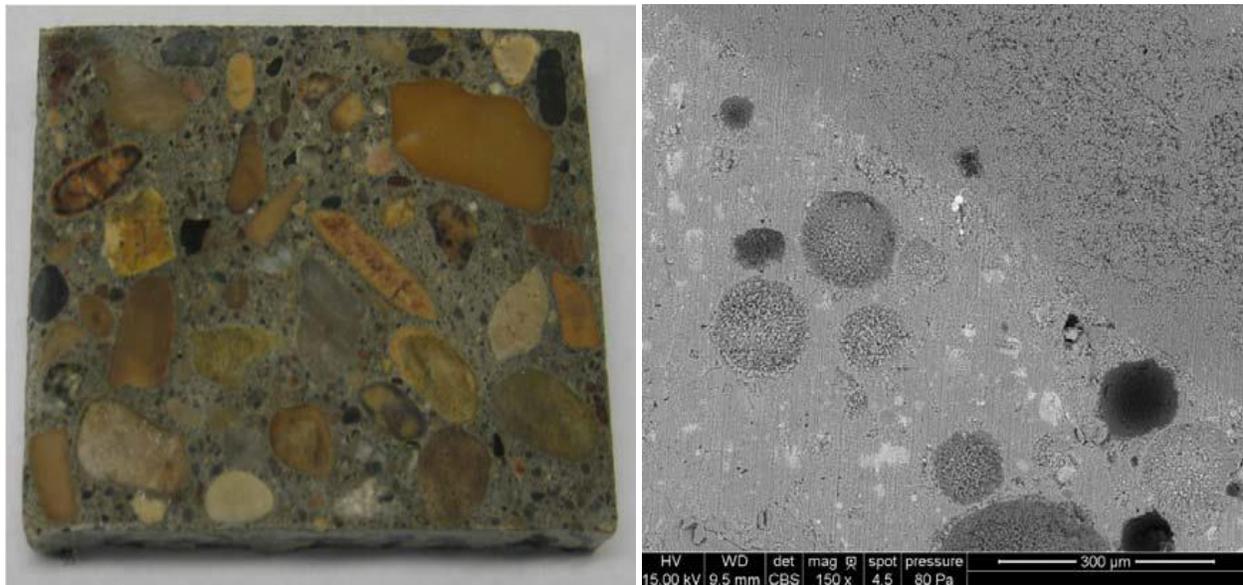
Figure 13. Typical sample tested in water after 56 days at 40°F: optical image (left) and SEM image (right)

Solution	Visual observations	SEM observations
H ₂ O	No distress (Figure 13, left)	No distress (Figure 13, right)
NaCl	No distress (Figure 14, left)	Minor microcracking throughout the paste system. No signs of Cl ⁻ concentrations or dissolution of hydration products in the ITZ (Figure 14, right)
MgCl ₂	Aggregate faces appear to be below paste surface level, indicating paste expansion (Figure 15, left)	No signs of Cl ⁻ concentrations or dissolution of hydration products in the ITZ. However, cracks were observed around the aggregate particles. Cracking was more prevalent closer to the face of the sample exposed to the solution (Figure 15, right)

- Exposure to water and NaCl above freezing temperatures results in negligible distress.
- The failure mechanism in MgCl₂ does not appear to be related to any of the three hypothesized above.
- The paste appears to expand in the presence of MgCl₂ and thus becomes debonded from the coarse aggregate particles that are not expanding. The mechanism of expansion is likely the

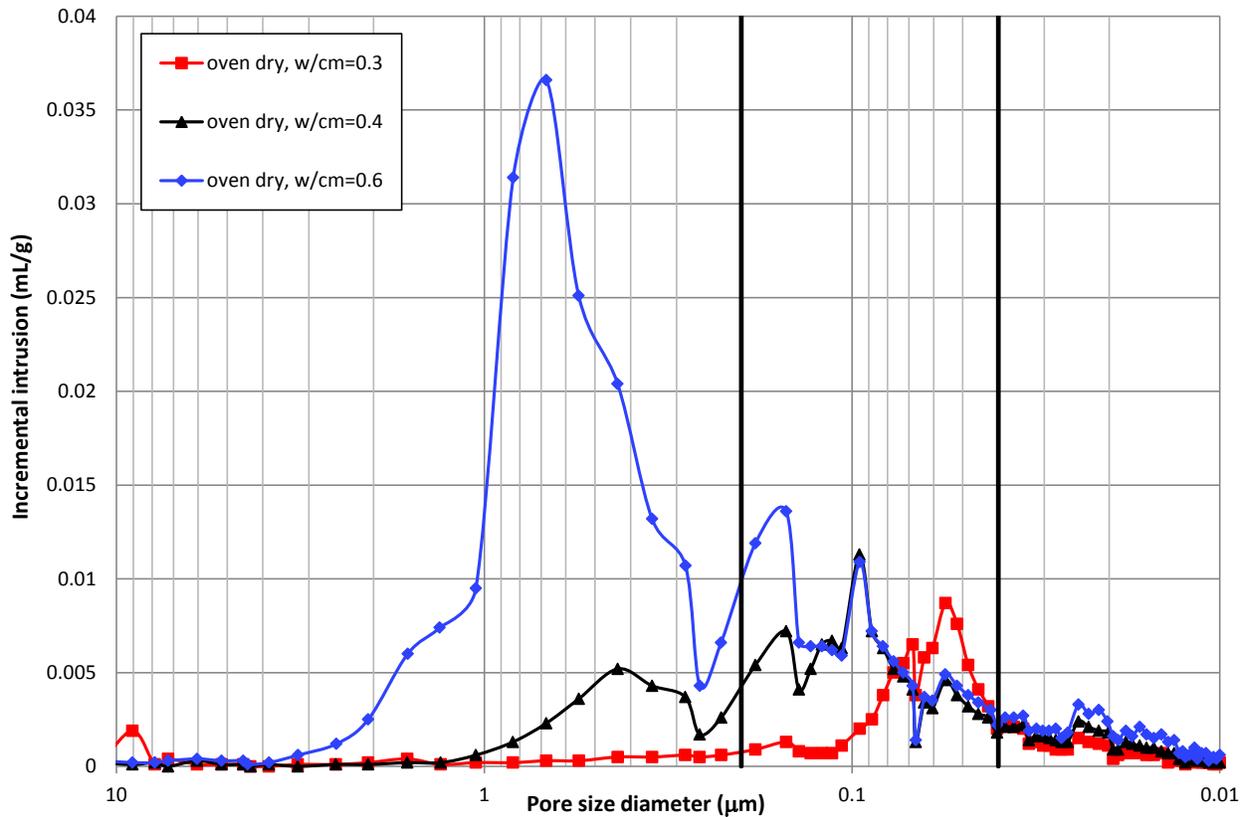
Figure 16. Pore distribution of oven-dried paste with various w/c ratios

Figure 16 shows the pore size distributions for the oven-dried pastes made with plain cement and with w/cm ratios ranging from 0.30 to 0.60.

The curves indicate the pore size distribution of each sample, and the area under each curve indicates the total porosity of that sample.

The darker vertical lines in Figure 16 are the range of values normally considered to indicate aggregates at high risk of D-cracking (0.20 to 0.04 μm). As expected, decreasing the w/cm ratio significantly decreases the porosity of the systems, as exhibited by the areas under the lines. In addition, decreasing the w/cm ratio pushes the peak of each line to the right, indicating that the systems contain finer pore systems. It is notable that the peaks for the mixtures with w/cm ratios equal to 0.3 and 0.4 are within the range where drying is difficult. While the mixture with a w/cm ratio equal to 0.6 also has a peak in the same range, the bulk of the curve is toward the coarse side of the envelope.

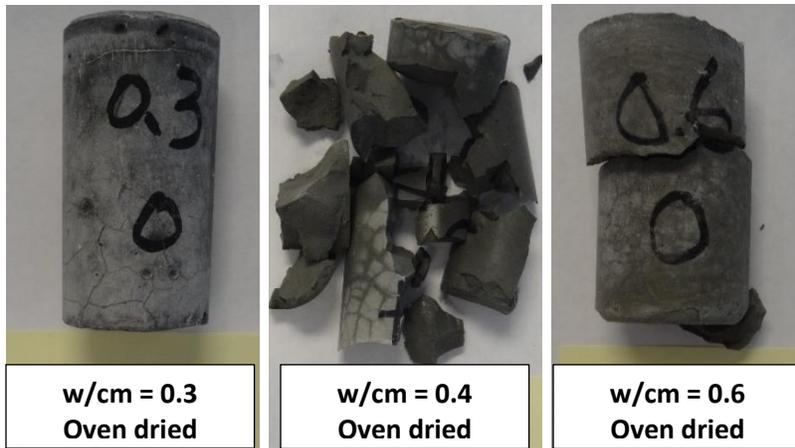
Figure 17. Oven-dried paste samples with different w/cm ratios after one freeze-thaw cycle

Freeze-thaw testing (Figure 17) indicated that the greatest distress was in the sample with a w/cm ratio of 0.4.

This is consistent with the model, which holds that open systems allow water to move freely, tight systems do not allow sufficient water to enter, and intermediate systems allow water to enter but not to leave readily.

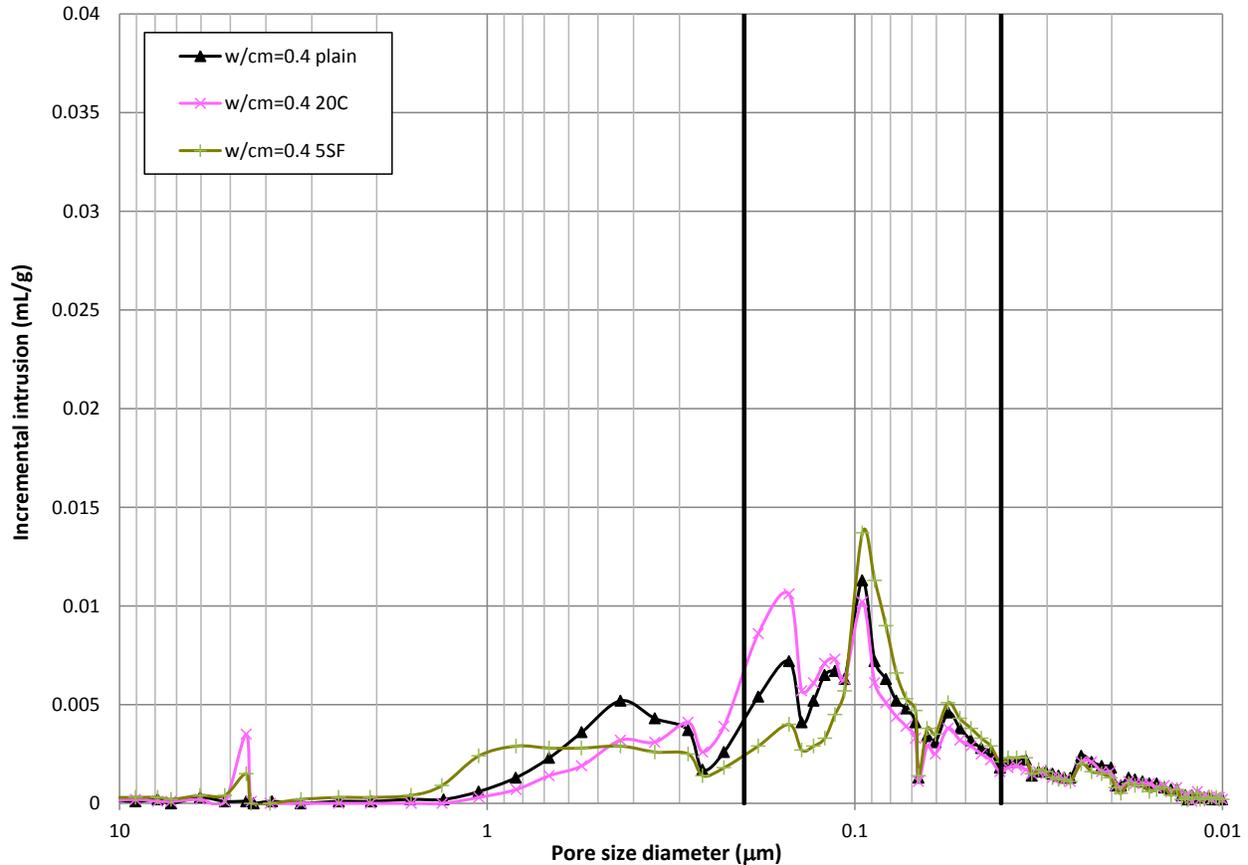
Figure 18. Pore distribution of samples with $w/c = 0.4$ and various binder systems after 7 days hydration

Figure 18 provides the pore size distribution of oven-dried paste samples with a w/cm ratio of 0.40 and containing different binder systems.

No significant differences were observed between the mixtures. This result indicates that w/cm ratio is the primary controller of the pore structure of the paste at two weeks of age. This is consistent with the literature, which has stated that SCMs do not significantly influence the pore size of the paste samples during the early stage of curing.

In the freeze-thaw testing, the plain sample had the most distress, and the sample containing 20% C fly ash had the least distress. It is possible that the damage incurred by drying is less marked in the presence of fly ash.

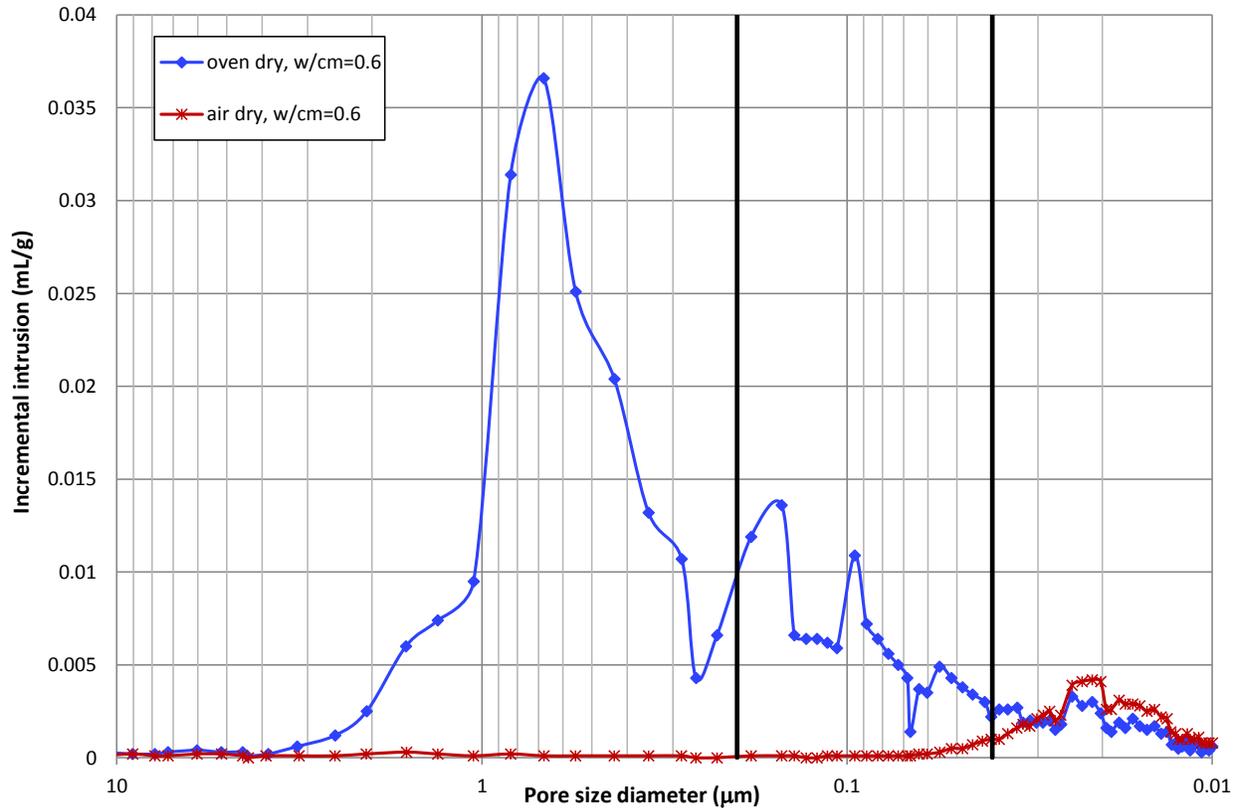
Figure 19. Pore size distribution of samples with $w/c = 0.6$, oven dry versus air dry

Figure 19 shows the pore size distributions of paste samples with a w/cm ratio of 0.60 and treated by oven or air drying.

The data from the oven-dried sample show significantly larger pores and greater porosity than the data from the air-dried sample, as expected. This reflects the significant effect that the water remaining in the pores has on the information provided by a MIP test. Moreover, the air-dried samples were cured for 35 days and the oven dried samples were cured for 14 days, with the effect that the longer curing time resulted in more hydration product being formed, which thus reduced porosity.

In the freezing and thawing test, no visible damage was observed in the air-dried sample, but the oven-dried sample exhibited significant damage. This is likely due to damage incurred in the sample during oven drying.

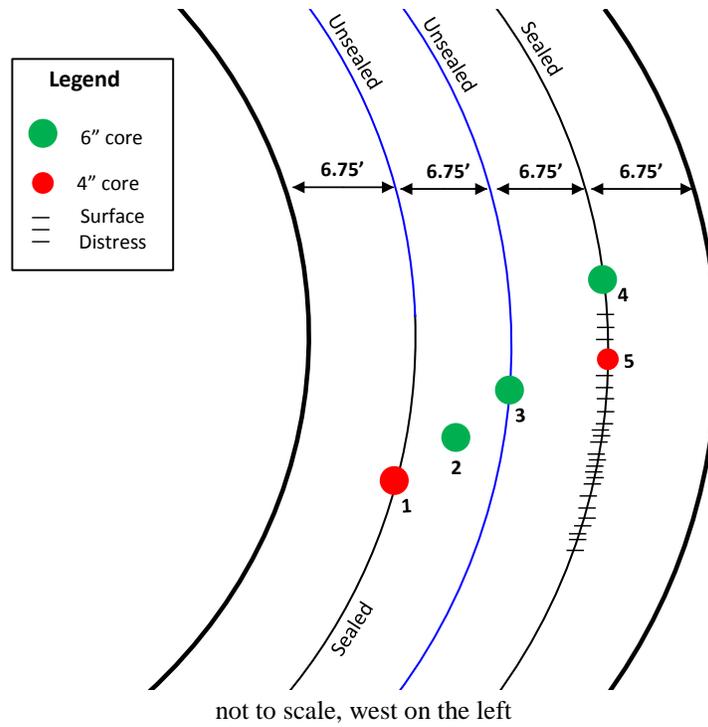
Figure 20. Plan view of coring and distressed locations

The extent of the distress was mapped, along with details of where joints had been sealed (Figure 20).

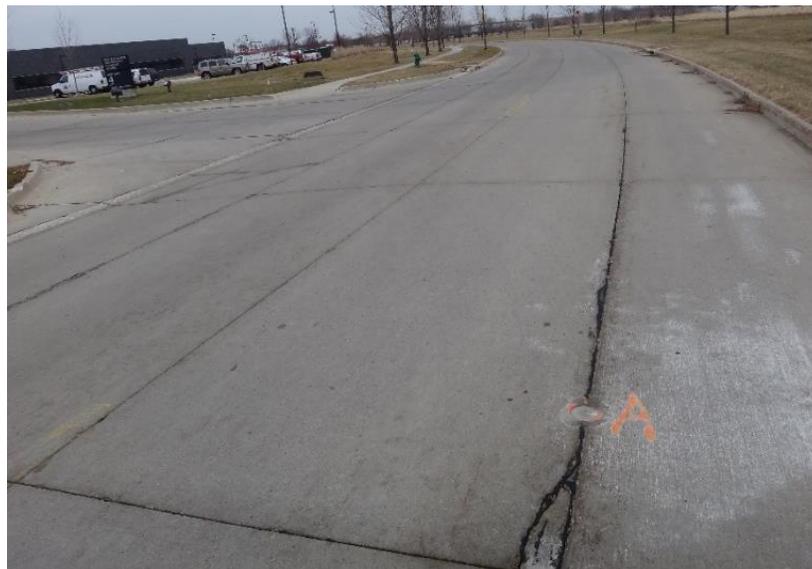
Figure 21. Field view of the location of Core 4, showing joint distress

Five cores were extracted from the pavement over a period of two years. Core 1 from a sound joint and Core 4 from a distressed joint were sent for petrographic examination. Figure 21 illustrates a distressed joint, while Figure 22 shows Core 4 obtained from that joint.

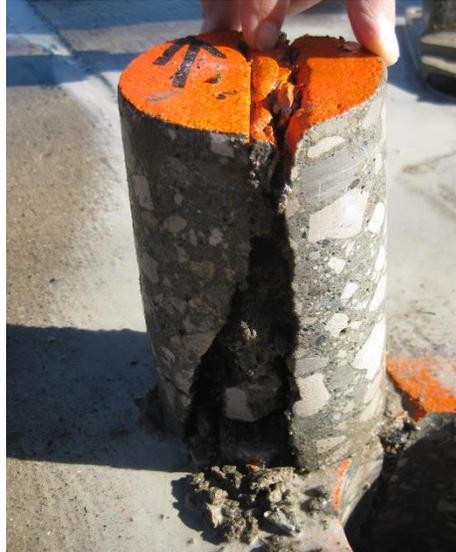
Figure 22. Core 4 taken from the distressed joint

The core exhibits bottom-up distress, which indicates that saturation of the concrete was from a source of water at the bottom of the slab.

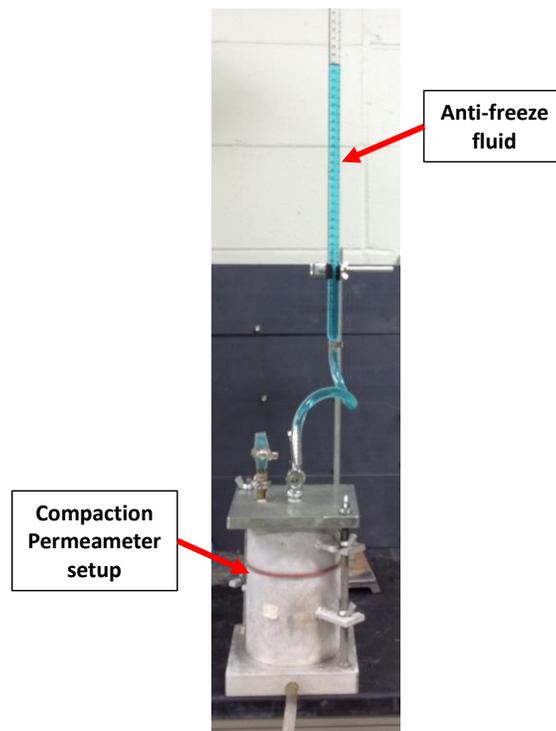
Figure 23. Laboratory falling head permeability test setup

The influence of freezing on the permeability of moist base material was then evaluated in the laboratory. Due to the limited amount of material that could be sampled from the field, a selected base material with a gradation similar to that of the base material from below the mid-panel was used in the laboratory permeability test. Samples were prepared at moisture contents of 0% to 10% at 2% increments and then compacted with standard proctor energy. The compacted samples were frozen at -18°C (0°F) for 24 hours before a falling head permeability test was conducted. The temperature was chosen to mimic the temperature experienced in Iowa that winter. An antifreeze windshield washer fluid with a freezing point of -29°C (-20°F) was used as the test fluid to prevent it from freezing during testing (Figure 23).

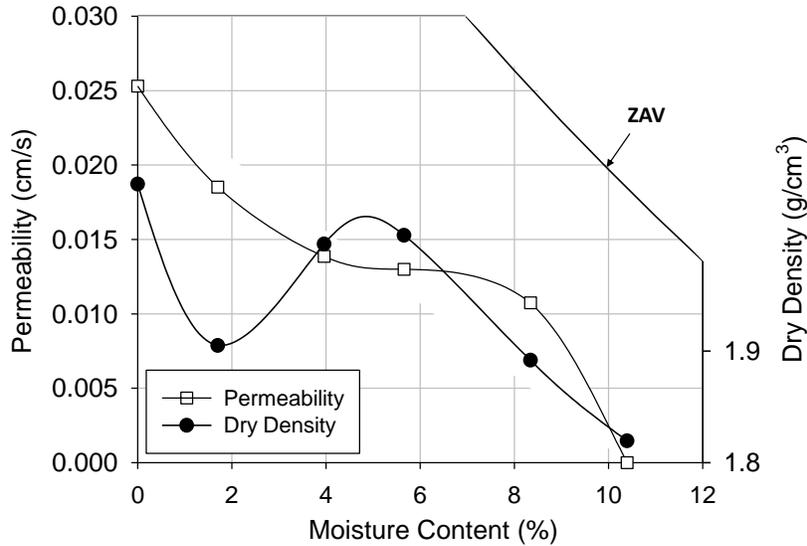
Figure 24. Moisture and permeability relationship under a frozen condition

Figure 24 illustrates the relationship between moisture content and the dry unit weight of the compacted specimens.

The sample has a maximum dry unit weight when the moisture content is about 5%. Figure 24 also reports the permeability data as a function of moisture content. The permeability decreases as moisture content increases under a frozen condition, and the frozen, saturated sample was impermeable. This finding supports the hypothesis that freezing water within a moist sample increases pore blocking.

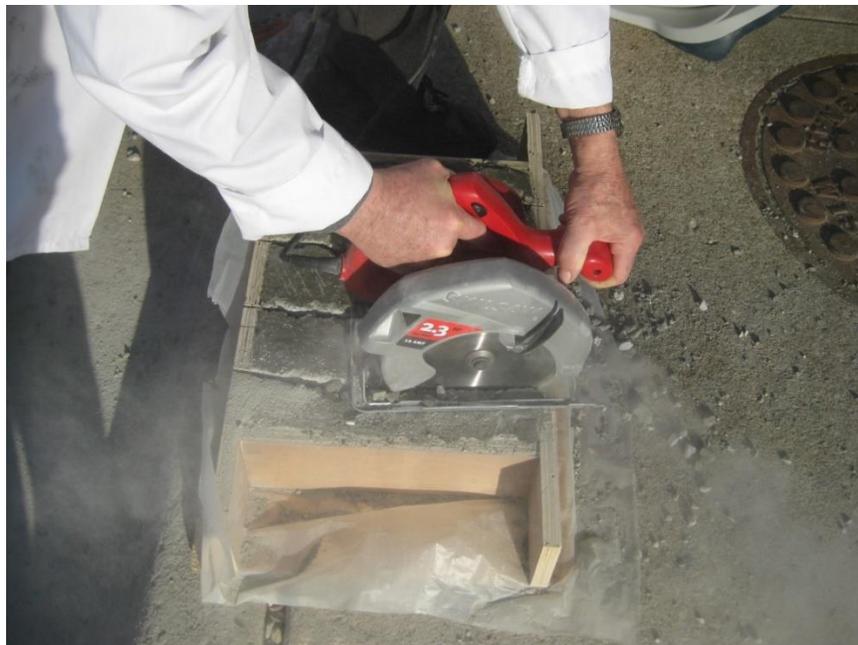
Figure 25. Saw cutting the test slab

An exercise was conducted in the laboratory to assess whether sawing practice influences the amount of damage in a joint. A 12 by 18 by 4 inch slab was cast outdoors using a standard paving mixture. A handheld saw fitted with a diamond blade was used to dry-cut joints in the slab starting too early (as indicated by the extreme raveling). The operator was asked to push hard on the blade and to induce a curve to mimic the worst possible practice (Figure 25).

After the slab had been allowed to harden and gain strength, a full-depth section was cut perpendicular to the hand-sawn joints to observe the condition of the concrete at the bottom of the cuts.

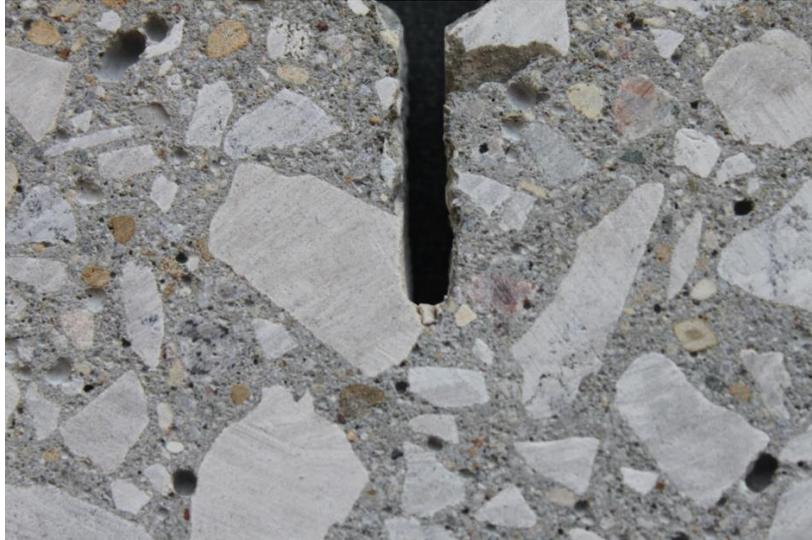
Figure 26. View of damage at saw cut tip

Following examination under an optical microscope, the only evidence of damage was a small piece of aggregate cracked at the tip of one of the cuts (Figure 26).
