GEORGIA DOT RESEARCH PROJECT 07 - 07

**ASSESSING TECHNIQUES AND
PERFORMANCE OF THIN OGFC/PEM OVERLAY
ON MICRO-MILLED SURFACE**

1. Report No.: FHWA-GA-11-0707	2. Government Accession No.:	3. Recipient's Catalog No.: N/A	
4. Title and Subtitle: Assessing Techniques and Performance of Thin OGFC/PEM Overlay on Micro-milled Surface		5. Report Date: August 2014

By
James Lai, Ph.D.

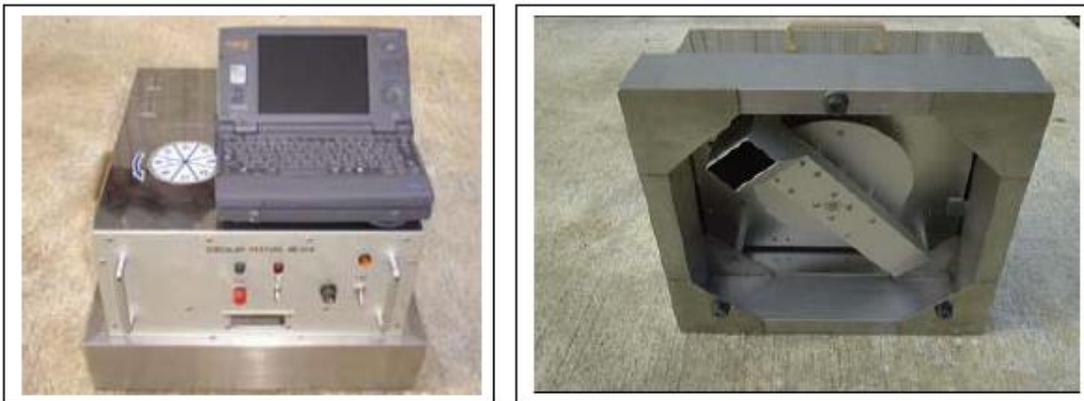
being measured (Figure 2-2 [2]). The device is controlled by a notebook computer. When initiated by the computer, a DC (direct current) motor drives the arm to rotate for a full 360-degree revolution, producing the measurement. The surface texture profile along the path of the traversed arm is recorded in the computer memory. The profile data are divided into eight segments for analysis (Figure 2-3). The computer software processes the data to report the mean profile depth (MPD) in accordance with ASTM E-1845 [3], the root mean square (RMS), or both for each segment, or the average of all eight segments. The length of each segment is about 100 mm (4 in.). The concept behind the calculation of the MPD by the CTM is illustrated in Figure 2-4. The apparatus is lightweight and portable, and it can be used in the laboratory and in the field. It generates an MPD reading in approximately 30 seconds.

Figure 2-2 Circular Track Meter

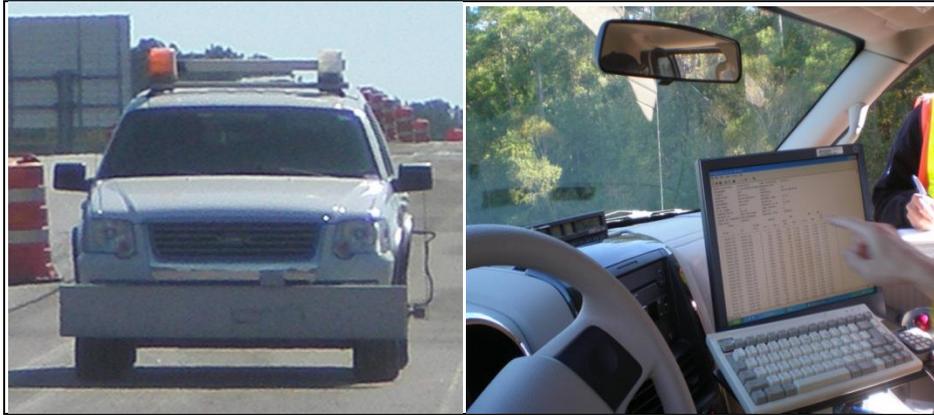
equipped with a 32 kHz laser, resulting in a sampling spacing of about 0.6 mm (175 samples per 100 mm distance) when traveling at 40 mph. The accuracy for measuring the vertical depth is at least 0.025 mm.

Figure 2-5 GDOT’s Laser Road Profiler

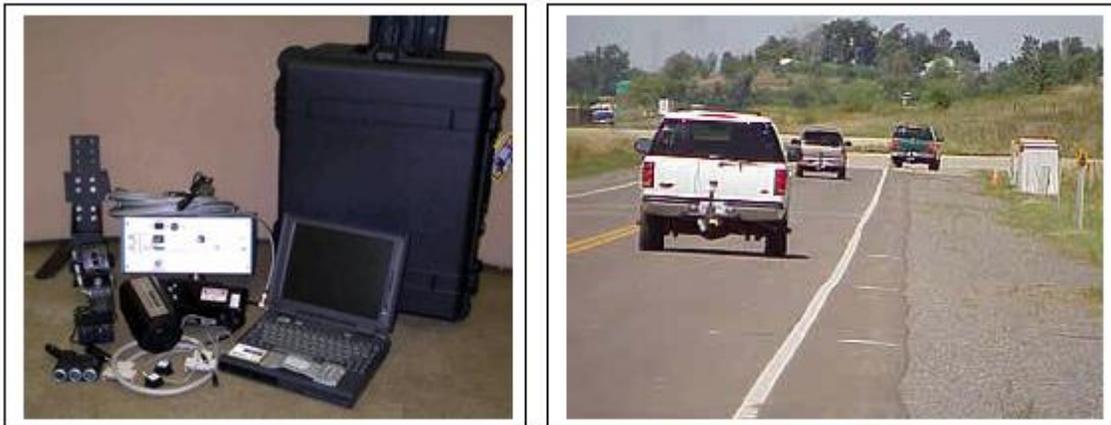
The Road Surface Analyzer shown in Figure 2-7 [4] is a mobile laser-based automated system for measuring pavement texture at highway speeds along a linear path. With the exception of the computer, the entire unit fits in one case and is transportable. The unit can be mounted on vehicles with a step bumper or any vehicle on which mounting brackets can be installed. ROSAN is capable of measuring pavement surface texture at sampling speeds ranging from 24 km/h (15 mi/h) to 104 km/h (65 mi/h) and sample intervals ranging from 0.25 mm (0.00975 in.) to 25 mm (0.975 in.), depending on the sampling speed. The laser resolution is about 0.03 mm. Figure 2-8 shows the typical readout from ROSAN.

Figure 2-7 Road Surface Analyzer

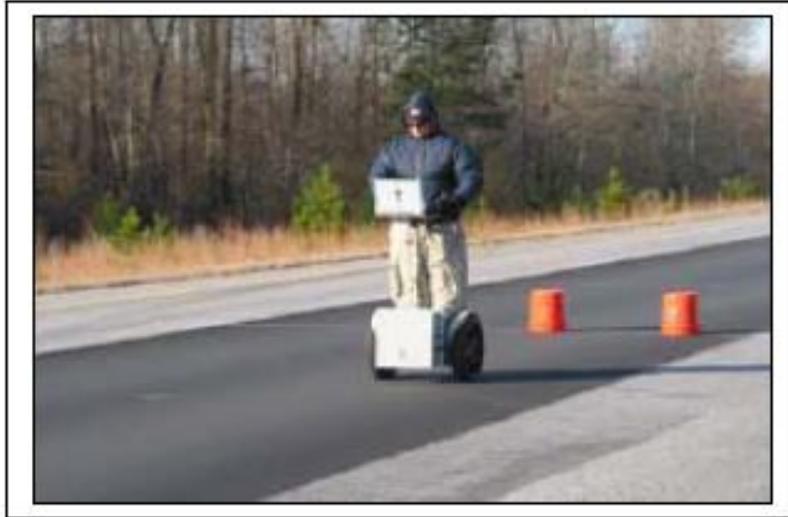
The Ultra-Light Inertial Profiler is a laser-based device designed to measure surface profiles in order to evaluate surface texture or roughness. It consists of a Segway™ Human Transporter with a mounted sensor box attached to a laptop computer for data acquisition and analysis as shown in Figure 2-9. The sensor box is equipped with triggers, a laser, and accelerometers. Compared to the CTM and Sand Patch Method, the advantage of the ULIP for measuring surface macrotexture is that an entire length of pavement section can be evaluated. This allows better assessment of texture variability across the entire tested section, compared to spot measurements with the CTM and Sand Patch Method. The ULIP is capable of measuring pavement surface texture at sample intervals of 0.5 mm. More detailed information of the characteristics of the ULIP, including the accuracy of the measurements and the method for calculating the ridge-to-valley texture depth of a pavement surface profile, is presented later in this report.

Figure 2-9 Ultra-Light Inertial Profiler (ULIP) [6]

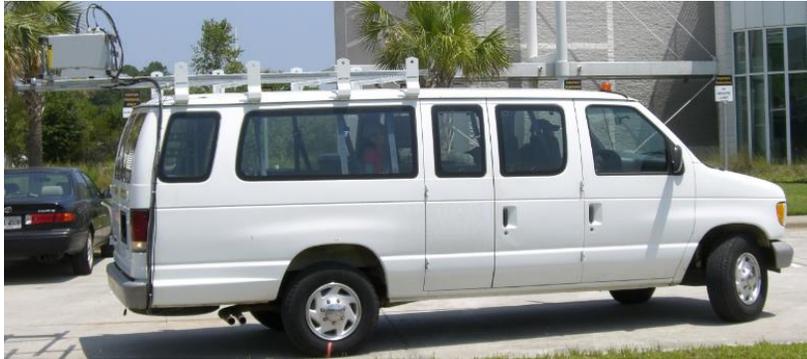
The three-dimensional (3-D) pavement macrotexture measurement system (Figure 2.11), developed by Georgia Tech [8], consists of a laser crack measurement system and a high-resolution distance measurement instrument (DMI). The LCMS sensors are mounted on the back of the van to acquire 3-D continuous transversal profiles, and the high-resolution DMI is mounted on the rear wheel to control the interval between two consecutive transversal profiles. The LCMS sensors are designed to have a tilt angle to the transversal direction in order to prevent the acquired profiles from aligning with the transverse cracks and pavement joints.

Figure 2-11 Georgia Tech's Sensing Van

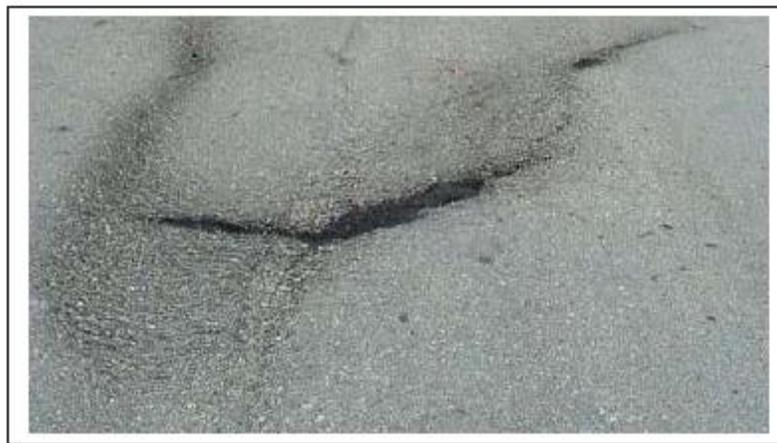
Many distresses of asphalt pavements can be directly attributed to the lack of proper bonding between HMA layers. Two of the most commonly occurring distresses due to poor bonding between the surface layer and its substrata are delamination and slippage cracking of an asphalt pavement surface layer. Slippage failure (Figure 3-1) is the most commonly observed problem related to poor bonding between layers; it often occurs at locations where traffic accelerates, decelerates, or turns.

Figure 3-1 Slippage Failure of Asphalt Surface due to Poor Bond

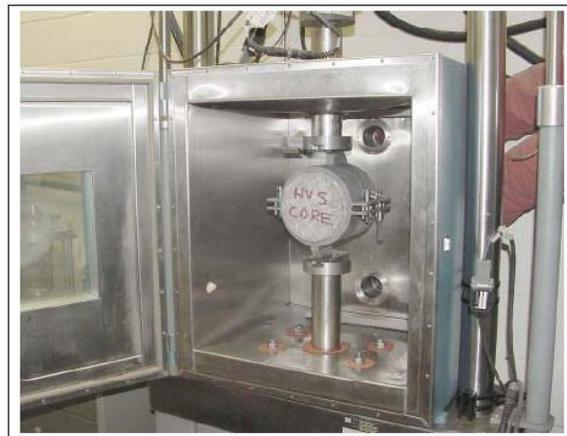
machine to study the bond strength while evaluating the effects of several material variables and test conditions. The MTS environmental chamber was used to maintain temperature during the test. FDOT [11] also used an MTS for performing the bond strength testing (Figure 3-2), as shown in Figure 3-3. The device is similar to the one several other researchers have used with some modifications, which allows for applying normal pressure (perpendicular to the direction of shear) to the test specimen. Use of this more sophisticated testing machine allows the bond strength testing to be performed under controllable loading rates and controllable testing temperatures.

Figure 3-2 MTS for Bond Strength Testing

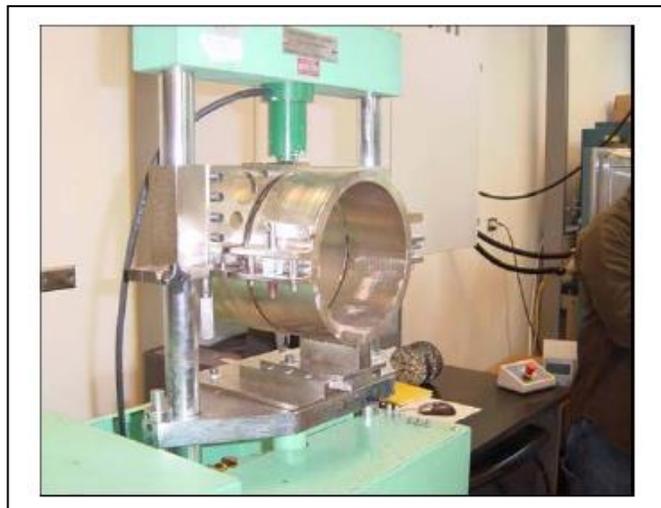
FDOT initially used a universal testing machine (Tinius Olsen), but found the test procedure cumbersome and the test results unsatisfactory. As a result, FDOT researchers switched to the MTS system. Although NCAT and FDOT successfully used the MTS system in the bond strength studies, both recommended using the Marshall Tester for bond strength testing (Figure 3-4) [10, 11]. Molenaar et al. [14] also used this device to evaluate shear resistance between HMA layers with several treatments, including a stress-absorbing interlayer with and without a tack coat. The Marshall Tester is readily available in most highway materials testing laboratories, and the testing procedure is quite simple. This is the principal reason the FDOT and NCAT studies recommend using this equipment for bond strength testing. However, there are some limitations for using the Marshall Tester, such as the fixed strain rate (2.0 in./min). The effects of these limitations on the bond strength are discussed later in this chapter.

Figure 3-4 FDOT Bond Strength Testing Device

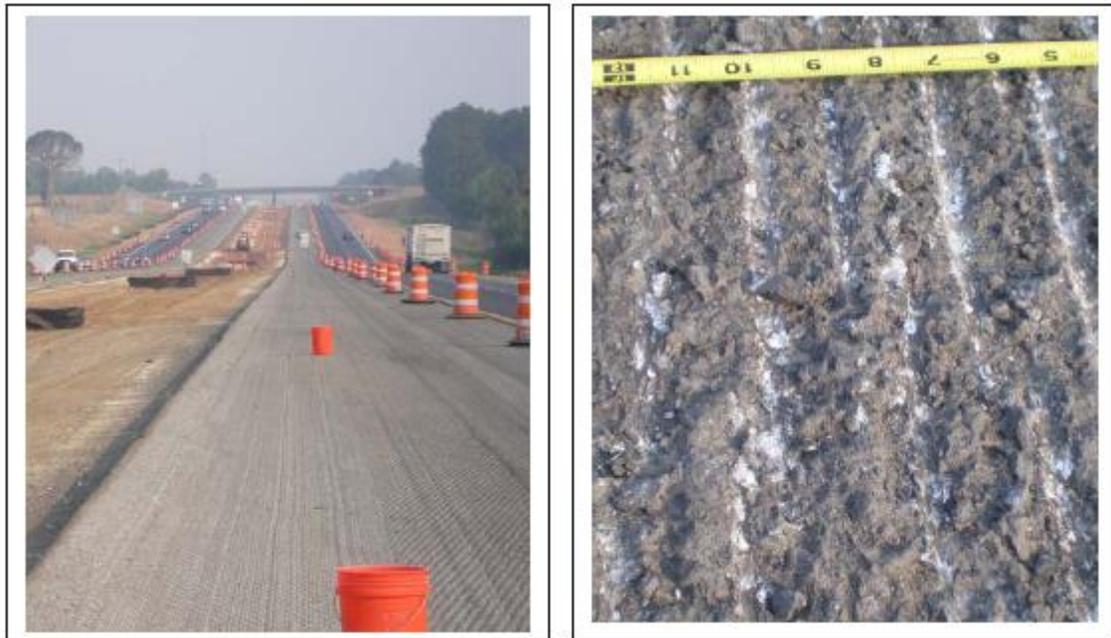
Before the formal testing of micro-milled surface textures at I-75 near Perry, Georgia, began, a trial test for measuring surface texture depths of rough (conventional) milled asphalt pavement surfaces using the CTM and the ULIP was performed. A 150-ft pavement section was selected at Milepost (MP) 78 of I-75 in a southbound lane (see Figure 4.1). The test was conducted on May 1, 2007.

Figure 4-1 Conventional Milled Surface on I-75 at Milepost 78

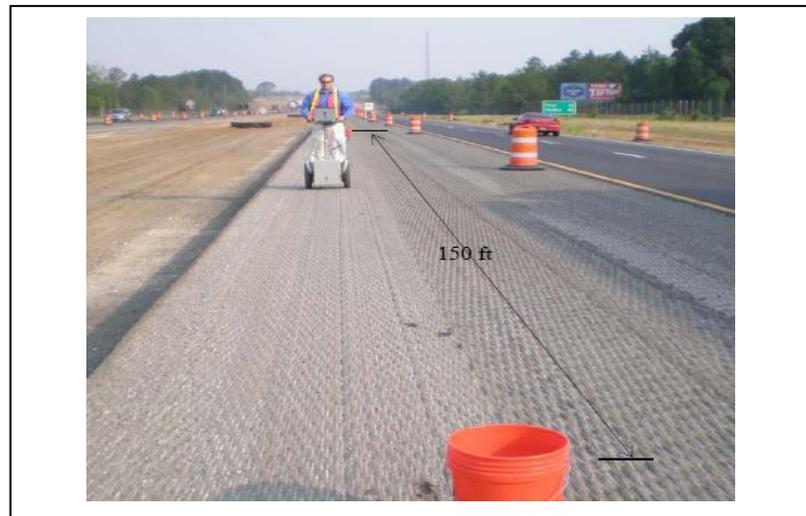
Figure 4-2 Measuring Milled Surface Texture by ULIP

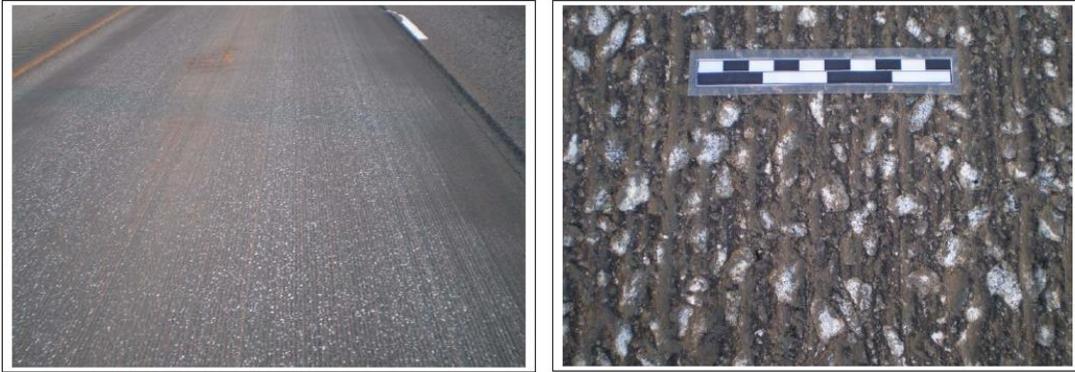
The micro-milling operation of the test section started at about 8:30 p.m. on May 13, 2007. The milling speed was about 18–20 ft./min. The micro-milled surface textures (Figure 5-3 and Figure 5-4) showed rather irregular patterns.

Figure 5-3 Micro-milled Surface Texture

Figure 5-4 Irregular Milled Surface Texture

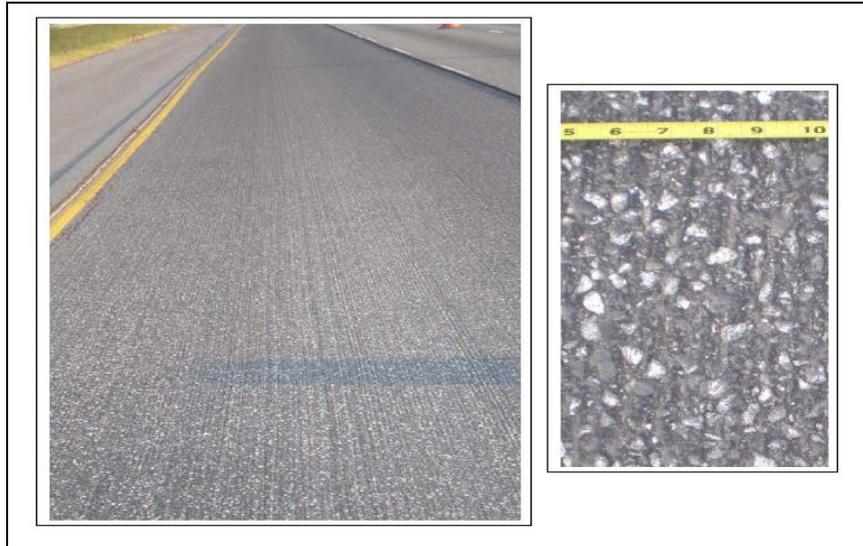
Figure 5-7 Typical Micro-milled Surface Texture for the Second Trial Test Section

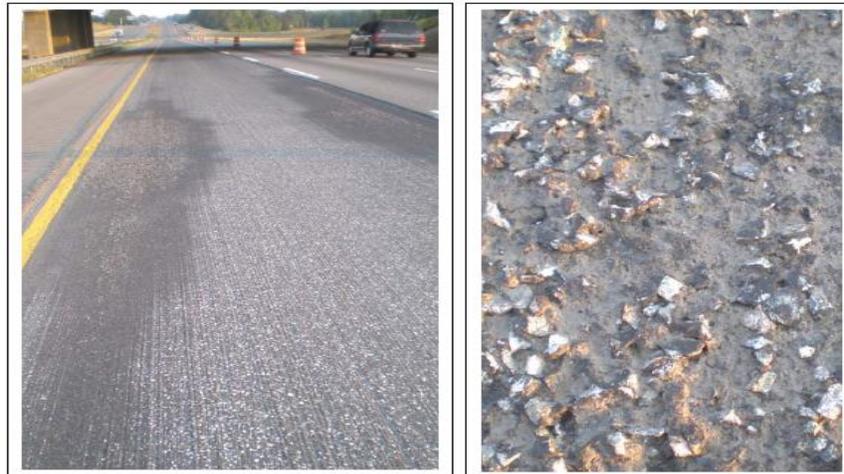
Figure 5-8 Scabbed Milled Surface on Second Trial Test Section

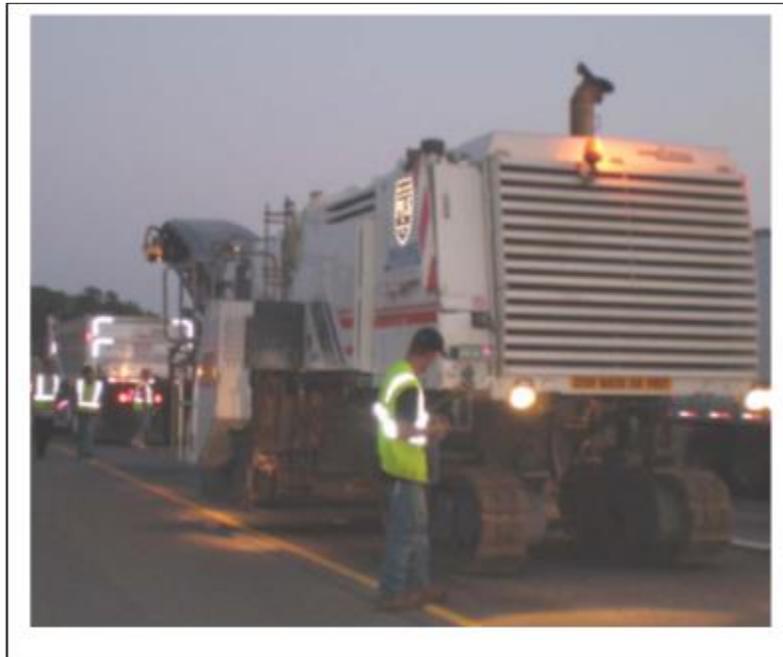
Figure 5-9 Wirtgen W2200 Four-Track Milling Machine

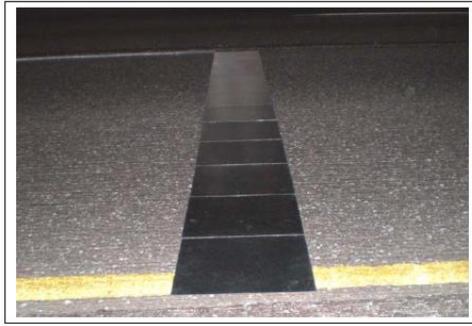
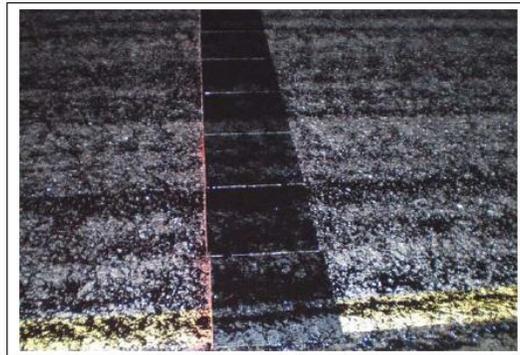
Figures 8-2 and 8-3 show the pad assembly placed on the test section before and after the asphalt tack coat was sprayed. As soon as the asphalt distributor had sprayed the tack coat over the pad assemblies, the pads were removed one by one in sequence from the pavement surface and were weighed to the nearest 0.1 gram and recorded on the data sheets. The results are summarized in Table 8-3. Detailed data and results are shown in Table 8-4A to Table 8-4D. Unfortunately, the actual tack coat application rates tested (see Table 8.3) indicated that the actual tack coat applied on both test sections was about 0.06 gal/yd² instead of 0.08 and 0.06 gal/yd² as originally planned. Instructions for applying 0.08 gal/yd² tack coat for TCS-1 and 0.06 gal/yd² for TCS-2 were conveyed to the contractor. It was not clear what caused the actual tack rate applied on TRC-1 section to be incorrect.

Figure 8-2 Pad Assembly before Tack Coat is Sprayed

Figure 8-3 Pad Assembly after Tack Coat is Sprayed

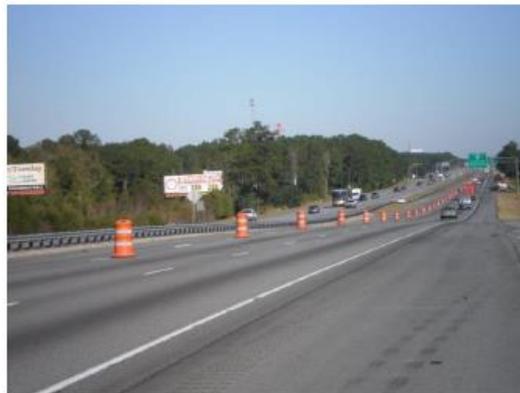
Figure 9-2 Six Lane I-95 near Savannah, Georgia

The project was performed on six lanes of I-95/SR 405, beginning at US 17/SR 25 and extending north to I-16/SR 404 located between Chatham County and Bryan County near Savannah (see Figure 9-1 and Figure 9-2). The total length of the project was approximately 14.095 miles. The project included micro-mill of roadway mainline to remove the existing OGFC overlay of about $\frac{5}{8}$ in. to $\frac{7}{8}$ in. thickness and resurfacing with 90 lb/yd² of 12.5 mm OGFC. The Plant Improvement Co. Inc. of Brunswick, Georgia, was the contractor.

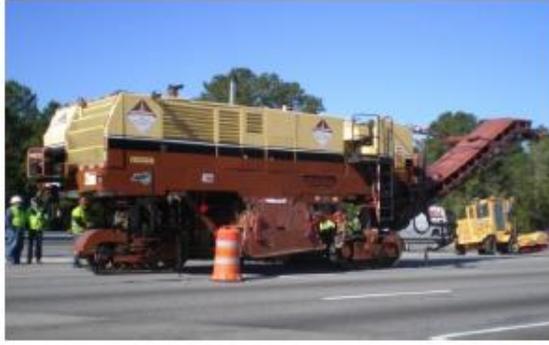
³ Editor's Note: While the tractor was a Roadtec®, the milling head was not.

Figure 9-3 Milling Machine used on the I-95 Project

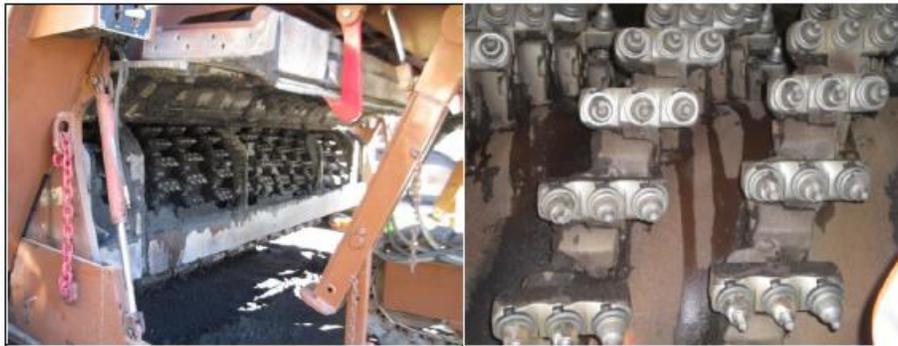
Figure 9-4 Milling Drum and Micro-milling Teeth Used in the Milling Machine

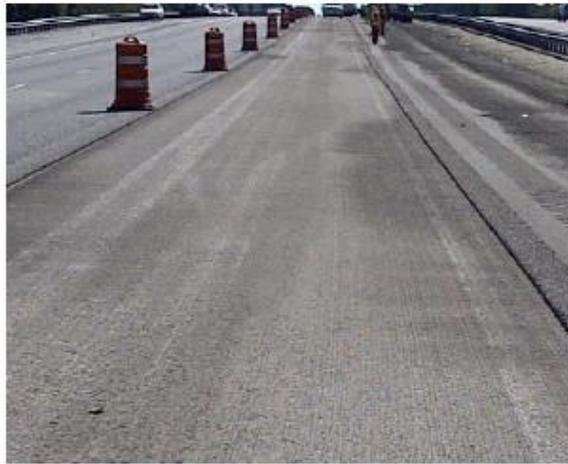
Figure 9-5 Scabby Area on Micro-milled Surface

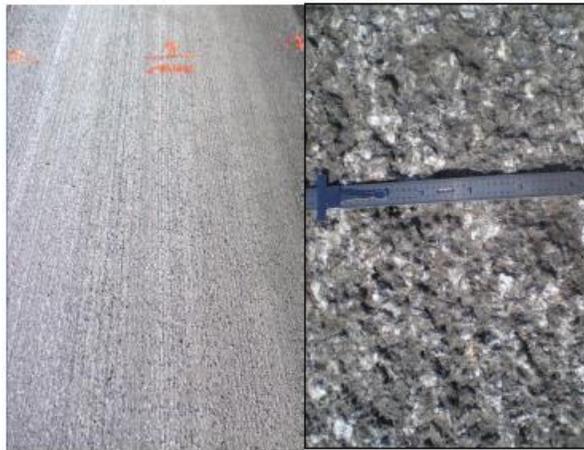
inspection of the micro-milled surface of these three test sections revealed that pockets of holes appeared on the milled surface (see Figure 9-6 and Figure 9-7), while no such phenomenon was evident on the I-75 project (see Figure 9-8). The presence of the holes can be explained by the following. The underlying asphalt mix on the I-75 project was a 12.5 mm HMA, while that on the I-95 project was a 12.5 mm SMA. When the milling teeth struck the SMA surface, the coarse aggregates in the SMA underlying layer were more susceptible to being dislodged by the milling teeth and leaving pockets of holes on the surface than if the underlying material was a dense-graded HMA. The effects of the holes left on the milled surface textures are discussed later in this section.

Figure 9-6 Detailed Milled Surface Texture

Figure 9-7 Micro-milled Surface on the I-95 Project

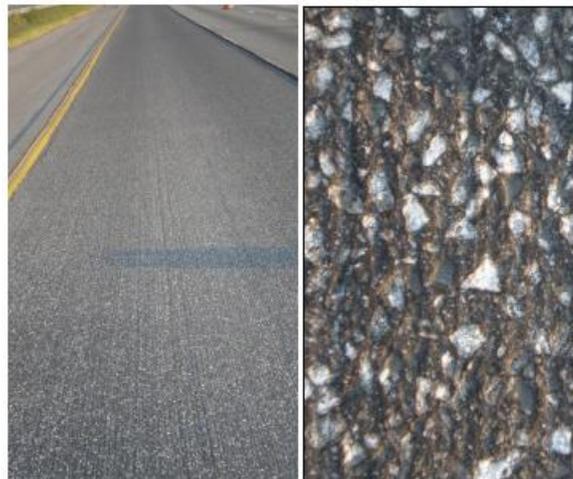
Figure 9-8 Micro-milled Surface on the I-75 Project
