# Cathodic Protection Field Trials on Prestressed Concrete Components, Final Report

PUBLICATION NO. FHWA-RD-97-153

JANUARY 1998

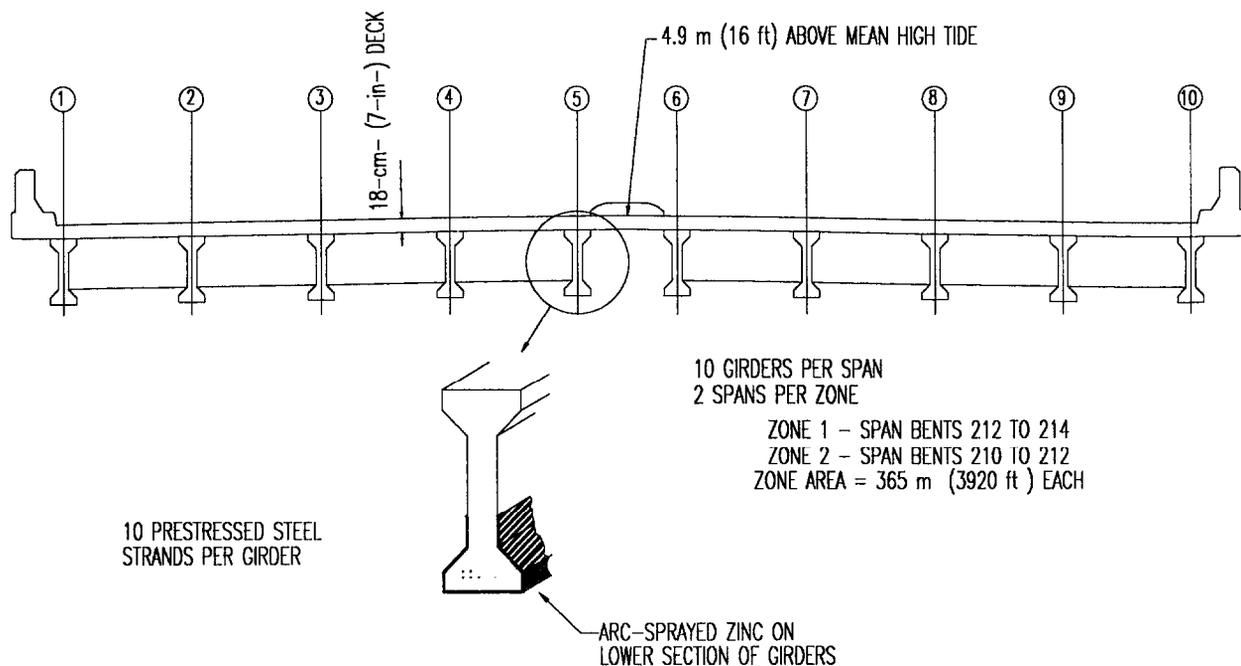
Figure 1. Howard Frankland Bridge—zinc beam zones section view.

It was decided to cathodically protect the 10 bottom prestressing strands of 20 girders in each of 2 zones as shown in figure 1. Zinc coating was not required on the upper portions of the girders due to a lack of corrosion activity in this area. The two zinc anode zones, also shown in figure 2, each had an area of 359 m<sup>2</sup> (3865 ft<sup>2</sup>), totaling 718 m<sup>2</sup> (7730 ft<sup>2</sup>) for both zones. A thickness of 0.25 to 0.38 mm (10 to 15 mil) of 99.9-percent pure zinc was specified. During quality control monitoring of the installation, zinc thicknesses were measured between 0.28 and 0.36 mm (11 and 14 mil).

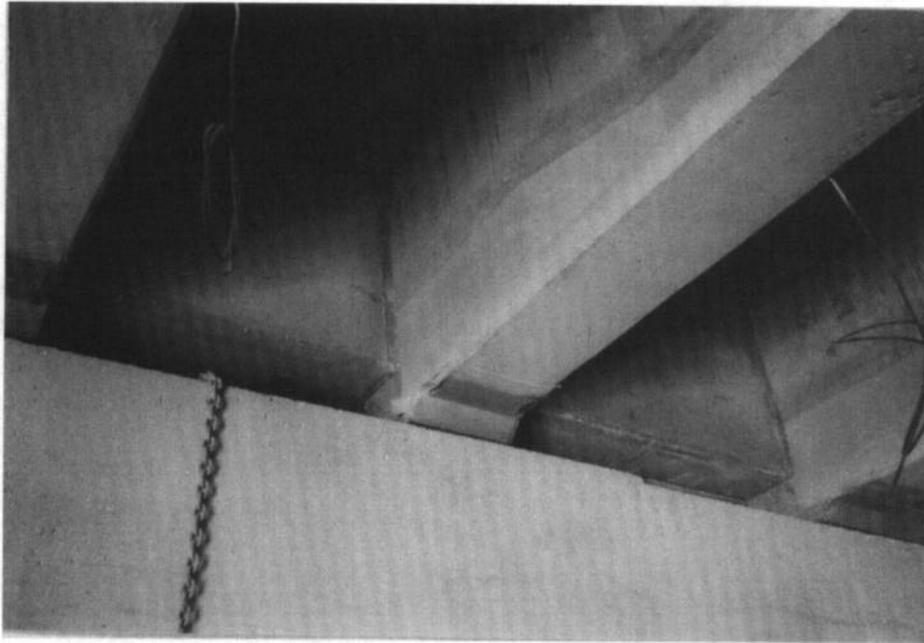
Figure 2. Completed zinc anode on bottom of girder.

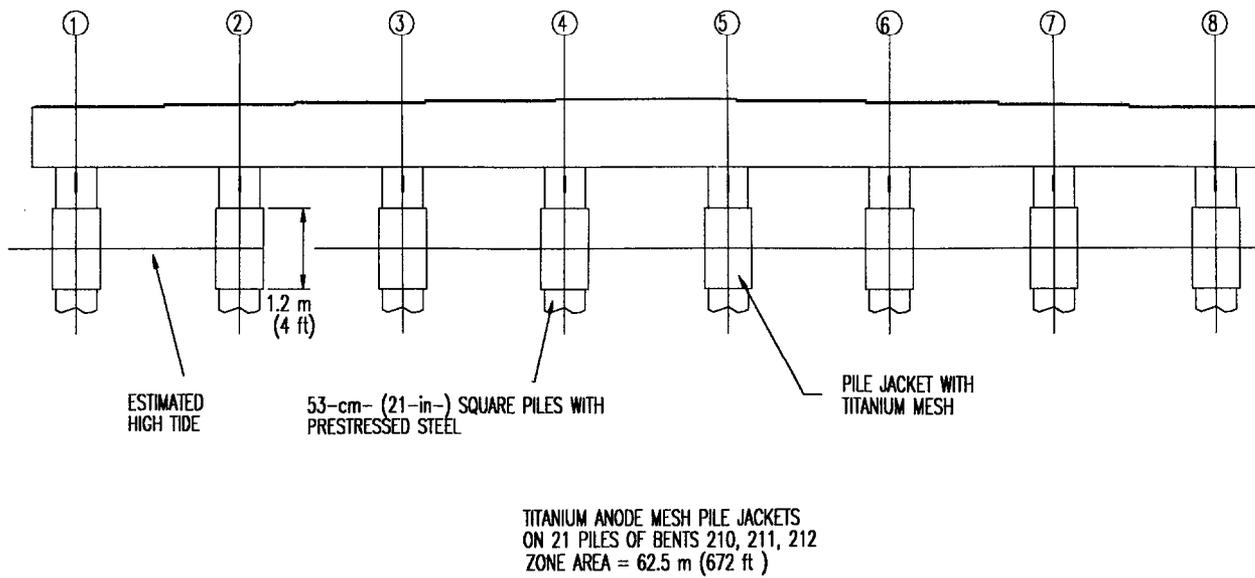
Figure 3. Howard Frankland Bridge—mesh pile jacket zone section view.

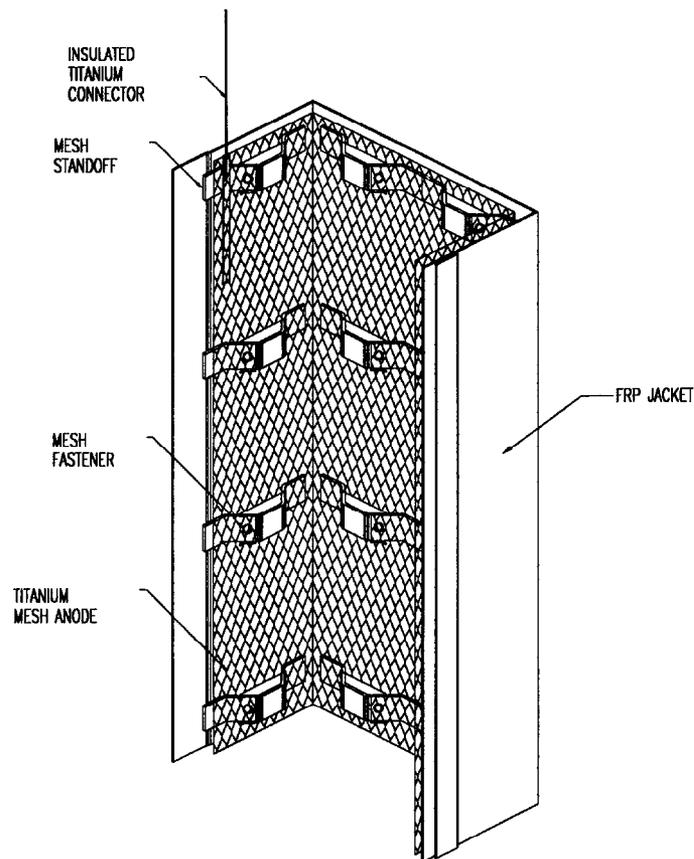
Figure 4. Howard Frankland Bridge—integral mesh anode pile jacket half assembly.

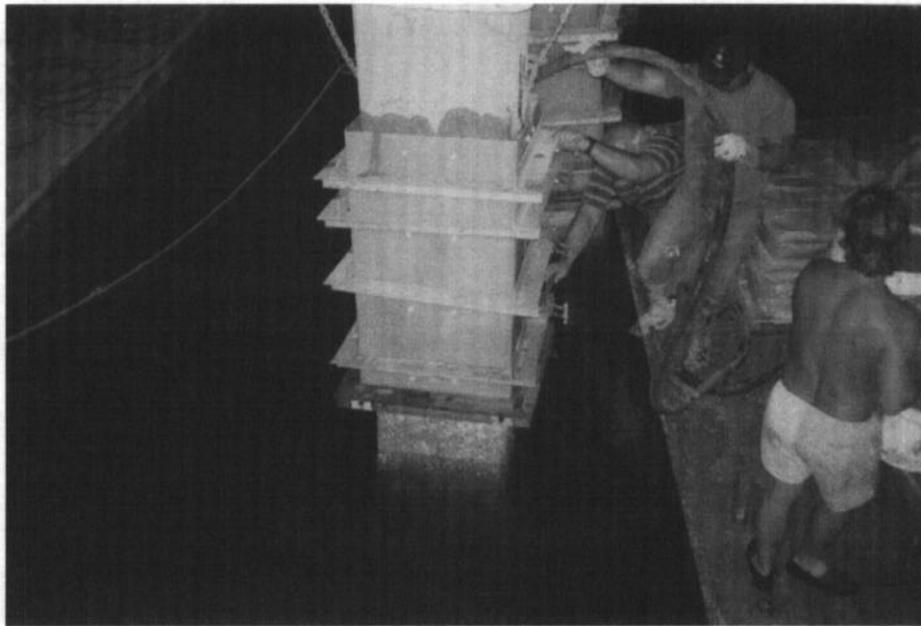
Figure 5. Pumping grout into installed pile jacket with horizontal bracing to prevent jacket deflection.

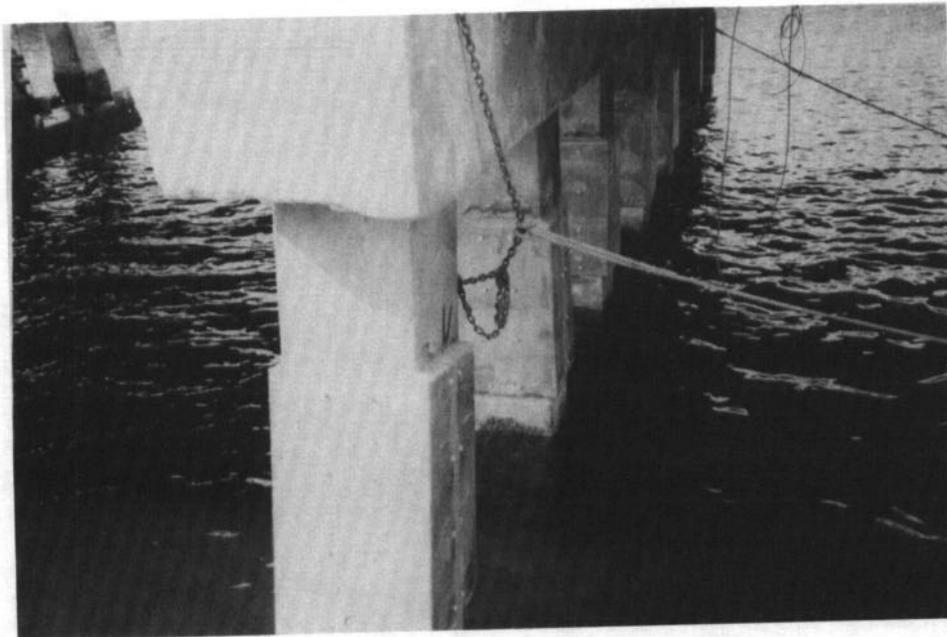
Figure 6. Completed titanium mesh anode zone.

Care was taken to ensure that no air voids were present in the grout and that the grout completely encapsulated the titanium mesh. The finished pile jackets of the titanium mesh anode zone are shown on figure 6.

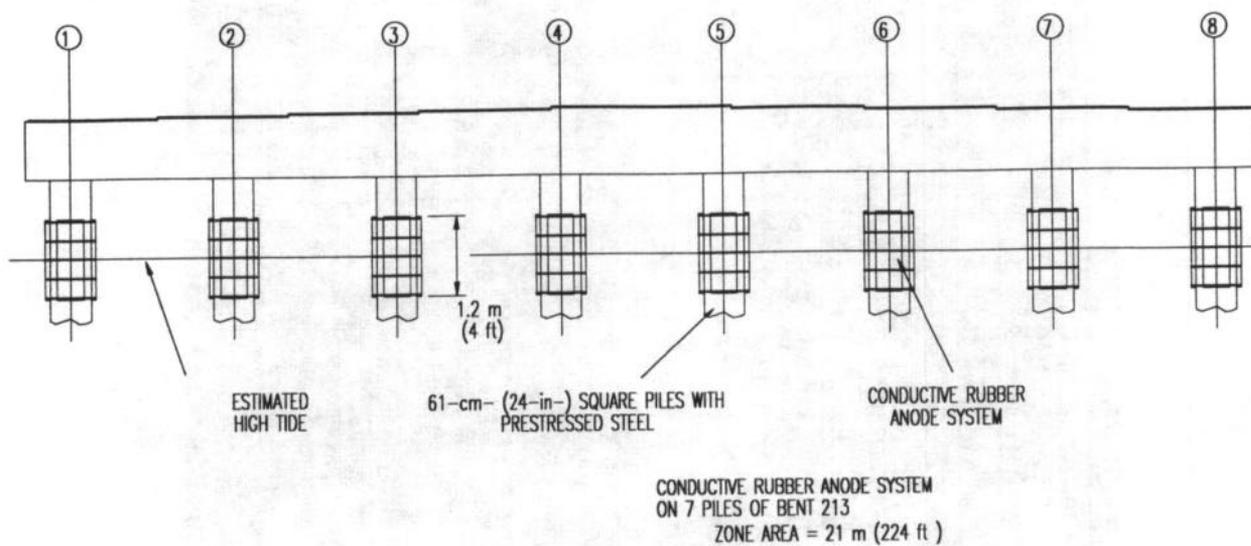
Figure 7. Howard Frankland Bridge—conductive rubber pile zone section view.

The conductive rubber anode system was installed on eight prestressed concrete piles as shown in figure 7. The anodes consisted of flat sheets of carbon-loaded ethylene propylene diene monomer (EPDM) conductive rubber. Anode sheets were held in place on the flat surfaces of the pile by four fiberglass panels, which also had a layer of nonconductive rubber adjacent to the fiberglass panels. One panel was mounted on each face of the pile. Five permanent stainless steel straps, which were wrapped around all four jacket segments, were used to press the jackets against the piles. Conductive rubber anode details are shown in figure 8.

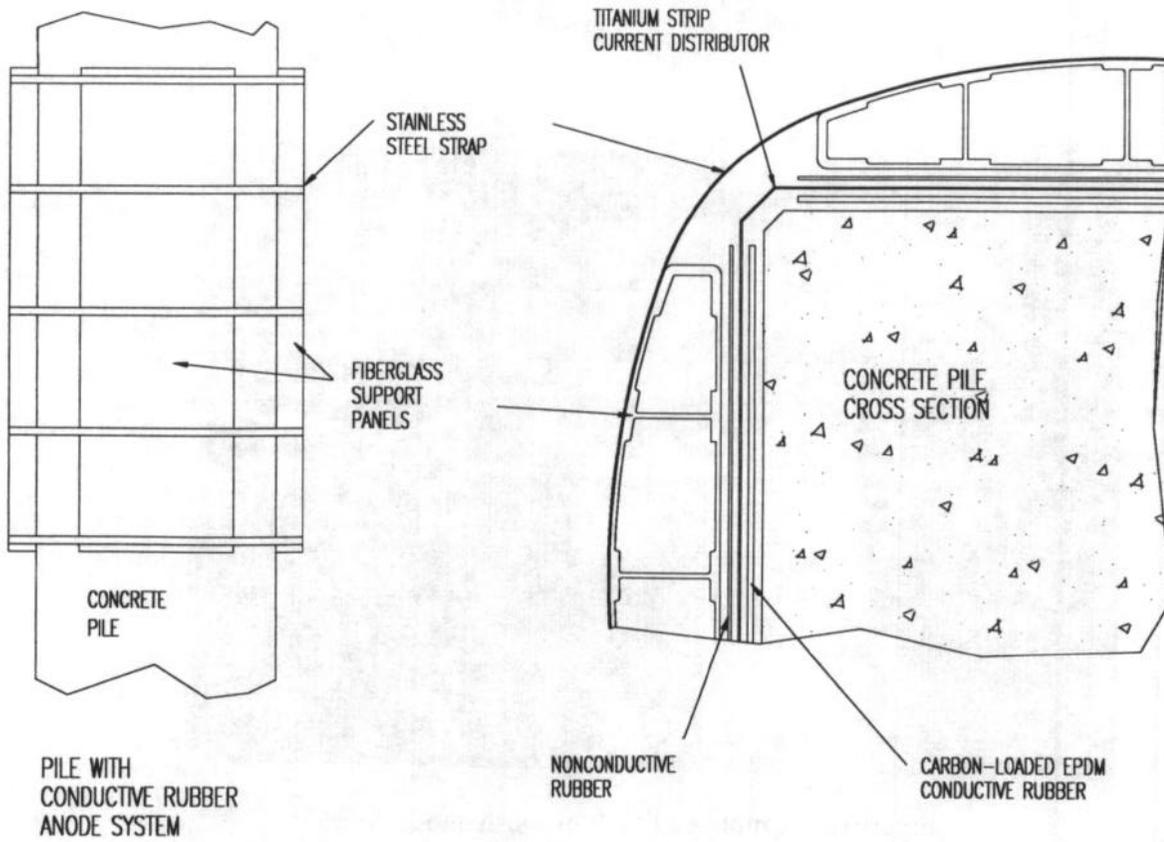
Figure 8. Howard Frankland Bridge—conductive rubber anode system and cross section.

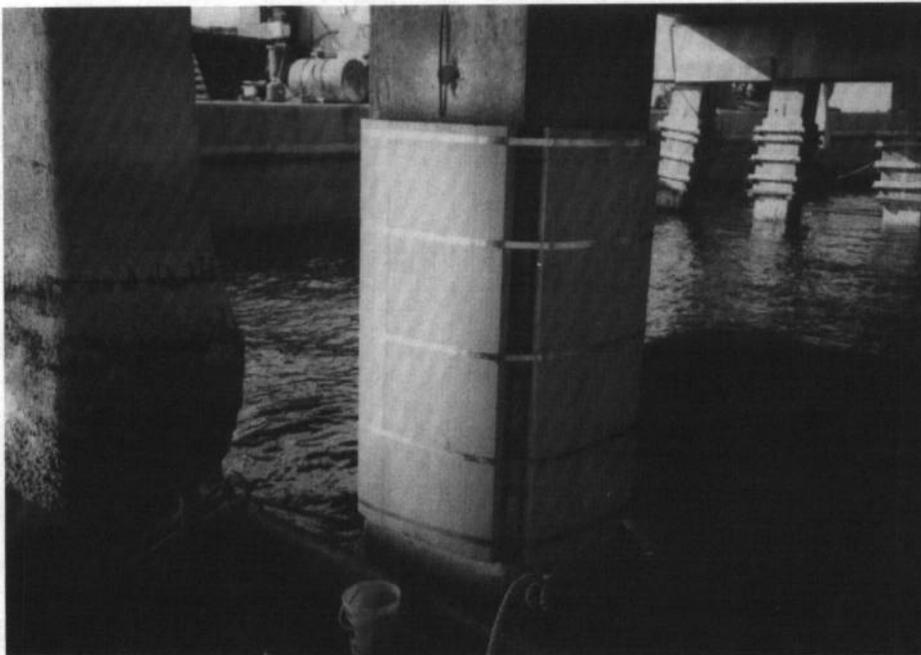
Figure 9. Installed conductive rubber anode.

The electrical connection to the titanium bar, which distributed current to the conductive rubber anode, was made with a butt splice. Connections were covered in nonconductive epoxy and heat-shrink tubing. A piling installed with conductive rubber anodes is shown in figure 9.

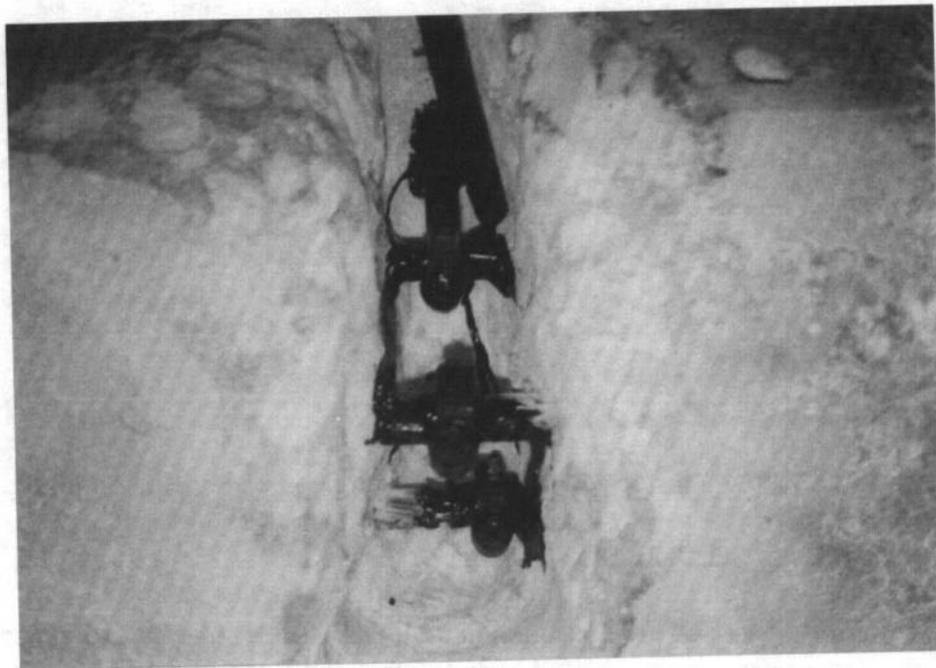
Figure 10. Coated wire and prestressing strand connections.

Electrical continuity of the prestressing strands was not assumed, and provisions were made to excavate the girders and pilings to assure full electrical continuity. Continuity was established by using stainless steel hose clamps and a 5.3-mm<sup>2</sup> (#10 AWG THHN) wire. These connections were then coated with nonconductive epoxy, as shown in figure 10, and excavations were filled with grout. This method was used for both system negative and reference ground connections, and provided good mechanical and electrical connection without damage to the strands.

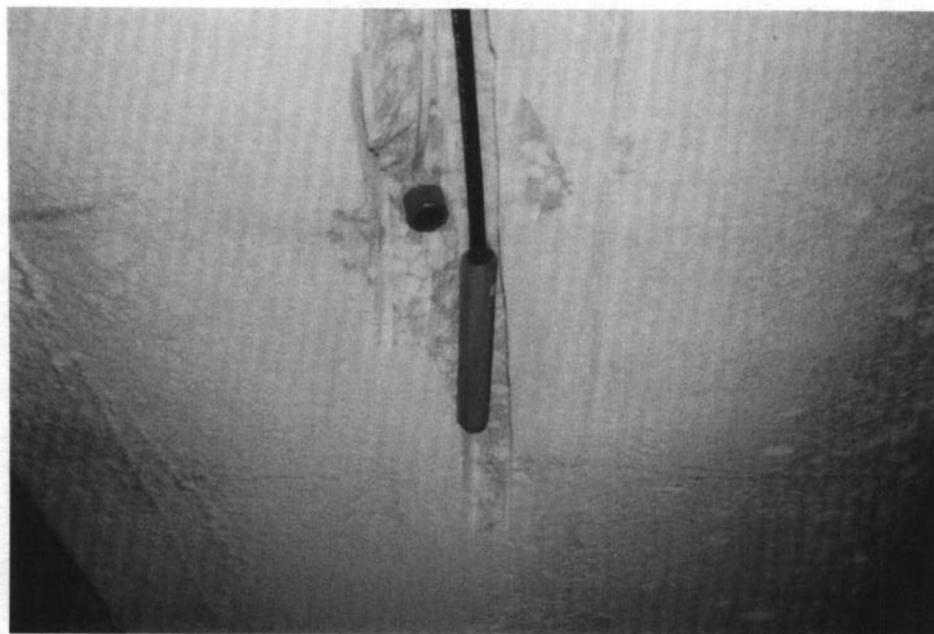
Figure 11. Hydrogen probe and reference electrode in excavation on piling.

One embedded hydrogen cell was also installed in each electrical zone. The hydrogen cell was a sealed Devanathan probe with a palladium membrane capable of transmitting hydrogen. This membrane was connected to the system negative (steel), and if hydrogen was generated, the cell internally converted the flux of hydrogen into an electrical current. The current, if generated, is sensed as a millivolt signal and recorded by the RMU. The location and installation procedures for the hydrogen cell were similar to that used for the reference electrodes, except that backfill was made with salt-free patching concrete. A hydrogen probe and reference electrode are shown in an excavation in figure 11.

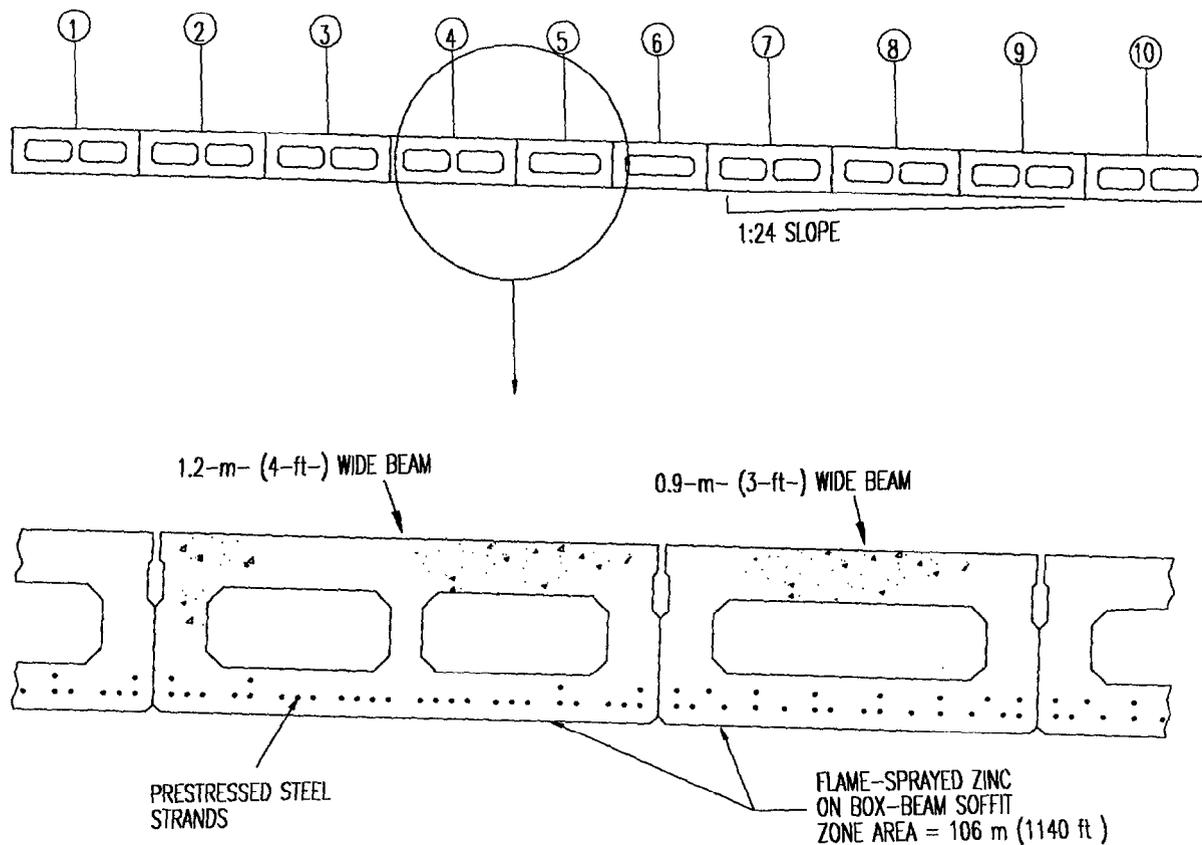
Figure 12. Abbey Road Bridge—box beam section view.

A single metallized zinc anode zone was installed on the soffit of the bridge, which was comprised of 10 prestressed box beams totaling an area of 106 m<sup>2</sup> (1140 ft<sup>2</sup>). A layout and section view of the CP system are shown in figure 12.

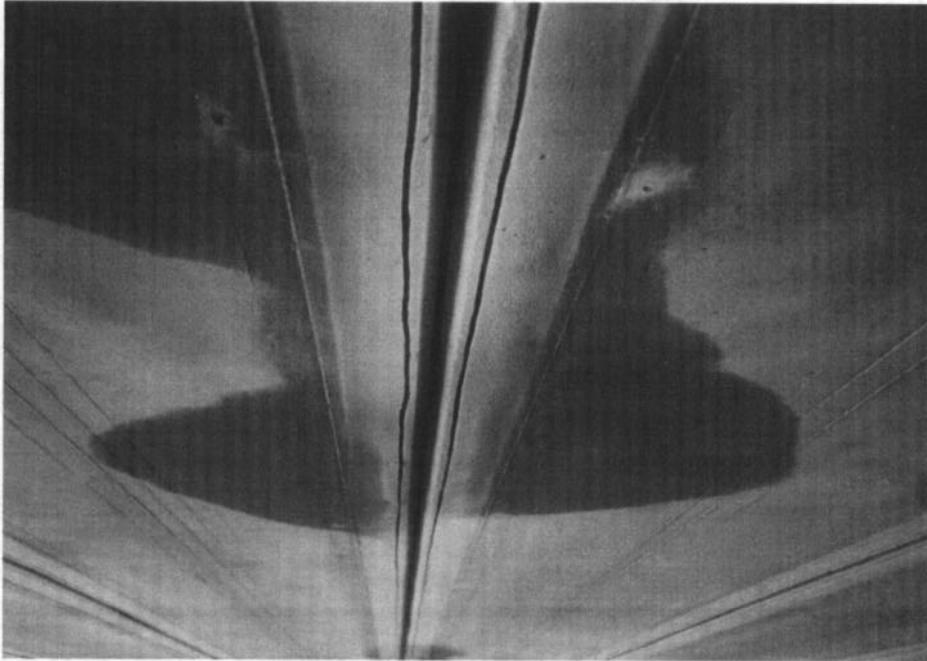
Figure 13. Finished grooves on each side of the joint between adjacent box beams.

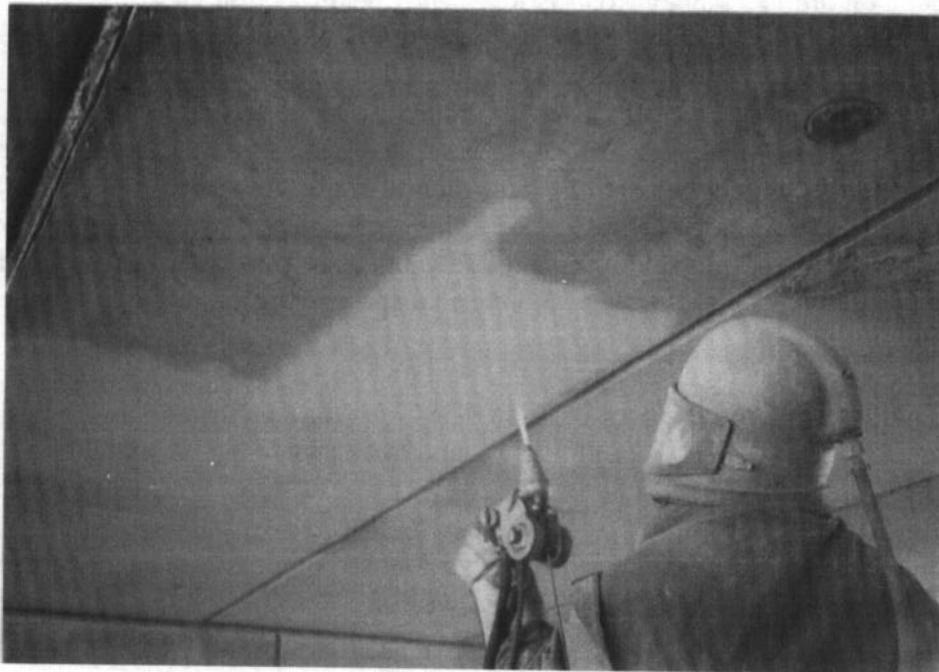
Figure 14. Flame spraying of zinc onto prepared surface.

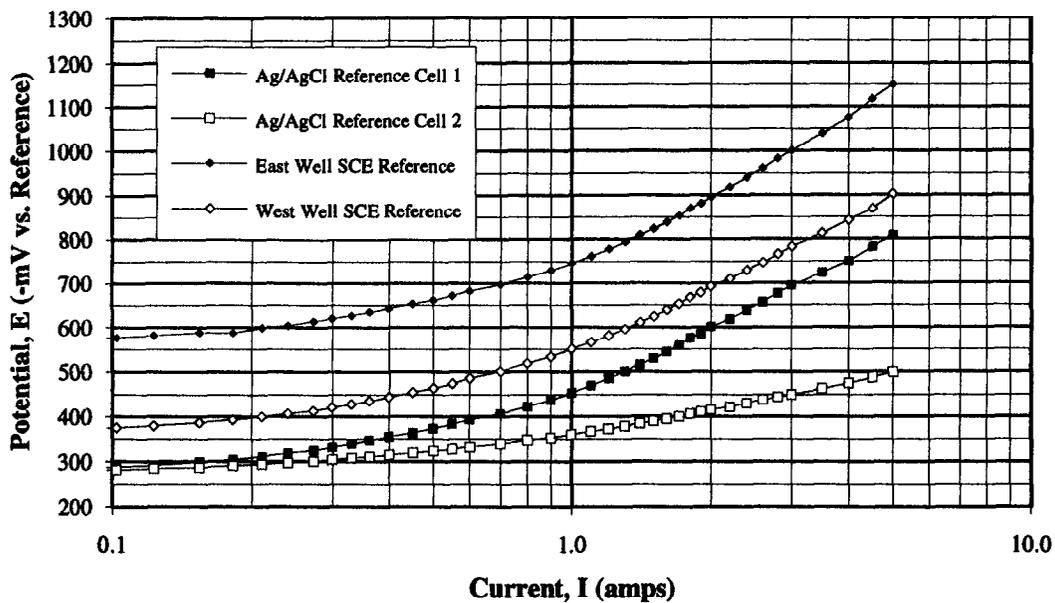
Figure 15. E-Log I of Abbey Road Bridge.

E-Log I tests were conducted on April 26, 1994, using the embedded Ag/AgCl reference electrodes and portable saturated calomel reference electrodes in the potential wells. All four E-Log I curves, shown in figure 14, exhibit a straight-line portion. The cathodic protection current ranged from 1.15 to 1.50 A or 10.8 to 14.0 mA/m<sup>2</sup> (1.00 to 1.30 mA/ft<sup>2</sup>). This was considered reasonable for this structure. Cathodic protection potentials ranged from -380 to -830 mV versus Ag/AgCl (-474 to -904 mV versus CSE), indicating the nonhomogeneous nature of this structure.

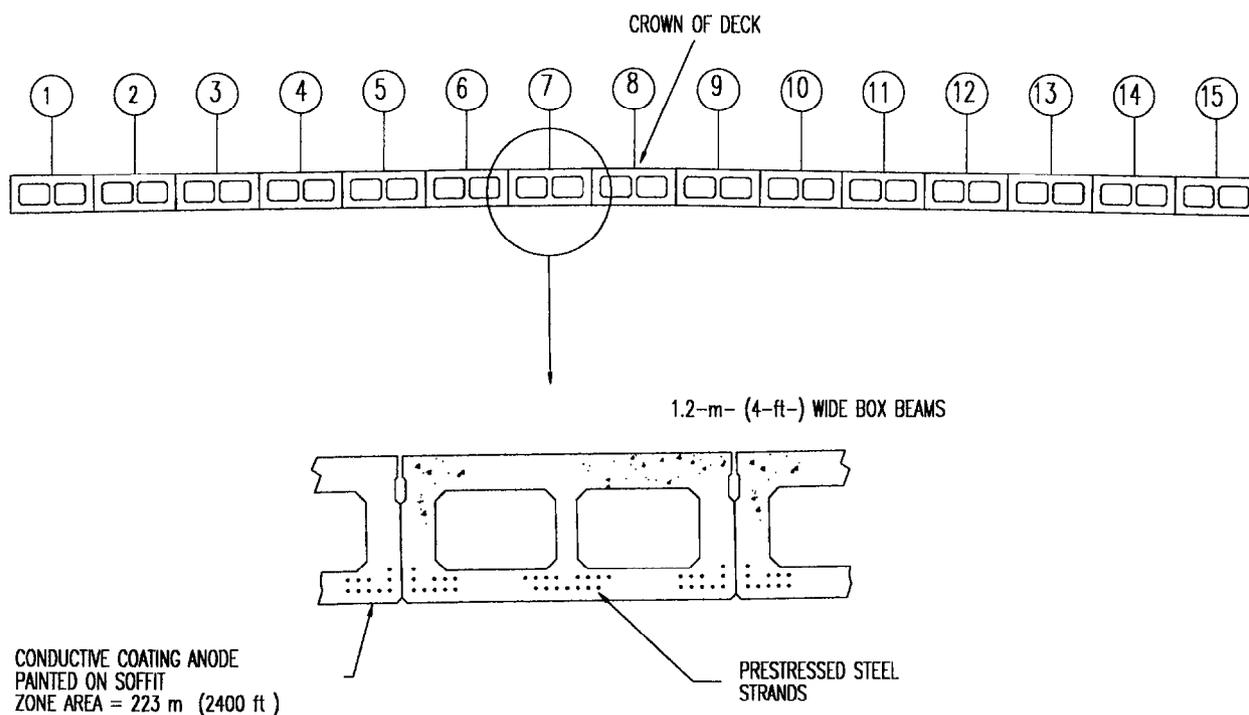
Figure 16. West 130<sup>th</sup> Street Bridge—box beam section view.

The single conductive paint anode system zone was installed on the soffit of the bridge, which was comprised of 15 prestressed box beams totaling 223 m<sup>2</sup> (2400 ft<sup>2</sup>), as shown in figure 16.

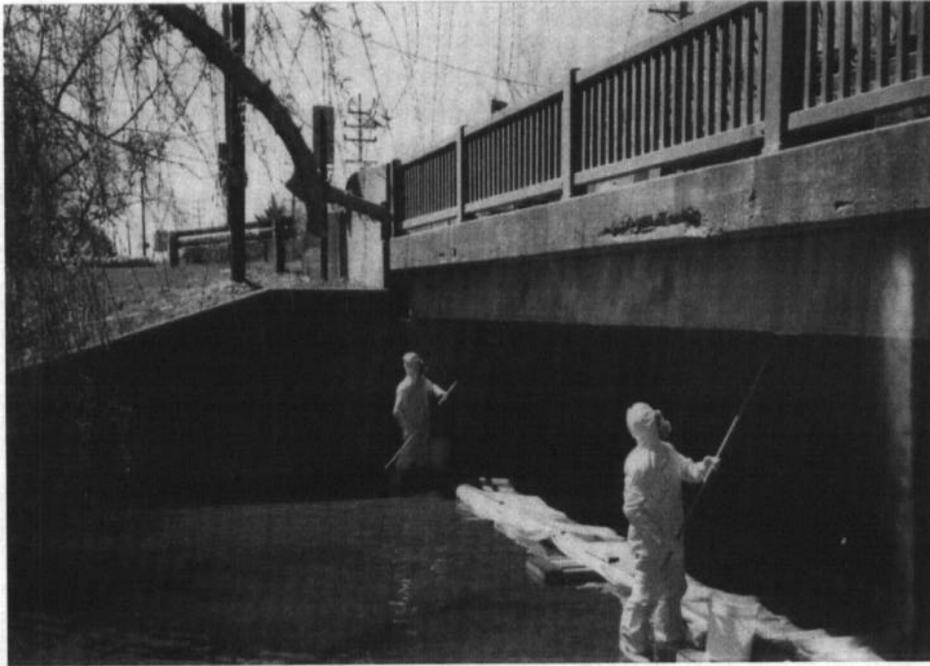
Figure 17. Roller application of conductive coating with polyethylene-covered frame used to catch coating spills and drips.

Two coats of conductive coating were applied using rollers over an adhesion-promoting primer. A moveable, plastic-covered wooden frame (shown in figure 17) was placed on the ground under an area being painted to prevent drips and spills from entering Baldwin Creek. The coating thickness was measured during placement with a thickness gauge and after final application with a Tooke gauge. The specified minimum 0.25-mm (10-mil) dry-film thickness was achieved.

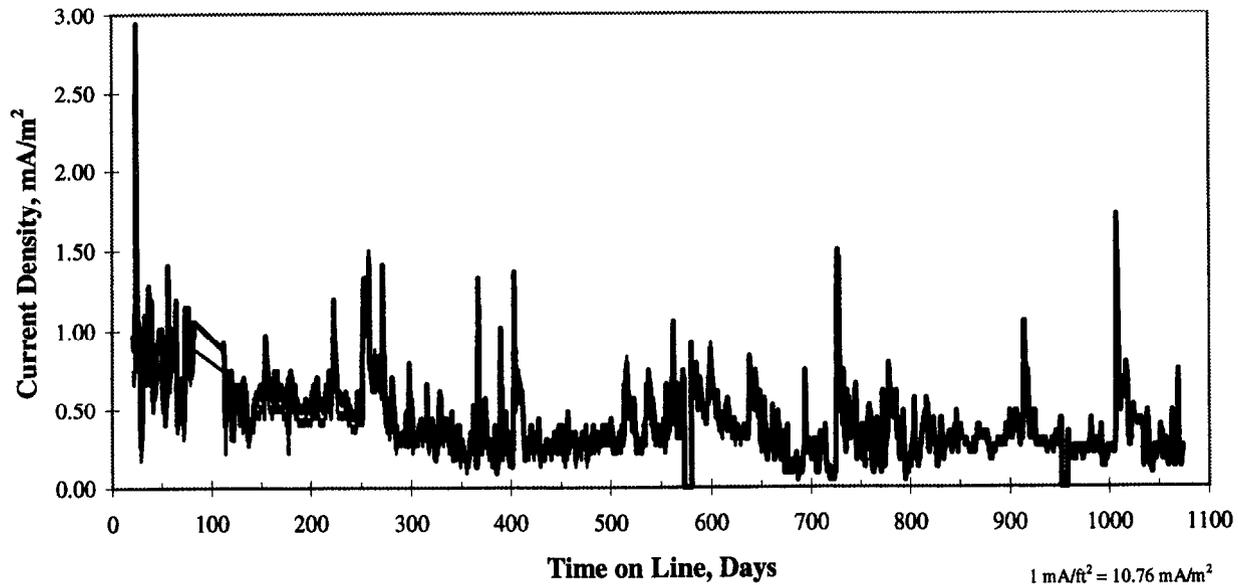
Figure 18. Current density versus time for metallized zinc anode system.

Current did decrease with time for the zinc in galvanic mode, as expected. This decrease is shown graphically on figure 18. Over the first 38 months of operation, current density decreased from  $1.6 \text{ mA/m}^2$  ( $0.15 \text{ mA/ft}^2$ ) to  $0.2 \text{ mA/m}^2$  ( $0.02 \text{ mA/ft}^2$ ). But throughout this period of time, adequate depolarization was recorded for the steel in these zones and the accepted polarization criterion of 100 mV was met. These data are shown in table 5. It is somewhat surprising that polarizations of over 200 mV were consistently achieved at such low current densities. This is due to the passive nature of most of the steel in these zones. Both of the zones with metallized zinc anodes were left in galvanic mode of operation following the monitoring phase of this contract.

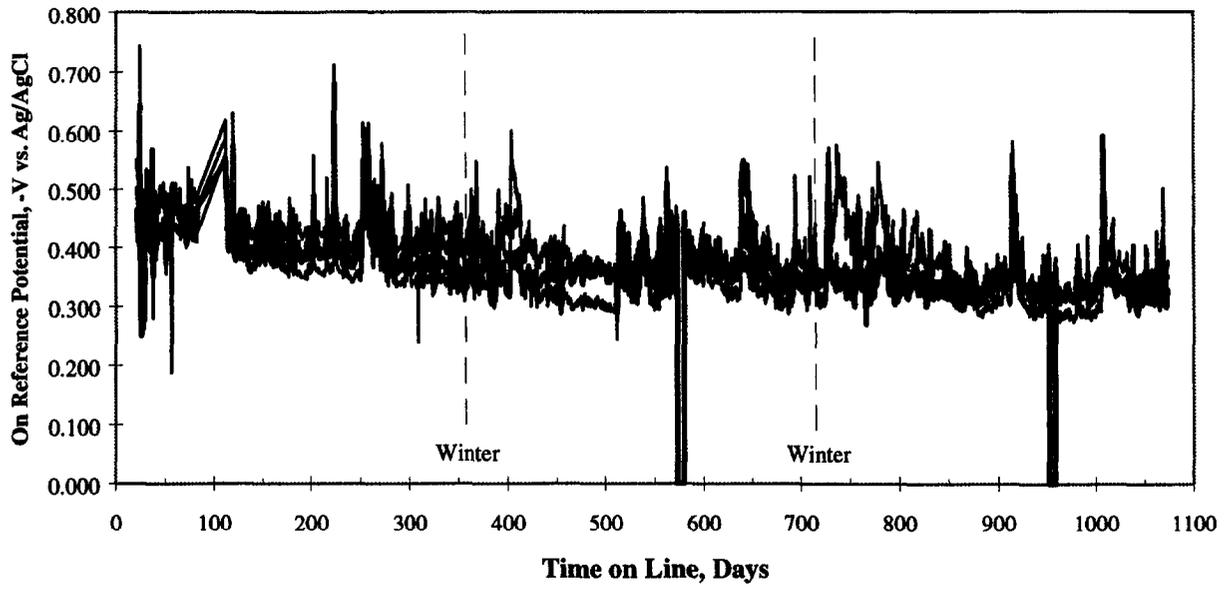
Figure 19. Potential versus time for metallized zinc anode system.

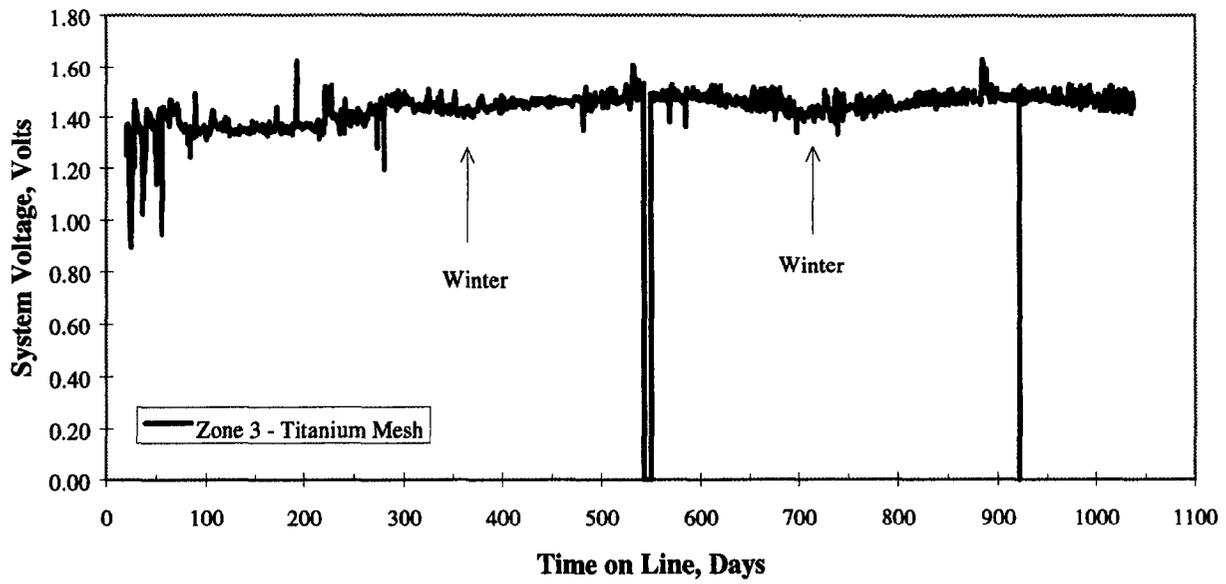
Figure 20. Voltage versus time for fiberglass jacket/titanium mesh anode system.

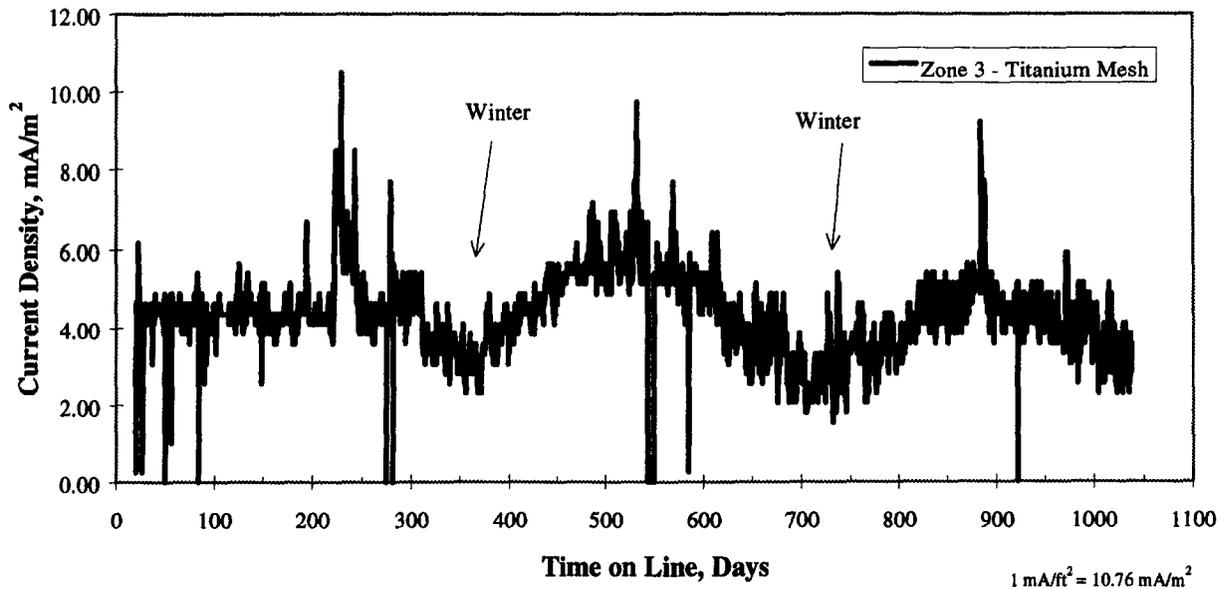
Figure 21. Current versus time for fiberglass jacket/titanium mesh anode system.

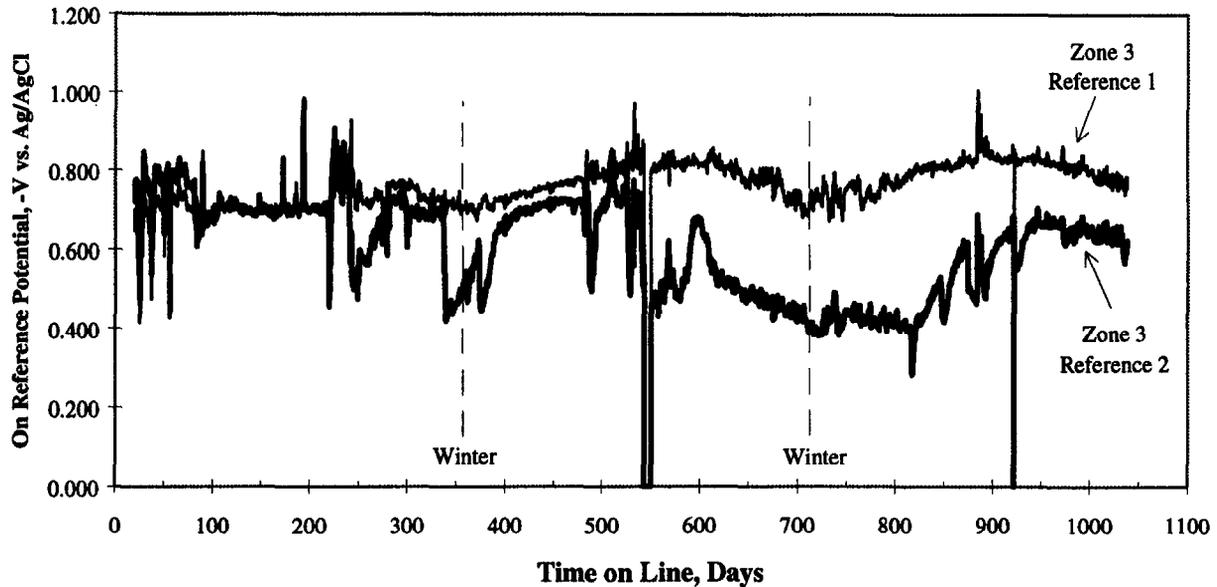
Figure 22. Steel potential versus time for fiberglass jacket/titanium mesh anode system

Potentials taken by remote monitor on the fiberglass jacket/titanium mesh anode system during this contract are shown on figure 22. Potentials are seen to be generally more negative during the summer months, a result of higher current densities in warm weather, but at no time did potentials exceed -840 mV versus Ag/AgCl (-847 mV versus SCE). These data again show that steel potentials were less negative than those required to cause hydrogen embrittlement during the entire monitoring period.

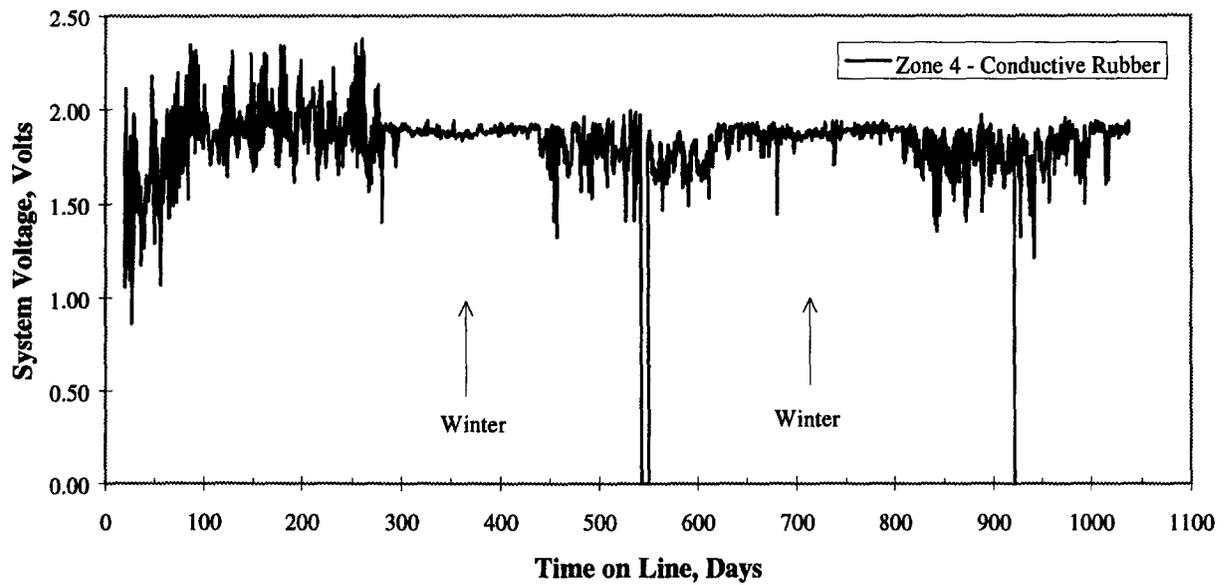
Figure 23. Voltage versus time for conductive rubber anode system.

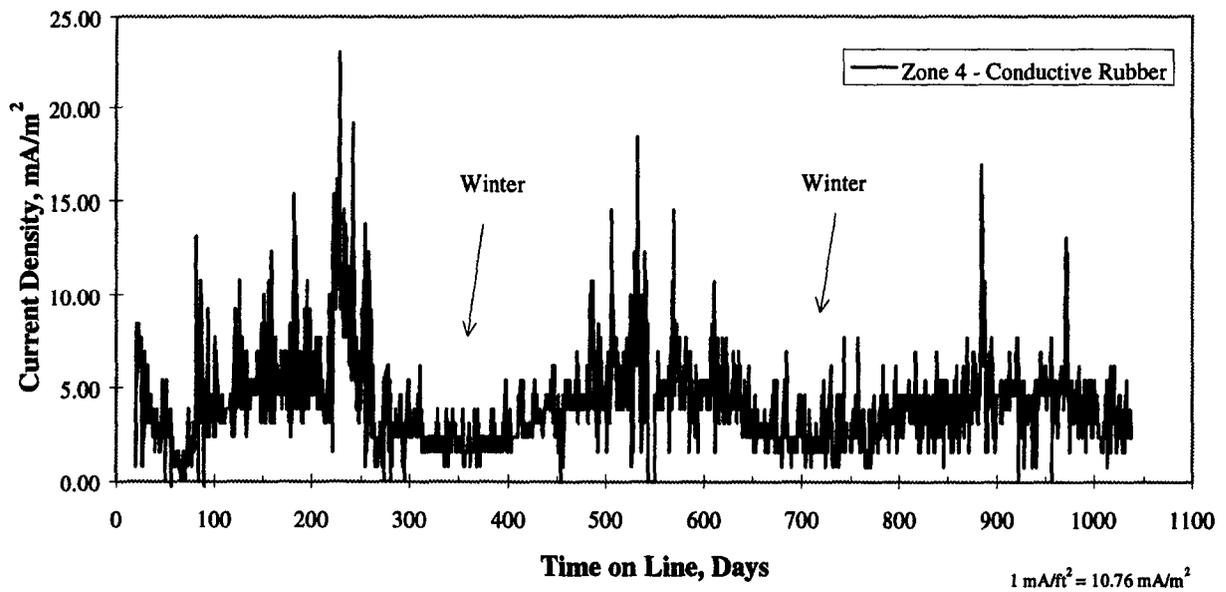
Figure 24. Current versus time for conductive rubber anode system.

Current density versus time for the conductive rubber anode CP system is shown on figure 24. Once again, current density is seen to increase during the summer months as a result of warm temperatures and lower electrolyte resistance. Current is seen to be much more erratic than that for the zone with titanium mesh anode. This is again a result of direct contact of the anode with seawater and current surges during periods of high tide.

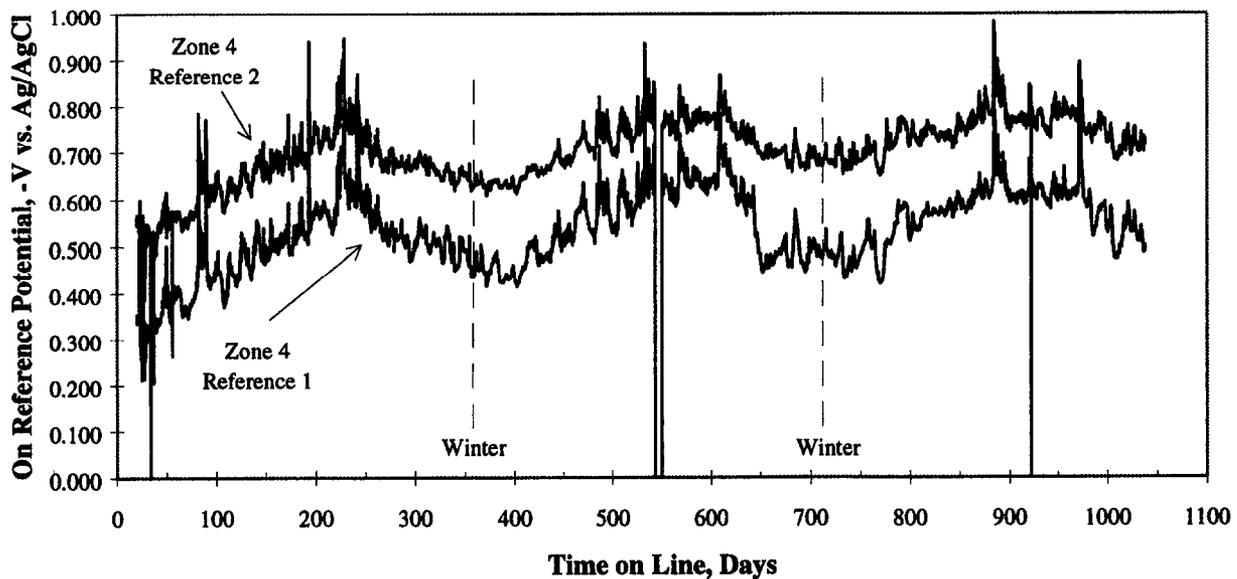
Figure 25. Steel potentials versus time for conductive rubber anode system.

Potentials taken by remote monitor on the conductive rubber anode system during this contract are shown on figure 25. Potentials are again seen to be generally more negative during the summer months, a result of higher current densities in warm weather.

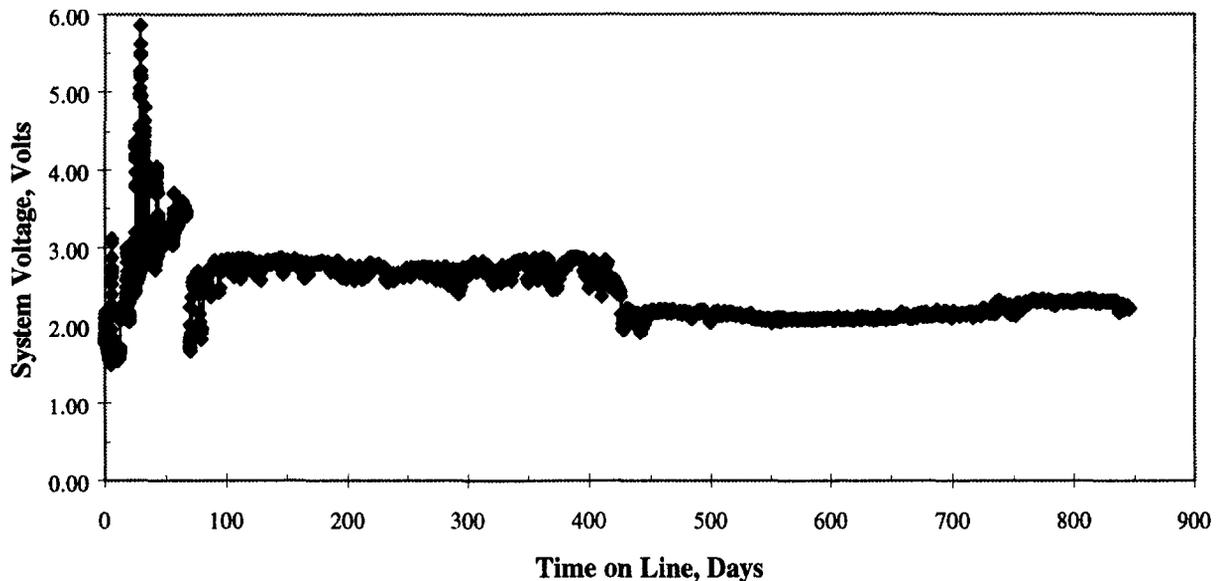
Figure 26. Voltage versus time for West 130<sup>th</sup> Street Bridge.

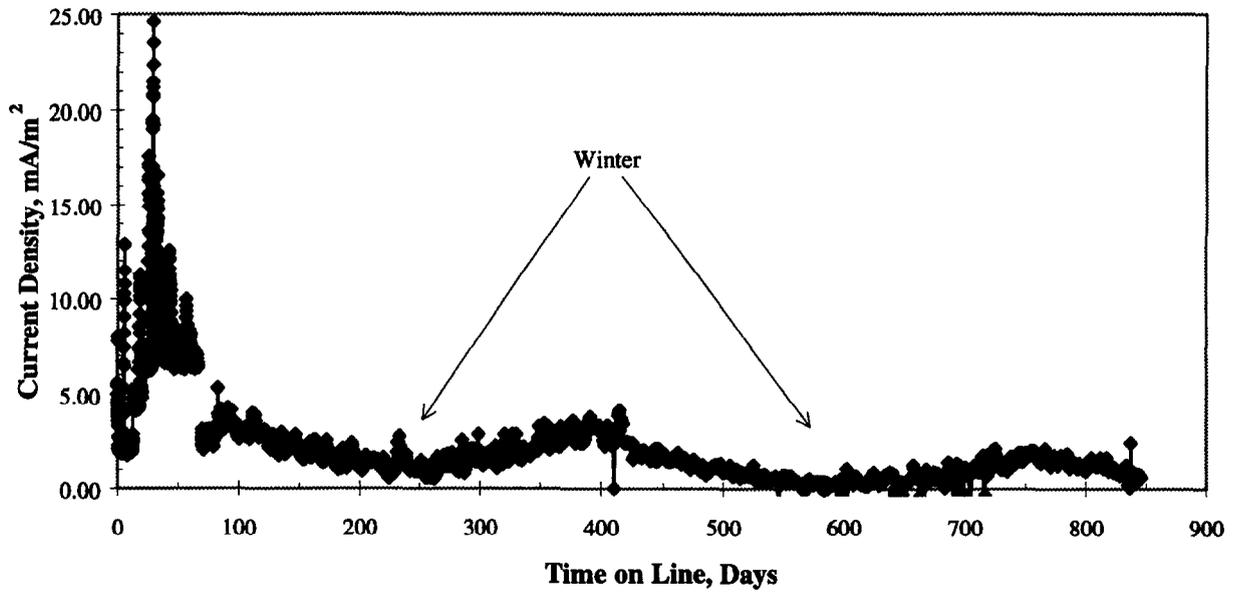
Figure 27. Current versus time for West 130<sup>th</sup> Street Bridge.

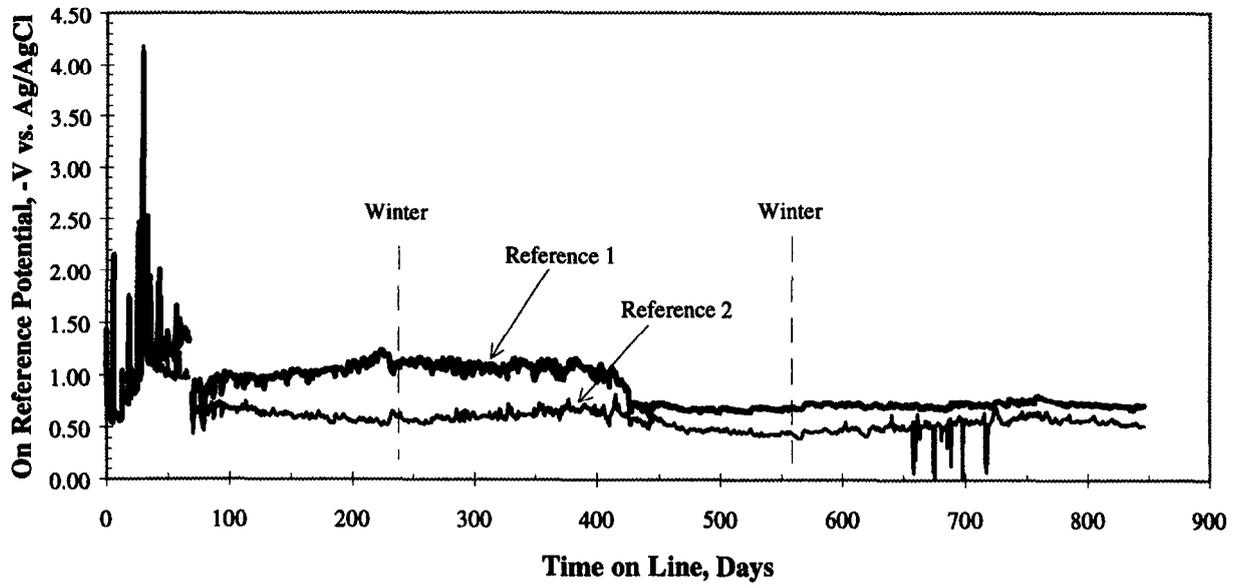
Figure 28. Steel potentials versus time for West 130<sup>th</sup> Street Bridge.
