# Cathodic Protection Field Trials on Prestressed Concrete Components, Final Report

PUBLICATION NO. FHWA-RD-97-153

JANUARY 1998

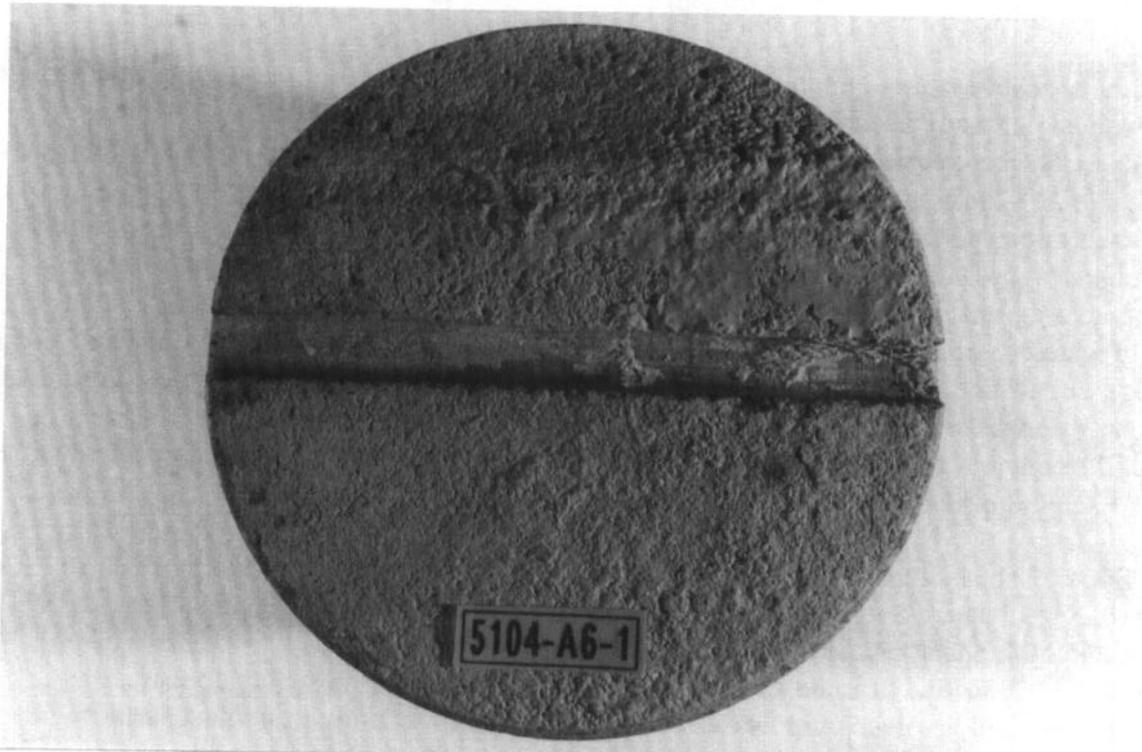
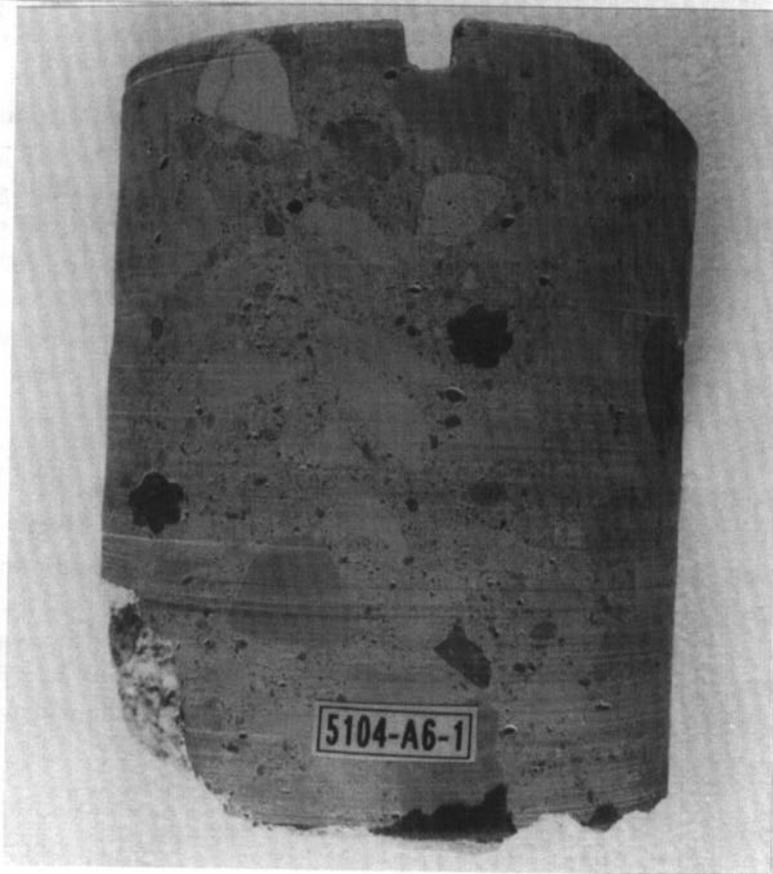
Figure 29. Core taken from Beam #6 of Abbey Road Bridge in as-received condition.

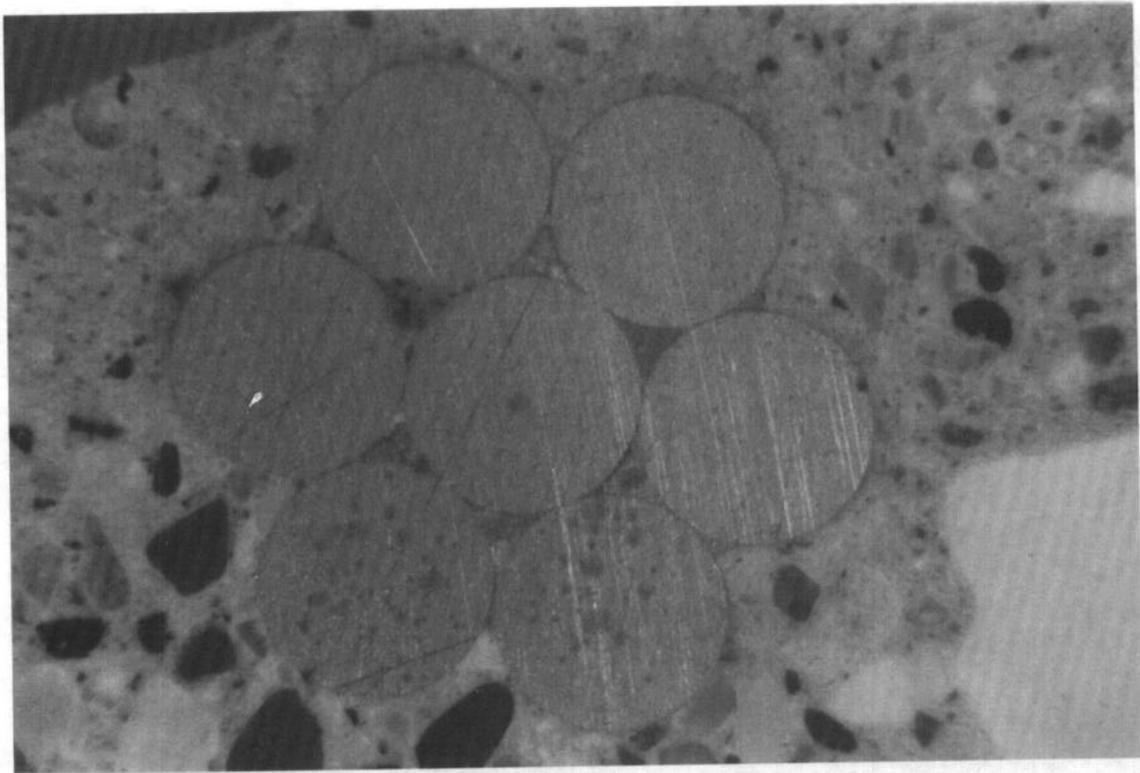
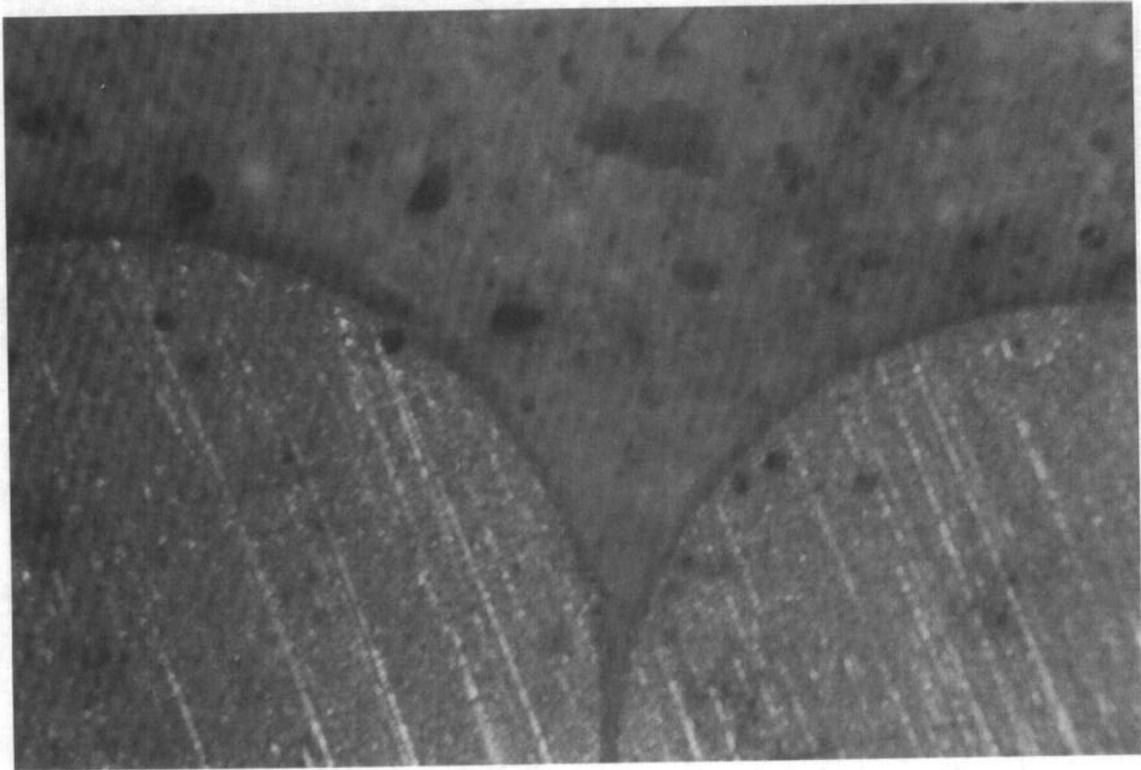
Figure 30. Section views of core taken from Beam #9 of Abbey Road Bridge.

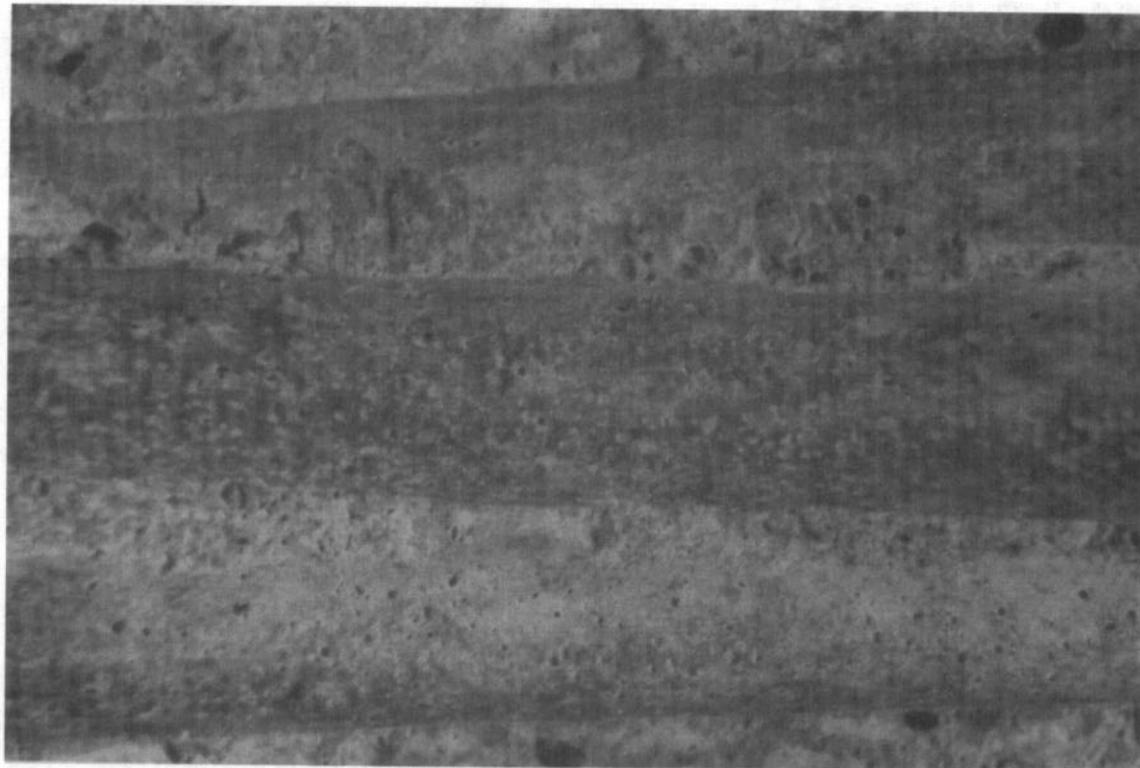
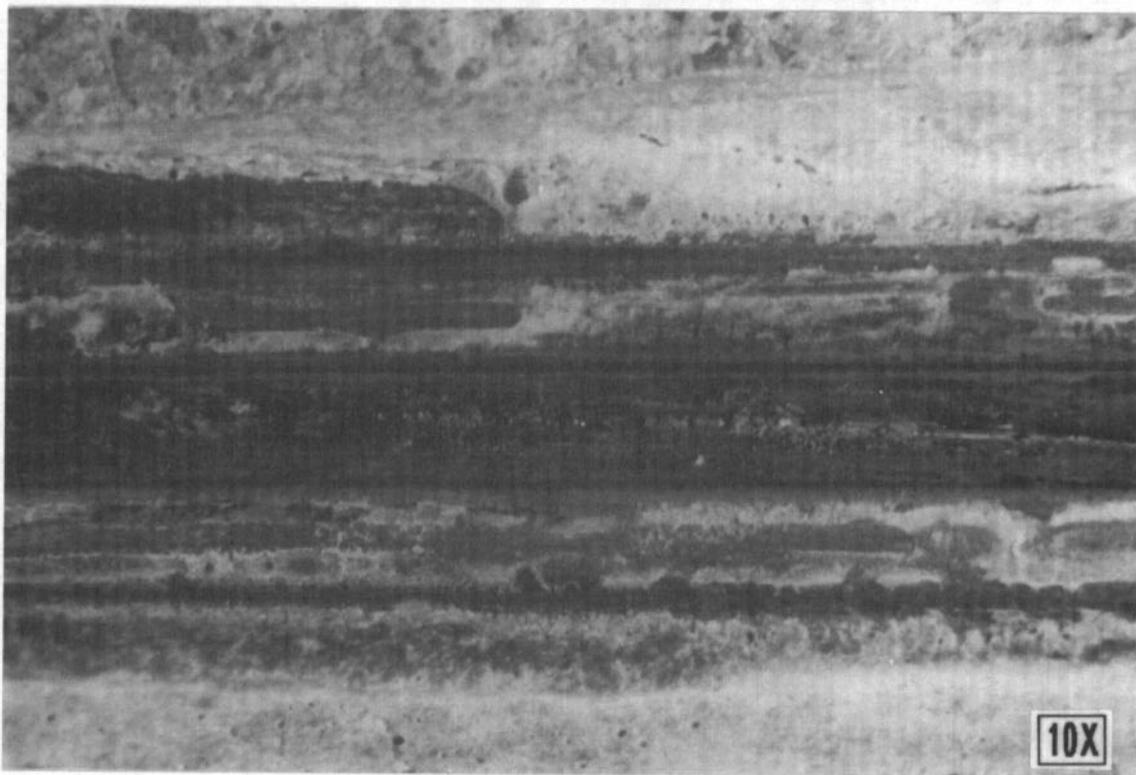
Figure 31. Optical microscope view showing fracture of core from Beam #2 of Abbey Road Bridge.

The bottom photograph in figure 31 shows prestressing steel wires still in place in the concrete alongside concrete from which the prestressing wire had been removed. The steel surfaces shown here were those defining the interior of the prestressing strand bundle. In all of the Abbey Road Bridge samples examined, there was very little penetration of the concrete into the interior of the steel wire strand. Interior steel surfaces not in contact with concrete typically show light corrosion such as that shown in the bottom photograph of figure 31. The overall condition of the prestressing wires in all of the cores examined here following the CP treatment was characterized as excellent with virtually no loss of steel section.

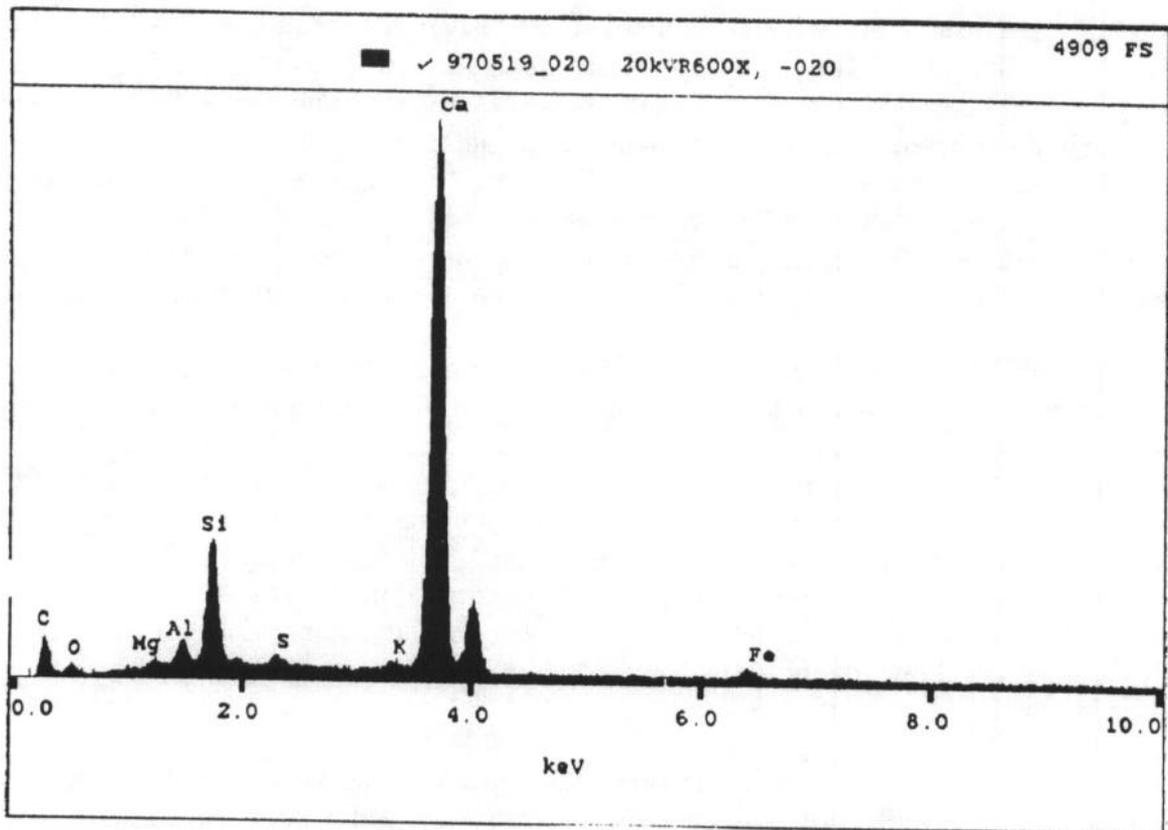
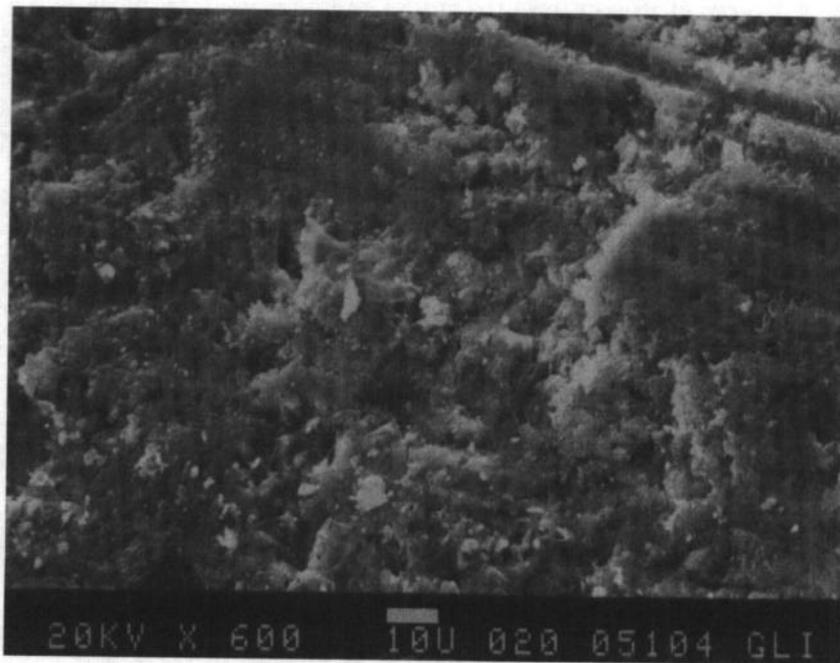
Figure 32. EDS spectrum and photograph (600X) of the steel/concrete interface in specimen from Beam #2.

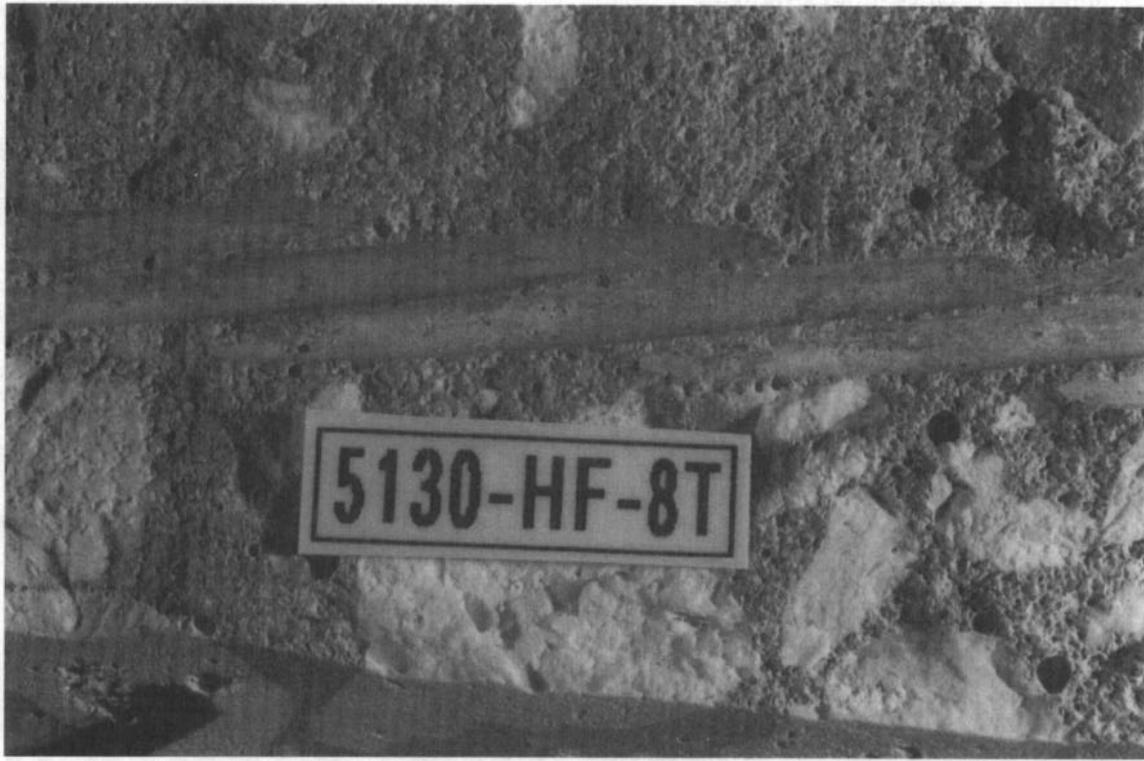
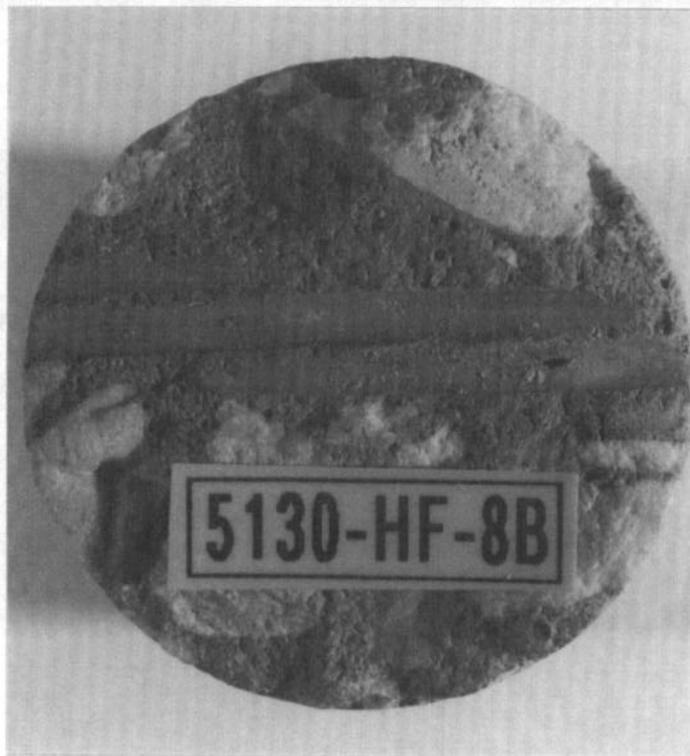
Figure 33. Optical microscope views of the Howard Frankland Bridge samples.

The Howard Frankland Bridge samples were examined using the same procedures described previously for the Abbey Road Bridge samples. The principal modes of examination used optical microscopy and SEM/EDS procedures. Optical microscope views of the prestressing steel/concrete bond surfaces are shown in figure 33.

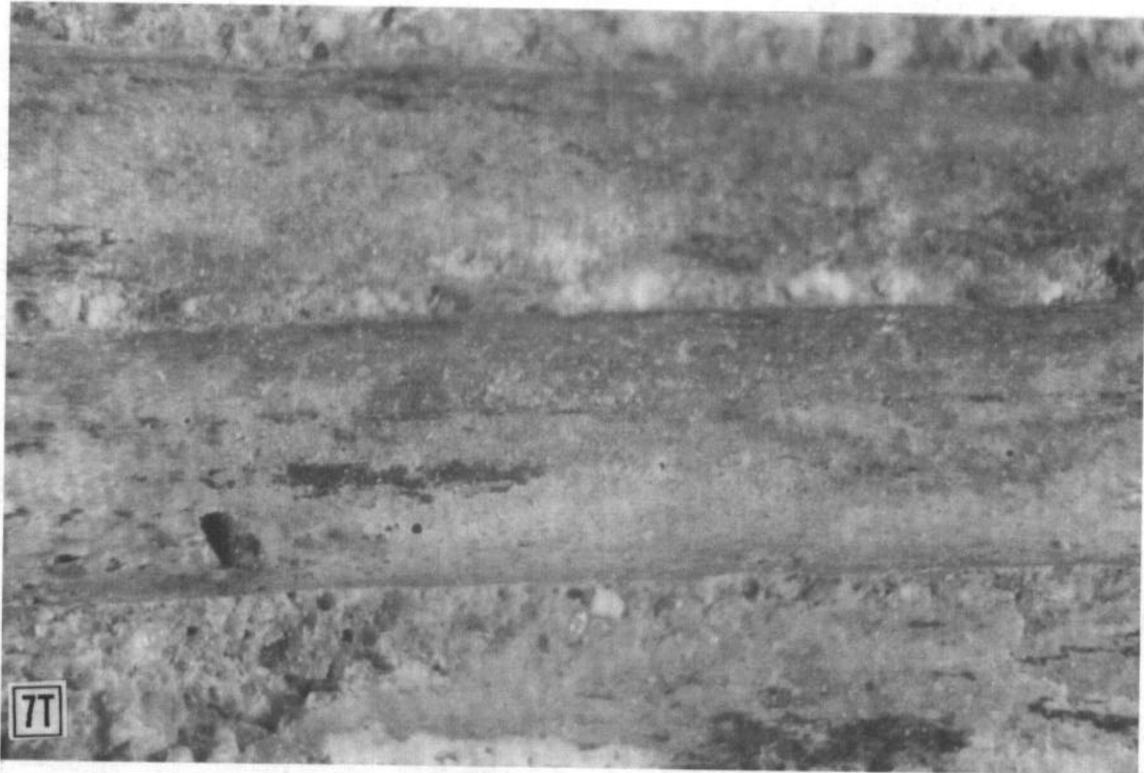
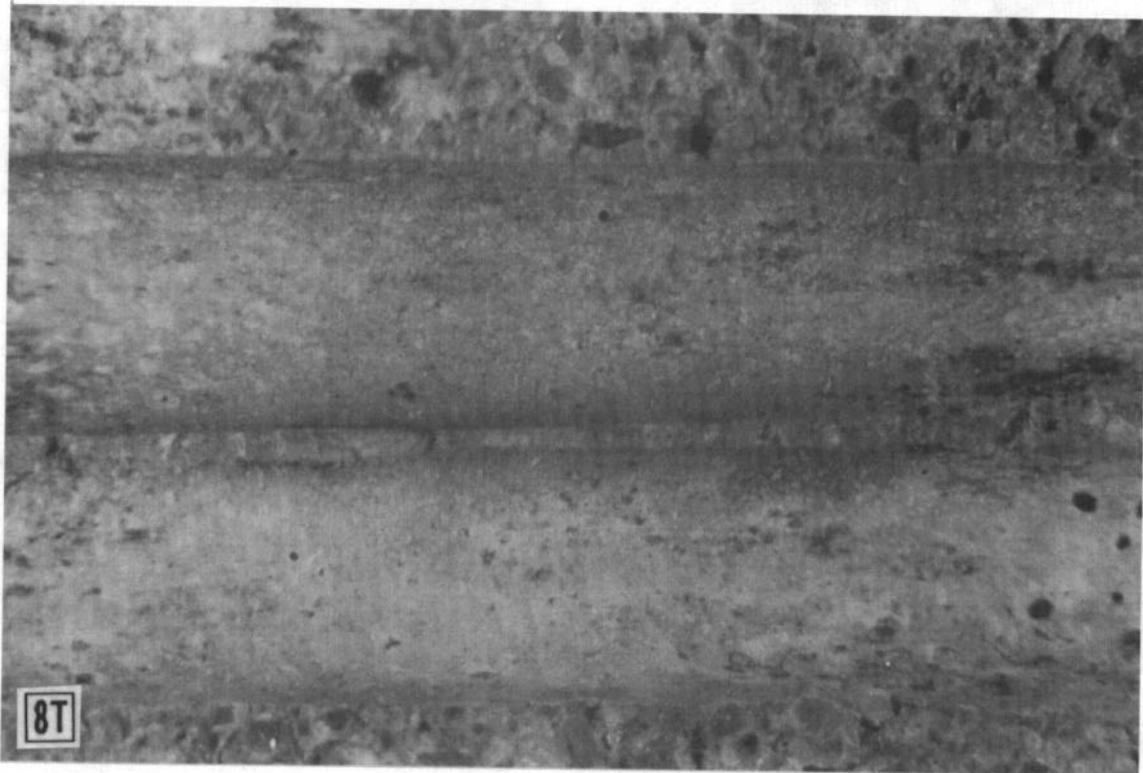
Figure 34. Prestressing steel/concrete interface surfaces in Howard Frankland Bridge samples.

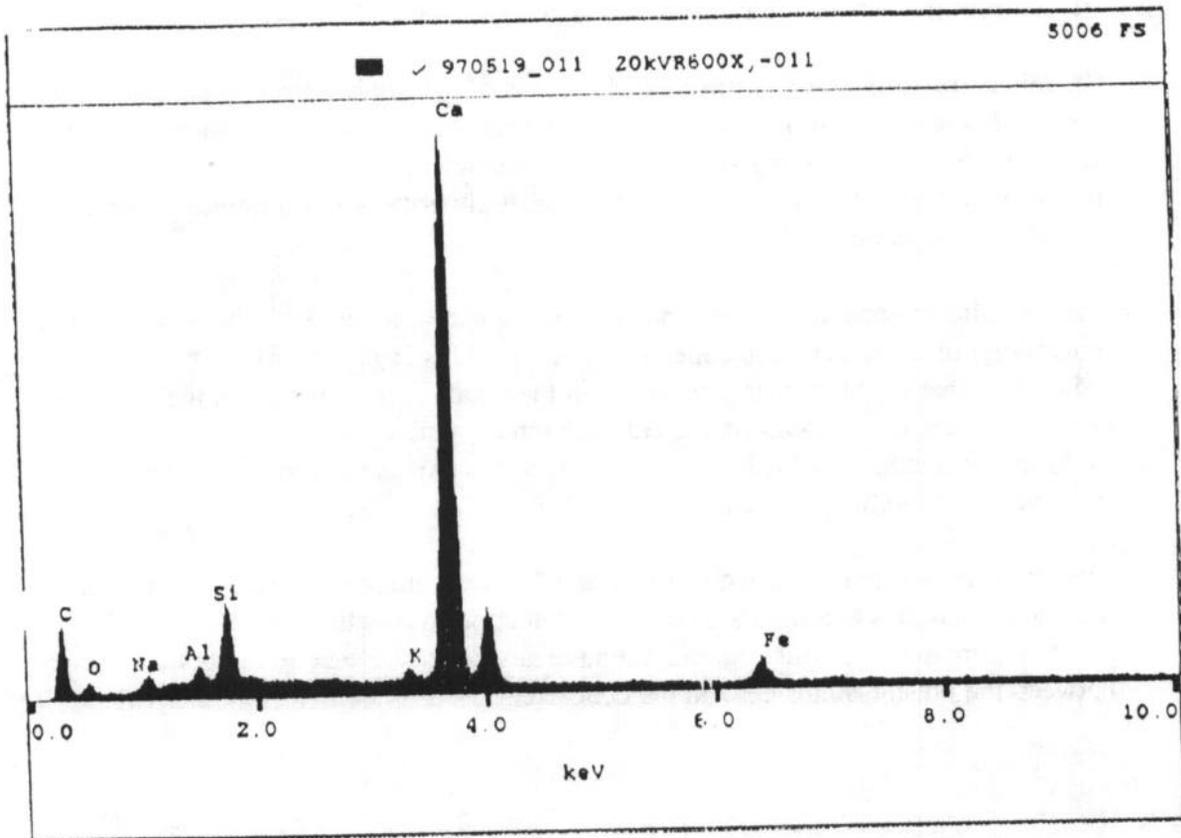
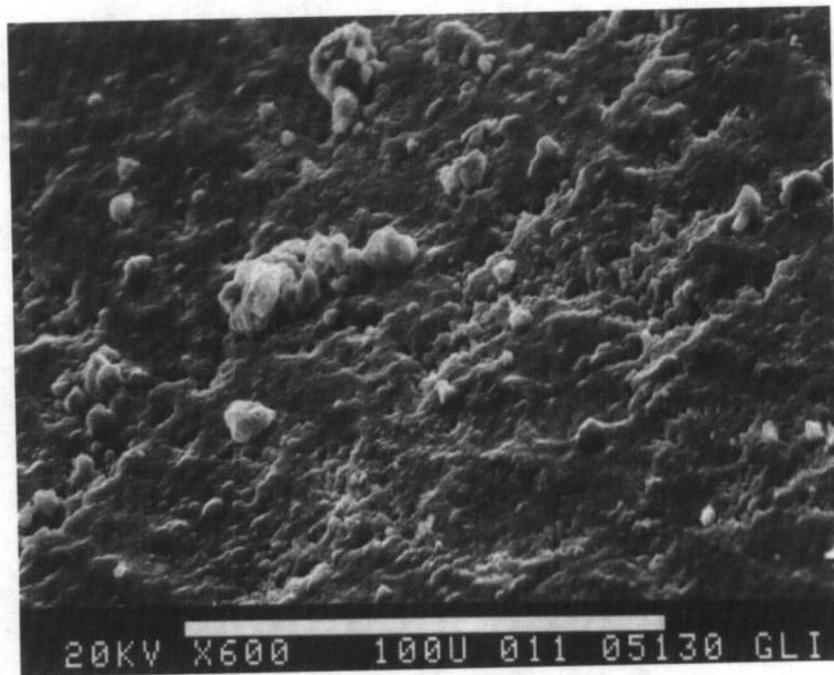
Figure 35. EDS spectrum and photograph (600X) of the prestressing steel/concrete interface surface in Howard Frankland Bridge sample.
