Analysis, Inspection, And Repair Methods For Pin Connections On Illinois Bridges

Physical Research Report No. 107

Illinois Department of Transportation

Bureau of Materials and Physical Research

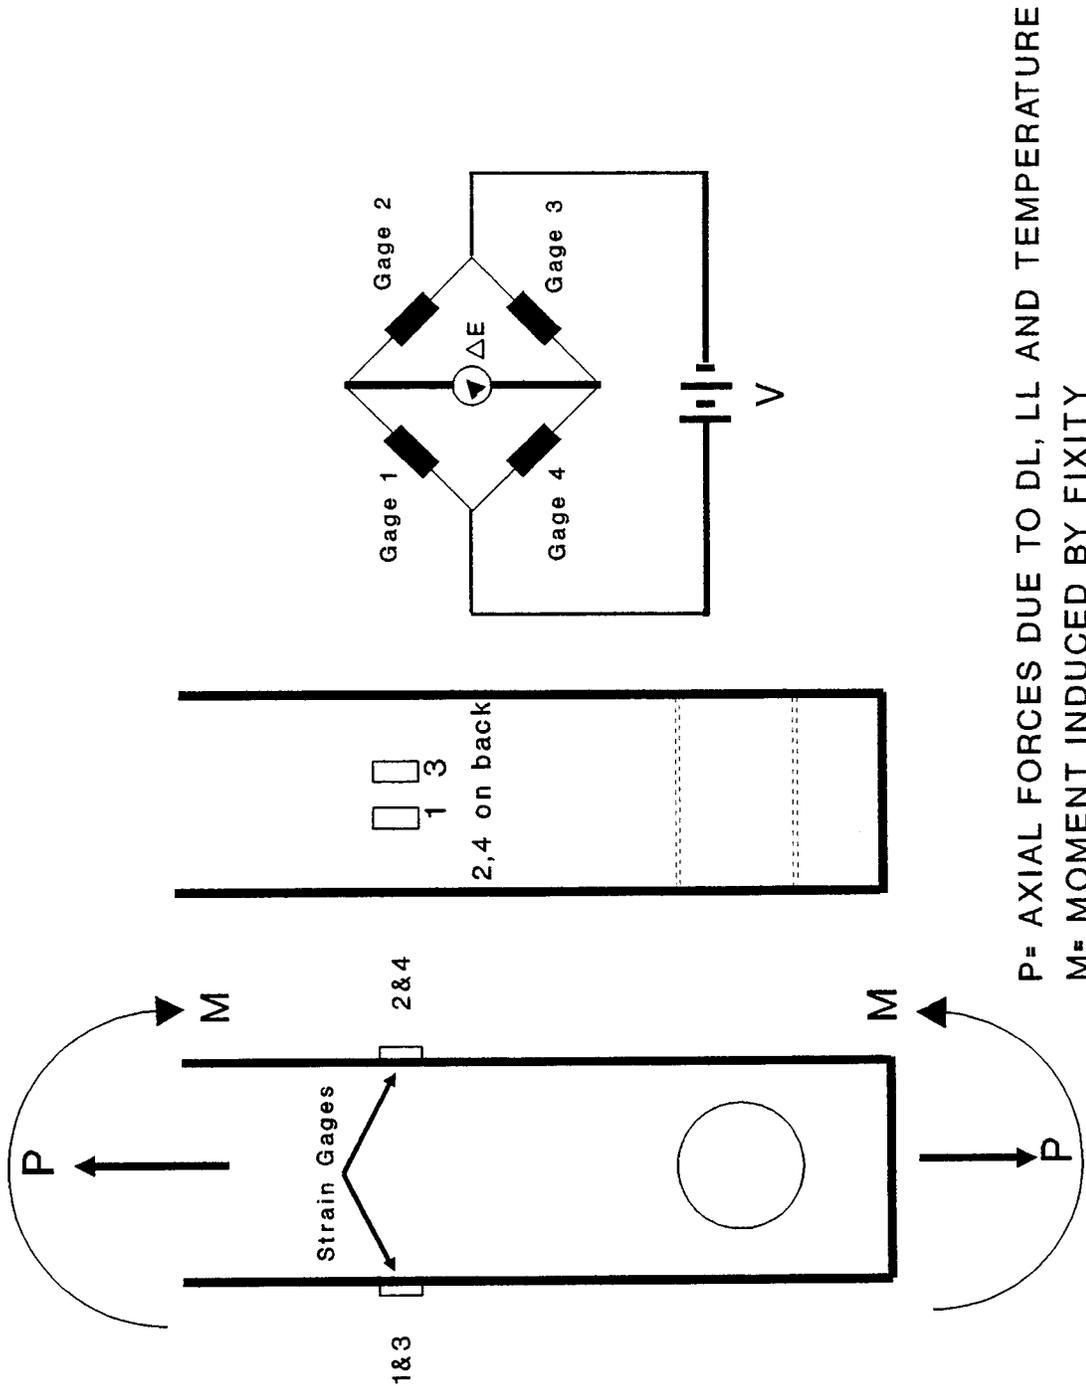
P= AXIAL FORCES DUE TO DL, LL AND TEMPERATURE
M= MOMENT INDUCED BY FIXITY

Figure 4. Strain gage installation for detection of bending strains induced by pin fixity.

An electrical resistance strain gage installation was designed to measure bending stresses in a hanger or link eyebar while being insensitive to axial stresses.² See Figure 4. The theory behind this method was that free pins would not introduce any bending stresses into the hanger, while partially fixed and fixed pins would induce some degree of bending. Several hangers on the I-270 bridge and I-474 over the Illinois River at Peoria were instrumented in this fashion. See Figure 5. This method has the advantage of being extremely sensitive to bending stresses. The major drawbacks of this idea were: 1) strain gages can be

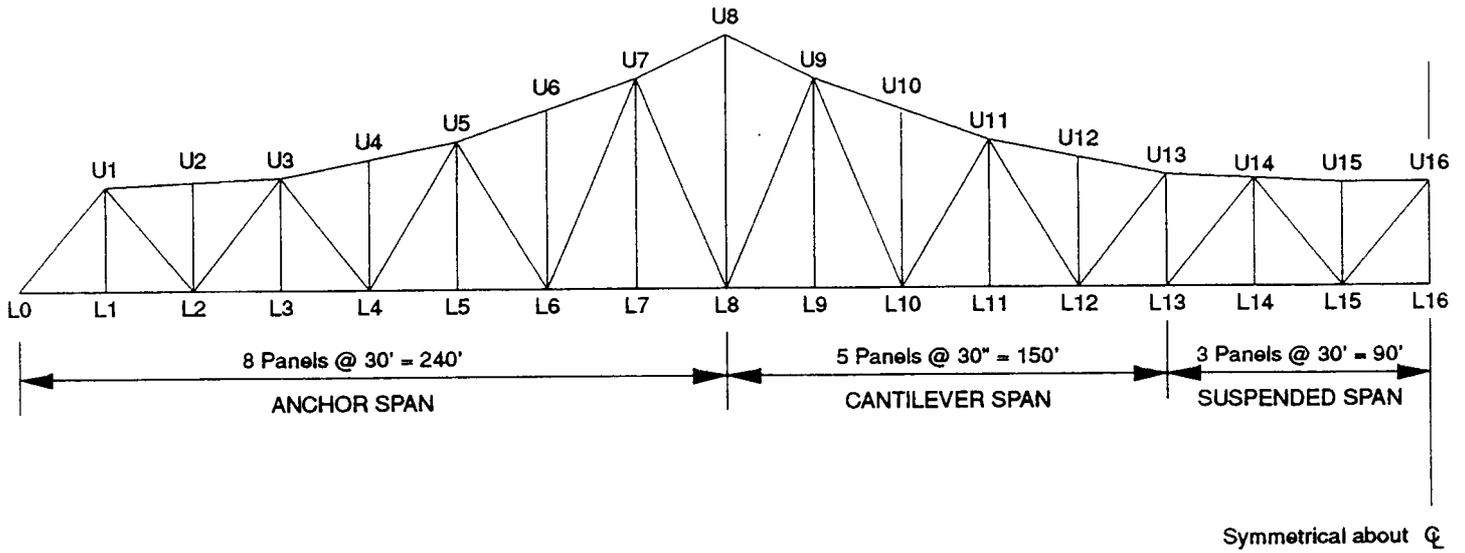
Figure 7. I-270 over Chain-of-Rocks Canal. Bridge is symmetrical about the centerline.

The truss section of the Chain-of-Rocks Canal bridge is 960 feet long. The cantilevered portion is 150 feet long, and the suspended span is 180 feet long. The structure was built circa 1960. The truss members are riveted box sections and were modeled using line elements. Since the truss members have oval holes (approximately 8 x 16 inches) cut in them on approximately three-foot spacings, the net section properties were used in the model for each individual member. Stringers, diaphragms, and floorbeam flanges and stiffeners were also modeled as line elements. The floorbeam webs and the concrete deck were modeled with hybrid elements which are a combination of plate bending and plane stress/plane strain elements. Only half of the structure was modeled in order to take advantage of symmetry. See Figure 7. Figure 8 shows a section of the bridge as a finite element approximation. Pins are located at nodes M13 and G13. The model was checked graphically to check the accuracy of the input geometry data and was subjected to various static loadings to check overall displacement behavior. See Figure 9. Movement due to temperature change was checked with simplified calculations (using a constant coefficient of thermal expansion). The computer output for thermal movement was within three percent of the simplified calculation. This check does not necessarily prove either method to be correct, but the close approximation of the two solutions indicates no gross modeling errors. The torque on the pins for a temperature change of 50°F was generated by the computer model and the resulting torsional shear stress on the seven-inch diameter pins (ASTM A237 Class A Steel) was calculated from

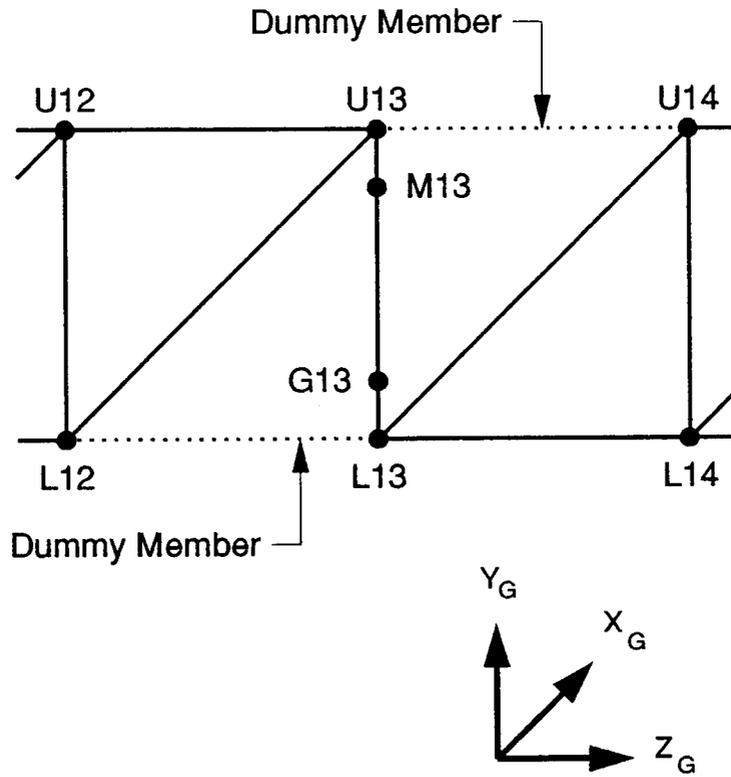
Figure 8. Finite element approximation of a truss section near a hanger on I-270 over Chain-of-Rocks Canal. Pins are located at nodes M13 and G13.

A finite element model contains two types of nodes; free nodes and support nodes. Free nodes experience displacements and/or rotations according to structural analysis type. Free nodes in a truss analysis disregard rotations since the truss assumption allows only axial forces. Free nodes in a frame analysis may experience both displacements and rotations. Support nodes are the points in the model which support the model in space (e.g. piers and abutments). In a mathematical sense, support nodes are where displacement or rotation boundary conditions are applied. Support nodes may be modified to act as rollers, fixed points with rotation allowed, elastically supported points or completely clamped points. Support nodes experience reaction loads. Since the object of the finite element analysis was to estimate loads on pins, the bridge pins in the computer models were simulated by defining them as support nodes. All displacements were released in order to simulate a free node. The no fixity condition was simulated by allowing all rotations. The full fixity condition was simulated by restricting the rotations.

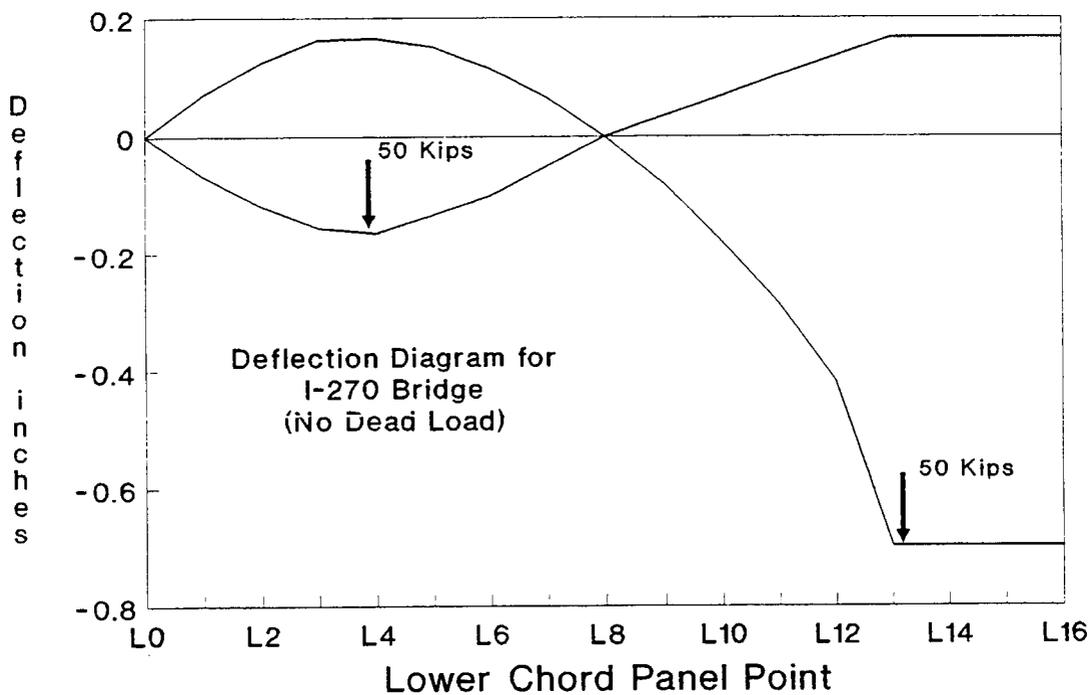
Figure 9. Static deflection diagram of lower chord of I-270 bridge, without deadload effect.

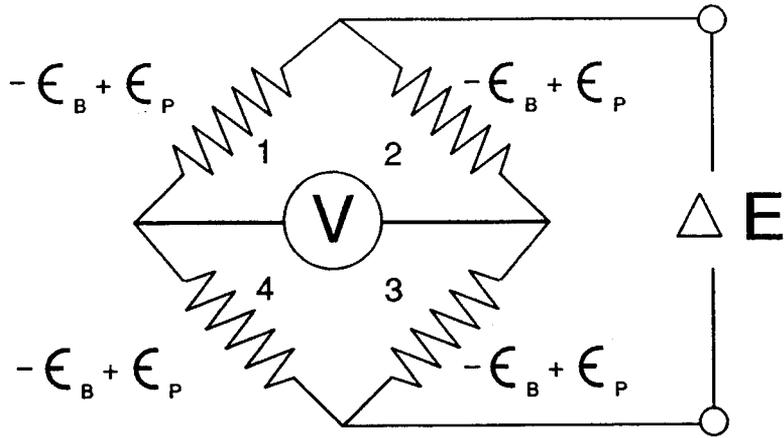
Figure 11. Wheatstone bridge circuit diagram for measurement of bending strains with insensitivity to axial strains.

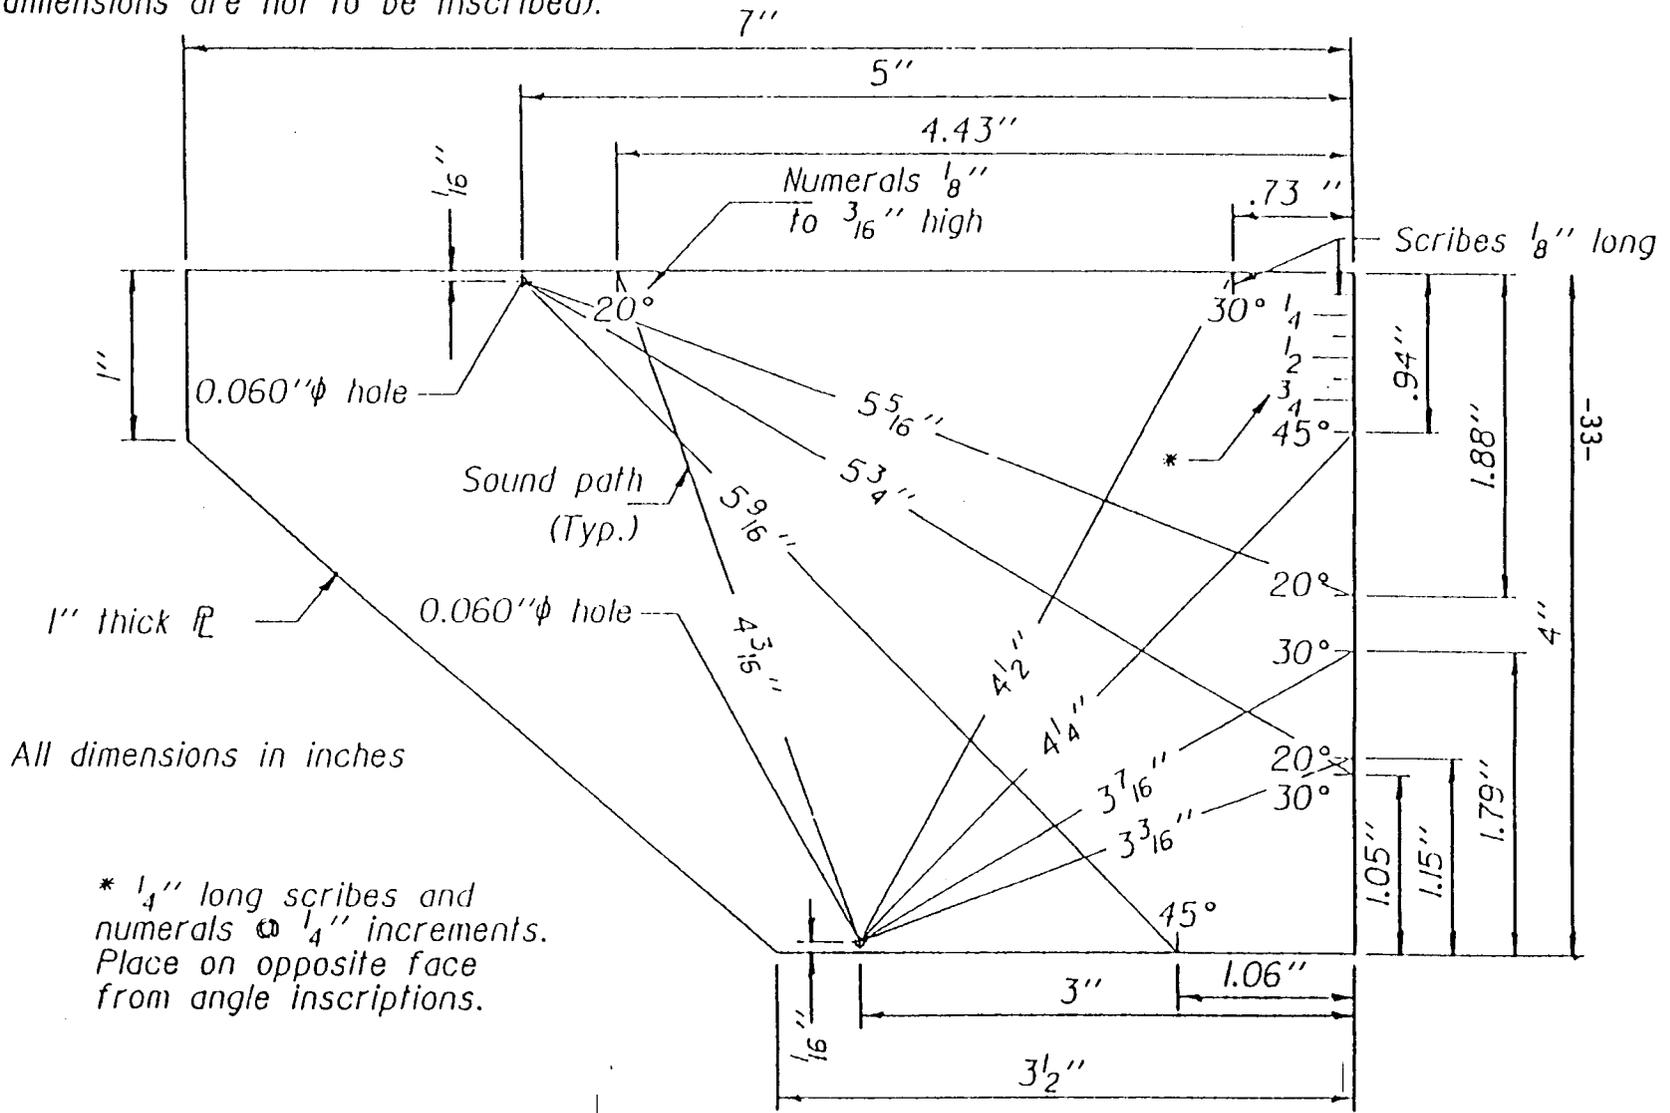
Figure 12. Distance and Sensitivity Calibration-Pin (DSC-P) calibration block developed for use with pin inspections.

* $\frac{1}{4}$ " long scribes and numerals @ $\frac{1}{4}$ " increments. Place on opposite face from angle inscriptions.

IL DOT DSC - P* test block
* Distance & Sensitivity Calibration - Pin

1. The dimensional tolerance between all surfaces involved in referencing or calibrating shall be within ± 0.005 in (.13 mm) of detailed dimension.
2. The finish of all faces to which sound is applied or reflected from shall have a maximum ANSI surface roughness of 125μ in (r.m.s.)
3. All material shall be AISI 1018 or acoustically equivalent, with no detectible internal defects @ 80 dB setting with a $\frac{1}{2}$ " ϕ , 3.5 MHz, straight beam transducer.
4. All holes shall have a smooth internal finish and shall be drilled at 90 degrees to the material surface.
5. Degree lines and identification markings shall be indented into the material surface so that permanent orientation can be maintained. (Sound paths and dimensions are not to be inscribed).

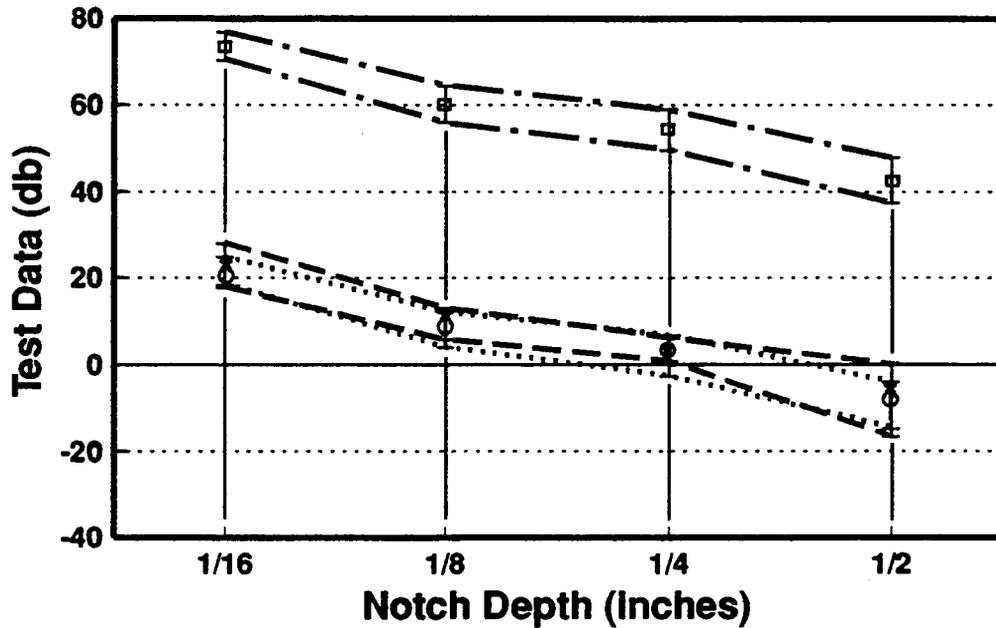
Ultrasonic Data For Actual Pin Specimen Straight Beam Transducer f=3.5MHz

Figure 14. Ultrasonic test data for an actual 3-inch diameter pin specimen using a straight beam transducer. Figure shows unadjusted data, results from IDOT procedure, and results from IDOT procedure without distance attenuation correction factor.

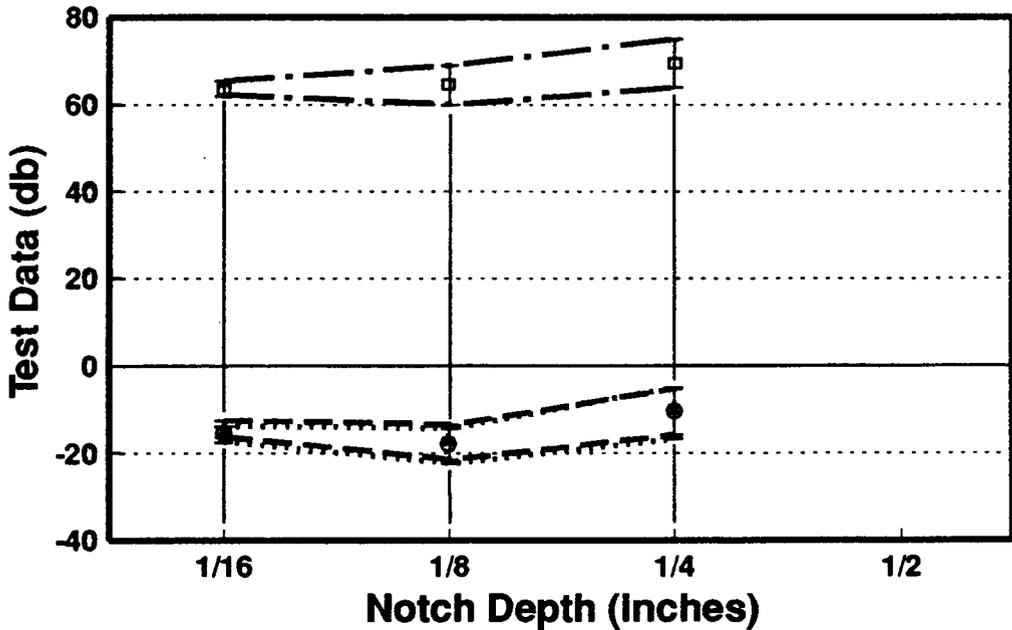
Ultrasonic Data For Actual Pin Specimen 20 Degree Angle Beam Transducer f=3.5MHz

Figure 15. Ultrasonic test data for an actual 3-inch diameter pin specimen using a 20 degree angle beam transducer. Figure shows unadjusted data, results from IDOT procedure, and results from IDOT procedure without distance attenuation correction factor.

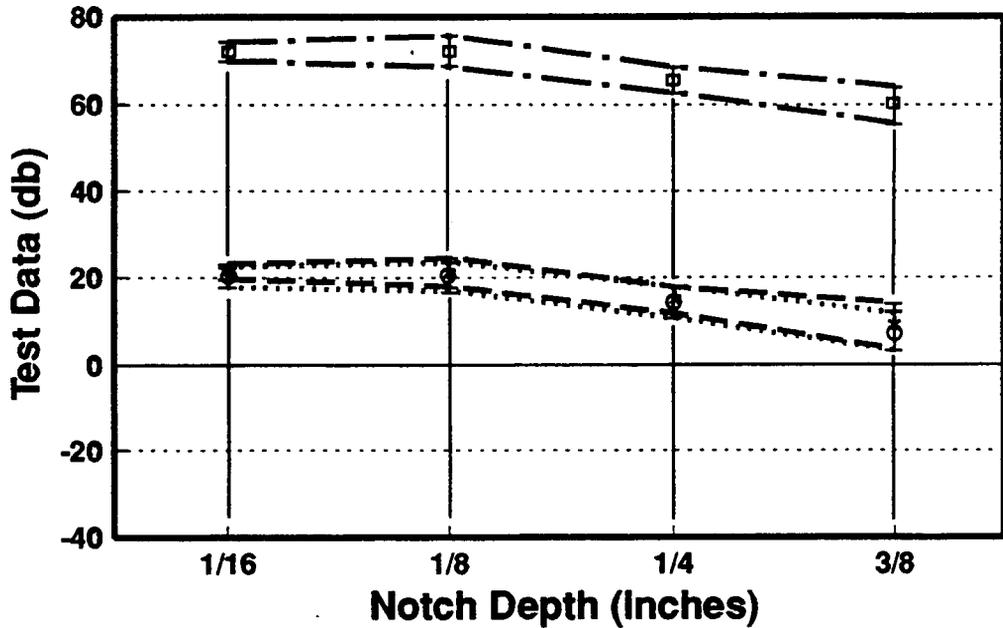
Ultrasonic Data For A572 Plate Specimen Straight Beam Transducer f=3.5MHz

Figure 18. Ultrasonic test data for a plate specimen of ASTM A572 steel using a straight beam transducer. Pertinent specimen geometry was the same as that of the tested pin specimen. Figure shows unadjusted data, results from IDOT procedure, and results from IDOT procedure without distance attenuation correction factor.

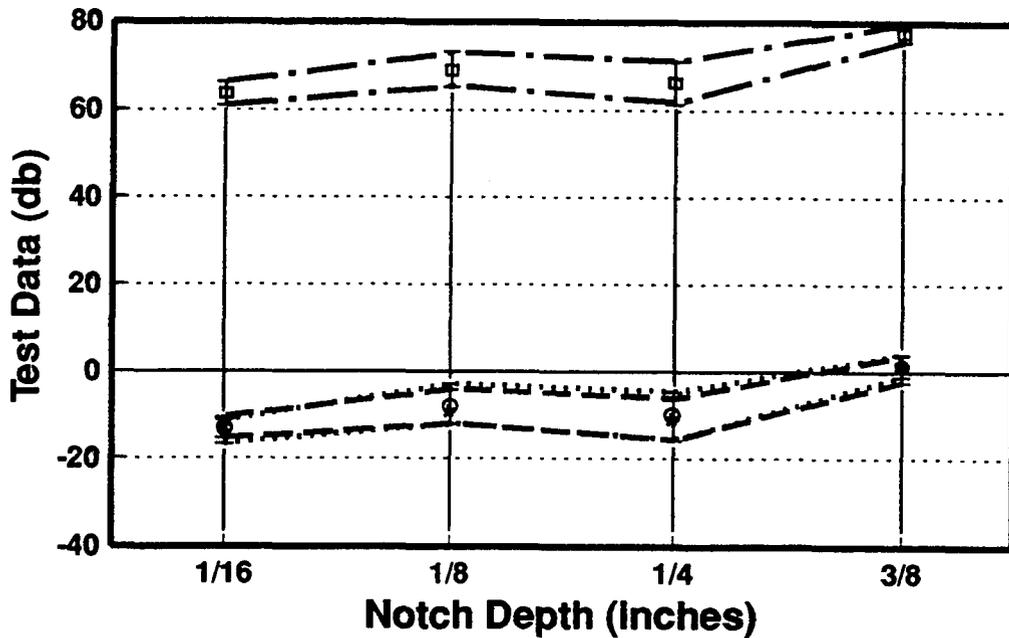
Ultrasonic Data For A572 Plate Specimen 30 Degree Angle Beam Transducer f=3.5MHz

Figure 20. Ultrasonic test data for a plate specimen of ASTM A572 steel using a 30 degree angle beam transducer. Pertinent specimen geometry was the same as that of the tested pin specimen. Figure shows unadjusted data, results from IDOT procedure, and results from IDOT procedure without distance attenuation correction factor.

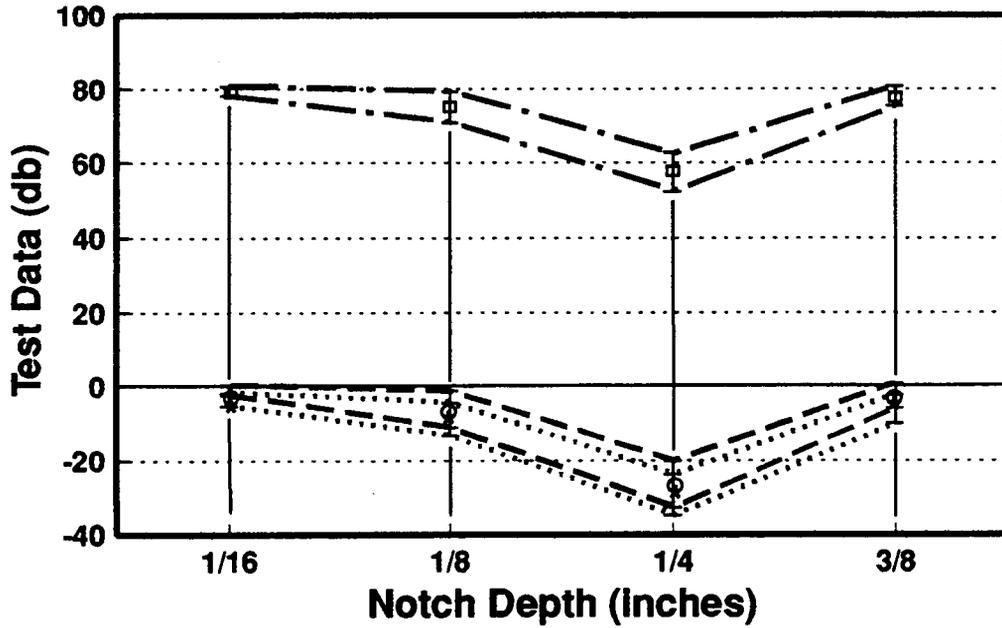
Ultrasonic Data For A572 Plate Specimen 45 Degree Angle Beam Transducer f=3.5MHz

Figure 21. Ultrasonic test data for a plate specimen of ASTM A572 steel using a 45 degree angle beam transducer. Pertinent specimen geometry was the same as that of the tested pin specimen. Figure shows unadjusted data, results from IDOT procedure, and results from IDOT procedure without distance attenuation correction factor.

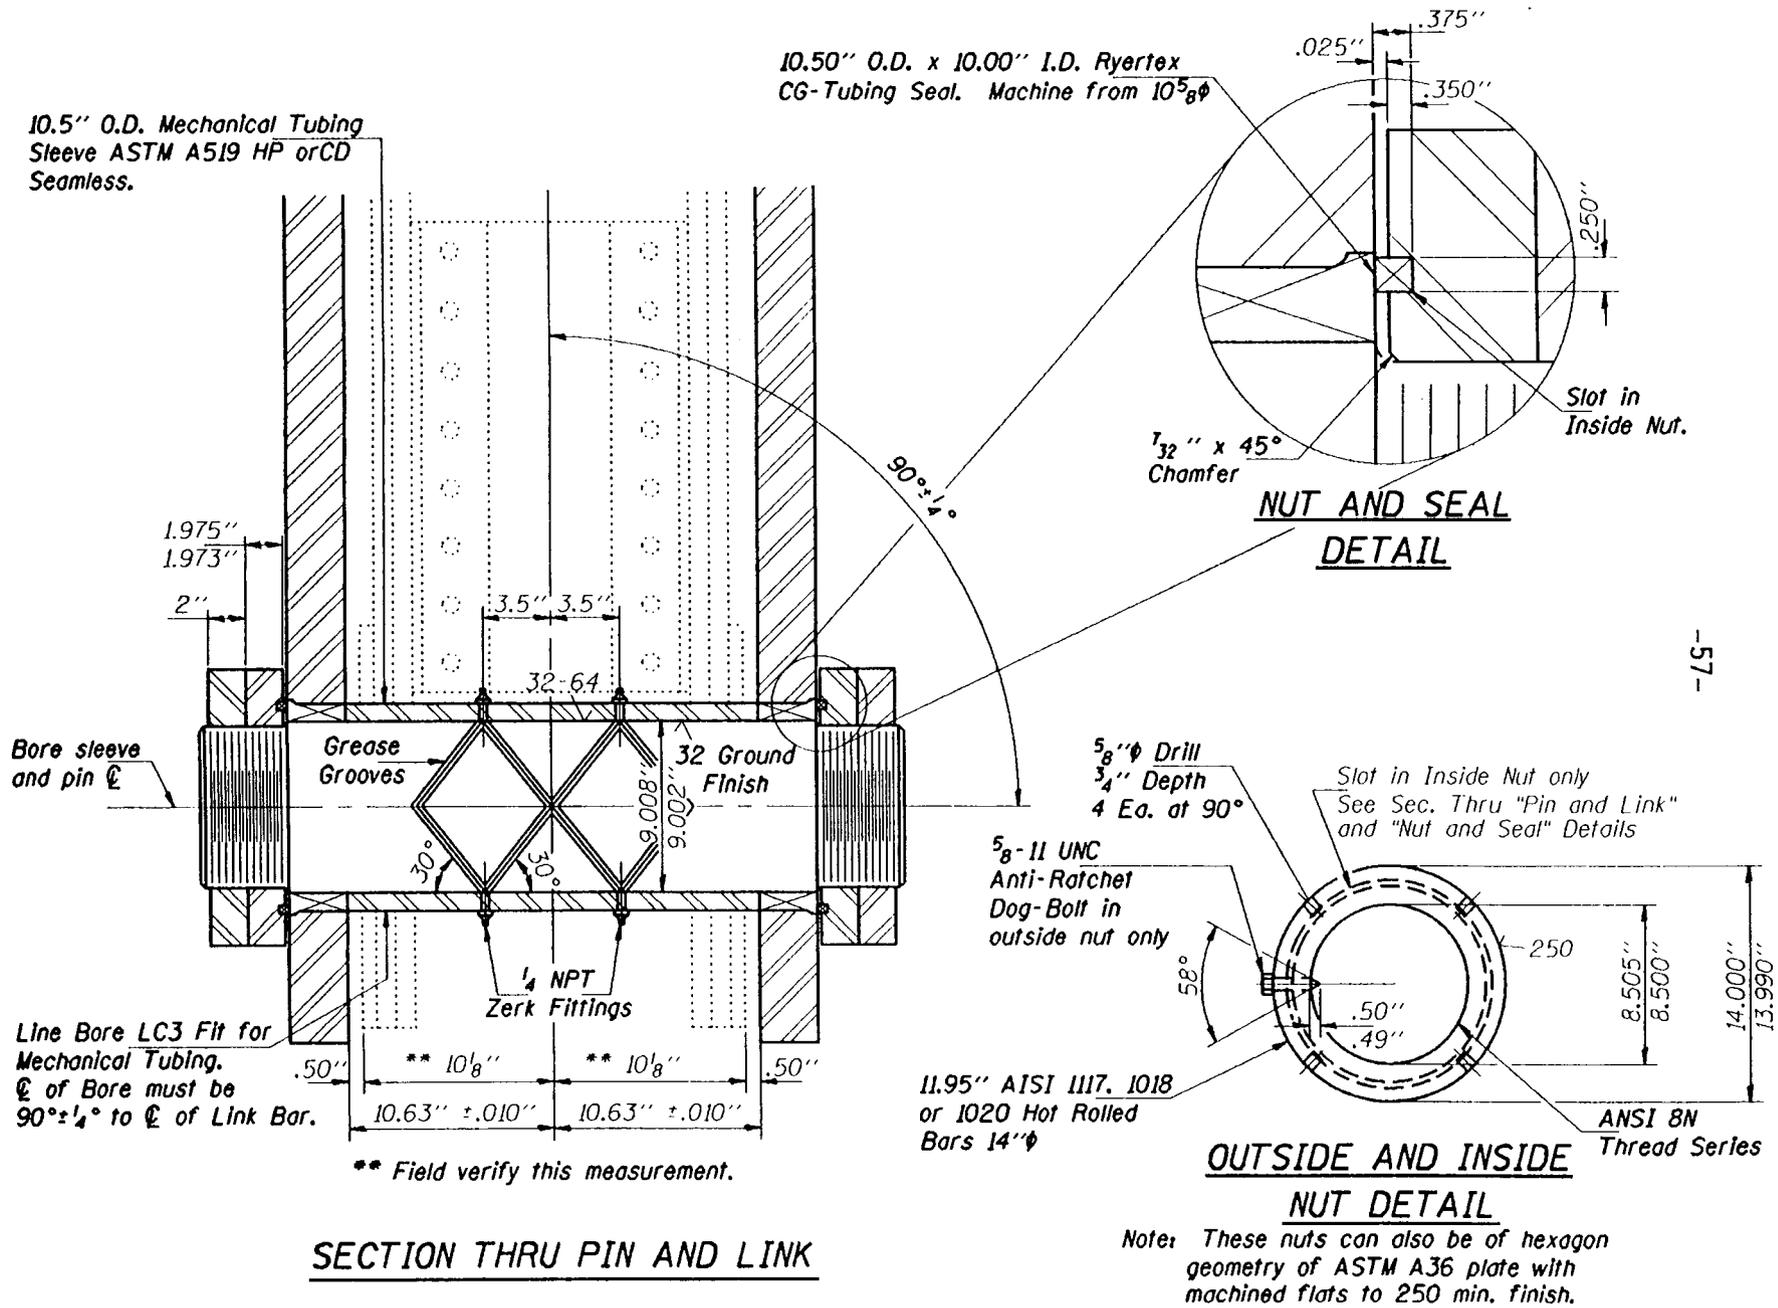
Figure 22. A typical new 9-inch diameter pin connection detail.

by flame or plasma cutting. The pin passes through the link eyebar bearing and is secured by two nuts. The first nut is specially chamfered so that when it is tightened, it provides a clearance of approximately .025" for a grease seal made of Ryertex CG, a synthetic machinable composite that is impregnated with graphite. The outer nut is also circular to limit torque. A special wrench that applies 450 ft.-lbs. nominal torque is provided, as shown in Figure 23. The wrench is designed so that if too much torque is applied, the AISI 41L50 cold finished bar insert will shear off. These pin nuts can also be fabricated from plate steels into a hexagonal form, and torque can also be limited by wrench handle length. These nuts interface with the bronze bearing insert in the link eyebar, forming a corrosion-resisting seal to exclude moisture. This nut and seal arrangement is shown in Figure 24. An additional safety precaution is built into the nut by the use of anti-ratchet dog bolts.

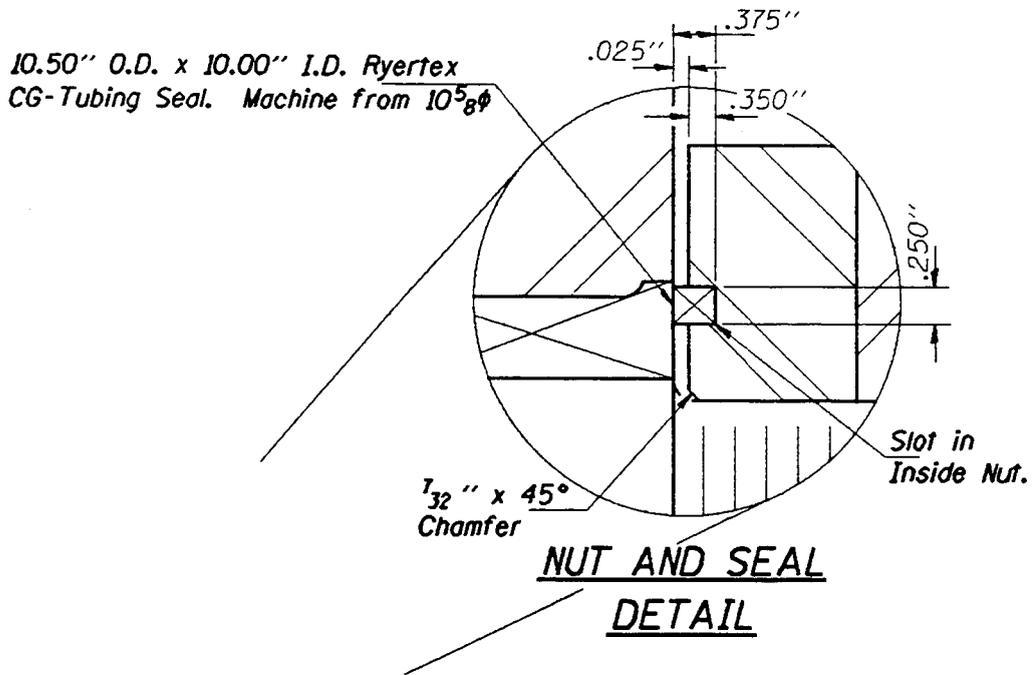
Figure 24. Nut and seal detail for moisture exclusion.

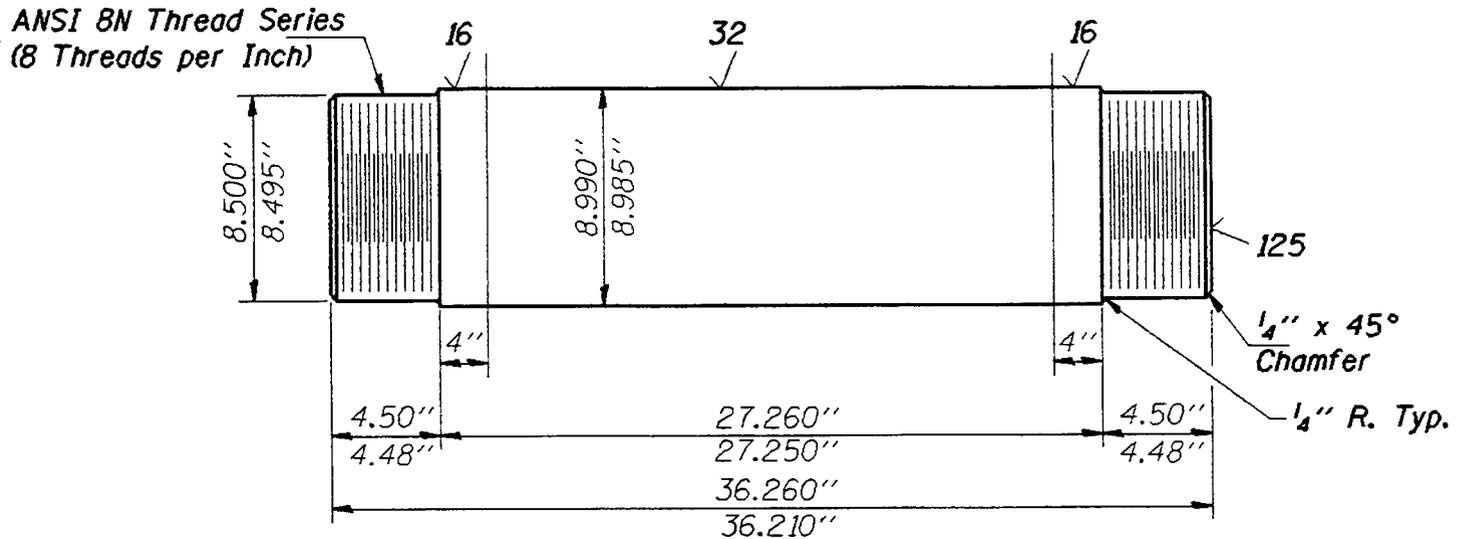
PIN DETAIL

Pins shall be AISI 9310 normalized and tempered, aircraft or bearing quality 250 BHN min., 80 ksi yield strength min., 17% elongation min. or AISI 4620 normalized and tempered, aircraft quality, 183 BHN min., 63 ksi yield strength min., 22% elongation min. Toughness Requirement: 45 Ft.-Lbs. at 0° F. CVN.

The pin itself, as detailed in Figure 25, is a ground and polished round bar made of AISI 9310, a low carbon, 3% nickel and 1% chromium alloy steel with high toughness, particularly in the normalized or quenched and tempered state. When specified as aircraft quality, the pin is inspected for surface flaws. The bearing surfaces are ground to a 16 micro-inch finish, minimizing both seizure and corrosion. The radiused portion of the pin has only a 0.25-inch radius. Previous pin designs showed a much sharper step which reduces the scanning ability of an ultrasonic transducer to search for cracking. The reduced gentle radius now permits full straight beam scanning for internal cracks or flaws.

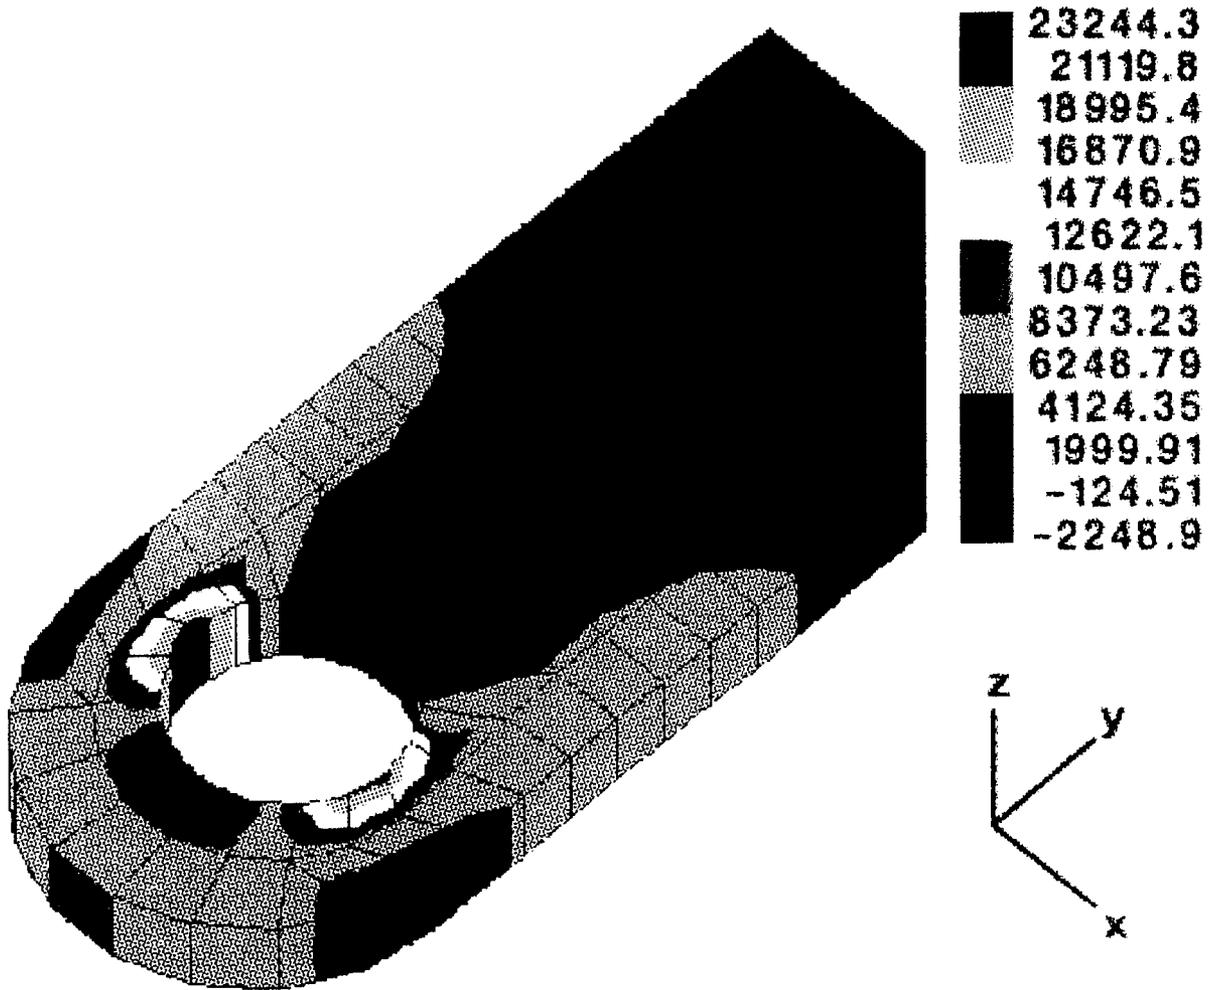
Figure 26b. Finite element model of the link eyebar. Stresses are for maximum loadings for the Peru Bridge. Note that eyelet peak stresses are about 3X nominal stress. Stress values in the legend are in psi.

The link eyebar, as described in Figure 26a, is probably the most vulnerable detail to rupture. Its highest area of stress concentration

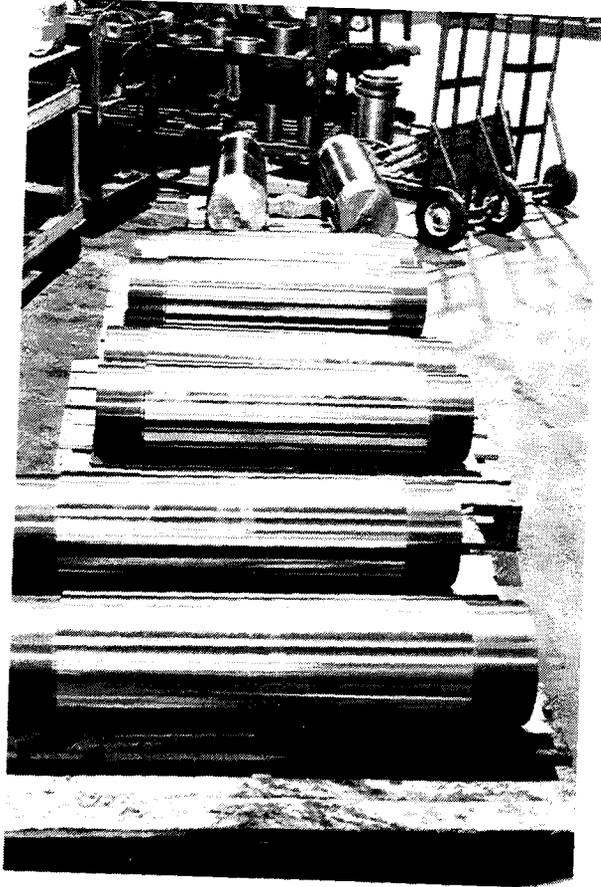
Figure 27. Machined and finely ground pins for Peru Bridge.

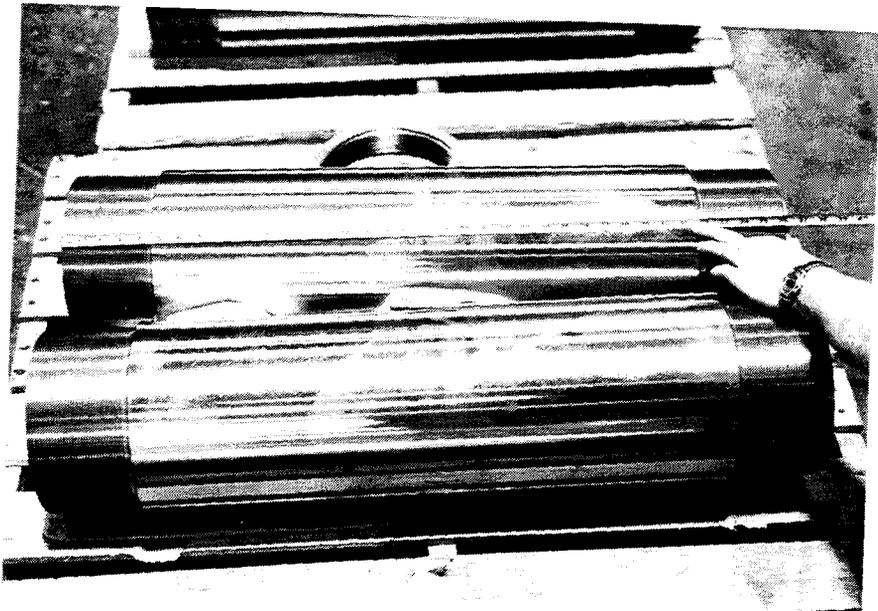
Figure 28. Closeup of pin and general size.

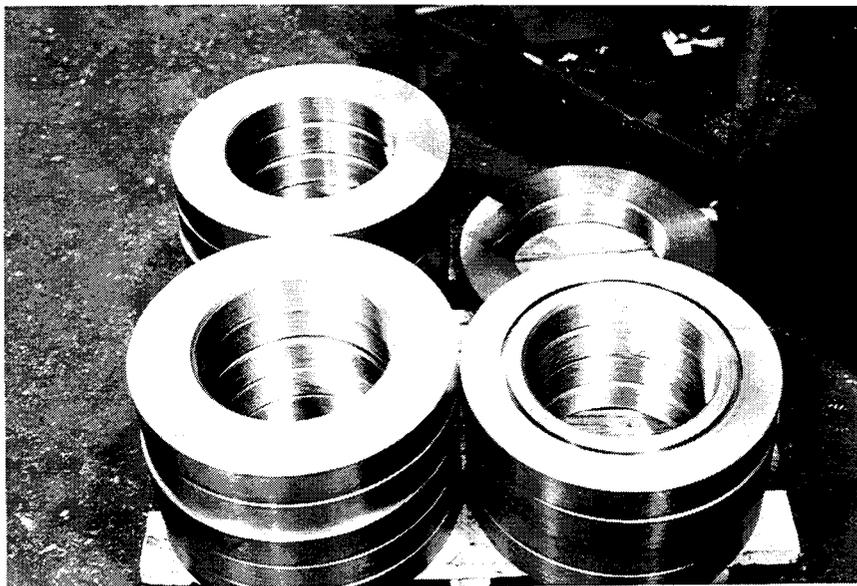
Figure 29. Circular nuts for pins. All grooves and holes for dog bolts were not yet machined out.

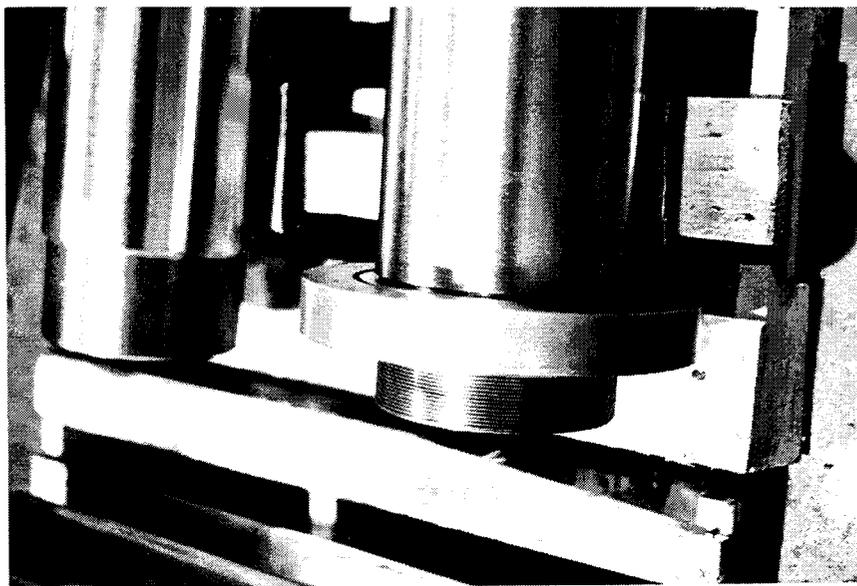
Figure 30. Special chamfer which permits a space for a grease seal situated between the nut and link eyebar.

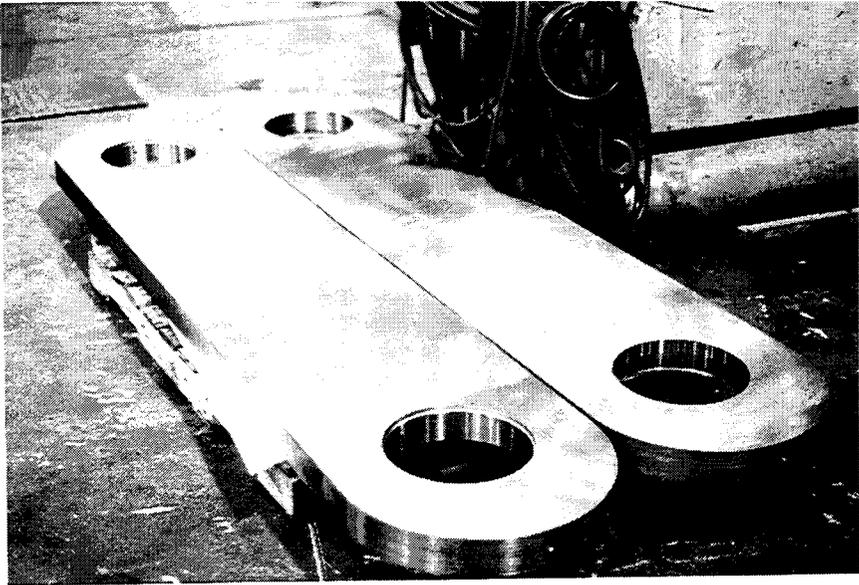
Figure 31. Machined link eyebars, milled to be completely flat and with radii with smooth finishes. Bearings have not yet been inserted in this picture.

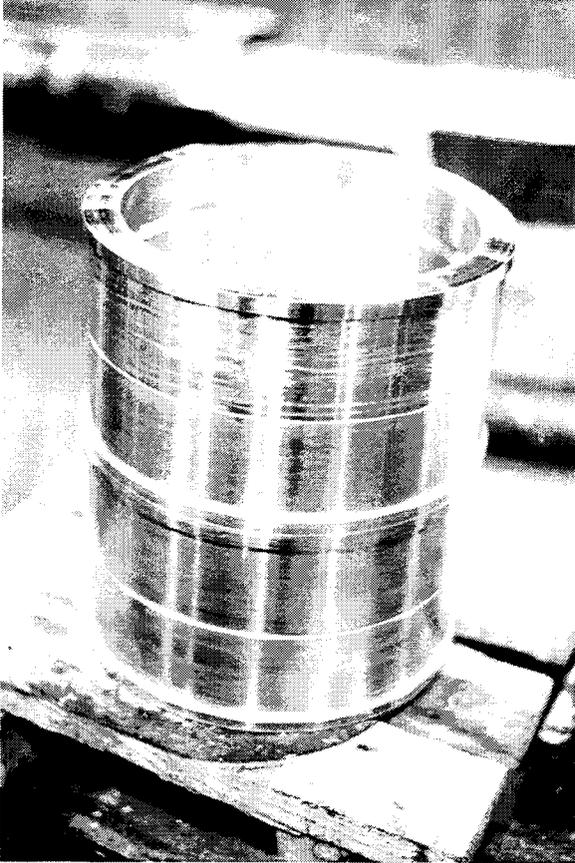
Figure 32. A stack of four bronze bearing inserts, showing internal grease groove.

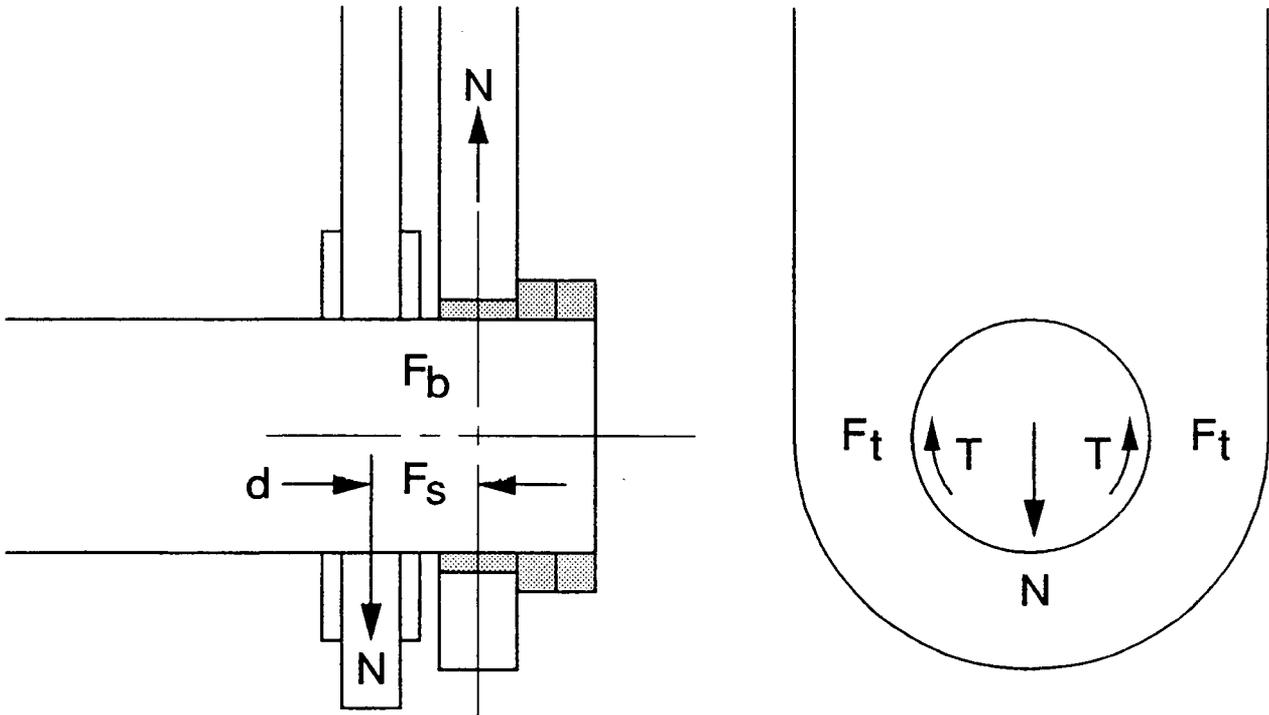
Figure 33. Principal forces and stresses on pins and link eyebars. N is the normal force exerted on the bearing; F_b is the bending stress on the pin; F_s is the shear stress on the pin; F_t is the torsional force on the link; T is the torsional stress on the pin.

A pin and link eyebar are subjected to a variety of forces throughout their lifetimes. The principal pin forces are (1) bending stresses induced by the offset distance between the web's line of action and the link's line of action; (2) the shear forces on the pin itself; (3) the torsional forces which develop on the pin from friction or permanent seizure at the pin-link interface. The principal link eyebar forces are (1) tensile and compressive stresses from loading and (2) torsional forces resulting from friction or actual seizure with the pin due to poor lubricity as the link moves due to thermal expansion of the bridge. See Figure 33. These shear and tensile stresses have both a steady stress component derived from dead load and an alternating stress component originating from live loads. The torsional stress is also alternating, since it is derived from rotation induced by thermal expansion.

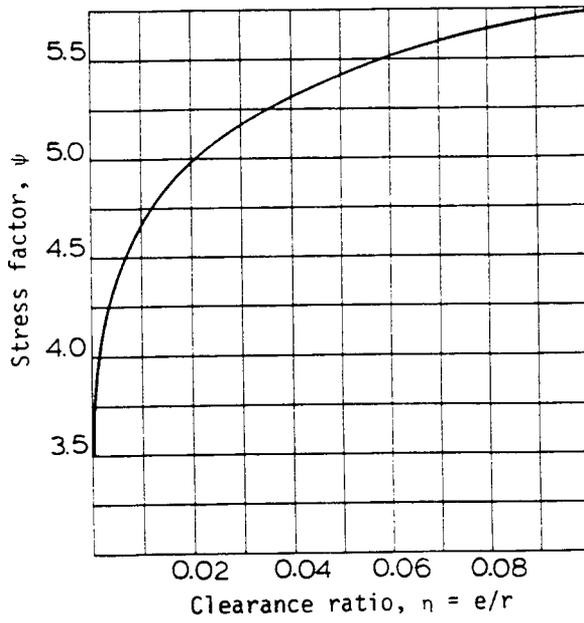
Figure 34. Stress factor for typical eyebar design (Ref. 6, page 376).

Link eyebar tensile stresses are at their maximum at the 90° & 270° positions. The equation predicting such maximum stresses is⁶:

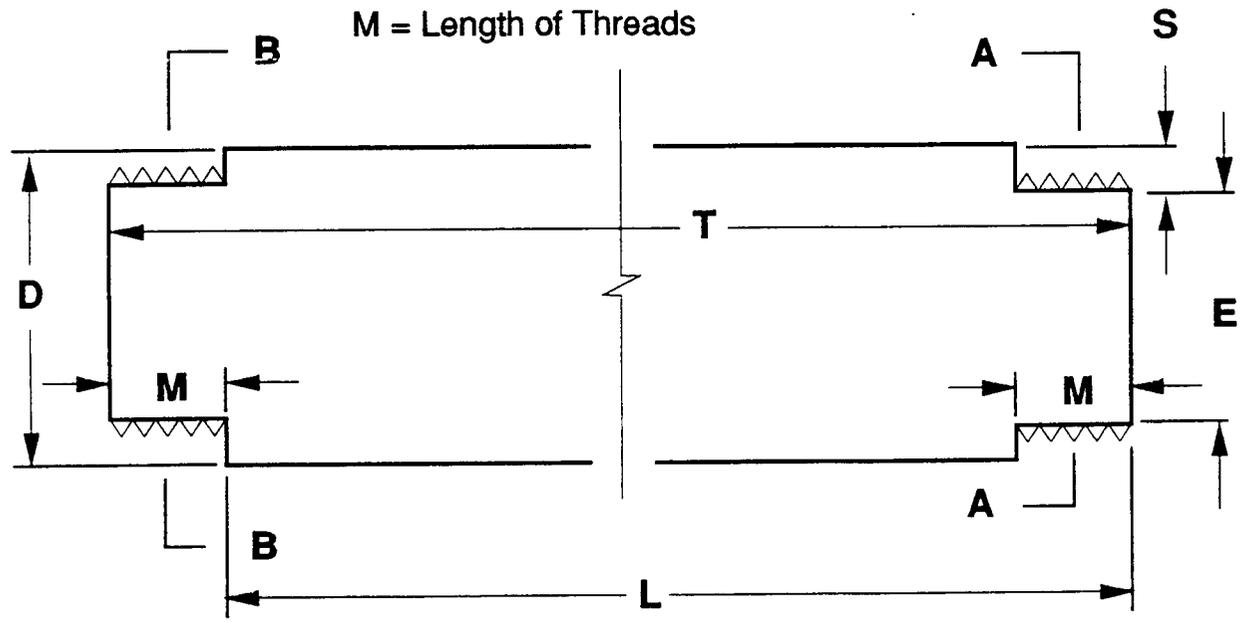
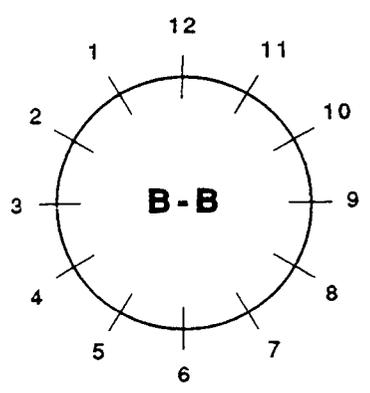
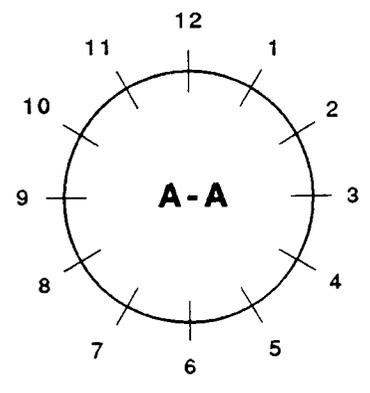
Figure A2.

The transducer is moved with even pressure along a diametral line starting at the 12:00 position, See Figure A2, and rotating clockwise around the end of the pin until the entire surface of the pin is covered. The transducer should not be lifted off the face of the pin end. The scanning motion is as follows: 12:00 to 6:00, 7:00 to 1:00, 2:00 to 8:00, etc. It is essential that a generous amount of couplant be maintained between the surface of the pin and the transducer at all times, especially if the ends of the pins are pitted from rust or original fabrication. The sound path to the defect is recorded under "Sound Path". Special measures are necessary to scan pins with cotter pin holes, centering holes from original machining, extremely long threads, no turned-down shoulders, or end caps with capture bolts. Procedures for these situations shall be coordinated with the Engineer.
