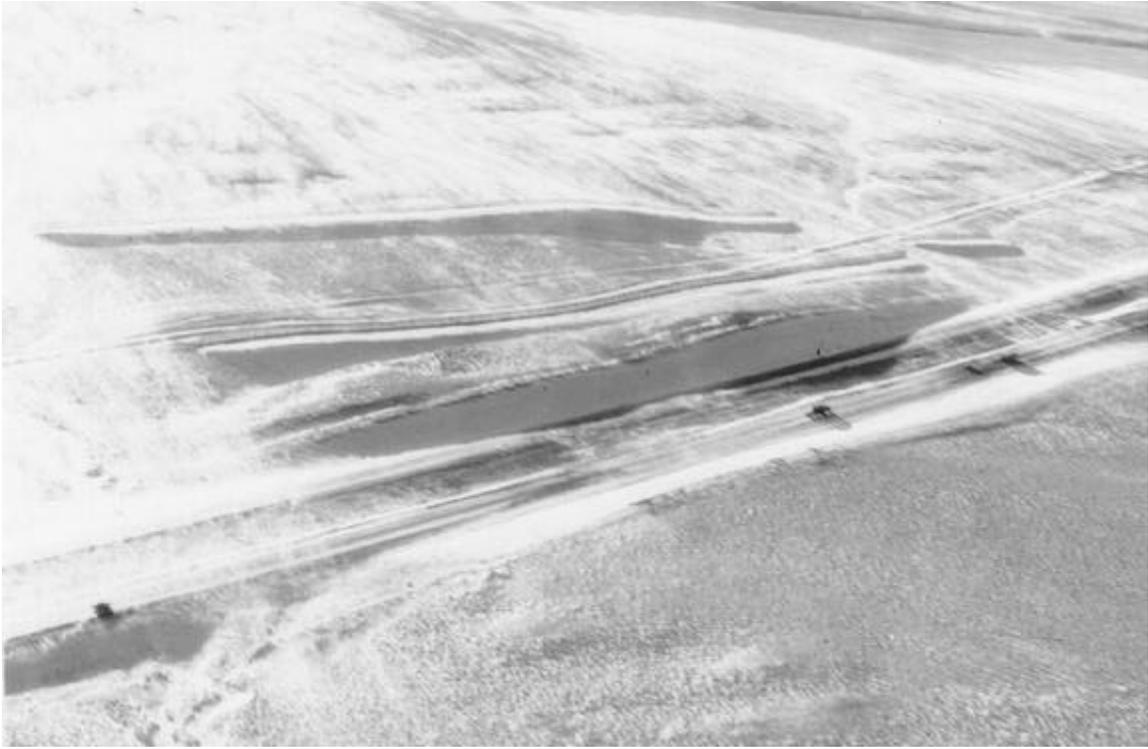
Figure 3.1. Aerial view showing effectiveness of snow fences in reducing blowing snow arriving at road section (I-80 Mile 263.0). Photo by Robert L. Jairell (Tabler 1994).

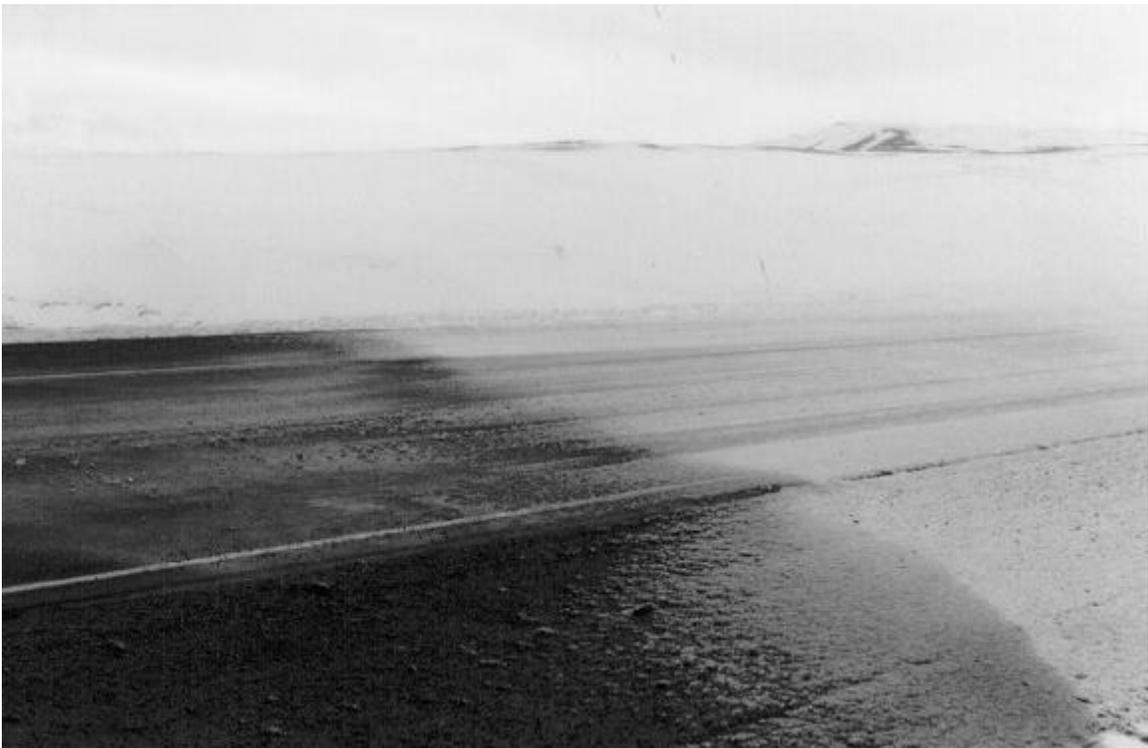
Figure 3.2. Transition from frozen slush to wet pavement corresponding to the beginning of a 3.8-m-tall snow fence extending left from the center of the picture (looking upwind). Fence is 150 m upwind. I-80 Mile 247.6.
