Operation of an Aluminum-Intensive Vehicle: Report on a Six-Year Project

Linda Gaines and Roy Cuenca

Center for Transportation Research, Argonne National Laboratory

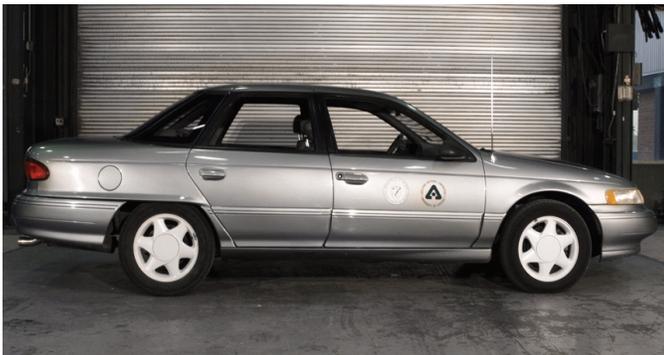
Figure 1 AIV after 6 Years of Use

The finish was still smooth and shiny and the color was still true. No change in shape could be observed. Similarly, the engine looked new, with no signs of corrosion. On closer inspection, some minor imperfections in the finish were observed and recorded; these are discussed here.

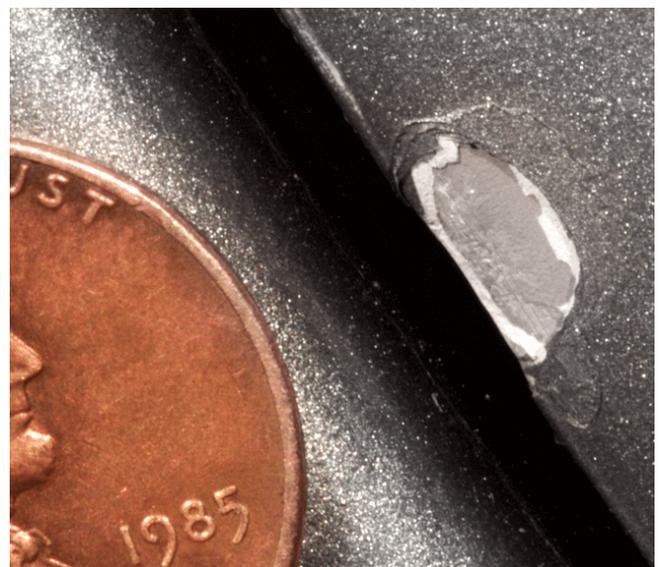
There were several places where small areas of paint had chipped off. These included one on the driver's door handle, one on the top corner of the left passenger door, and one on the edge of the right rear door (see Figure 2). In each case, the chip occurred in an area likely to have hit something when a door was opened. Several layers of the finish had chipped off (in some cases down to the substrate), but no corrosion resulted. There were a few small scratches and scrapes where one or more layers of paint had been removed, presumably by interaction with some external object. No further deterioration was observed at these sites. These imperfections were seen near the top of the driver's door panel, on the left rear passenger door and right rear door, on the deck lid, at the back of the roof, and near the gas cap.

The imperfections identified so far all are likely to have resulted from impacts with something outside of the vehicle. In addition, however, there were minor imperfections in the finish that appeared to be the results of problems with adherence of the paint to the aluminum substrate. Consultation with Ford [8] revealed that the

Figure 2 Paint Chipped Off on Door Edge

vehicle had not received an E-coat prior to painting (for logistical reasons). This explains the minor paint adhesion problems, which do not occur in mass-produced Al closures.

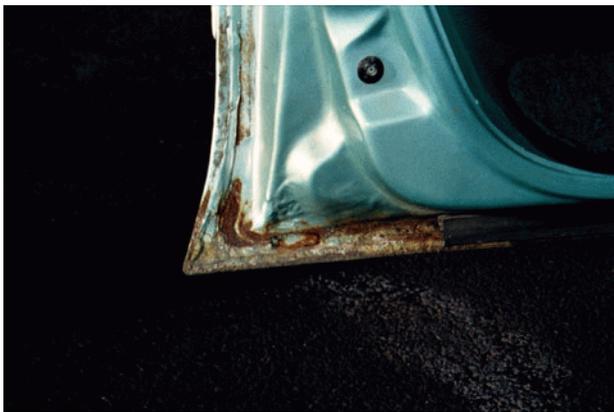
Vehicle 3: This vehicle had significant rust on the inside of the driver's door, which had been damaged in an accident

and repaired (see Figure 3). In addition, blistering was observed in the paint on the window frame.

Figure 3 Rust on Conventional Vehicle Door

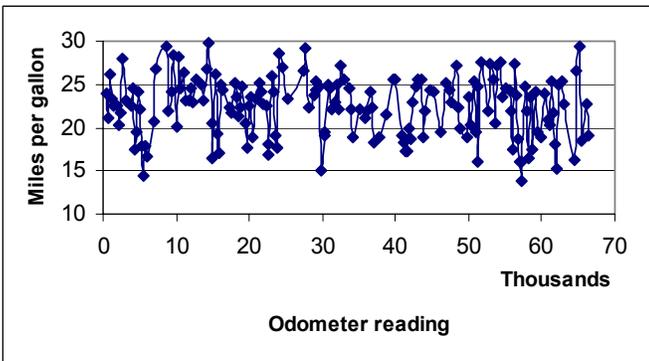
Although measurement of fuel economy was not included in the scope of our project, we did attempt to keep records because of the general interest in the topic. However, because essentially anyone could drive the vehicle, refueling information was not always reliably recorded. Therefore, data analysis required removal of points that showed apparent unrealistically high mileage because of missing fuel data. In addition, there was probably considerable variation among the acceleration patterns of different drivers and in how full they got the tank. These factors account for some of the variations observed in the refueling data (see Figure 4, which has outliers removed); further variation can be explained by differences associated with season and trip length.

Figure 4 Trip MPG vs. Odometer Reading

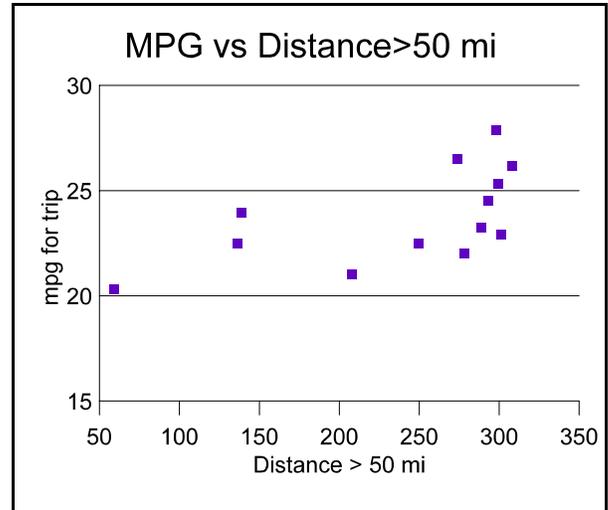
Another confounding factor affecting the fuel efficiency was the fuel type used. The SHO powertrain was designed to use high-octane fuel, but also functioned well with regular (the engine sensed pre-ignition and retarded the timing). There was no noticeable difference in the sound, power level, acceleration, or any other vital sign when operating with either fuel. Because the Argonne fuel depot did not carry high-octane gasoline, it was decided to use regular (87 octane) unleaded gasoline. However, when out on the road, many drivers preferred to purchase high-octane gasoline (at commercial stations). Therefore, there was some mixing of the two fuels in the early years. Analysis of the limited data suggests that the vehicle was probably more efficient with high-octane fuel. However, use of premium fuel was correlated with longer off-site trips, which is more likely to account for the improvement. Longer trips tended to be at highway speeds and yield higher fuel efficiency, as can be seen in Figure 5. These are data for the first fall of operation, so there should be no seasonal variations confounding the trend. Since most fuelings were for a mixture of long and short trips, the X-axis for the graph is number of miles between fill-ups that were on trips over 50 miles. The fuel efficiency also seemed to be

Figure 5 Fuel Economy vs. Trip Length

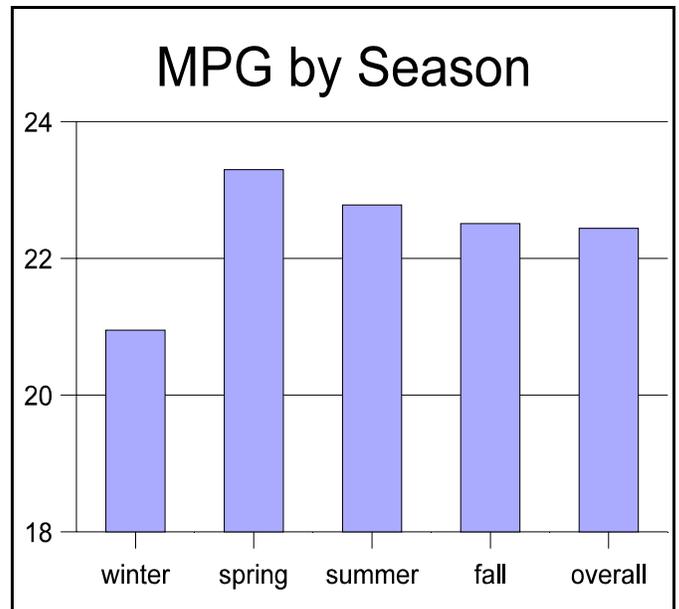
seasonal, decreasing during the winter and peaking during the spring, as can be seen in Figure 6. The reason was probably a combination of low ambient temperature and trip length, which tended to be particularly short in the winter. Fuel efficiency did not change significantly over the test period, as can be seen in Table 5.

Figure 6 Seasonal Variation of AIV Fuel Economy
