**Report No. CDOT-DTD-R-00-1
Final Report**

PCCP Texturing Methods

**COLORADO DEPARTMENT OF TRANSPORTATION
RESEARCH BRANCH**

1. Report No. CDOT-DTD-R-00-1	2. Government Accession No.	3. Recipient's Catalog No.	
4. Title and Subtitle PCCP Texturing Methods Project IR (CX) 070 - 4 (153)		5. Report Date January 2000	6. Performing Organization Code

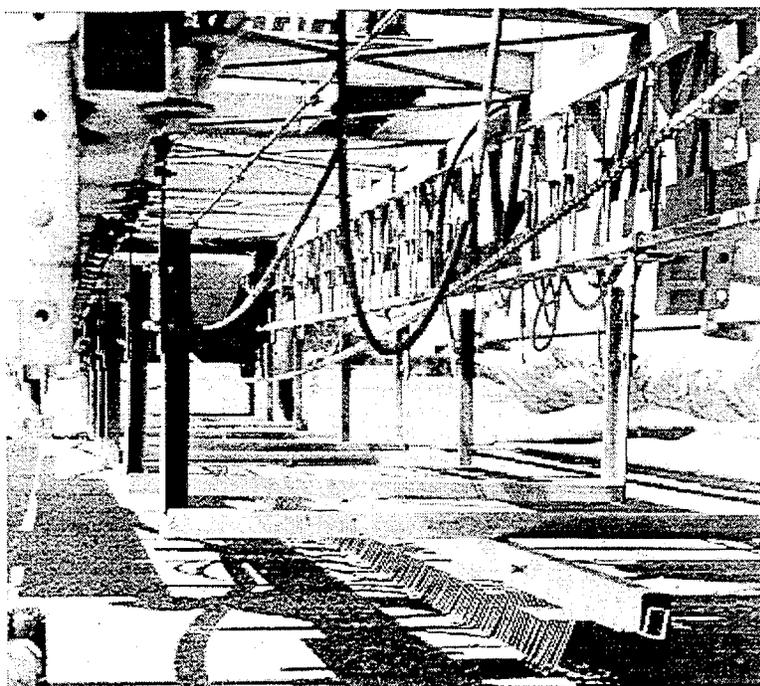
Photo 3: View of the longitudinal timing assembly

The tining-bridge was also used to drag astro-turf in the front and to apply curing compound from the back. During the installation of the longitudinal tining, the tines rolled the concrete paste (mortar) into popcorn-like balls all over the surface of the pavement (Photograph 4). However, once the concrete cured, these mortar balls were crushed by the traffic at the construction site and then easily removed by brooming.

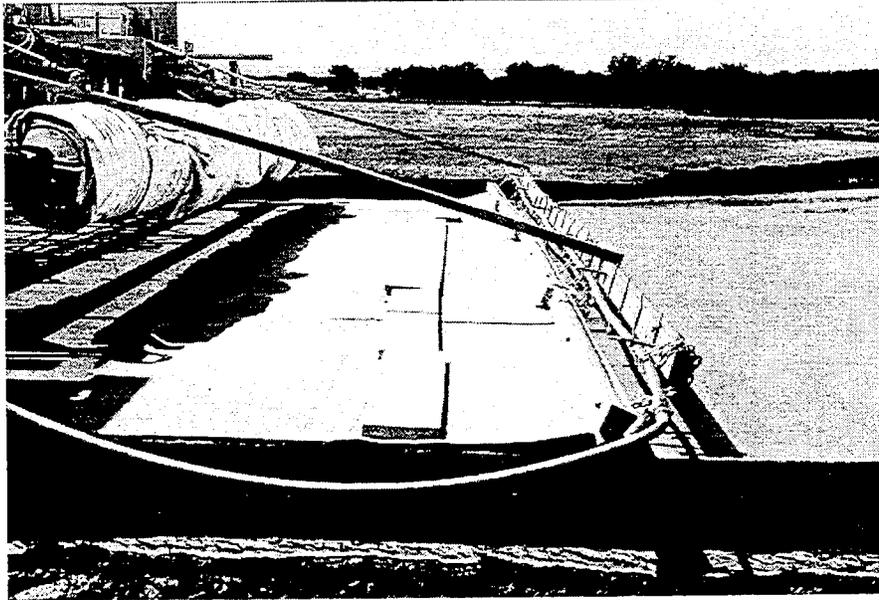
Photo 6: View of the astro-turf drag with planks for added weight

The longitudinal astro-turf drag was applied from the front of the bridge simultaneously with longitudinal tining. The astro-turf used was 38 feet wide, covering the entire width of the pavement surface and 5.8 feet long, of which 4.8 feet contacted the surface. Due to a very stiff mix (slump of less than 1") the astro-turf was not capable of forming deep enough texture. To make the texturing more pronounced, several boards were placed on the astro-turf as shown in Photograph 6. Occasionally, the surface of the contact area became plugged with mortar (Photograph 7) and the tining operator had to raise the astro-turf and shake out the excess grout.

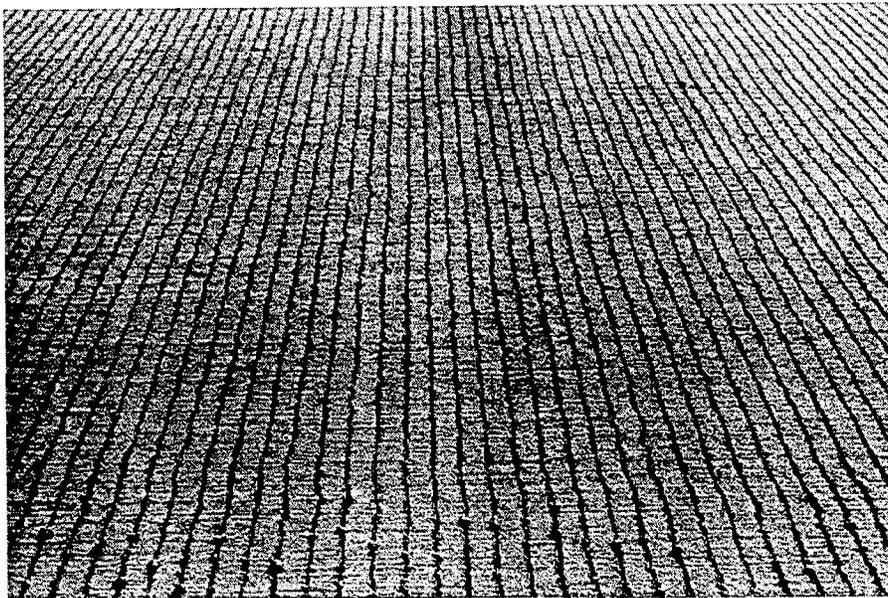
Photo 11: 1-inch uniform spaced transverse tining (state standard)

Photograph 10 shows a typical transverse tining operation. The state standard test section (control) which uses a combination of longitudinal burlap drag and 1" uniform transverse tining is shown in Photograph 11. Photograph 12 shows the combination of astro-turf drag with transverse tining of 1/2" uniform spacing. Transverse tining with random spacing of 5/8", 7/8" and 3/4" is shown in Photograph 13.

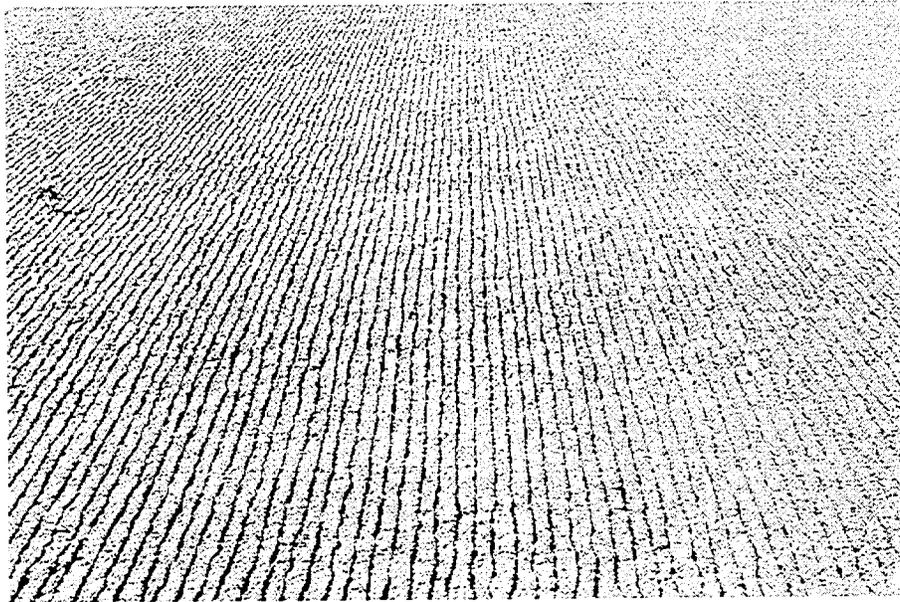
Photo 12: 1/2-inch uniform spaced transverse tining

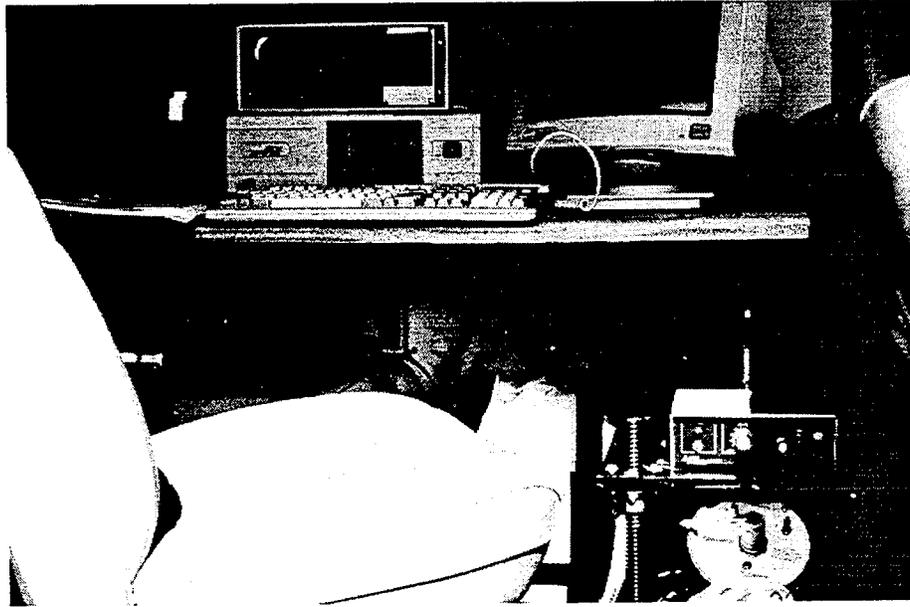
Photo 19: Inside of a texture measuring van

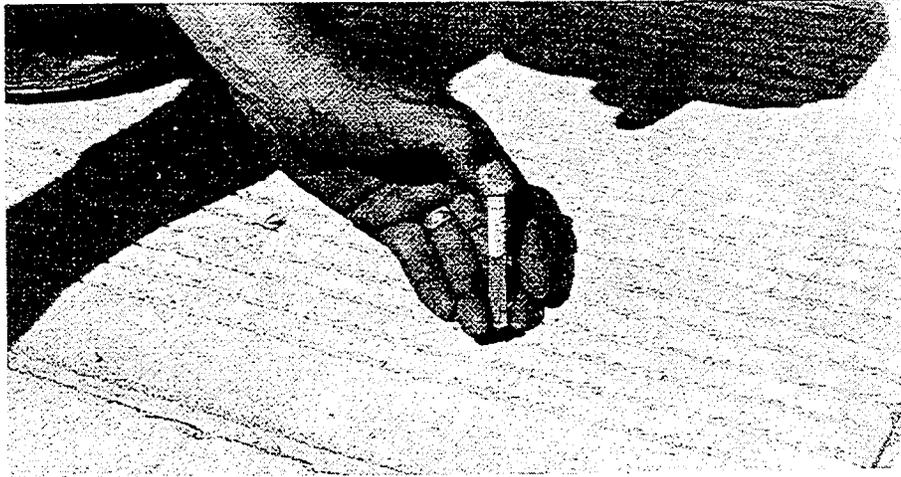
Photo 23: Texture depth measurement using a tire tread depth gauge
