**Non-Destructive Estimate of the Rate of Change of Structural
Degradation of the Lavic Road Overcrossing**

N. Stubbs¹, S. Park², R.W. Bolton³, S. Choi⁴
Texas Engineering Experiment Station
College Station, Texas 77843

C. Sikorsky⁵
State of California
Department of Transportation
Sacramento, CA 95816

October 1999

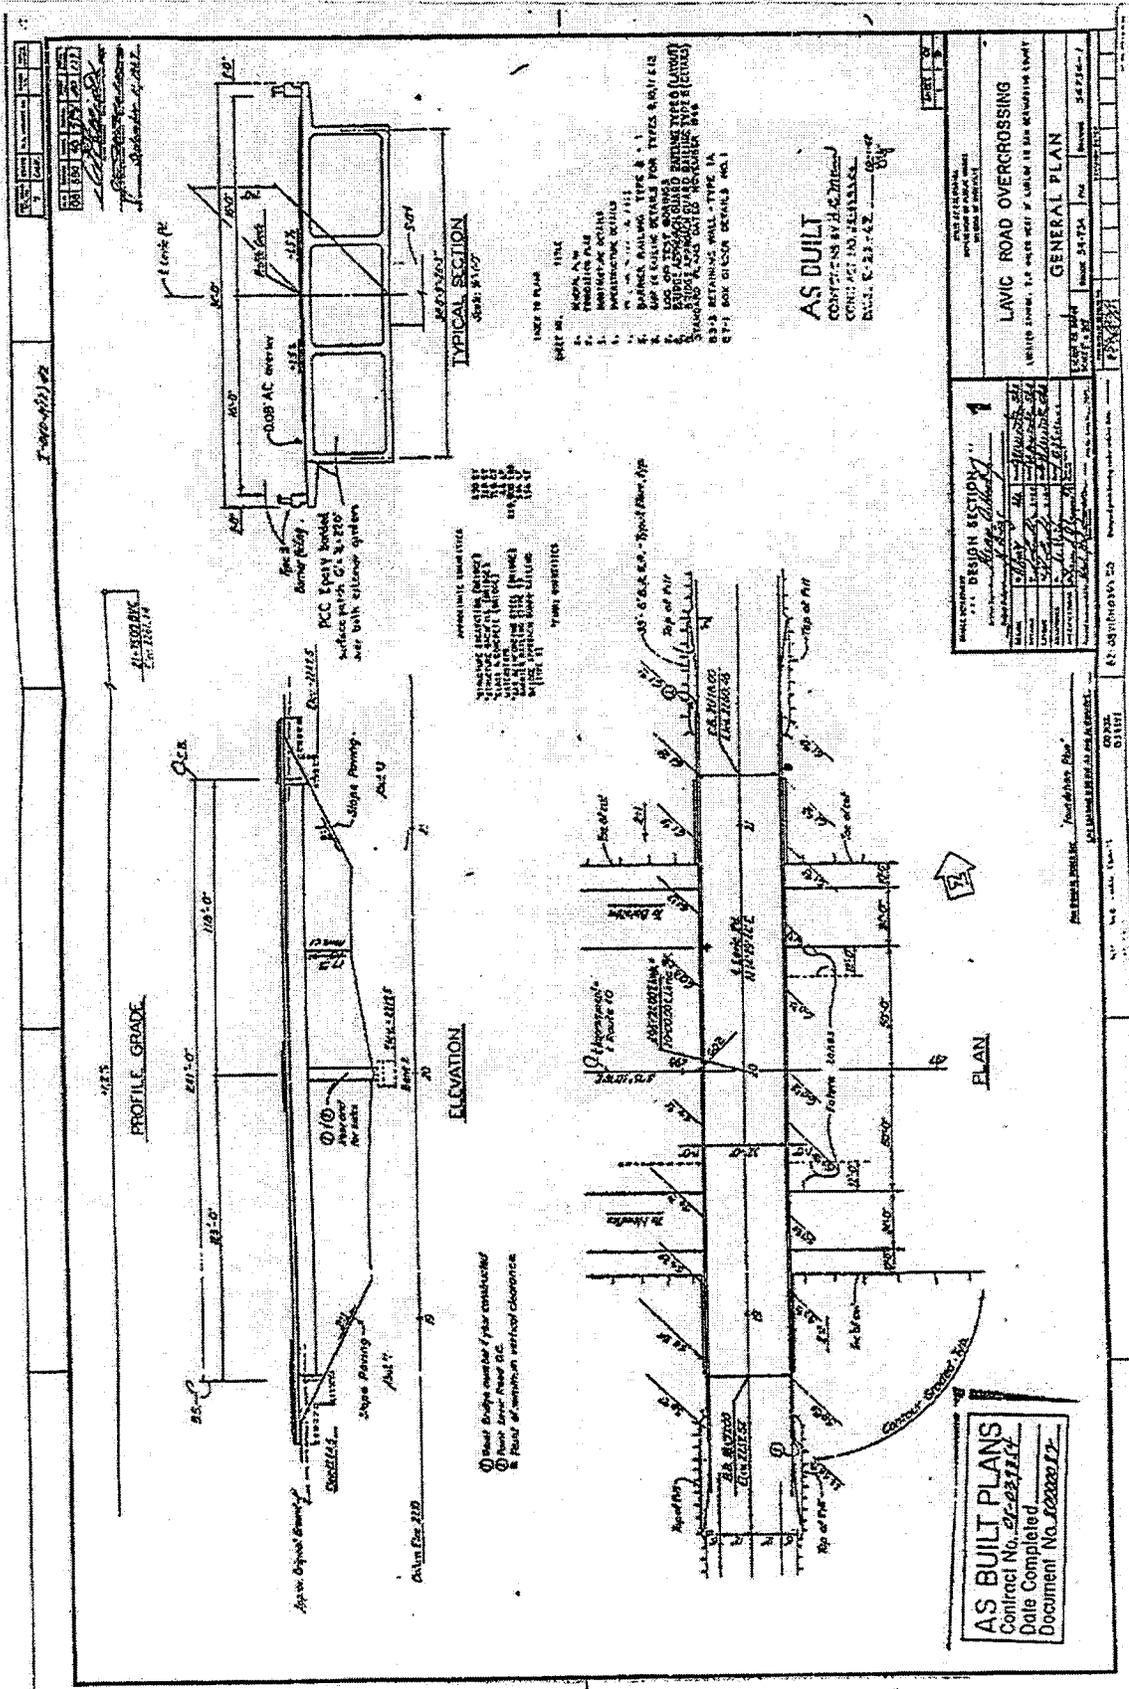
Figure 2.1 General Plan of Lavic Road Overcrossing

The Lavic Road Overcrossing (Bridge #54-734) is located in San Bernardino County, California and passes over Interstate I-40 approximately 7 miles west of the town of Ludlow. The structure was completed in 1968. The general layout of the structure is shown in Figure 2.1. The structure is oriented in a North-South direction and spans the four-lane interstate highway. The south span is 123 ft. long while the north span is 118 ft. long. The superstructure is a 7 ft. deep reinforced concrete triple box girder which includes a 34 ft. wide deck (including overhangs) and four 8-inch wide webs spaced at 8 ft. 9 inches. The structure is supported at the South end by Abutment #1 and at the North end by Abutment #3. The bridge is supported approximately at mid-span by Bent #2 which consists of a 5 ft. diameter column which in turn is supported on a spread footing resting on sand. The abutments essentially consist of an end diaphragm supported by a beam resting on a strip footing. Details of Bent #2 and Abutments #1 and #3 are provided in Figure 2.2.

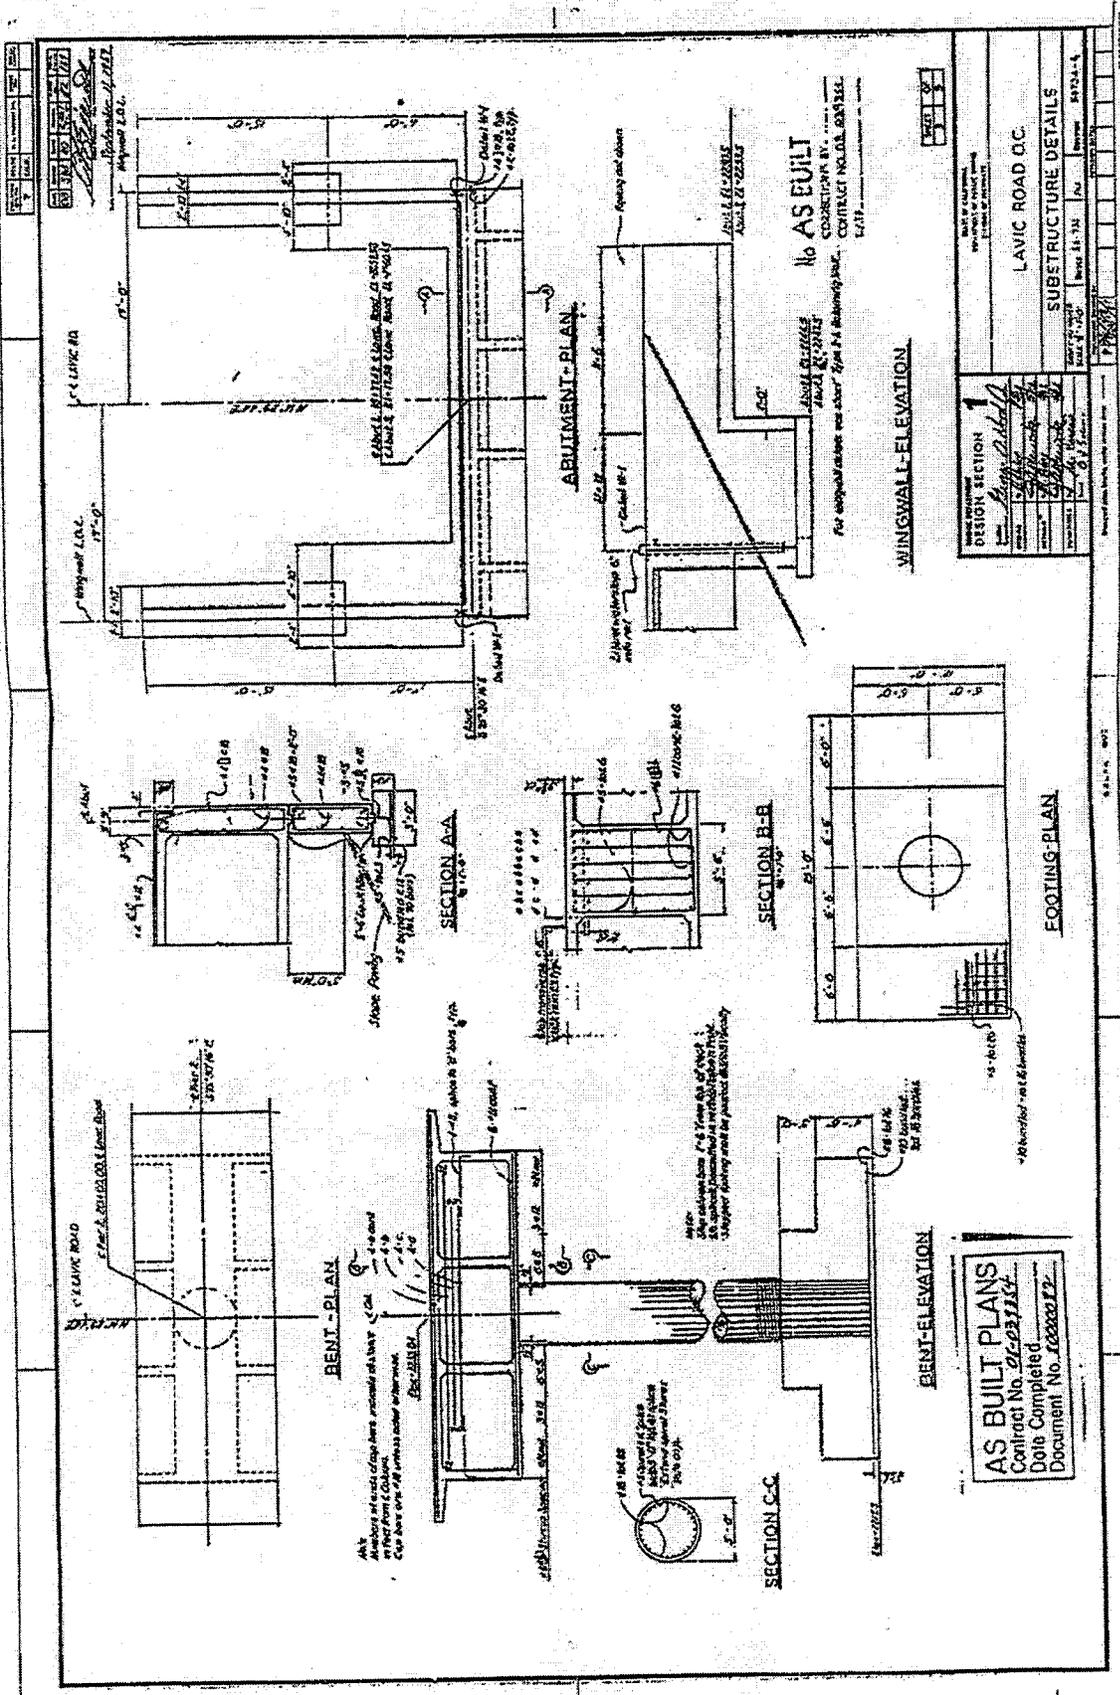
Figure 2.2 Details of Bent and Abutment

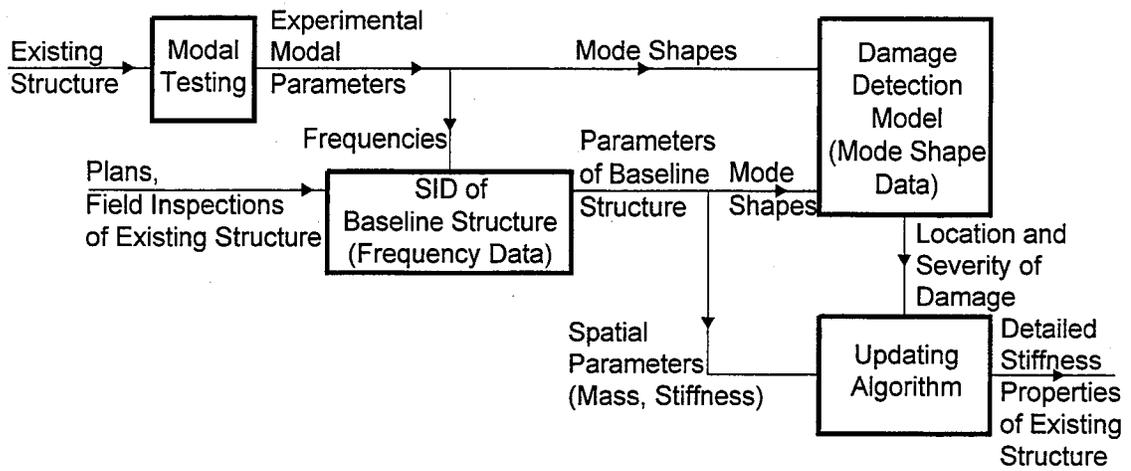
Figure 3.1 Schematic of Approach Used to Identify Stiffness Properties of Baseline and Existing Structures

A schematic of the approach used here to develop the stiffness properties of the existing structure is shown in Figure 3.1. The modal parameters of the existing structure are combined with information provided on as-built plans of the structure and a sensitivity-based systems identification (SID) procedure to generate a set of modal parameters for an idealized pristine (baseline/as-built) structure. The measured modal parameters of the existing structure and the theoretically-generated modal parameters of the pristine structure are used in combination with a proven damage detection method to generate possible locations and severity of damage in the existing structure relative to the pristine structure. Finally, by combining the location and severity of the damage in the existing structure with the pristine structure using a simple updating algorithm, the stiffness properties of the existing structure are identified. These properties can now be used to analyze the response of the existing structure. Note that the systems identification technique and the damage detection scheme mentioned above have been described in great detail elsewhere [Stubbs and Kim (1996),

The objective of this section is to generate an estimate of the appropriate stiffness properties of the Lavic Road Overcrossing using the field data measured in September 1998. The same schematic (Figure 3.1) in the previous section is utilized for systems identification, generation of possible locations and severity of damage in the existing structure, and estimation of the stiffness properties of the existing structure.

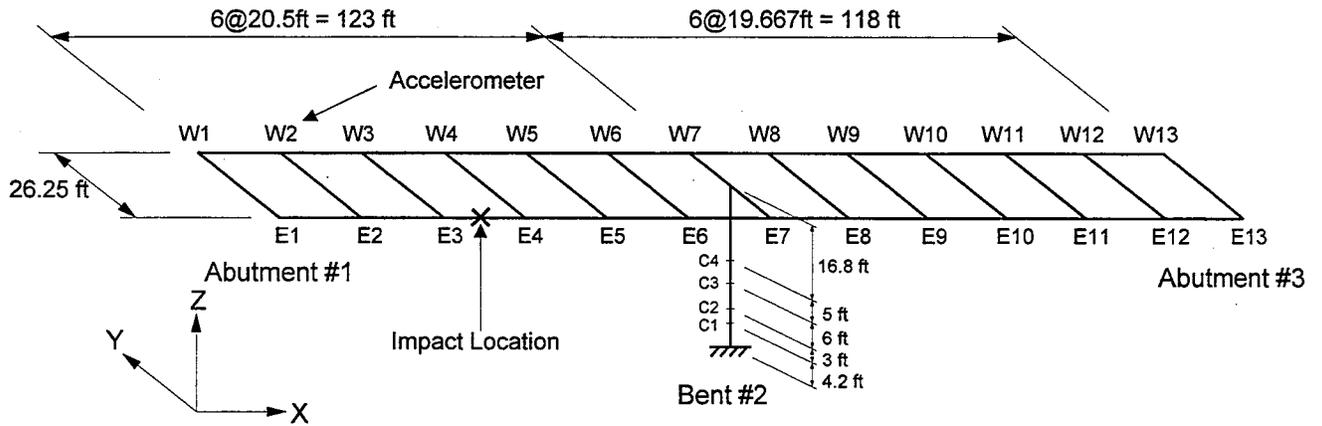
Figure 3.2 Locations of Accelerometers on the Bridge

1. Estimate a detailed modal amplitude representation for the deck by interpolating the thirteen sensor readings obtained in the field (i.e., W1-W13 and E1-E13) shown in Figure 3.2 using cubic-spline functions;
2. Estimate a detailed modal amplitude representation for the column by interpolating the four sensor readings obtained in the field (i.e., C1-C4) shown in Figure 3.2 using cubic-spline functions;
3. Generate the curvatures for the deck and the column using mode shapes from the baseline model and the field measurements;
4. Calculate the damage index DI_j for each element j ;
5. Calculate the normalized damage indicator z_j ; and
6. Determine if the structure is damaged or not damaged at Element j according to the pre-assigned decision rules with 84% of confidence level: (a) the element is damaged if $z_j \geq 1$; or (b) the element is not damaged if $z_j < 1$.

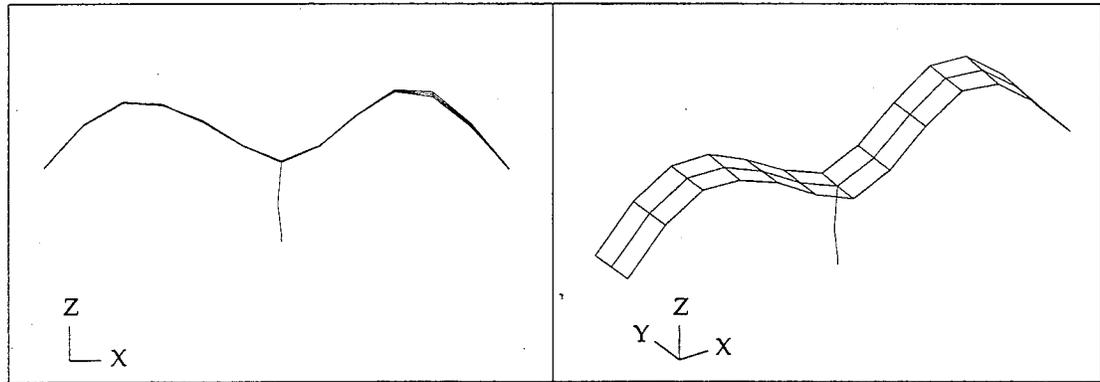
**Figure 3.5 Second Bending Mode Identified in the Z-direction at 4.426Hz
(December 1997)**

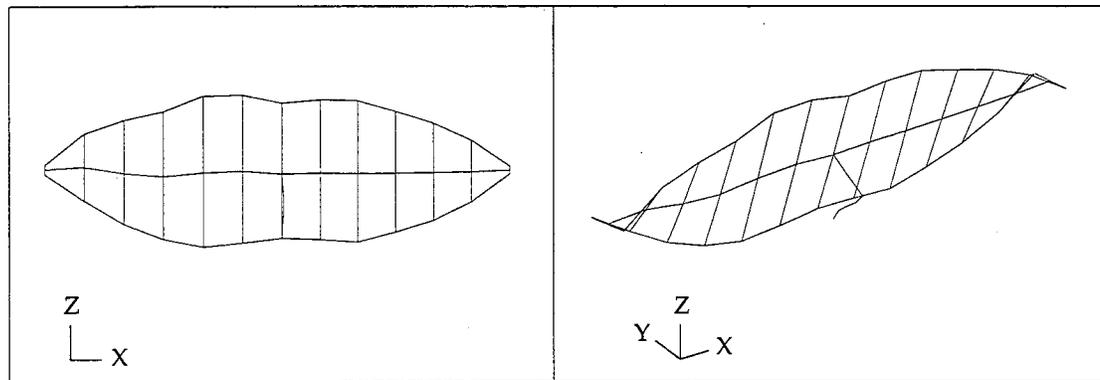
Figure 3.6 First Torsional Mode Identified at 6.781Hz (December 1997)

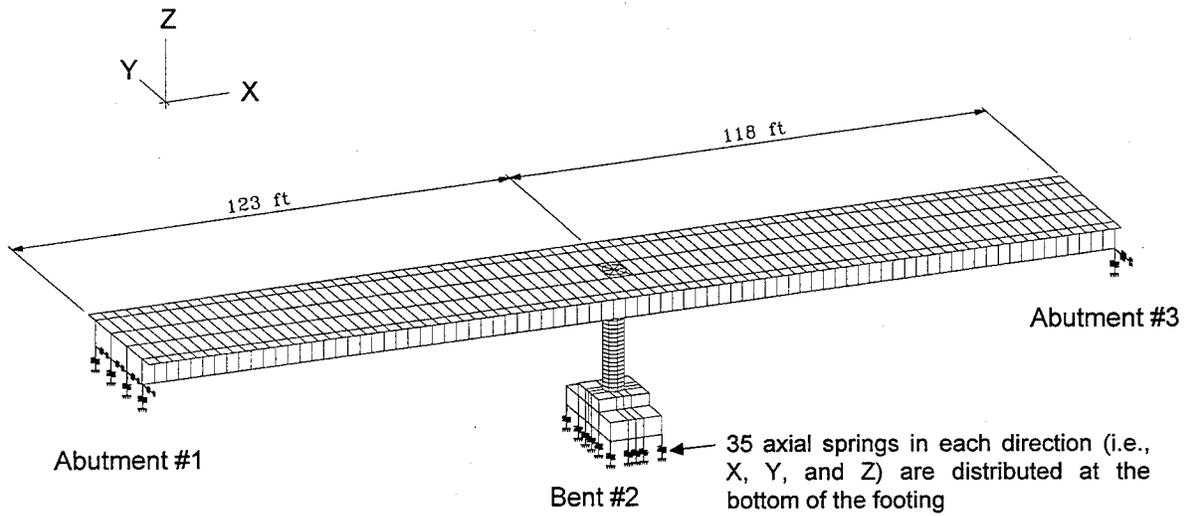
Figure 3.8 Schematic of Finite Element Model

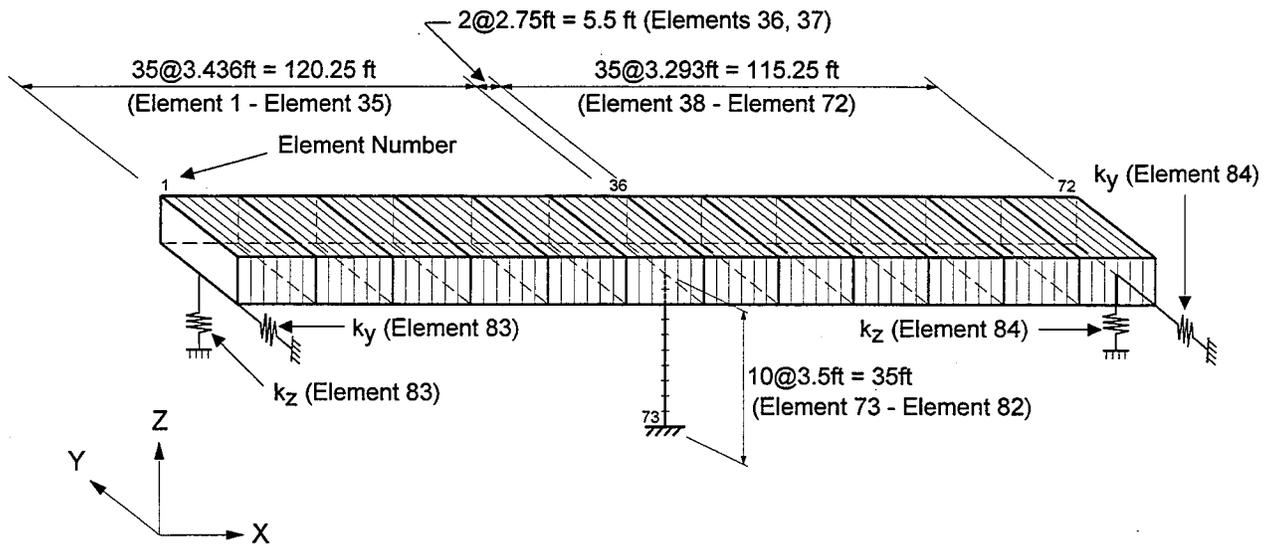
Figure 3.10 Damage Detection Model

The damage detection model used in this study for the location of damage and the estimation of the severity of damage is shown in Figure 3.10. The damage detection model has 84 elements, i.e., Elements 1 to 72 for the deck, Elements 73 to 82 for the column, and Elements 83 and 84 for the Abutment #1 and Abutment #3, respectively. The sectional properties for each member are listed in Table 3.17. The polar moment of inertia J is calculated by sum of the second moment of area

about the Y-axis (I_{yy}) and the second moment of area about the Z-axis (I_{zz}). Note that Elements 36 and 37 represent the bentcap. For the two bending modes in the Z-direction and a torsional mode, the deck (i.e., Elements 1 to 72) and the column (i.e., Elements 73-82) are considered as Euler-Bernoulli beam elements and only springs in the Z-direction (i.e., k_z in Figure 3.10) are included in the damage detection model for Elements 83 and 84. For the two bending modes in the Y-direction, the deck (i.e., Elements 1 to 72) and the column (i.e., Elements 73-82) are also considered as Euler-Bernoulli beam elements and only springs in the Y-direction (i.e., k_y in Figure 3.10) are included in the damage detection model for Elements 83 and 84.

The damage detection model for the location of damage and the estimation of the severity of damage is shown in Figure 3.10 and the sectional properties for the members are listed in Table 3.17. For the two bending modes in the Z-direction and a torsional mode, the deck (i.e., Elements 1 to 72) and the column (i.e., Elements 73-82) are considered as Euler-Bernoulli beam elements and only springs in the Z-direction (i.e., k_z in Figure 3.10) are included in the damage detection model for Elements 83 and 84. For the bending mode in the Y-direction, the deck (i.e., Elements 1 to 72) and the column (i.e., Elements 73-82) are also considered as Euler-Bernoulli beam elements and only springs in the Y-direction (i.e., k_y in Figure 3.10) are included in the damage detection model for Elements 83 and 84.

In this comparison, the properties of interest are referenced to the damage detection model shown in Figure 3.10. Recall that in the damage detection model Elements 1-72 represent approximately 3.4 ft. linear sections of the deck, Elements 73-82 represent 3.5 ft. linear sections of the column, and Elements 83 and 84, respectively, represent the south and north abutment systems. The bending, torsional, or axial stiffnesses associated with each element are summarized in Table 3.19 and Table 4.15 for the 1997 and 1998 structures, respectively.

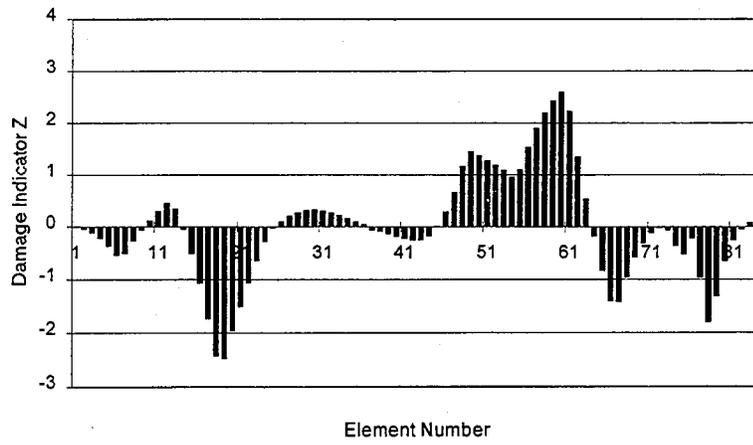
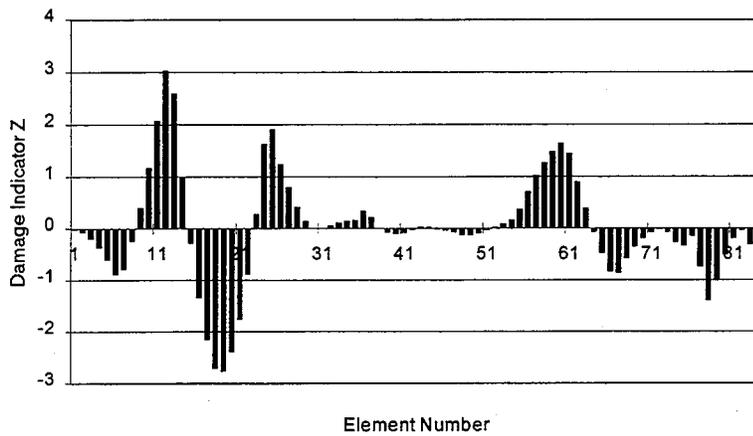
Figure 3.11 Damage Localization Results Using the First Bending Mode in the Z-dir. (December 1997): (a) Result using the measurements along the west girder (W1-W13);(b) Result using the measurements along the east girder (E1-E13).

The results for the predicted damage locations are summarized in Figures 3.11 to 3.15 in which the individual mode is used to locate the possible damage area. Note that for the two bending modes in the Z-direction, the measurement

The damage severity estimation is performed as follows. First, the baseline and post-damage sensitivities are obtained as described in the latter section. Second, the predicted damage locations are obtained from Figures 3.11 to 3.15. Finally, for each predicted damage location, the damage severity are estimated using the severity estimator (see Appendix A for detail). The estimated damage severities are listed in Table 3.18. Note that the magnitude of damage about the X-axis were estimated using the first torsional mode, the magnitude of damage about the Y-axis were estimated using the first two bending modes in the Z-direction, and the magnitude of damage about the Z-axis were estimated using the first two bending modes in the Y-direction. These magnitudes are fractional stiffness changes of those elements.

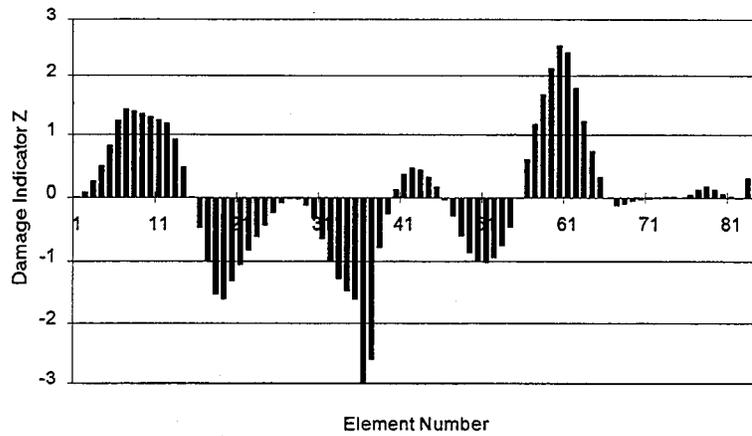
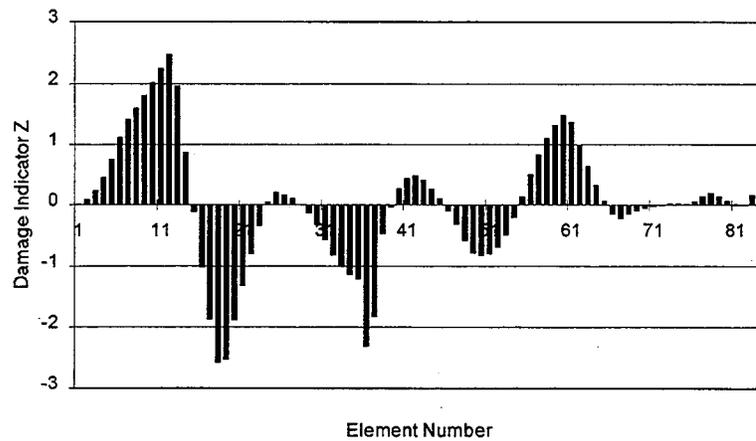
Figure 3.12 Damage Localization Results Using the Second Bending Mode in the Z-dir. (December 1997): (a) Result using the measurements along the west girder (W1-W13); (b) Result using the measurements along the east girder (E1-E13).

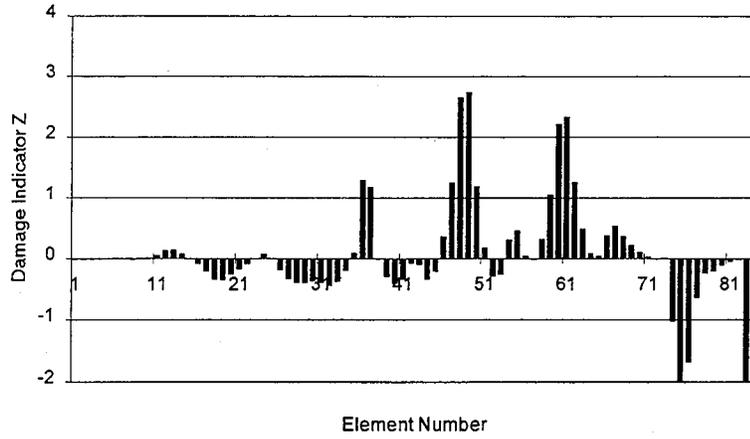
Figure 3.13 Damage Localization Results Using the First Bending Mode in the Y-dir. (December 1997)

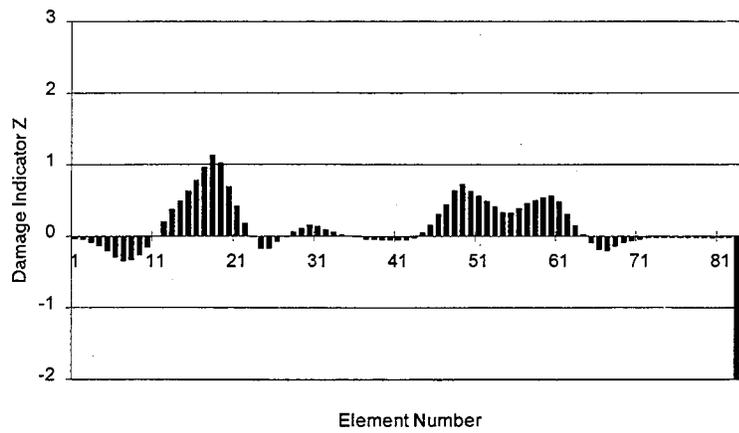
Figure 3.14 Damage Localization Results Using the Second Bending Mode in the Y-dir. (December 1997)

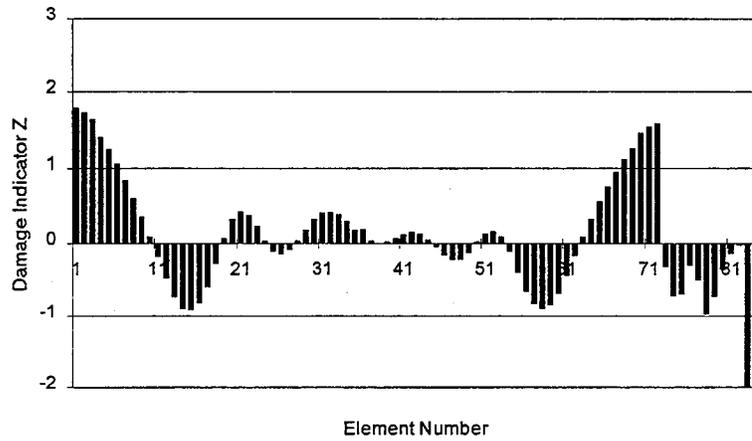
**Figure 3.15 Damage Localization Results Using the First Torsional Mode
(December 1997)**

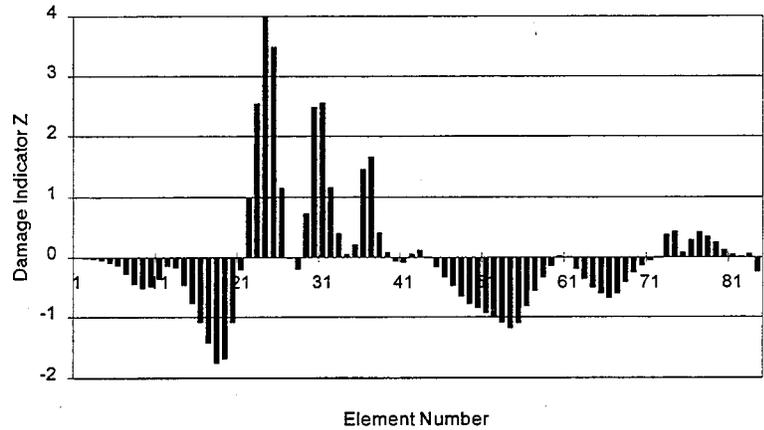
Figure 4.5 Damage Localization Results Using the First Bending Mode in the Z-dir. (September 1998): (a) Result using the measurements along the west girder (W1-W13);(b) Result using the measurements along the east girder (E1-E13).

The location of potential damage is implemented using the same steps provided in the Section 3.4. The results for the predicted damage locations are summarized in Figures 4.5 to 4.8. Note that for the bending modes, the measurements along the west girder (i.e., W1-W13) and the measurements along the east girder (i.e., E1-E13) are used separately.

The damage severity estimation is performed as follows. First, the baseline and post-damage sensitivities are obtained as described in the latter section. Second, the predicted damage locations are obtained from Figures 4.5 to 4.8. Finally, for each predicted damage location, the damage severity are estimated using the severity estimator. The estimated damage severities are listed in Table 4.14. Note that the magnitudes of damage about the X-axis were estimated using

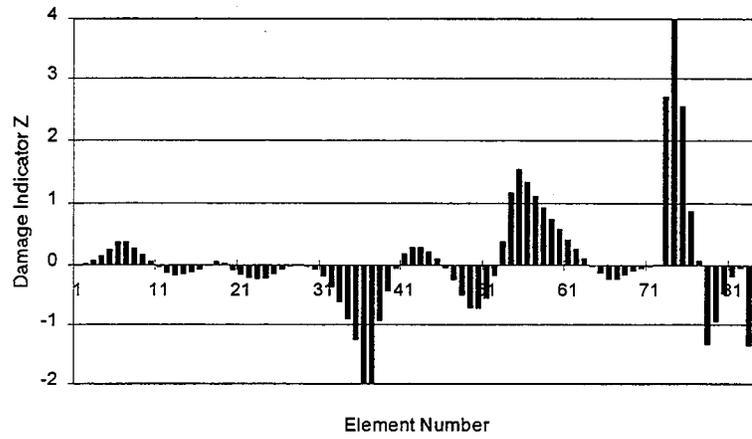
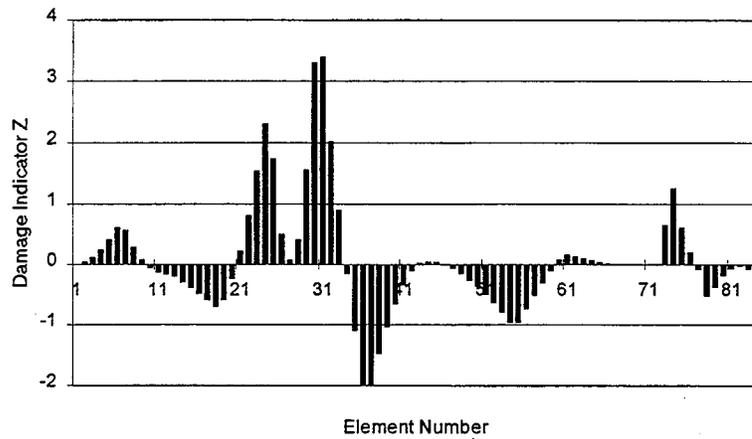
Figure 4.6 Damage Localization Results Using the Second Bending Mode in the Z-dir. (September 1998): (a) Result using the measurements along the west girder (W1-W13); (b) Result using the measurements along the east girder (E1-E13).

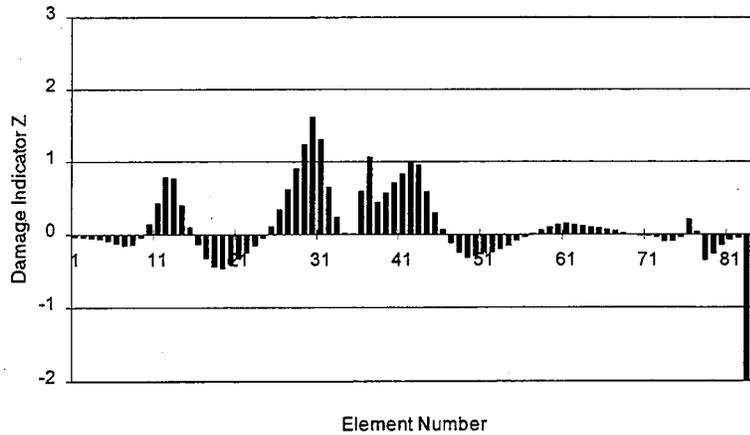
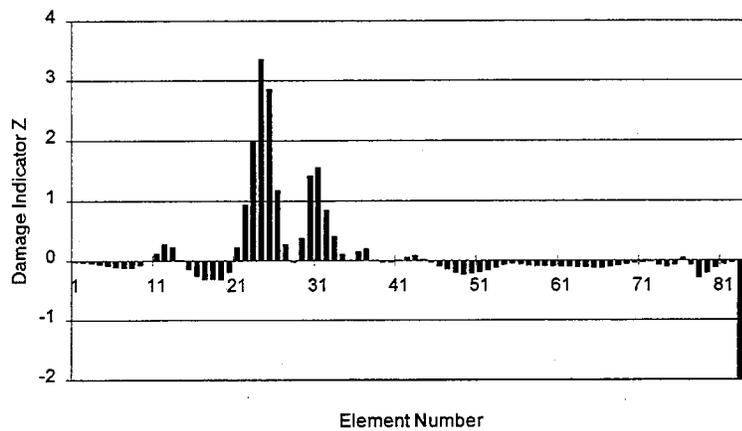
Figure 4.7 Damage Localization Results Using the Second Bending Mode in the Y-dir. (September 1998): (a) Result using the measurements along the west girder (W1-W13); (b) Result using the measurements along the east girder (E1-E13).

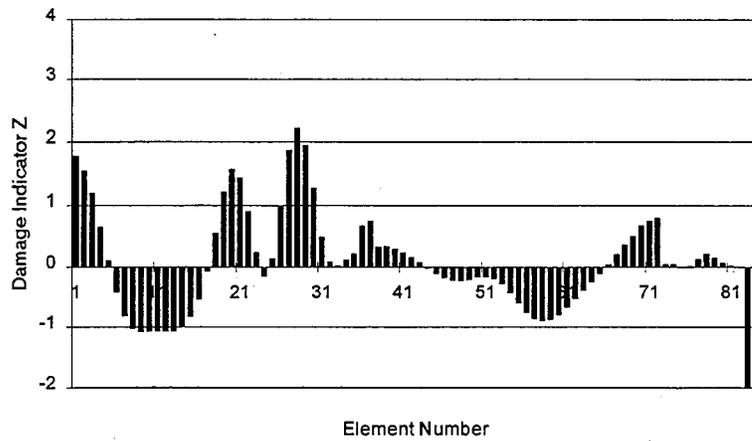
Figure 4.8 Damage Localization Results Using the First Torsional Mode (September 1998)

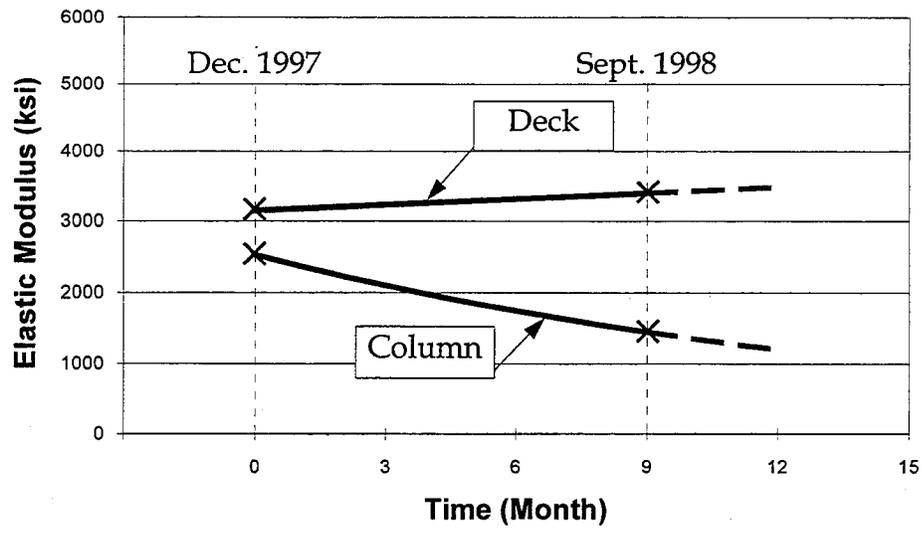
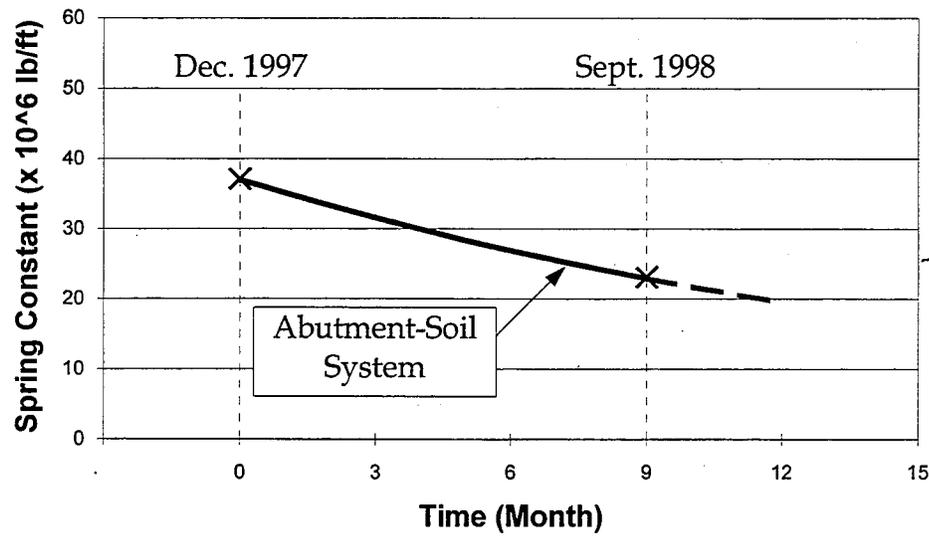
Figure 5.1 Changes in Average Stiffness Properties: (a) Elastic Modulus of the Deck and Column; (b) Spring Constant of Abutment-Soil System

1. During the period of interest there was no significant change in the average stiffness of the deck;
2. The degradation in the stiffnesses of the column and abutments was significant; and
3. The density of the superstructure appears to change significantly during the wet months and dry months.

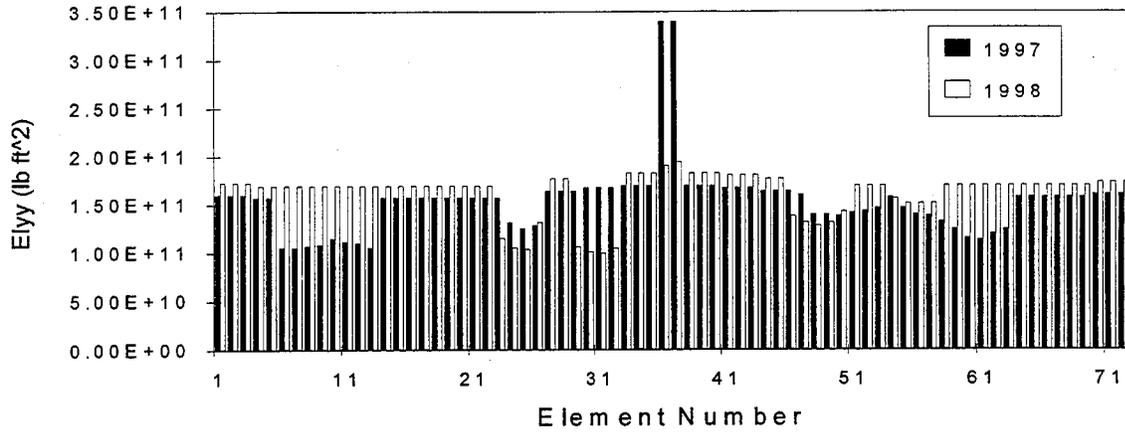
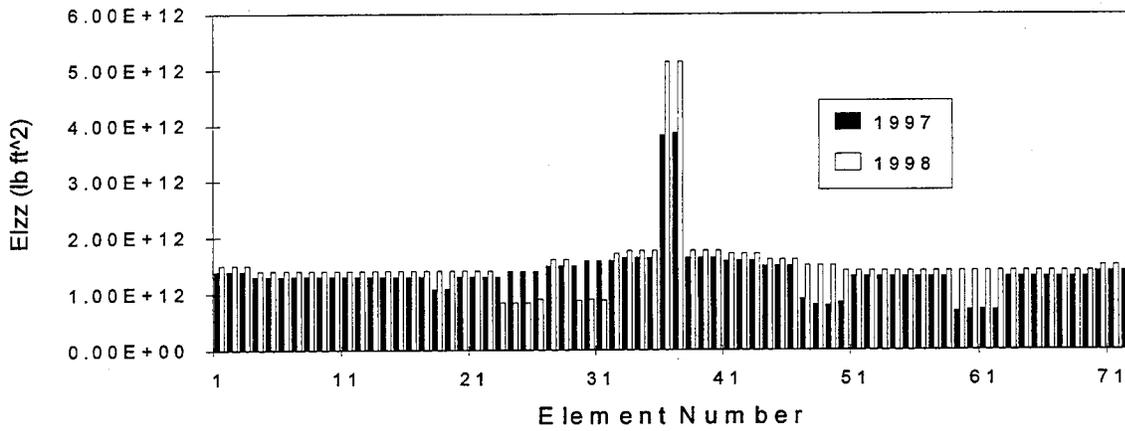
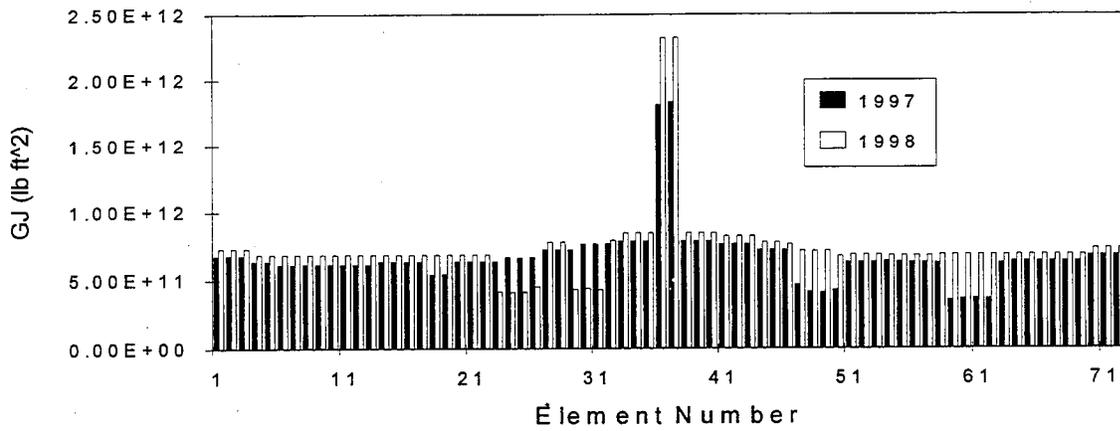
Figure 5.2 Stiffness Changes of the Deck: (a) EI_{yy} ; (b) EI_{zz} ; (c) GJ

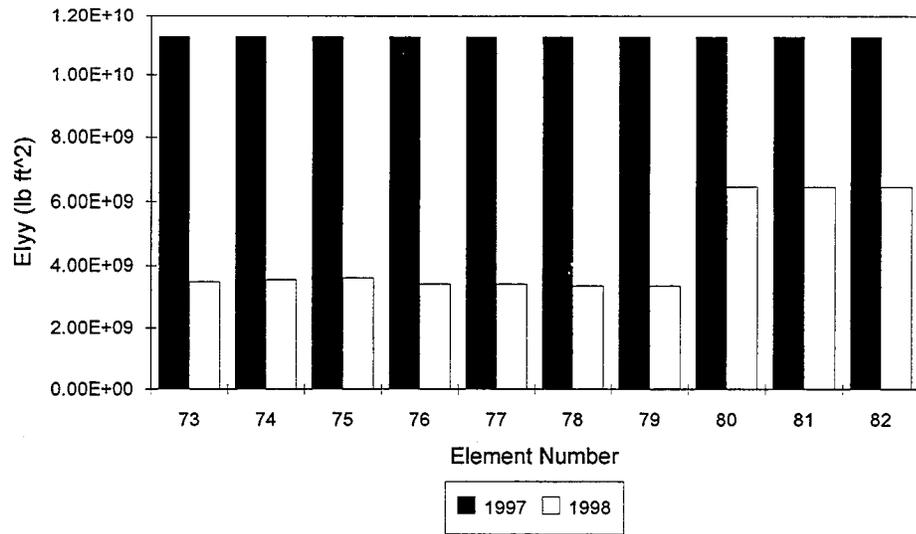
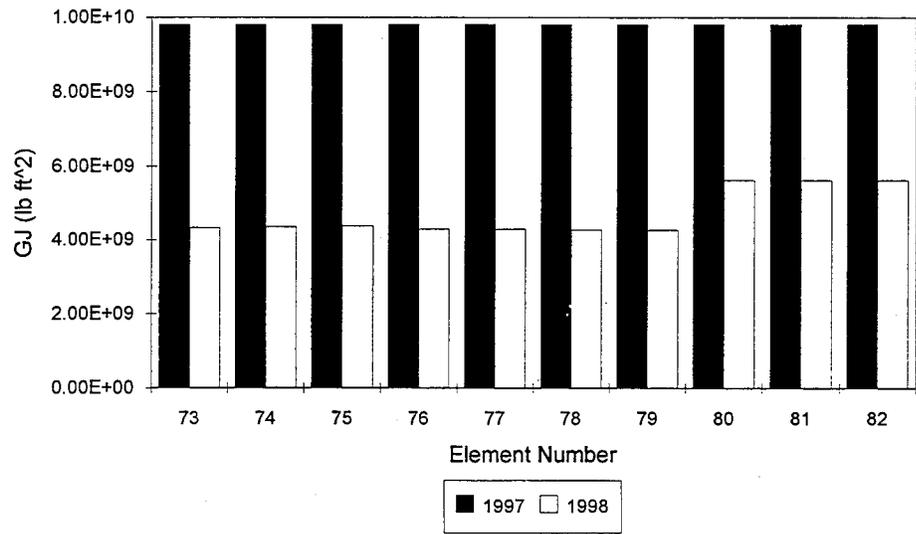
Figure 5.3 Stiffness Changes of the Column: (a) EI_{yy} ; (b) GJ

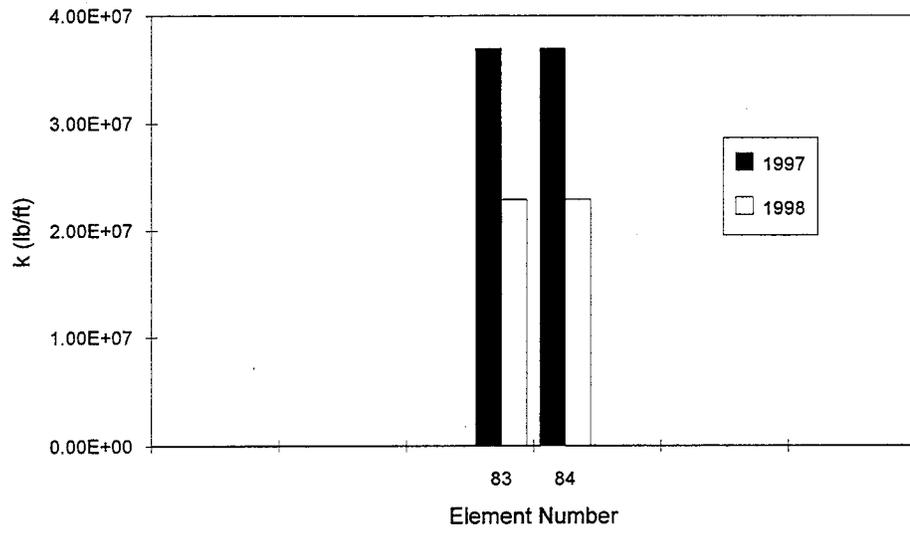
Figure 5.4 Stiffness Changes of the Abutments

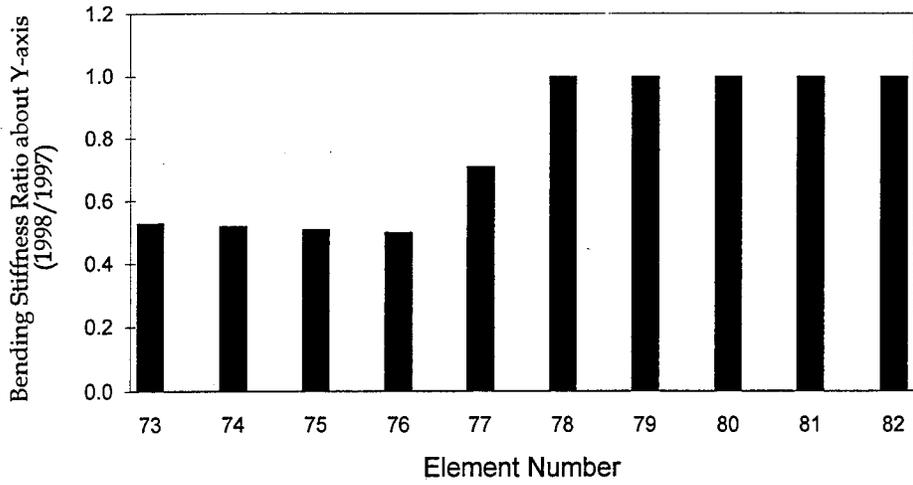
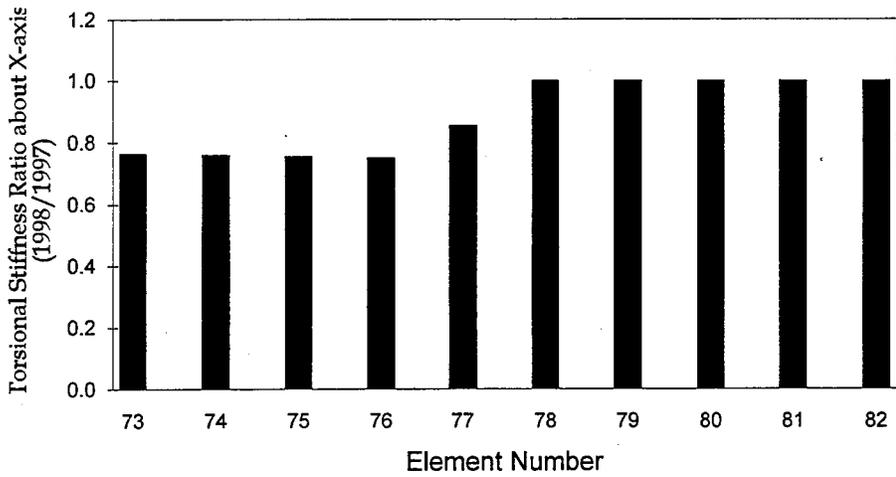
Figure 5.6 Estimated Stiffness Ratio of the Column from the 1997 and 1998 Field-Measured Data: (a) $EI_{yy, 1998}/EI_{yy, 1997}$; (b) GJ_{1998}/GJ_{1997}

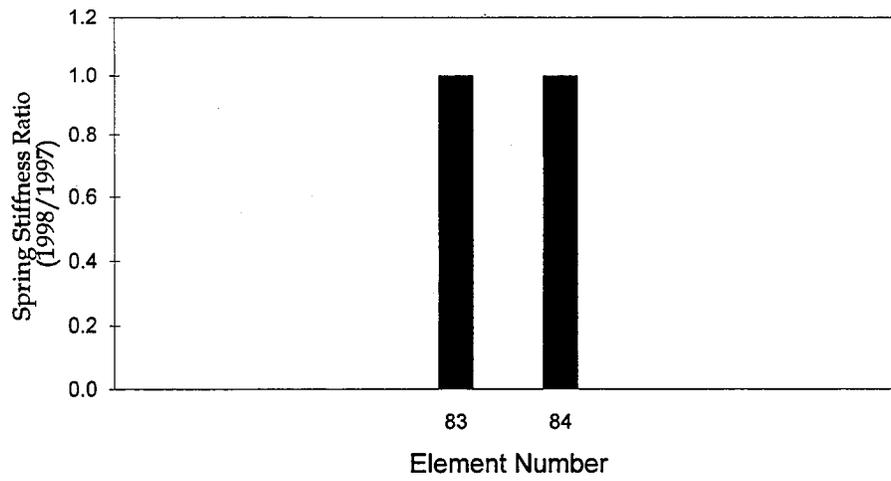
Figure 5.7 Estimated Stiffness Ratio (k_{1998}/k_{1997}) of the Abutments from the 1997 and 1998 Field-Measured Data

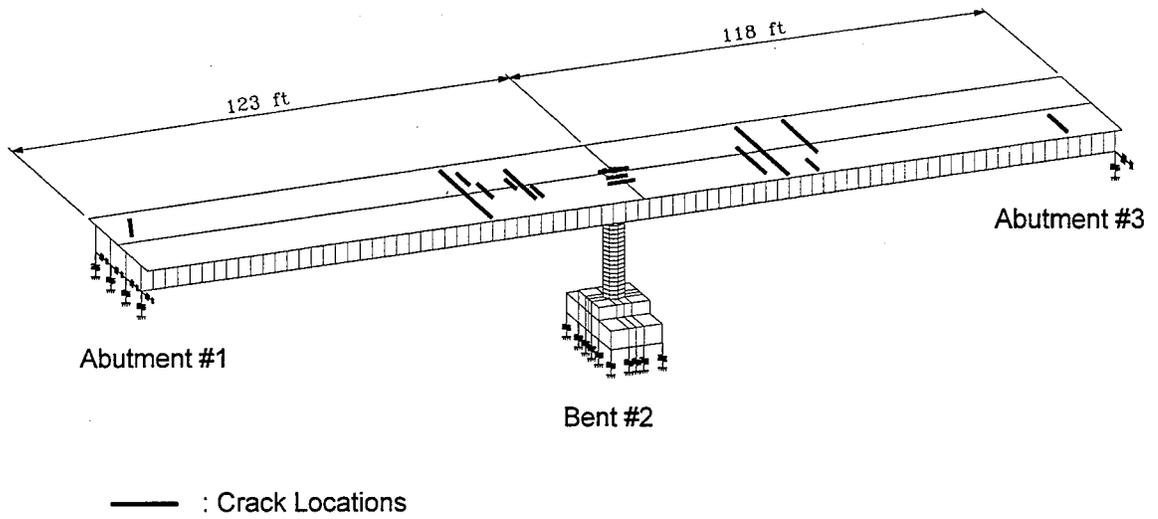
Figure 6.1 Surface Crack Pattern on the Deck

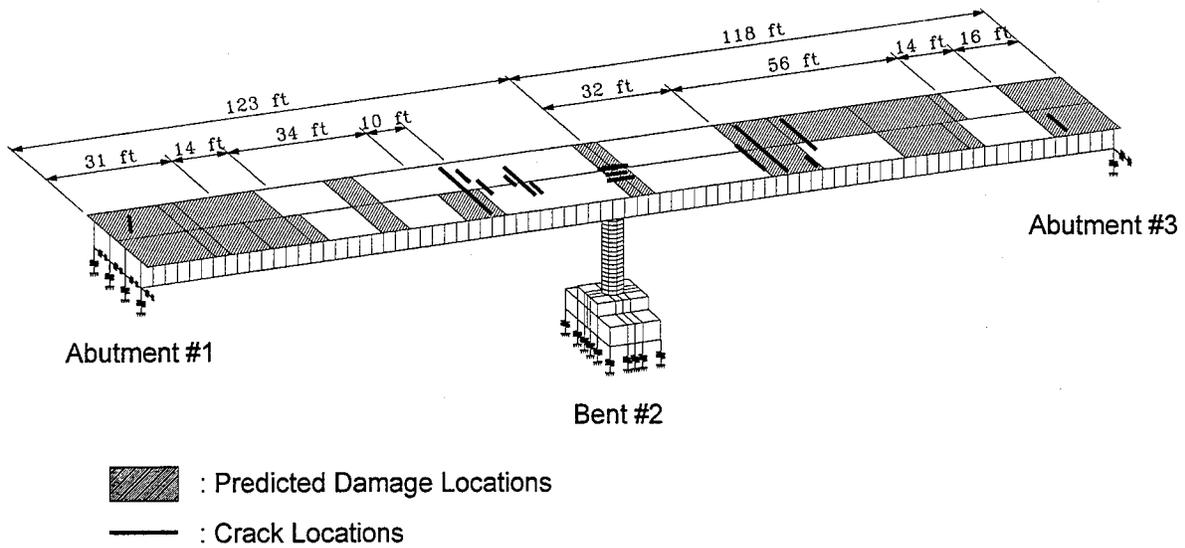
Figure 6.2 Comparison of Surface Cracks with Damage Localization Results using Superposition of All Modes from the 1997 Measurements

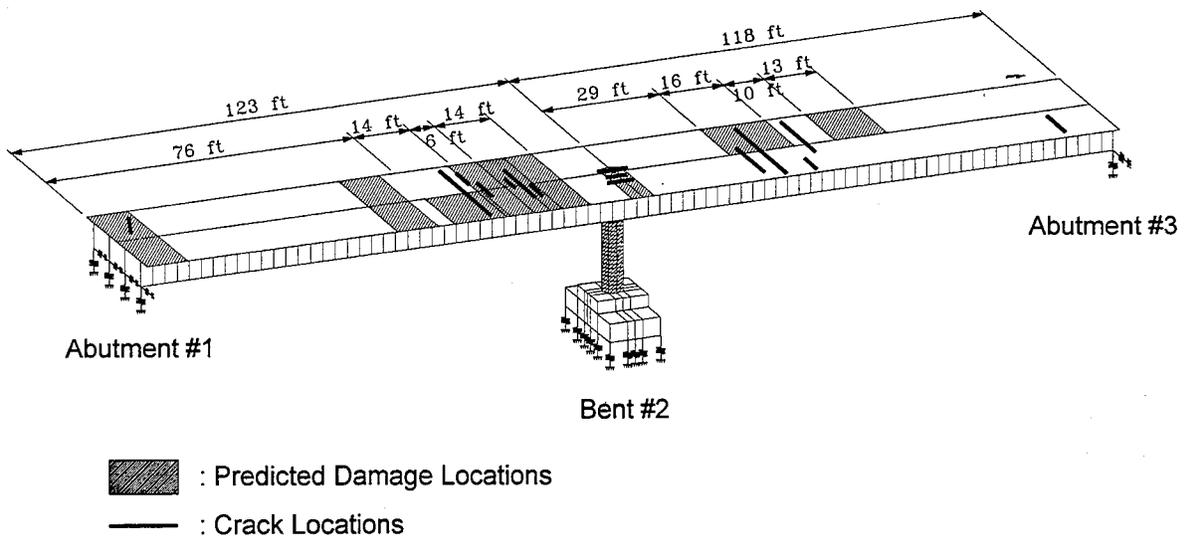
Figure 6.3 Comparison of Surface Cracks with Damage Localization Results using Superposition of All Modes from the 1998 Measurements

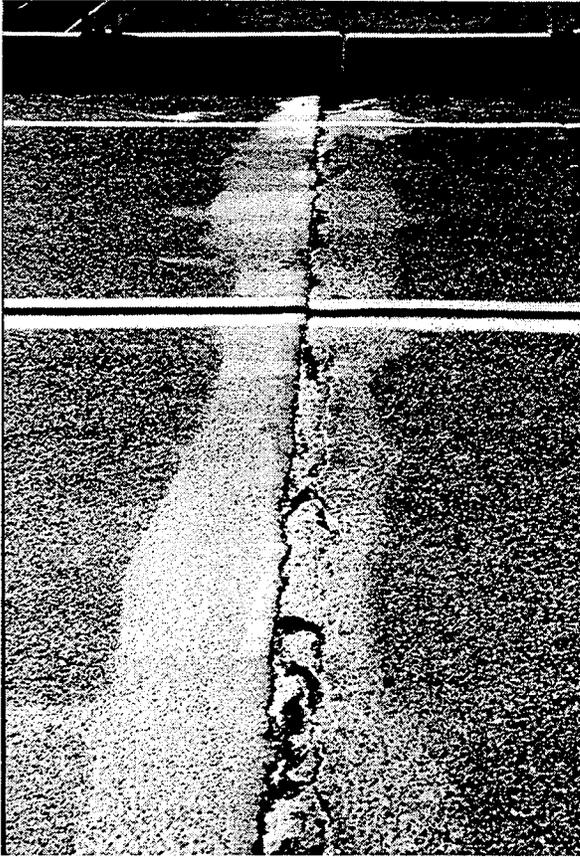
Figure B.5 Grouted expansion joint

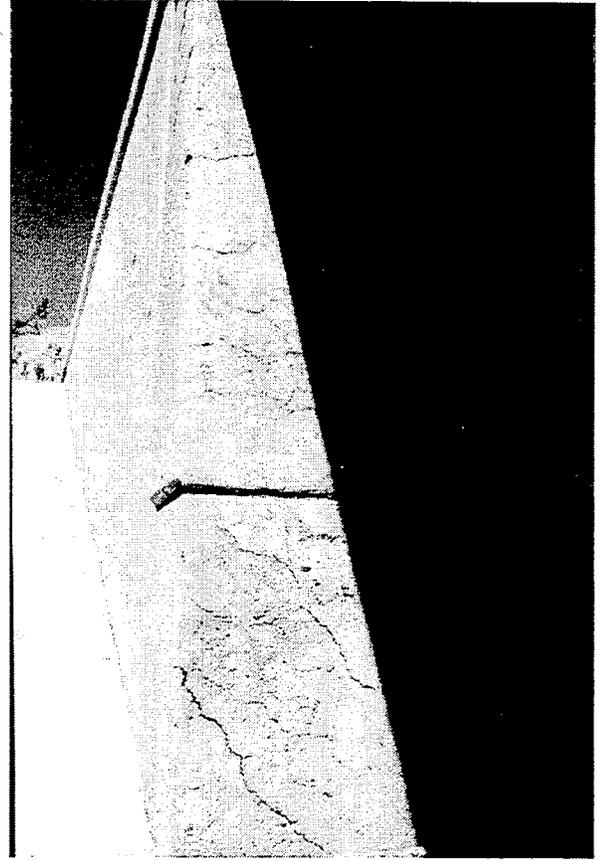
Figure B.6 Wingwall Deterioration
