**Non-Destructive Estimate of the Rate of Change of Structural
Degradation of the Lavic Road Overcrossing**

N. Stubbs¹, S. Park², R.W. Bolton³, S. Choi⁴
Texas Engineering Experiment Station
College Station, Texas 77843

C. Sikorsky⁵
State of California
Department of Transportation
Sacramento, CA 95816

October 1999

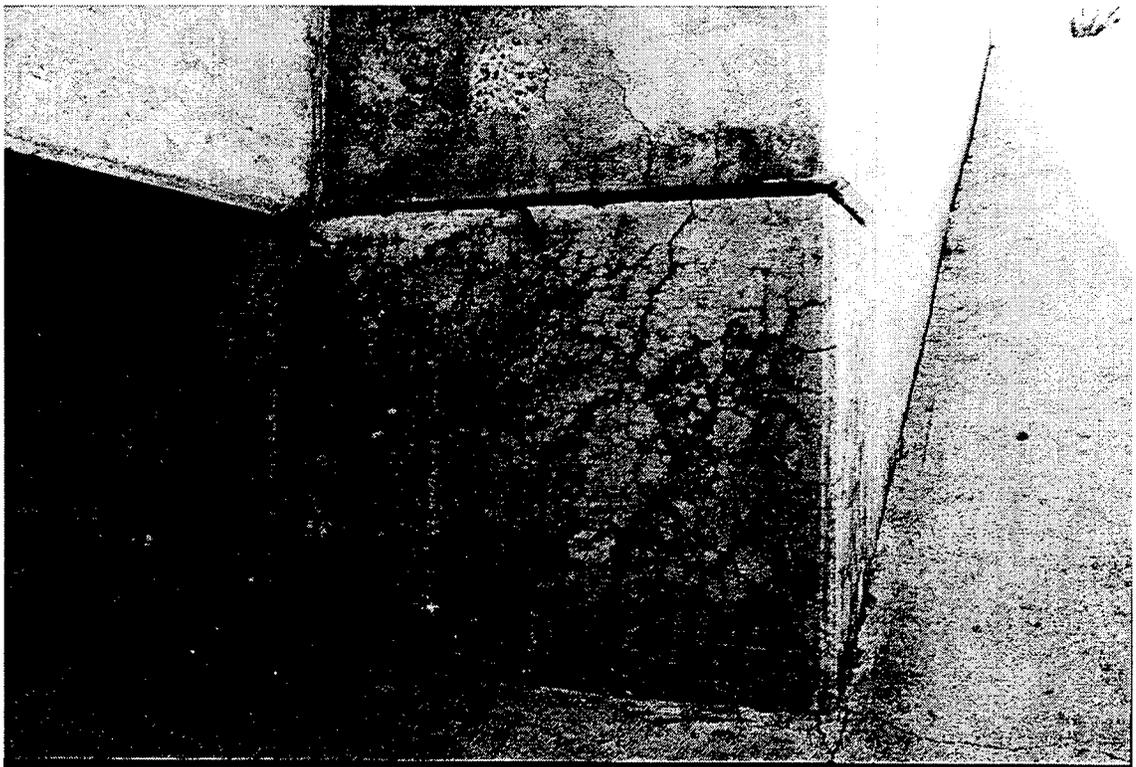
Figure B.7 Visible deterioration of abutment

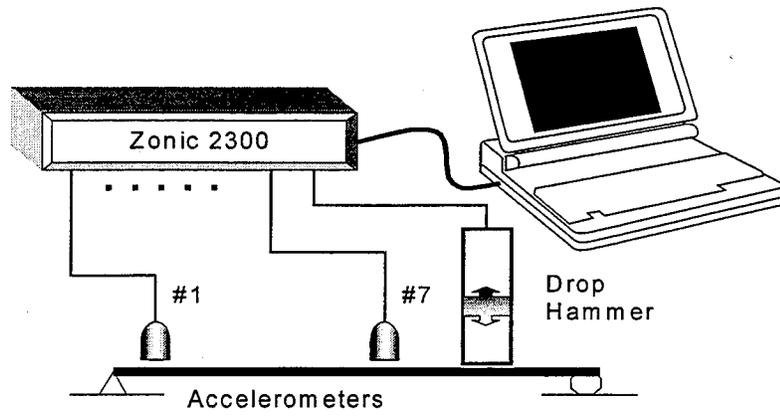
Figure B.8 Schematic of basic instrumentation setup

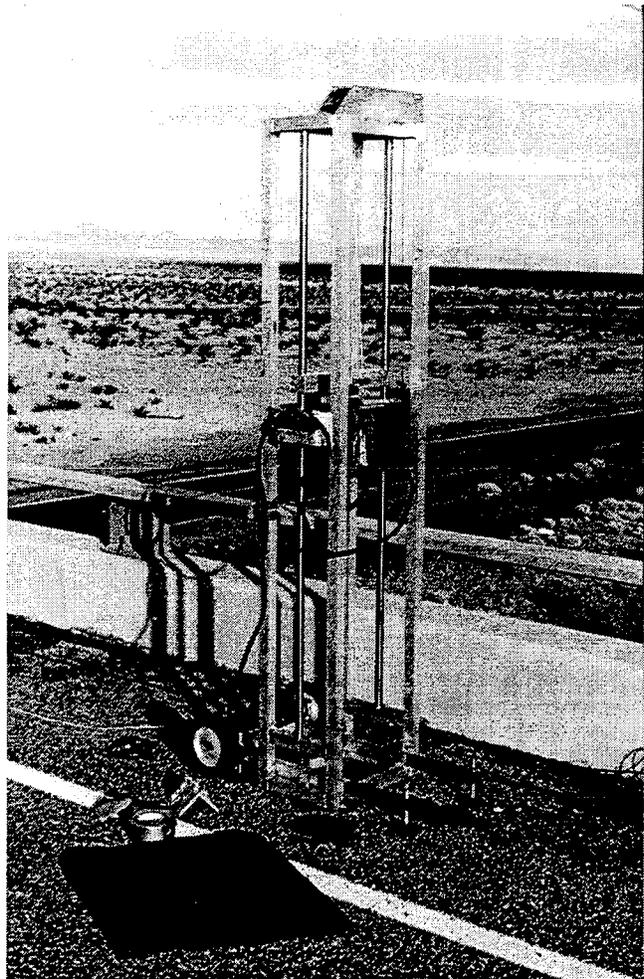
Figure B.11 Impact hammer

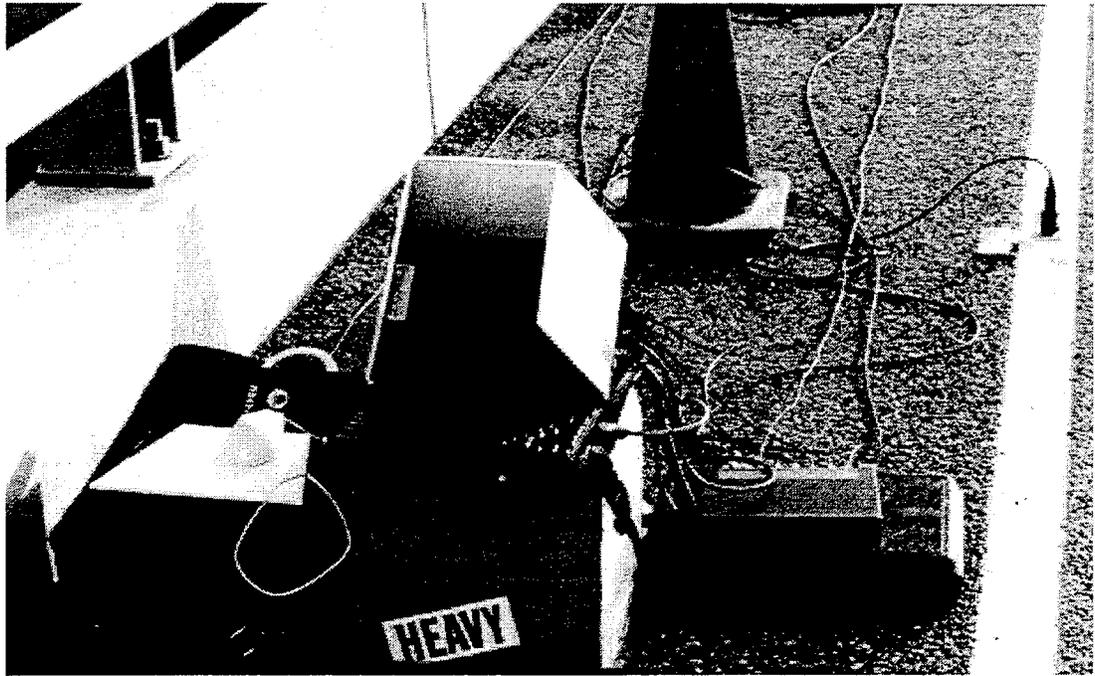
Figure B.12 Acquisition instrumentation for first field test

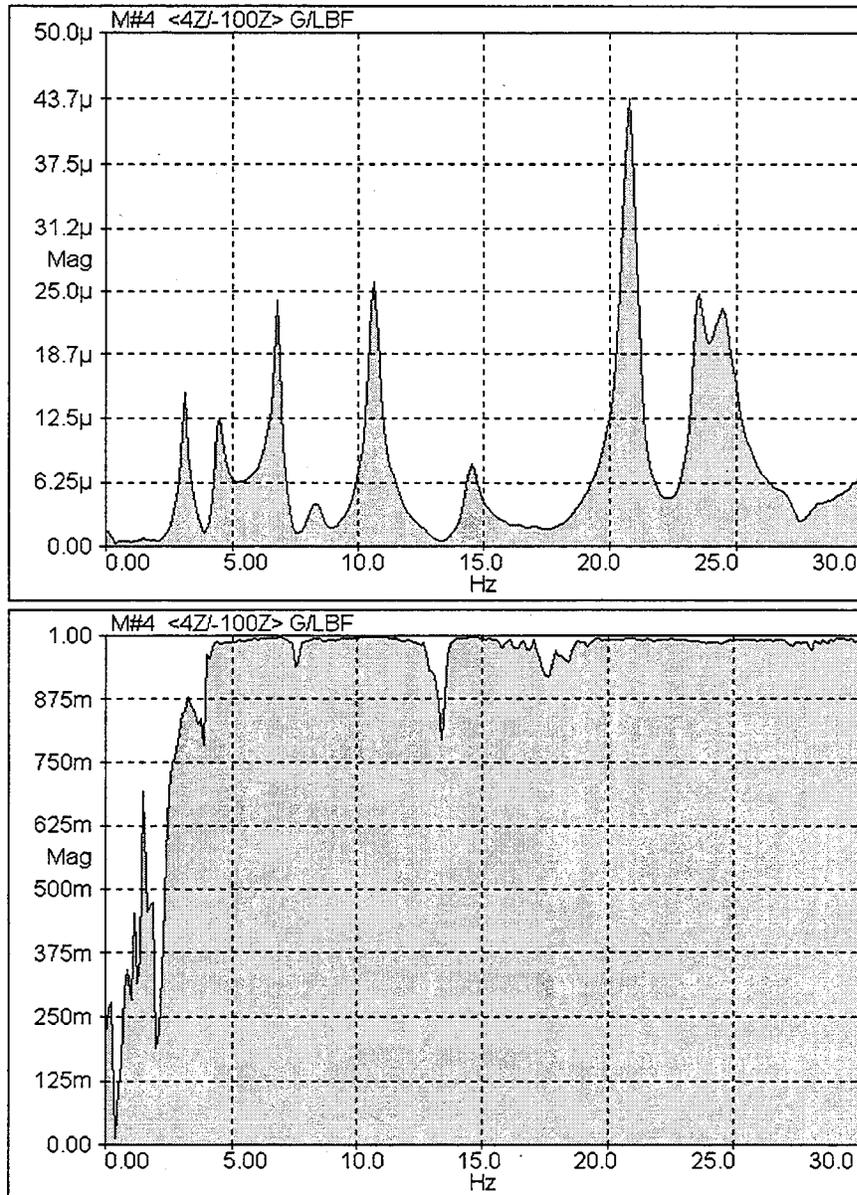
Figure B.19 Typical vertical FRF for deck response point and corresponding coherence function

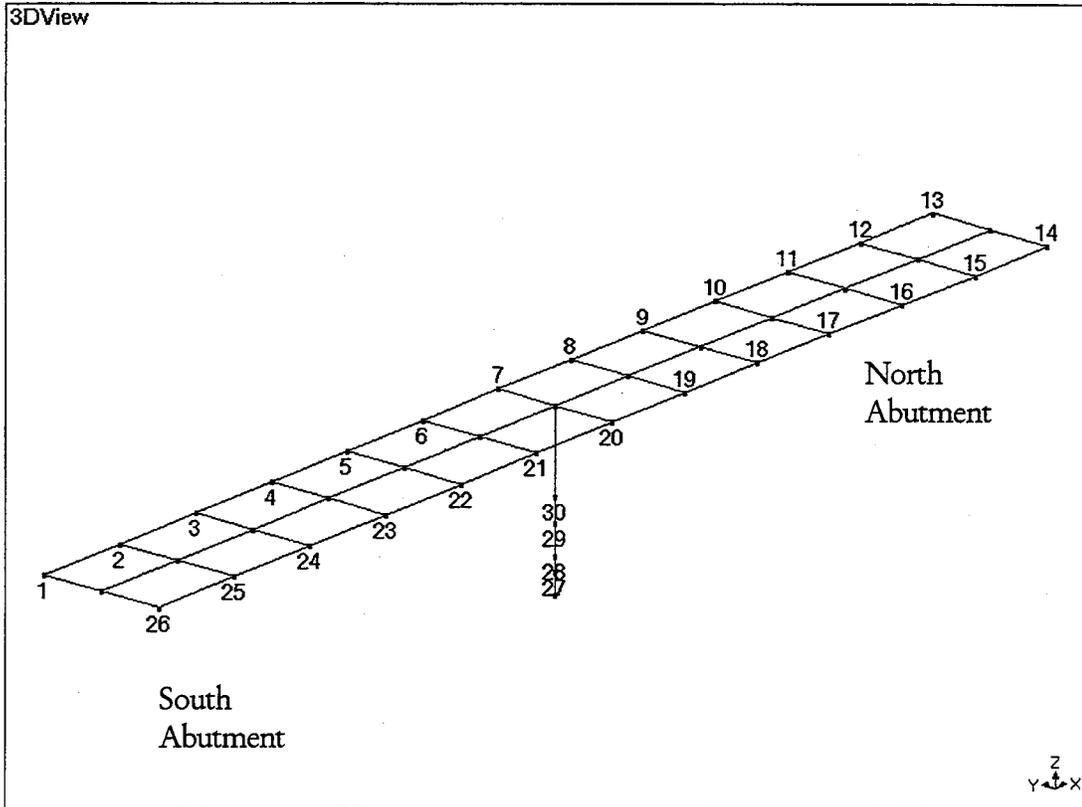
Figure B.21 Wireframe model for analysis of modal field data with response point locations shown

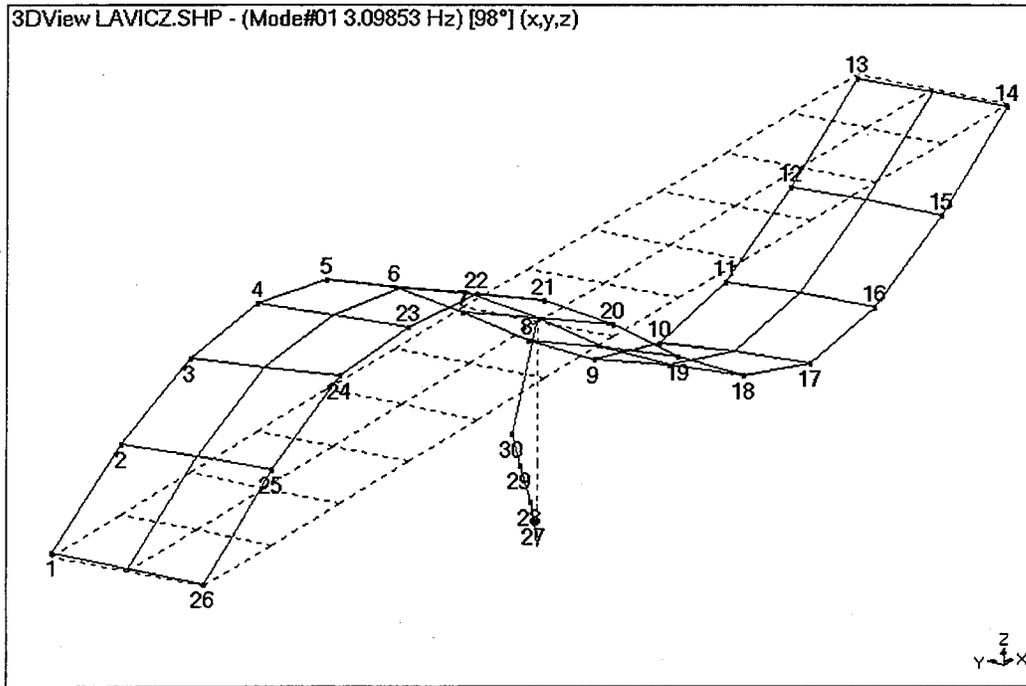
Figure B.22 Mode 1 -- 1st longitudinal bending (1997)

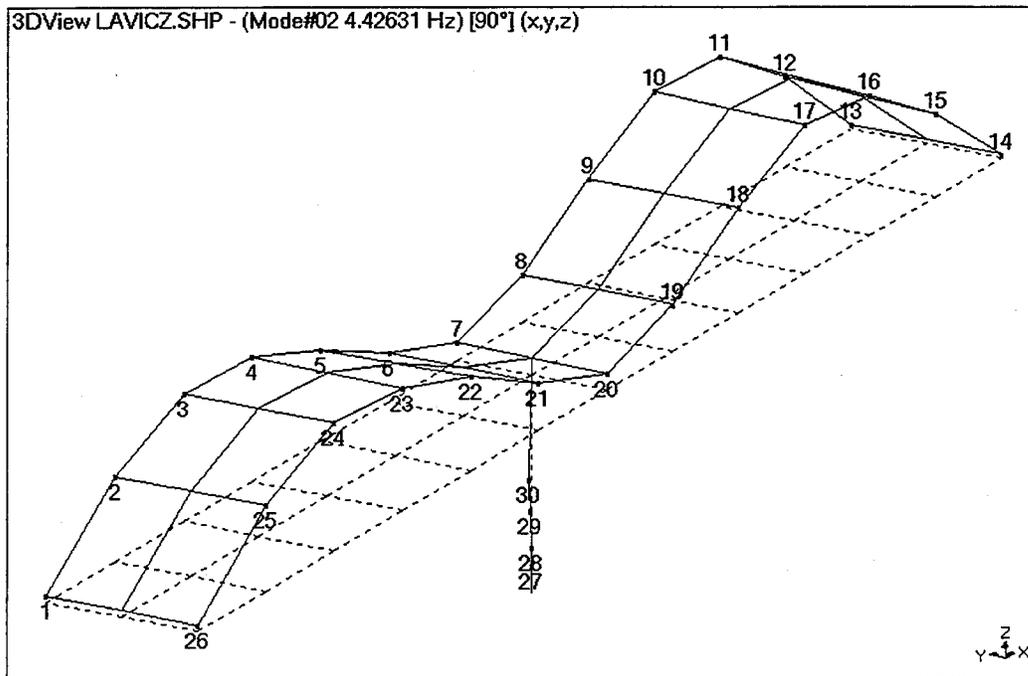
Figure B.23 Mode 2 -- 2nd longitudinal bending (1997)

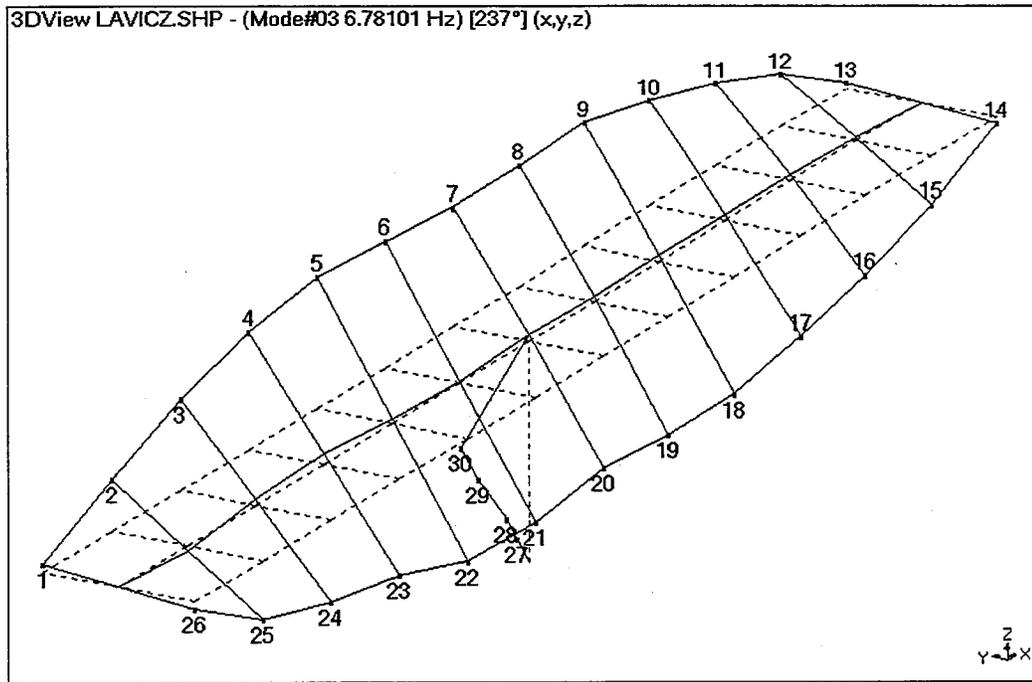
Figure B.24 Mode 3 -- 1st torsion mode (1997)

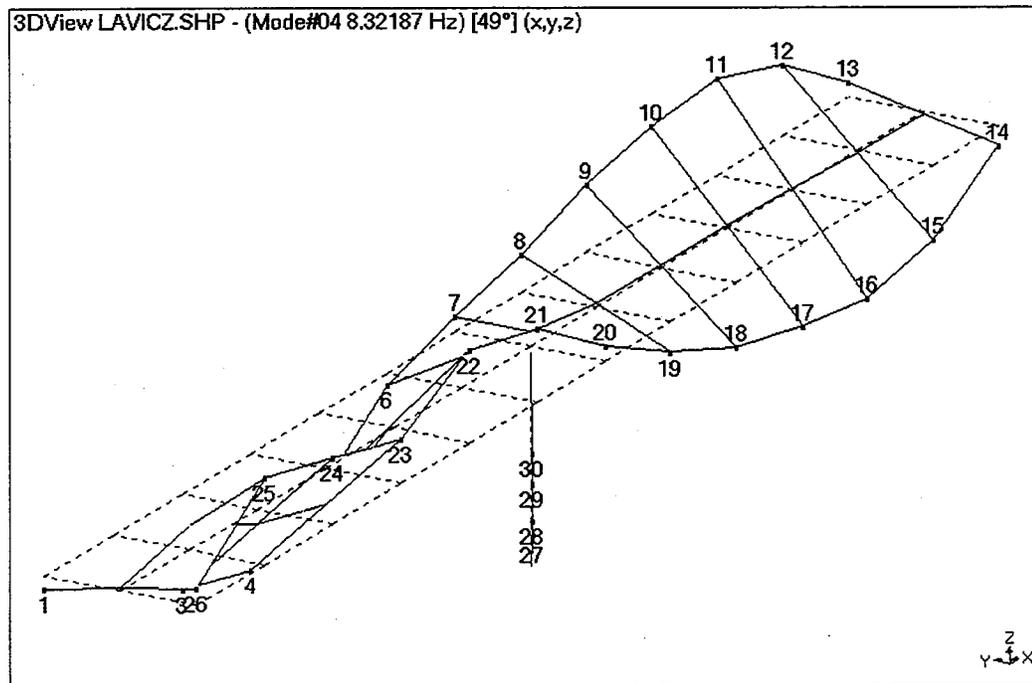
Figure B.25 Mode 4 -- Complex 2nd torsion mode some bending (1997)

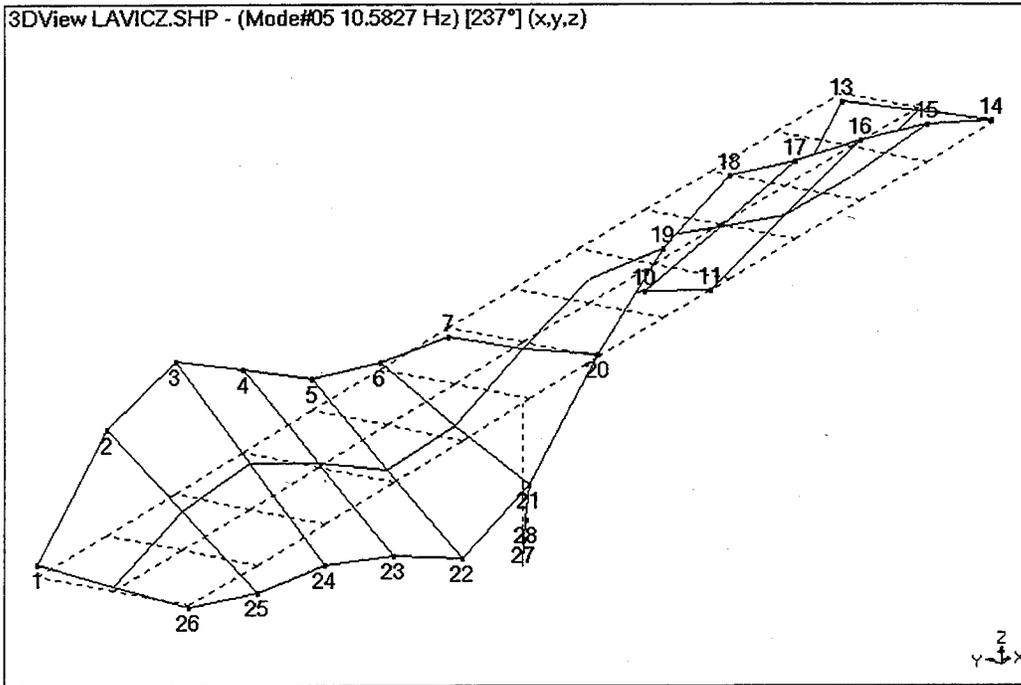
Figure B.26 Mode 5 -- Complex 2nd torsion + 3rd bending (1997)

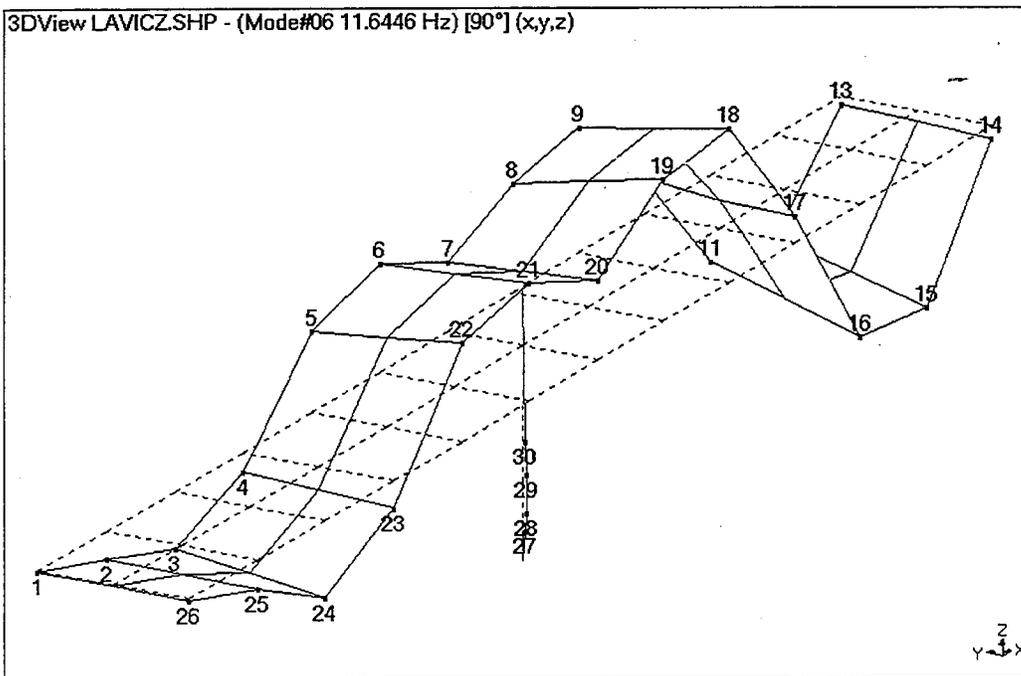
Figure B.27 Mode 6 -- 3rd longitudinal bending mode (1997)

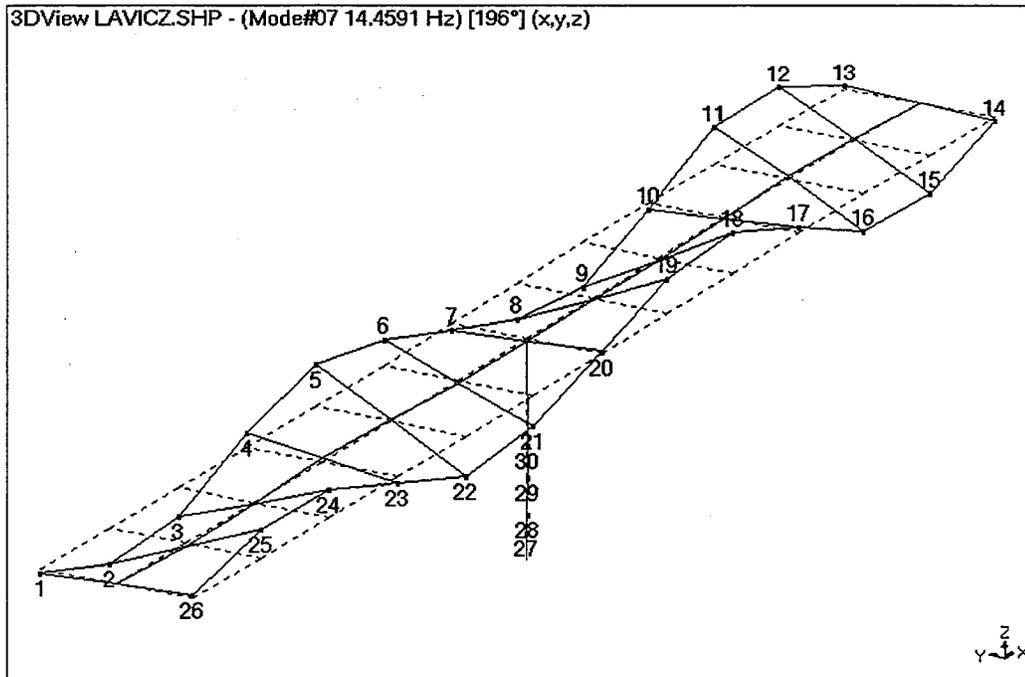
Figure B.28 Mode 7 -- 3rd torsion mode (1997)

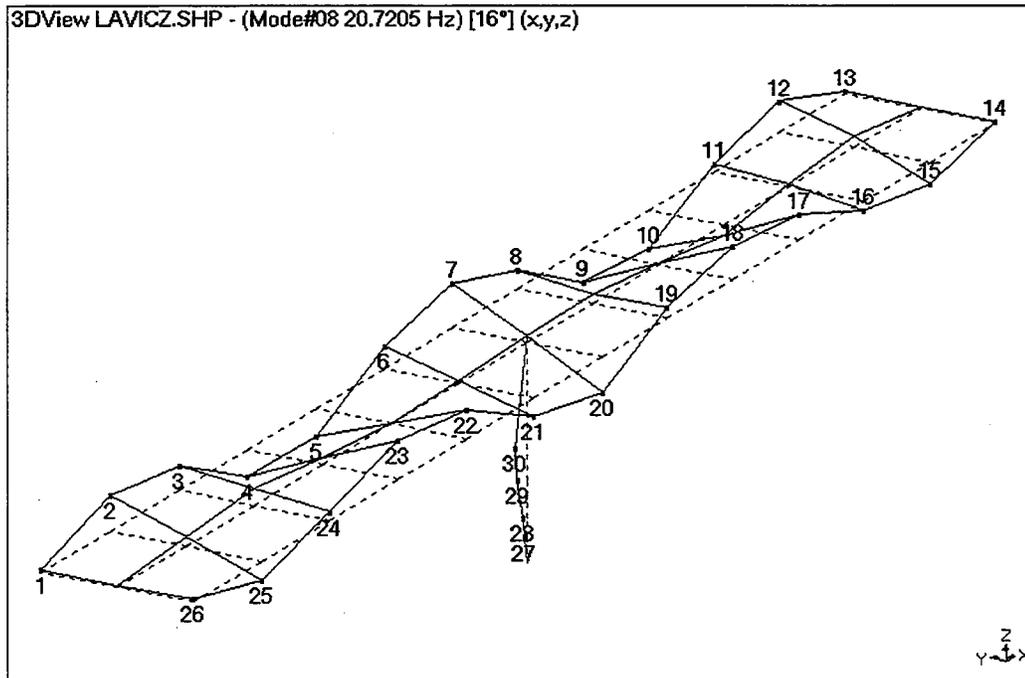
Figure B.29 Mode 8 -- 4th torsion mode (1997)

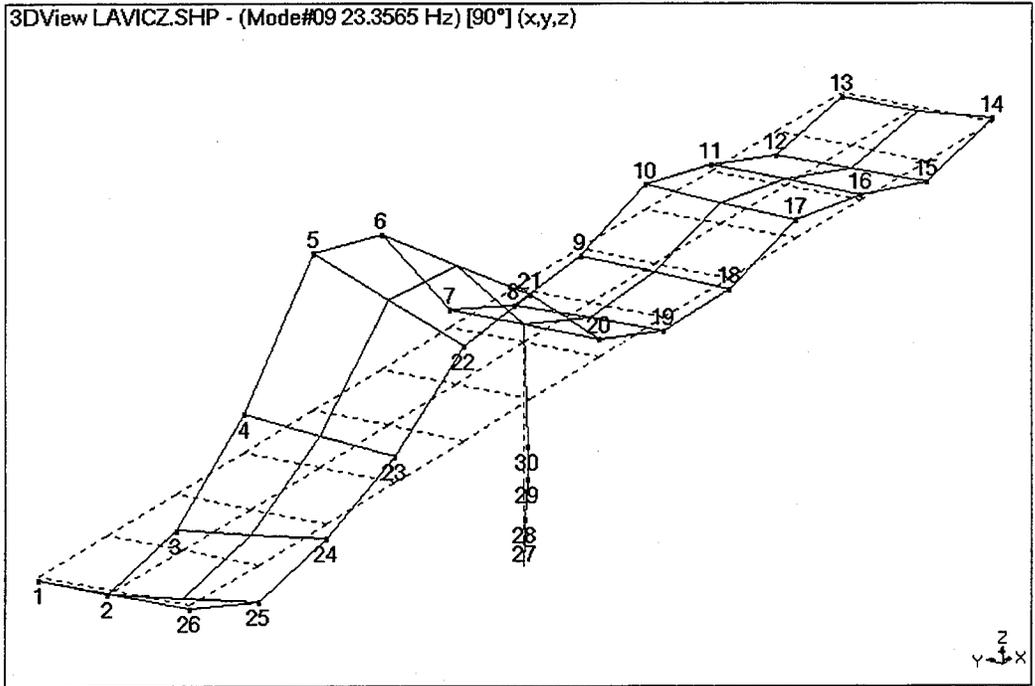
Figure B.30 Mode 9 -- Complex possible harmonic of 3rd bending mode (1997)

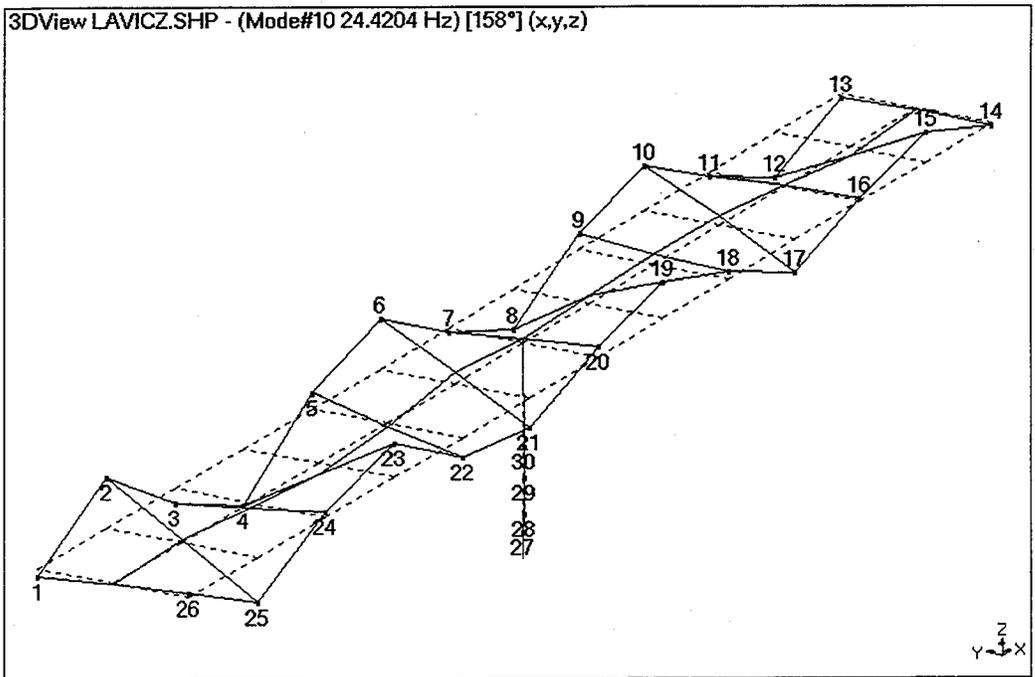
Figure B.31 Mode 10 -- 5th torsion mode (1997)

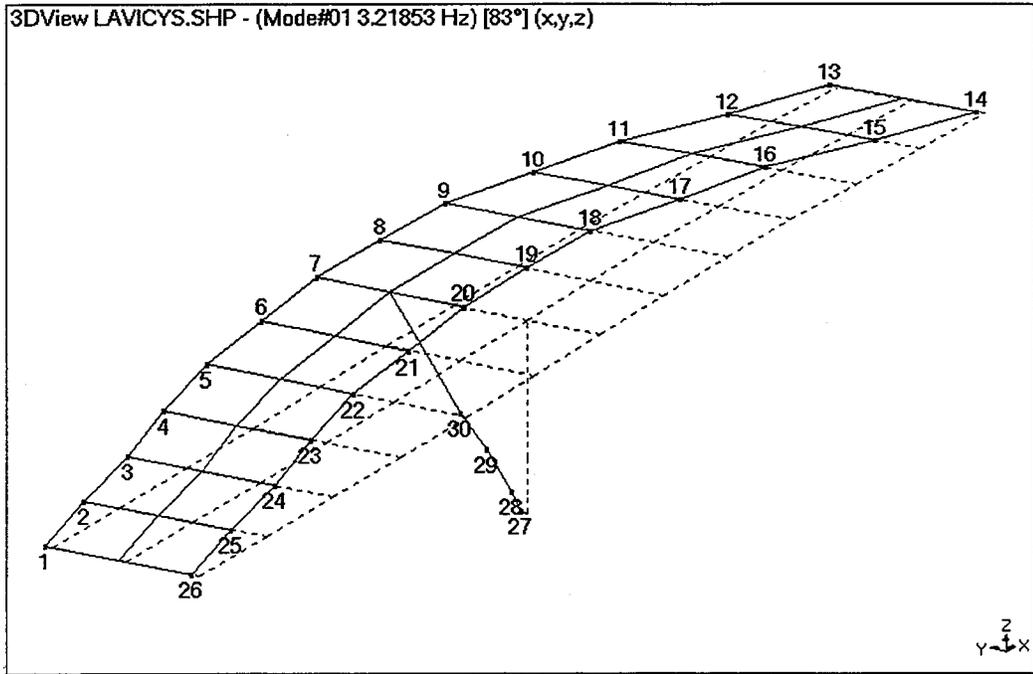
Figure B.32 Mode 1 -- 1st Transverse bending mode (1997)

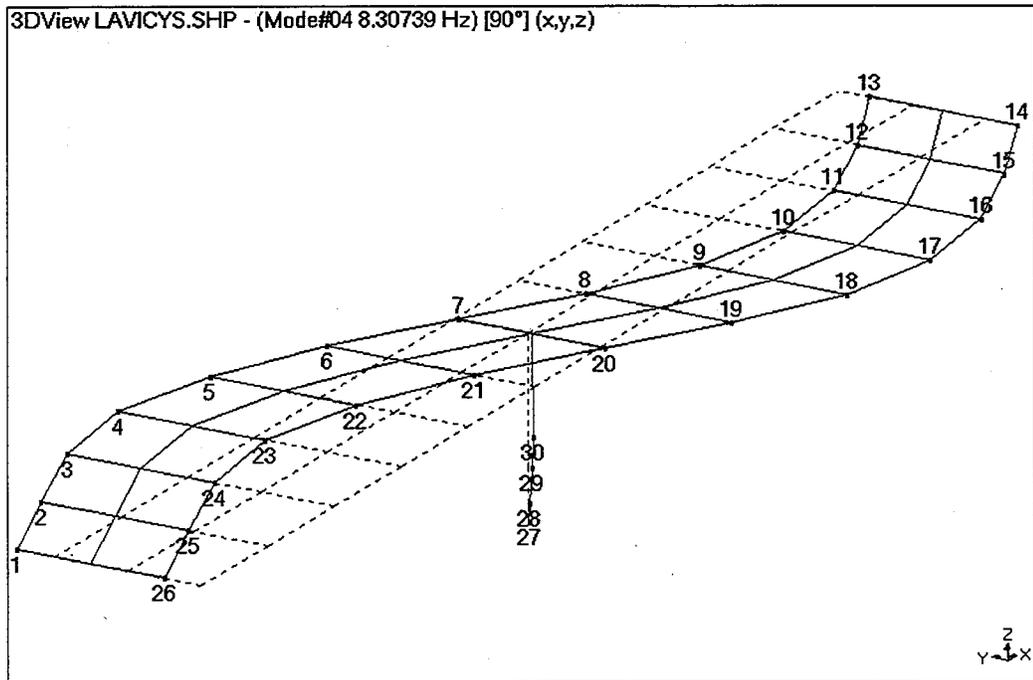
Figure B.33 Mode 4 -- Complex transverse bending mode (1997)

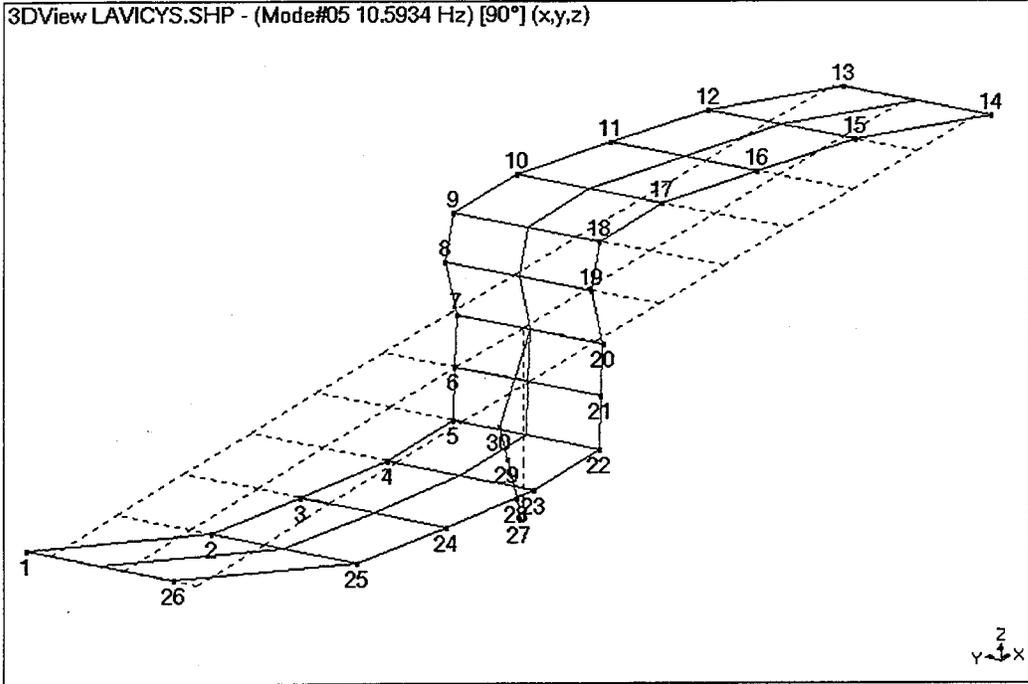
Figure B.34 Mode 5 -- Complex transverse bending mode (1997)

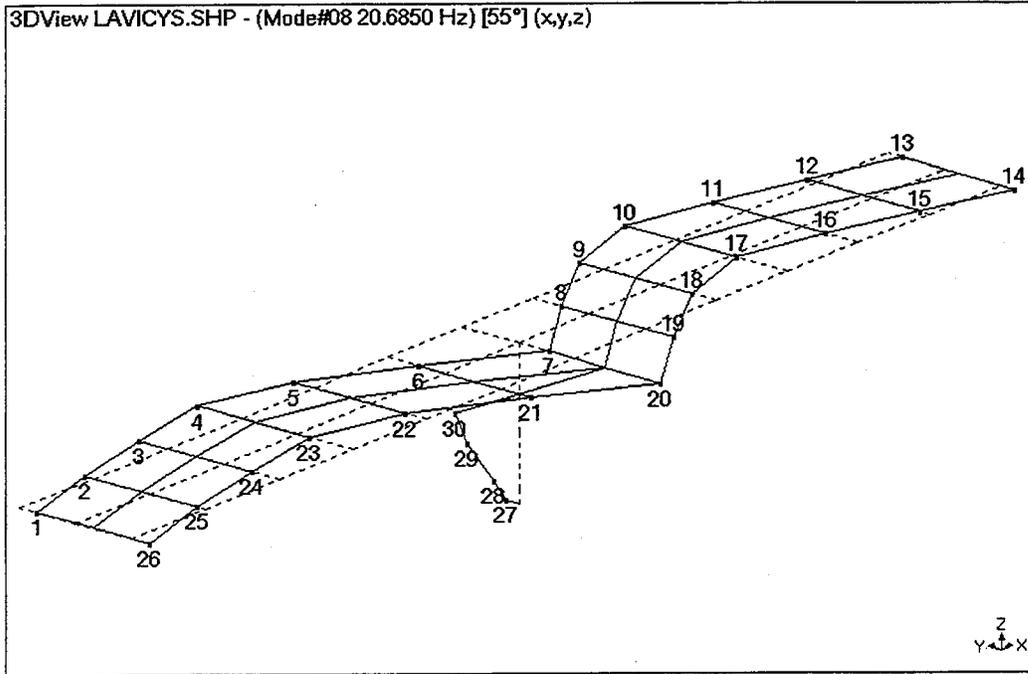
Figure B.35 Mode 8 -- Higher order transverse bending mode (1997)

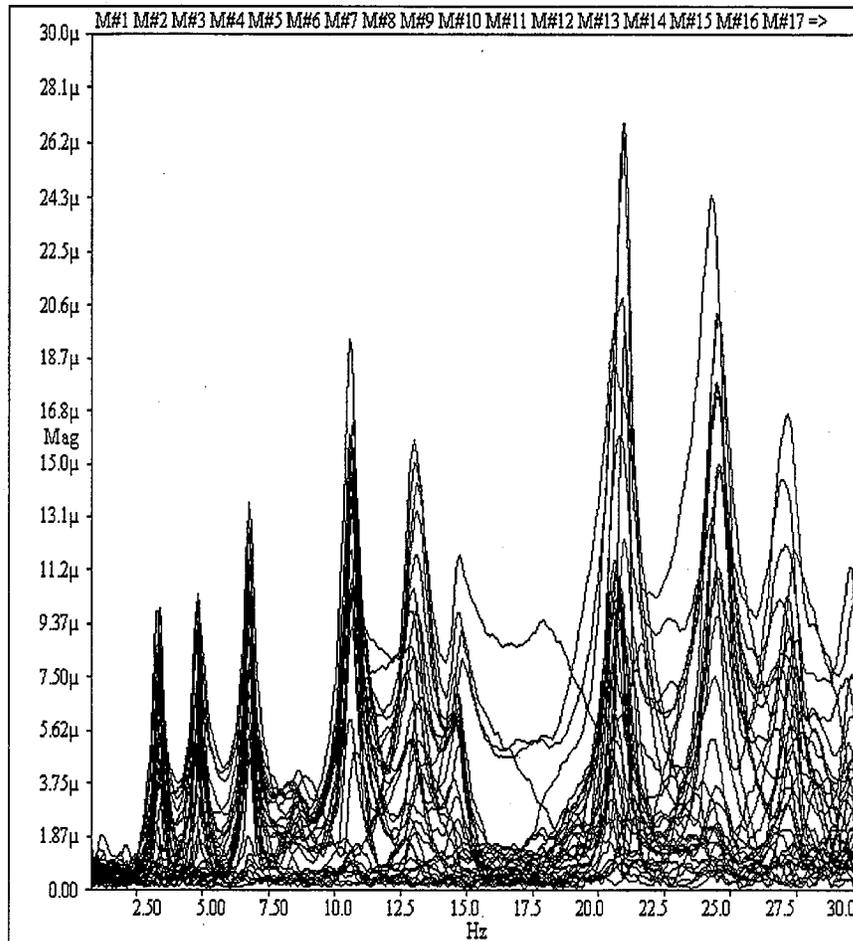
Figure B.36 Composite vertical motion FRF responses for 1998 field test

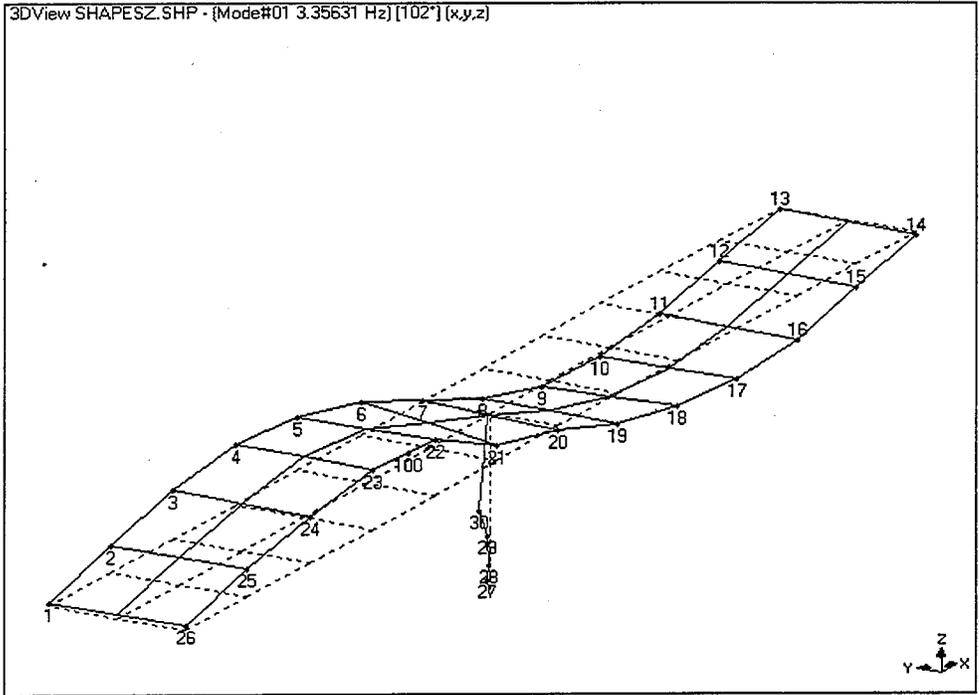
Figure B.37 Mode 1--1st bending mode(1998)

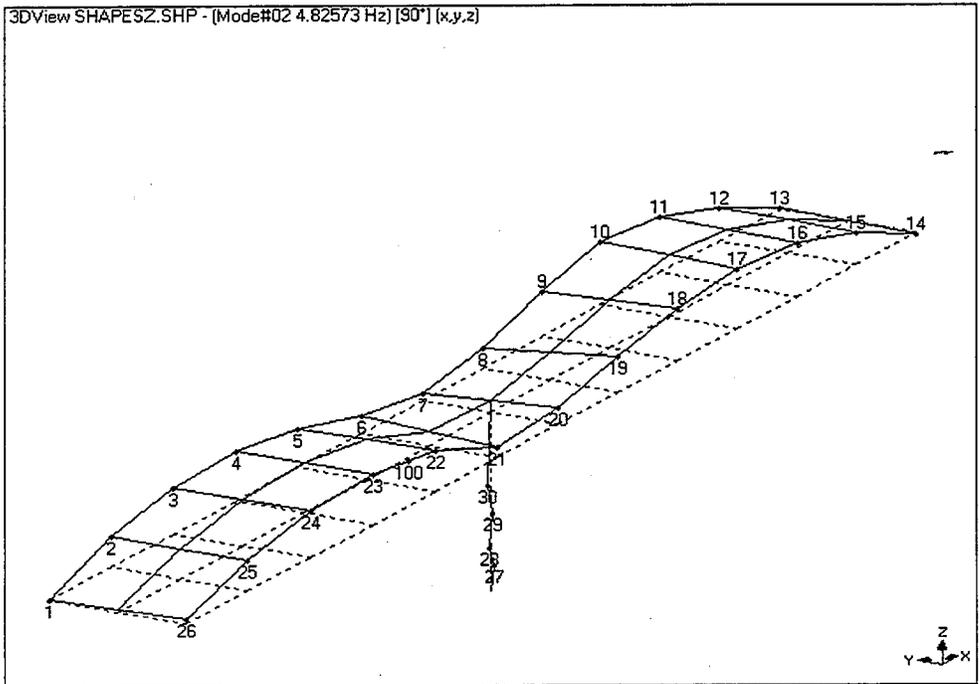
Figure B.38 Mode 2--2nd bending mode (1998)

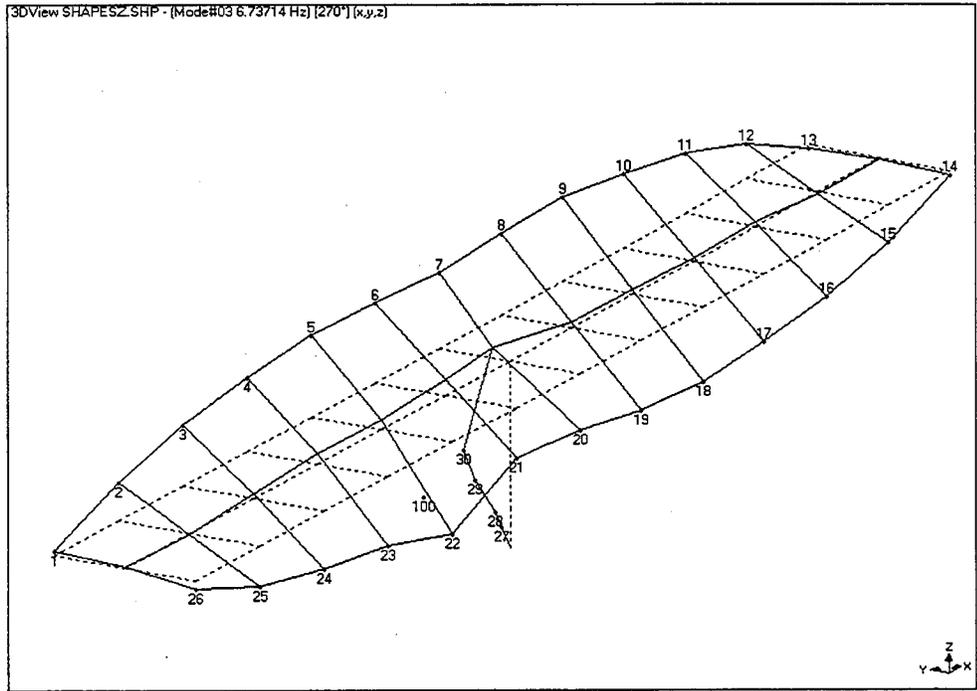
Figure B.39 Mode 3--1st Torsional mode (1998)

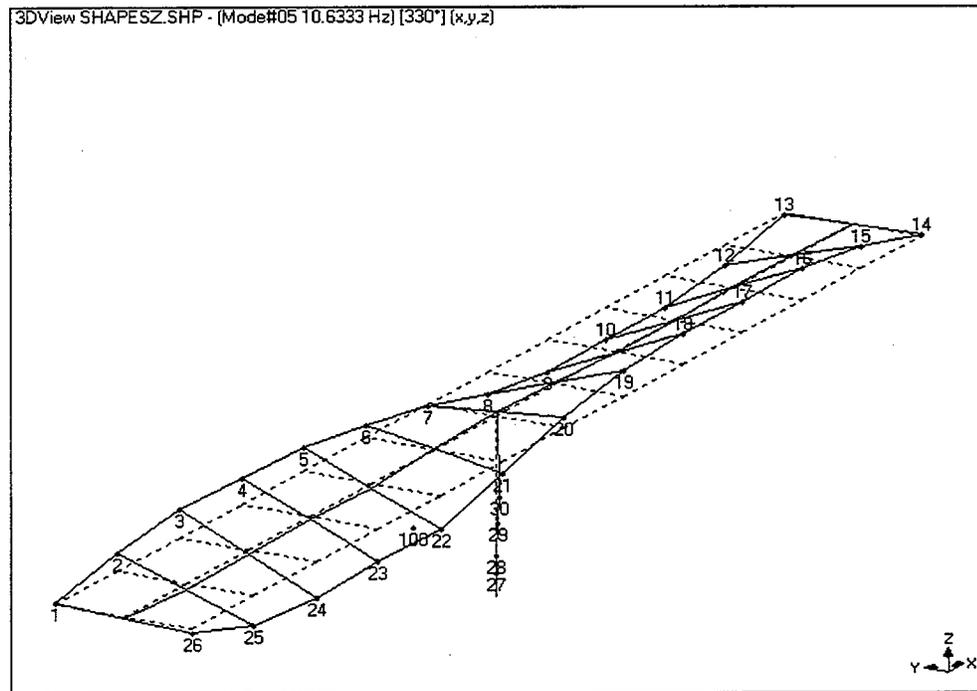
Figure B.40 Mode 4--2nd Torsional mode (1998)

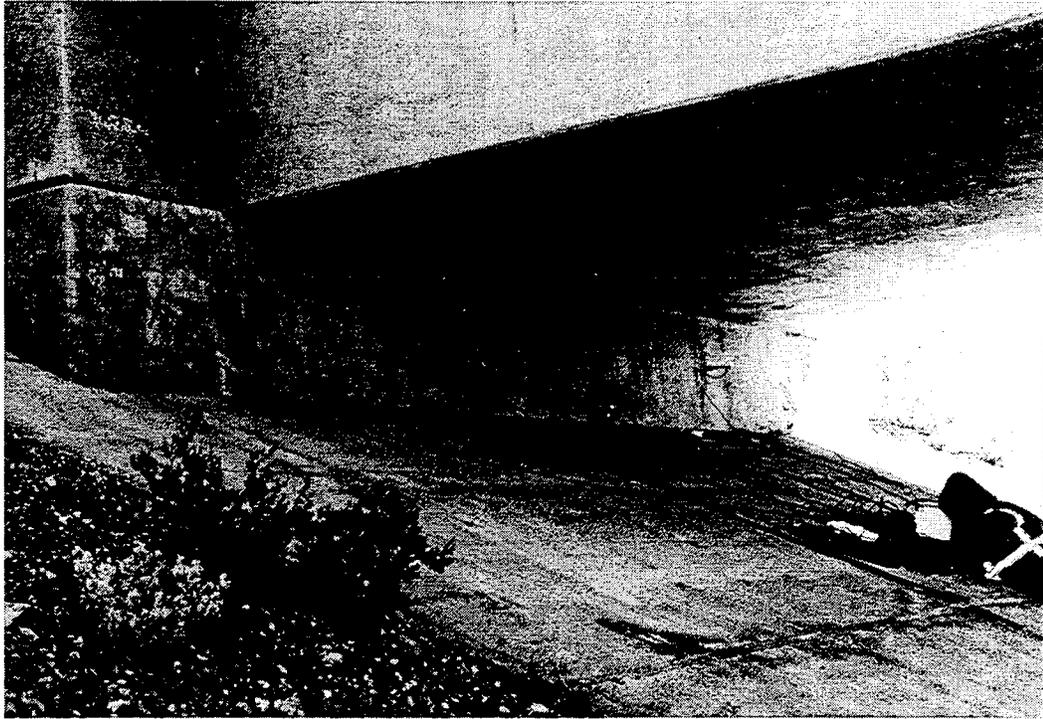
Figure C.1 Accelerometer layout on north abutment wall

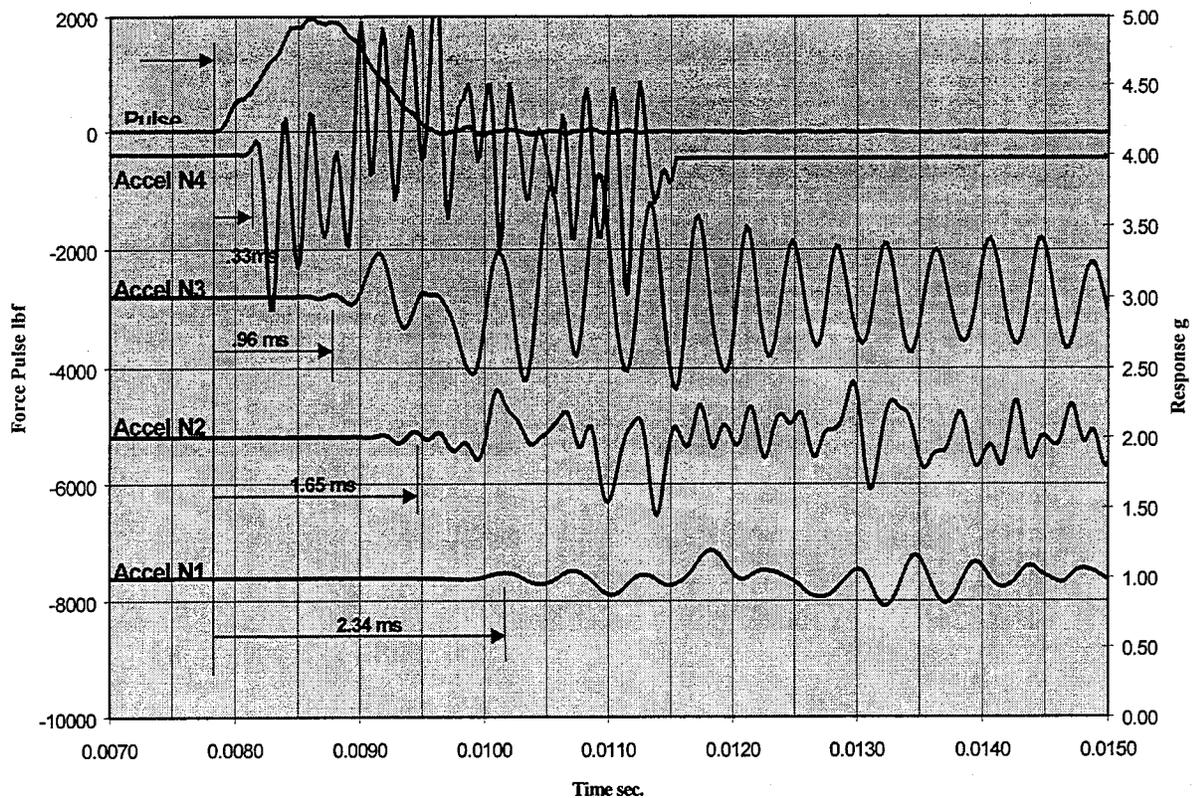
Figure C.2 Wave front times for accelerometers N1 through N4

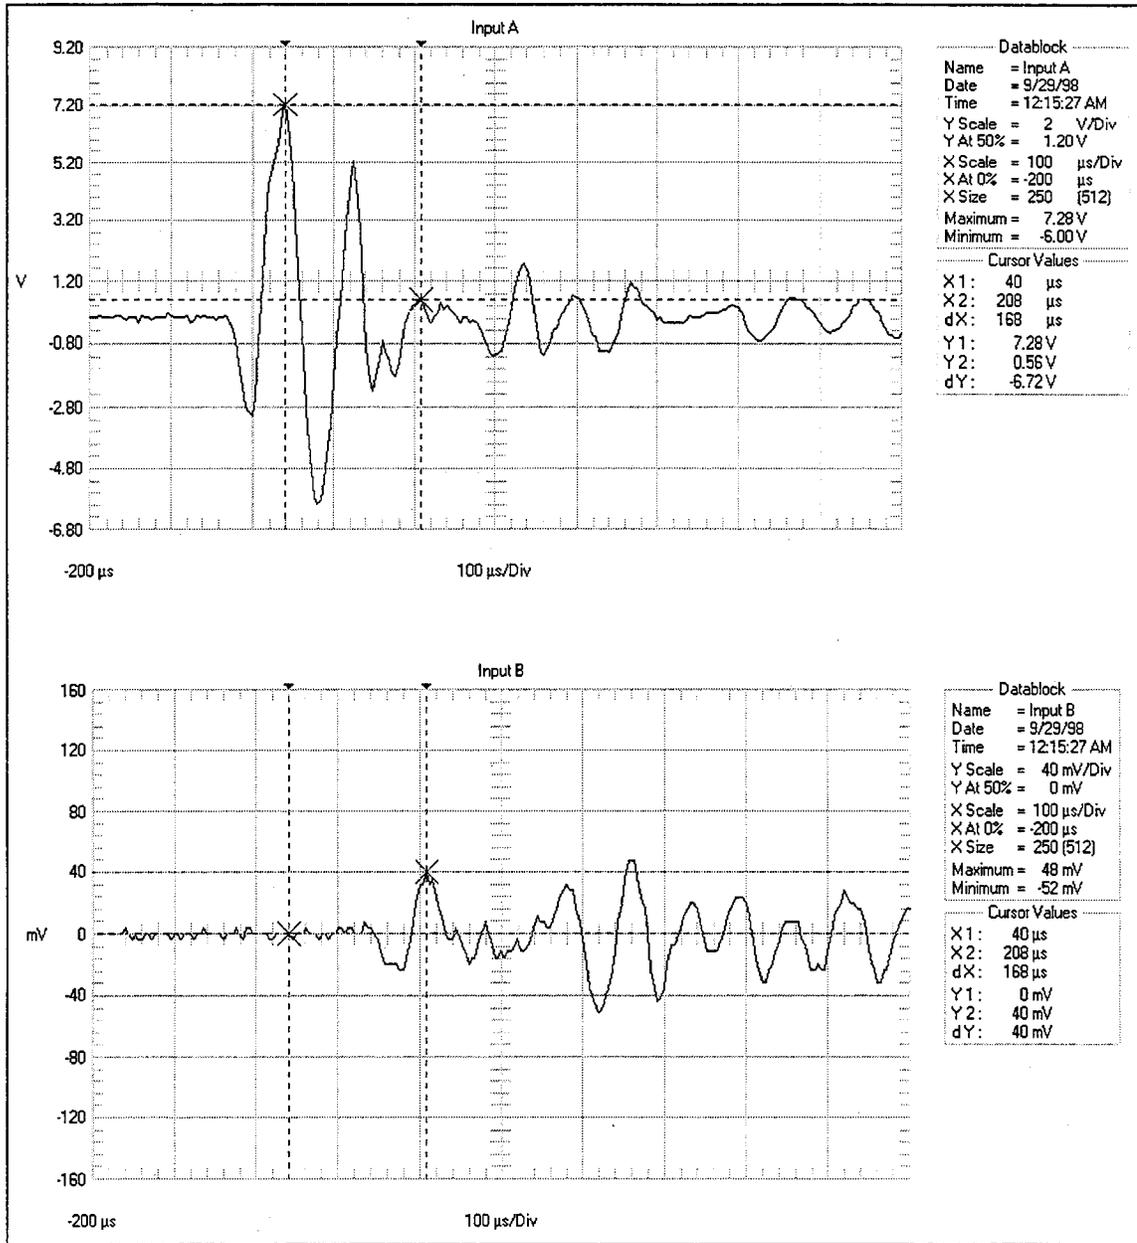
Figure C.3 Typical pulse response of PCB Microsensors
