**FIELD PERFORMANCE EVALUATION OF HYDRATED,
FLY ASH BASES IN THE ATLANTA DISTRICT: YEAR 3**

Report 2966-3
Project Number 7-2966
Research Project Title:
Durability of Surface Treatments as the Wearing Course
Placed on Crushed Fly Ash and Long-Term Performance
of Crushed Fly Ash for Flexible Base

Sponsored by the
Texas Department of Transportation

October 1999

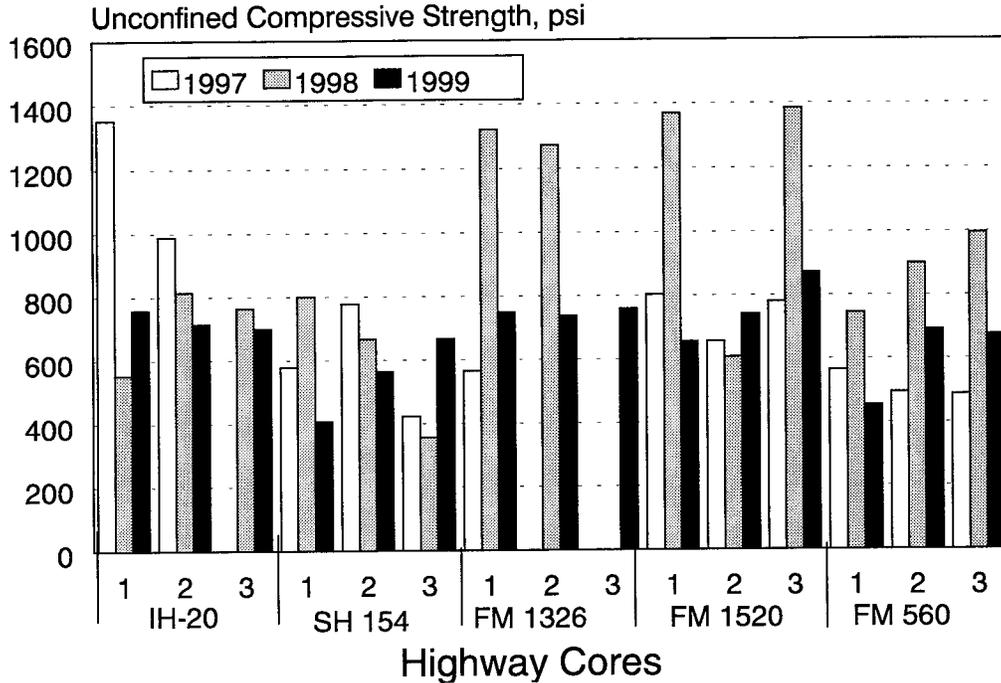
Figure 1. Unconfined Compressive Strength of Highway Cores

Texas Transportation Institute (TTI) performed unconfined compressive-strength testing on the field cores. Plaster was used to cap the ends of the specimens prior to testing. For unconfined compressive strength, it is desirable to have a sample length (L) to diameter (D) ratio of at least 2. However, some of the cores were very short. Adjustment factors were used to facilitate comparing cores of different thickness as described in Tex 418-A. Table 7 shows results of the field core strength tests. Figure 1 compares results with previous year's results.

Three cores were obtained from this pavement as shown in Figure 1. The pavement core strengths are similar to the core strengths measured last year. There is very little change in the FWD data exhibited in Figure 3 since 1997. Note in Figure 3 that the last data point may coincide with the beginning of a different type of pavement section..

From what appears to be shrinkage cracking, one would expect this pavement to be the stiffest of the six. This is true in terms of FWD data (Figure 4). Base moduli values along the pavement exceed 1,000,000 psi in some locations. Base moduli values in 1999 appear to be similar to values in 1998 and 1997. Compressive strengths of the cores (on the average) are also close to the values obtained the previous year (Figure 1).

Cores obtained from FM 1326 in 1999 show a significant decrease in strength over that exhibited in 1998. However, the base moduli values as calculated from FWD data (shown in Figure 5) do not indicate a significant change is occurring in the pavement.

Three cores were obtained from FM 1520 and these cores had an average strength which was lower than last year's core data. However, the strengths are about the same as that measured in 1997. FWD data (Figure 6) on this pavement indicate that there may be a general decrease in moduli values; however, most of the values still fall between 100,000 and 300,000 psi as in previous years.

All three cores obtained from FM 560 had lower compressive strengths than the cores obtained in 1998 but about two of the 1999 cores had higher strengths than the 1997 cores as shown in Figure 1. The base on this pavement has two different thicknesses along its length: 9 inches and 16 inches. Because of the difference in thicknesses, two separate FWD analyses were performed as shown in Table 13. Results from both analyses, however, were combined for Figure 7. Moduli values for this pavement are generally higher in 1999 than for the previous years.

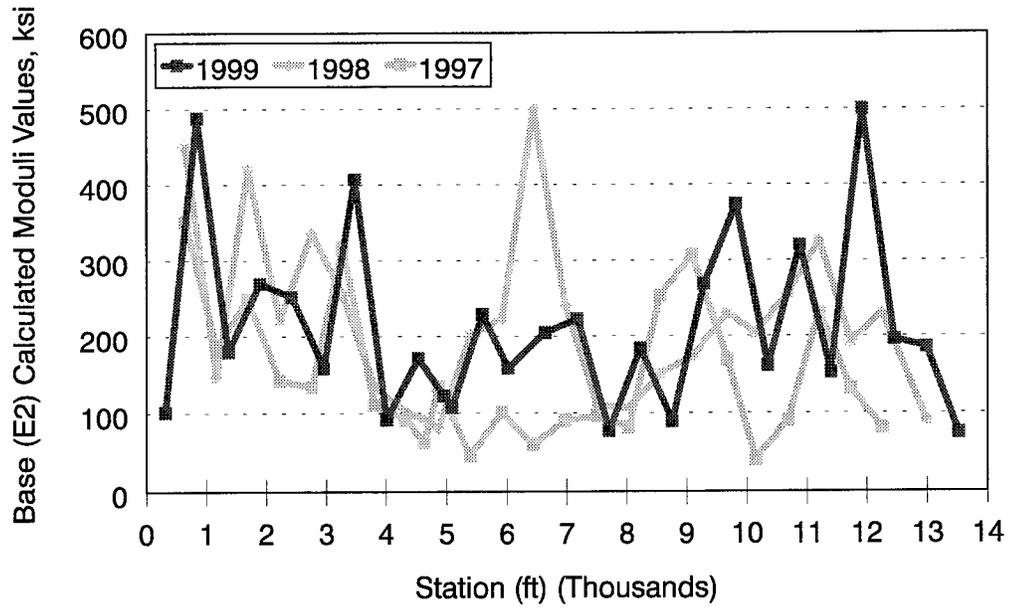
Figure 2. Base Moduli Values for Loop 390

No cores were obtained from this pavement. Unsuccessful attempts were made in 1997, 1998, and again in 1999. As shown in Figure 2, there is some variation in the moduli values since 1997; however, it doesn't appear that the base is overall exhibiting a deteriorating strength. Some locations indicate an increase in stiffness while others show a decrease.
