TRUCK ROUTE ACCESS EVALUATION

Campbell-Hausfeld
Leitchfield-Grayson County
Site # 2637

Report No. KTC-99-47

“Freight Movement and Intermodal Access in Kentucky”
Project No. SPR 98-189

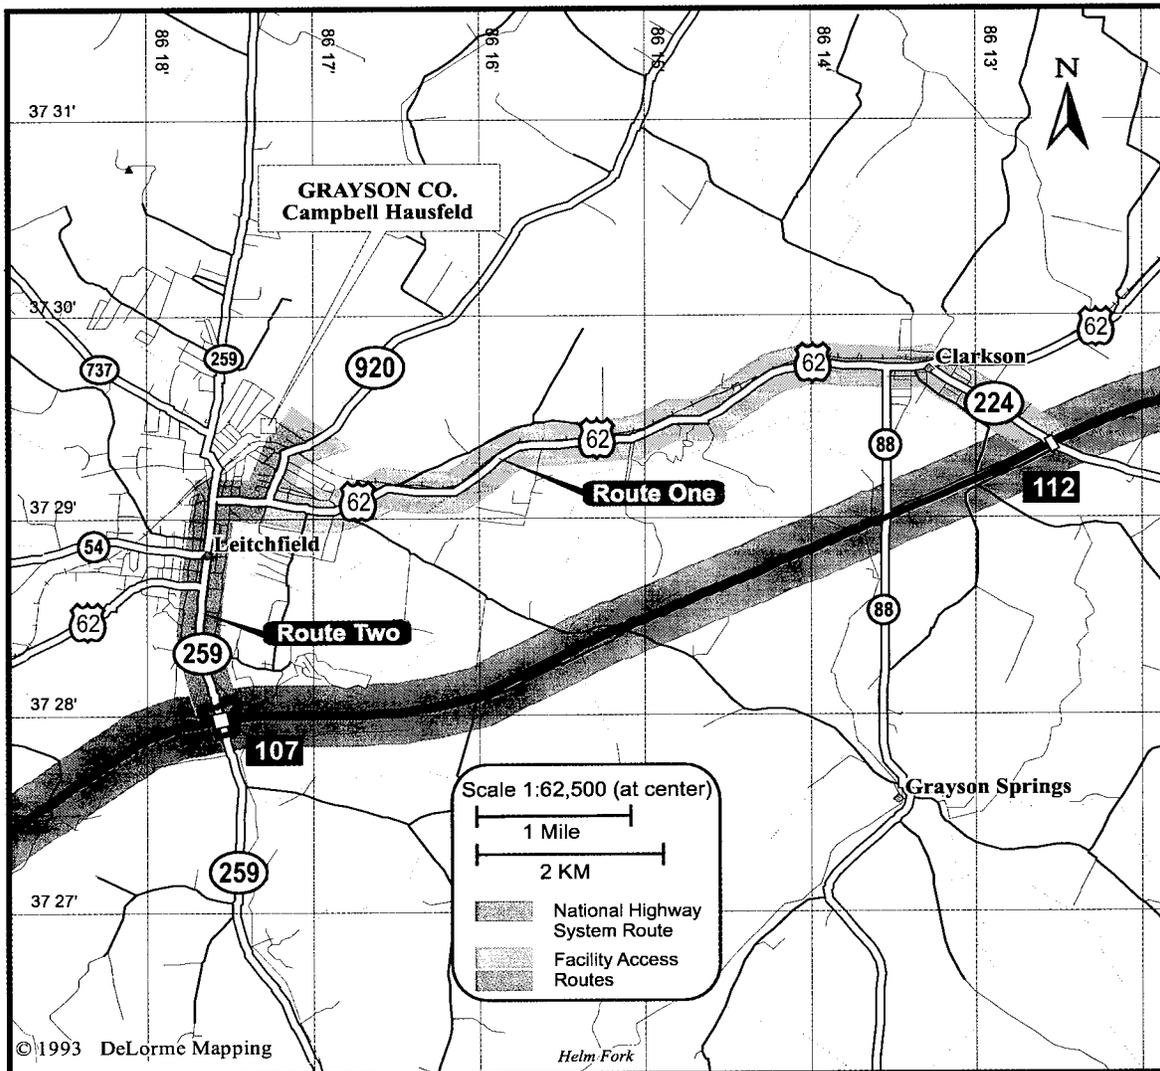
Figure 1: Location of Truck Generating Site

As shown in Figure 1, trucks use one of two routes to reach the NHS. Both routes follow Embry Drive to KY 920 and then follow KY 920 to US 62. The eastern route (shown in green) is used primarily by trucks traveling to Cincinnati. The route follows US 62 east to KY 224 which connects with the Western Kentucky Parkway and is approximately 5.1 miles in length. The western route (shown in orange) is used by trucks traveling west to Owensboro, and is approximately 2.1 miles in length. This route follows US 62 west through downtown Leitchfield and KY 259 to Exit 107 at the Western Kentucky Parkway. KY 920 passes through residential and urban areas near US 62 in Leitchfield. The US 62 east route passes through urban and rural areas. All roads except Embry Drive are state maintained. A detail map of Leitchfield is shown in Figure 2. There are two traffic signals along the eastern route and six along the western route. A route designation summary is shown in Table 1.

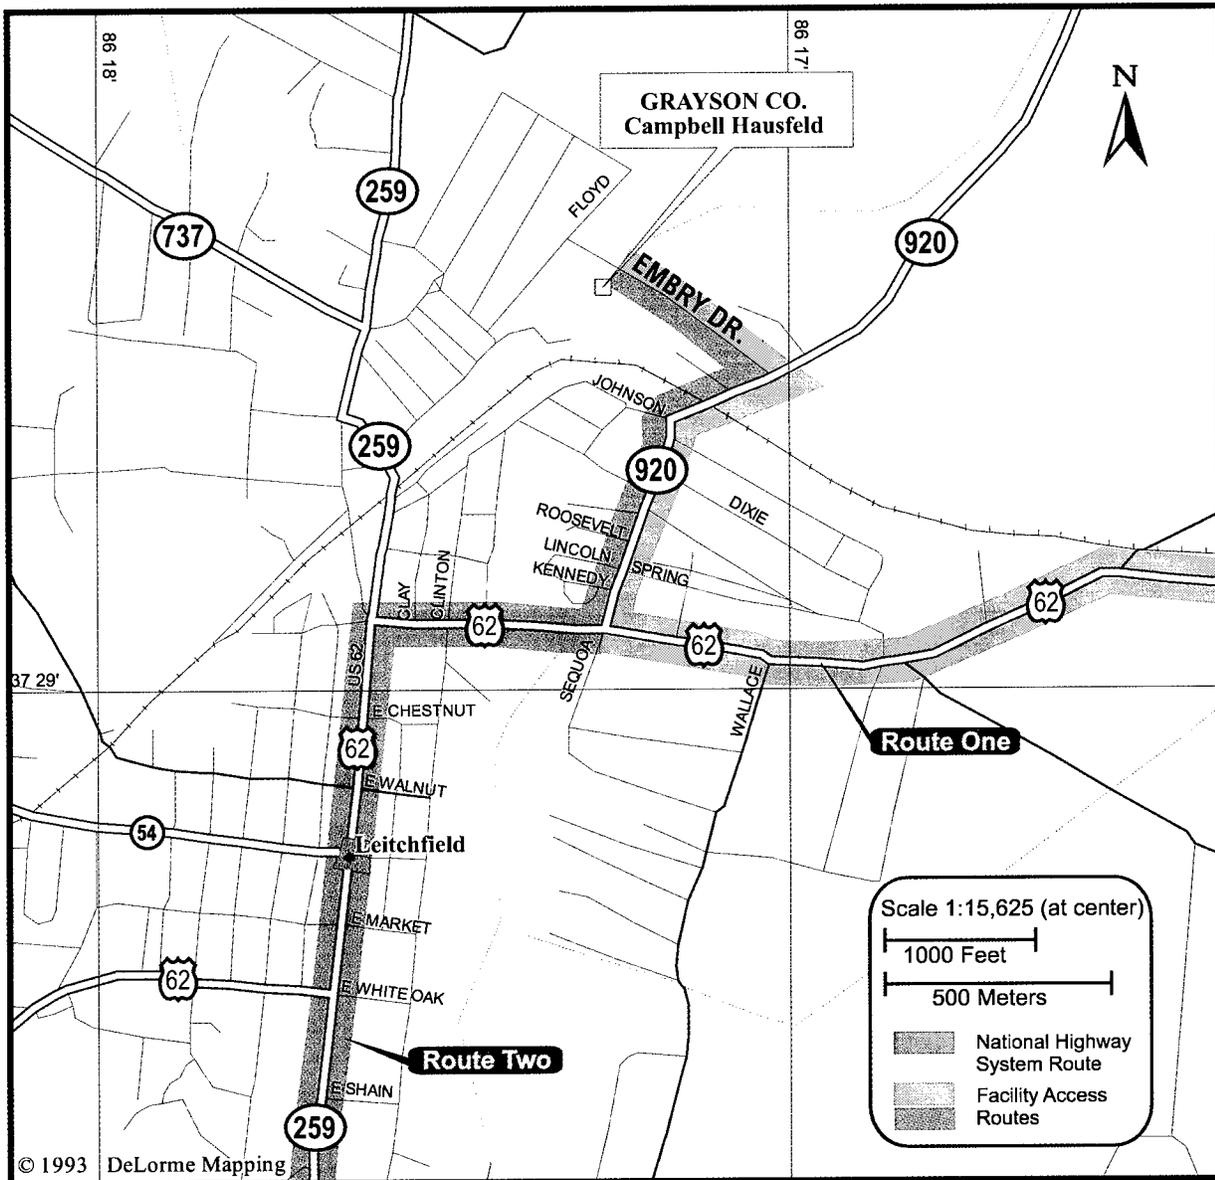
Figure 2: Detail Map of Routes in Leitchfield

There is one at-grade railroad crossing on the routes to this site. The crossing is on KY 920 near the intersection with Embry Drive as shown in Figure 2. The crossing has warning signs, flashing lights, gates and is relatively smooth giving it a “preferred” rating.

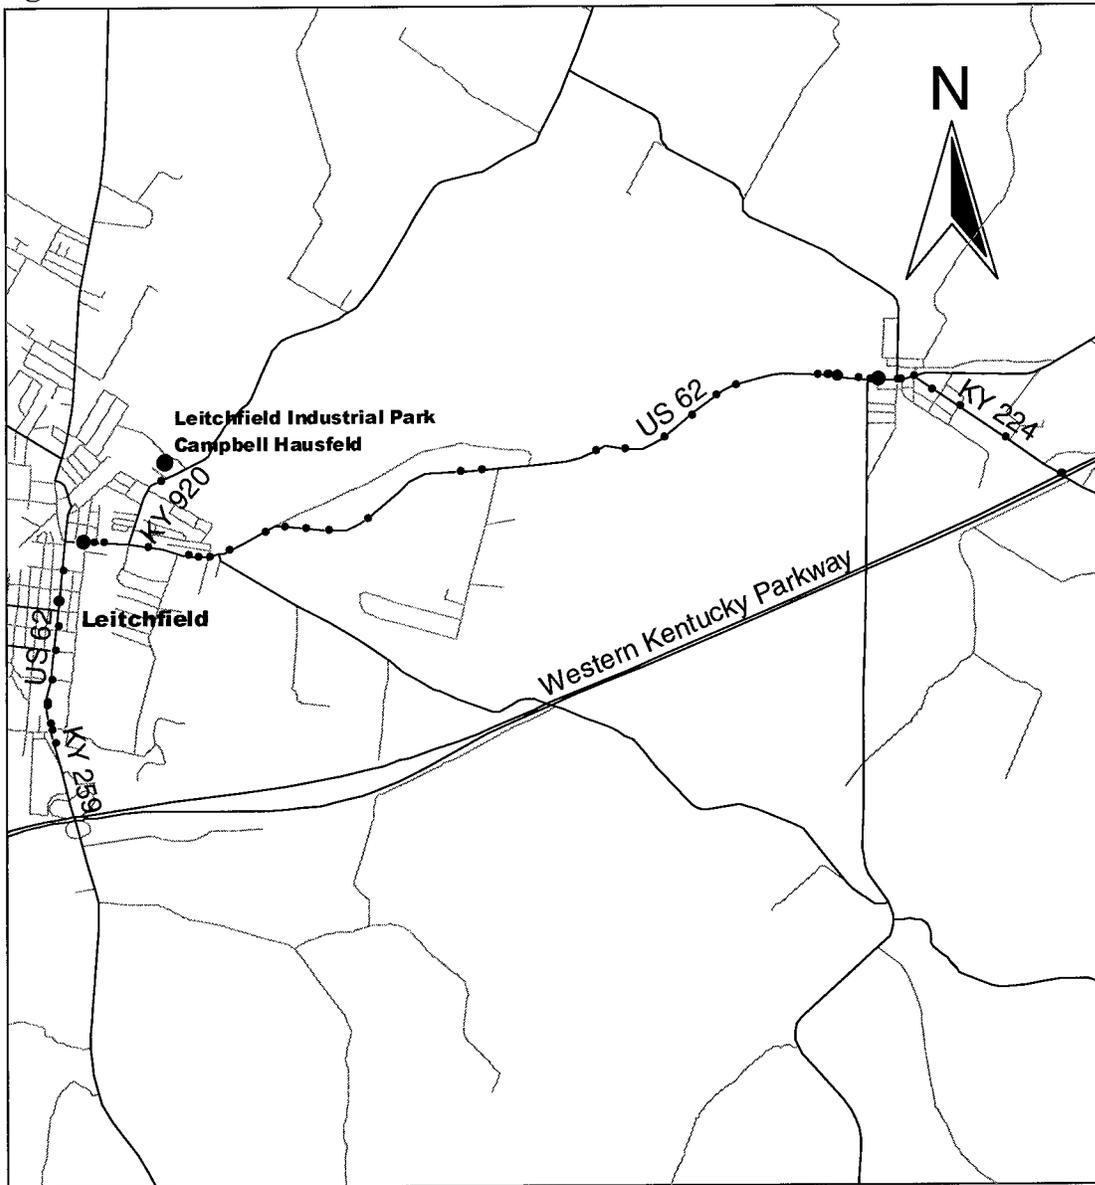
Figure 3: Accident Locations (1995-1997)

Figure 3 shows the locations of accidents during the years 1995, 1996 and 1997. The figure shows that the accidents were scattered along both routes with a significant number occurring in Leitchfield and Clarkson.

A summary of the accidents along the truck routes is shown in Tables 3 and 4 for the same three year period. The 8.3% of accidents involving trucks on the eastern route is higher than the percent trucks along US 62 (5.6%), but lower than the percent trucks using KY 920 (11.2%) and KY 224 (8.4%). The 3.2% of accidents involving trucks on the western route is lower than the percent trucks along that route (US 62 - 6.5%, KY 259 - 6.5%, KY 920 - 11.2%). The percent trucks was obtained from 1998 KYTC Vehicle Classification Counts and HIS data.

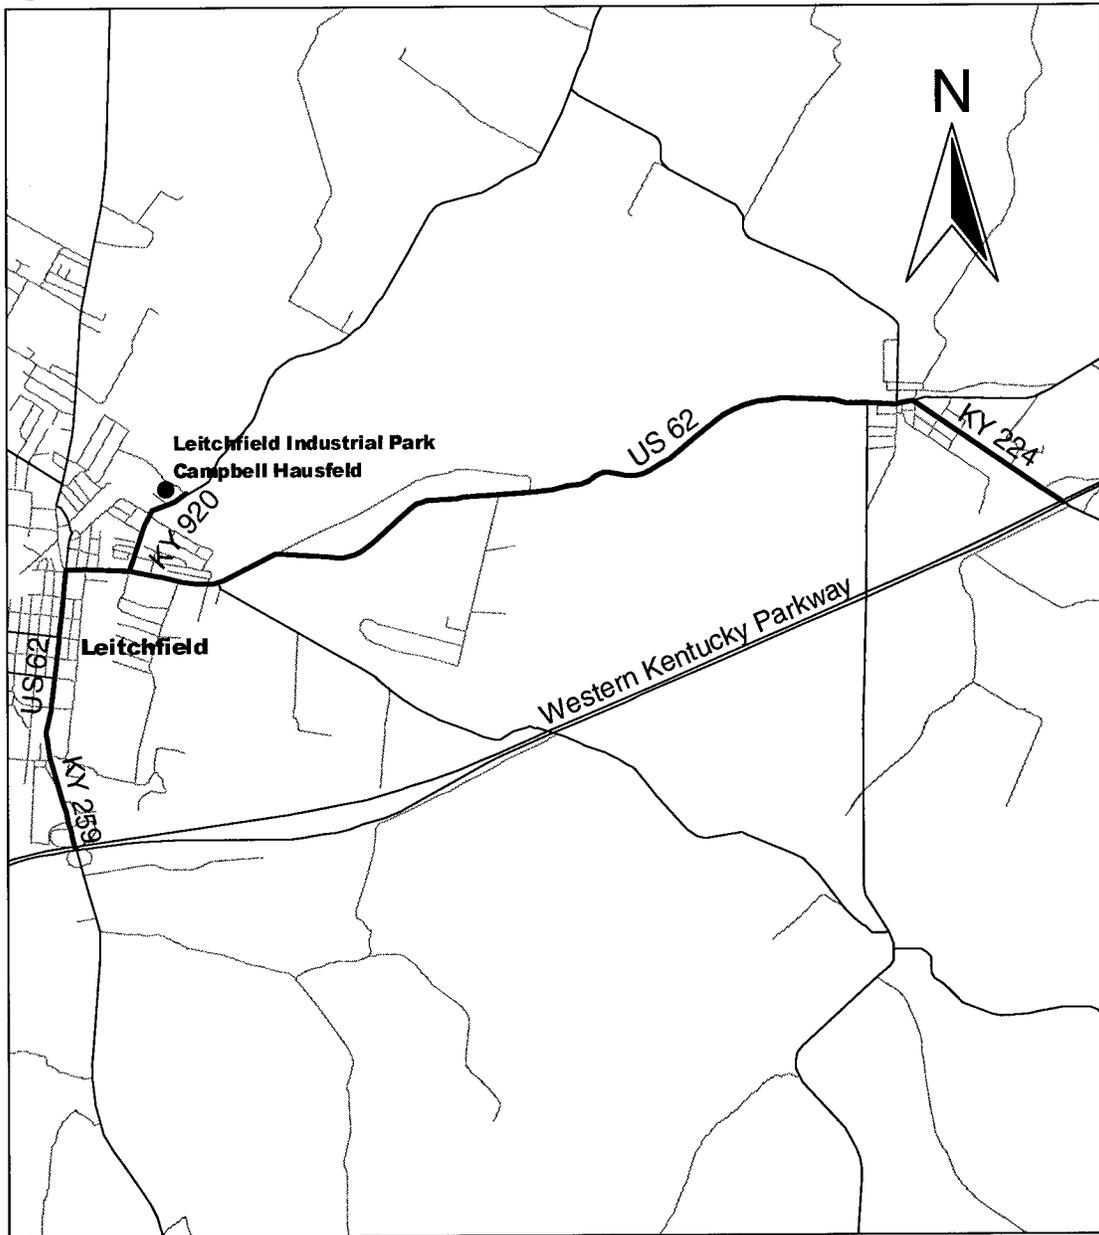
Figure 4: Lane Widths

Figures 4 and 5 illustrate the sections of the routes having different widths of lanes and shoulders. Along the eastern route, US 62 has “adequate” 11-foot lanes near KY 920 in Leitchfield and “less than adequate” 10-foot lanes in the rural areas. The “less than adequate” lane widths along KY 224 range from 9-10 feet. Along the western route, US 62 has “less than adequate” 10-foot lanes from KY 920 to the junction of KY 259. KY 259 has four “preferred” 12-foot lanes. There are no shoulders on Embry Drive or KY 920, while US 62 in Leitchfield is curbed. All other roadways have “less than adequate” two-foot shoulders. Ditches and side slopes cause clear zone problems along most of the routes. The pavement was generally good on most of US 62, KY 224 and KY 259, while it was in fair condition on KY 920 and Embry Drive.

The recommended improvement is the reconstruction of the intersection of KY 920 and Embry Drive to eliminate turning radius problem. Other roadways with lane and shoulder width problems could be addressed by rebuilding those sections of highways.

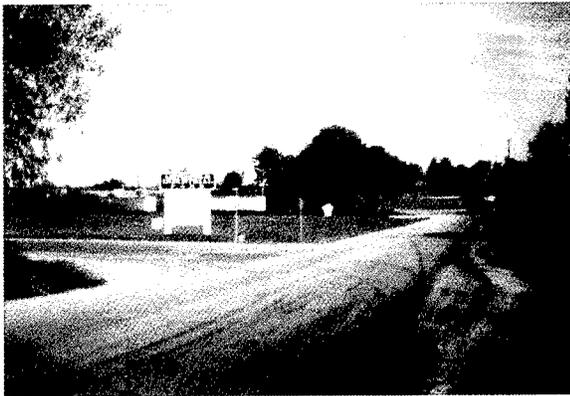
The turning radii at the intersection of KY 920 and Embry Drive was observed to be “less than adequate” as shown in Figures 6, 7, and 8. Several vehicles were observed encroaching into the opposing lane while making a right turn from Embry Drive onto KY 920. When making left turns into the industrial park from KY 920, vehicles also drove off the pavement either on KY 920 or Embry Drive. The approximate layout of this intersection is shown in Figure 9. The near 45° angle at which Embry Drive joins KY 920, along with the pavement width, increases the required turning radius. The original pavement intersected KY 920 without any widening. The turn from KY 920 onto Embry Drive, which is approximately 45°, was rated “less than adequate” because trucks drive off the pavement to make the turns, as shown in Figures 6, 7 and 8.

Figure 6: KY 920 at Embry Drive

Figure 7: KY 920 at Embry Drive

Figure 8: Embry Drive at KY 920

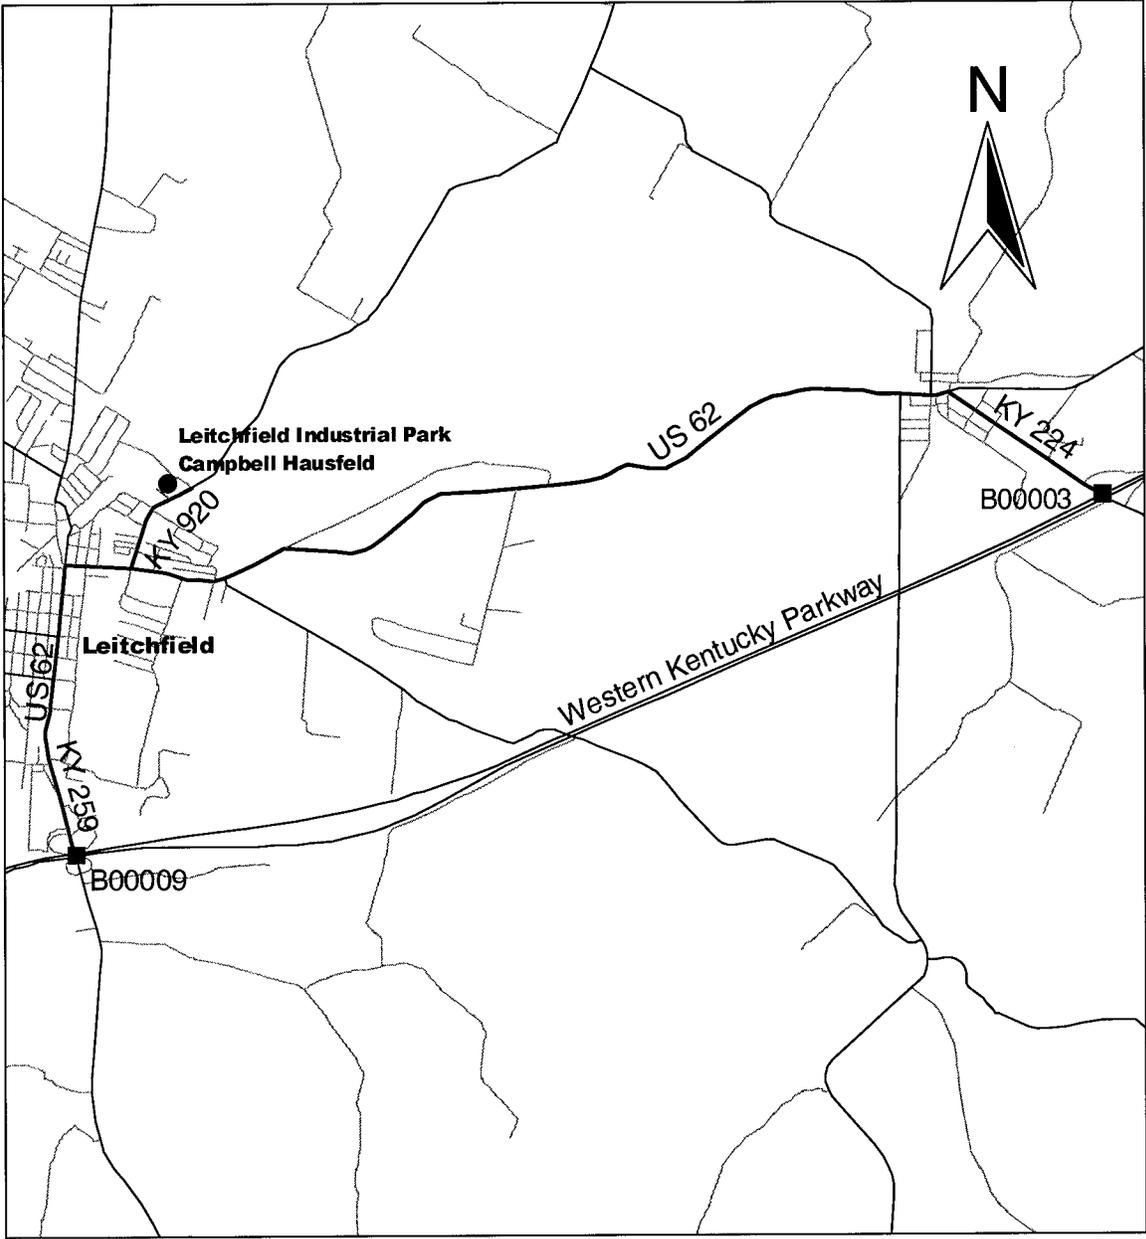
Figure 10: Bridge Locations

Figure 10 shows the location of the two bridges on these routes. The bridges are located at the points where the access routes intersect with Western Kentucky Parkway. The Kentucky Transportation Cabinet’s Division of Operations maintains a database of bridge sufficiency ratings that are based on the serviceability (as well as other factors) of the structure. The bridge along the eastern route on KY 224 over the Western Kentucky Parkway has a sufficiency rating of 75.2 giving it an “adequate” rating. The bridge on KY 259 over the Western Kentucky Parkway has a sufficiency rating of 66.8 which is also “adequate” for this study. A sufficiency rating of 80 or higher (out of a possible 100) is considered “preferred,” and a rating of at least 50 is “adequate.”
