Minne-Alf Project Overview and Retro-Fit Dowel Study Results

1. Report No. MN/RC - 2000-02	2.	3. Recipient's Accession No.	
4. Title and Subtitle MINNE-ALF PROJECT OVERVIEW AND RETRO-FIT DOWEL STUDY RESULTS		5. Report Date December 1999

**Development of an
Accelerated Load Test Platform
for Pavements**

Rebecca A. Embacher, Graduate Research Fellow
Mark B. Snyder, Associate Professor

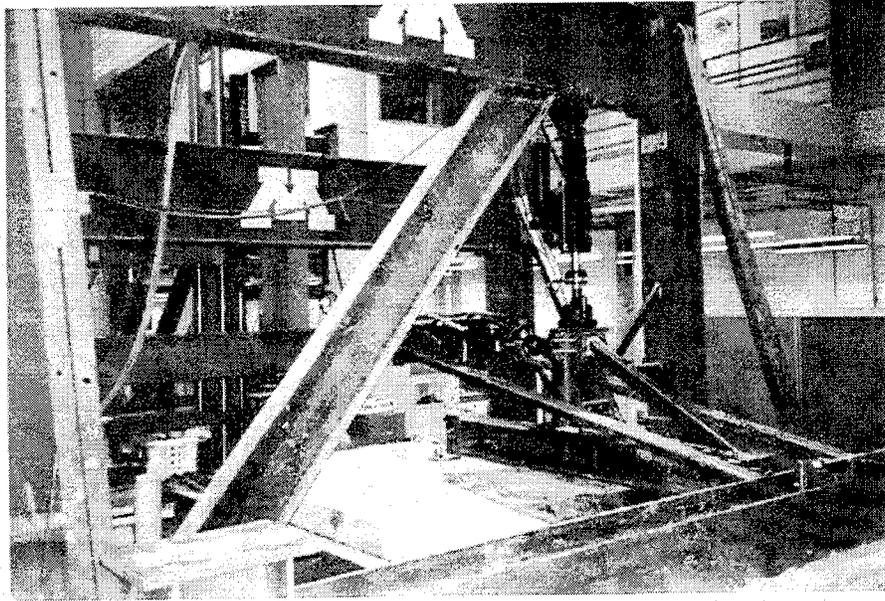
Figure 2.1. Photo of modified ALF rocker beam/actuator design.

The rocker beam/actuator arrangement was modified to eliminate the “cross-coupling” difficulties that were apparently present in the original system. A short section of W10 x 60 steel beam was attached to the center of the original rocker beam to form a “tee.” One actuator was attached vertically to this short section and connected to an overhead reaction beam. This actuator was operated in load control and applied the programmed load profile to the rocker beam.

The other actuator was oriented horizontally in the same plane as the rocker beam; it also was attached to the top of the short beam section and to a reaction beam that was added at one end of the frame. This actuator was operated in stroke control to push the rocker beam back and forth. Figure 2.1 is a photograph of the modified rocker beam/actuator design.

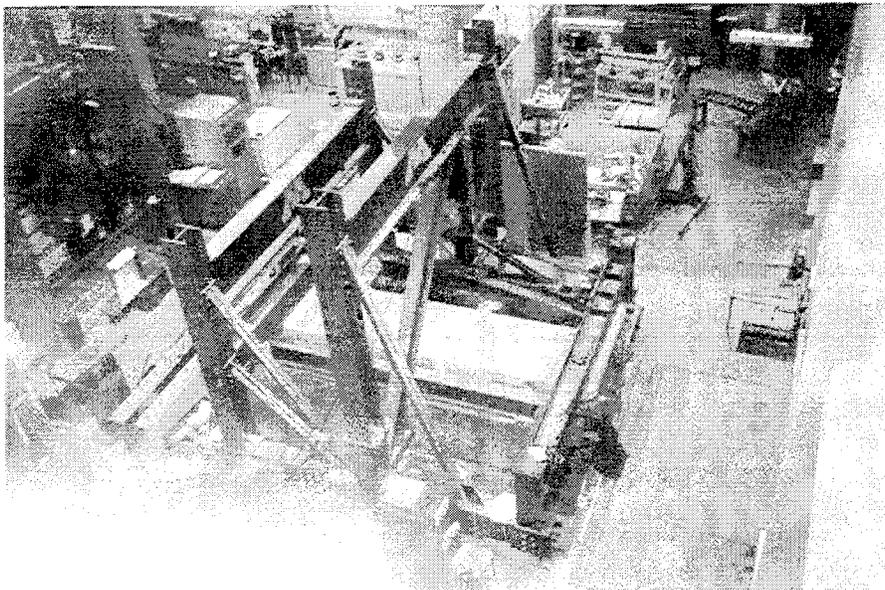
Figure 2.2. Photo of modified ALF test stand.

A photograph of the modified test frame is presented in figure 2.2 (2). Complete construction drawings of the modified test frame are presented in Appendix B.

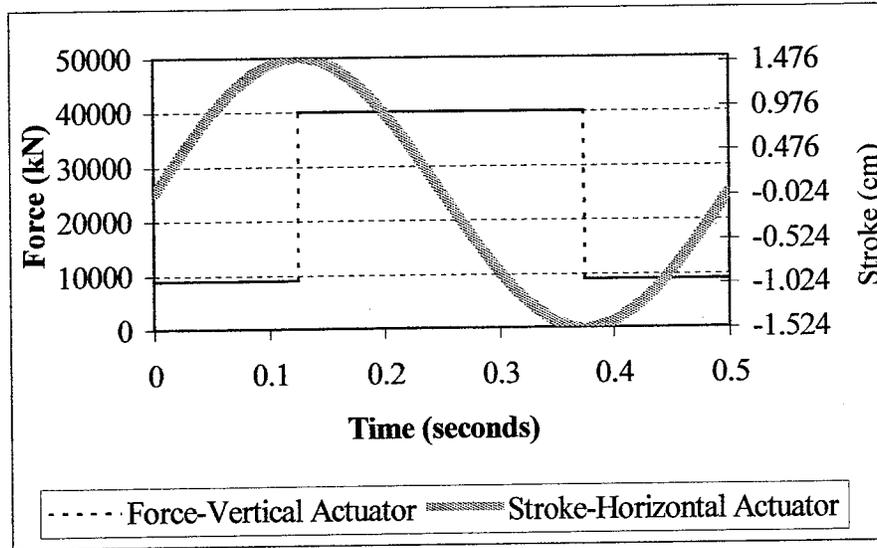
Figure 2.3. Actuator load and stroke profiles for current test program.

The tests described in this report were performed with the rocker beam being loaded to 40 kN (9,000 lb) in one direction and with the load reduced to 8.9 kN (2,000 lb) in the return direction. This direction-dependent loading is intended to simulate the directional nature of traffic over a given lane of highway pavement. While this directional loading is probably not necessary for structural testing purposes, it will be necessary for the simulation of moisture movement under pavement slabs in later pumping studies. For structural evaluation studies, the test program can be modified to allow loading of the rocker beam in both directions, if desired. The minimum load of 8.9 kN (2,000 lb) is maintained on the vertical actuator at all times to ensure constant contact between the rocker beam and test slab, thereby eliminating the possibility of unintentional impact loads that might otherwise result from loss of beam-slab contact during reversals of rocker direction.

Figure 2.3 illustrates the load and stroke profiles that were used to control the magnitude and speed of the simulated moving wheel load. Each rocker cycle required 0.5 seconds, resulting in a loading frequency of 2.0 Hz and the simulation of up to 172,800 40-kN (9-kip) wheel load passages per day.

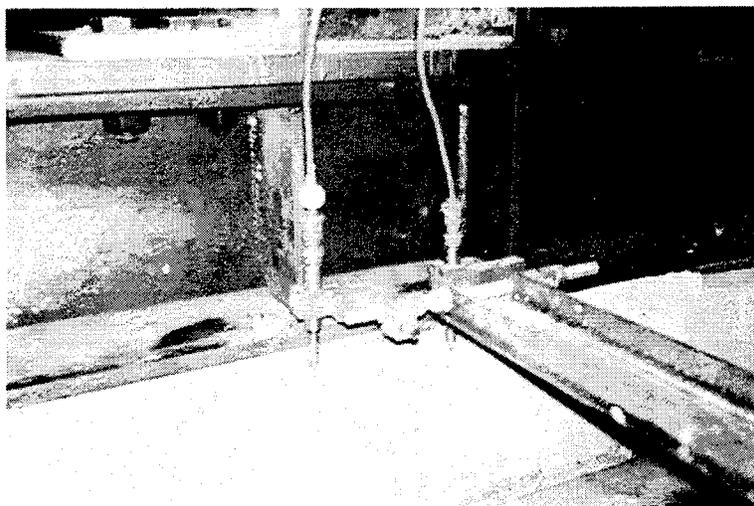
Figure 2.4. Original LVDT mounting bracket.

Estimates of joint/crack load transfer are currently measured using two LVDTs placed in the vicinity of the joint/crack and 2.5 cm (1 in) from the edge of the slab. The LVDTs were originally mounted on a short cantilever arm that was attached to the test frame near the center of the rocker beam. However, significant “noise” observed in the data collected from slab 1 was attributed to vibration of the mounting frame. Prior to the testing of slab 2, a different LVDT stand was designed (as a part of Task 1A) to minimize vibration effects and to more accurately measure differential deflections between the approach and leave side of the slabs. This stand was bolted to the approach side of the slab with an extended bracket to allow an LVDT to rest on the leave side of the joint, thereby allowing direct measurement of differential deflections with a single LVDT. The original LVDT stand was used for the second LVDT, but was stiffened to reduce vibration. This stand was attached to the central reaction column; the attached LVDT measures the overall deflection of the leave side of the joint/crack. These two LVDT stands are illustrated in figures 2.4 and 2.5.

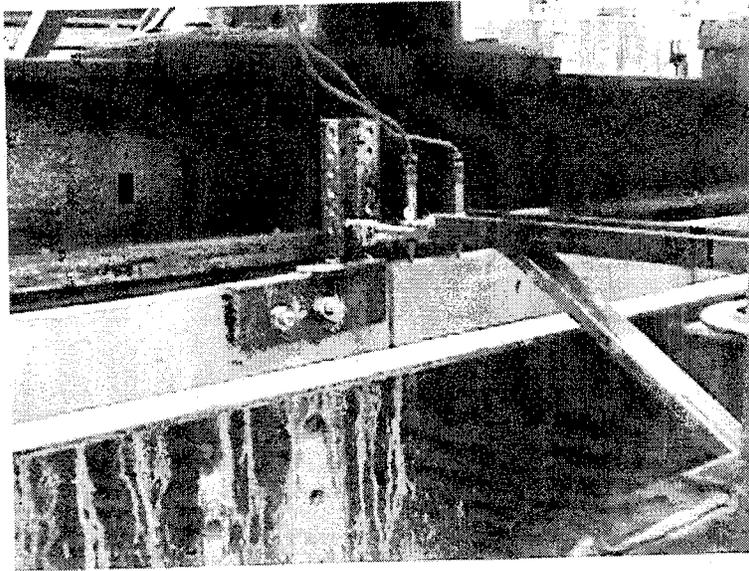
Figure 2.5. Modified LVDT mounting brackets.

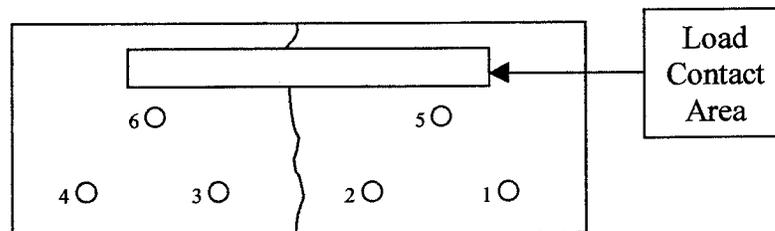
Figure 2.6. Slab 1 grout injection hole locations.

A total of six holes were drilled in the slab surface to provide ports for grout injection. One hole was drilled on each side of the crack at approximately the center of the slab; the other four were drilled at various locations along the edge of the slab at a distance of approximately 30 cm (1 ft) from the slab edge. Figure 2.6 illustrates the location of the grout injection holes.

Holes one, two and three accepted grout readily. Hole one was injected twice until grout ran from the end of the slab. Grout immediately ran out the side of the slab when hole 2 was injected. Holes four, five and six did not accept significant quantities of grout. A partially successful attempt was also made to inject grout from the side of the slab at the slab-foundation interface.

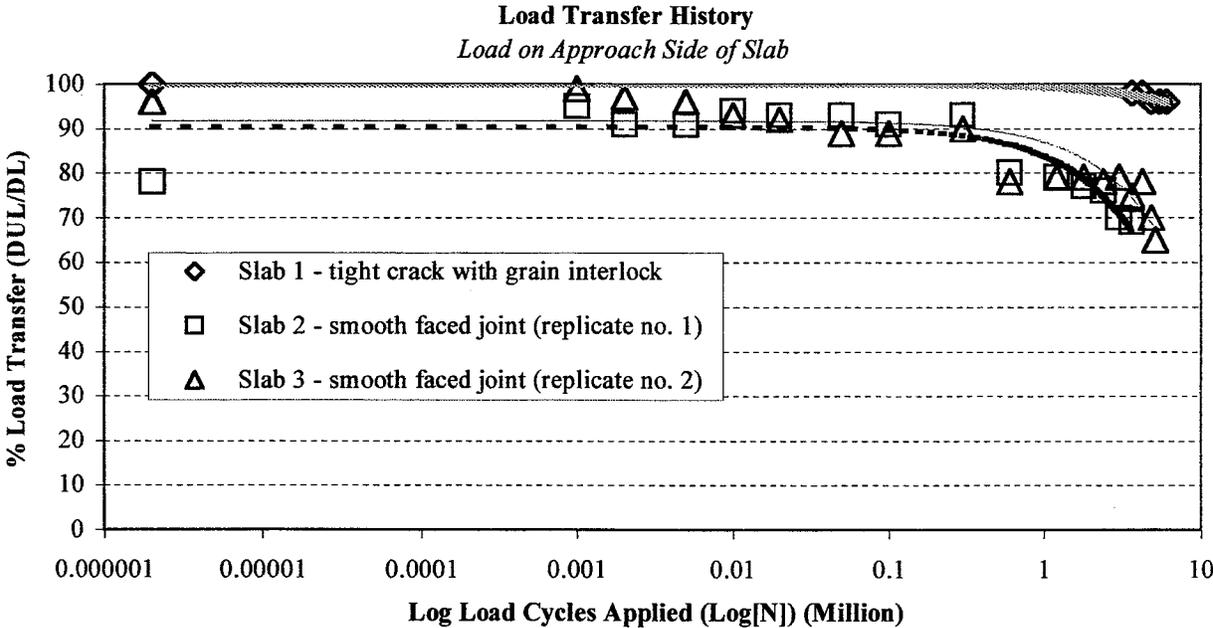
Figure 4.1. Effect of Joint Face Texture on Load Transfer Efficiency.

The effect of joint face texture on load transfer and potential field performance was evaluated by comparing the LTE and differential deflection history of test slab 1 (which featured a tight crack with grain interlock) with those of slabs 2 and 3 (which contained smooth-faced joints approximately 6.4 mm (0.25 in) in width. Tables 4.1 and 4.2 summarize the LTE and differential deflection data obtained for the three test slabs. Figures 4.1 and 4.2 are graphical presentations of the same data.

Slabs 1, 2 and 3 were subjected to simulated single-wheel load applications totaling 6.7, 3.6 and 5.1 million cycles, respectively. The following LTE and differential values were calculated at test termination for each specimen when loaded on the approach side of the joint:

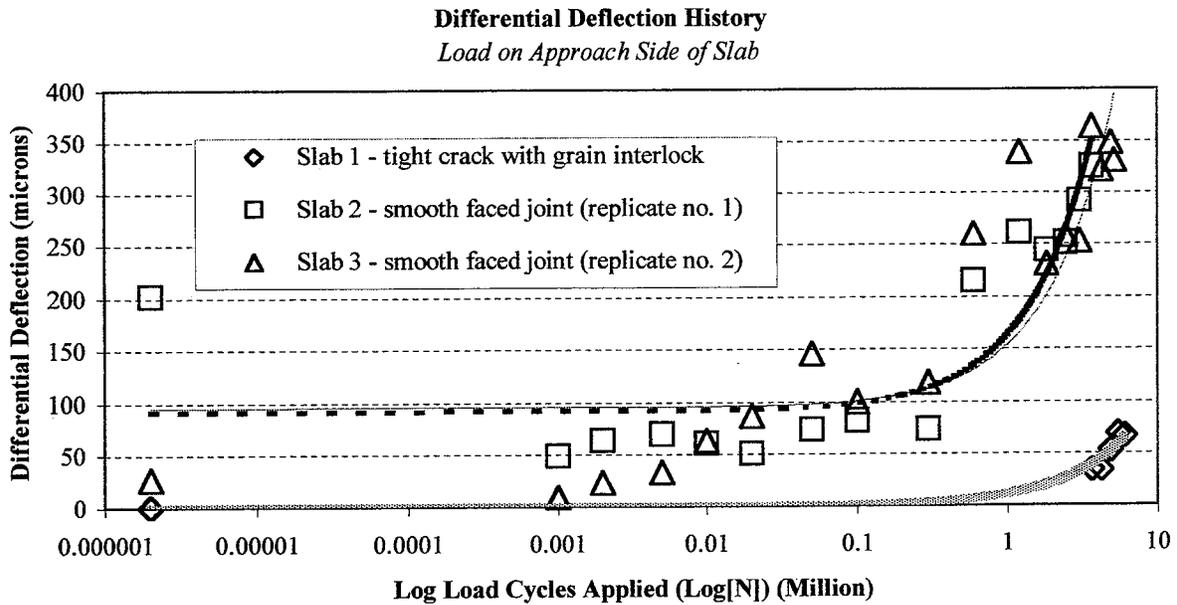
Figure 4.2. Effect of Joint Face Texture on Differential Deflection.

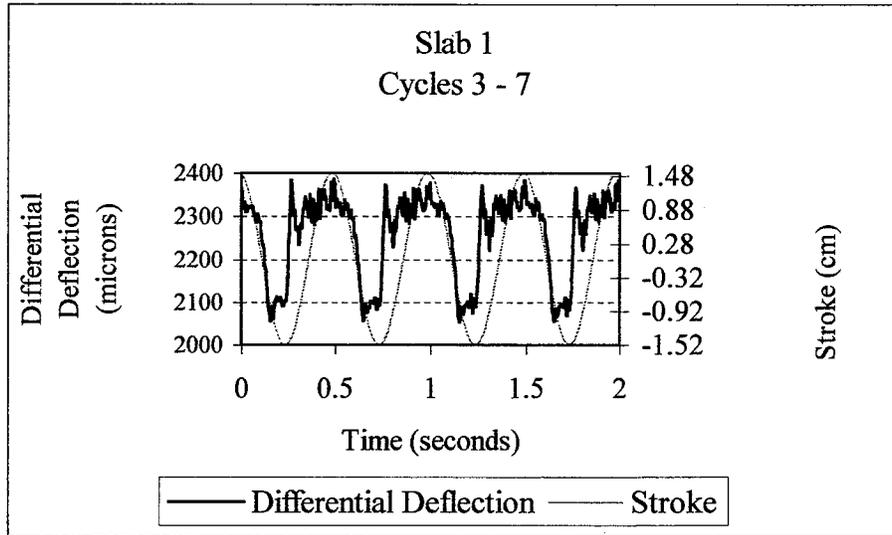
Figure 4.3. Illustration of slab 1 deflection data when LVDTs mounted on original bracket.

Performance measures could not be computed for slab 1 using any of the data collected during the first 3 million load cycles because the LVDT data collected appeared to be extremely offset in time with respect to where the load placement should have been when considering horizontal actuator stroke measurements. Figures 4.3 and 4.4 illustrate the problems with the LVDT readings during the first 3 million cycles. Attempts were made to adjust these LVDT readings using known zero values (e.g., the differential deflection should approach zero when the stroke is at zero [i.e., when the rocker beam is crossing the transverse joint]); these attempts did not yield reasonable results and were discarded. The LVDT problem was eventually attributed to inadequate stiffness in the LVDT mounting brackets. This problem was corrected, as described previously, and subsequent LVDT data were reasonable and useful.

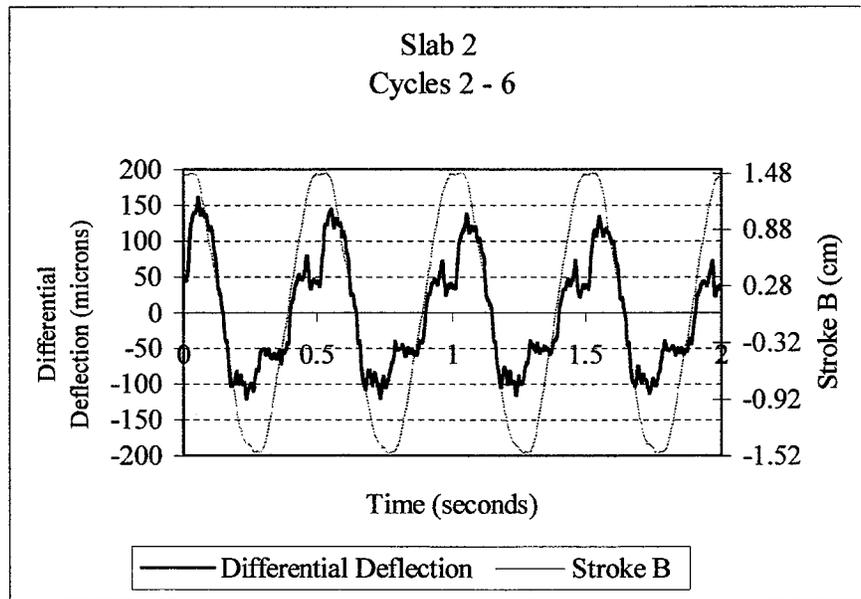
Figure 4.4. Illustration of slab 2 deflection data when LVDTs mounted on modified brackets.

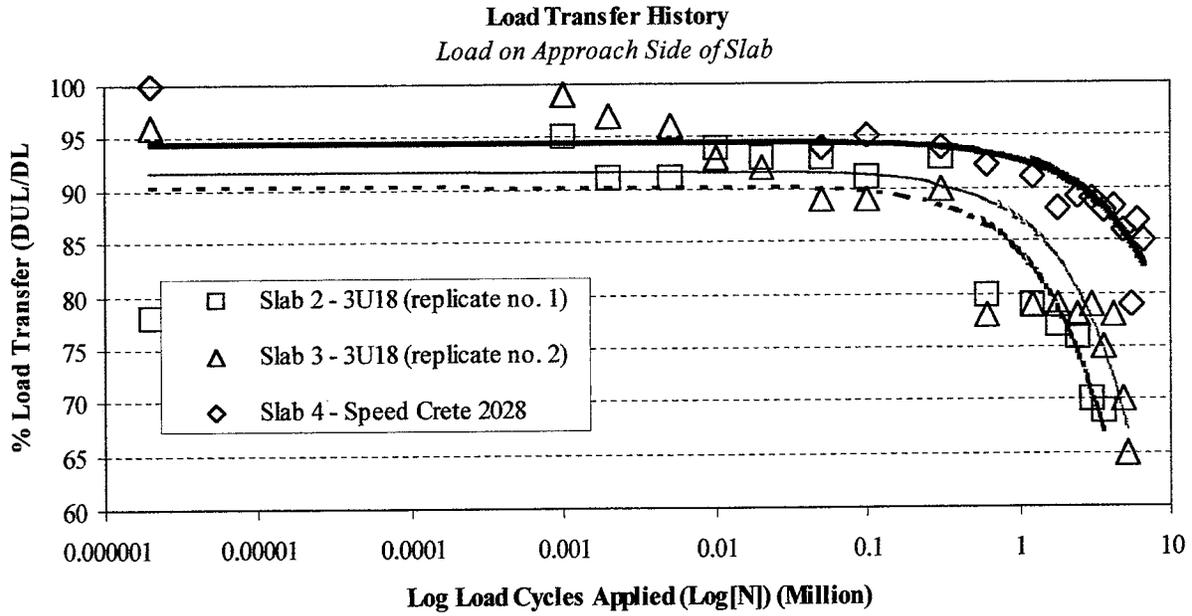
Figure 4.5. Effect of Concrete Backfill Material on Load Transfer Efficiency.

The effect of PCC backfill material on load transfer and potential field performance was evaluated by comparing the LTE and differential deflection history of test slab 4 (containing Speed Crete 2028) with those of slabs 2 and 3 (which contained 3U18 concrete backfill). Figures 4.5 and 4.6 graphically present the LTE and differential deflection data obtained for these three test slabs.

Slabs 2, 3 and 4 were subjected to simulated single-wheel load applications totaling 3.6, 5.1 and 6.6 million cycles, respectively. The following LTE and differential values were calculated at test termination for each specimen when loaded on the approach side of the joint:

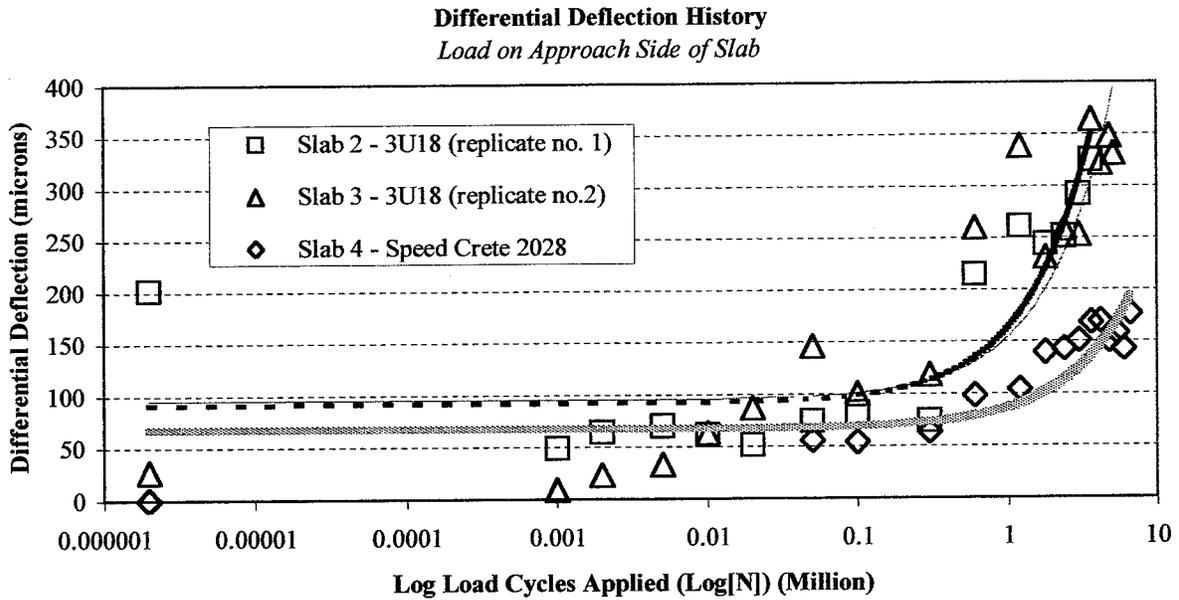
Figure 4.6. Effect of Concrete Backfill Material on Differential Deflection.

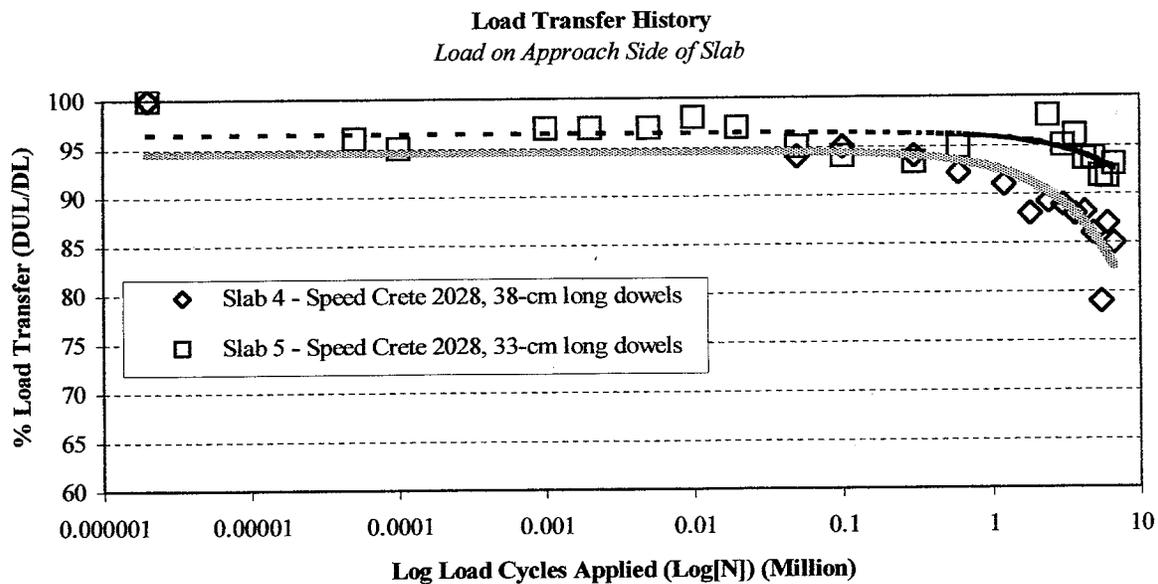
Figure 4.7. Effect of Dowel Bar Length on Load Transfer Efficiency.

As illustrated in figures 4.7 and 4.8, the LTE and differential deflection histories of slab 5 (containing 33-cm [13-in] long dowels) were better than those obtained for test slab 4 (containing 38-cm [15-in] long dowels). This result was unexpected and was investigated further.

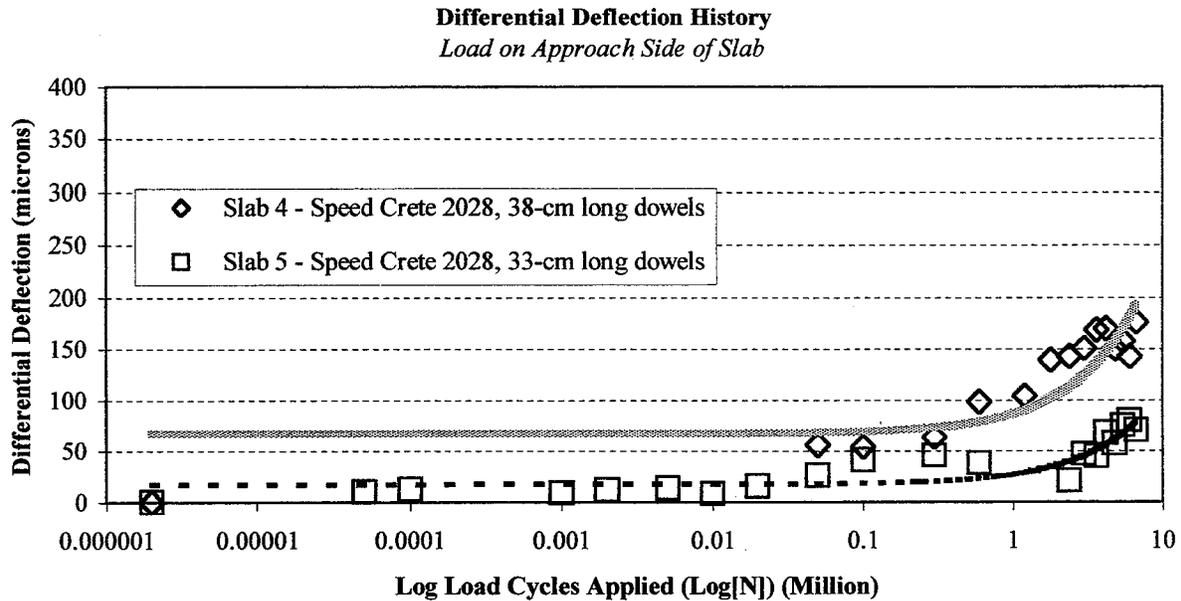
Figure 4.8. Effect of Dowel Bar Length on Differential Deflection.

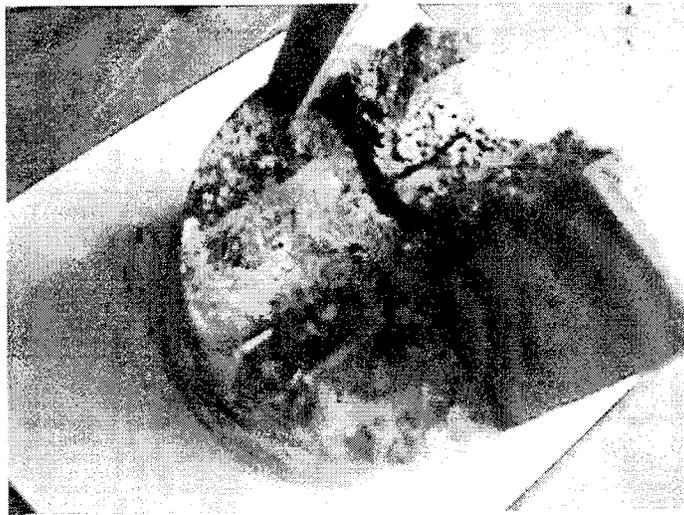
Figure 4.10. Photo of Backfill Material Beneath Critical Dowel Bar of Slab 5.

Figure 4.10 is a photo of the backfill material beneath the critical dowel bar from slab 5. This material shows little evidence of honeycombing, which may help to explain why this slab performed better than slab 4, in spite of the reduced dowel length. It is likely that there would have been little difference in the performance of these two slabs if they had both had comparable dowel support. Replication of these test slabs is recommended to confirm this hypothesis.

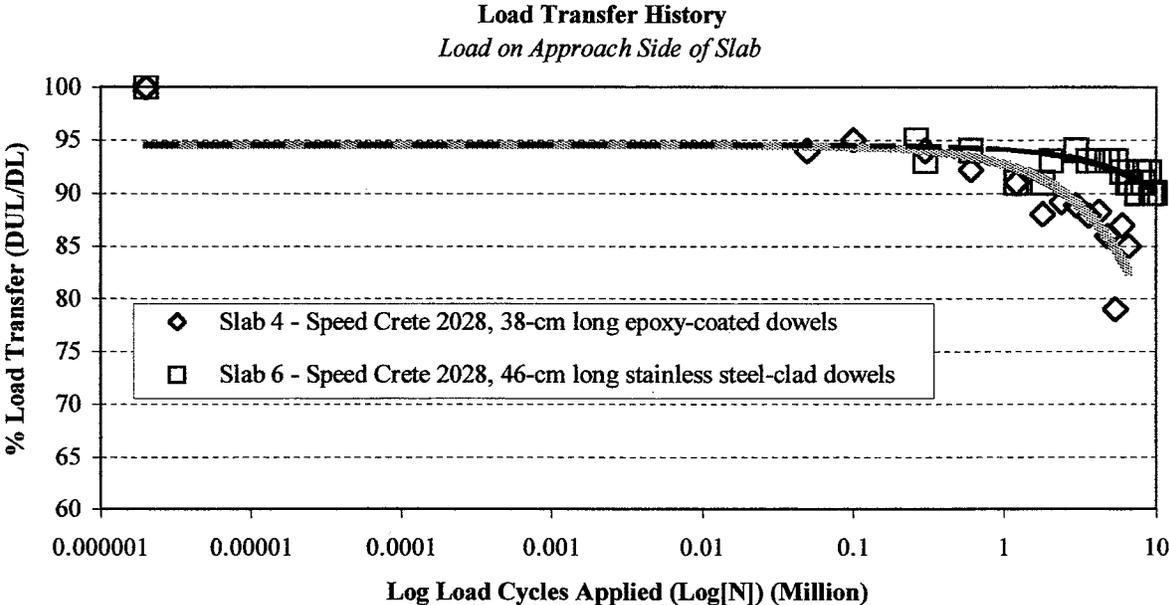
Figure 4.11. Effect of Dowel Bar Type on Load Transfer Efficiency.

The effect of using stainless steel-clad dowels on load transfer and potential field performance was evaluated by comparing the LTE and differential deflection histories of test slab 4 (containing Speed Crete 2028 and 38-cm [15-in] long epoxy-coated dowels) with those of slab 6

(containing Speed Crete 2028 and 46-cm [18-in] long stainless steel-clad dowels). Figures 4.11 and 4.12 present the LTE and differential deflection data obtained for these two test slabs.

Slabs 4 and 6 were each subjected to 6.6 and 9.8 million load cycles, respectively, after which the following LTE and differential values were measured when loaded on the approach side of the joint:

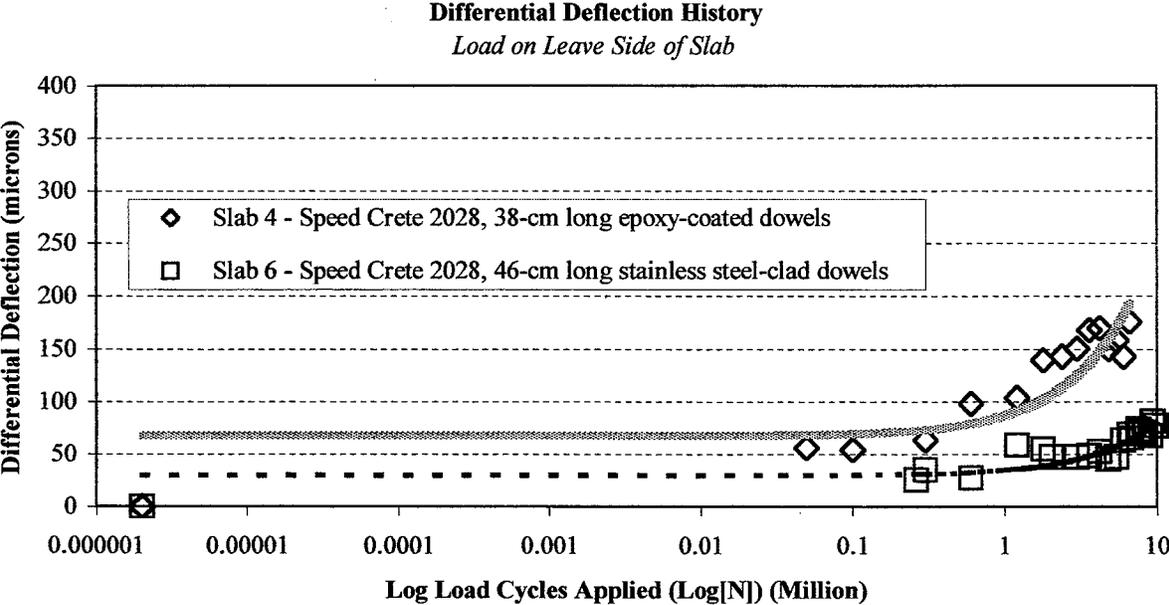
Figure 4.12. Effect of Dowel Bar Type on Differential Deflection.

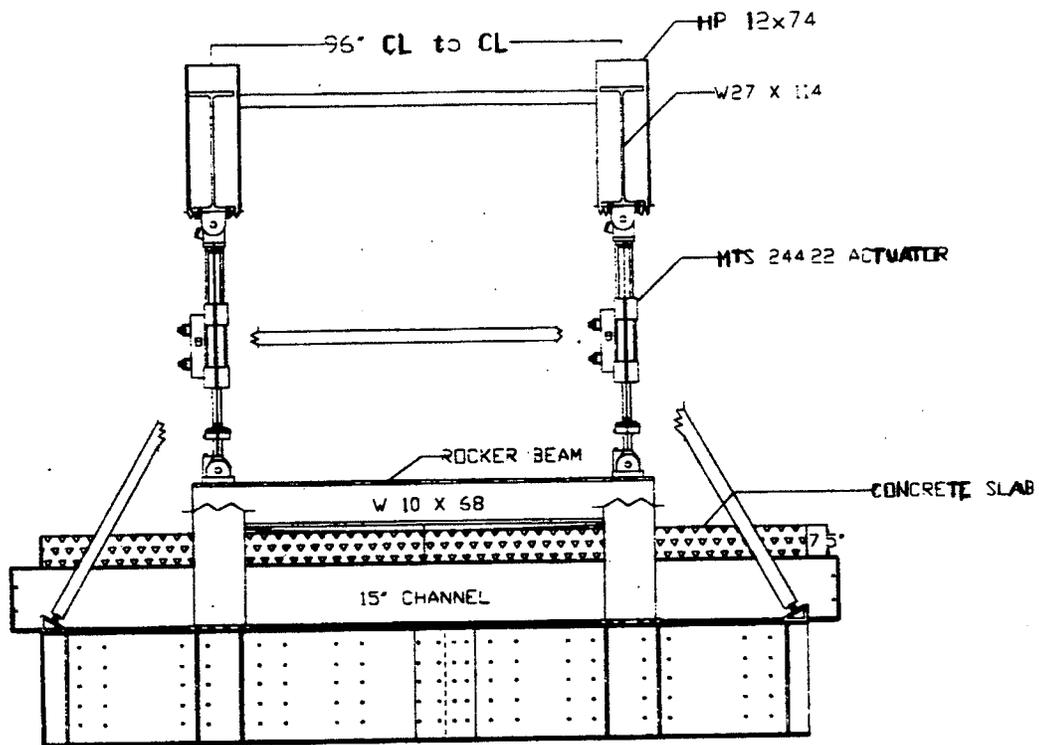
Figure A-1. Transverse elevation cut-away view of complete test stand.

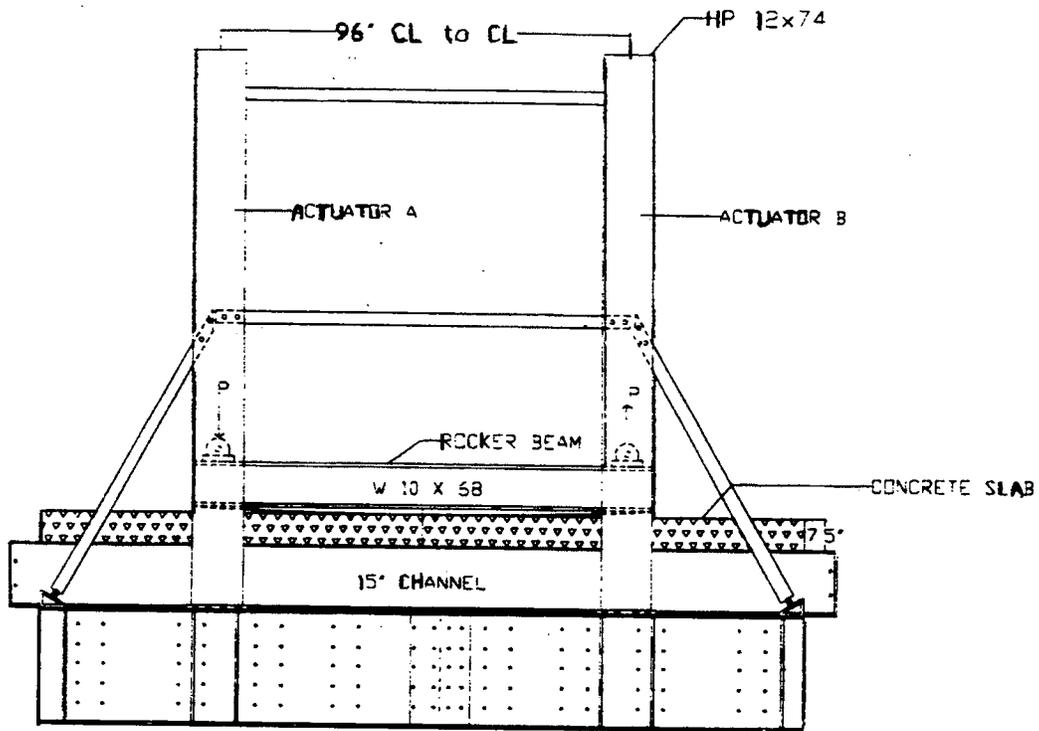
Figure A-2. Transverse elevation of test frame.

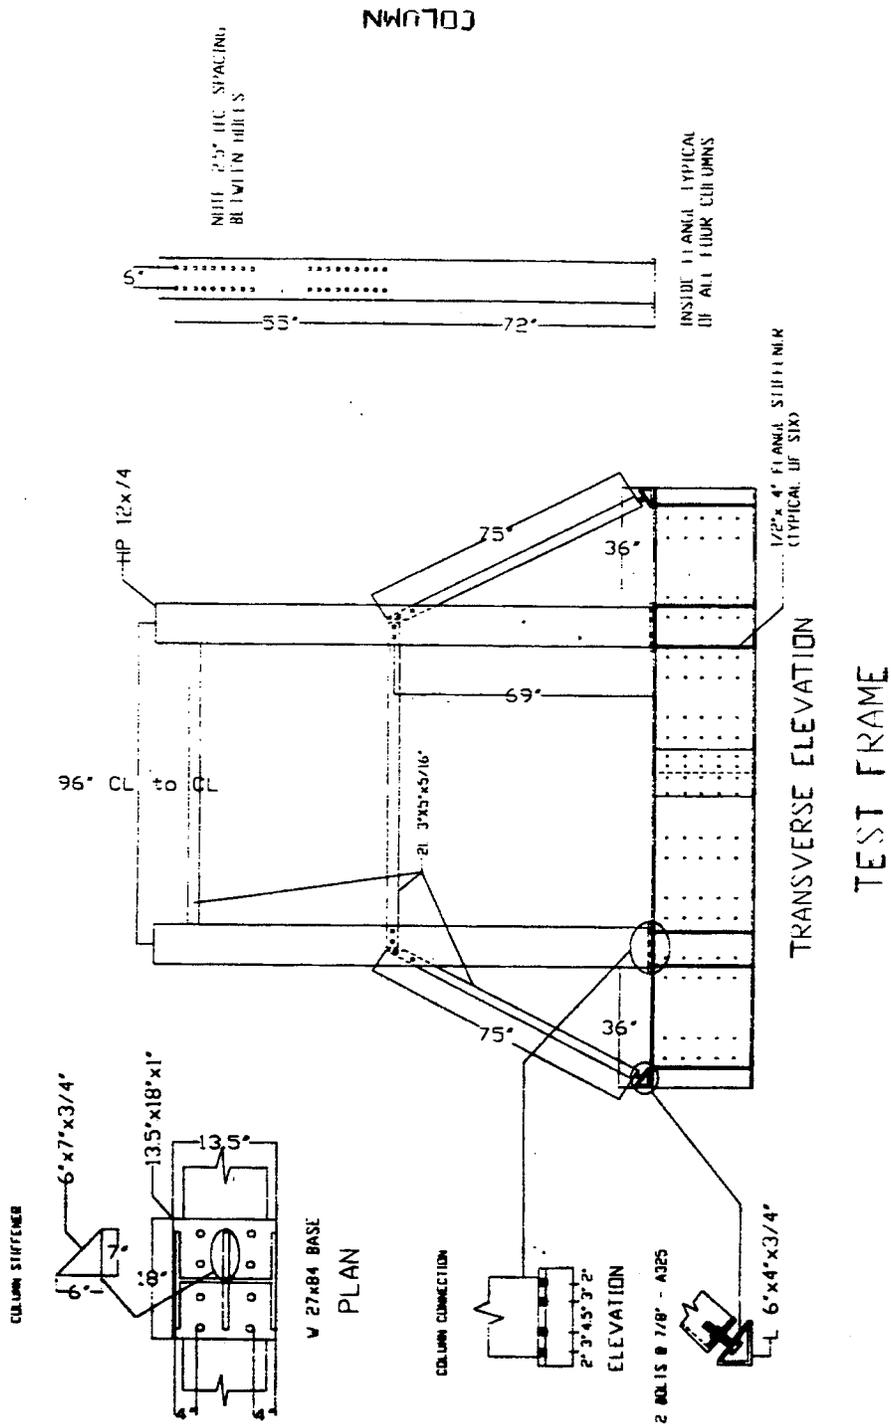
Figure A-3. Transverse elevation view of frame with details.

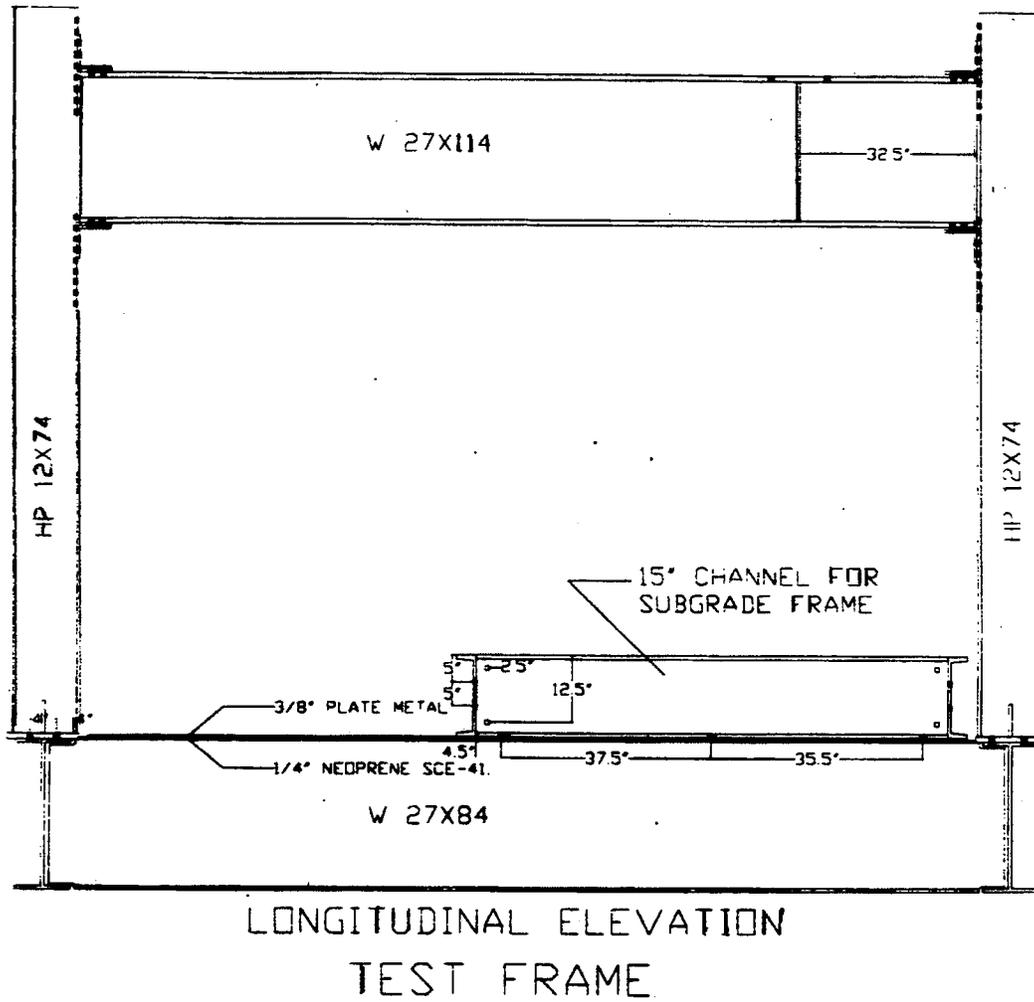
Figure A-4. Longitudinal elevation view of test frame.

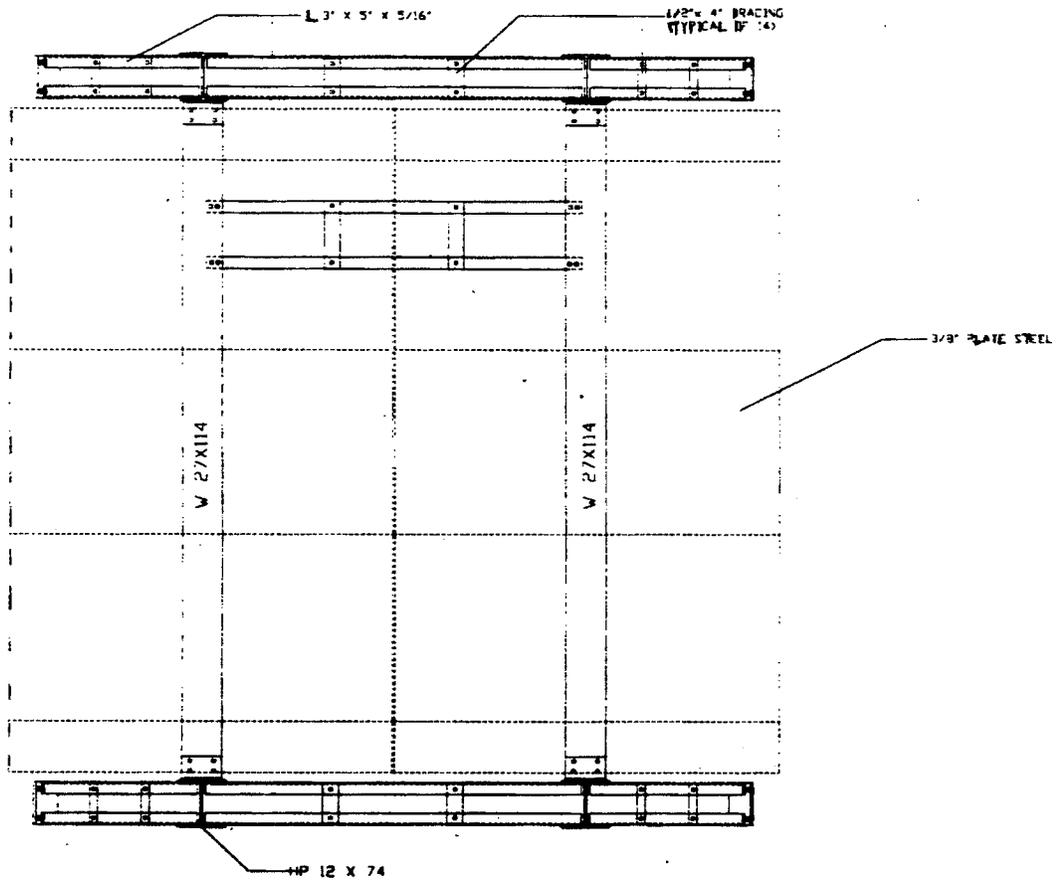
Figure A-5. Plan view of test frame.

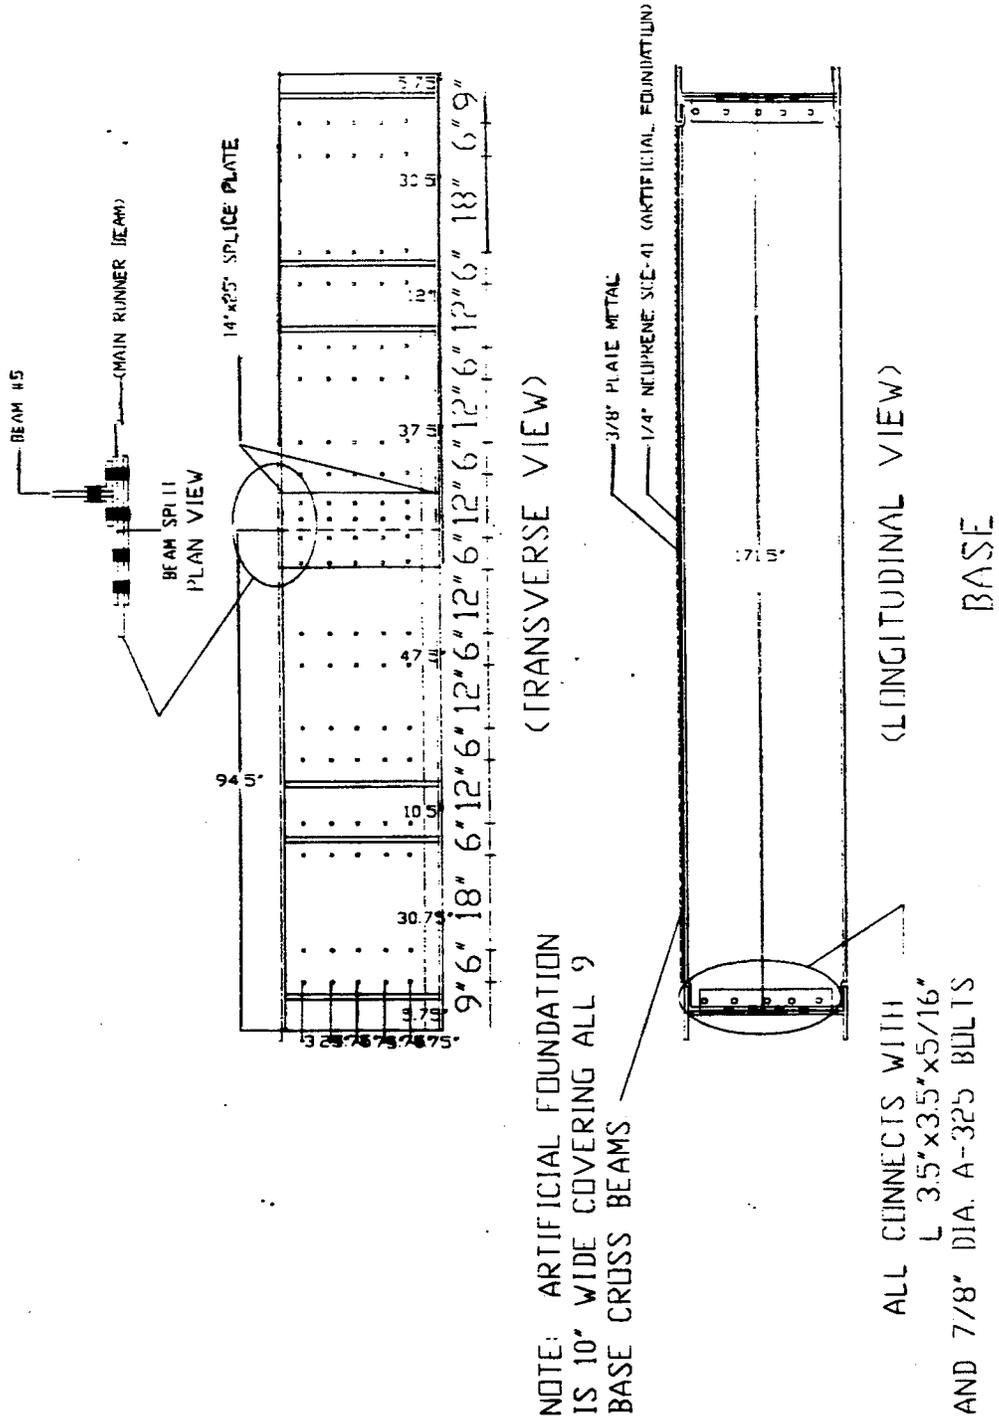
Figure A-6. Base longitudinal view with details.

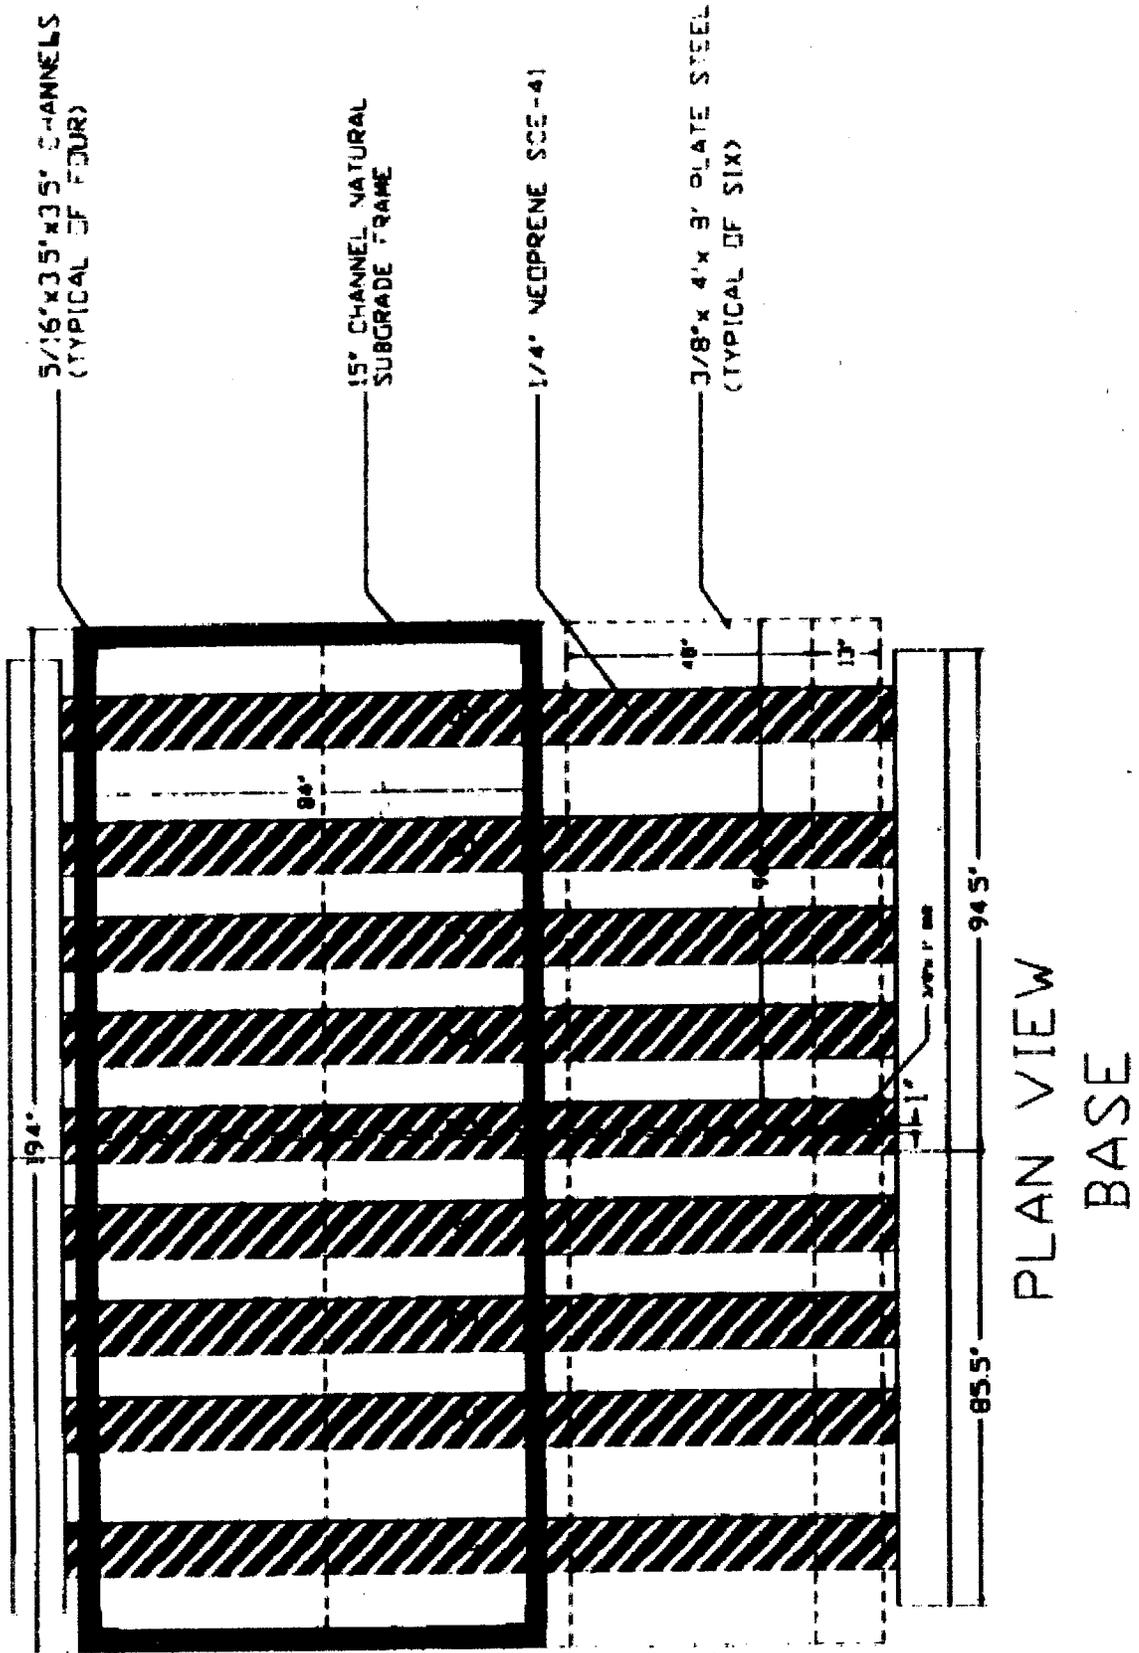
Figure A-7. Base plan view.

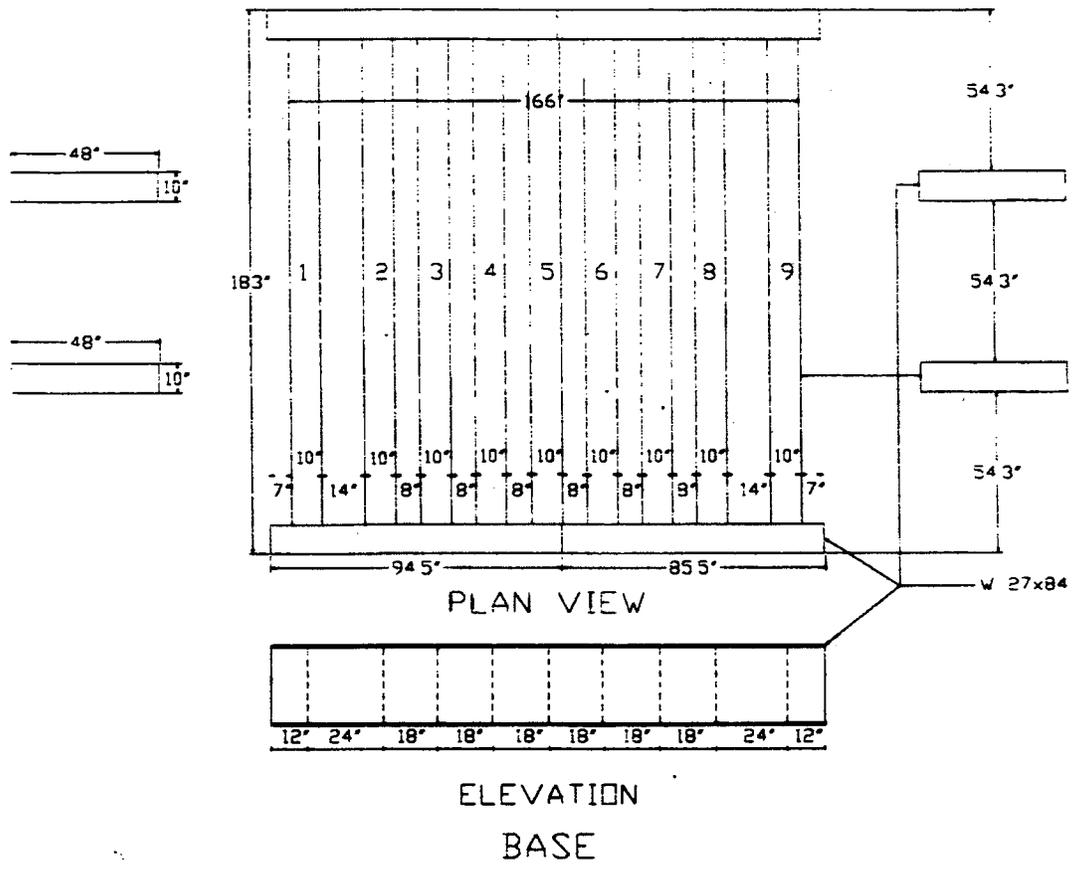
Figure A-8. Base plan and elevation view of girders.

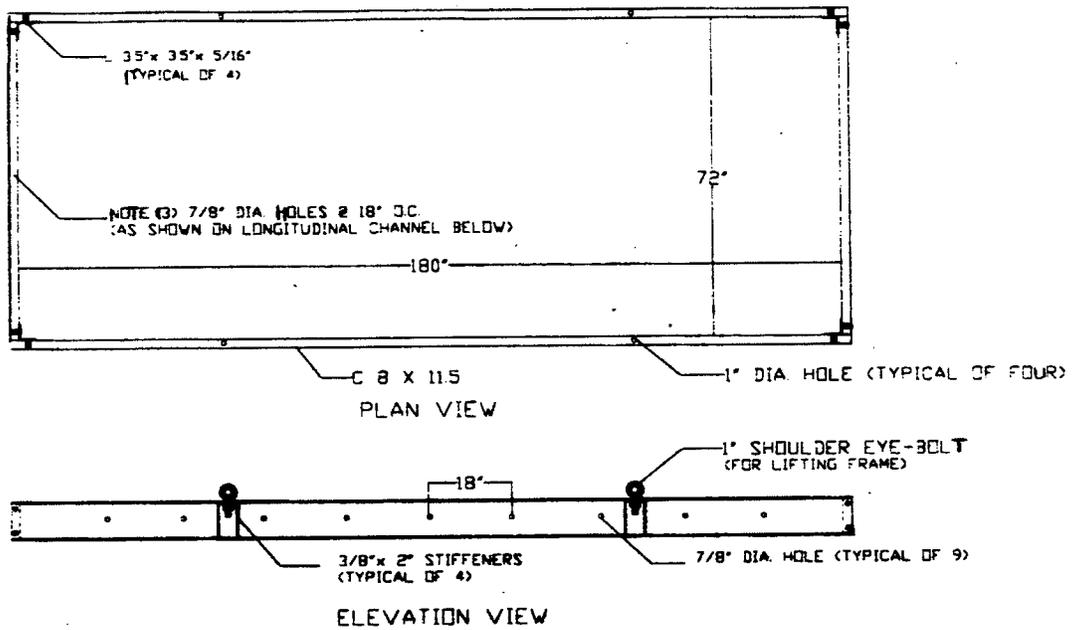
Figure A-9. Plan and elevation view of concrete slab casting frame.

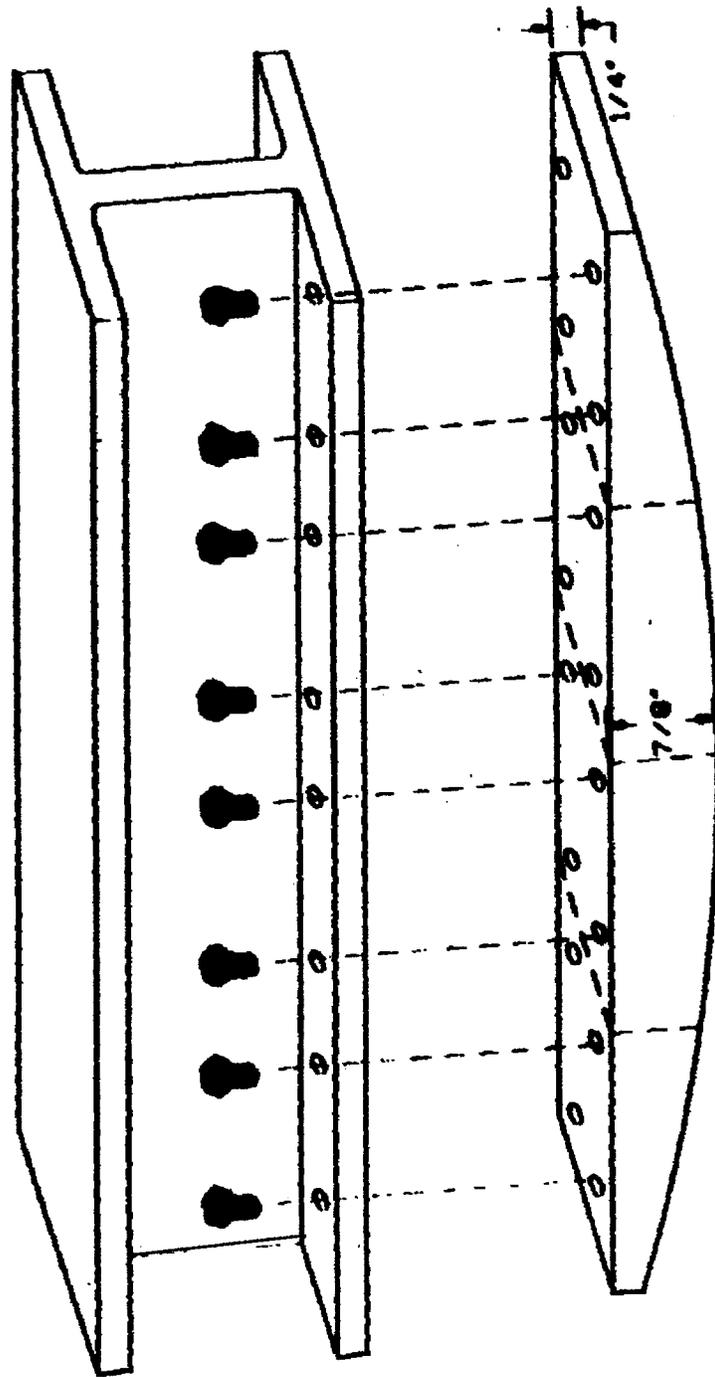
Figure A-10. Rocker-beam connection.
