Minne-Alf Project Overview and Retro-Fit Dowel Study Results

1. Report No. MN/RC - 2000-02	2.	3. Recipient's Accession No.	
4. Title and Subtitle MINNE-ALF PROJECT OVERVIEW AND RETRO-FIT DOWEL STUDY RESULTS		5. Report Date December 1999

**Development of an
Accelerated Load Test Platform
for Pavements**

Rebecca A. Embacher, Graduate Research Fellow
Mark B. Snyder, Associate Professor

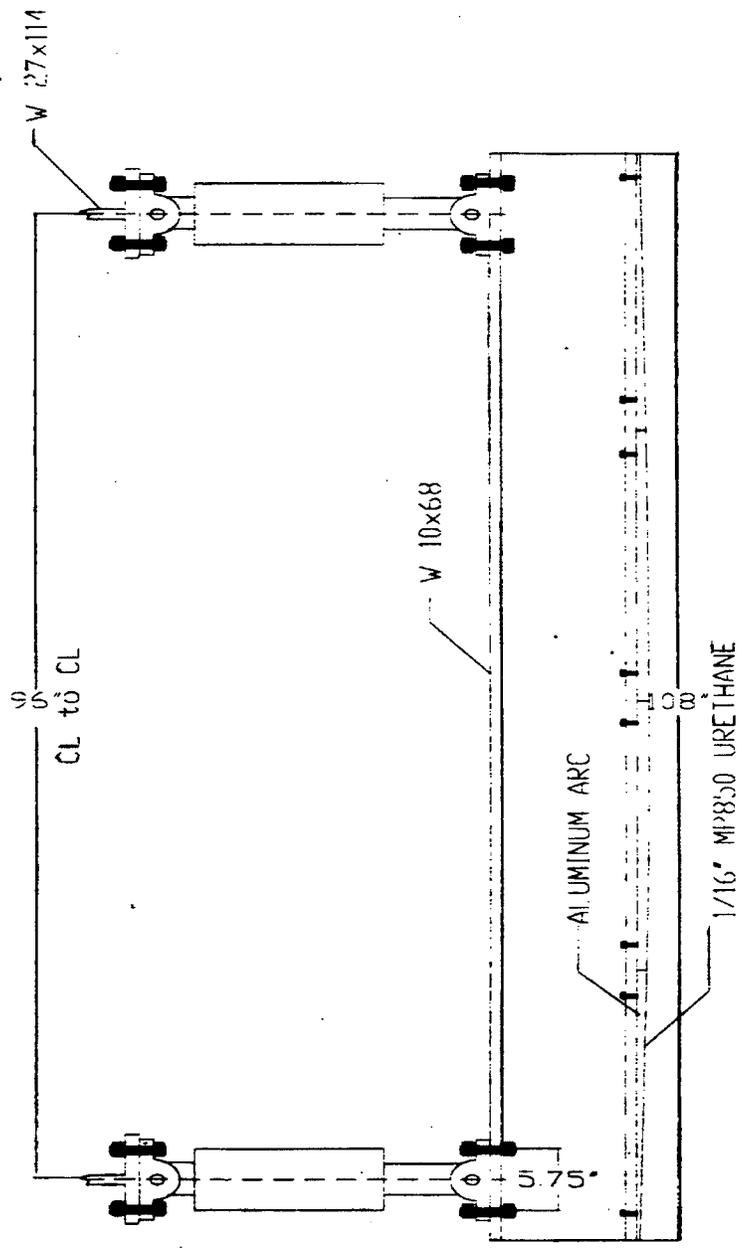
ARC: Radius = 2333.1125"
 Length = 9.0'
 Width = 8.0"

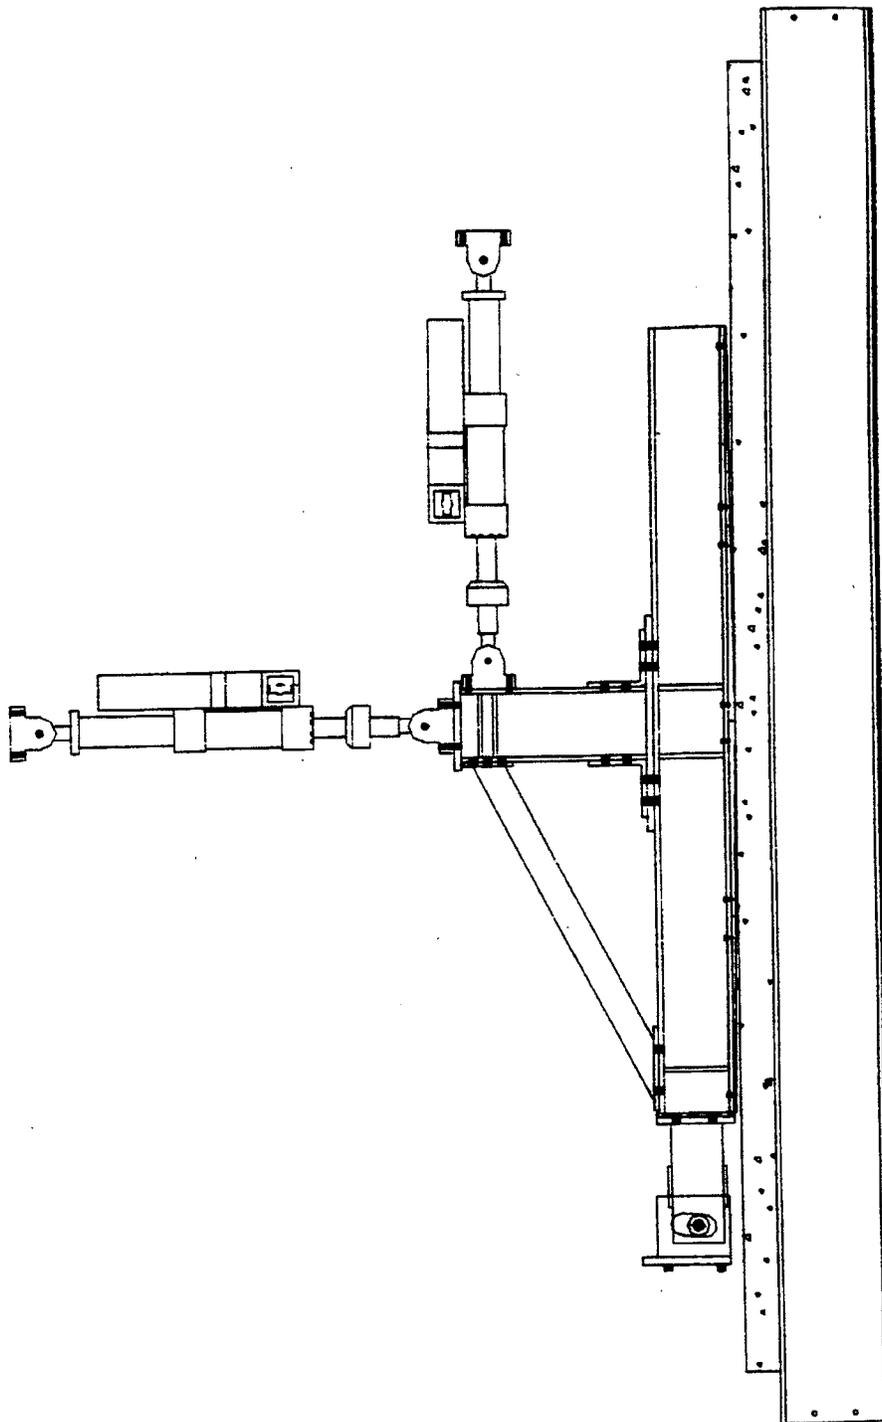
Figure B-1. Rocker beam and slab configuration.

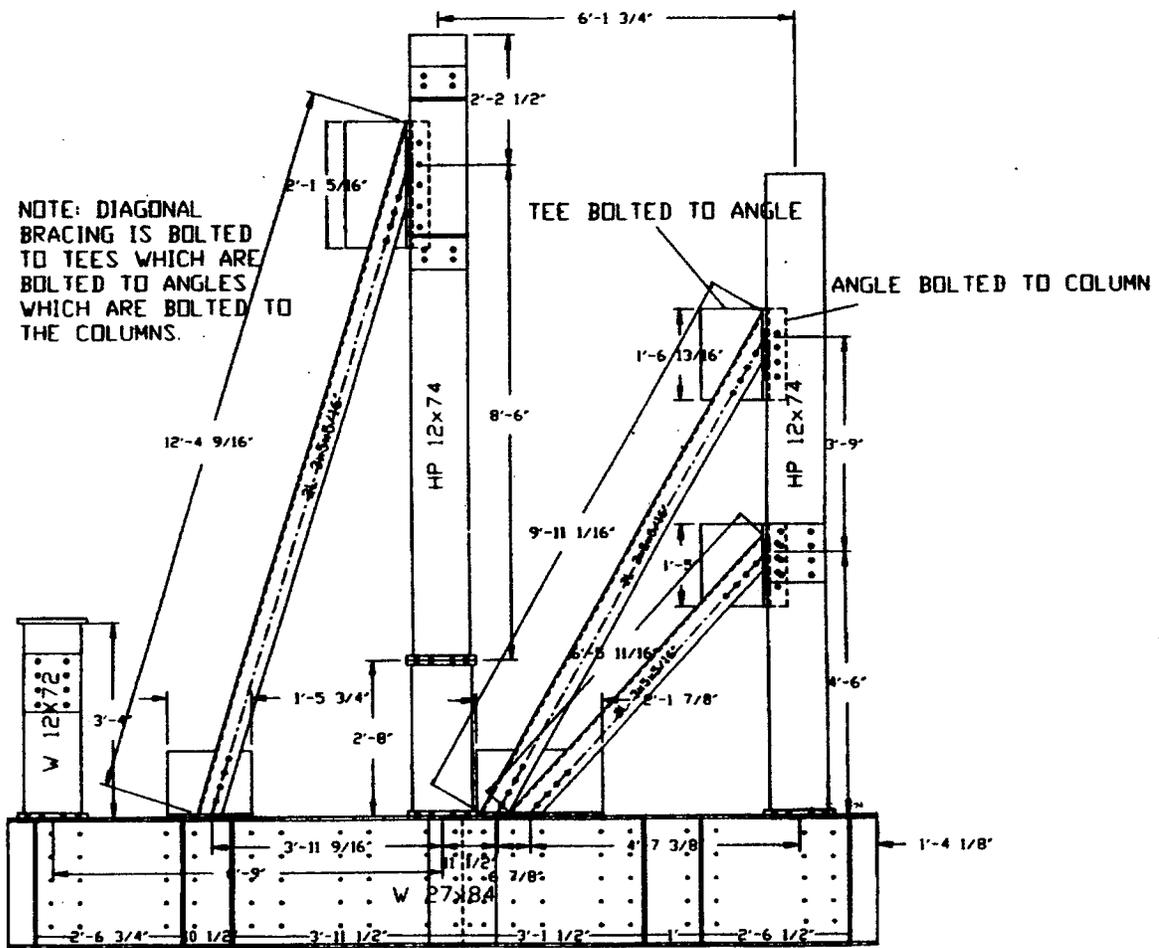
Figure B-3. Transverse elevation of modified Minne-ALF.

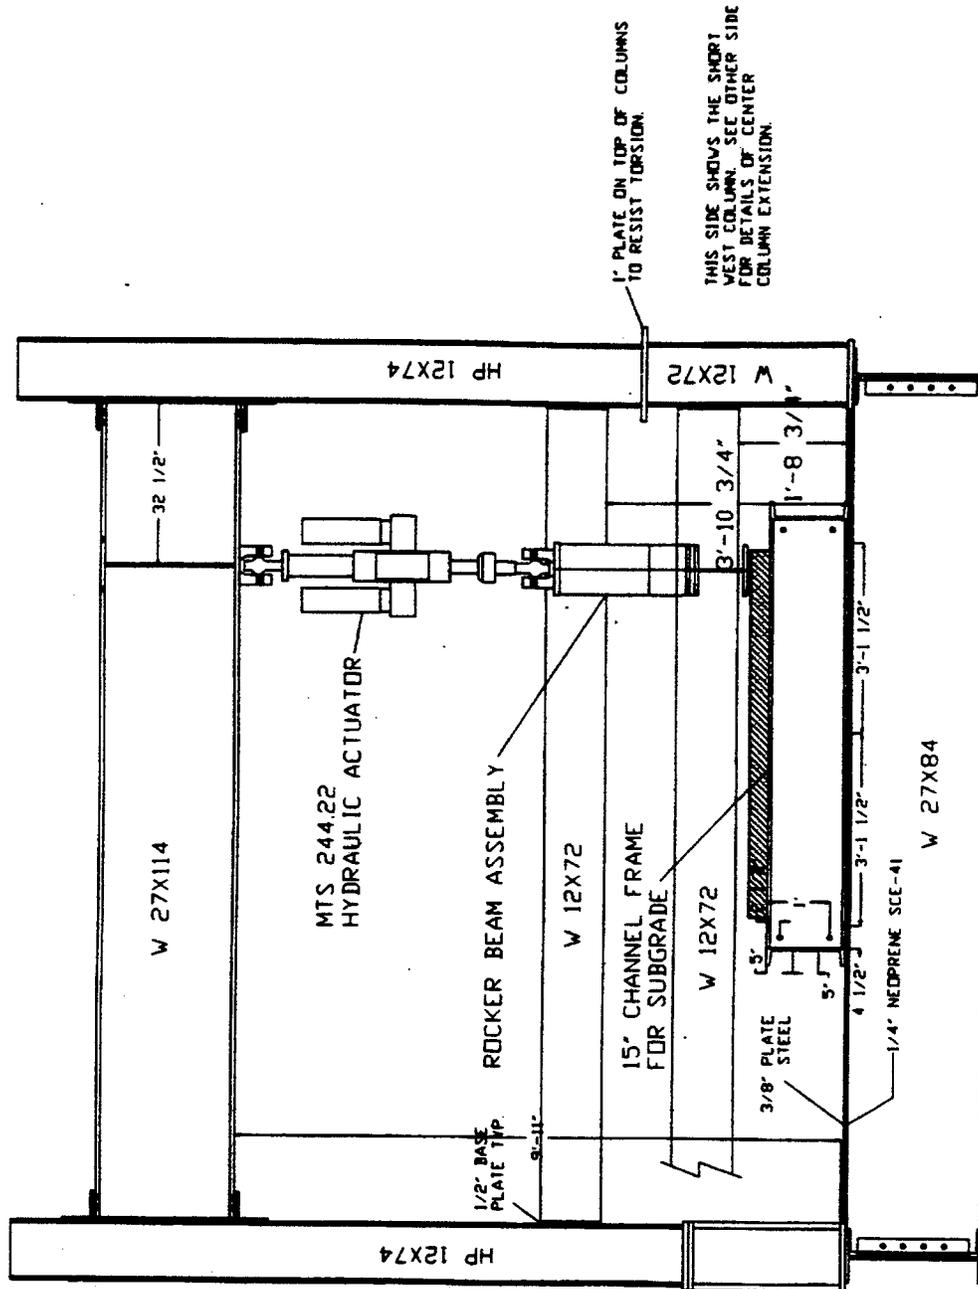
1" PLATE ON TOP OF COLUMNS
 TO RESIST TORSION.

THIS SIDE SHOWS THE SHORT
 WEST COLUMN. SEE OTHER SIDE
 FOR DETAILS OF CENTER
 COLUMN EXTENSION.

Figure B-4. Longitudinal elevation of modified Minne-ALF.

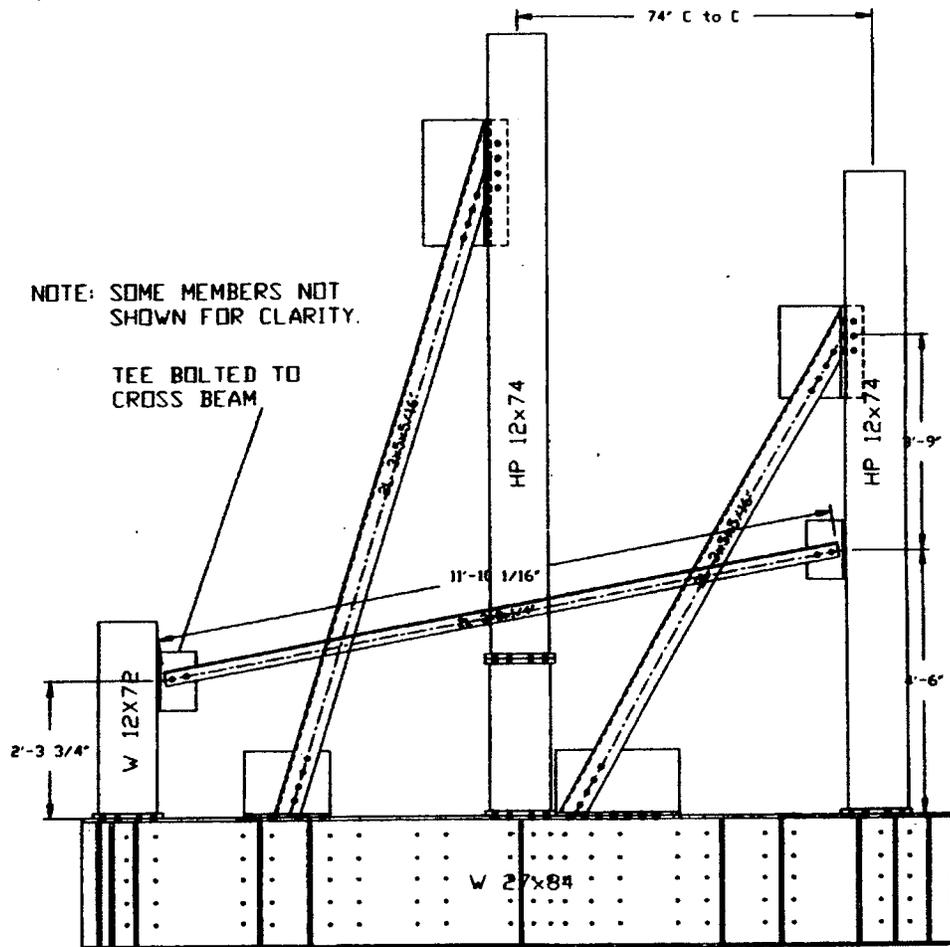
Figure B-5. Side view of diagonal stiffeners.

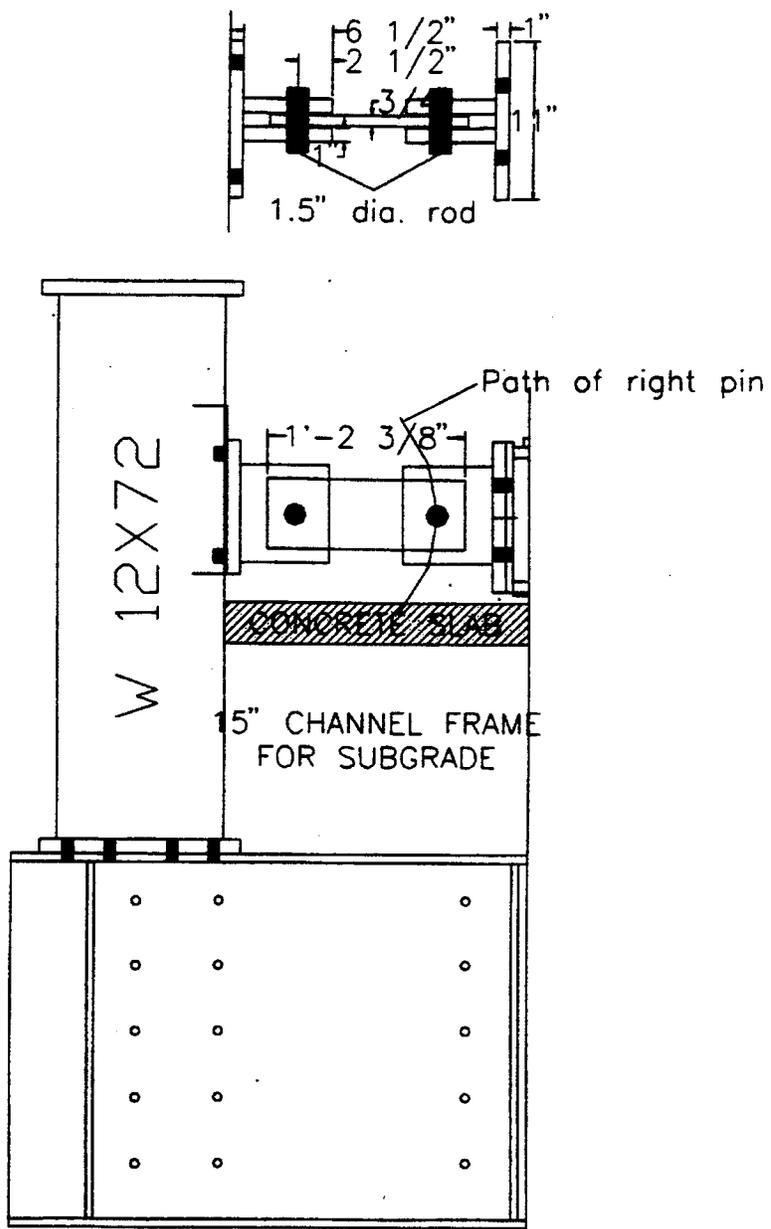
Figure B-6. Two-pin hinge connection.

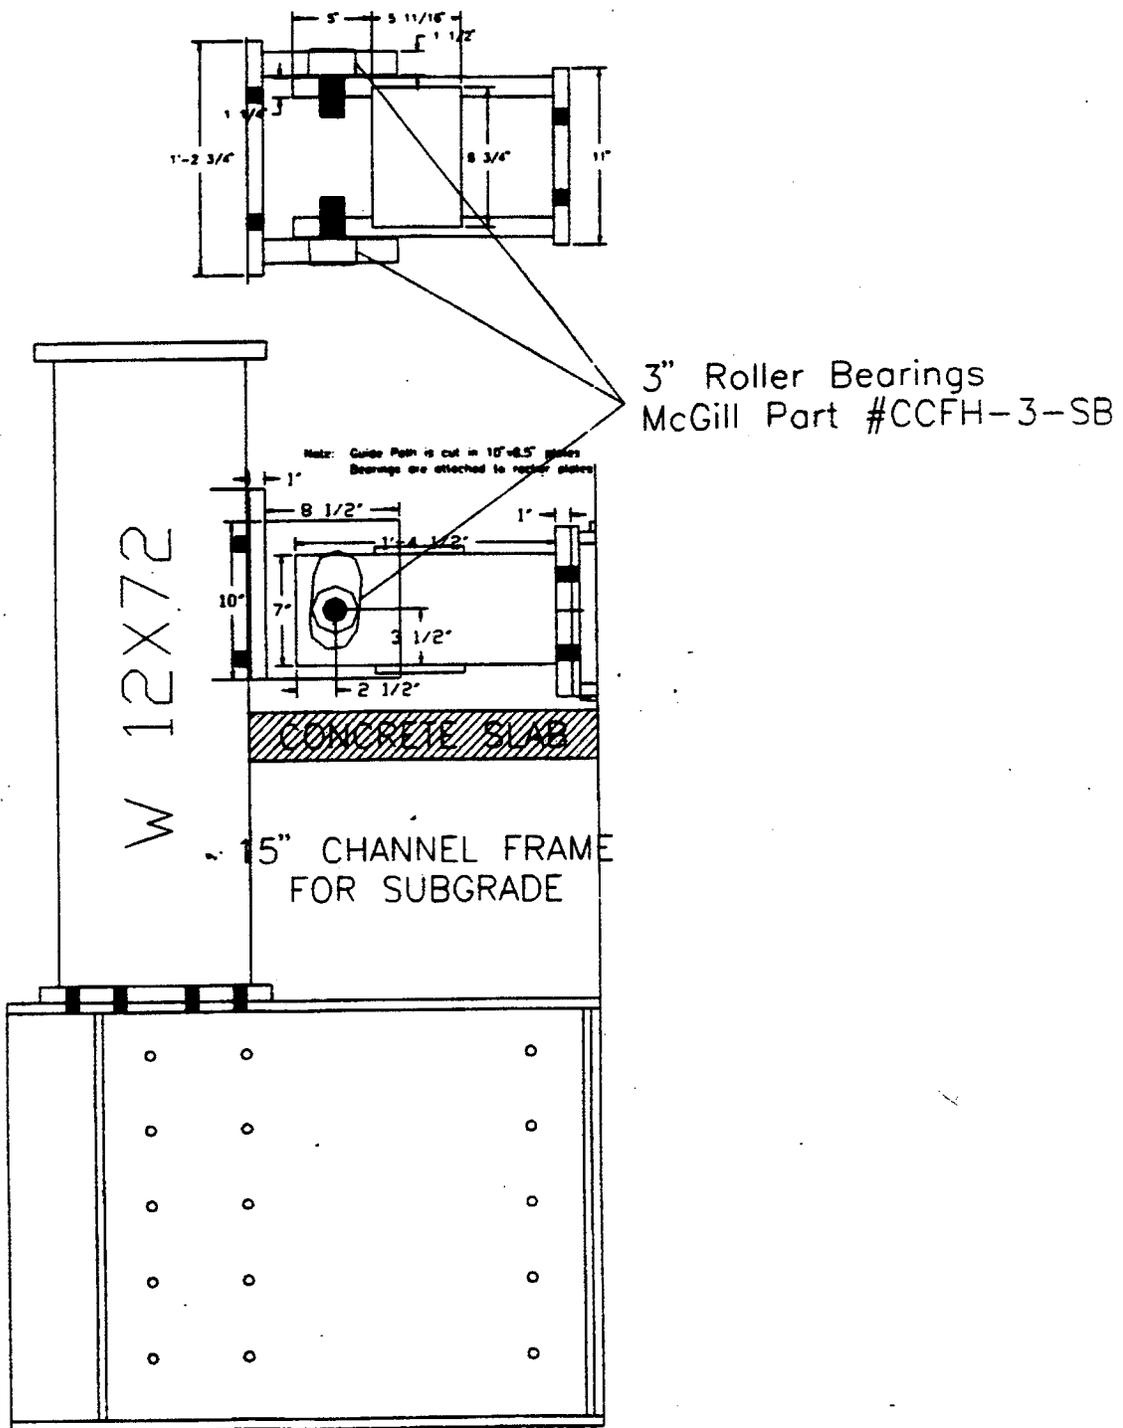
Figure B-7. Hinge connection between rocker beam and frame.

All plates are 1" thick and 6" wide.
Four additional holes are in same locations, but 3" out of plane of drawing.

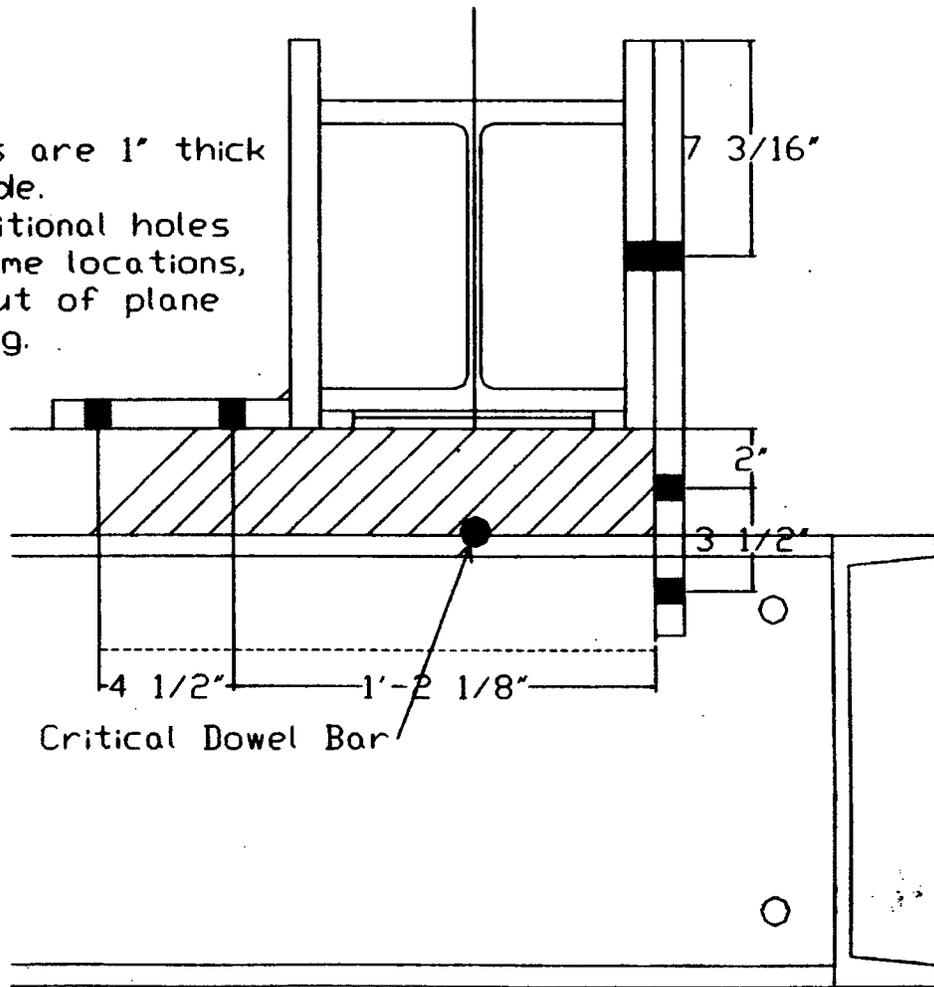
Figure B-8. Rocker beam guide plates.

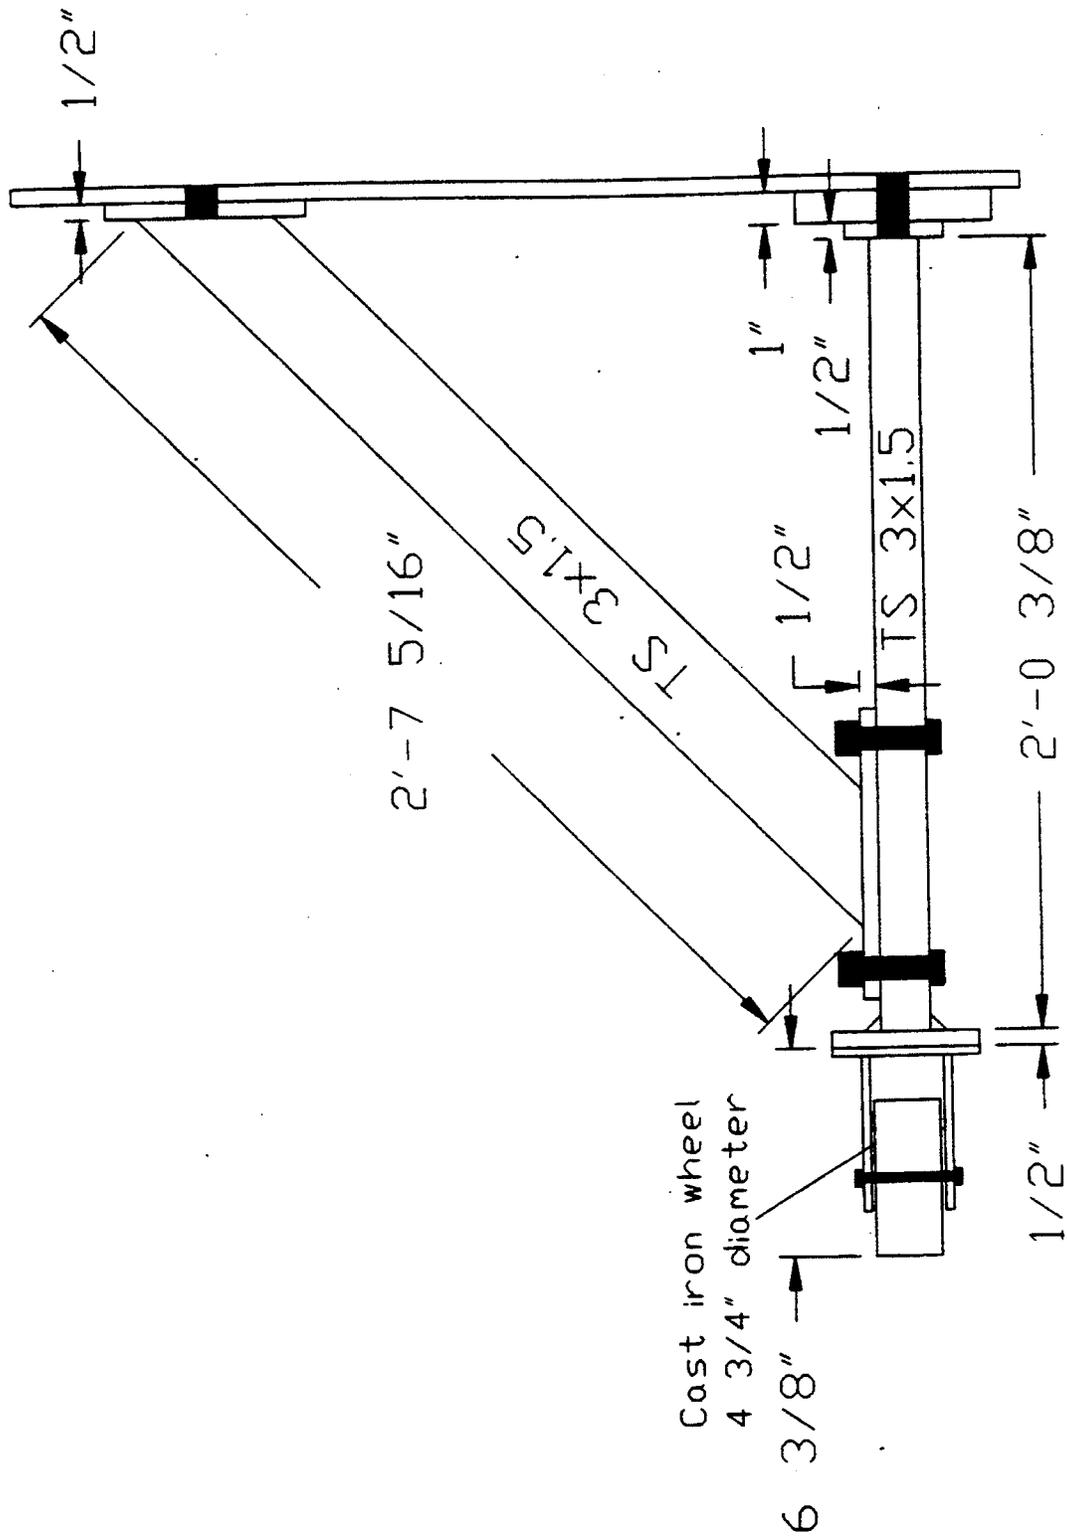
Figure B-9. Wheel brace for side of rocker beam.

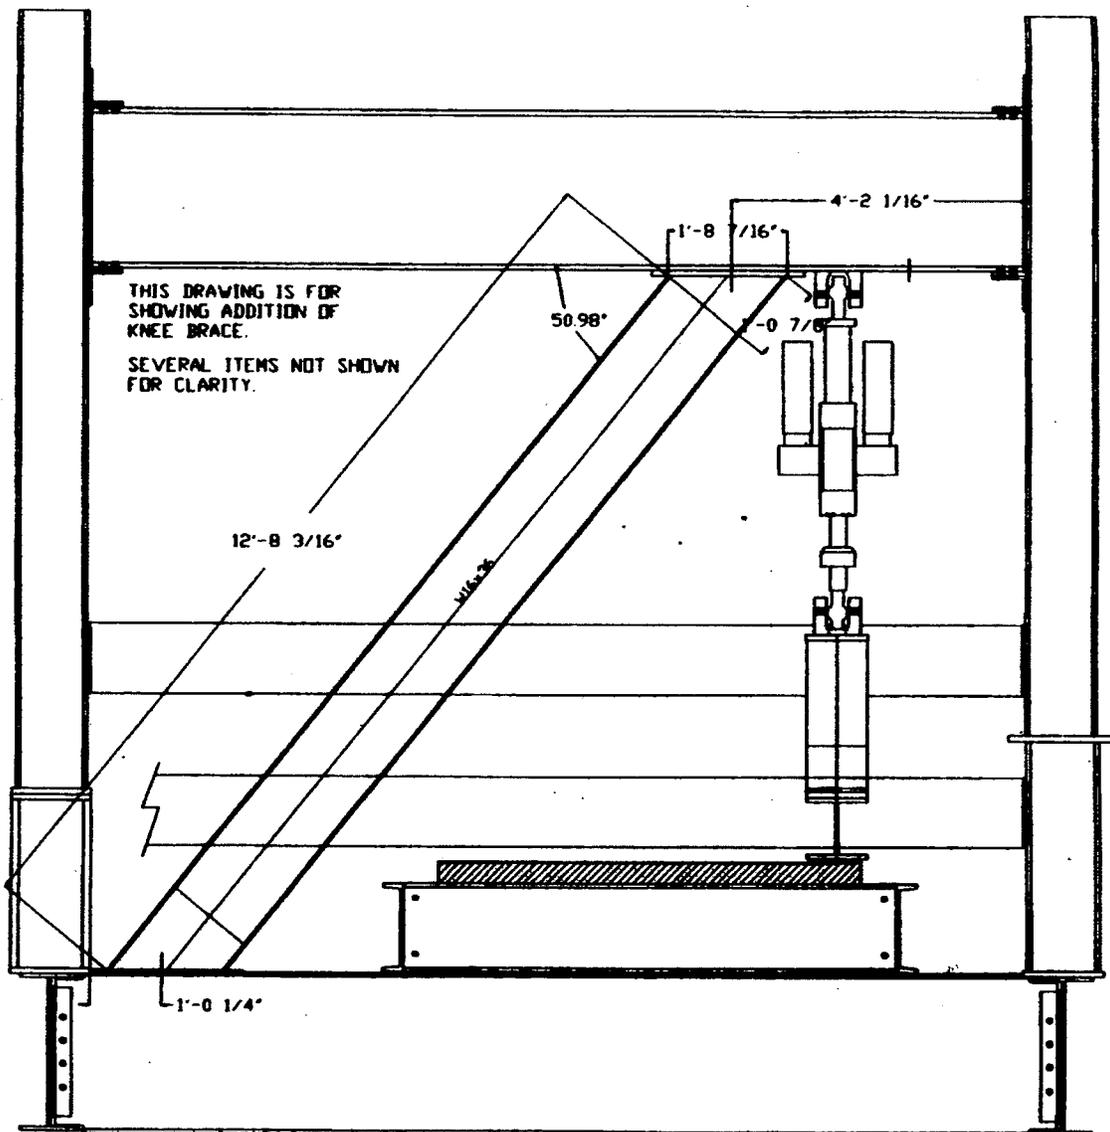
Figure B-10. Knee brace.
