**EVALUATION OF A CHEMICAL HUMECTANT
APPLIED TO AN EXISTING METALLIZED ZINC
CATHODIC PROTECTION SYSTEM**

SEPTEMBER 2000

Performed by Corrosion Technology Branch

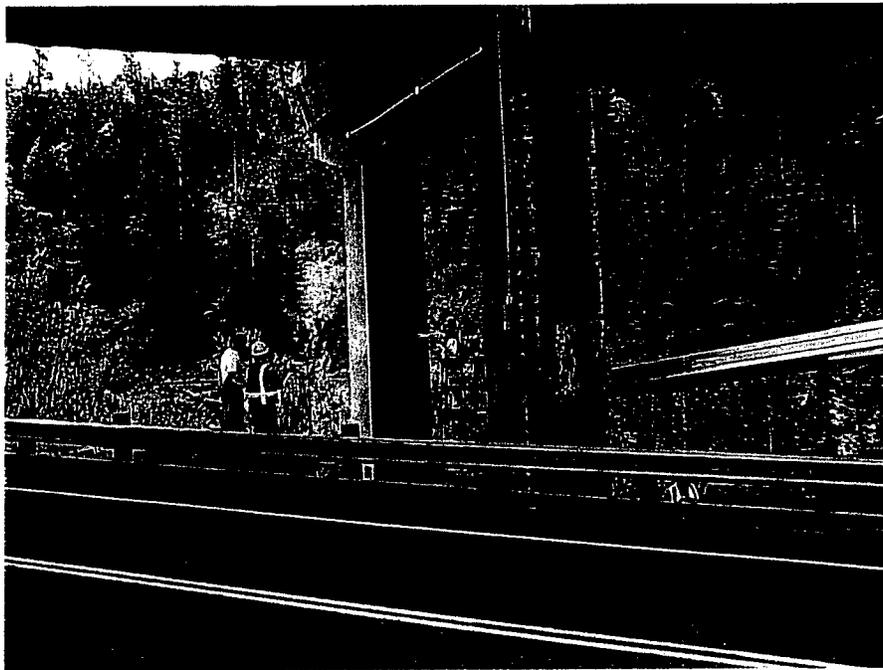
Photo 3: Application of Enhance-3™ humectant by spray. The paint subcontractor estimated 10% overspray. Photo taken 5/24/00.

On May 24, 2000, humectant was applied by an airless sprayer to the entire metallized zinc surface of Bent 4R. The corrosion engineering consultant, Corrosion Restoration Technologies Inc., recommended use of the Enhance-3™ humectant. Enhance-3™ is a lithium bromide aqueous solution that is clear, colorless, odorless, and generally non-hazardous. The product was packaged in 19-L (5-gallon) plastic containers.

On the day of the treatment, the weather was cool, dry, and sunny. The entire application, including set-up and take down, took about four hours (8:00 a.m. to 12 p.m.). However, actual spraying time was only about 30 minutes. The entire metallized zinc surface (including two columns and bent cap) were sprayed. Total surface area sprayed was approximately 130 m² (1400 ft²). At an application rate of 9.8 m²/L (400 ft²/gal), approximately 14 L (3.8 gal) of Enhance-3™ was applied. The painter estimated that approximately 10% of material was lost due to overspray (see Photograph 3). As recommended by the corrosion engineering consultant and humectant supplier, only one coat was necessary to saturate the concrete surface with humectant. Photographs 3 through 5 show the application of the humectant.

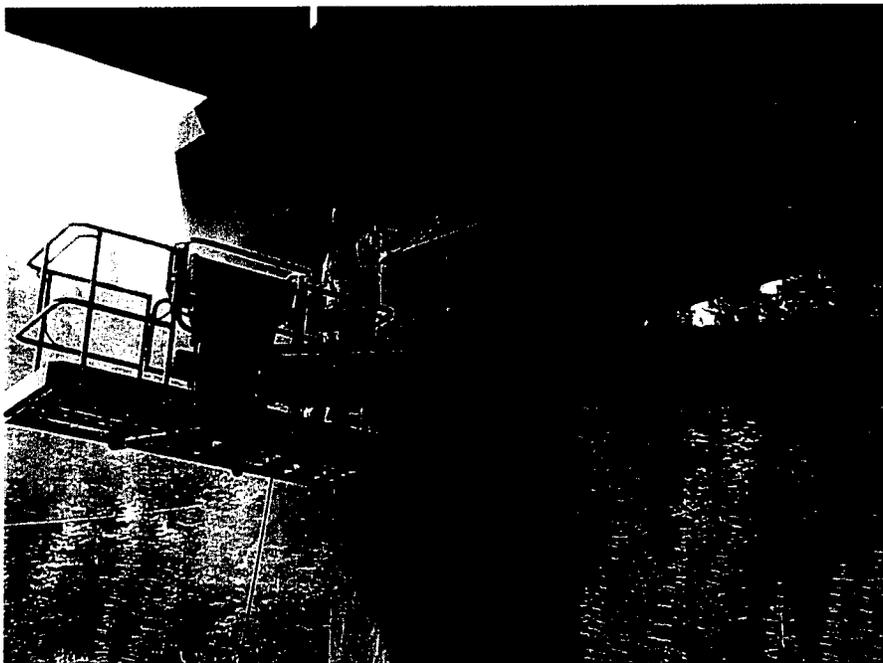
Photo 4: Application of Enhance-3™ humectant by spray. A 225 kg (500 lb.) JLG 600S man-lift with an 18-m (60-ft) extension was used to raise the painter. Photo taken 5/24/00.
