**NCHRP REPORT 350 TEST 3-11 ON THE
MODIFIED PennDOT TYPE 2 GUIDE RAIL - TEST 3**

Work Order No. 50
Project No. RF473750-3

Sponsored by
Pennsylvania Department of Transportation

June 2000

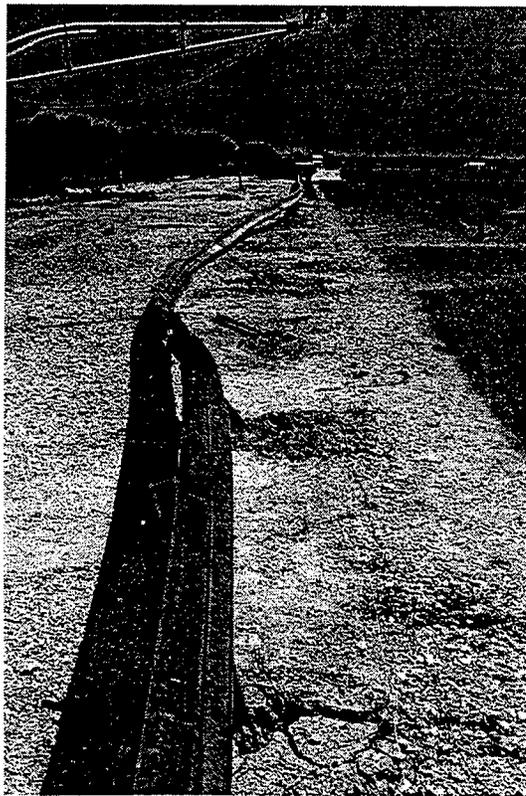
Figure 6. Vehicle trajectory after test 473750-3.

from the overhead camera view; however, the exit angle was approximated from tire marks after the test at less than 2 degrees. At 2.160 s the vehicle contacted the rail element a second time and at 2.209 s the frame member of the vehicle contacted the rail. The vehicle contacted the rail again near post 17, remained in contact with the rail element, and rode off the end of the terminal at 5.492 s. Brakes on the vehicle were not applied and the vehicle subsequently came to rest 68.6 m (225.1 ft) down from the impact point and in line with the traffic face of the rail. Sequential photographs of the test period are shown in appendix C, figures 14 and 15.

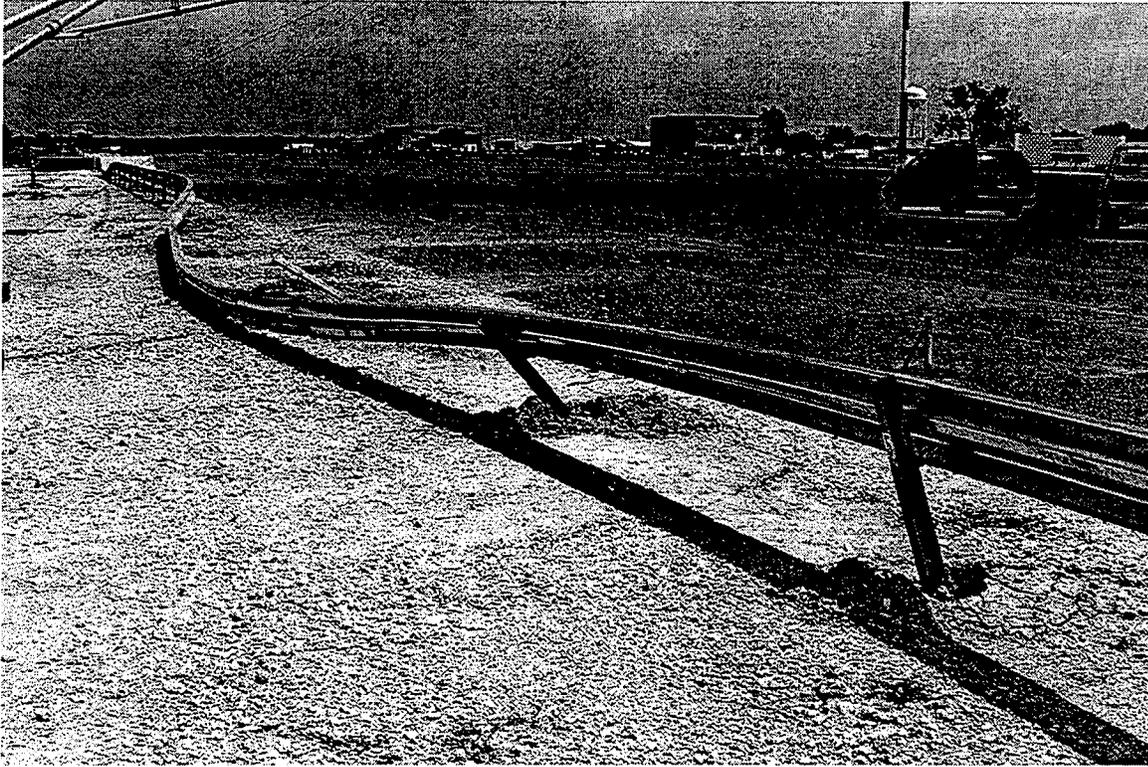
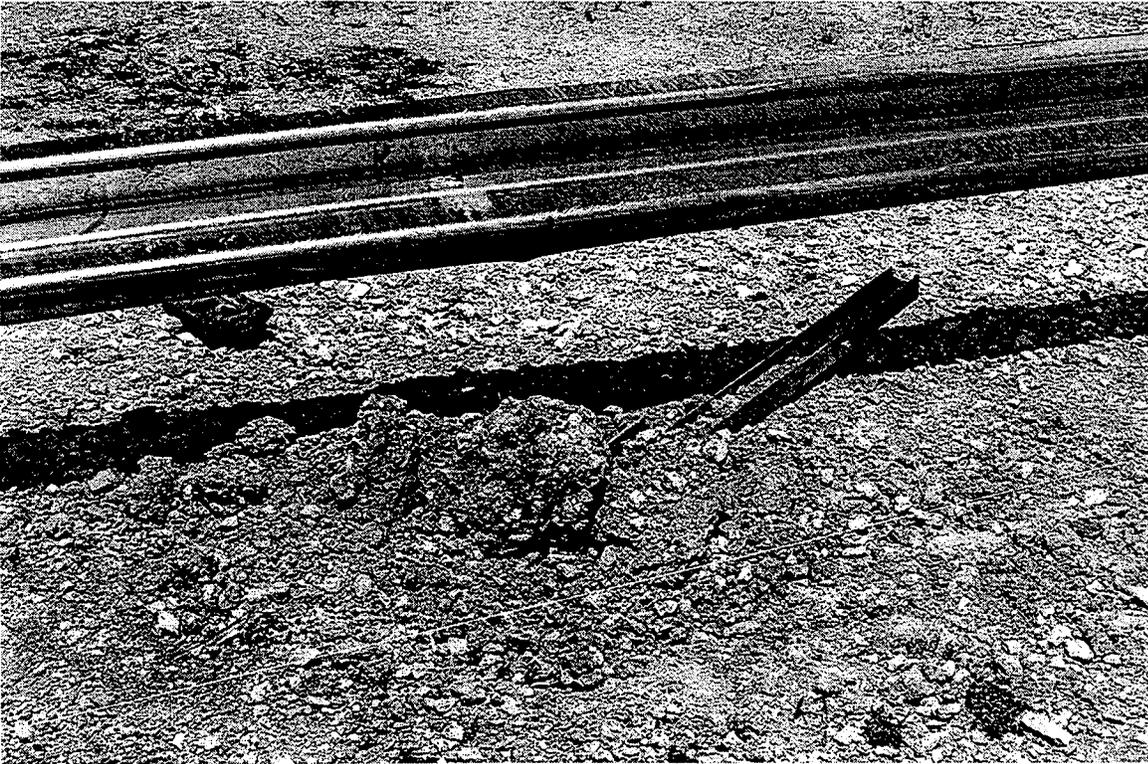
Figure 7. Rail damage after test 473750-3.

Damage to the modified Type 2 PennDOT guide rail installation is shown in figures 6 through 8. The upstream end terminal through post 2 were disturbed. Post 3 moved rearward 13 mm (0.5 in), post 4 moved rearward 63 mm (2.5 in), post 5 - 150 mm (5.9 in), post 6 - 610 mm (24.0 in), post 7 - 580 mm (22.8 in) and post 8 - 490 mm (19.3 in). Posts 9, 10, and 11 were pulled out of the ground and resting 4.6 m (15.1 ft), 3.0 m (9.8 ft) respectively, near the rail. Post 12 was pulled up but the end remained in the ground. Post 13 was pulled rearward 40 mm (1.6 in) and posts 14 through the end were disturbed. The downstream end terminal was pulled longitudinally 10 mm (0.4 in). The rail was separated from posts 7 through 13. Length of contact of the vehicle with the rail element was 25.6 m (84.0 ft). Maximum dynamic deflection of the rail element during the test was 2.12 m (6.94 ft). Maximum permanent deformation of the rail element was 1.64 mm (5.40 ft) between posts 8 and 9.

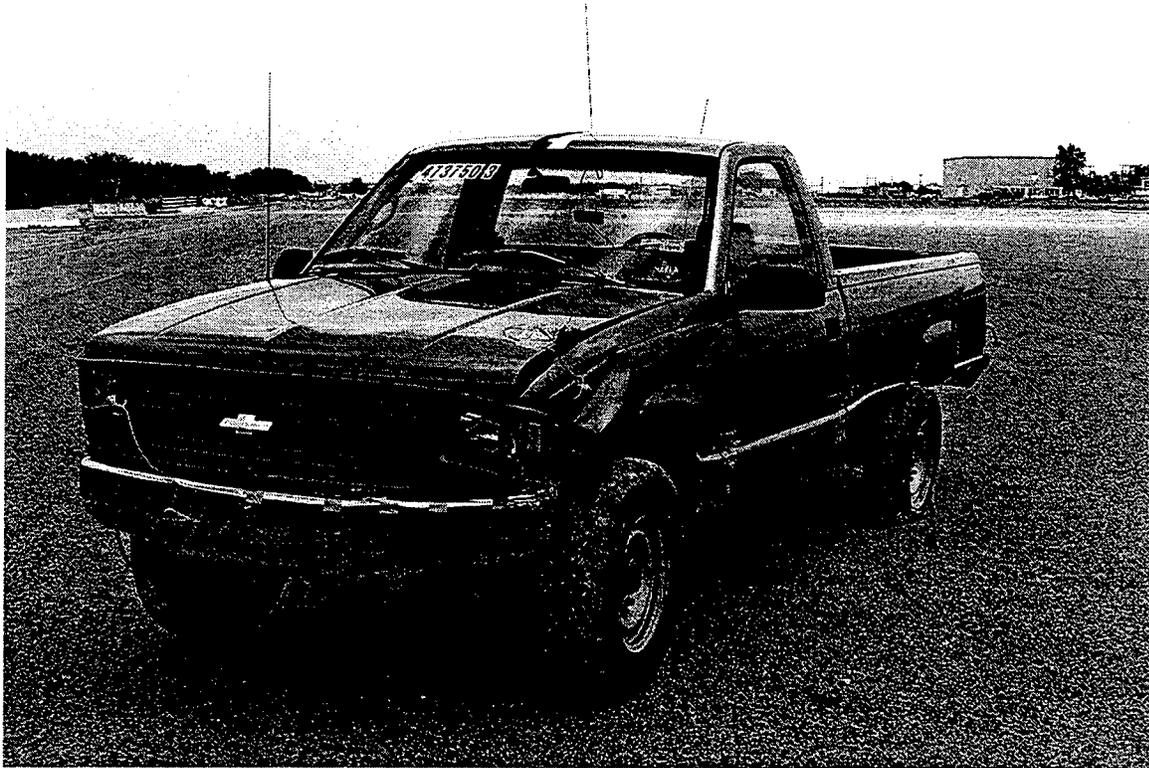
Figure 9. Vehicle after test 473750-3.

The vehicle sustained minor damage as shown in figure 9. No structural damage was imparted to the vehicle; however, the bumper, grill, left front and rear quarter panels, left door and left rear tire were damaged. Maximum exterior crush to the vehicle was 230 mm (9.1 in) at the left front corner. No deformation or intrusion into the occupant compartment occurred from the impact with the guardrail. The interior of the vehicle is shown in figure 10. Exterior vehicle crush and occupant compartment measurements are shown in appendix B, tables 2 and 3.
