# Long-Term Durability of Geosynthetics Based on Exhumed Samples From Construction Projects

FHWA-RD-00-157

APRIL 2001

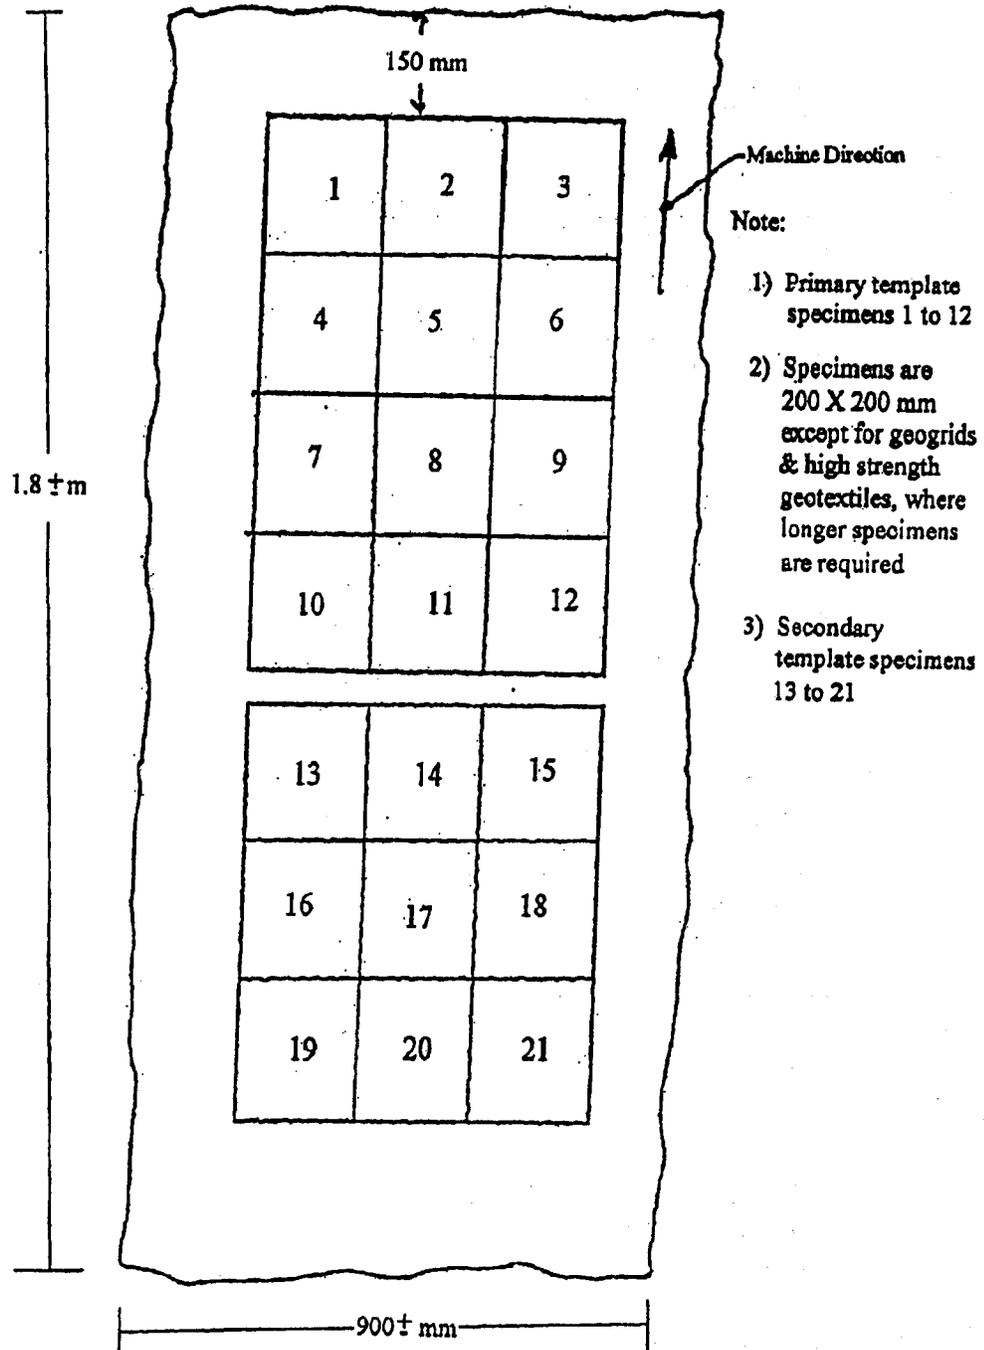
Figure 1. Scheme for sampling test specimens.

Twelve adjacent specimens 200 mm by nominally 200 mm shall be cut and numbered in accordance with figure 1. Specimens having areas marked with damage from the retrieval process shall not be tested. A minimum of nine specimens with consecutive marked numbers shall be tested initially. For high-strength geotextiles, the length shall be increased to accommodate the roller grip requirement. For stiff geogrids, the specimen size shall be such to contain three ribs in the machine direction and five ribs in the cross direction. For flexible geogrids, up to seven cross direction ribs may be necessary to accommodate the required roller clamps.

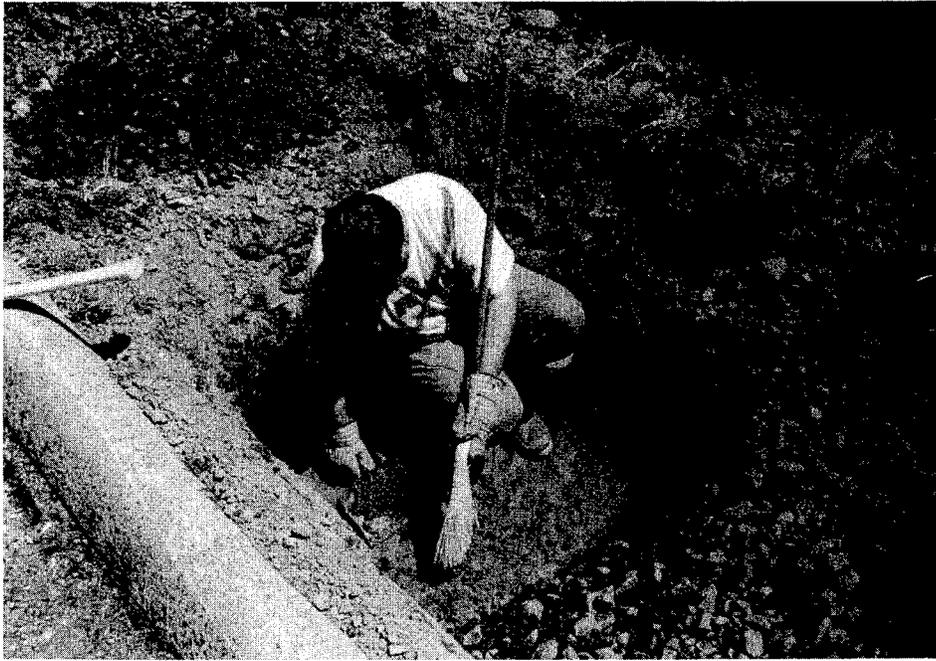
Figure 5. Excavation of PET geotextile. Layer 1.

Although excavated from the same depth below the unpaved area between the asphalt gutter and the wall face, within 15 m of each other, the PET sample (Bidim) was completely soaked while the PP sample (Fibretex) was essentially dry. This would suggest that PET retains infiltrating moisture to a greater extent than PP. Climatological data indicate average precipitation in the Olympic Peninsula in the range of 1500 to 2000 mm per year. By contrast the PET samples from about the same depth excavated from Site #4, Glenwood Canyon, were dry, which was not surprising since the average rainfall in the area is on the order of 250 mm per year.

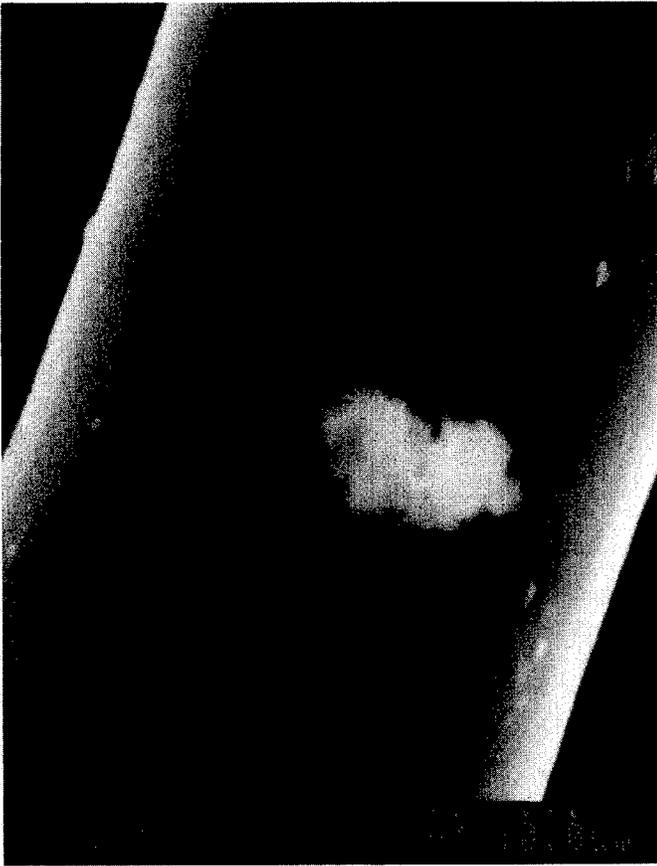
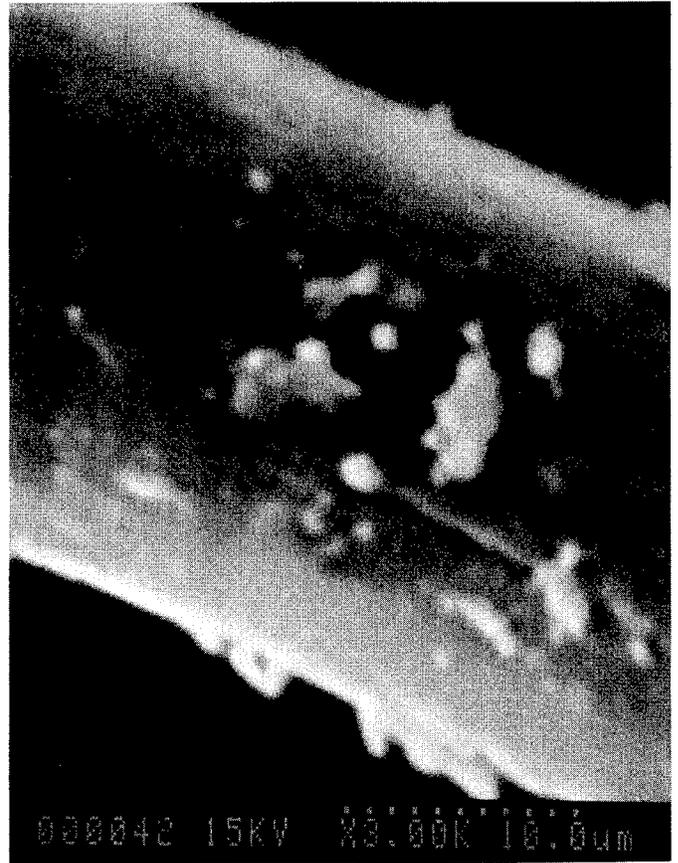
The SEM photographs for the retrieved sample appear to have some longitudinal cracking not visible in the "archive" sample and appear to have a slightly reduced diameter. The latter measurements may be questionable as the "archive" sample is simply a sample believed to be representative of production in that area. Figures 7 and 8 indicate the above effects.

Figure 7. SEM, "archive" sample 5A-AR.

Figure 8. SEM, retrieved sample 5A-2.

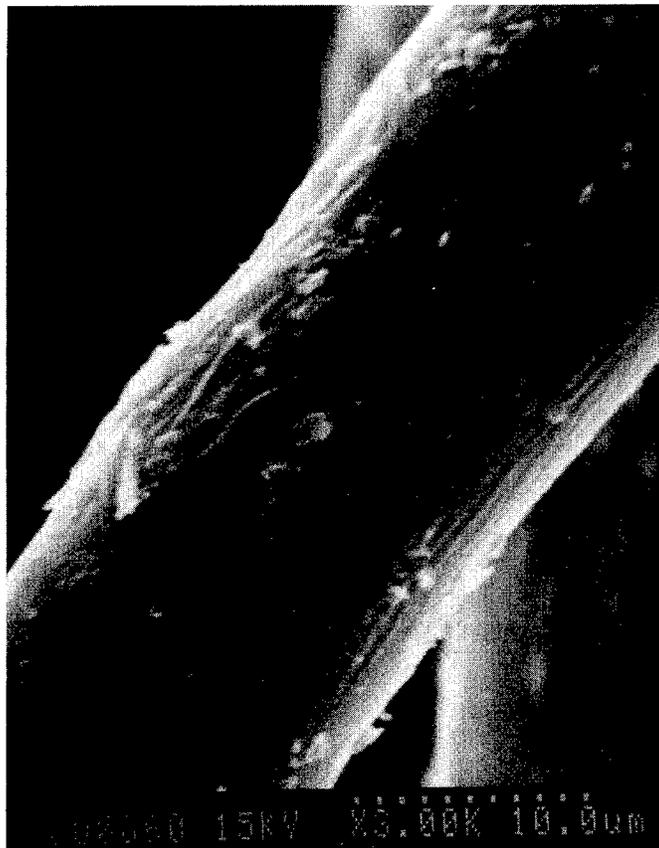
The PP geotextile strength loss appears to be consistent with installation damage. Polymer index tests indicate a small decrease of antioxidant and no molecular weight change. SEM examination indicates no cracking and no obvious evidence of construction damage as shown in figure 9.

Figure 9. SEM, retrieved sample 5B-1.

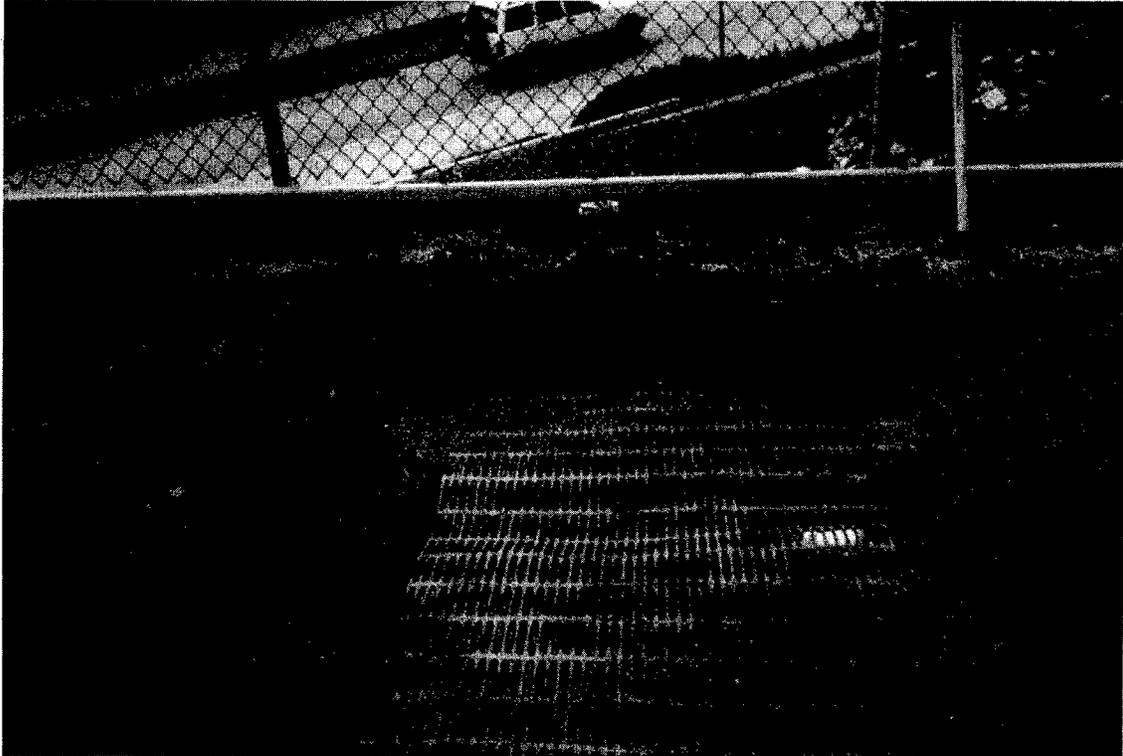
Figure 10. Site excavation, #6.

The tensile strength measured by a single rib tensile test indicated a strength of 1.41 KN/rib. Archive samples were not available, but a search of the literature of that era indicated that, characteristically, 1.59 KN/rib could be anticipated. It is interesting to note that in TRB 1439, Bright et al. reported archive and exhumed values of approximately 1.9 KN/rib. Part of the difference in exhumed values can be attributed to the selection of ribs for testing. The tested ribs from the exhumed sample under this program included ribs that had some visible construction damage. The small loss of strength (approximately 10 percent) appears to be from construction damage, which is confirmed by the insignificant reduction in OIT values from 65 to 62 min which is within the range of repeatability for this test. The reduction in OIT is even smaller than reported in TRB 1439, although the testing methodology was significantly different. The melt flow index of 0.14 g/10 min is less than the reported archive melt flow of 0.22 g/10 min. Assuming that the archive melt flow reported in the literature is correct, the decrease would indicate a typical initial increase in molecular weight indicating a cross-linking phase of oxidation to which strength loss is typically not attributed, or that the testing methods reported in the literature varied from those used in this program. The small loss of strength is clearly the result of either construction or exhumation damage. No evidence of strength loss due to oxidation is indicated.

Soil chemistry is neutral and benign. The excavated site and sample are shown in figure 10.

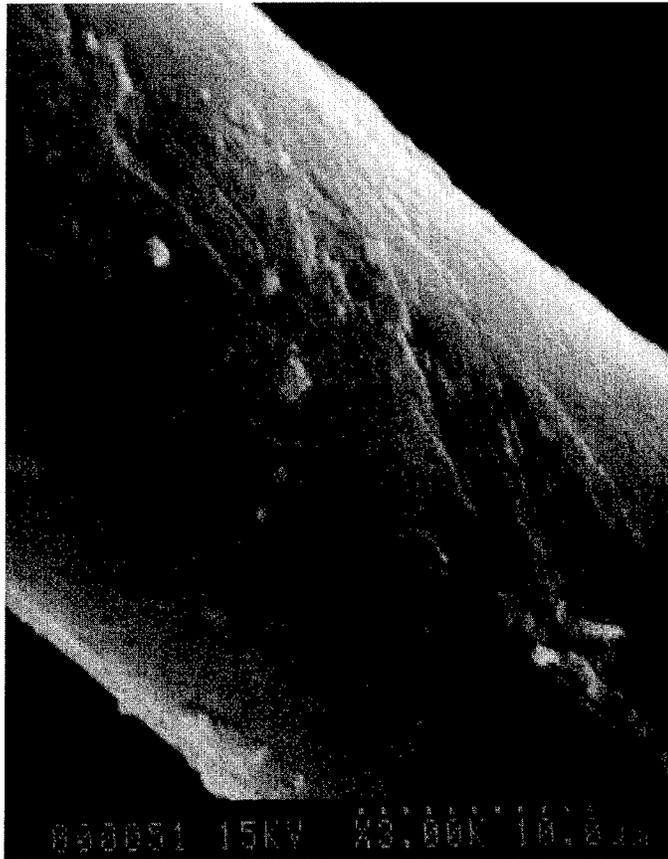
Figure 12. SEM, sample 10E, PET.

The loss of strength in excess of 40 percent as measured from archive to first retrieval should be substantially associated with construction damage. The subsequent strength loss on the order of 5 percent can be ascribed to hydrolysis as the coefficient of variation for both retrievals and archive samples were substantially equal. The initial strength loss is similar to the strength loss measured at Site #5, where the same geotextile style was used.

Although a project-specific archive sample was not available, testing of a sample produced in that era indicated a viscosity on the order of 0.6 and CEG in the range of 59-65. The retrieved sample viscosity was in the range of 0.45 with CEG in the range of 50 to 60. The polymer index data strongly suggest that some hydrolysis has occurred, which would lead to strength loss. The SEM micrograph, figure 12 clearly shows minor fiber erosion and cracking, which is indicative of strength loss due to hydrolysis. The level of strength loss of 0.25 to 0.35 percent per year is consistent with laboratory data developed in FHWA-RD-97-144, although the viscosity decrease suggests a potential greater strength loss. The relatively small change of CEG is also indicative of a minor strength loss.

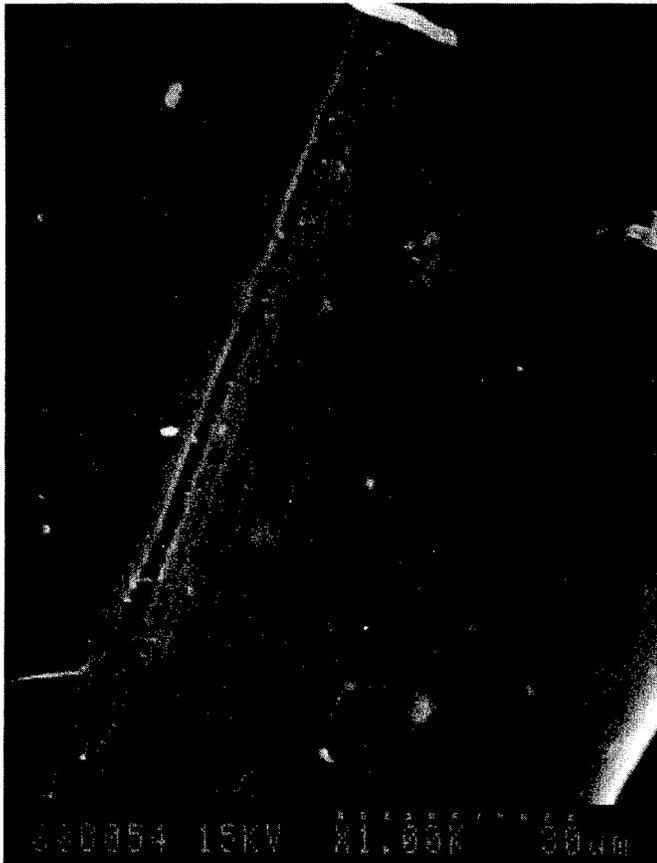
Figure 14. SEM, archive and retrieved sample.

The reduction in tensile strength should be attributed to construction damage, as the polymer index properties (OIT) strongly suggest that significant antioxidant is still present after 10 years of burial even though the lower soil material exhibited very high total iron concentrations, which is consistent with fill leachates measured by others and reported in TRB 1422. The construction damage level is somewhat surprising given that the fill (wood chips) does not appear to be abrasive. It is interesting to note that both the archive sample (AR) and the retrieved sample exhibit longitudinal cracking, which is typical for production slit film geotextiles as shown in figure 14.

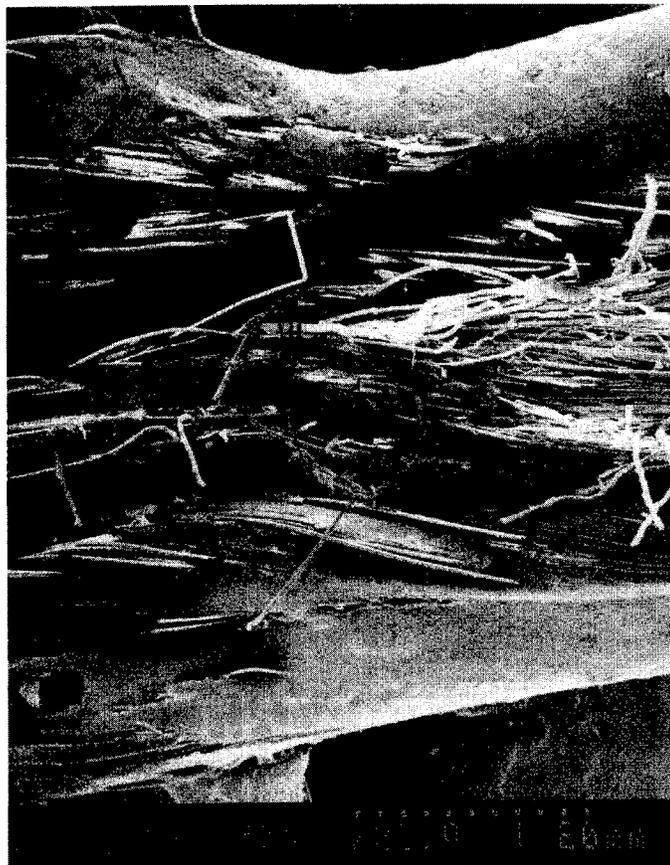
Figure 15. SEM, sample 12.

The strength loss measured is principally related to construction damage, as shown in SEM reproduced as figure 15.

The viscosity decrease is indicative of the initial stages of hydrolysis, which, however, in 5- to-6 years could not have contributed to a strength loss greater than 1 to 2 percent.
