Report No. CDOT – R1-R-2001-9

**Noise and Skid Measurements on US285
in the Turkey Creek Canyon Area
Project NH 2854-068**

June 2001

Project NH 2854-068

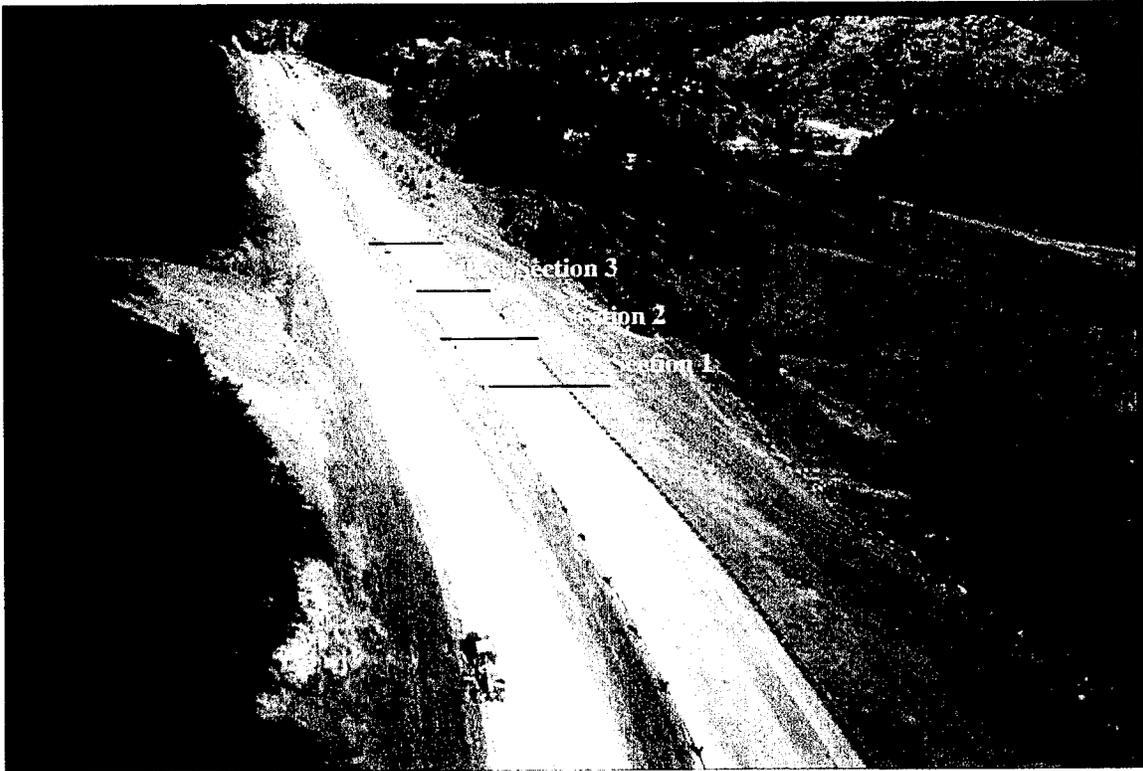
Figure 2. Oblique view looking east at Test Sections 1 through 3 along US285.

This site selective study was conducted in October 2000 under Project NH 2854-068. The study area is shown in Figure 1. The purpose of the project was to acoustically assess the impact of various paving surfaces inside a vehicle, at the tire of a vehicle, and at the roadside. Additionally, the skid numbers of both original and reconstructed pavement surfaces were compared to evaluate safety impacts due to noise reduction techniques. Region I planned to construct several test sections of roadway to evaluate possible treatments to address noise problems on Phase I and II of US285. Only one concrete treatment test section was constructed this fall. The concrete pavement surface was ground $\frac{1}{4}$ inch to remove the transverse tining. (See Figures 2 through 4.)

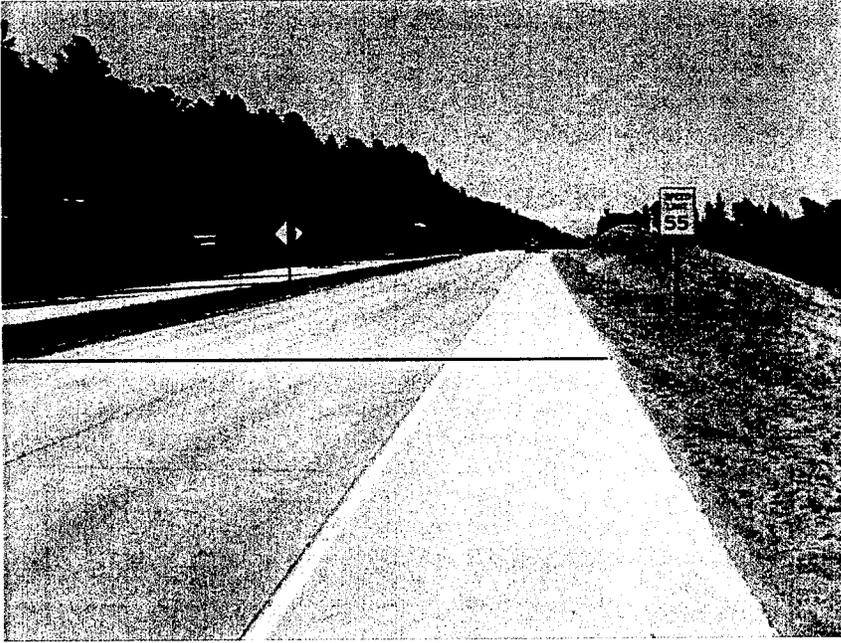
Figure 3. View looking east at transverse tining Test Sections 1, 2 and 3 along US285 mileposts 244.42 to 224.53.

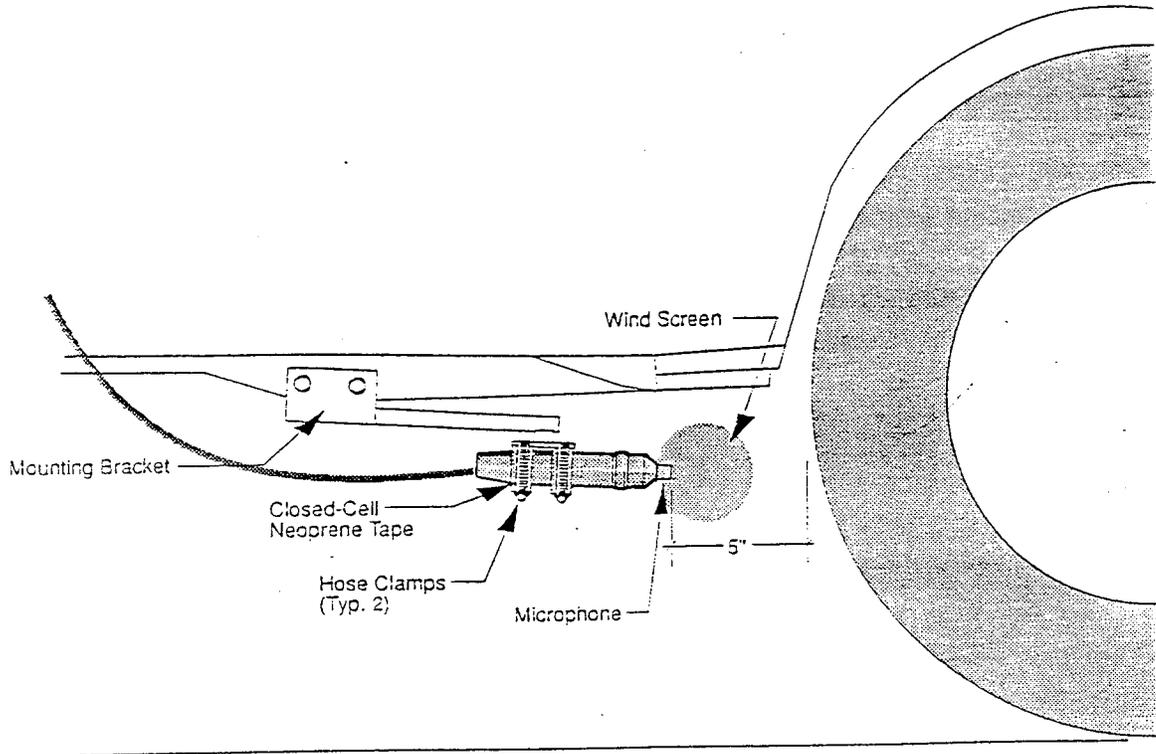
DAVID L. ADAMS ASSOCIATES, INC. 1741 Scudder Street Denver, Colorado 80218 303/455-1900 FAX 303/455-9137	Microphone Mount at Tire Location		
	CDOT: Turkey Creek		
	11-5-30	Project No. 6171	Drawn by MSS

Figure 5. Microphone mount at the tire location.

2. A mounting bracket was fabricated to allow sound measurements to be taken near the rear tire well away from the exhaust pipe. See Figure 5 for illustration of microphone configuration. The sound measurements reported reflect the average sound pressure levels sampled throughout the period in which the vehicle was traveling over sections of each pavement surface.

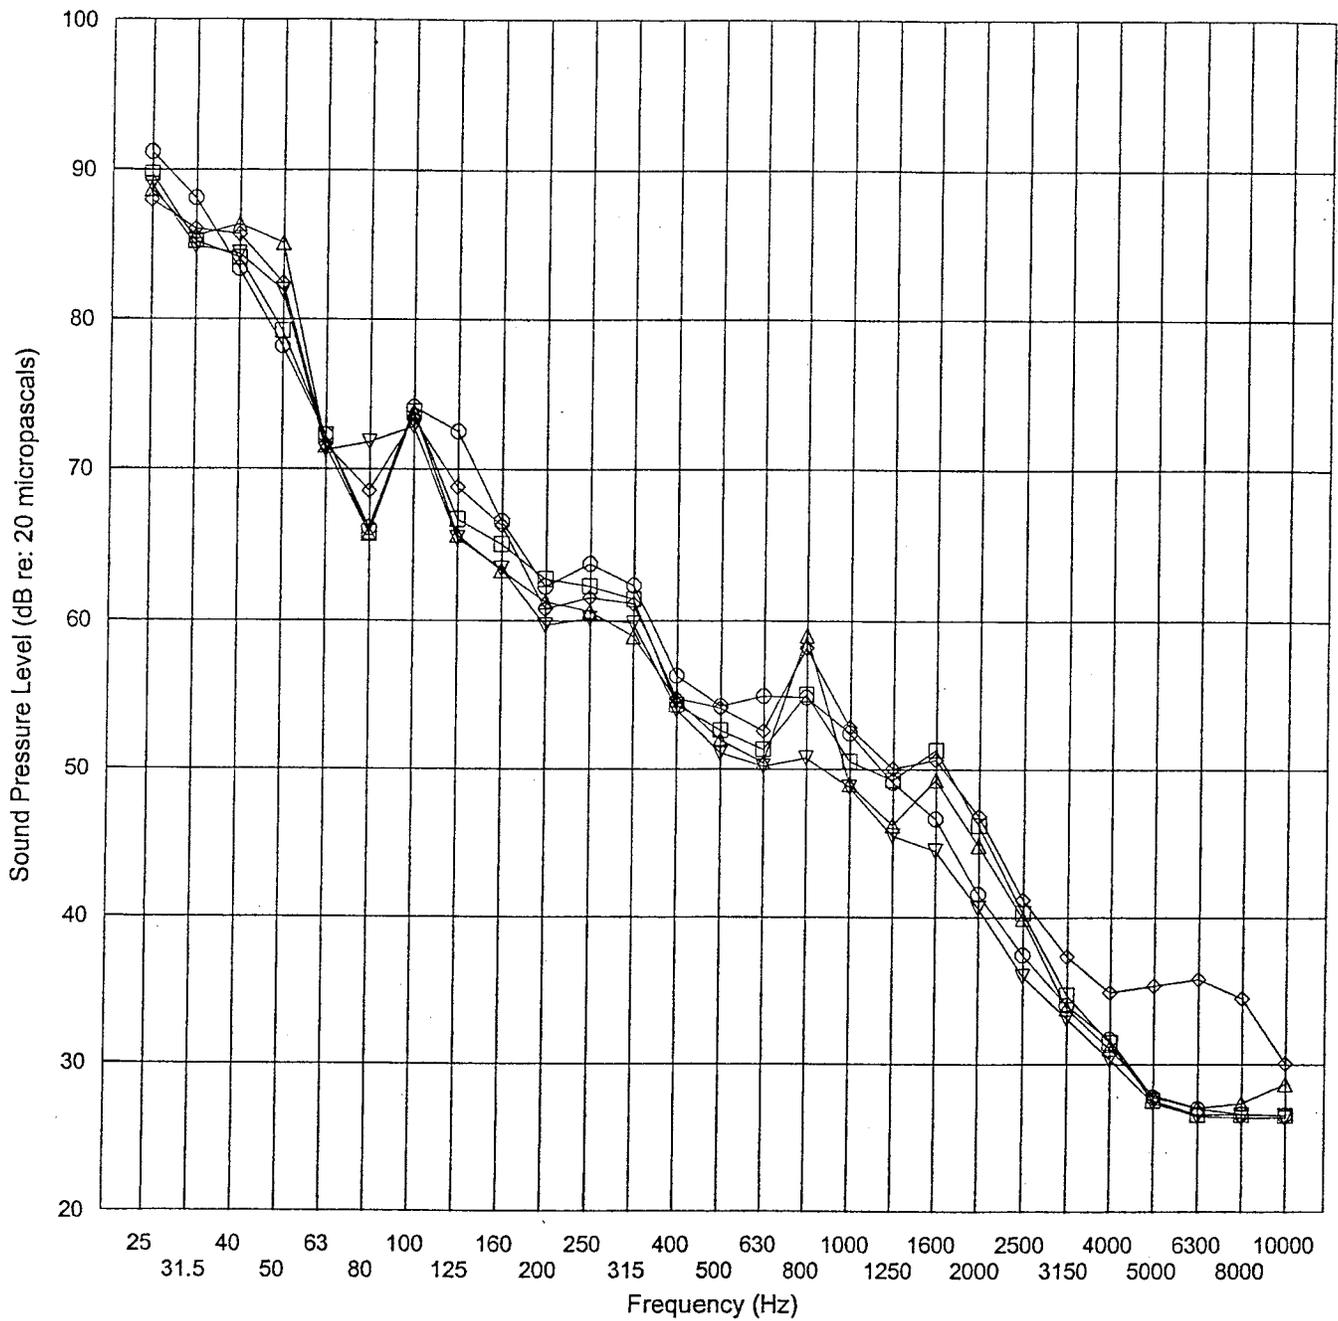
Sound Measurements Taken Inside the Vehicle

Sound Measurements: In Vehicle

The results of the base-line noise measurements are provided in Tables 2 through 4. Frequency spectra data has also been plotted in Graphs 1 through 3 to compare the five roadway test sections under the three measurement conditions of inside vehicle, at the tire well, and at the roadside.

related to the subject vehicle. Graph 1 illustrates an anomaly at the high frequency tail of sound measurements taken inside the vehicle for Test Section 2. This deflection of 2 to 5 dB from the data trend occurs only once and is attributed to extraneous noise generated inside the car, such as driver movement.

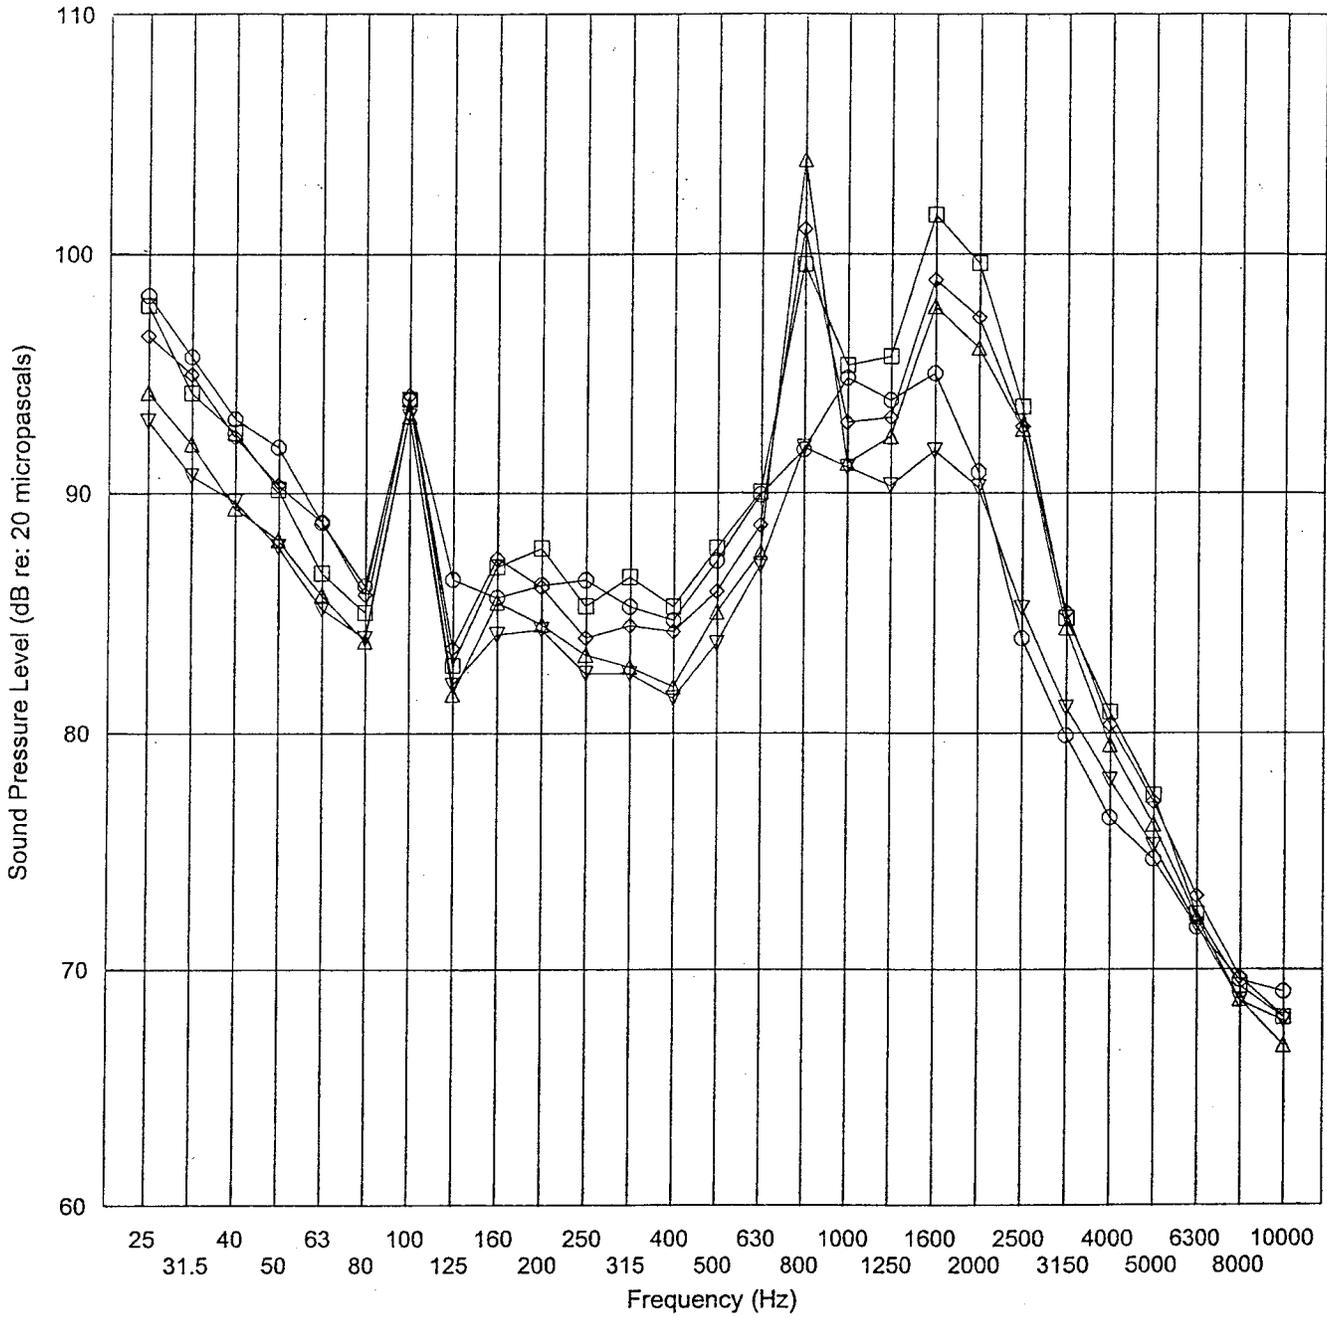
Graph

Sound Measurements Taken at Tire

Sound Measurements: At Tire

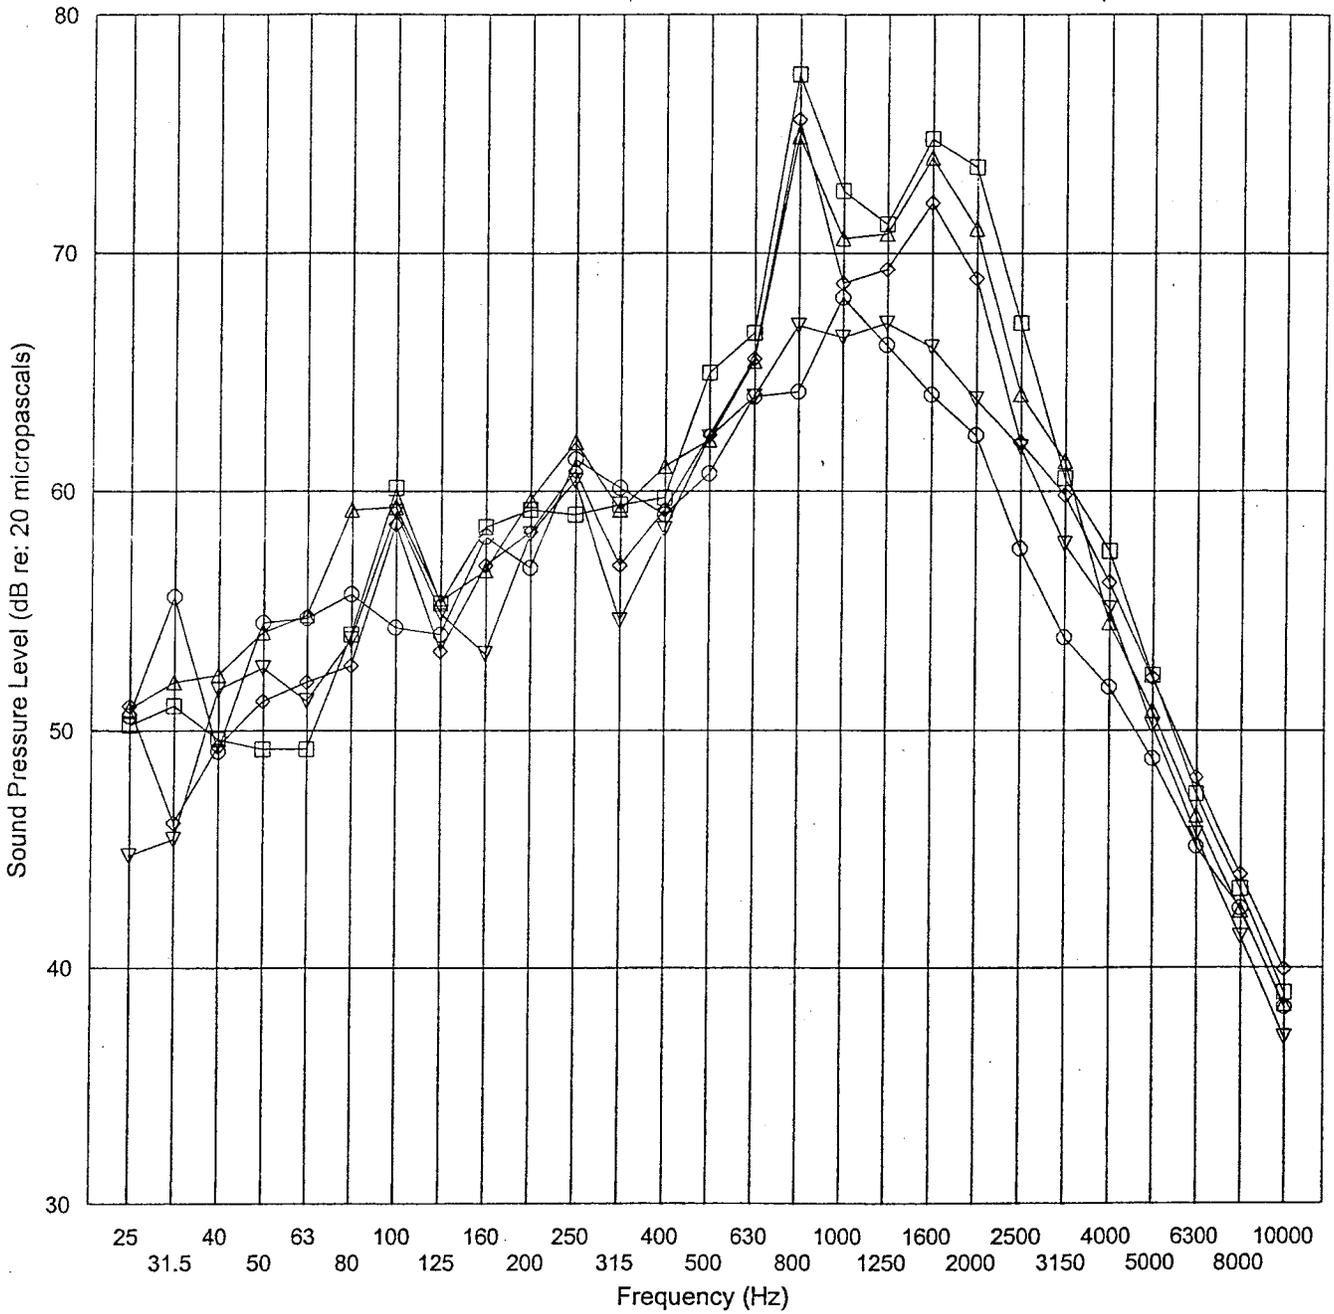
Graph

Sound Measurements Taken at Roadside

Sound Measurements: At Roadside

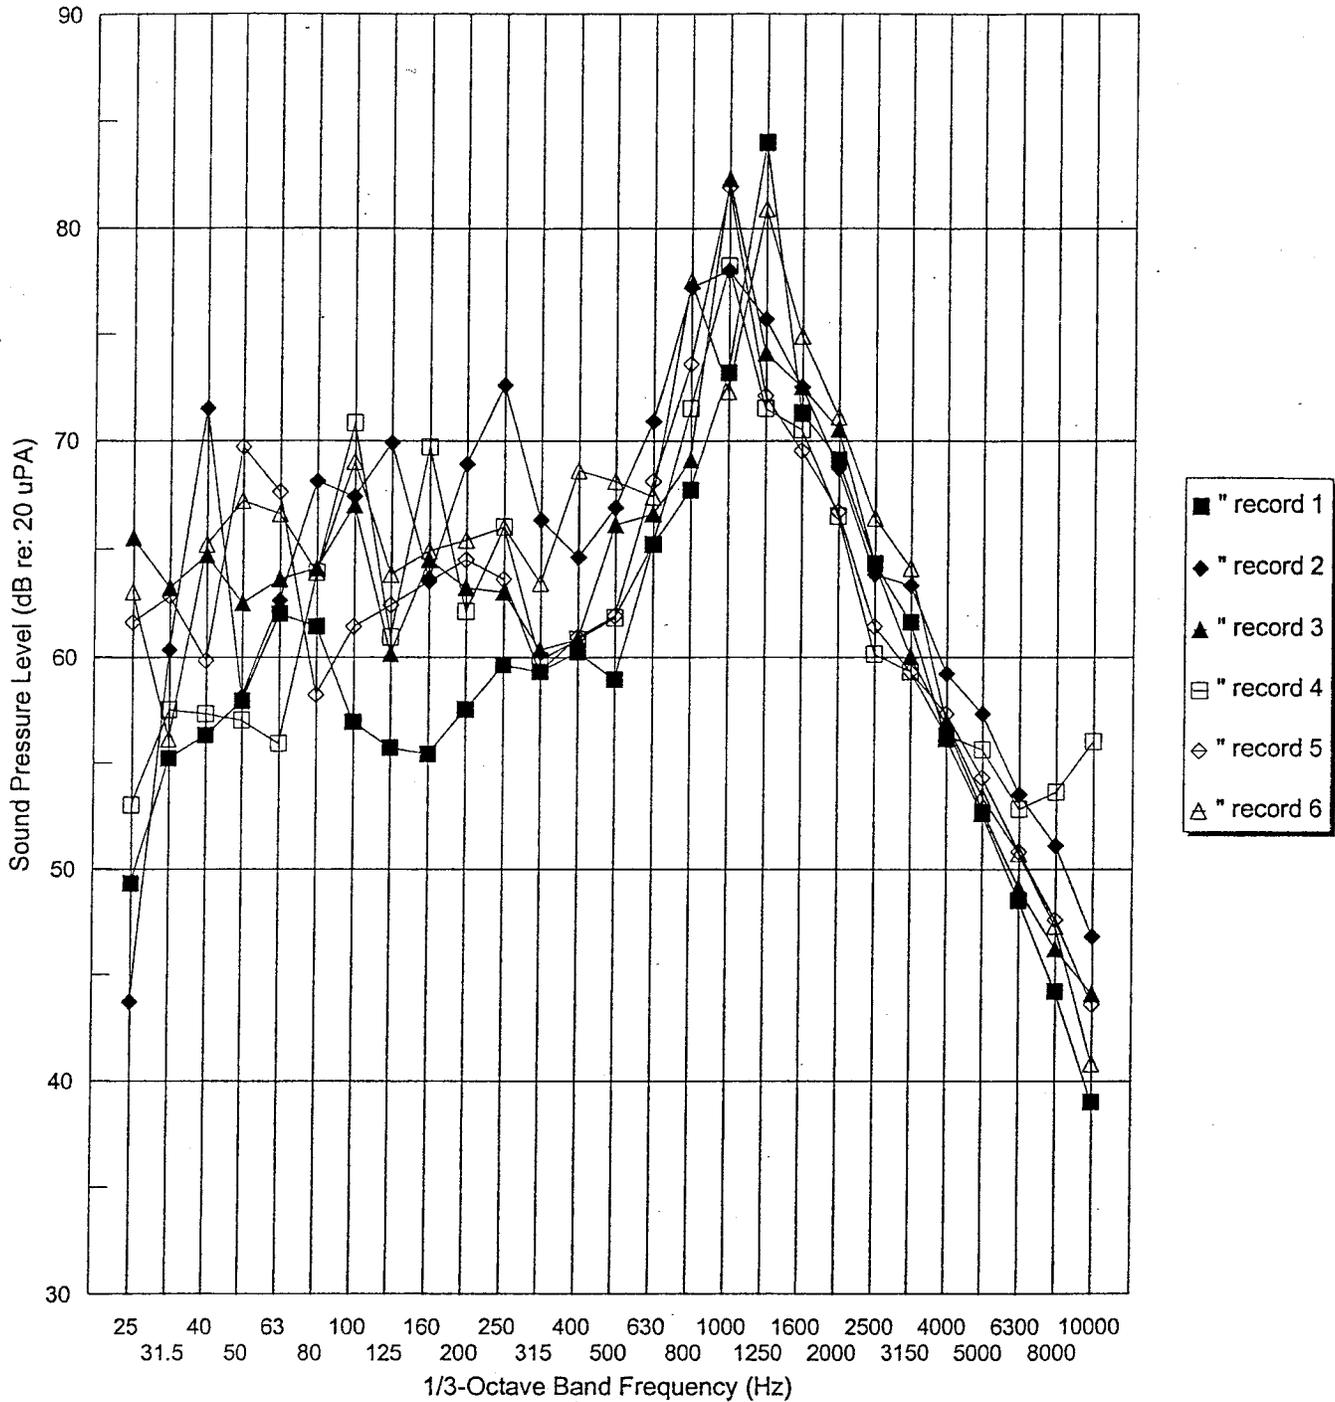
Various Drive-Bys, Unidentified Vehicles

Sound Measurements: Roadside

During the measurements, other random vehicles were sampled on the transverse tined roadway. No record of type of vehicles is provided. The frequency readings for the Oldsmobile station wagon tended to peak at 800 Hz at the roadside (see Graphs 1-3), whereas other vehicles peaked at 1000 Hz or 1250Hz (see Graph 4).

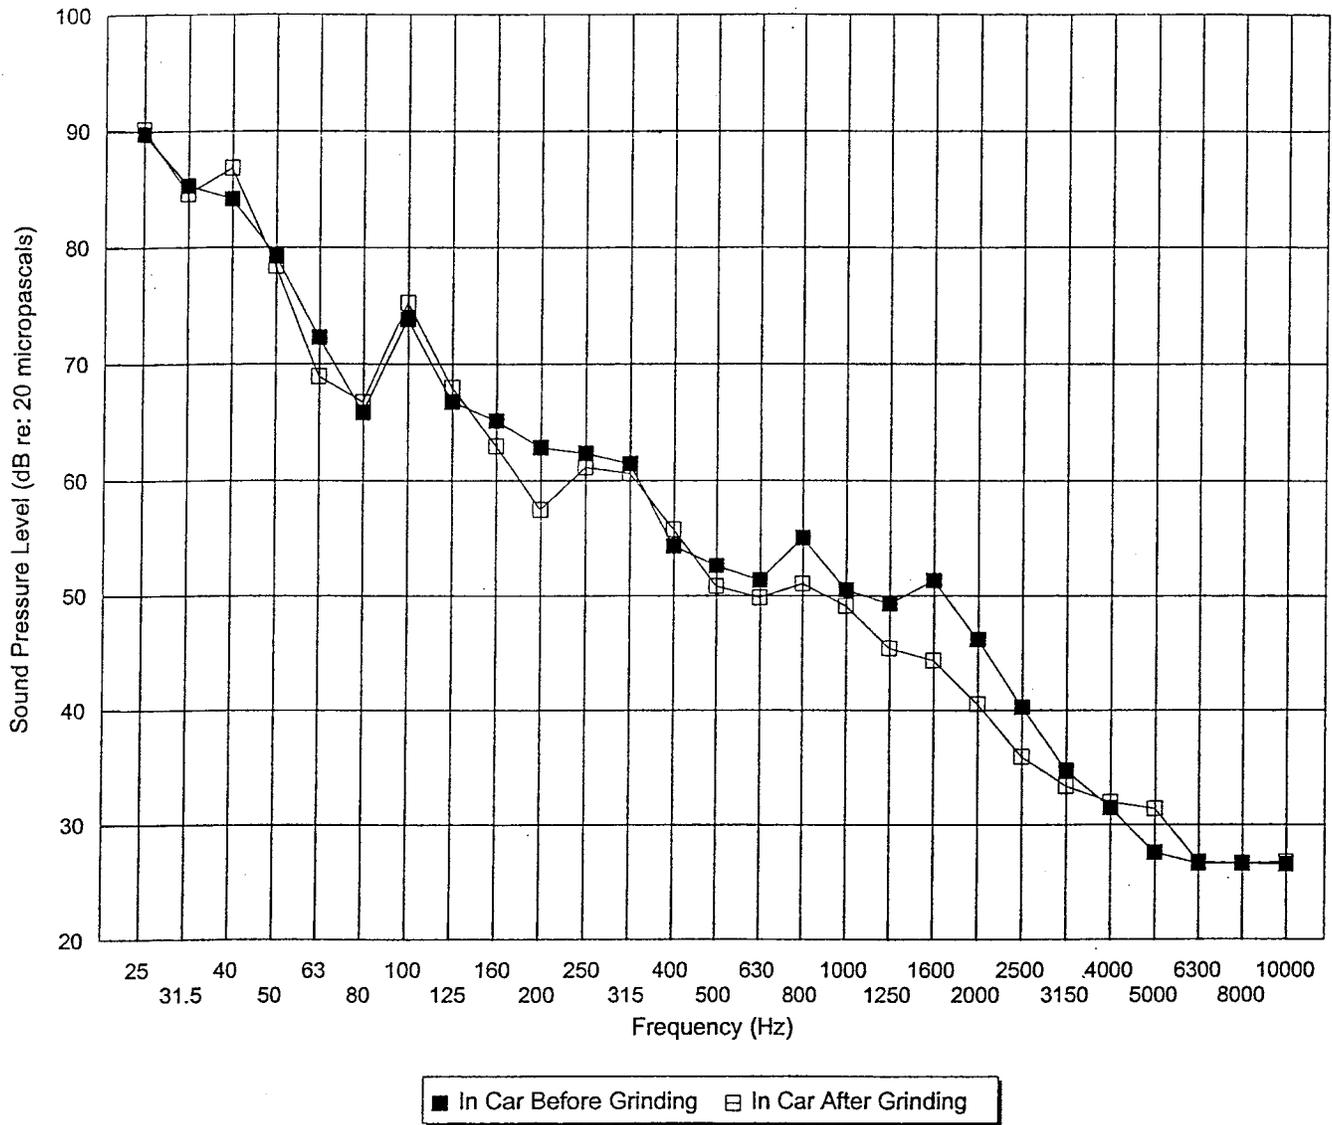
Graph

CDOT: Highway 285, Turkey Creek
 Sound Measurements Inside Car of Transverse Tining vs. Ground Down Road

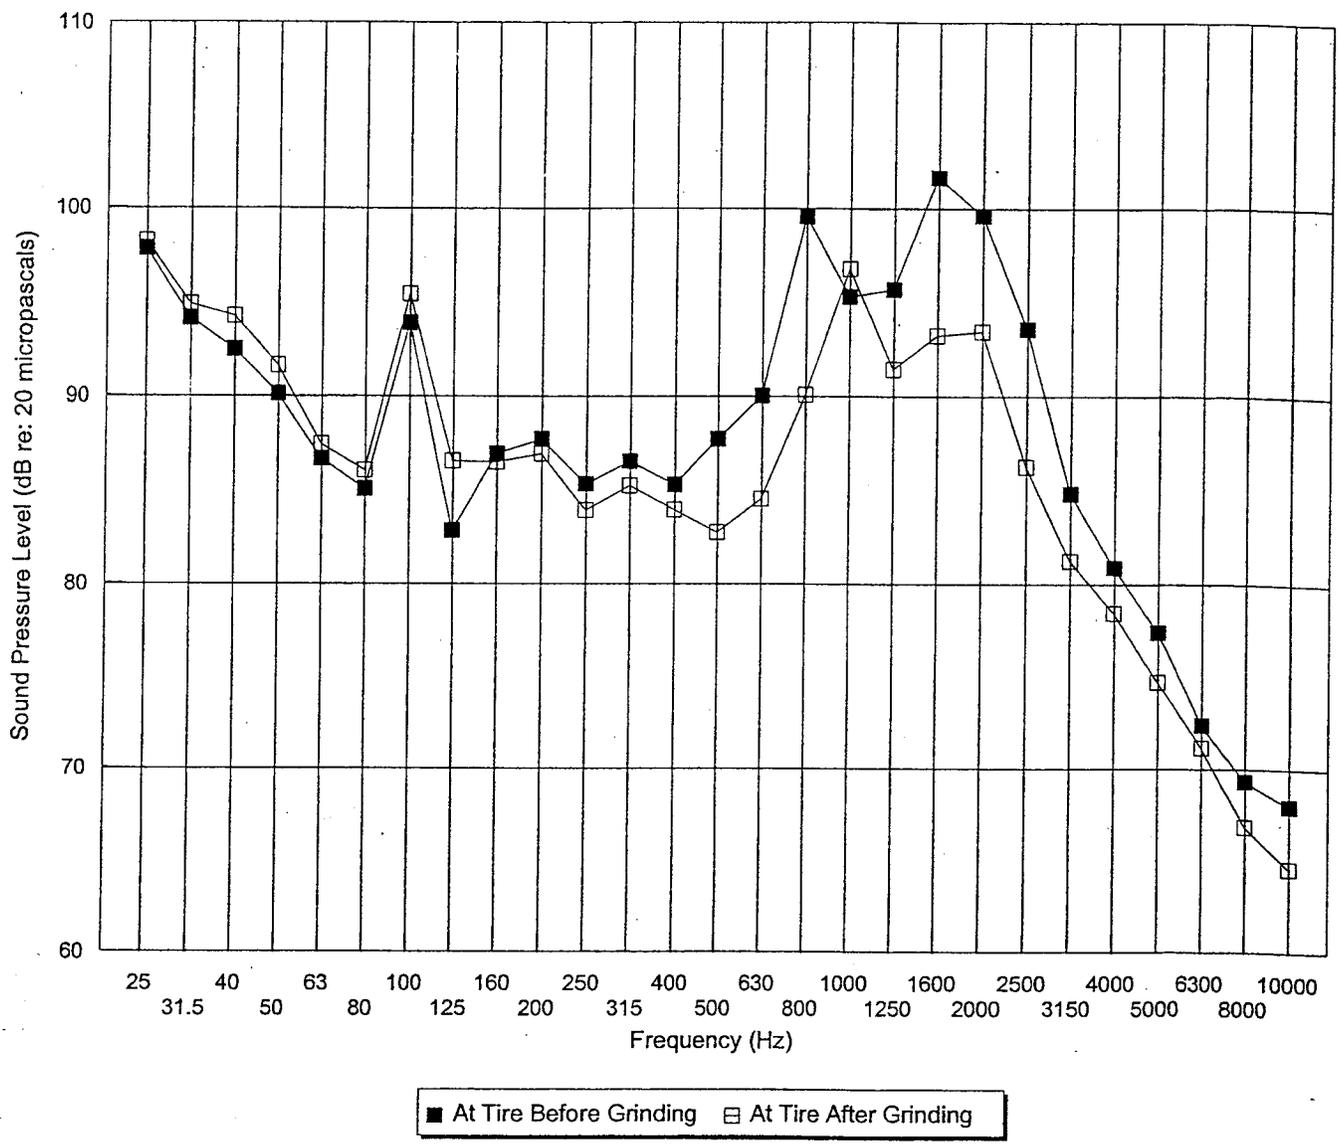
Graph
6

CDOT: Highway 285, Turkey Creek
 Sound Measurements at Tire of Transverse Tining vs. Ground Down Concrete Road

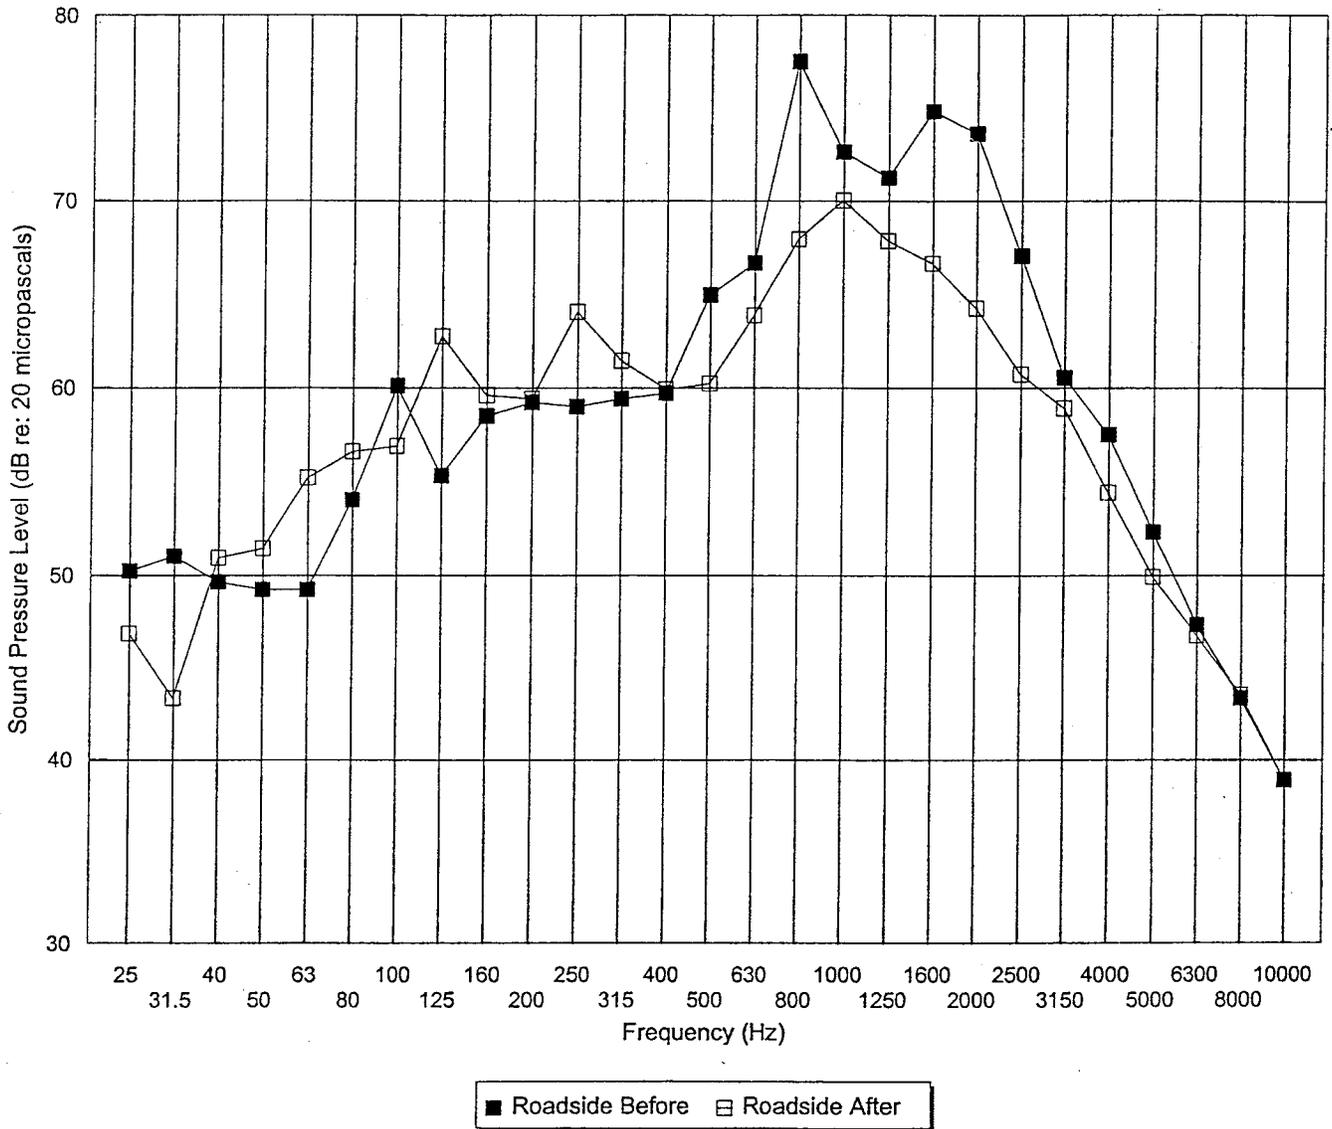
Graph

CDOT: Highway 285, Turkey Creek
 Sound Measurements at Roadside of Transverse Tining vs. Ground Down Concrete Road

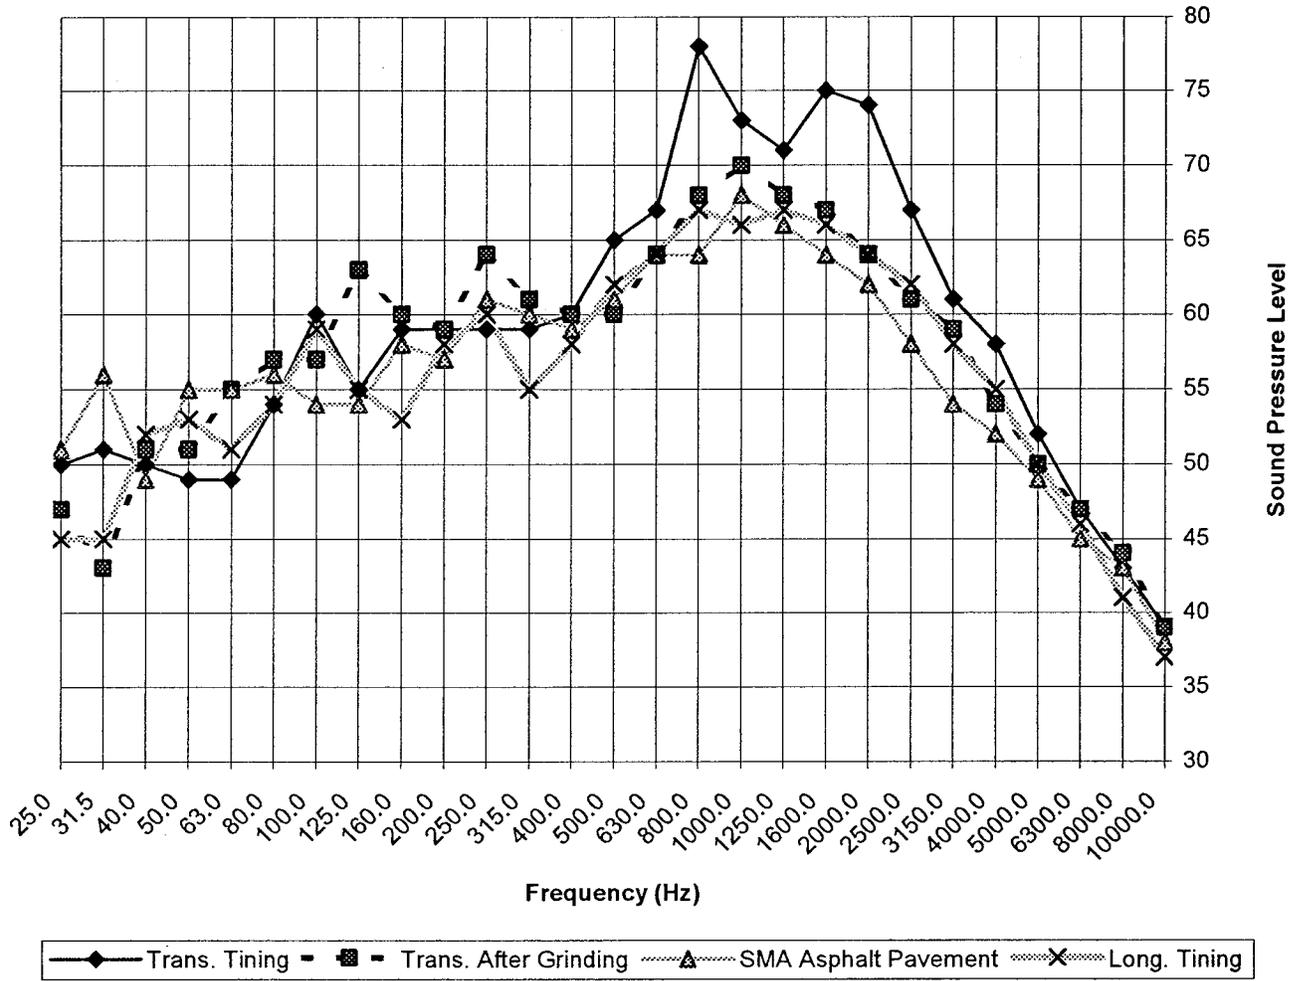
SH 285 Noise Measurements beside Roadway (25 feet from center of Lane)

Graph 8. Comparison of all test sections at roadside to ground transverse tining section.

The result of grinding down ¼ inch of transverse tining at Test Section 1 was a net noise reduction of 6 dB. This is a noticeable noise reduction for the area residents. FHWA noise abatement criteria cites a 5 dB sound level reduction as significant for residential areas. The before and after grinding noise level comparisons for Section 1 are presented in Table 5 and the frequency spectra are plotted as Graphs 5-7. The roadside before and after grinding noise frequency spectra comparisons are charted as Graph 8.
