Report No. VTRC 98-R4	Report Date October 1997	No. Pages 38	Type Report: Final Period Covered: 1/93-6/97	Project No.: 9812-010-940 Contract No.
Title and Subtitle: Field Investigation of the Corrosion Protection Performance of Bridge Decks and Piles Constructed with Epoxy-Coated Reinforcing Steel in Virginia				Key Words: epoxy-coated reinforcement, corrosion, bridge decks, piles
Authors: R.E. Weyers, Ph.D., M.M. Sprinkel, W. Pyc, J. Zemajtis, Y. Liu, and D. Mokarem				
Performing Organization Name and Address: Virginia Polytechnic Institute & State University Blacksburg, VA				
Sponsoring Agencies' Name and Address: Virginia Transportation Research Council Virginia Department of Transportation 530 Edgemont Road 1401 E. Broad Street Charlottesville, VA 22903 Richmond, VA 23219				
Supplementary Notes				
<p>Abstract</p> <p>The corrosion protection performance of epoxy-coated reinforcing steel (ECR) was assessed in three bridge decks and the piles in three marine structures in Virginia in 1996. The decks were 17 years old, two of the marine structures were 8 years old, and the other marine structure was 7 years old at the time of the investigation. The deck investigations included v

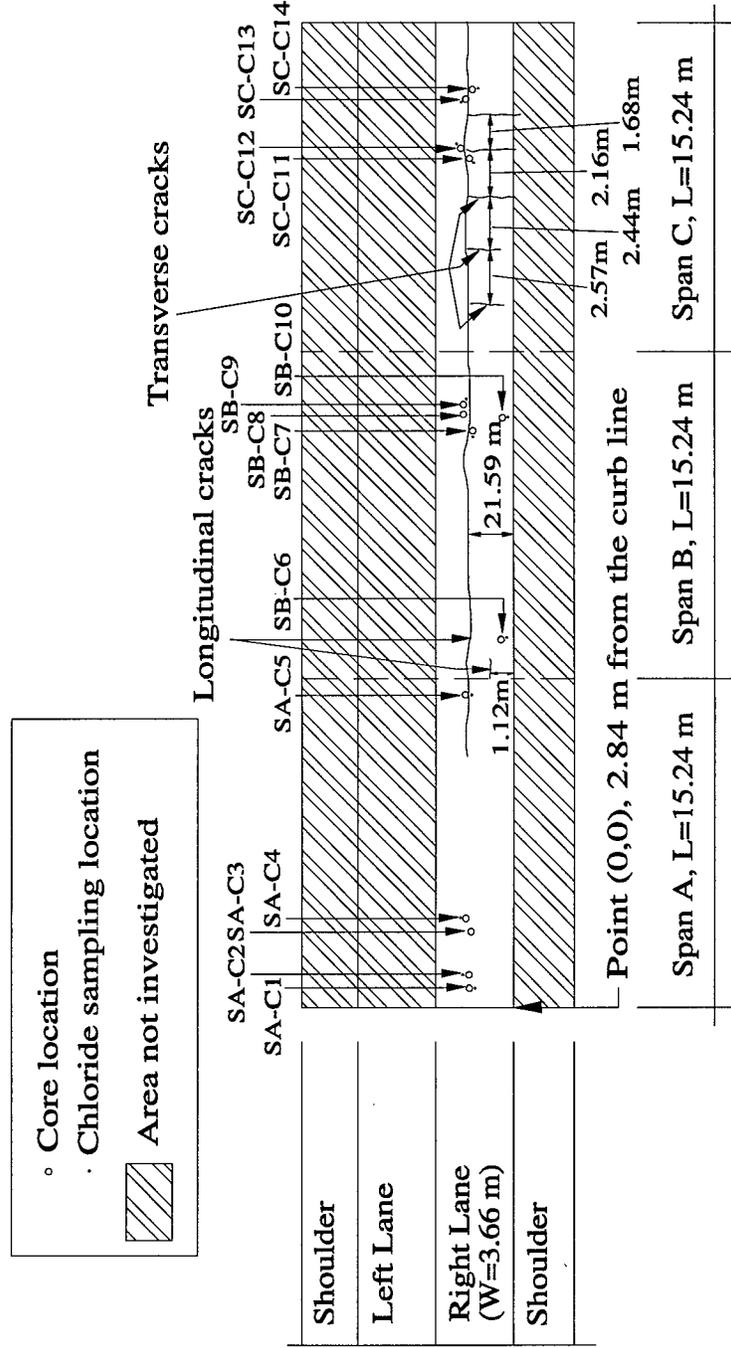
VA 1029 Bridge, Rte. 220 NBL, Franklin Co.

Figure 1. Bridge Deck Investigation Area, Sample Location and Cracking of SN 1026, Botatourt County

Figures 1, 2, and 3 show the visually observed cracks in SN 1026, 1029, and 8003, respectively. Cracking occurred in both the transverse and longitudinal directions. In general, transverse cracks occurred over the ECR, and the longitudinal cracks over girders. The crack frequency for the inspected area was 0.510, 0.273, and 0.429 m/m² for SN 1026, 1029, and 8003, respectively. The cracking appeared to be related to the flexibility of the structure and the quality of the concrete. SN 1029 has the shortest spans and the highest quality concrete based on visual appearance, percent absorption, and chloride diffusion constants. SN 8003 has the poorest quality concrete and is a continuous structure. SN 1026 has the longest simply supported span, and the quality of the concrete in this deck is between that of SN 1029 and 8003.

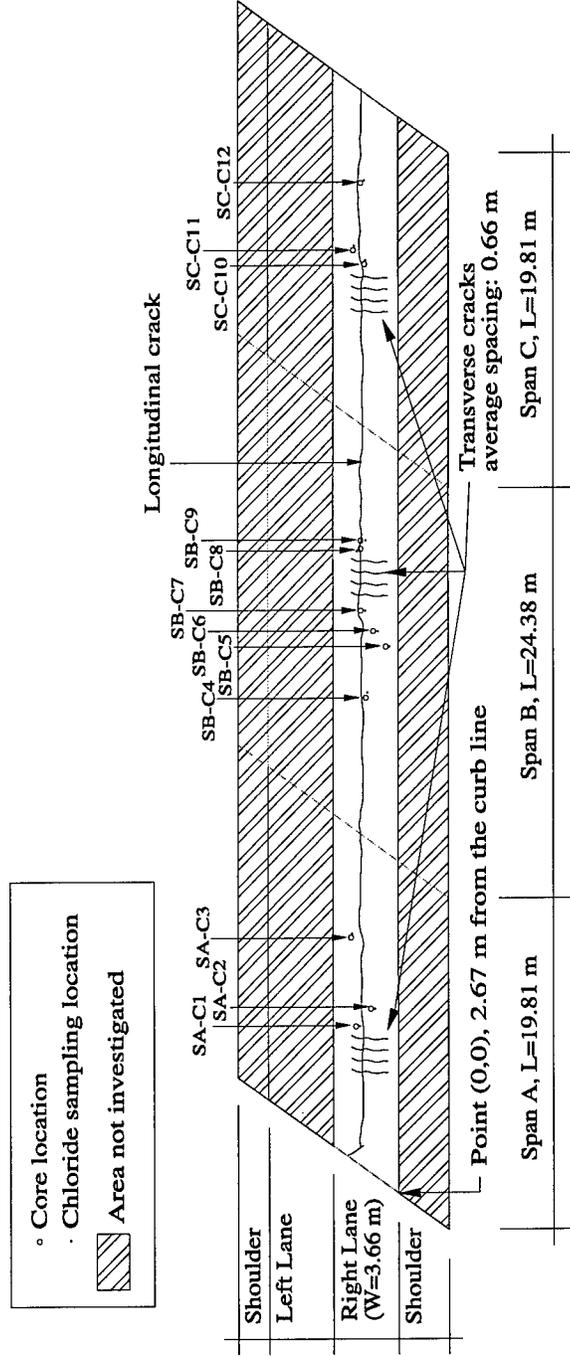
VA 1026 Bridge, Rte. 220 NBL, Botatourt Co.

Figure 2. Bridge Deck Investigation Area, Sample Location and Cracking of SN 1029, Franklin County

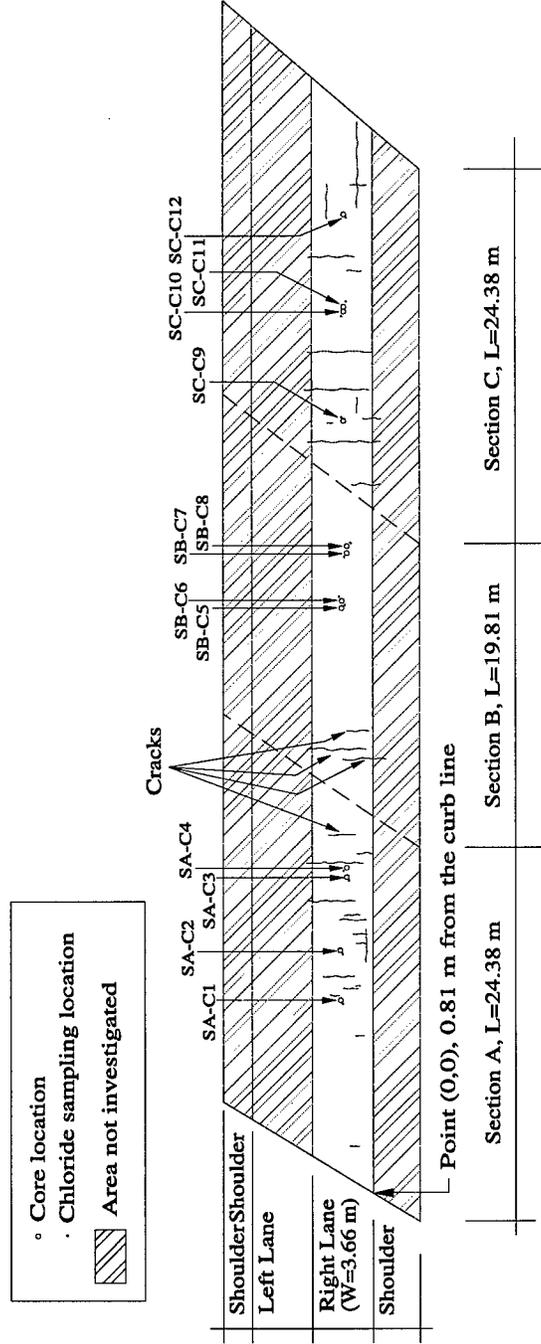
VA 8003 Bridge, Prices Fork Rd. over Rte. 460

Figure 3. Bridge Deck Investigation Area, Sample Location and Cracking of SN 8003, Blacksburg

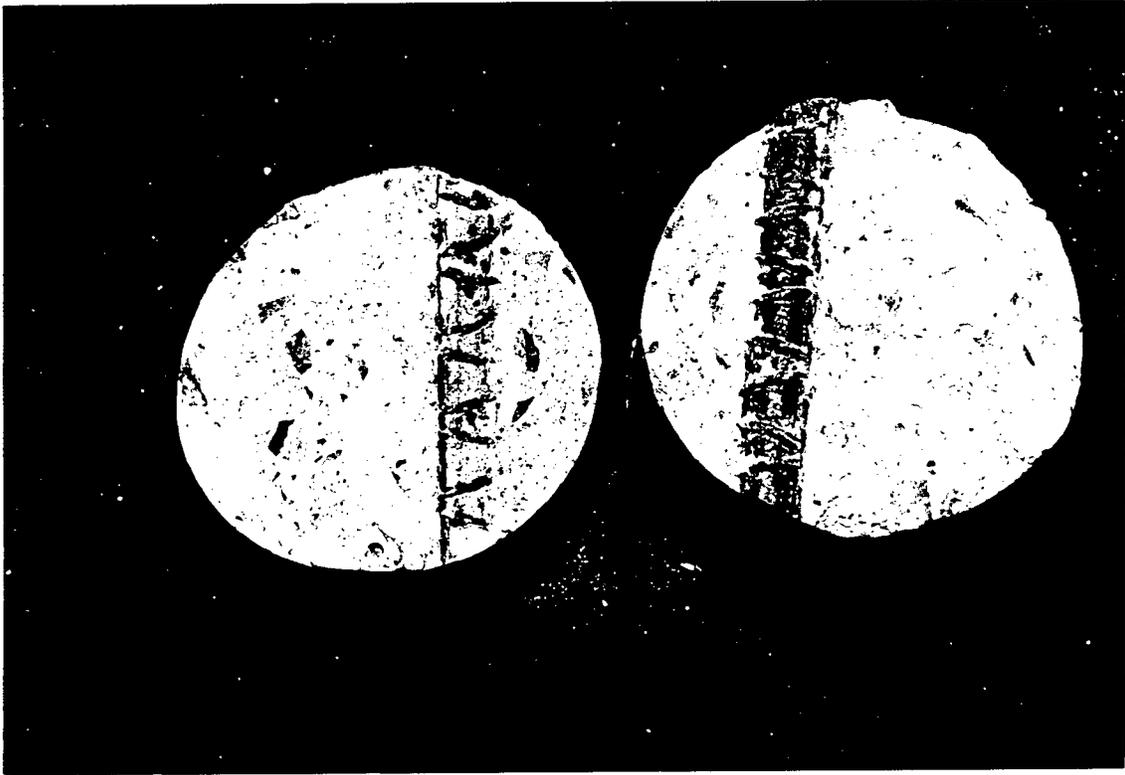
The epoxy coating is debonding from the steel bar surface in bridge decks in Virginia, and corrosion is occurring under the epoxy coating. Figure 4 presents Core SA-C1 SN 8003 and

Figure 4. Corrosion of ECR in Core SA-C1 from SN 8003, Blacksburg

shows corrosion in the ECR trace and on the ECR. Corrosion has occurred on the ribs, cross and longitudinal, and between the ribs. Core SA-C1 and C2 fractured at the depth of the ECR during removal and had corrosion products in the traces and entrapped air voids adjacent to the ECR. Fracture of these cores at the ECR depth occurred with very little resistance. The coring depth was at least 51 mm below the bottom of the ECR, and these two cores were the only cores that fractured at the depth of the ECR with such ease. It was our opinion, at the time of coring, that the corrosion of these ECRs had initiated a delamination crack at the depth of the ECR resulting in the fracturing of the concrete at the depth of ECR during removal. Subsequent sounding with a 1.36-kg hammer confirmed the delaminations at core locations SA-C1 and C2 from SN 8003. The delaminated areas at core locations SA-C1 and C2 were 0.60 and 0.14 m², respectively. The sounding at the remaining 10 core locations on SN 8003 indicated sound cover concrete.
