Report No. CDOT-DTD-97-10

# **LOADING TEST OF GRS BRIDGE PIER AND ABUTMENT IN DENVER, COLORADO**

Kanop Ketchart  
Jonathan T.H. Wu  
Reinforced Soil Research Center  
Department of Engineering  
University of Colorado at Denver

Final Report  
October 1997

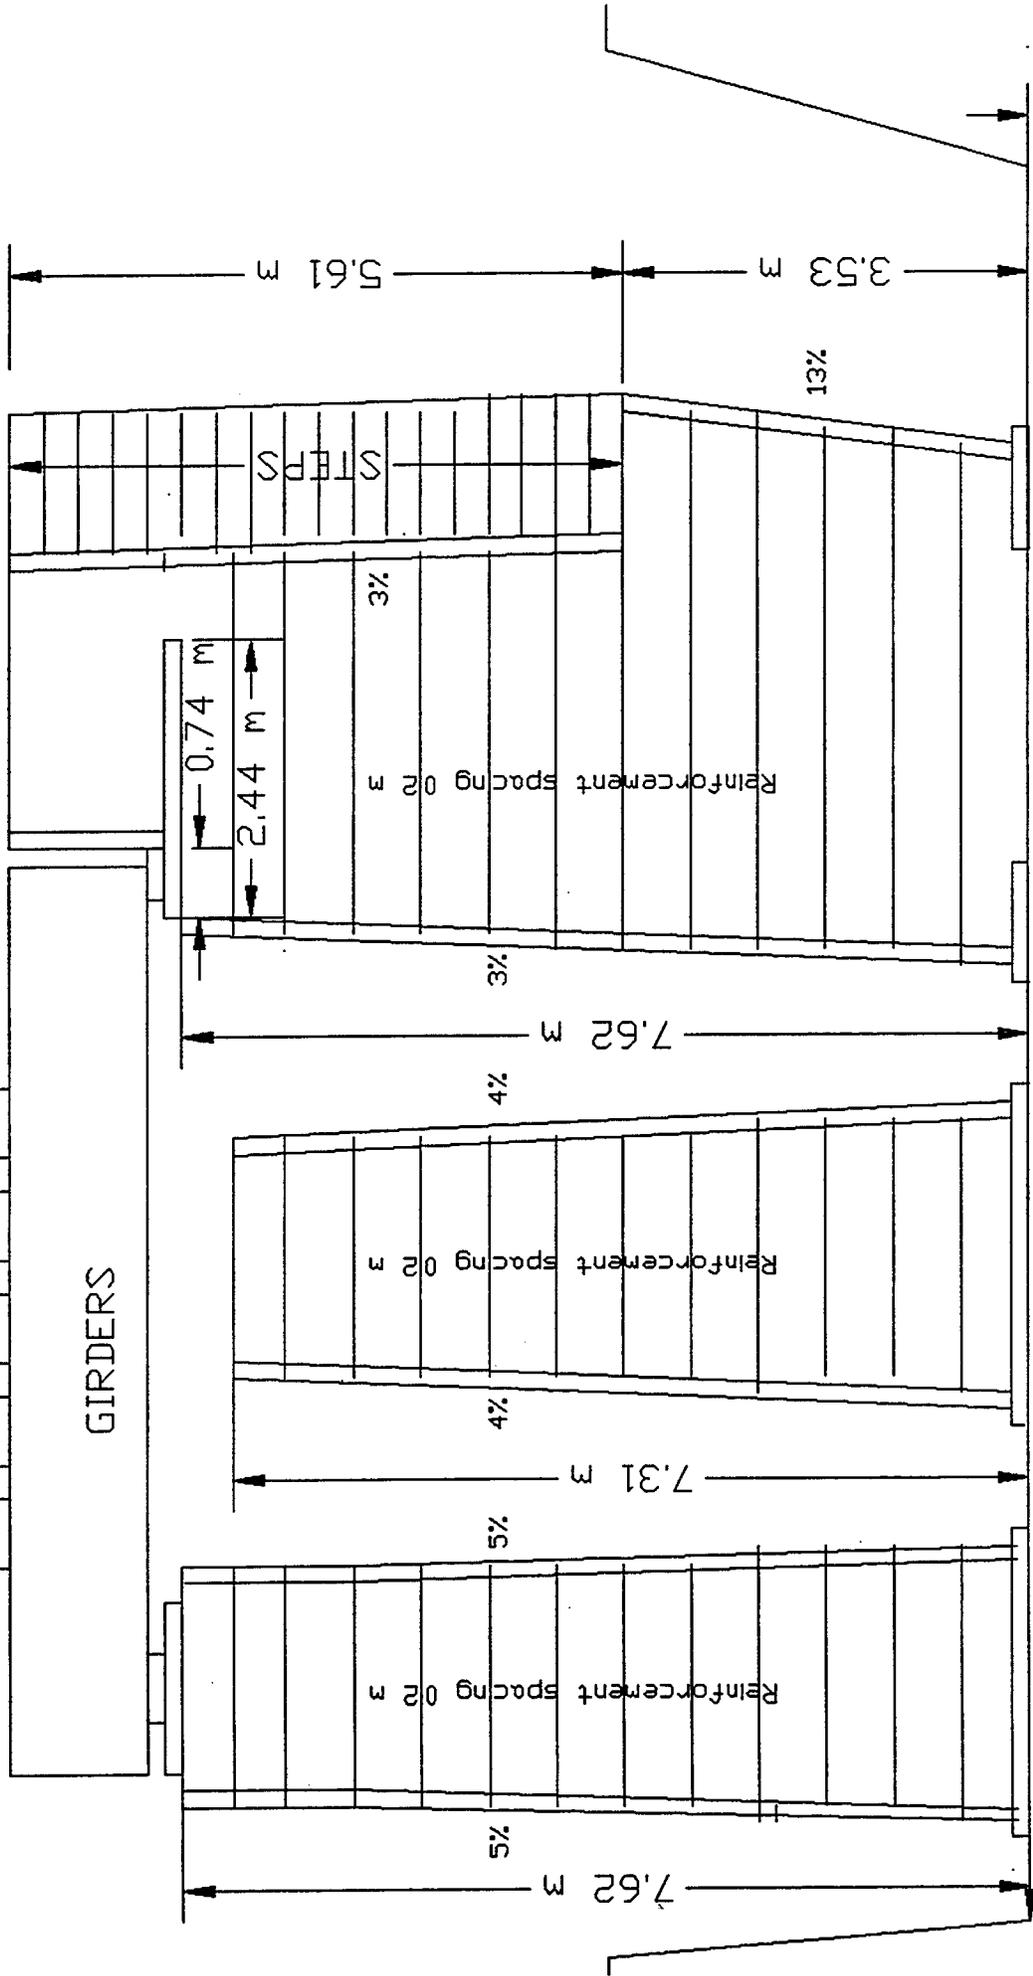
Fig. 1 Side View of the Structures

This project consisted of two piers and one abutment. These structures were situated in a 3.53-m deep pit as depicted in Figure 1. The outer pier and the abutment were 7.6 m tall. The center pier was 7.3 m tall, 0.3 m shorter than the outer pier and the abutment. The pier was made shorter for the purpose of a second-stage load test to be conducted at a later time.

The piers and the abutment were constructed on a 0.15-m thick concrete pad placed over the reinforced soil foundation (see Figure 1). The vertical spacing of the geotextile reinforcement in all three structures was 0.2 m. The reinforcement covered the entire top surface area of backfill and facing blocks at each construction lift. The top four layers of the reinforcement in the abutment employed a wrapped-around procedure behind the facing block. A geotextile "tail", 1.2 m in length, was placed between each of these four layers to connect the backfill to the facing blocks. Modular blocks, 0.2 m in height, were used as the facing element for all three structures. Compaction of the backfill was conducted at each course of the facing blocks. The facing element was made to incline from the base to the top of approximately 5% in outer pier, 4% in the center pier and 3% in the abutment. On the east side of the abutment, the facing assumed a 13% negative batter up to a height of 3.5 m. From 3.5 m to the top of the abutment were walking steps as shown in Figure 1. The negative batter was made to examine the feasibility and stability of such a facing configuration.

On top of the piers and the abutment were 0.3 m-thick concrete pads to support steel bridge girders. The concrete pads were 0.9 m wide and 3.1 m long for the piers and 2.4 m wide and 3.7 m long for the abutment, as shown in Figure 2. It is to be noted that the clearance of the concrete pad was only about 0.02 m behind the back face of the abutment facing blocks (see Figure 1).

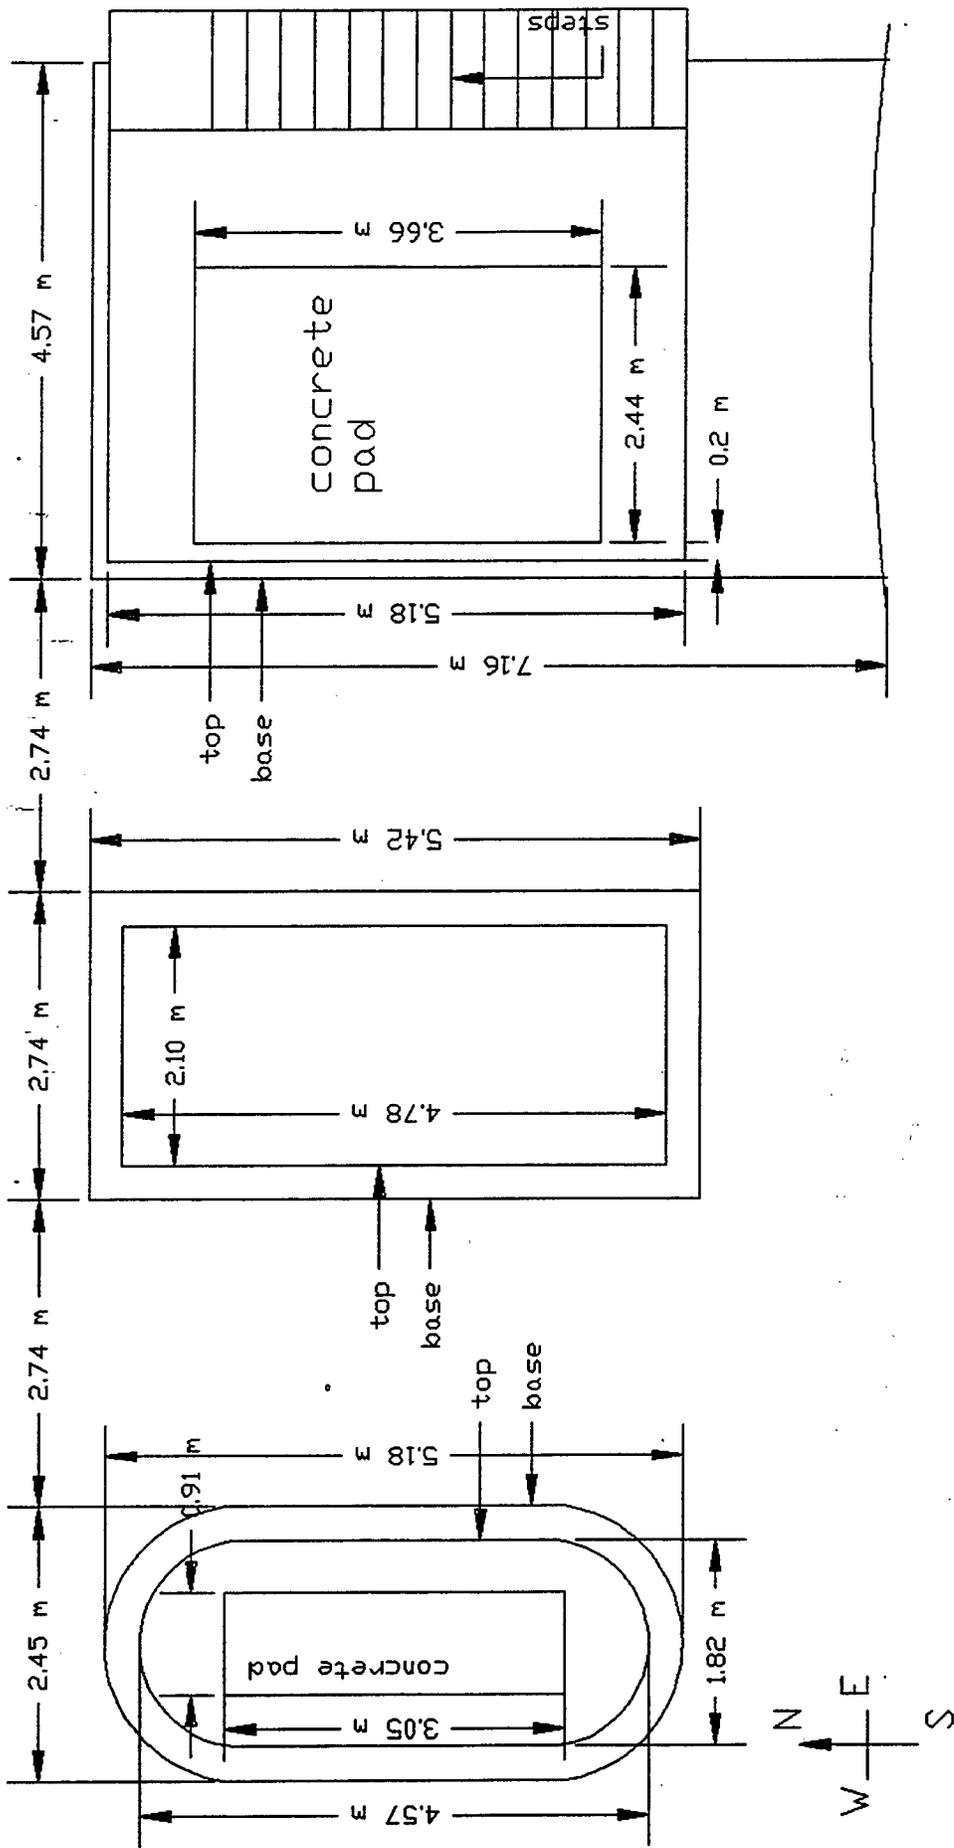
Fig. 2 Top View of the Structures

The center pier and the abutment were of a rectangular shape and the outer pier was of an oval shape, as shown in Figure 2. The bases of the outer pier, the center pier, and the abutment were 2.4 m by 5.2 m (major and minor axes), 2.7 m by 5.4 m, and 4.6 m by 7.2 m, respectively. The tops of the outer pier, the center pier, and the abutment were, respectively, 1.8 m by 4.6 m (major and minor axes), 2.1 m by 4.8 m, and 3.6 m by 5.2 m. The edge to edge distance between the outer pier and the center pier and between the center pier and the abutment was 2.7 m.

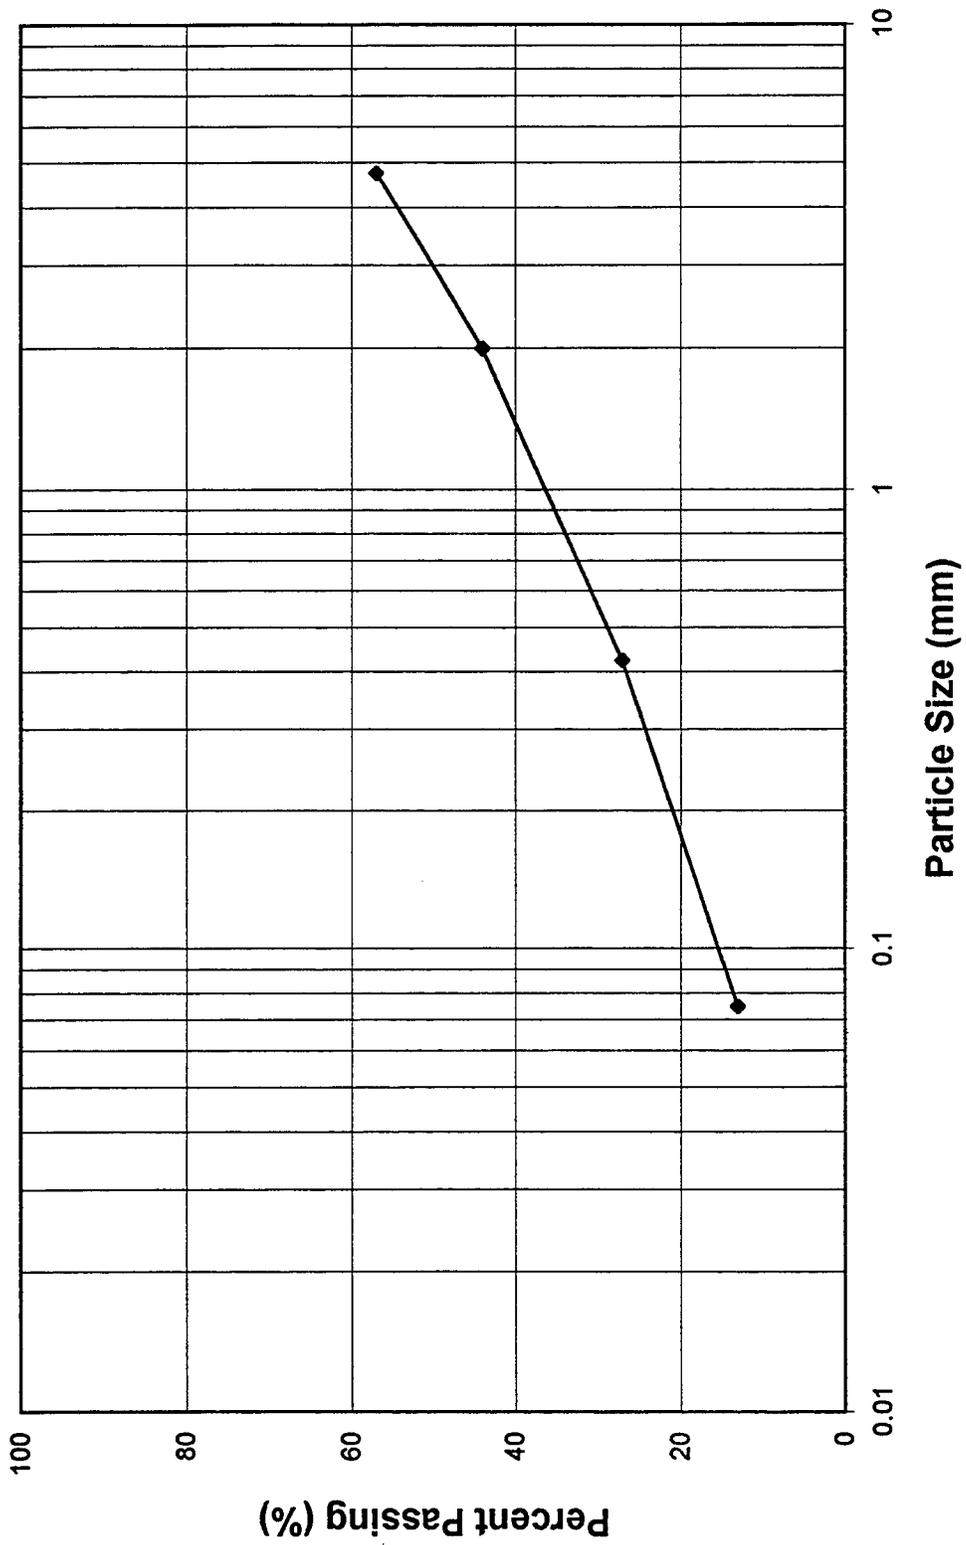
Fig. 3 Gradation Curve

The backfill was a "road base" material classified as A-1-A(0) according to AASHTO. It has 13% of fine particles (passing sieve #200). The gradation curve is shown in Figure 3. The maximum dry unit weight, per AASHTO T180 method D, is  $21.2 \text{ kN/m}^3$ . The optimum moisture is 6.7 %.

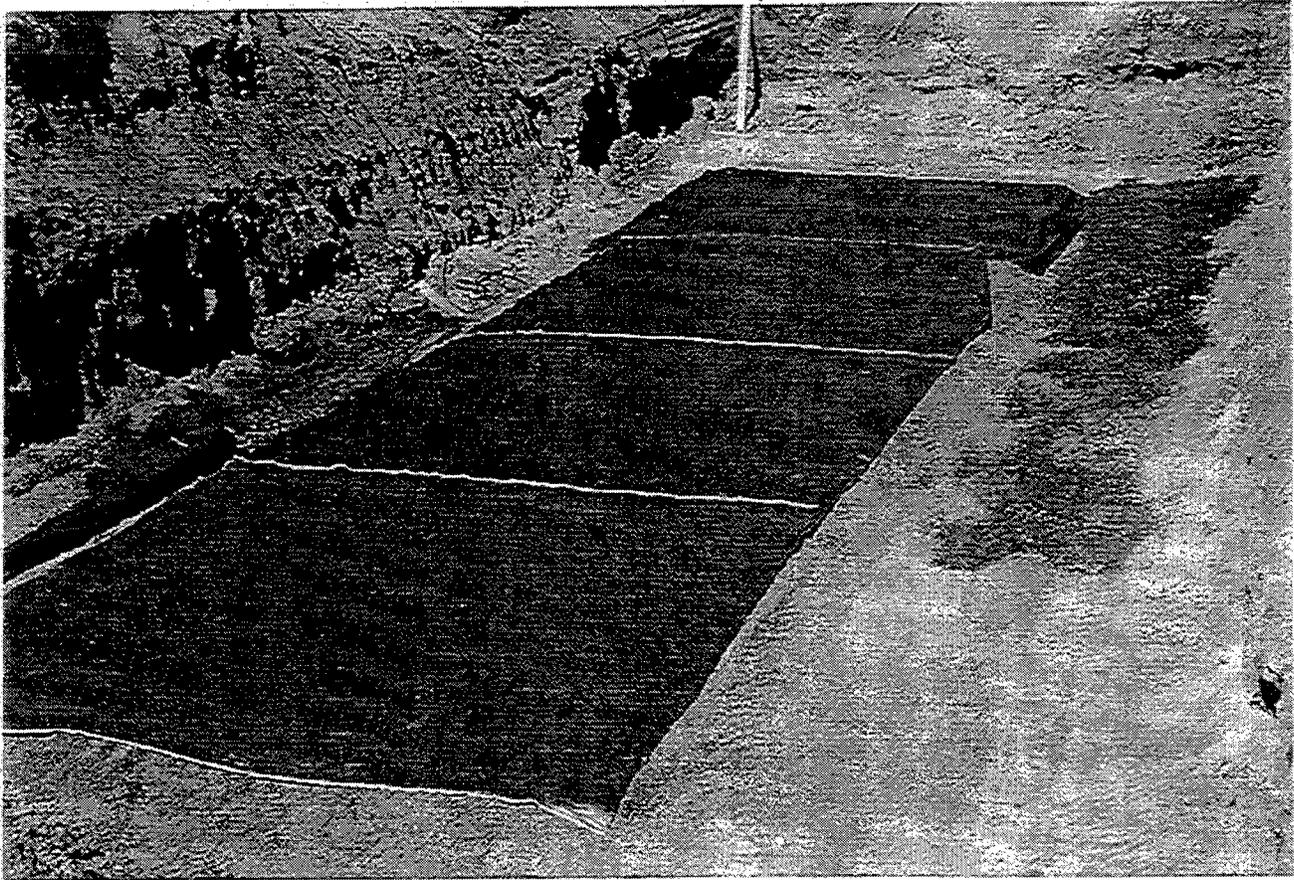
Plate 3 Reinforced Soil Foundation with a Woven Geotextile Reinforcement

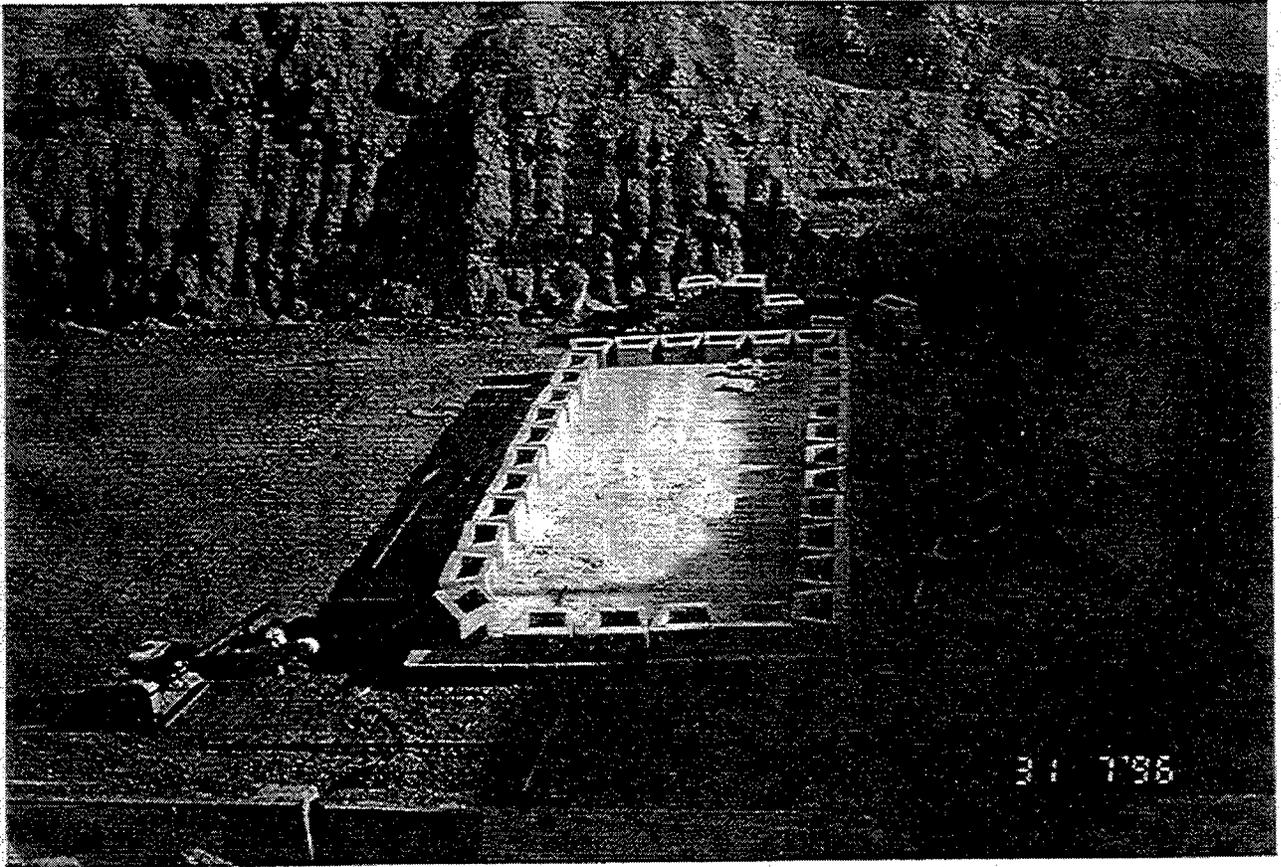
Plate 4 Laying the First Course Facing Block on a Concrete Pad  
*(Note the light-weight compaction plant at the lower left-hand corner)*

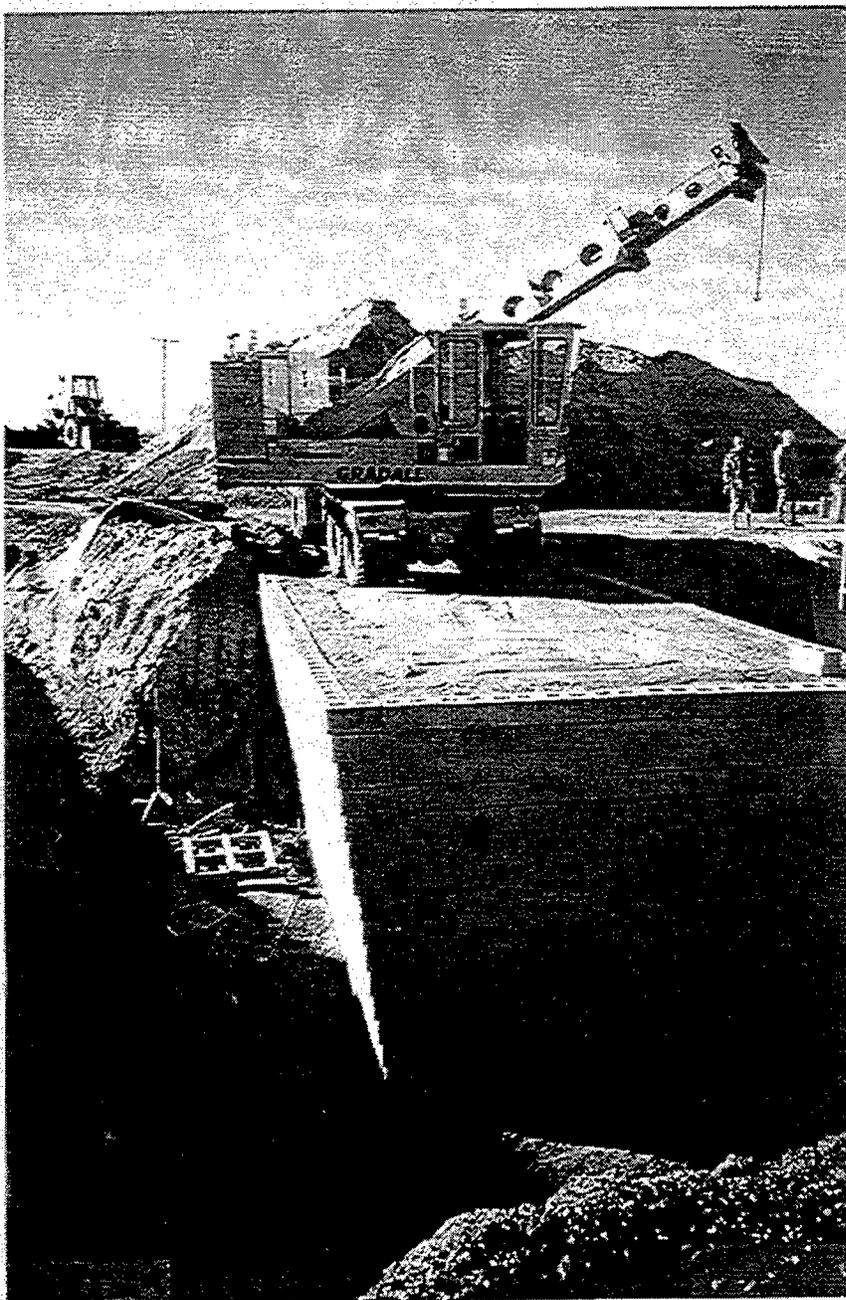
Plate 8 Construction of the GRS Abutment with a Negative Batter

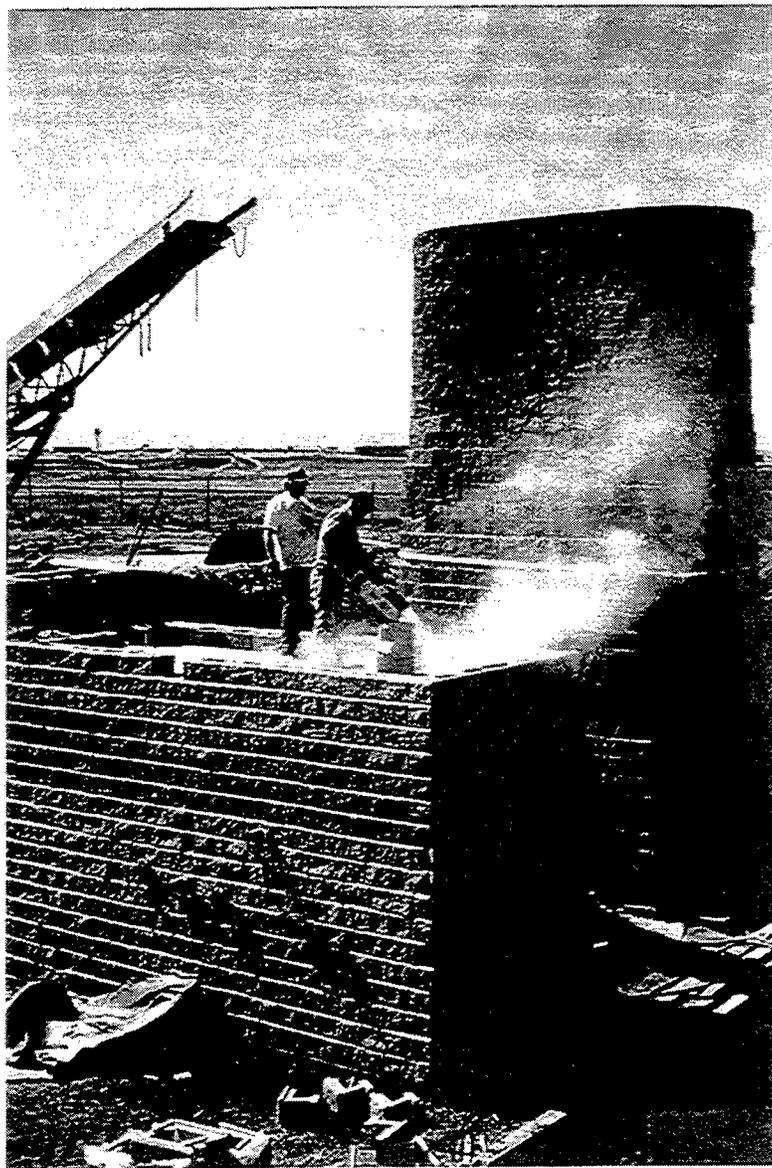
Plate 9 Cutting Concrete Blocks to Conform to the Designed Configuration

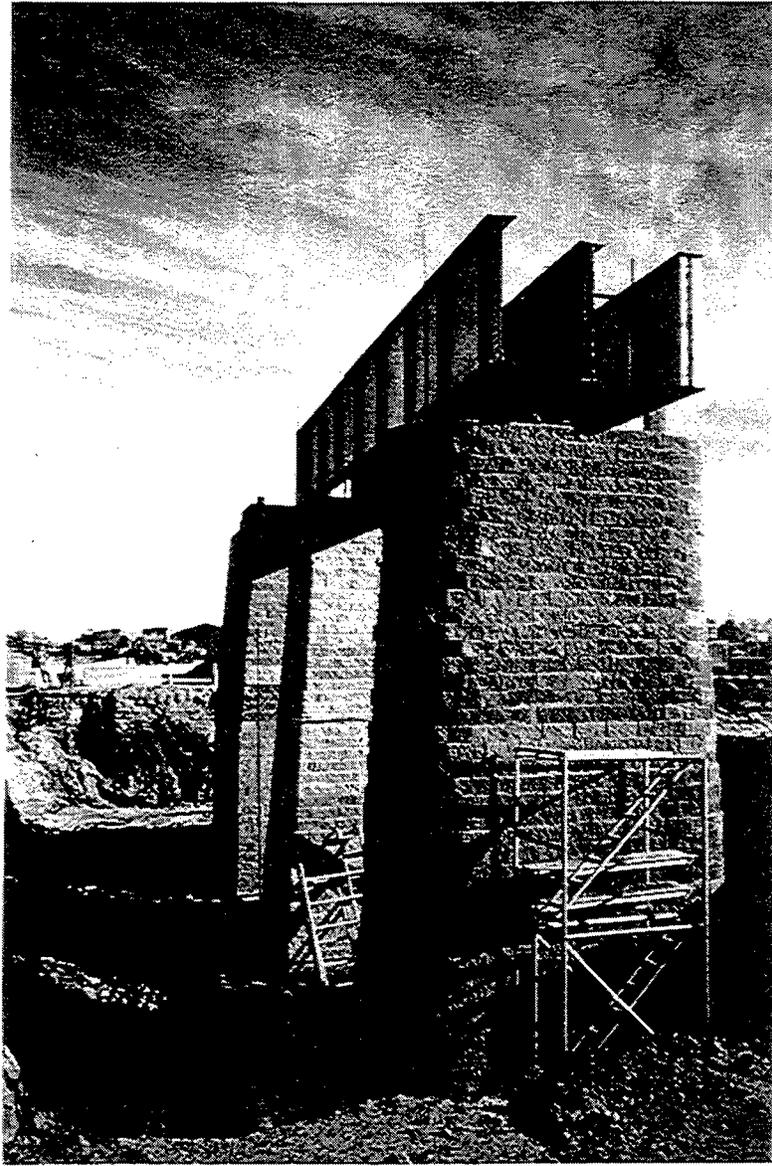
Plate 11 Three Steel Bridge Girders were Welded Together

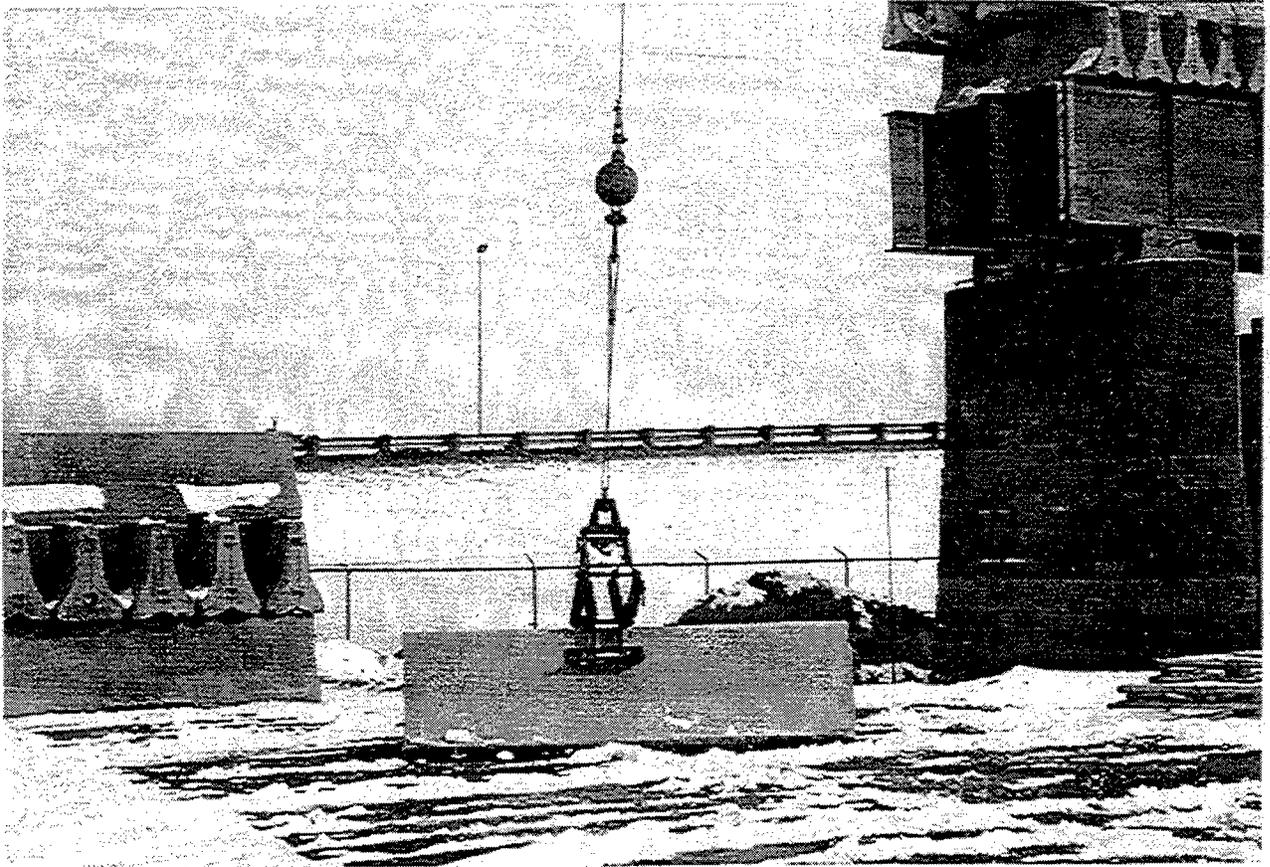
Plate 12 A Clamp of a Forklift was Used to Lift a Jersey Barrier

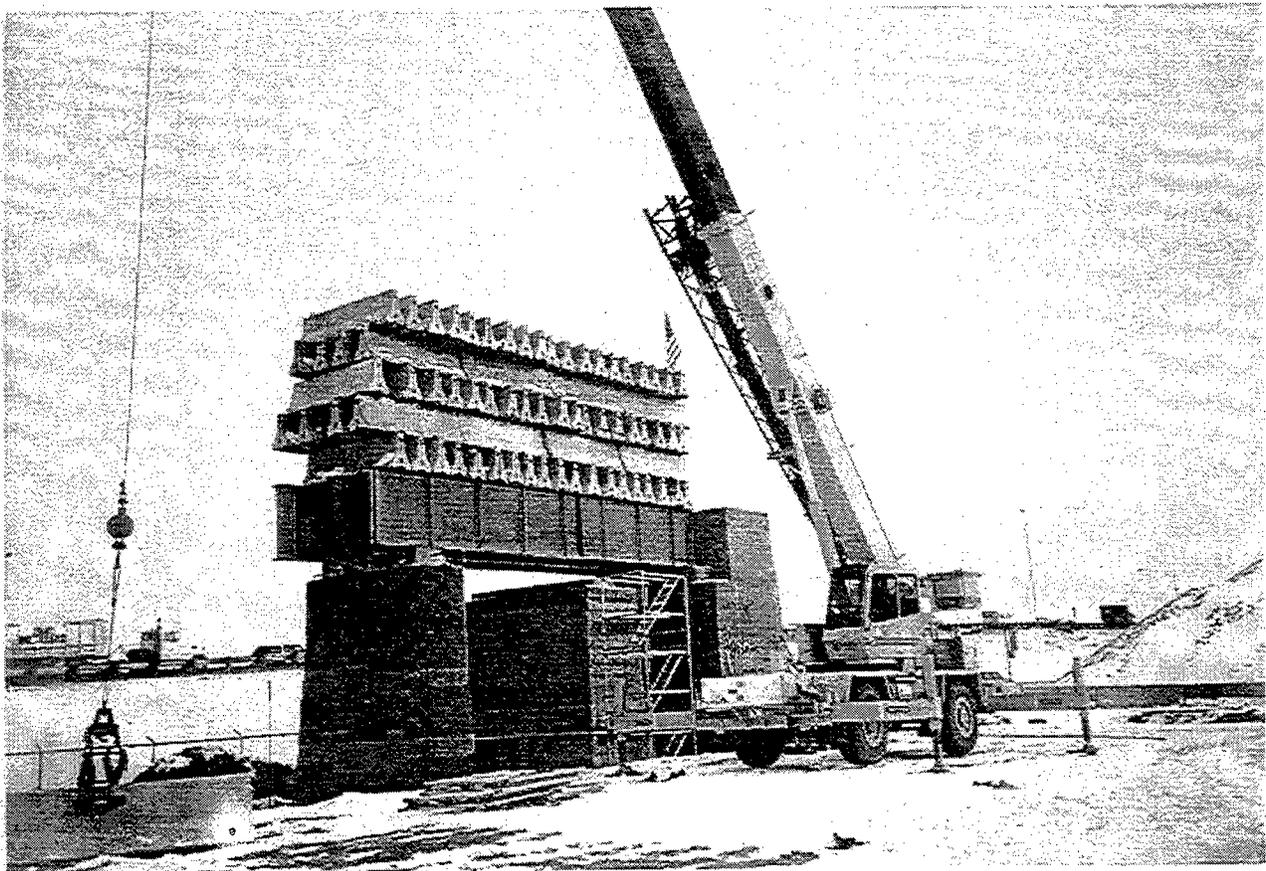
Fig. 4 First-Stage Load Test

Three steel bridge girders were placed over the top concrete pads of the outer pier and the abutment. Each girder was supported by steel bearing plates resting on the concrete pads. The steel bearing plates were located along the center line of the top concrete pad of the outer pier, and a 0.3 m offset from the back face of the abutment facing blocks. The span of the girders was 10.4 m. A total of 124 concrete blocks ("Jersey Barriers") was placed on the girders in seven layers as shown in Figure 4. The total load was 2,340 kN which corresponded to an applied pressure of 232 kPa on the outer pier. Note that such a pressure is slightly higher than the 200 kPa maximum pressure suggested in the FHWA Demo 82 (1996) for mechanically stabilized bridge abutments. Also note that the maximum applied pressure of the Turner-Fairbank's test was 900 kPa which was about four times higher than the suggested maximum pressure.

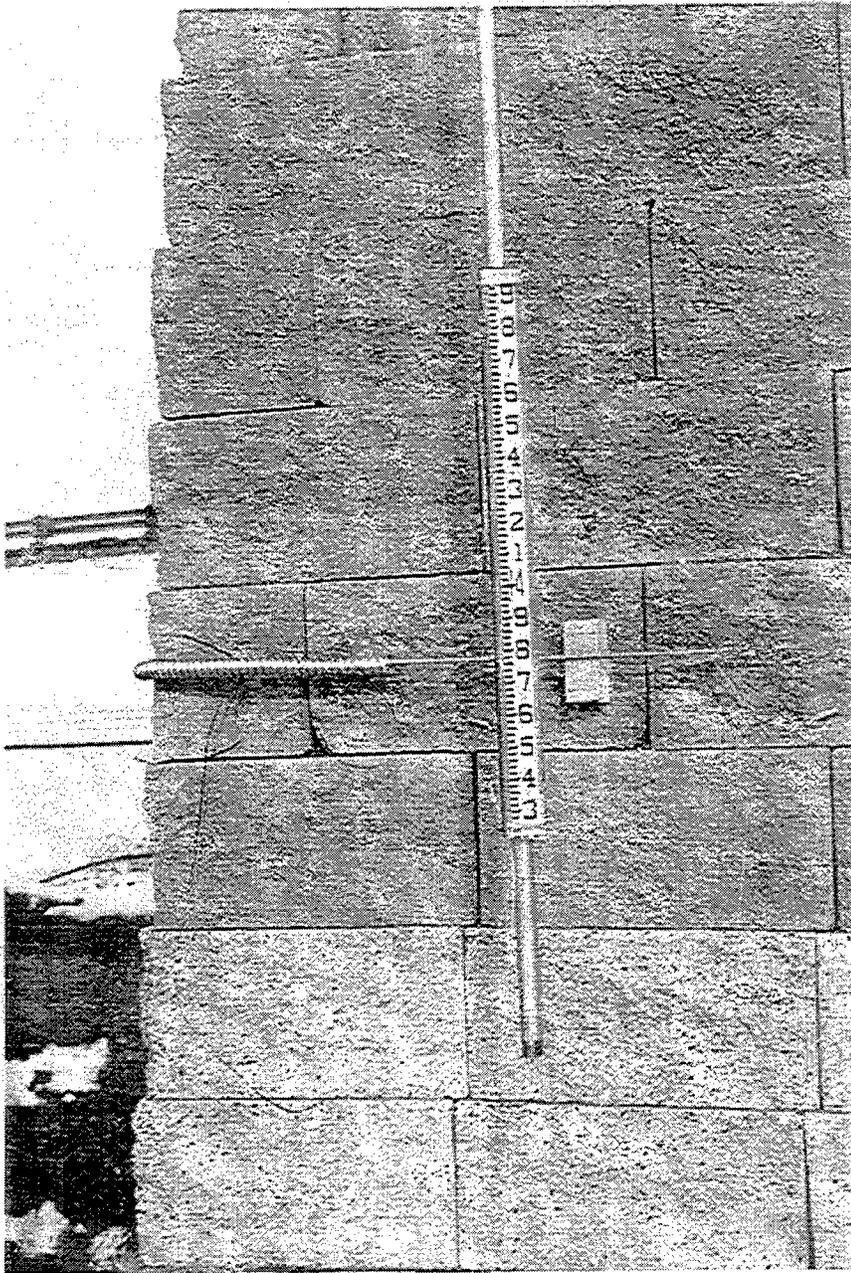
Fig. 5 Instrumentation for Vertical and Lateral Movements

A leveling rod was attached to a metal pipe, as shown in Figure 5, with one end fixed to either the top or the base concrete pads. The vertical movement of the concrete pads was measured by a precision survey transition of the leveling rod. Two fixed posts for survey transit were installed outside the test pit to the north and south of the outer pier and the abutment. The locations of the leveling rods are shown in Figure 6.

The term "lateral movement," unless otherwise specified, was referred to the total expansion along the perimeter of the structure. Elastic springs were wrapped around the circumference of the outer pier and three sides (north, west and south) of the abutment at selected heights. By measuring the elongation of the elastic spring, the lateral movement of the outer pier and the abutment was obtained. The heights at which the elastic springs were installed on the outer pier were 2.1 m, 4.6 m, and 6.6 m from the base. For the abutment, the elastic springs were located at 5.2 m, 6.0 m and 6.4 m from the base. The locations of

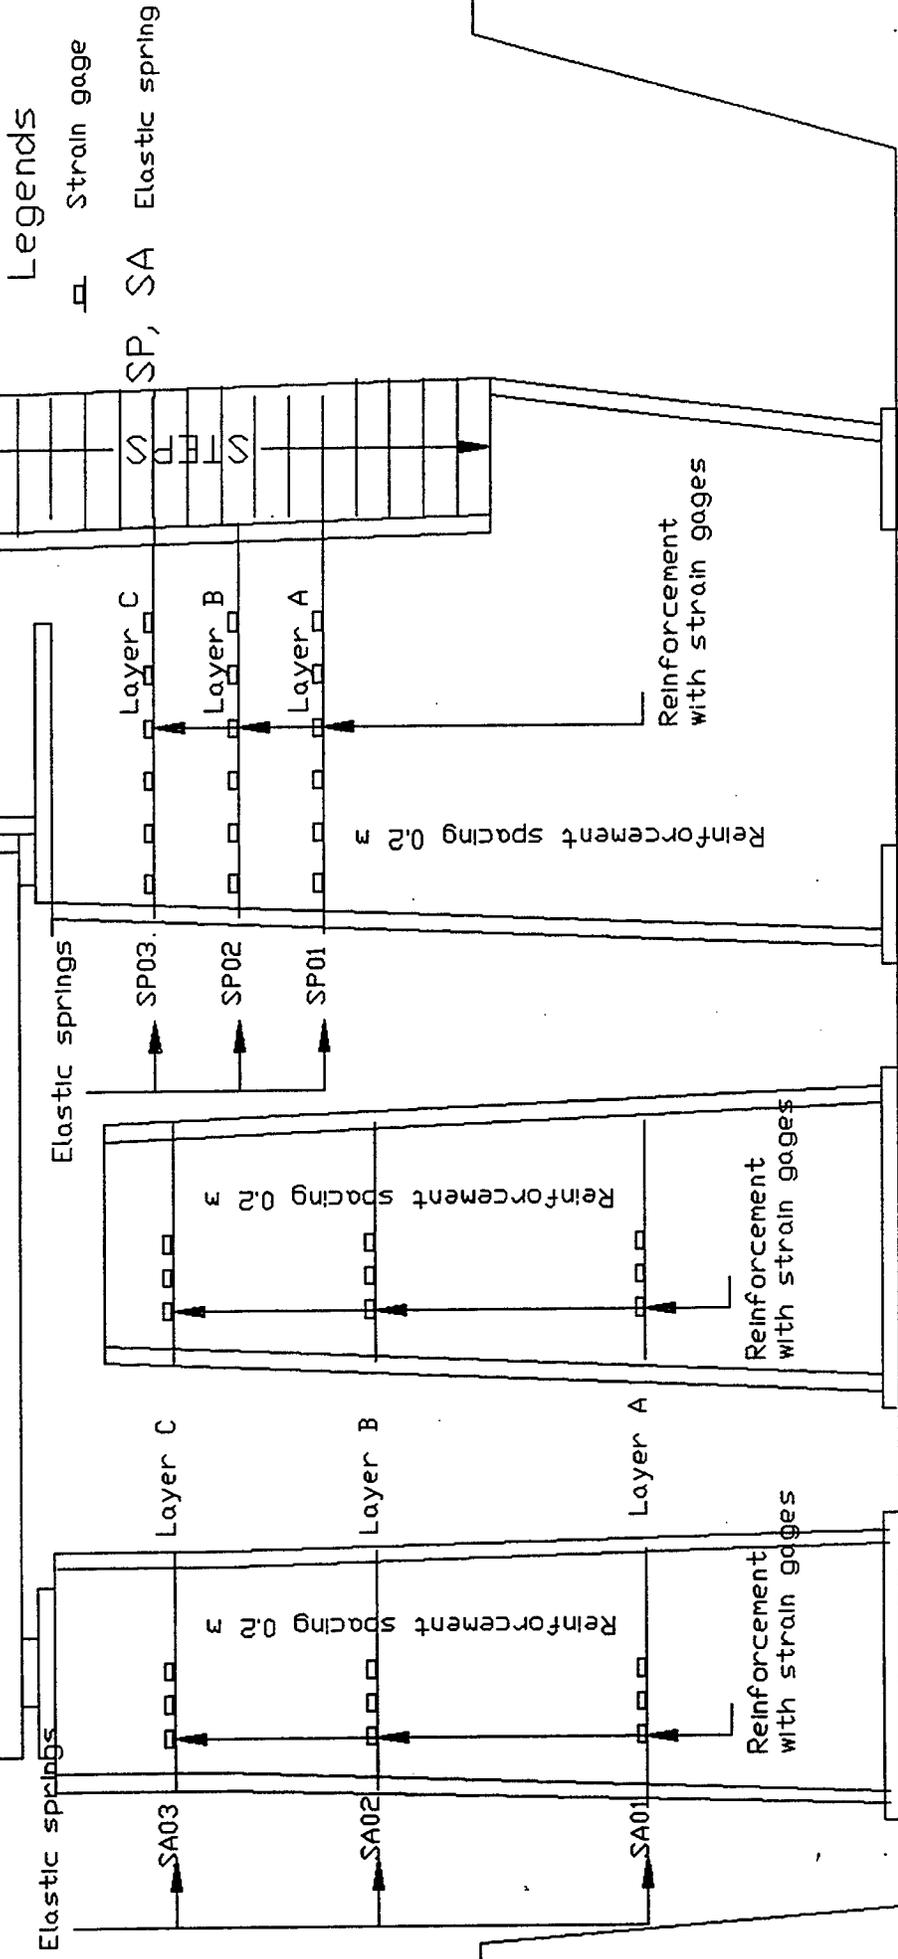
Fig. 7 Locations of the Reinforcements with Strain Gages and the Elastic Springs

the elastic springs (denoted as SP for the outer pier and SA for the abutment) are shown in Figure 7.

High elongation strain gages, manufactured by Measurements Group, Inc. (type EP-08-250BG-120), were used to measure the strain distribution in the geotextile reinforcement. A total of six strain gages were mounted along the fill and the warp directions of each instrumented sheet of reinforcement for the outer and center piers. There were three sheets of instrumented geotextile reinforcement located at 2.0 m, 4.5 m, and 6.5 m from the base in the outer pier and 1.9 m, 4.3 m, and 6.5 m from the base in the center pier. The abutment had three sheets of instrumented geotextile reinforcement with six strain gages along the fill direction on each sheet. They were located at carrying 5.1 m, 5.9 m, and 6.5 m from the base. The locations of the reinforcement sheets with strain gages are shown in Figure 7.

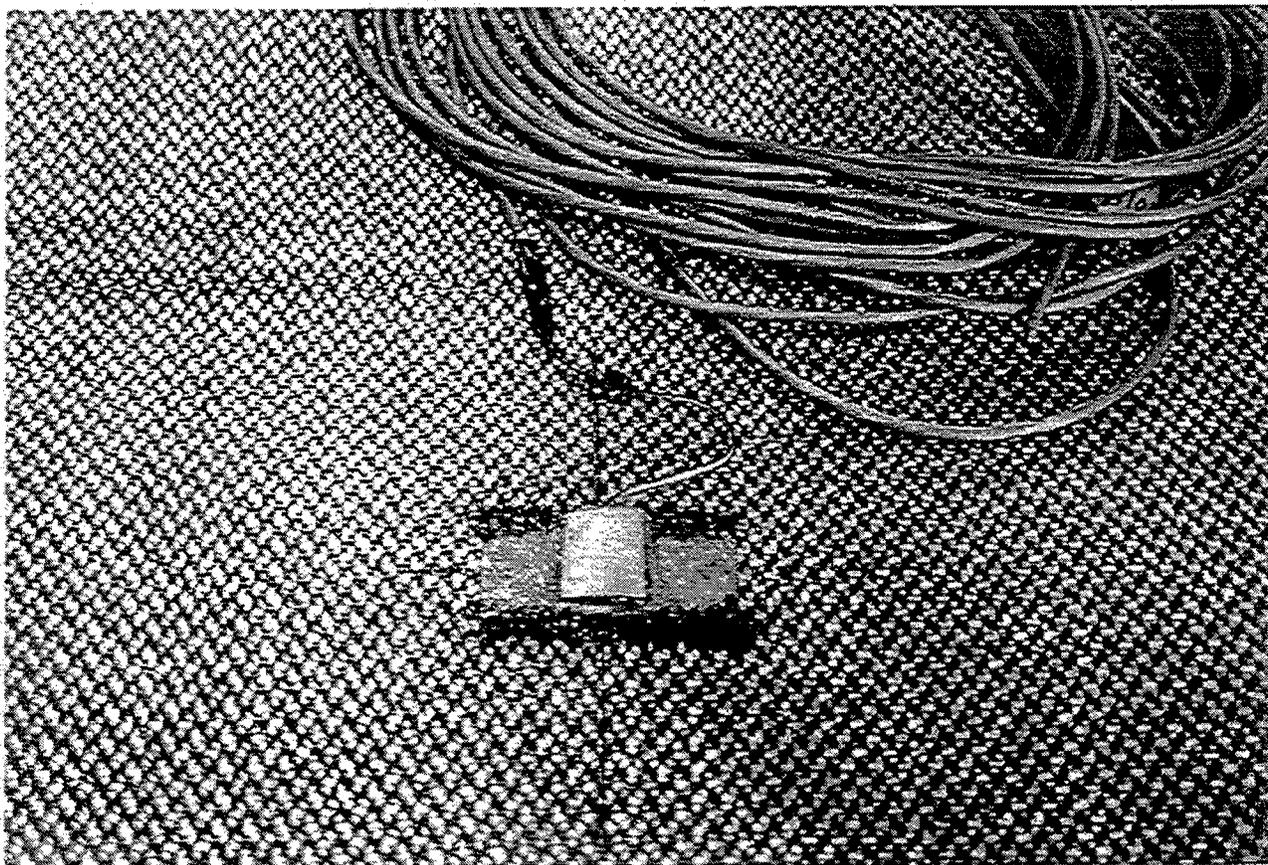
Fig. 8 Strain Gage Attachment

Each strain gage was glued to the geotextile only at the two ends to avoid inconsistent local stiffening of the geotextile due to the adhesive. The strain gage attachment technique was developed at the Reinforced Soil Research Center of the University of Colorado at Denver. The gage was first mounted on a 25 mm by 76 mm patch of a light weight nonwoven geotextile. The light-weight geotextile patch (with a strain gage and wax) was then attached to the woven geotextile reinforcement at selected locations. A microcrystalline wax material was applied over the gage to protect it from soil moisture. Figure 8 shows a strain gage mounted on a light-weight nonwoven geotextile

patch and attached to the woven reinforcement.

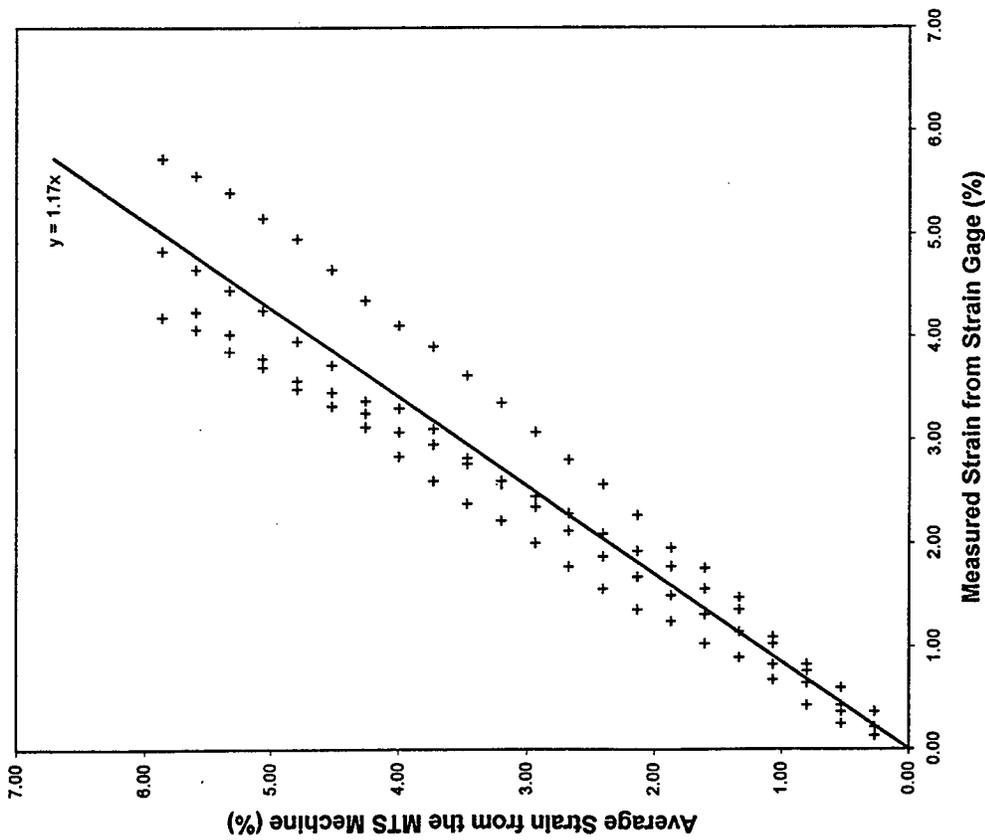
Fig. 9 Strain Gage Calibration in the Fill Direction of the Reinforcement

Due to the presence of the light-weight geotextile patch, calibration is needed. Calibration tests were performed to relate the strain obtained from the attached strain gage to the actual strain of the reinforcement. The calibration curves along the fill and the warp directions of the woven geotextile reinforcement used in the load test are shown in Figure 9 and Figure 10, respectively.

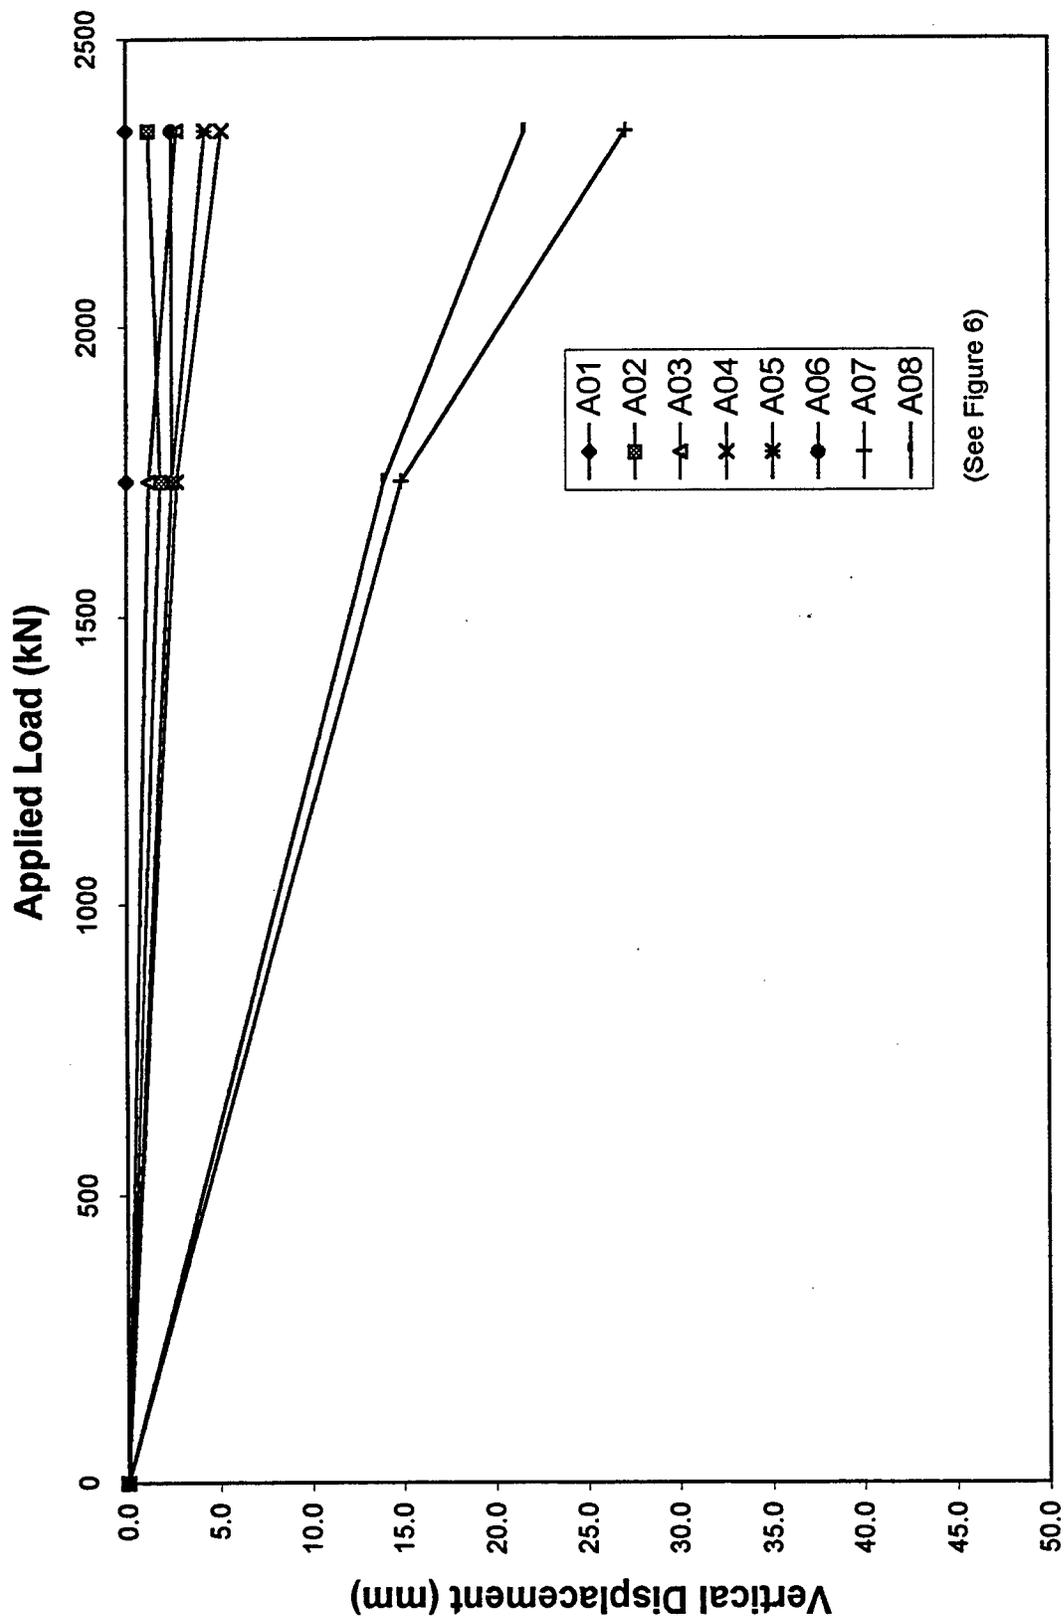
Fig. 11 Vertical Displacement versus Applied Load Relationships of the Abutment

Figure 11 and Figure 12 show the applied load versus displacement relationships of the abutment in the vertical and lateral directions, respectively. The vertical displacements were fairly uniform along the two axial directions. The maximum vertical displacements at 1,170 kN were 27.1 mm at the top and 5.2 mm at the base. The maximum lateral movement at 5.2 m from the base was 14.3 mm.

From the applied load versus displacement relationships of the abutment and the pier (Figures 11, 12, 13, and 14), the bearing capacity of the structures can be determined based on the tolerable vertical and lateral deformation upon loading. For example, the

bearing capacity of the abutment at the tolerable vertical settlement of 12.7 mm (0.5 in.) is limited to 146 kPa (see Figure 11).
