Report No. CDOT-DTD-97-10

# **LOADING TEST OF GRS BRIDGE PIER AND ABUTMENT IN DENVER, COLORADO**

Kanop Ketchart  
Jonathan T.H. Wu  
Reinforced Soil Research Center  
Department of Engineering  
University of Colorado at Denver

Final Report  
October 1997

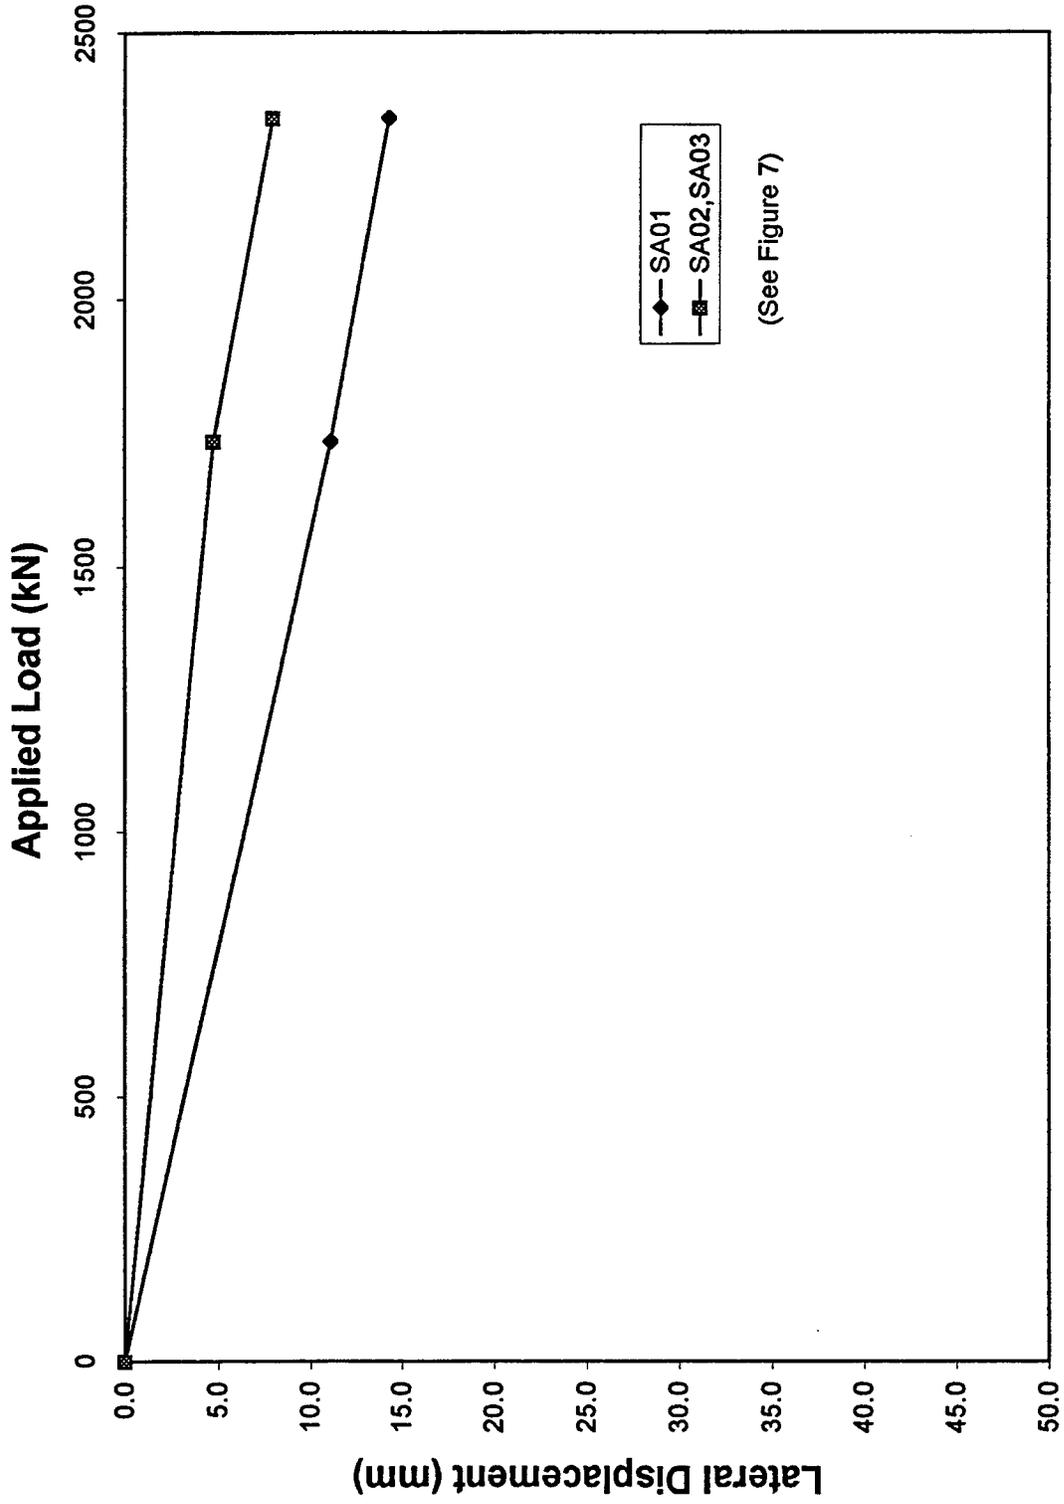
Fig. 12 Lateral Displacement versus Applied Load Relationships of the Abutment

Figure 11 and Figure 12 show the applied load versus displacement relationships of the abutment in the vertical and lateral directions, respectively. The vertical displacements were fairly uniform along the two axial directions. The maximum vertical displacements at 1,170 kN were 27.1 mm at the top and 5.2 mm at the base. The maximum lateral movement at 5.2 m from the base was 14.3 mm.

From the applied load versus displacement relationships of the abutment and the pier (Figures 11, 12, 13, and 14), the bearing capacity of the structures can be determined based on the tolerable vertical and lateral deformation upon loading. For example, the

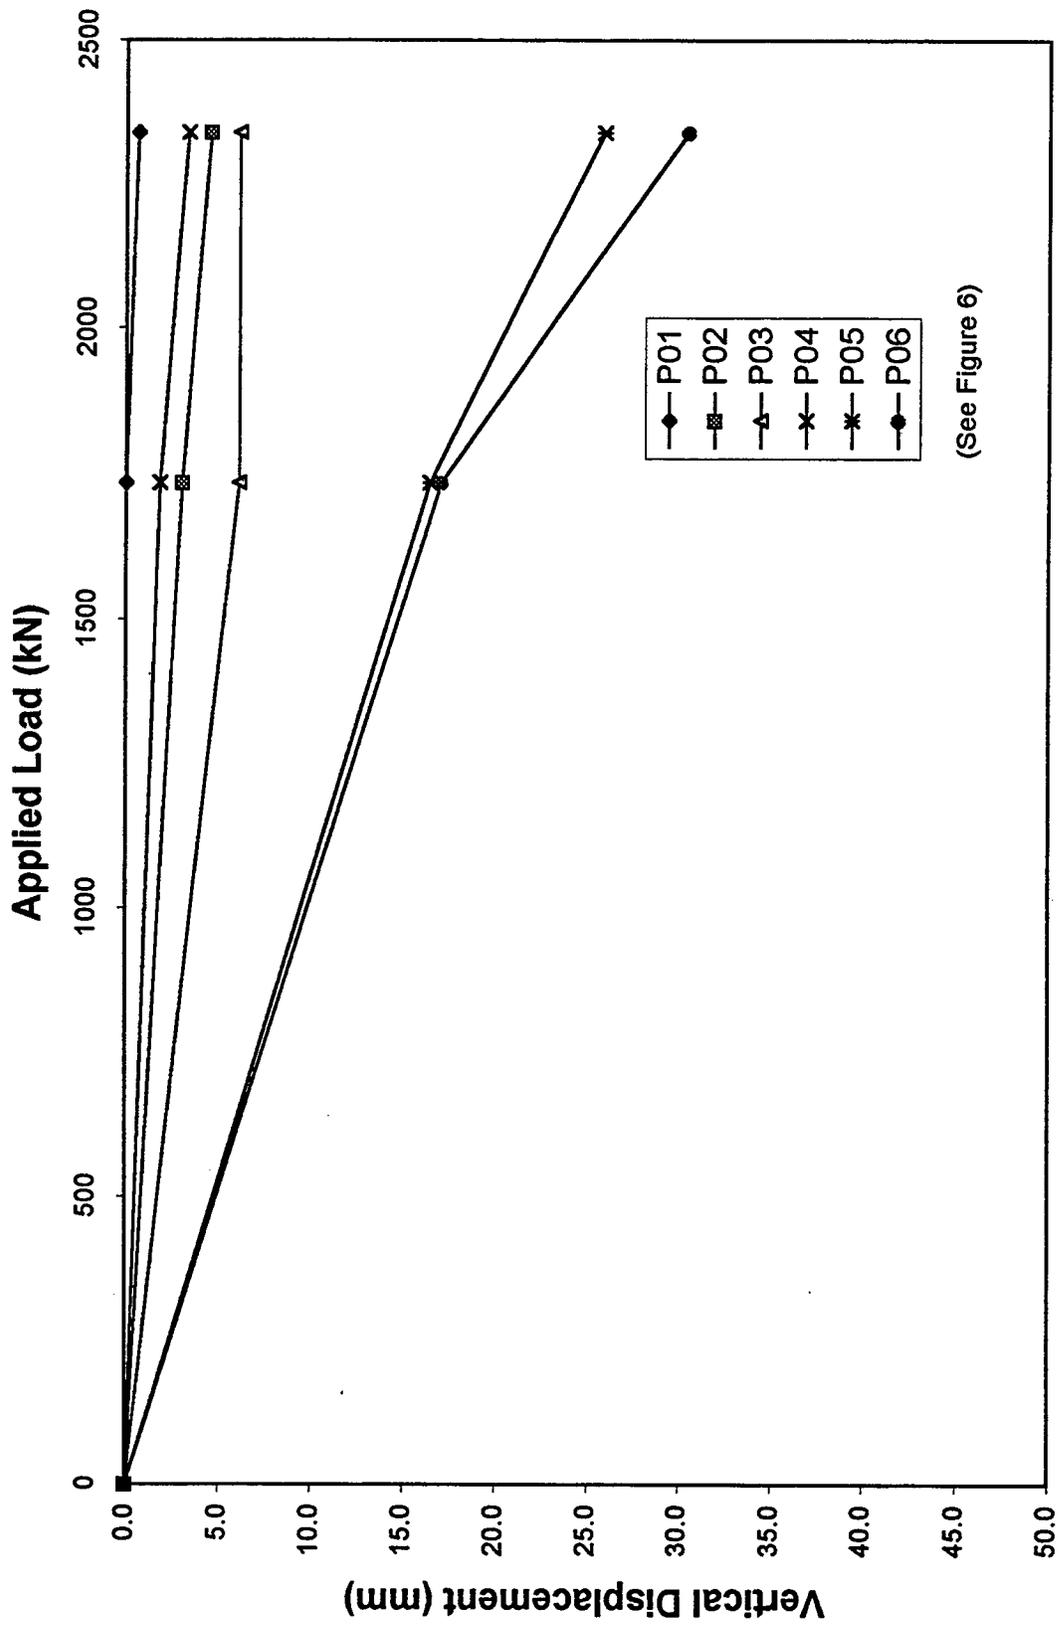
Fig. 13 Vertical Displacement versus Applied Load Relationships of the Outer Pier

Figure 13 and Figure 14 show the applied load versus displacement relationships of the outer pier in the vertical and lateral directions, respectively. Similar to the abutment, the vertical displacements were fairly uniform along the two axial directions. The maximum vertical displacements at 1,170 kN (232 kPa pressure) were 36.6 mm at the top and 6.1 mm at the base. The maximum lateral movement at 4.6 m from the base was

12.7 mm.

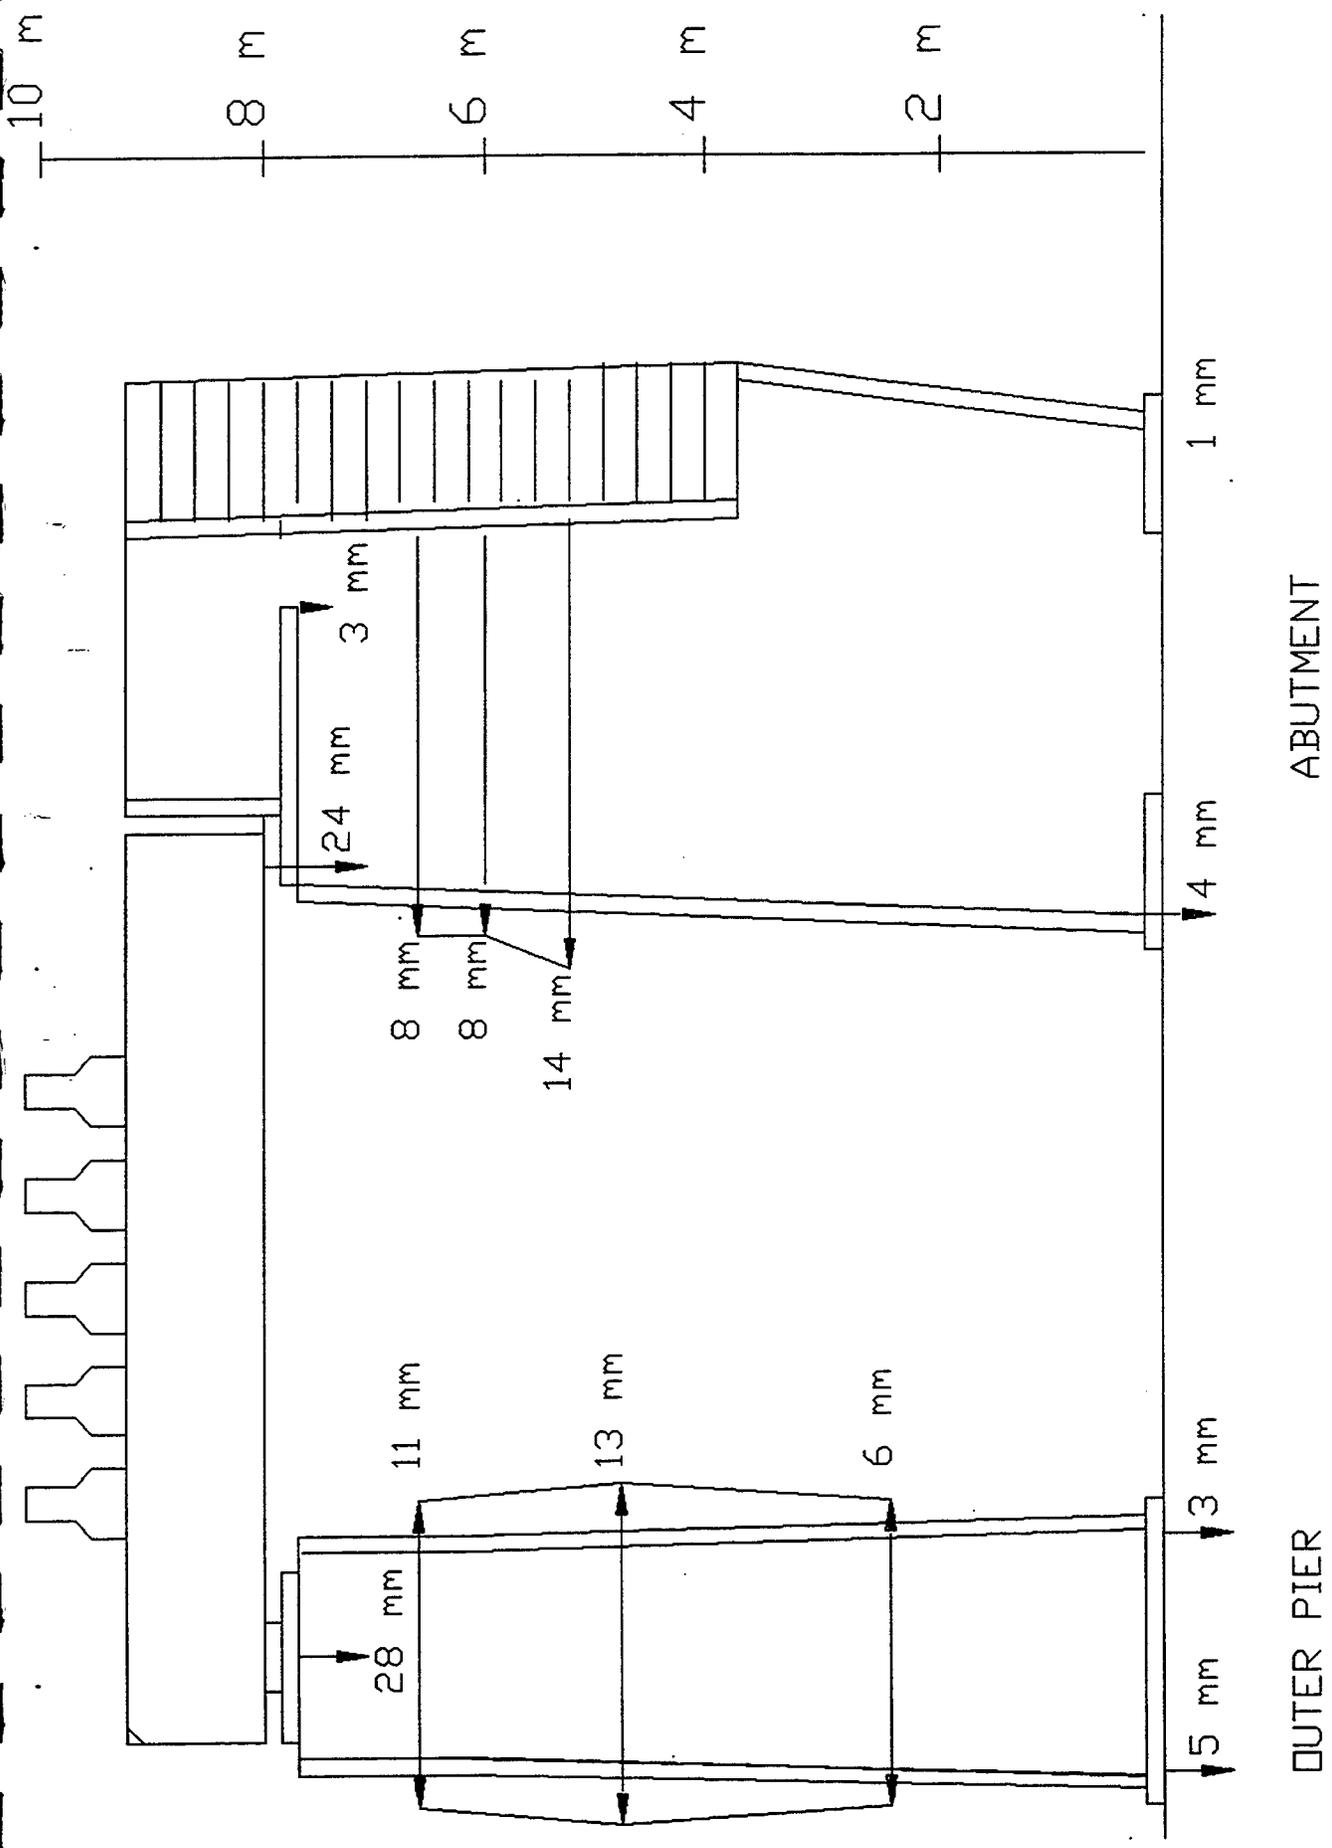
Fig. 15 Vertical and Lateral Movements of the Outer Pier and the Abutment at 1,170 kN

Figure 15 shows the vertical and lateral movements of the outer pier and the abutment at the applied load of 1,170 kN. Table 2 summarizes the maximum vertical and lateral movements of the outer pier and the abutment. It is shown that the vertical movement of the foundations for the outer pier and the abutment was about the same (6.1 mm for the pier, 5.2 mm for the abutment). The different magnitudes of the vertical movement on top of the pier and the abutment were, therefore, a result of the different amounts of vertical compression of the structures upon loading. The maximum vertical movement of the pier was 0.48% of its height. Such a value was higher than that of the Turner-Fairbank's load test which was 0.30% (without prestraining) at the same applied pressure. This may be attributed to the much lower compaction effort on the outer pier. The maximum lateral movements of the pier and the abutment were comparable (12.7 mm in the pier, 14.3 mm in the abutment).

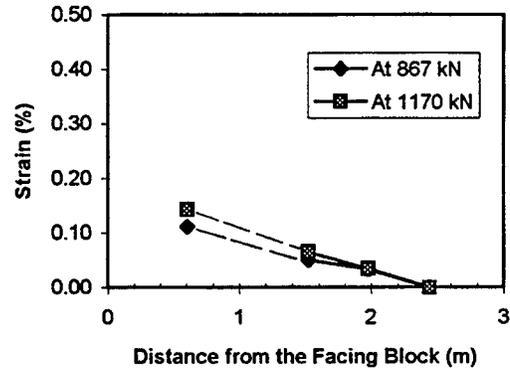
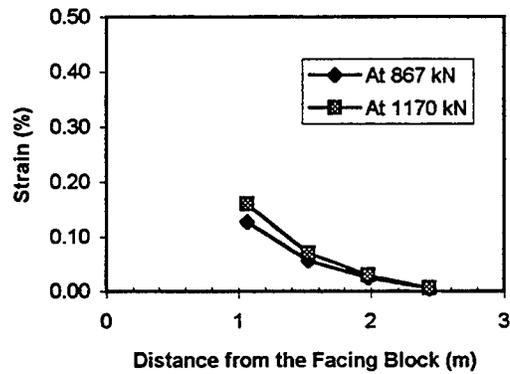
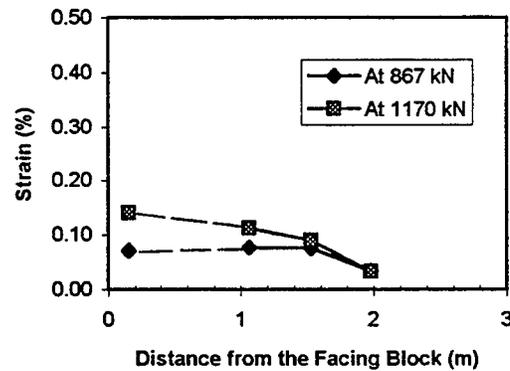
**Fig. 16 Reinforcement Strain Distributions in the Abutment**

Figure 16 shows the strain distributions in the fill direction along the length of the three instrumented sheets of reinforcement in the abutment. The largest strains were on the order of 0.15% to 0.18% at the applied load of 1,170 kN. The largest strains occurred adjacent to the facing (the center of bearing plates was only 0.3 m from the back face of the facing blocks) and decreased toward the other end. The strains were nearly zero at 2.5 m from the facing.

Compared the largest strains in the abutment and the outer pier (on the order of 0.2% to 0.4%) to the rupture strain (18%), the safety margin appeared to be very high against rupture failure of the reinforcement. However, the load carrying capacities of both structures may not be governed by the rupture failure of the reinforcement. Slippage between the backfill and the reinforcement or the shear failure of the backfill may occur first.

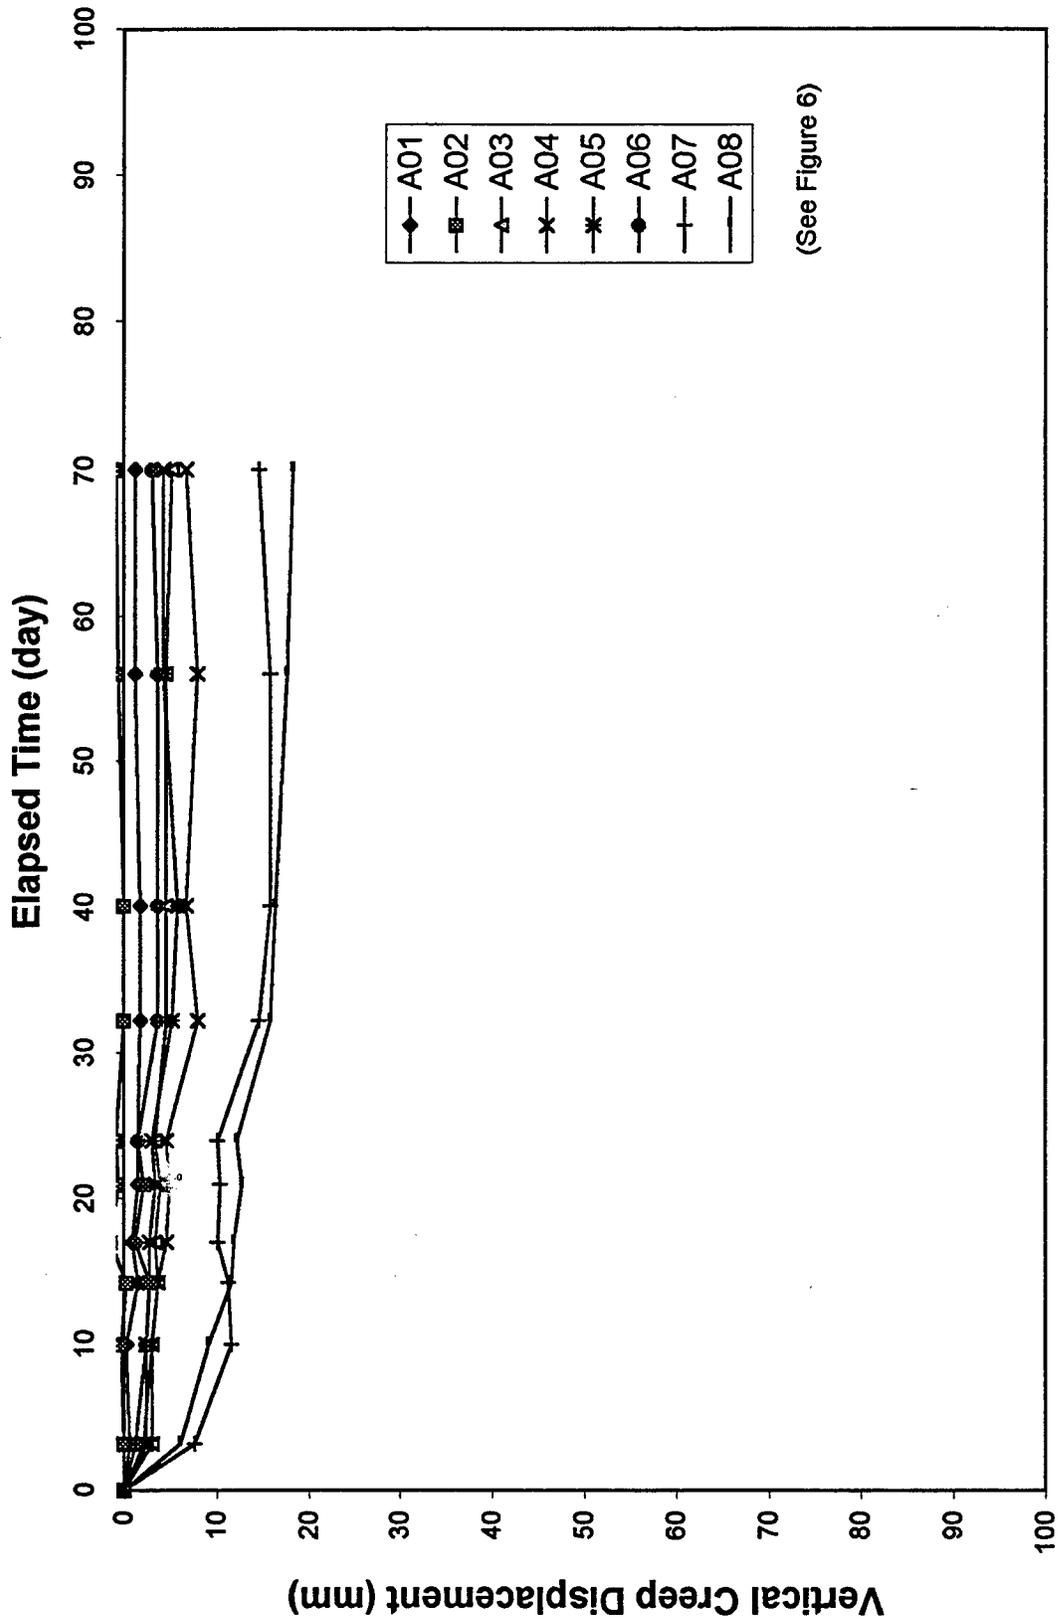
Fig. 17 Vertical Creep Displacement versus Time Relationships of the Abutment

Figure 17 and Figure 18 show, respectively, the vertical and lateral displacements versus time relationships of the abutment under the sustained load of 1,170 kN. The maximum vertical displacements at the top and the base after 70 days were 18.3 mm and 6.7 mm, respectively. The maximum lateral displacement was 14.3 mm after 70 days. Most of the maximum vertical and lateral displacements (12 mm and 13 mm, respectively) occurred in the first 15 days.

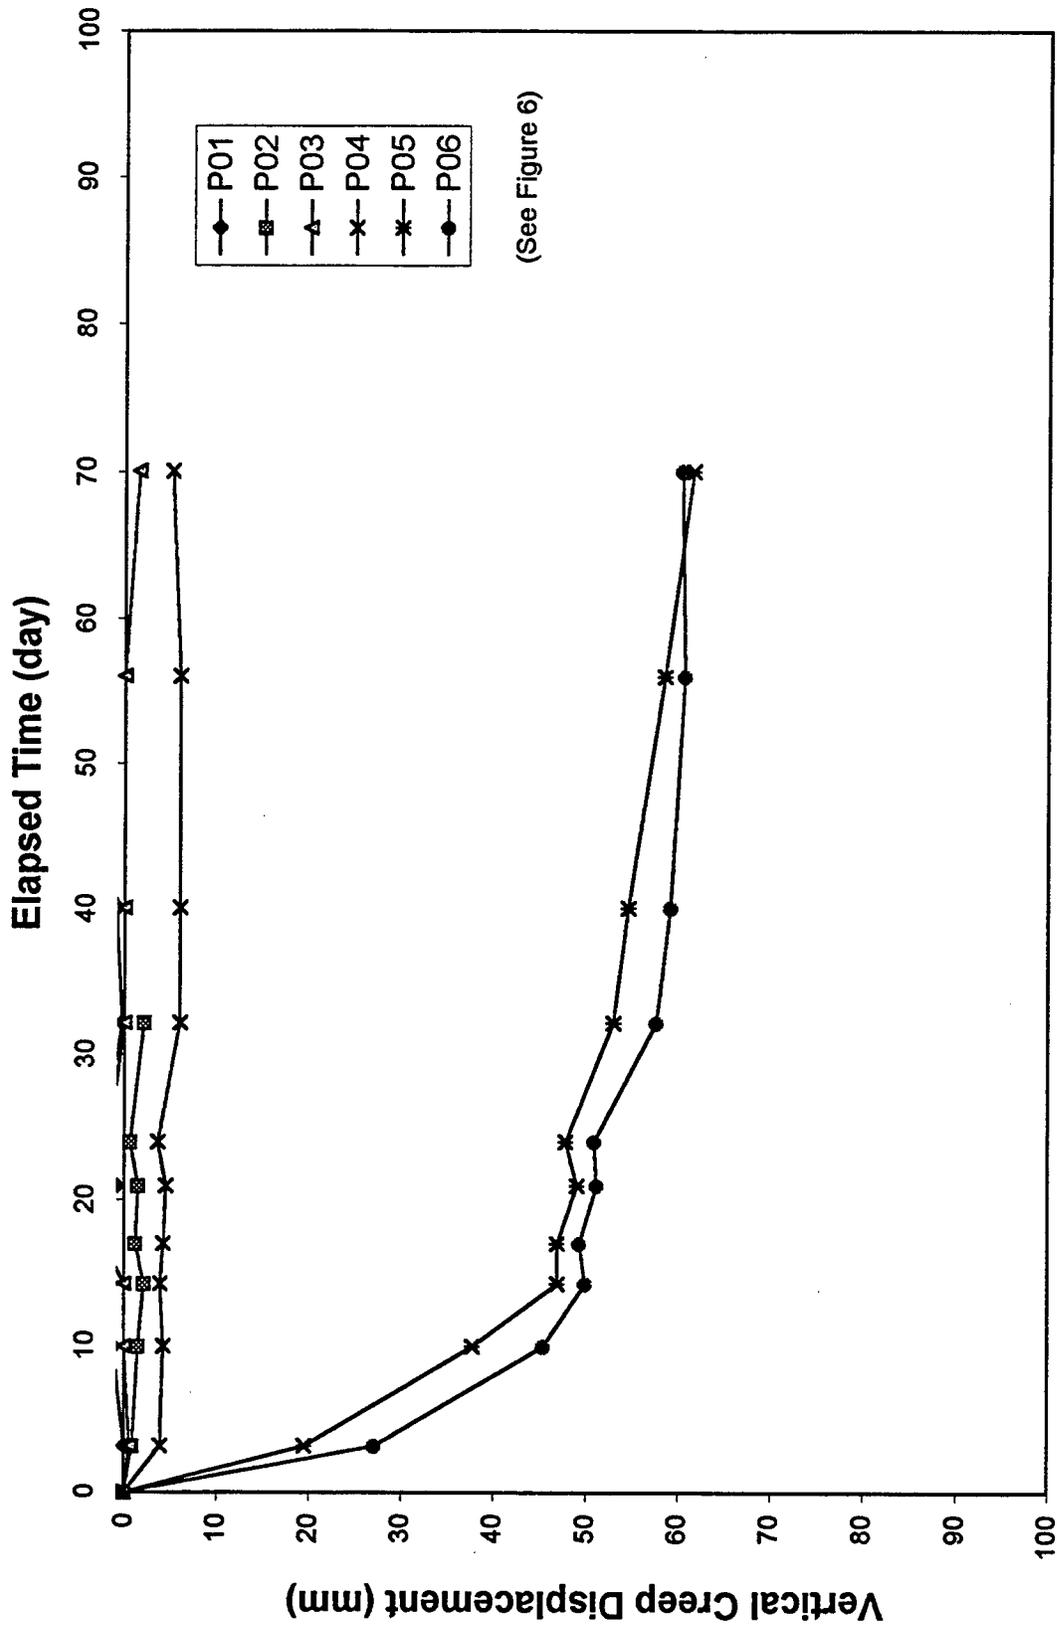
Fig. 19 Vertical Creep Displacement versus Time Relationships of the Outer Pier

Figure 19 and Figure 20 show, respectively, the vertical and lateral displacements versus time relationships of the outer pier under the sustained load of 1,170 kN. The maximum vertical displacements at the top and the base after 70 days were 61.6 mm and 5.2 mm, respectively. The maximum lateral displacement was 59.5 mm after 70 days. Similar to the abutment, a large portion of the maximum vertical and lateral displacements (48 mm and 46 mm, respectively) also occurred in the first 15 days. The maximum vertical and lateral displacements of the outer pier were about four times as large as those of the abutment. This is most likely due to poor compaction by a light weight vibrating plate used during construction.

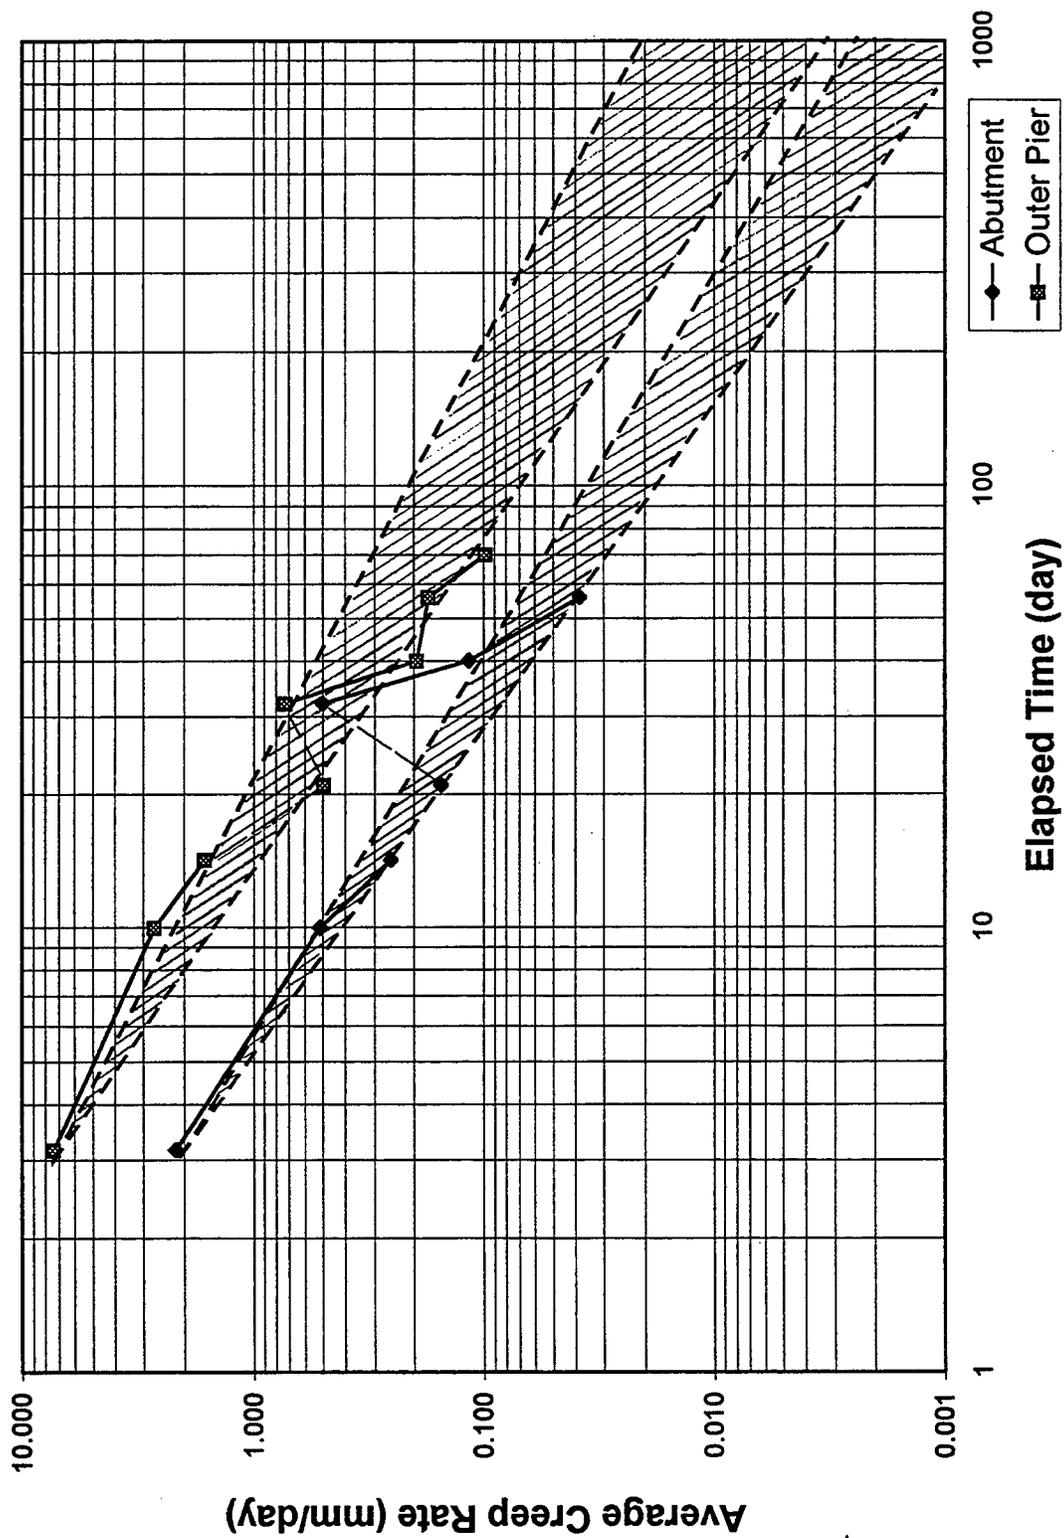
Fig. 21 Average Vertical Creep Rate at Top of the Outer Pier and the Abutment

Figure 21 shows the average vertical creep rate of the top loading pad versus time relationships of the outer pier and the abutment plotted on a log-log scale. It is shown that, for the most part, the vertical creep rate of both structures reduced nearly linearly (on a log-log scale) with time. The vertical creep rates in the abutment reduced from 2.2 mm/day after 3 days to 0.03 mm/day after 70 days in the abutment. During the same period of time, the creep rate reduced from 7.5 mm/day to 0.1 mm/day in the outer pier. At around 25 days, both creep rates of the pier and the abutment significantly increased as shown in Figure 21. This behavior is attributed to softening of the frozen backfill due to a temperature increase following an extended period of freezing temperatures. Extrapolations of the average vertical creep rates were drawn as the shaded areas in Figure 21. The extrapolation may be used to obtain approximate creep rates beyond the measurement period. For instance, after a year, the vertical creep rates of the abutment and the outer pier were in the ranges of 0.003 mm/day to 0.008 mm/day and 0.012 mm/day to

0.06 mm/day, respectively.

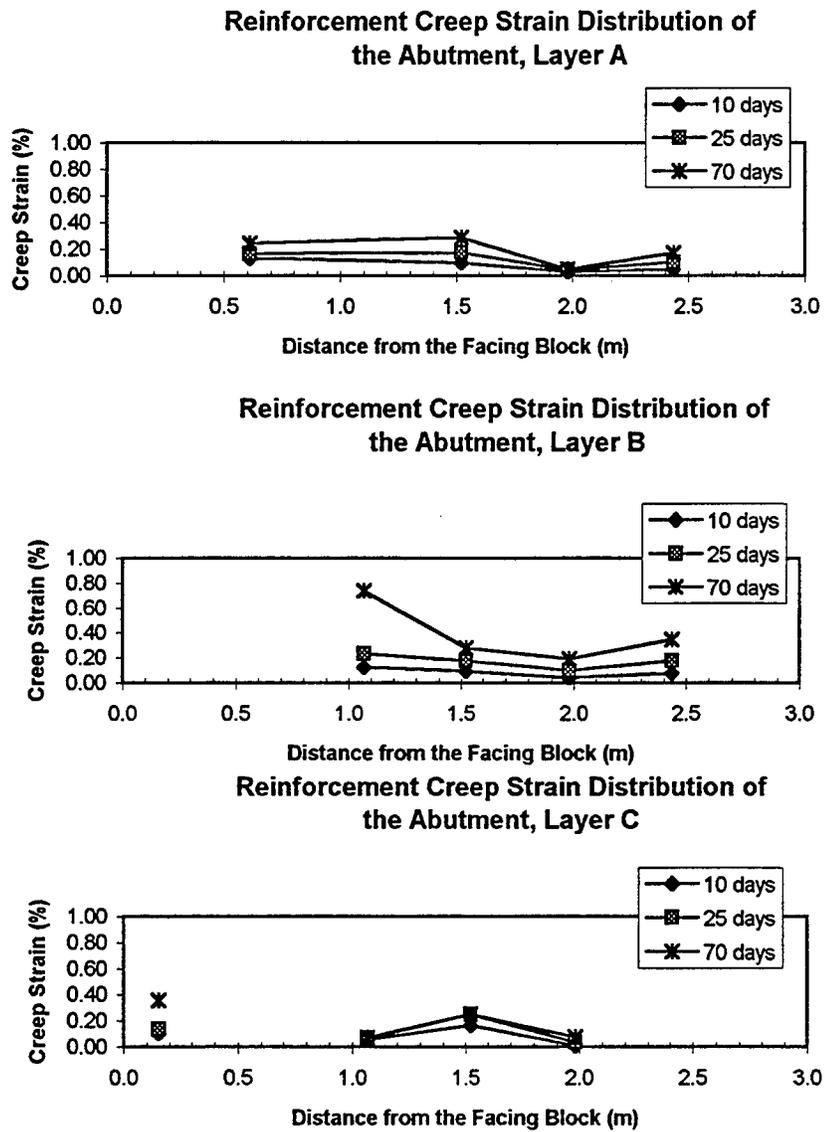
**Fig. 22** Reinforcement Creep Strain Distributions in the Abutment

Figure 22 shows the reinforcement creep strain distributions in layers A, B, and C (see Figure 7) of the abutment after 10, 25, and 70 days. The creep strain distributions were somewhat more uniform than the short-term reinforcement strain distribution. After 70 days, the maximum creep strains in layers A, B, and C were 0.30%, 0.75% and 0.38%, respectively. Note that such maximum creep strains were also far from the rupture strain (18%) of the reinforcement.

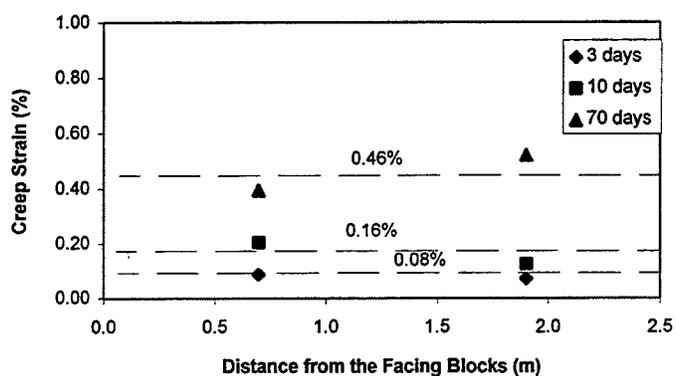
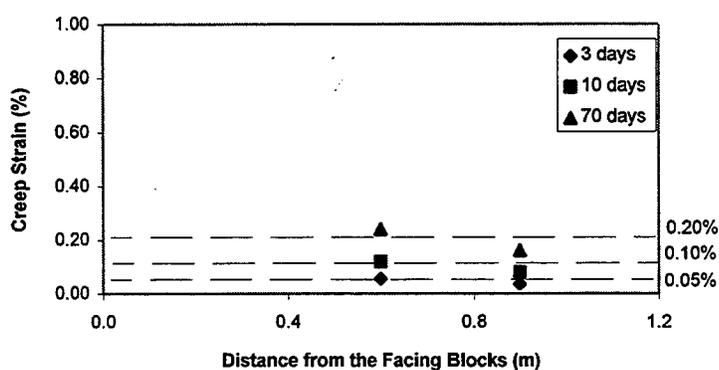
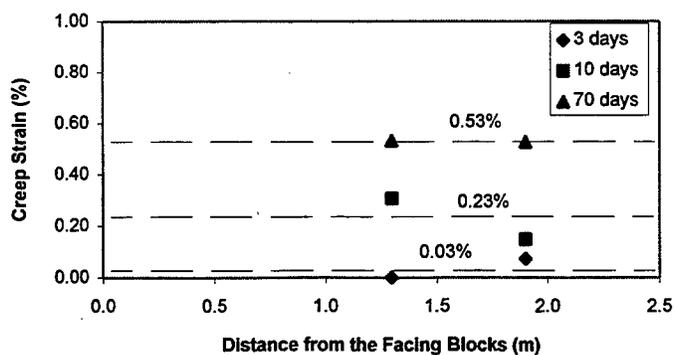
Fig. 23 Reinforcement Creep Strain Distributions in the Outer Pier

Figure 23 shows the reinforcement creep strain distributions in layer A (both the warp and fill directions) and layer C (the warp direction) of the outer pier after 10, 25, and 70 days. A uniform strain distribution was assumed in the reinforcement of the outer pier. The average strain of each layer was shown in Figure 23. After 70 days the average creep strains of layer A were 0.20% and 0.46% in the fill and warp directions, respectively, and 0.53% in the warp direction of the layer C. The higher creep strains in the warp direction was mainly due to the fact that the geotextile is nearly twice as likely to creep in its warp direction (Ketchart and Wu, 1996).

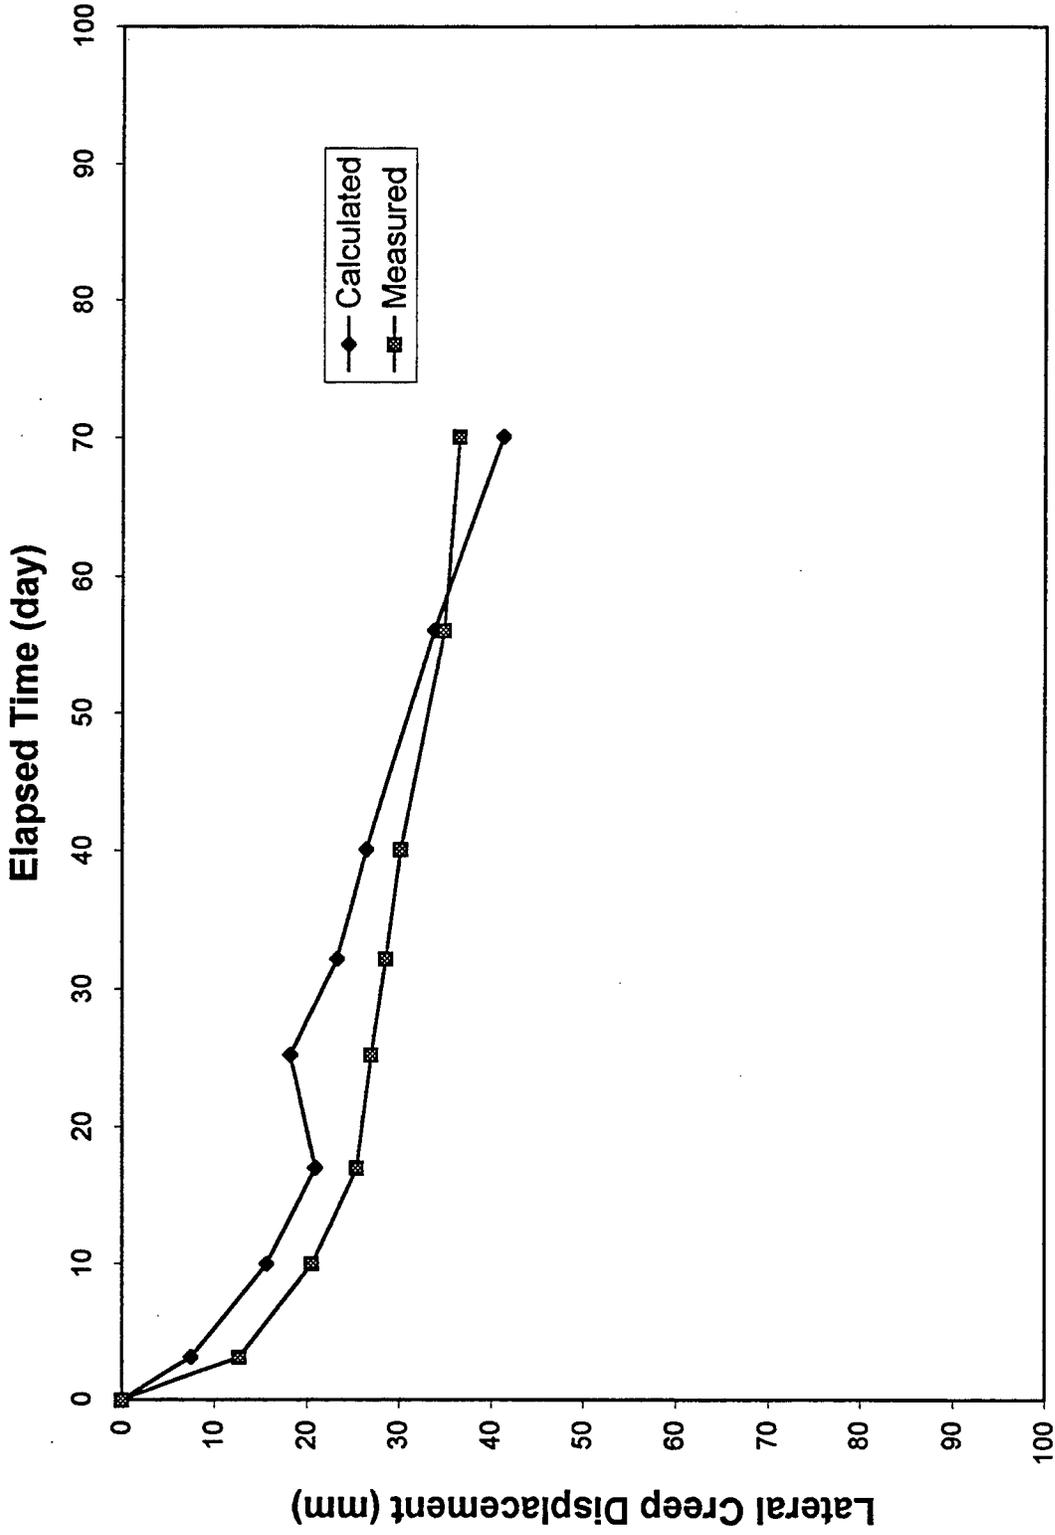
Fig. 24 Calculated versus Measured Lateral Creep Displacements of the Outer Pier

From the average strains in layer A of the outer pier, the lateral creep displacements were calculated and compared to the measured lateral creep displacements. The comparison is shown in Figure 24. It is seen that the calculated lateral creep displacements

(from the strain distributions) were in very good agreement with the measured displacements.
